Surface Analysis of OFE-Copper X-Band Accelerating Structures and Possible Correlation to RF Breakdown Events

S.E. Harvey*, F. Le Pimpec, R.E. Kirby, F. Marcelja, K. Adamson, E.L. Garwin
SLAC, 2575 Sand Hill Rd, Menlo Park, CA, 94025

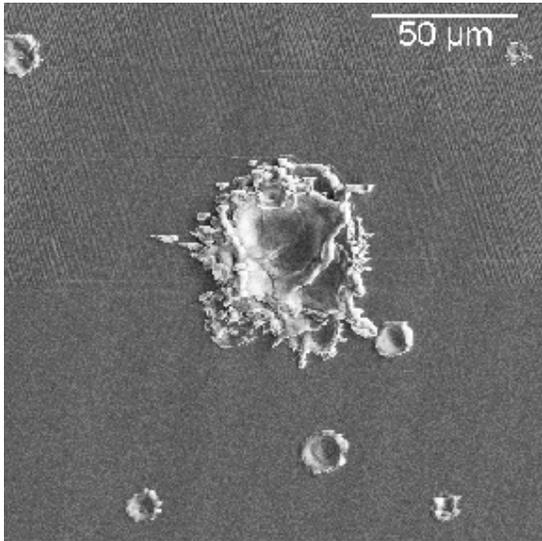
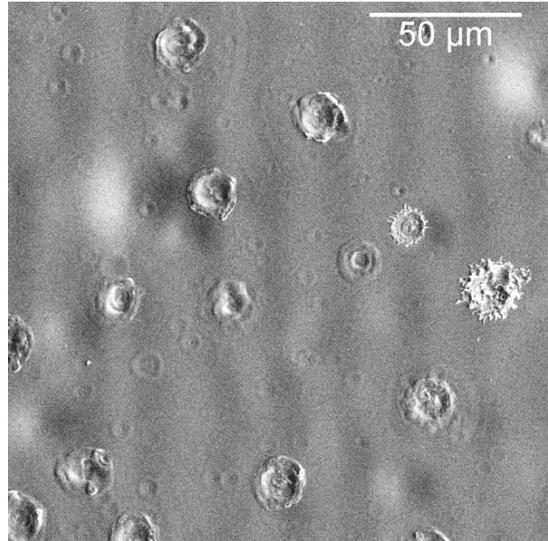
Figure 1: (a) sharp-edged craters (left); (b) smoothed-edged craters (right)

The defect dissipates some of the RF energy. Melting at the breakdown site creates craters that, due to their irregular geometry, can act as further sites for enhanced field emission and breakdown. The observed physical morphology of the craters falls into two distinct groups: irregular edges and softened edges. Fig.1(a) shows a crater with irreg-

ular edges; in Fig.1(b) a second type of crater is observed where there are few sharp edges and repeated melting appears to have taken place. The softened-edge craters often appear in close proximity with one another; irregularly edged craters are frequently spaced further apart. This suggests that the softened-edged craters may have started out irregularly edged, but have changed morphology due to repeated melting or plasma-ion bombardment.

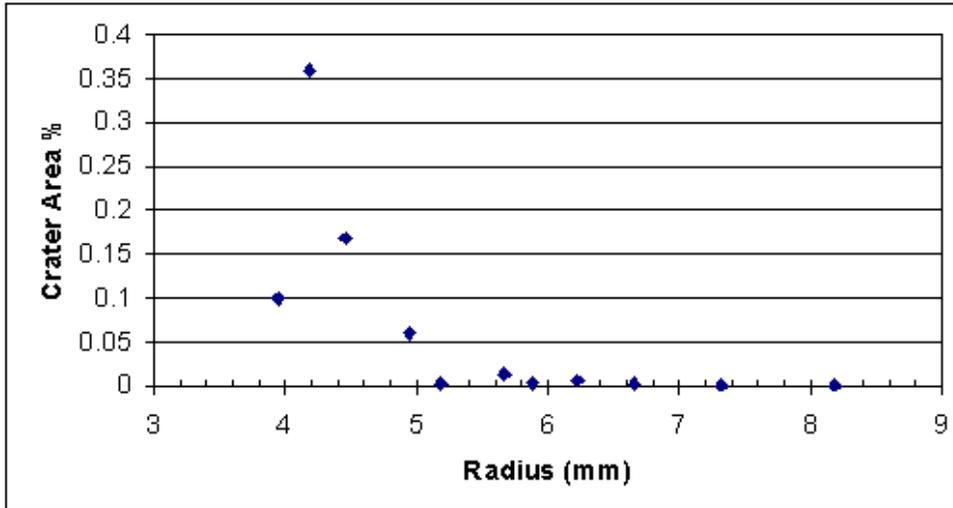
Figure 2: Average percentage area damaged by craters versus radial distance from center of aperture (30th Cell T53VG3RA)

In general the density of craters increases along the cell radius toward the center, where electric fields (\mathbf{E}) are highest, Fig.2. It is important to note that not every grain near the aperture exhibited craters and that the crater density varied substantially from grain to grain.

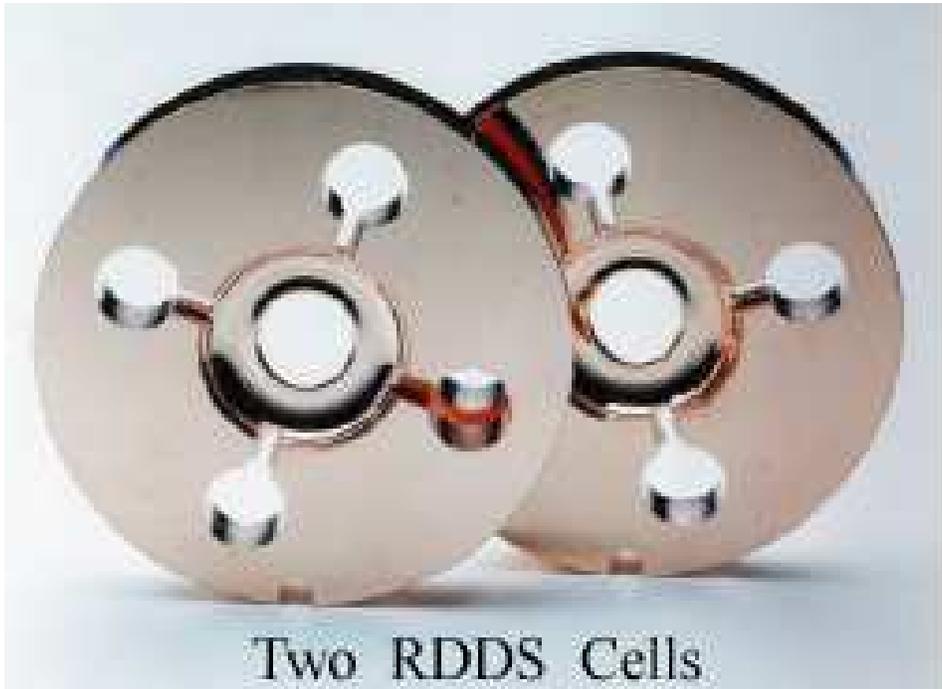
Figure 3: Damped Round and Detuned Structure Cells

The accelerator structure is manufactured from 99.99% pure OFE copper that has been evaluated as Class 1 material per ASTM-B66. To form a cell, Fig.3, the copper is machined either with a poly- or a mono-crystal diamond tool. Chemical cleaning and etching is performed after the final machining step to remove machining-related damaged material from the surface. An iris and a half cup side forms a half cell, Fig.3. After cleaning, the two half cells are diffusion bonded together in a dry hydrogen furnace to form a full accelerator cell. Several braze cycles are required for RF couplers and water lines and a wet/dry hydrogen cleanup furnace cycle follows the brazing steps. The structure is then vacuum fired at 650°C for two weeks to outgas dissolved dissolved gases, primarily hydrogen, which can be available for breakdown plasma formation. Vacuum-firing also reduces contaminant concentration on the structure surface. Desorption of surface/bulk gas contributes to the RF breakdown mechanism [5].

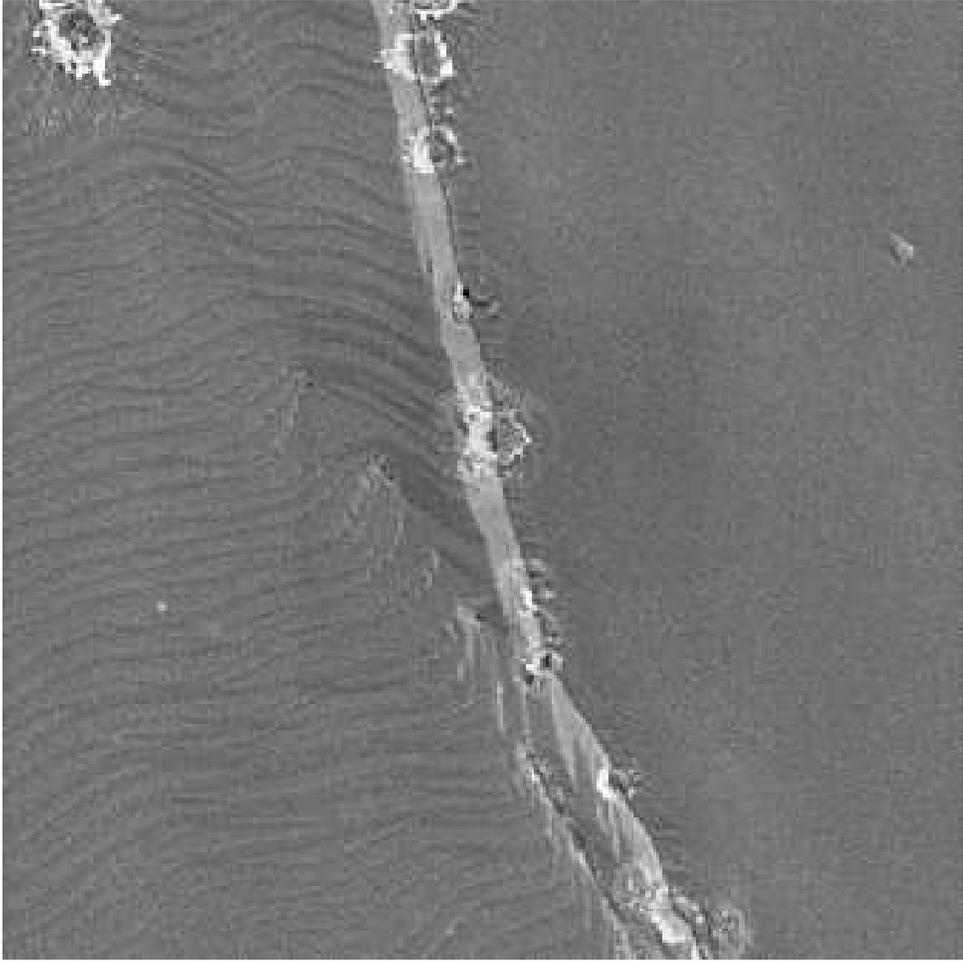
Figure 4: Breakdown on Grain Boundary

Craters were also seen at grain boundaries and at inclusions, Fig.4. Grain boundaries and inclusions are logical field emitters considering a Fowler-Nordheim model, equation.1. Both of these defect types have irregular geometries that increase the value of β (field-enhancement factor); simultaneously these defects indicate an area of high stress within the material, which could decrease the work function Φ , increasing the field emission:

Of particular interest is the role of copper surface plasticity in RF breakdown. Local heating, as well as the presence of high magnetic and electric fields, are known to create mass movement in copper [9]. Inclusions emerging at grain boundaries and microprotrusions (slip lines), created by local stresses due to mass movement, can act as field emitters. So, there can be a sufficiently high field or local heating that could induce mass movement in copper, thus resulting in RF breakdown. Fig.4 does present mass move-

ment inside a grain, and a crater with no traces of contaminant. However, we have not correlated systematic mass movement in a grain with breakdown events.

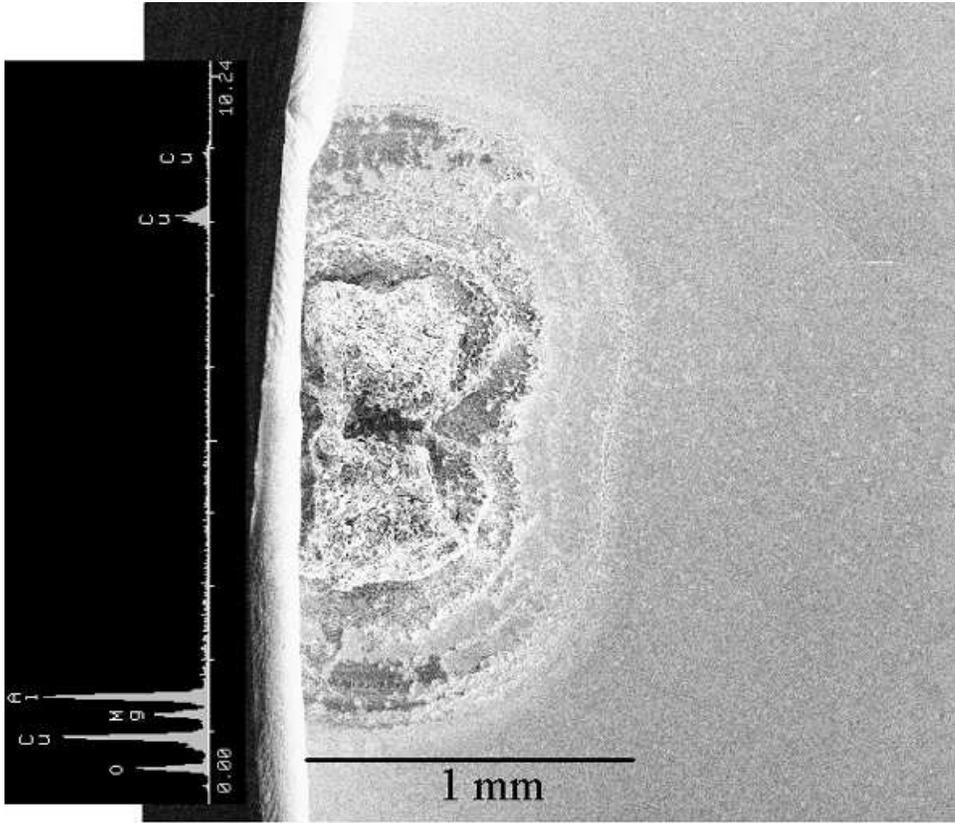
Figure 5: Aluminum particle (melted due to RF breakdown?) found on cell 13 of H90VG5

Two processed structures, H90VG5 and H90VG3N, did exhibit high RF breakdown in a localized region within the structure. At the bottom of the cell 13, between iris 12 and iris 13, of H90VG5, an aluminum sliver (mm length) was found, Fig.5. In cell 35-36 of H90VG3N a large (> 100 microns) stainless steel (S/S) particle, Fig.6 was found embedded in the sidewall of the cell. A high density of craters was found near the S/S particle, Fig.7. The aluminium sliver was likely introduced to the structure during assembly in the NLTCA. The process by which the S/S particle was introduced inside the structure is not so clear because the particle is now actually embedded into the copper.

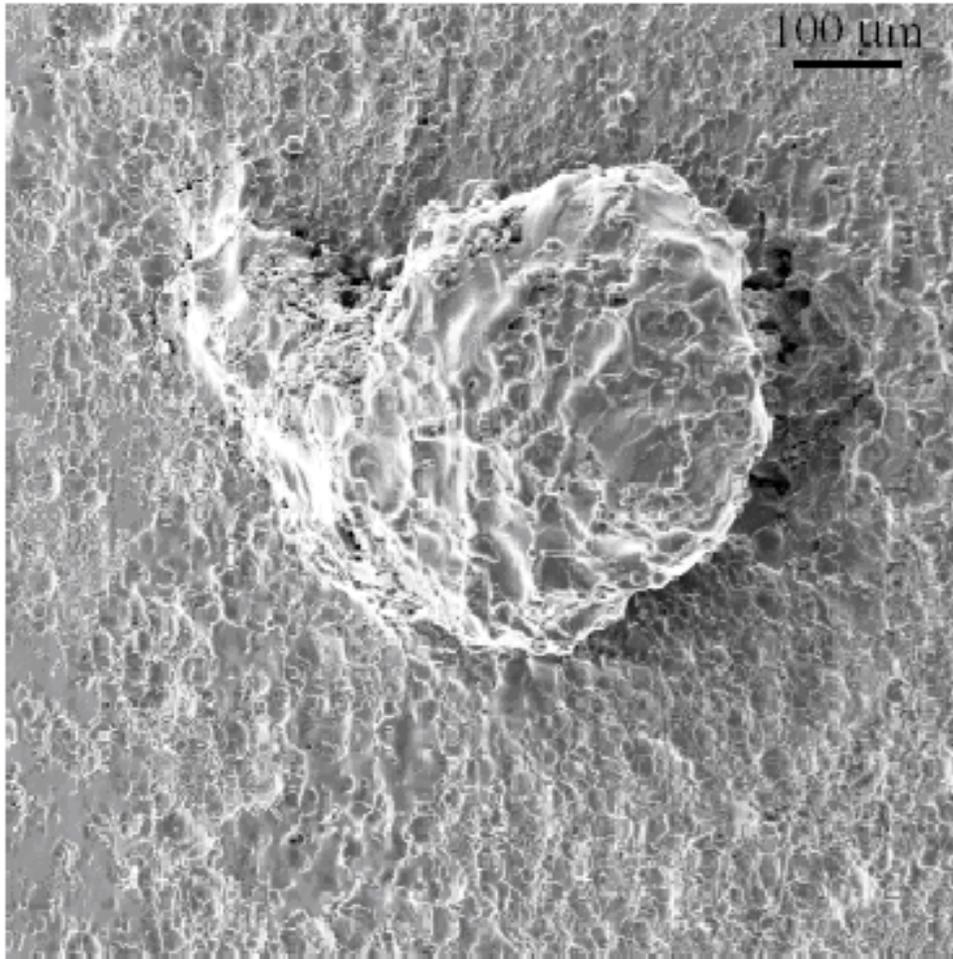
Figure 6: Stainless steel particle embedded in wall of H90VG3N

Using RF design simulation software the intensity of the magnetic or electric field inside a structure or a cell can be determined. At the location of the cup side the magnetic field (\mathbf{H}) of the RF wave is maximal 0.3 MA/m , on the iris it can be up to 5 times less. The surface electric field on the iris is 150 MV/m and is 7 MV/m at the location of the S/S particle. The pattern of the melting at the base of this particle is consistent with a high current induced by \mathbf{H} [13].

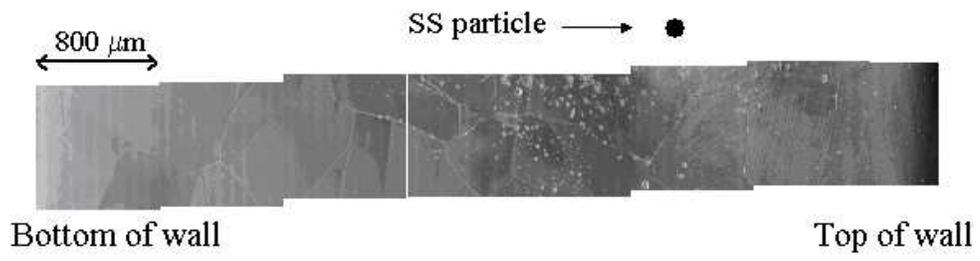
Figure 7: High density of RF breakdown events near stainless steel mushroom
