THE ENVIRONMENT EFFECT ON OPERATION OF IN-VESSEL MIRRORS FOR PLASMA DIAGNOSTICS IN FUSION DEVICES

V.S.Voitsenya^{*}, Ch.Gil¹, V.G.Konovalov, A.Litnovsky², M.Lipa¹, M.Rubel³, A.Sagara⁴, A.Sakasai⁵, B.Schunke¹, T.Sugie⁵, G. De Temmerman⁶, K.Yu.Vukolov⁷, S.N.Zvonkov⁷, P.Wienhold²

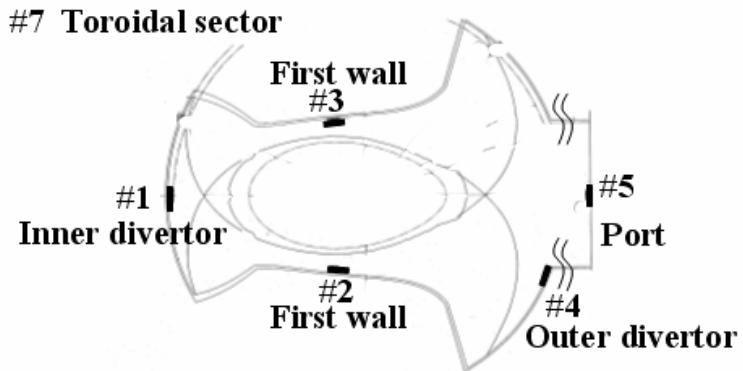
Fig. 1. The scheme of locations of SS mirror samples inside the LHD vessel.

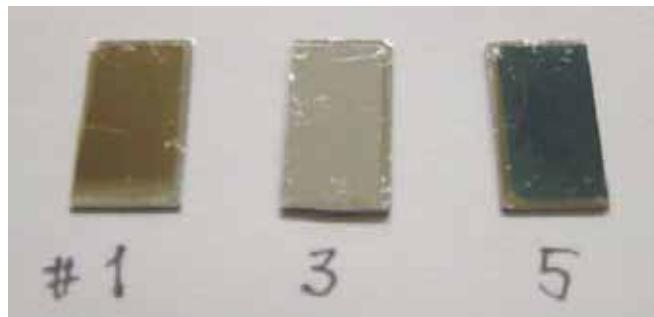
Fig. 2. The photos of samples after they were taken out of the LHD vacuum chamber.

The photos of Fig. 2 show how mirror samples looked just after finishing their exposure in LHD vacuum vessel. As a result of exposure in LHD the reflectance of all samples has changed from the identical initial level, Fig. 3.

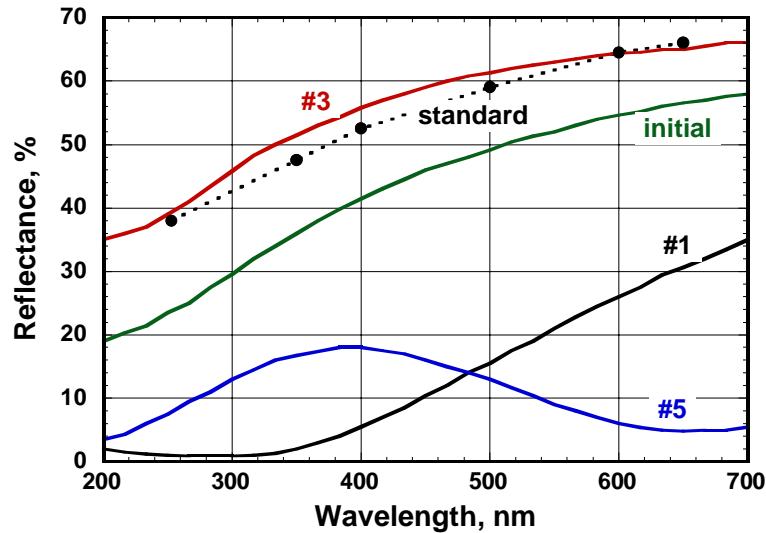
Fig. 3. Spectral reflectance of SS mirror samples before (marked as “initial”) and after exposure inside the LHD vessel (curves marked as #1, #3, and #5). Solid points show the typical spectral reflectance of a SS mirror subjected to cleaning by low temperature deuterium plasma after polishing and washing in an ultrasonic acetone bath.

The reflectance of mirrors #1 and #5 dropped strongly as a result of appearance of the contaminating films. From spectral dependence of reflectance one can conclude that the film on sample #5 is thicker than on the #1 sample. At the same time, the reflectance of sample #3 increased significantly and became close to what is usually observed when after rinsing in a

ultrasonic bath the samples are cleaned by low temperature plasma of an ECH discharge in deuterium, as shown by solid points (the curve “standard”). This effect is connected with not full cleaning of all three mirrors before they were installed inside the LHD vessel from contamination by some organic film appeared due to rinsing samples in acetone. This initially existed film was fully cleaned from sample #3 due to plasma impact but became overcoated by new films (to be immured) at samples #1 and #5. The high level of reflectance for mirror sample #3 measured after exposure samples in LHD was supported by very high quality of surface as follows from profilometry measurements (Fig. 4) and analysis of the SEM photos (not shown).

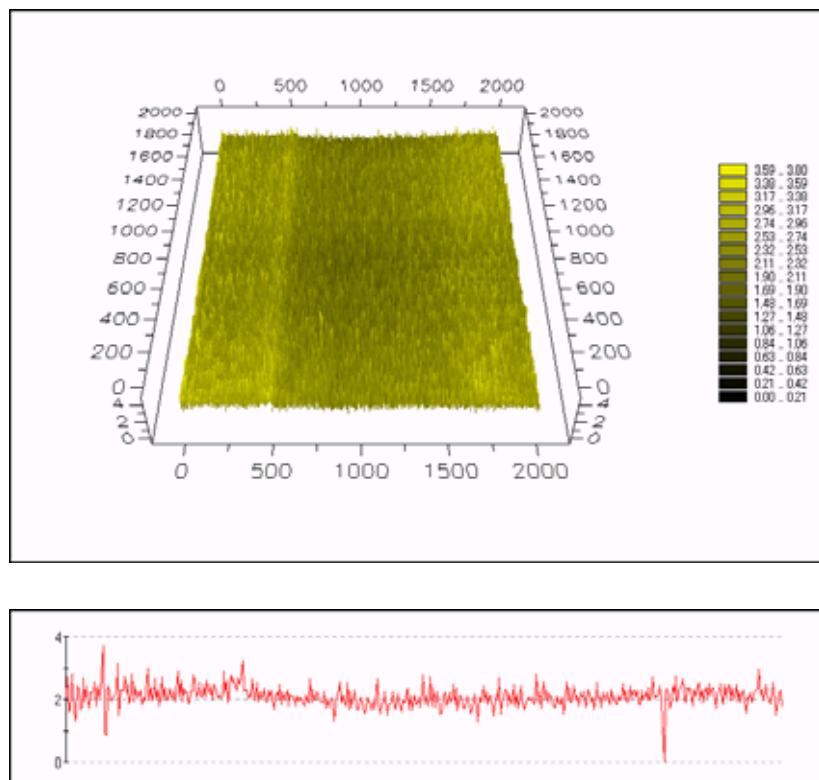
Fig. 4. Results of profilometry measurement of the surface morphology of the sample #3 after exposing in the LHD.

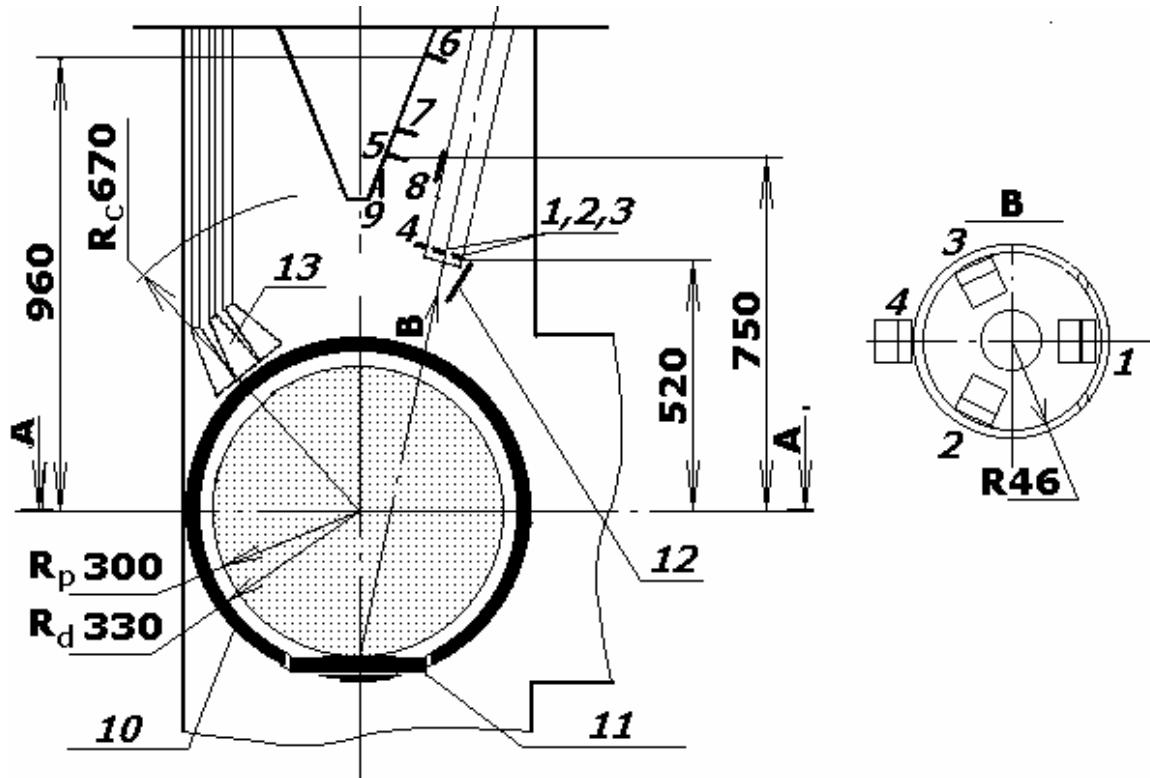
Fig. 5. The layout of experiments in T-10.

1-9 – mirrors (note, mirror #7 is in the shade of mirror #5), 10 - ring carbon based limiter, 11 - movable graphite limiter, 12 - shutter, 13 – ECRH antenna. Rc – radius of toroidal magnetic coils; Rp – plasma radius; Rd – radius of ring limiter.

Polished mirror samples of SS316 (10×10 mm^2 and 20×20 mm^2 , 4 mm thick) were used for experiments. They were exposed in diagnostic port of limiter section of T-10 at different distances from plasma as shown in Fig. 5 [6].

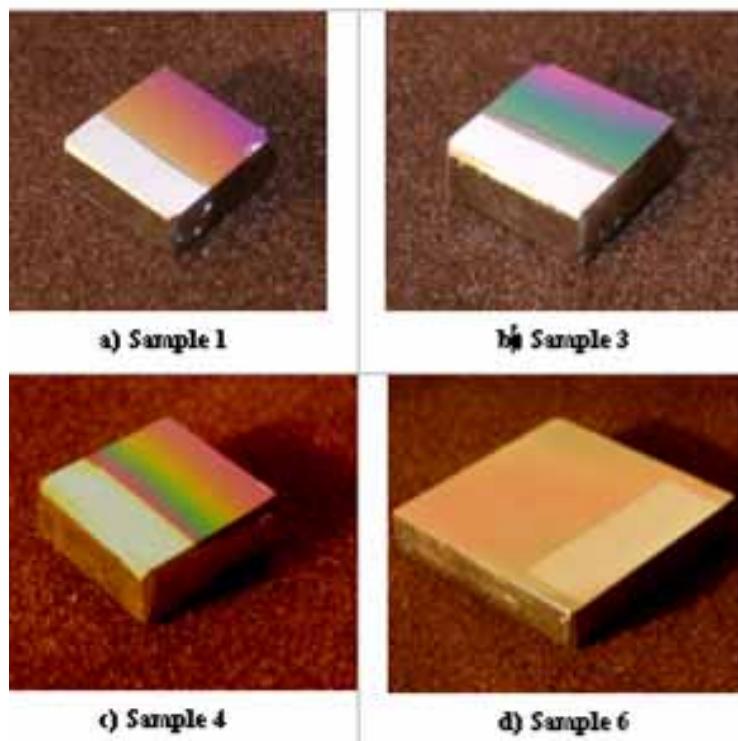
Fig. 6. Photos of samples after finishing the 2002 year campaign. Lighter parts of mirrors were closed during whole exposure time. The deposit has quite homogenous, fine-dispersed structure. On mirrors protected by shutter during conditioning it grew with the rate 0.2 nm/s in 2002 and 4 nm/s in 2003.

looked shining and smooth and the color of deposits varied from golden-crimson to violet-green. The screened parts of mirrors practically did not change by sight, Fig. 6. The deposits not only decrease the reflectance of mirrors but also distort the spectrum of reflected radiation because of interference phenomenon.

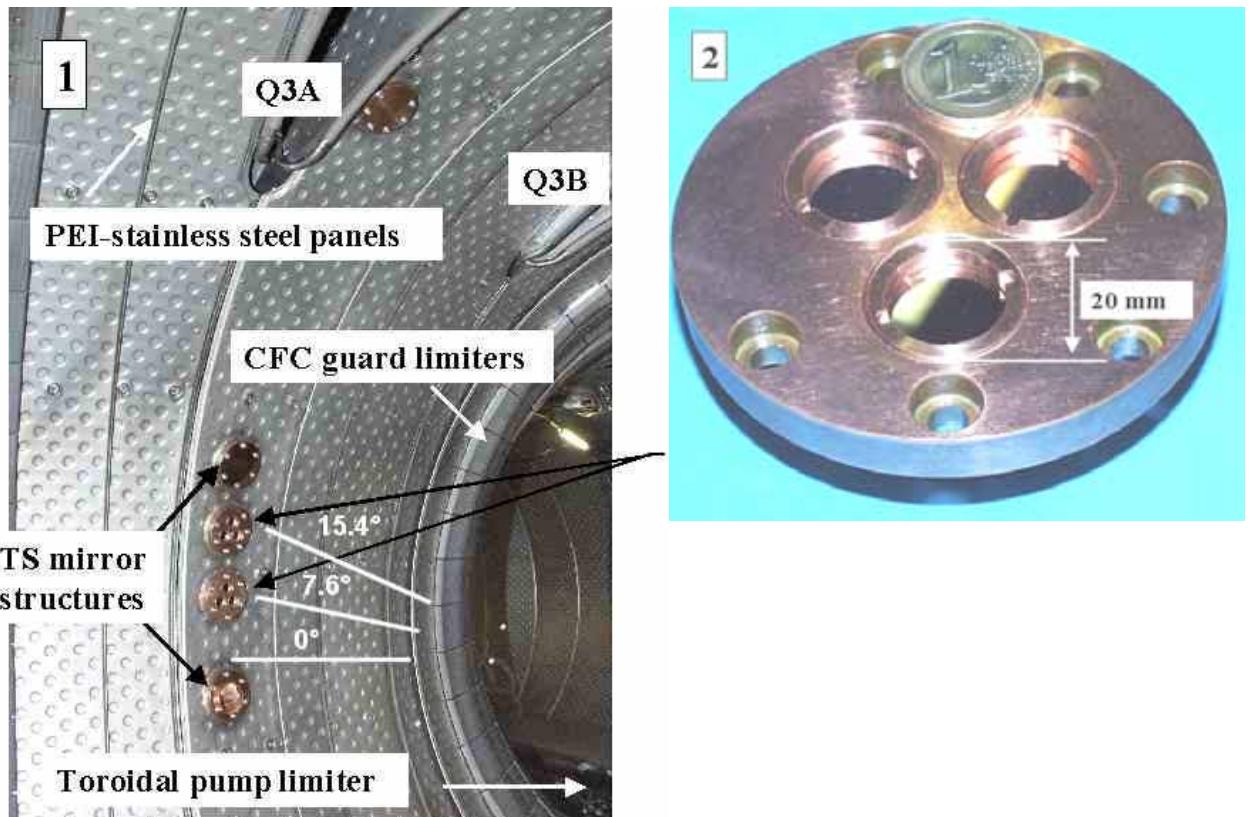
Fig. 7. Mo, SS and Cu mirror samples assembled in CuCrZr ring holders and fixed on Tore Supra vessel wall at high field side.

The mirror samples of 22 mm diameter and 4 mm thickness have been installed on the high field side of the TS plasma vessel. They were located at $\theta = 7.5^\circ$ and 15° out of the equatorial plane (Fig. 7) and positioned roughly 140 mm from the LCFS. The reflecting surface of all mirrors were oriented parallel (not inclined) to the toroidal field direction. The mirror assembly allowed contact cooling via the first wall steel panels. 2D- thermohydraulic finite element calculations of the mirror sample assembly showed temperatures not exceeding $\sim 150^\circ\text{C}$ for a typical “Gigajoule” operation scenario (~ 1 MW radiated plasma power loss during 36 s of pulse length).

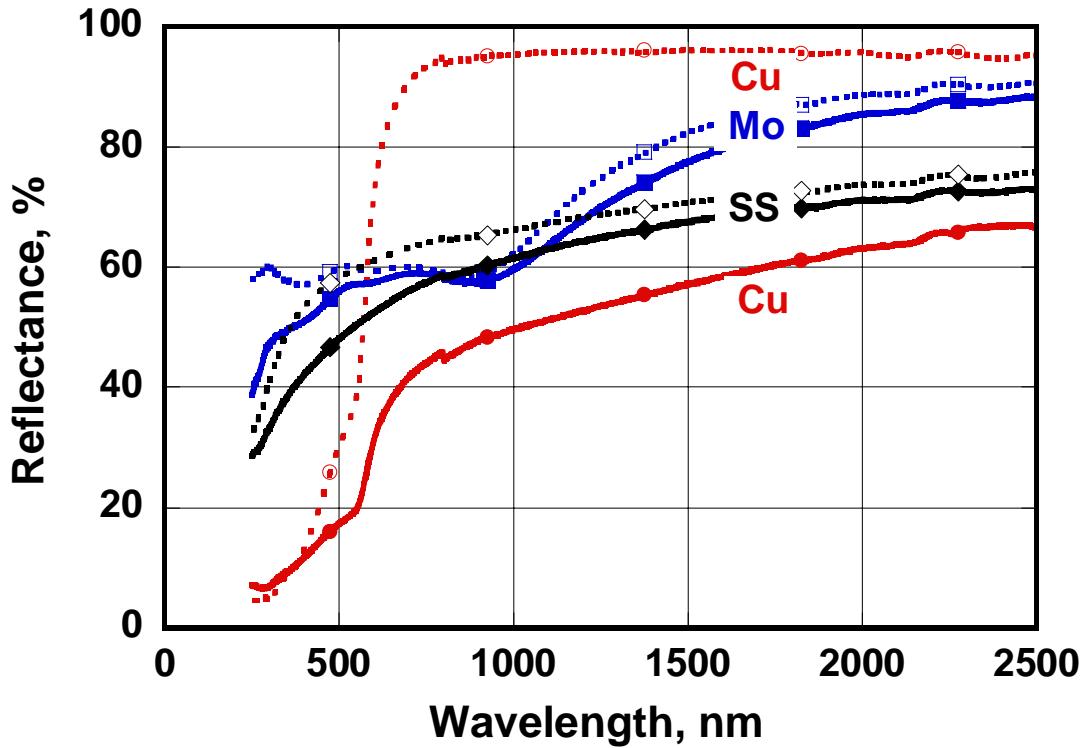
Fig. 8. Reflectance of mirror samples before (dotted lines) and after (solid lines) exposure inside Tore Supra.

It was found that all exposed mirror samples became not only eroded but also coated with some deposited layers what is the main reason for change of the total reflectance.

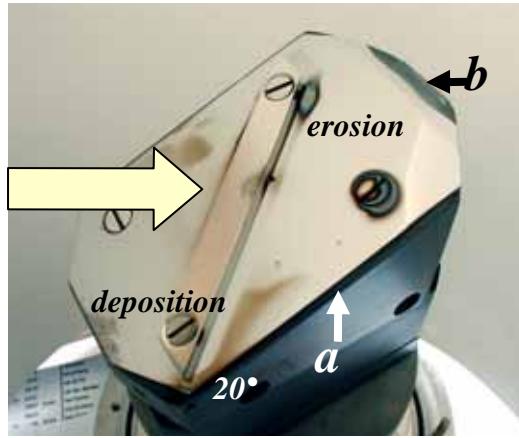
Fig. 9. Photograph of the mirror holder after exposure in the erosion dominated zone. The large mirror (a) is mounted 20° inclined on the graphite carrier, the small mirror (b) on the rear side perpendicular to the toroidal direction.

Polycrystalline mirrors from molybdenum were placed in the SOL plasma of TEXTOR [10]. The photograph in Fig. 9 shows the experimental set-up and the appearance of mirrors after exposure. One large mirror (115mm x 74mm) was fixed inclined at 20° to the toroidal fluxes. The mirror was partly protected by an aluminium bar which created a shadow. Outside the shadow some deposition becomes visible. One small mirror was placed for comparison at the rear side of the holder perpendicular to the toroidal direction. All mirrors were polished mechanically and had optically been pre-characterised.

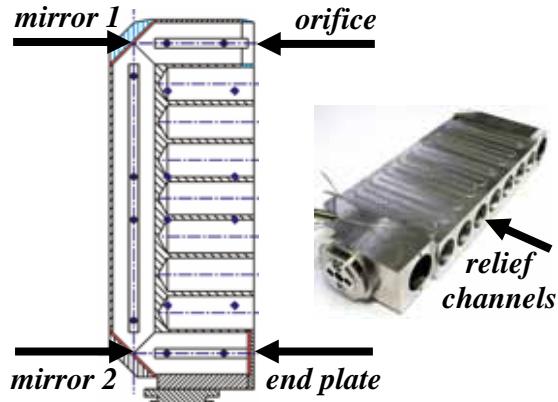
Fig. 10. Periscope system with mirror 1 (closest to the plasma), mirror 2 and end plate. The tubes (35mm) are wrapped inside with exchangeable steel foils fixed at the wall by bars. The photograph shows the stainless steel body without end plate. Relief channels reduce weight.

The set-up of a periscope-like system on TEXTOR simulates the ITER diagnostic ports transmitting the plasma radiation to further distant sensors. Two plane mirrors were installed in tubes facing each other at a distance of 275 mm. The mirrors are oriented 45° with respect to the line of sight. The orifice (35 mm diameter) is oriented perpendicular to the toroidal direction.

The second end was closed with a polished end plate as is shown in Fig. 10. The SOL fluxes hit the first mirror under 45°. Carbon transport inside and deposition can be investigated after dismounting of the system. The deposition patterns on exchangeable steel foils wrapped inside the tubes complete this information. The stainless steel body can be heated up to about 500°C. Mirrors made from TZM (99% Mo, 0.1% Zr, 0.5% Ti) were used for the pilot experiment. The edge closest to the plasma was kept at 25 mm from the LCFS and the system exposed to 89 (partly neutral beam heated) plasma pulses ($n_e = 1.5$ to $4.5 \times 10^{19} \text{ m}^{-3}$) with a total plasma exposure time of 1047 s. The temperature was 150 °C.

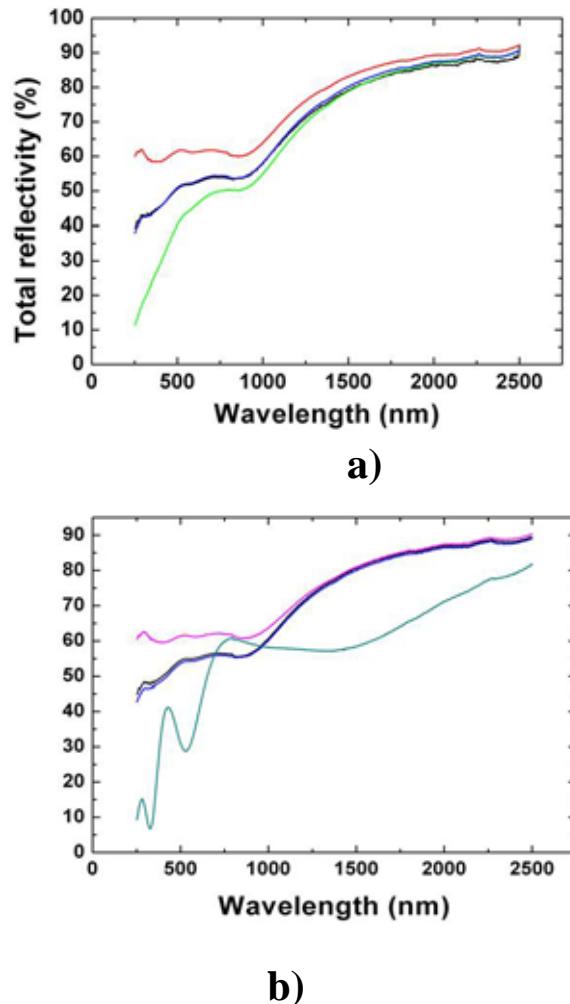
Fig. 11. Total reflectivity R_{tot} depending on wavelength measured on the molybdenum mirrors before and after exposure in a protected area (1) and after exposure in the deposition (2) and erosion (3) area. The mirrors (a) were exposed for 197 s in the erosion dominated zone (edge at LCFS+8mm) and (b) and for 312 s in the deposition dominated zone (edge at LCFS+25mm).

Surprisingly, an increase of R_{tot} was measured on surface areas which suffered from net erosion (curves 3). The increases are similar, independent whether the target mirror was exposed near the plasma edge (Fig. 11a) or deeper into the SOL (Fig. 11b). This increase is most pronounced ($\Delta R_{\text{tot}} \approx 10\text{-}20\%$) for short wavelengths and almost vanishes (1-3%) beyond about 1500 nm.

The decrease of the total reflectivity in deposition dominated areas is due to absorption and by destructive interference if the deposit is thick enough. The example given (curve 3 in fig. 11b) roughly fits the condition $i^* \lambda / 4 = n^* x$ ($i=1, 2, 3..$) for destructive or constructive interference using a film thickness of $x=220\text{ nm}$ and a refractive constant $n=1.65$. The term $n^* x$ deviates by about +10% in the IR and by -10% in the UV region. This is likely due to the varying thickness within spot size of the measurement. But diffraction of light cannot be excluded. Combining the results from SIMS depth determination and the deuterium analysis with NRA yields a ratio $D/C \approx 0.3$. The optical constants ($n=1.65, k=0.02$ for $\lambda=632\text{nm}$) were measured in the deposition zone of the molybdenum mirror. For ITER, a deposition of carbon on optical components is difficult

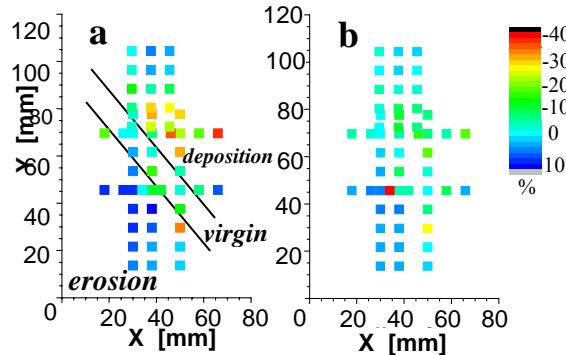
Fig. 12. Differences $\Delta R_{\text{tot}} = R_{\text{after}} - R_{\text{before}}$ given in colours at different surface locations for $\lambda=250\text{nm}$ (a) and 500nm (b). The co-ordinates x and y cover the mirror dimension (74mm x 115mm).

The local dependence of the reflectivity was measured at about $N=50$ different spots by shifting the mirror plates in the two directions (x and y) parallel to the sides. Before exposure the reflectivity scattered a little, i.e. the differences $\Delta R = R_i(\lambda) - R(\lambda)_{\text{av}}$ between one local measurement (index i) and the average out of the N measurements was less than about $\pm 3\%$ in the visible and the IR. For shorter wavelengths the scatter was about twice as much. After exposure the local changes were much larger. Fig. 12 shows the N differences $\Delta R_{\text{tot}} = R_{\text{after}} - R_{\text{before}}$ measured on the mirror exposed at LCFS+8mm. The differences are highest for $\lambda=250$ nm (a) and achieve more than +12% (dark blue) in the eroded part of the mirror, while reductions of -30% (deep red) occur in areas covered with deposits. In protected or shadowed areas ΔR_{tot} is in the scatter range ΔR observed before exposure (blue green). For increasing wave lengths (b) the changes are less pronounced. The intensity of the diffuse reflected light has also been measured at the identical locations, but contributes little since the differences do not exceed about $\pm 2\%$ on this mirror plate.

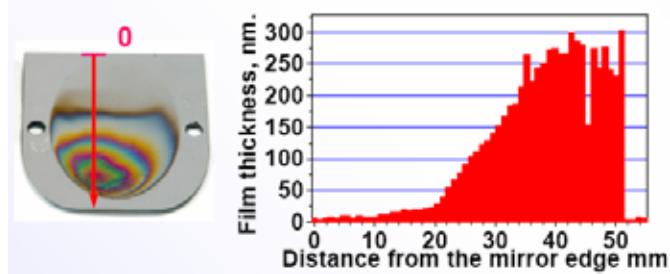
Fig. 13. Distribution along the indicated line of the carbon-based film thickness deposited onto the mirror #1 of the periscope system.

Mirror #1 exposed in the periscope for 1047 s showed a radial decaying deposit with a maximum thickness of about 300 nm, Fig. 13, as follows from electron probe micro-analysis (EPLM). The thickness corresponds to a deposition rate of about 0.4 nm/s (inclination angle 45°). Although the deposition rate on mirror 1 is high, no detectable deposition was found on the following mirrors and walls.

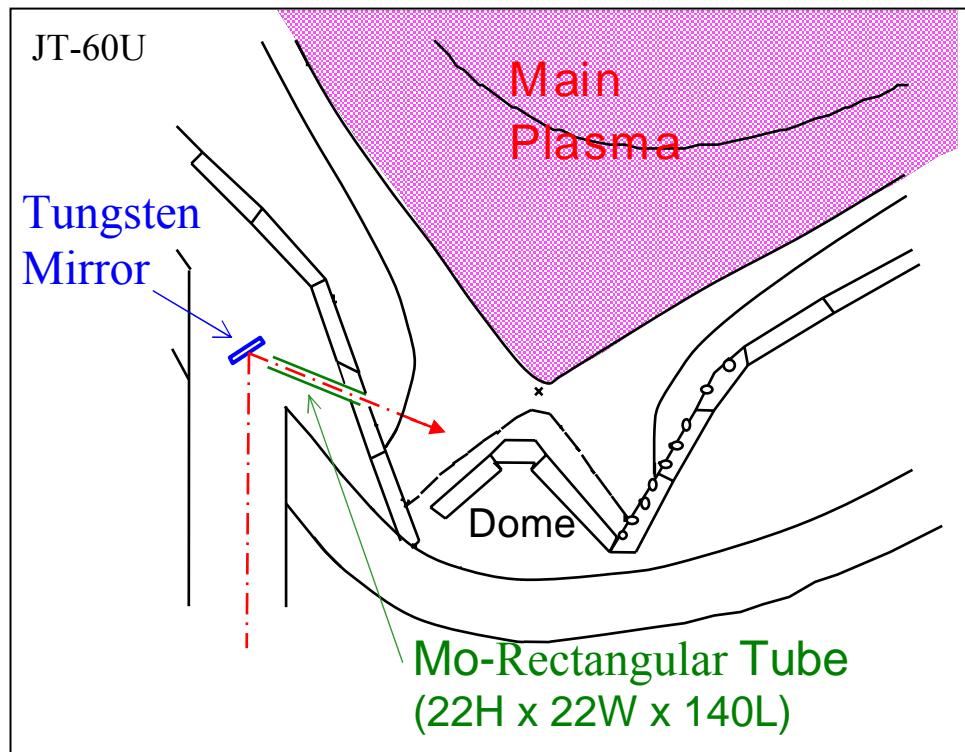
Fig.14. Disposition of W mirror for measurement of VUV and UV radiation emanating by the divertor plasma in JT-60U.

After the modification to the closed divertor (so called the W-shaped divertor) in 1997, a tungsten plane mirror was installed to view the divertor plasma as shown in Fig. 14. The tungsten mirror, which was fixed by a box type SS support, was electrically insulated from the

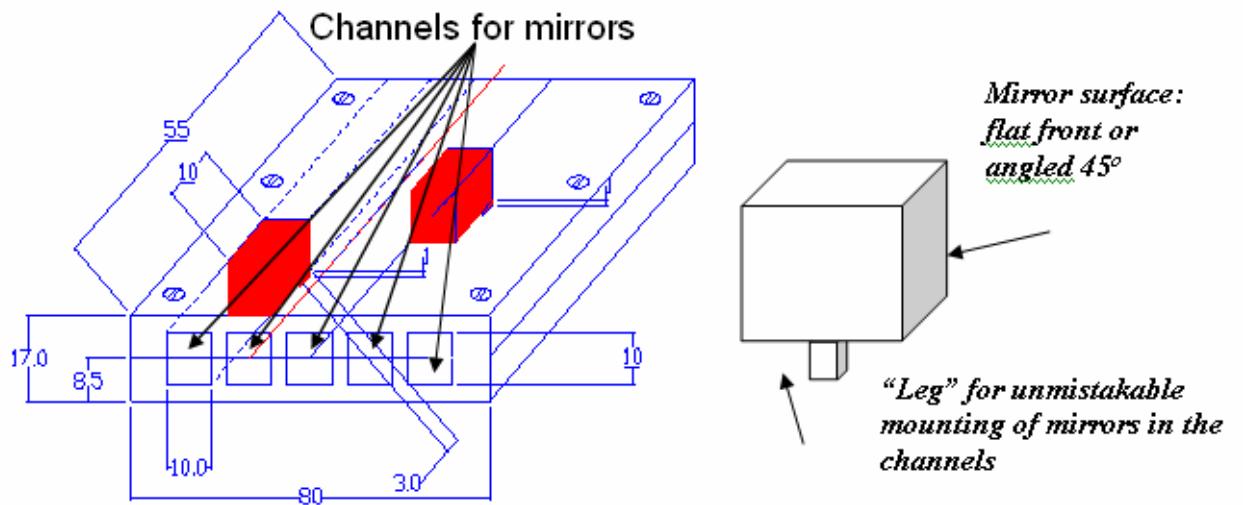
Fig. 15. A schematic view of a cassette and a mirror block for the test in JET.

Fig. 14 exemplifies a design of a stainless steel cassette with several channels in which the mirrors are mounted. The number of channels in a cassette, three or five, is dependent on the available space in various locations of the machine: three positions in the divertor (two cassettes in the inner, two in the outer two in the base) and two on the main chamber wall.

The cassettes are of a “pan-pipes” shape and they are composed of two detachable plates. The construction enables studies of deposition both inside the pan-pipes channels and on the mirror surfaces. Moreover, the exposure of mirror surfaces at various inclination angles and aspect ratio with respect to plasma is possible. Effects of sample temperature on deposition in the divertor may be studied by comparison with the QMB data [16]. Figures 15 a-c show the location of mirrors and other deposition monitors in the divertor base and the inner carrier. The arrangement of devices in the outer divertor is similar to that in the inner leg (see Fig. 15 d). There are also cassettes placed on the main chamber wall (Fig. 16) protected by magnetic shutters which open when the magnetic field is on. This ensures avoiding the deposition of beryllium during its evaporation on the JET wall. Installation of all the deposition monitoring devices in the JET vessel is compatible with remote handling [17]. The construction phase and commissioning of the diagnostic tools for TRS (including FMT) is to be ready for installation in 2004. The experiment itself will be carried out in 2005 until the next opening of the JET vessel.

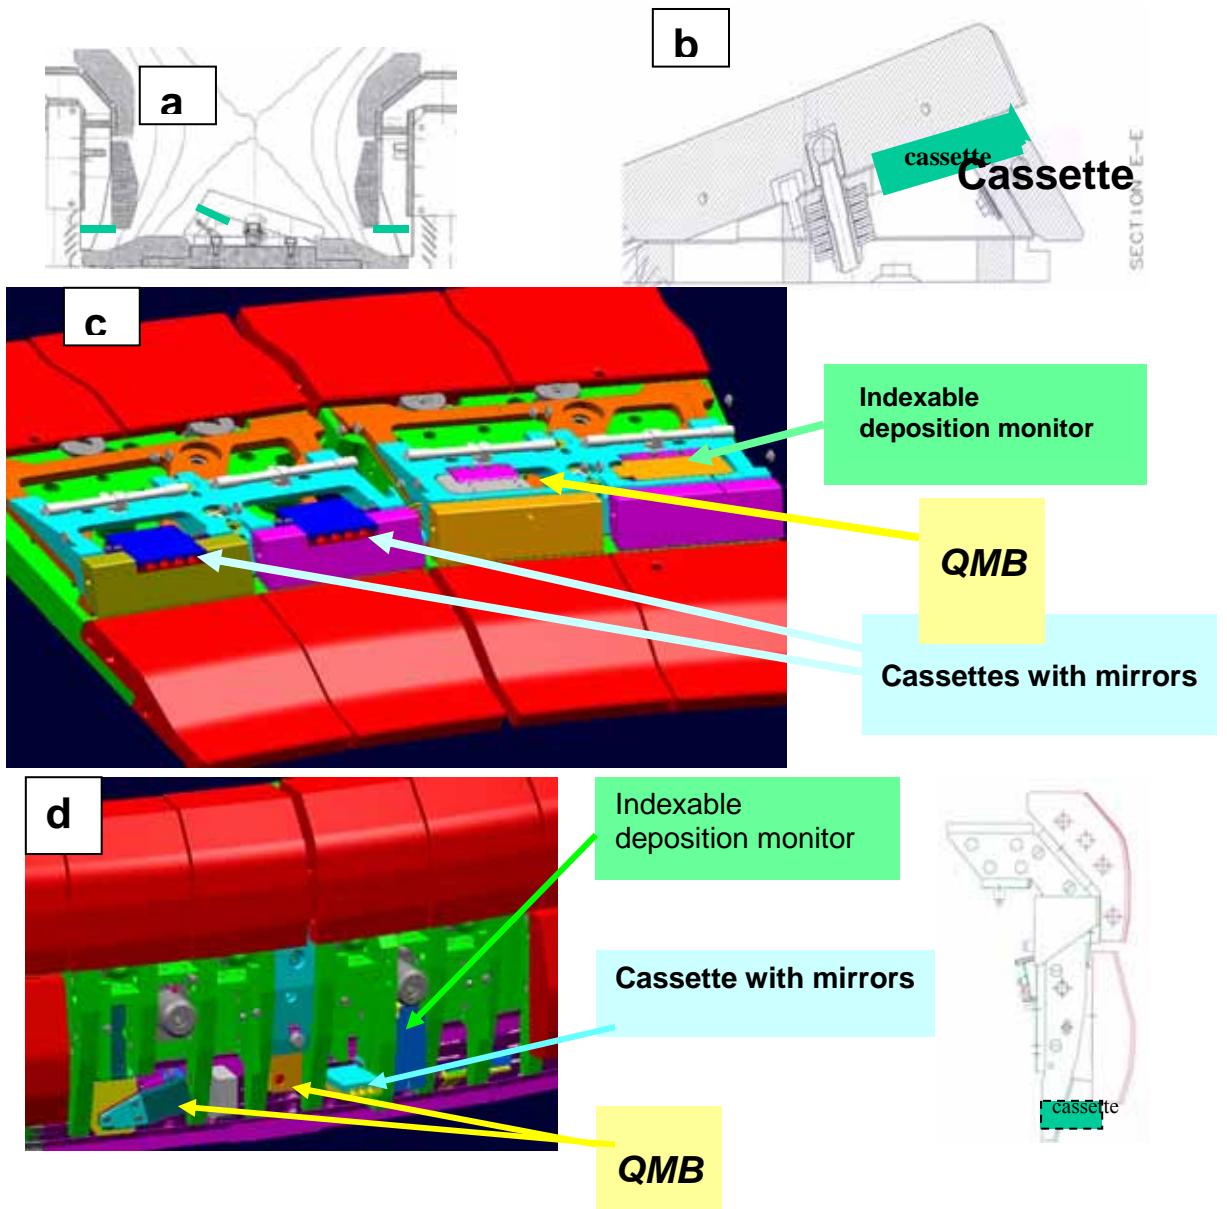
Fig. 16. (a) Divertor cross-section with a mirror cassettes (green boxes) in the inner, the outer carrier and below the load bearing plate (LBP made of carbon fibre composite); (b) base divertor module with a cassette; (c) location of several devices for monitoring the deposition mounted in the base divertor modules [Load Bearing Plate is removed]; (d) location of tested mirror and other deposition monitors in the inner divertor.

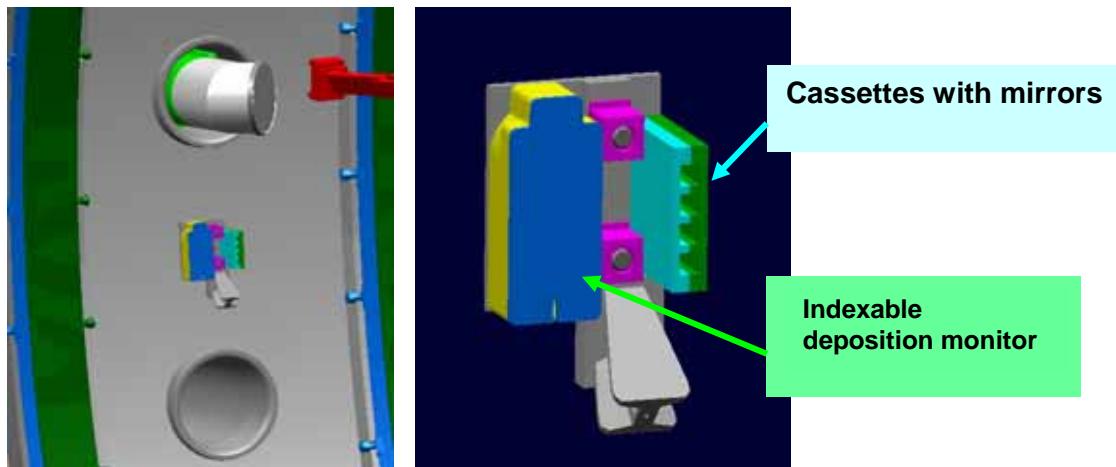
Fig. 17. Tested mirror and other deposition monitors in the main chamber wall mounted a clip (wall bracket) compatible with remote handling.
