# Field Emission Dark Current of Technical Metallic Electrodes

## Abstract

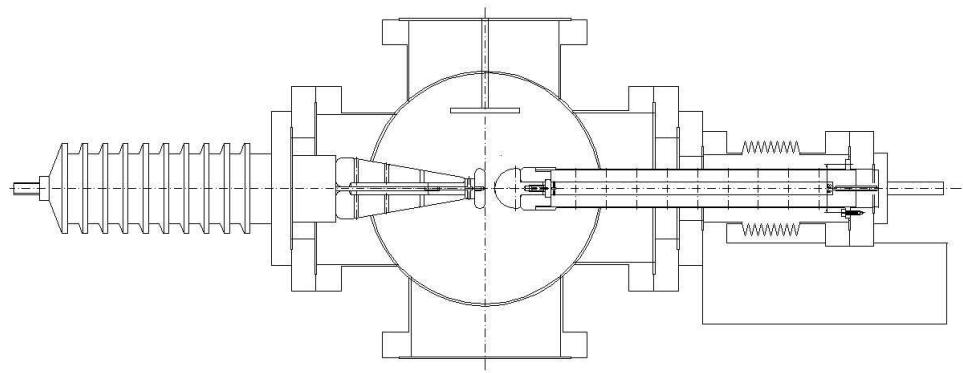
Figure 1: Dark Current -100 kV DC test stand.

The ultra-high vacuum (UHV) system shown in Fig.1, outside its metal confinement bunker for radiological protection, is pumped by a 150 l/s diode ion pump. The average pressure reached is in the low  $10^{-9}$  Torr scale after a quick bake of the ion pump. A more thorough bake brings the pressure down to the mid  $10^{-10}$  Torr. An injection line, a leak valve and a Torr capacitance gauge allow the controlled injection of a chosen gas into the system to prepare the glow discharge between the electrodes. In order to clean the anode and the cathode at the same time, a third electrode polarized positively in respect to the test electrodes is used, Fig.2. The distance of this third electrode from the center of the chamber is a constant.

A negative and continuous 0 to 100 kV bias is applied to the cathode through an insulating ceramic, (on the left in Fig.1). The anode is grounded. The capacitance of the system is close to 300 pF, hence the potential energy stored is 1.5 J at 100 kV. The current flowing from the cathode to the anode is measured across a  $1 \text{ M}\Omega$  resistor with a digital Fluke<sup>TM</sup> voltmeter. The gap separation between the electrodes is adjustable via a translation feedthrough and is controlled with a mechanical comparator. The sagging due to the weight at the end of the rods means that the two electrodes are not centered on each other. We do not expect this off centering to be of any consequence to the high voltage processing. However, it explains the off center damages seen on cathodes. Accurate measurement of the current to the 50 pA level is achieved.

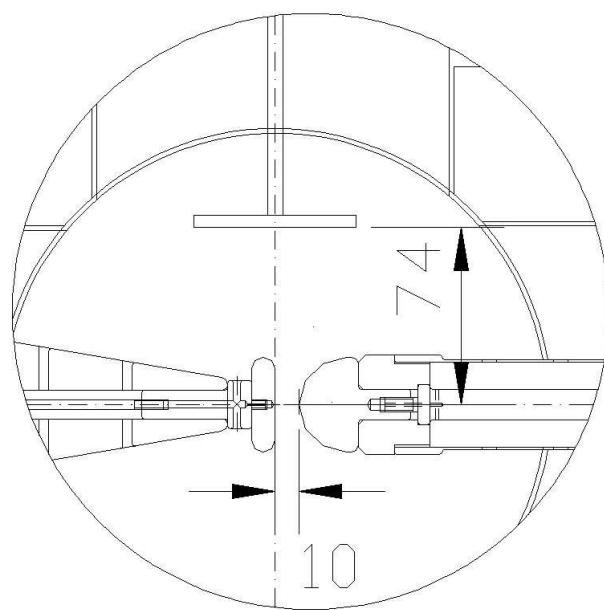
Figure 2: Dark Current -100 kV DC test stand. Zoom over the area containing the cathode (flat electrode) the anode (mushroom) and the plasma electrode located at 7 cm from the center of the system

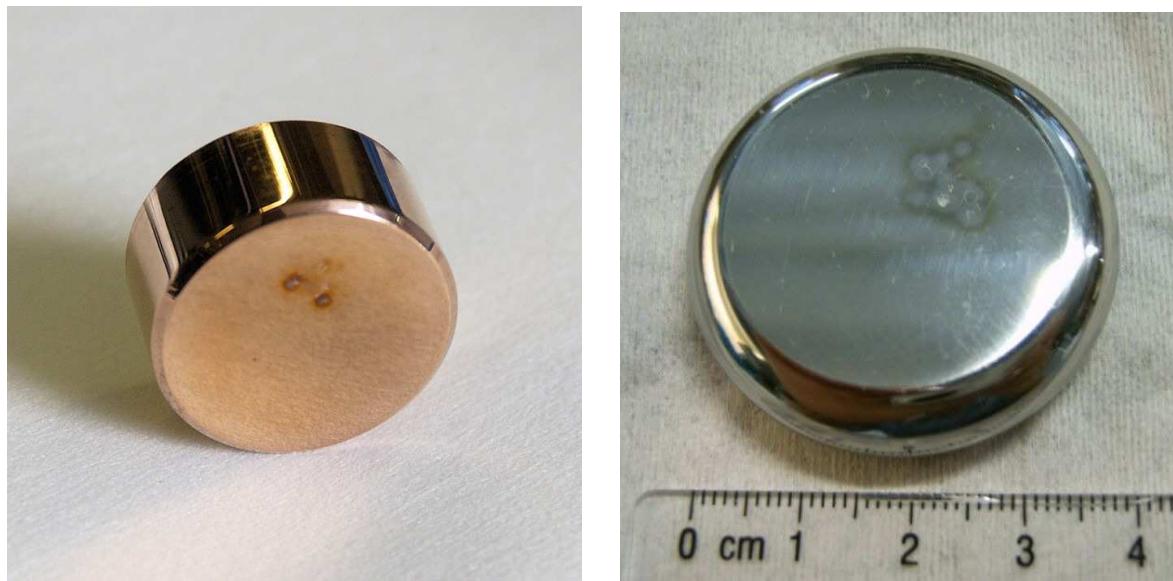
Figure 3: Cleaned Cu cathode after high voltage testing, left. Damaged Mo cathode, right picture. Damage can be clearly seen.

All our electrodes tested have the same shape, see Fig.3 & 4 for the cathode and anode, respectively. The mean roughness was, by design, defined to be less than  $R_a \leq 0.2\mu\text{m}$ . In Fig.4, the copper anode, has a hole in the middle. This hole was made to mimic the behaviour of the extracting anode of the 500 kV pulser. None of the other electrodes have this hole. The  $R_a$  of the electrodes was checked after high gradient testing.

In comparison to Al electrodes, craters in the Cu were neither as deep, nor as extended : see the 2 spots in Fig.3, compared to damages in Fig.7. All breakdown damage on the Cu anode remained localized around the hole of the mushroom. That suggests two possibilities without excluding a combination of the two. The energy in the arc was not sufficient to vaporize the Cu materials, by melting and sputtering the melted Cu, despite the fact that Cu has a higher sputtering rate than Al. Or the field was not strong enough to pull out droplets of Cu which could have then been vaporized [29].

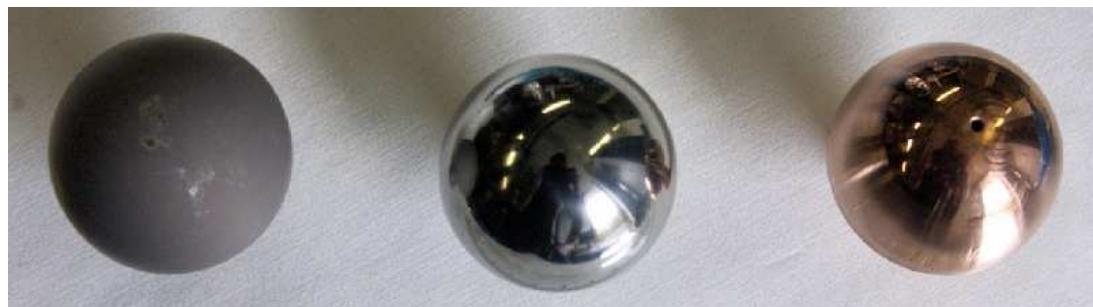
Figure 4: Three anodes used for HV testing, Ti on the left(grey black colour, after vacuum firing), Mo in the center and Cu on the right. Pictures taken after HV testing. Damage can be seen on the Ti electrodes

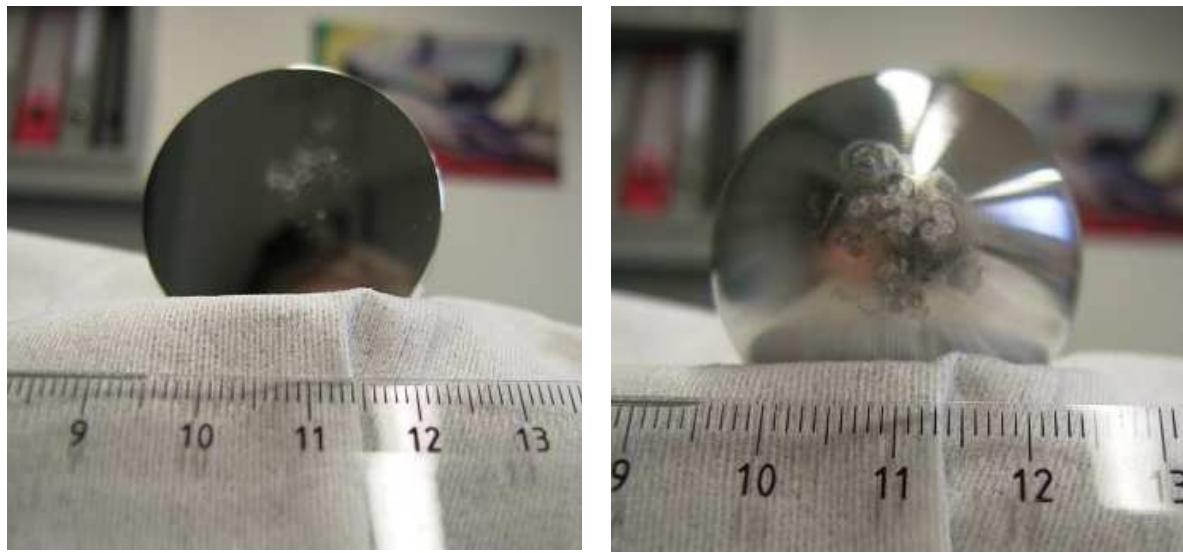
Figure 7: Breakdown damage withstood by the Al cathode (mirror finished-left) and anode (right) during the conditioning period. Scale in cm.

We then replaced the damaged Al cathode by a pristine mirror like finish Al (6082) cathode, machined to an  $R_a$  of 3 nm. The previously damaged mushroom anode was reused, after wiping with alcohol before reinstallation in the UHV system. The damage on the anode was localized around the summit of the anode, and resembled the right-hand picture in Fig.7.

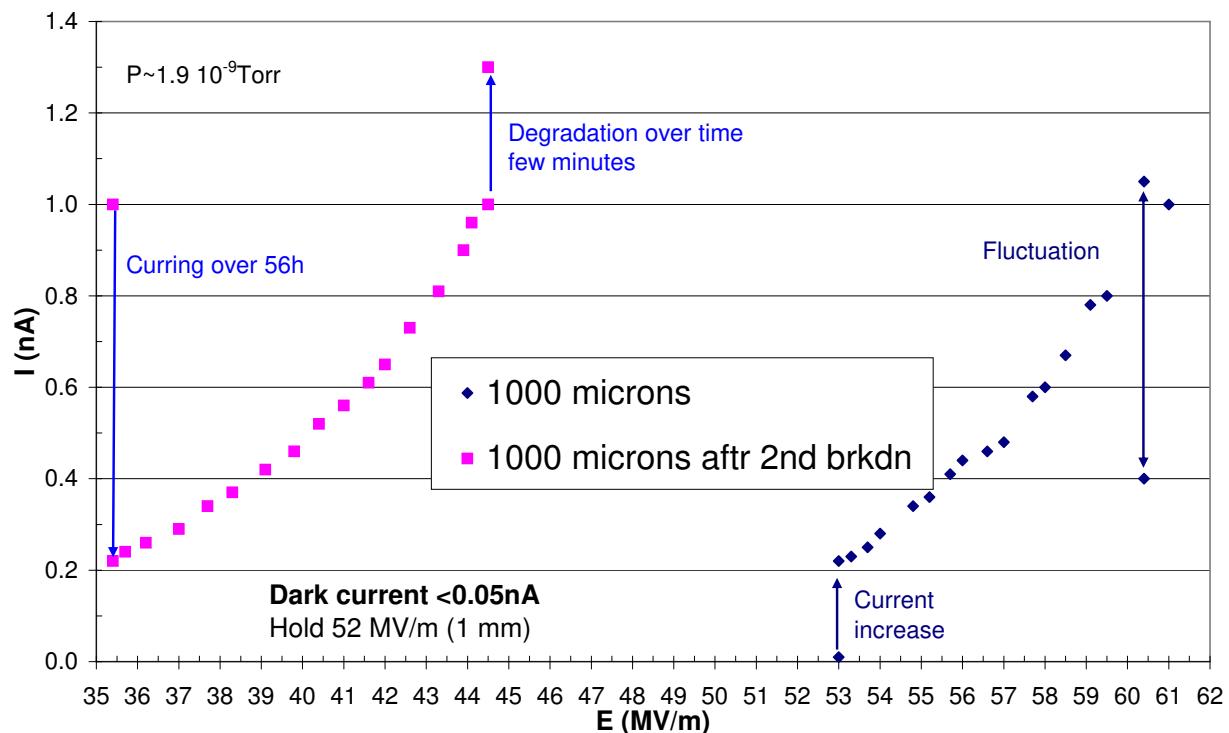
Figure 8: Dark current evolution of Ti electrodes after a 2<sup>nd</sup> Ar Glow Discharge. The square curve is obtained after a surface breakdown at 62 MV/m

In the case of Ti, we have observed after plasma treatment, a stable field holding at 52 MV/m without FE. Above 53 MV/m, dark current appeared and reached 1 nA at 62 MV/m, cf Fig.8 (diamonds). The field held at this value for a few minutes until arcing, which brought the current above 1  $\mu$ A. The field was then reduced to 35 MV/m in order to get a 1 nA current value, cf Fig.8 (squares.) This current value decreased over 56 hours of 35 MV/m field processing. A few MV/m were then gained to bring back the current to 1 nA.

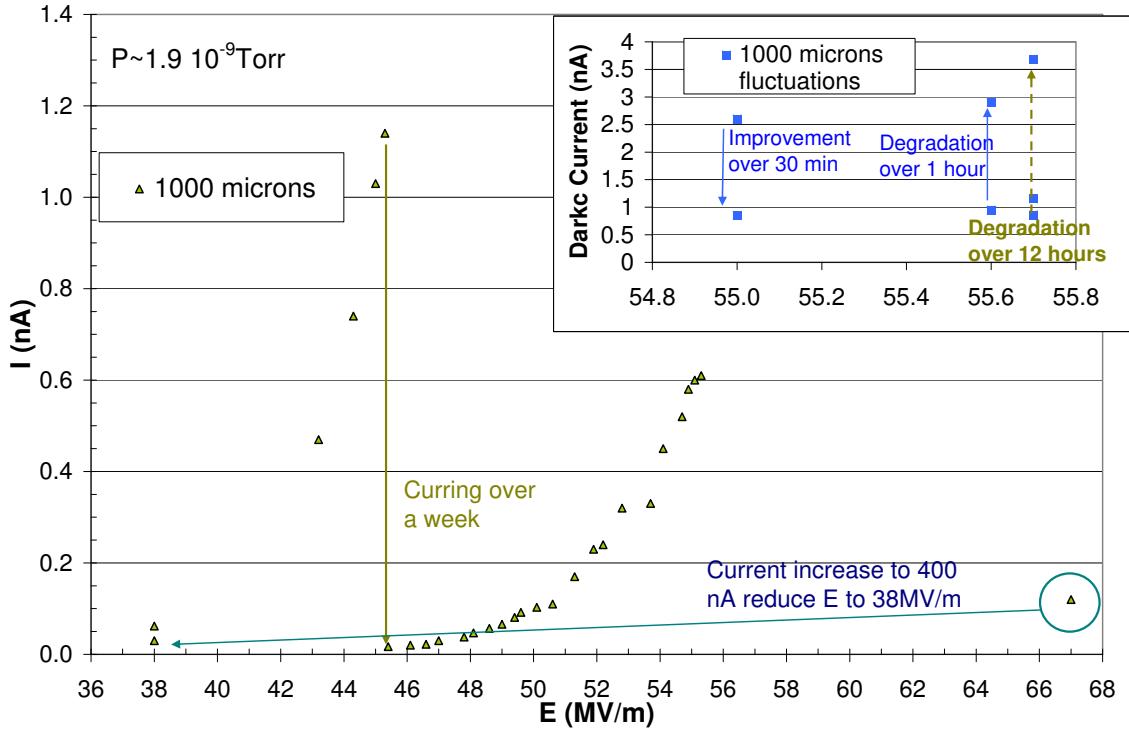
Figure 9: Dark current evolution of Ti electrodes after a 3<sup>rd</sup> Ar Glow Discharge.

field obtained for 1 nA at 1 mm gap is 55 MV/m, see insert in Fig.9. Above this level of field, the dark current does not diminish but it increases with time, Fig.9.

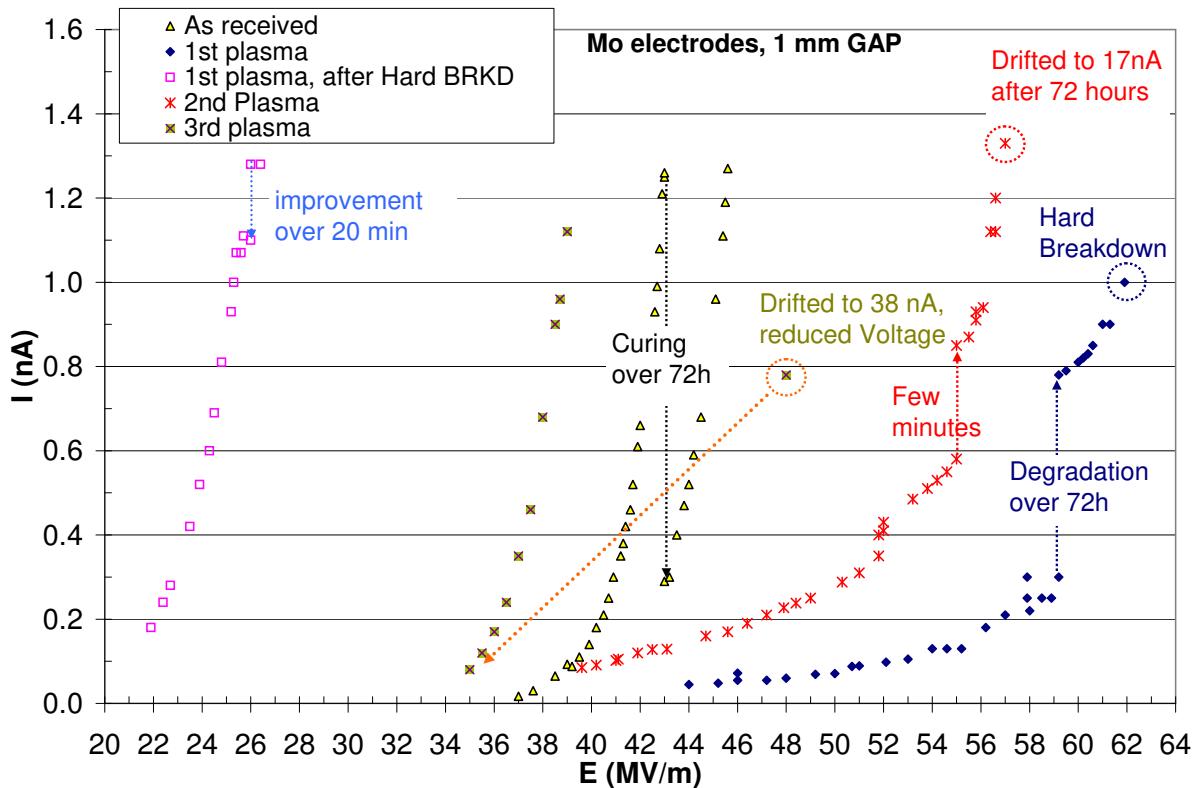
Figure 10: Dark current evolution of Mo electrodes after processing.
