# A Fiber Detector Radiation Hardness Test

J. Bähr, R. Nahnauer <sup>\*</sup>, S. Nerreter <sup>1</sup>, R. Shanidze <sup>2</sup>

*DESY Zeuthen, 15738 Zeuthen, Germany*

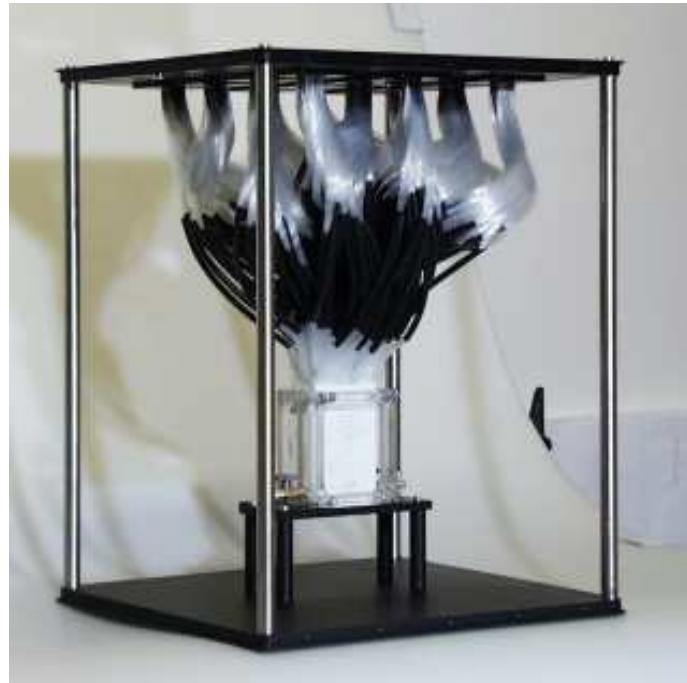
Fig. 1. Photo of the installation of the  $\mu$ FAST I detector within a black box. The loose ends of the scintillating fibers are coupled via plastic masks to photomultipliers which could be installed on top of the box.

A photo of  $\mu$ FAST I is displayed in fig. 1. The bottom side of the detector was polished and mirrored by an aluminium foil. The other end consists of 30 cm loose fibers.  $8 \times 8$  fibers of a plane were combined to form a macroscopic pixel. Using a plastic connector mask the 16 pixels of a plane were put to a 16 channel multianode photomultiplier Hamamatsu R5900-M16. The 192 pixels of the detector are readout in parallel using 12 such devices.

- Fig. 1 : Photo of the installation of the  $\mu$ FAST I detector within a black box. The loose ends of the scintillating fibers are coupled via plastic masks to photomultipliers which could be installed on top of the box.

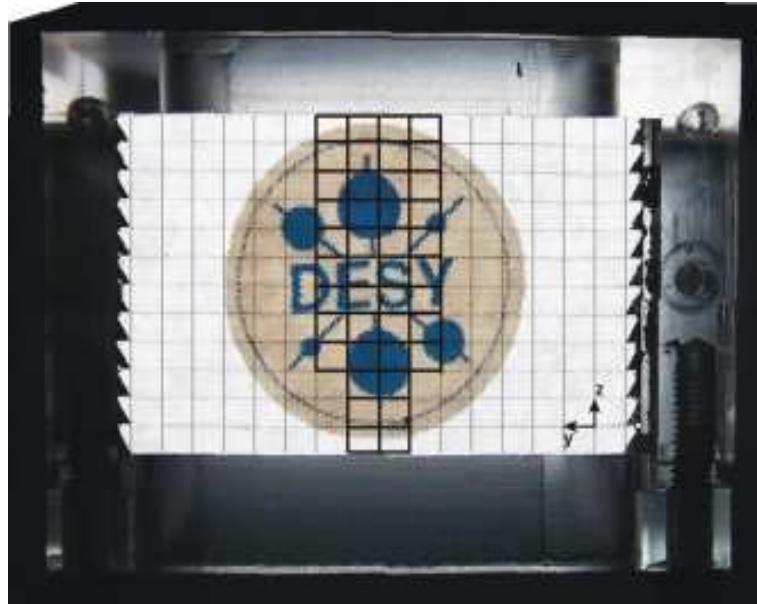
Fig. 2. Photo of a DESY-logo through the 10 cm long fibers of the  $\mu$ FAST II detector. The fiber planes and pixels in z and y-direction are indicated as well as the region in the center where pulse height measurements were possible

For  $\mu$ FAST II both ends of the glued fibers were cut and polished. This allows to look through the fibers and visually to inspect their quality. A corresponding photo is shown in fig. 2. The readout of the detector pixels of the same size as in  $\mu$ FAST I is done here by clear optical light guides. Using 500  $\mu$ m double clad KURARAY clear fibers exactly the same planes are produced as for scintillating fibers with the same winding drum. Polished at one end of the about 5 cm long glued part, the 30 cm long loose ends are again ordered to macro-pixels of  $8 \times 8$  fibers feed in masks fitting to the same multianode photomultipliers as mentioned above. Only four planes of this type were available and glued together to a compact block. Using pins and holes this block could be connected with moderate precision to all parts of the  $\mu$ FAST II scintillator block.

signals from particles hitting  $\mu$ FAST I or II. The signals from the 192 photomultiplier channels were splitted passively. After a beam trigger the arrival time of all signals appearing in an interval of  $\pm 20 \mu$ sec were registered by two VME-TDC's CAEN V767. In addition 42 PM channels were connected to the channels of six VME ADC's LECROY 1182 to measure signal amplitudes within a gate of 30 nsec after the beam trigger. The detector planes were arranged perpendicular to the incoming beam defining the z-direction. The pixels in a plane have increasing row numbers in y-direction. ADC-channels were connected to all planes of row numbers 8 and 9 and planes 4-12 in row numbers 7 and 10 (see also fig. 2).

- Fig. 2 : Photo of a DESY-logo through the 10 cm long fibers of the  $\mu$ FAST II detector. The fiber planes and pixels in z and y-direction are indicated as well as the region in the center where pulse height measurements were possible

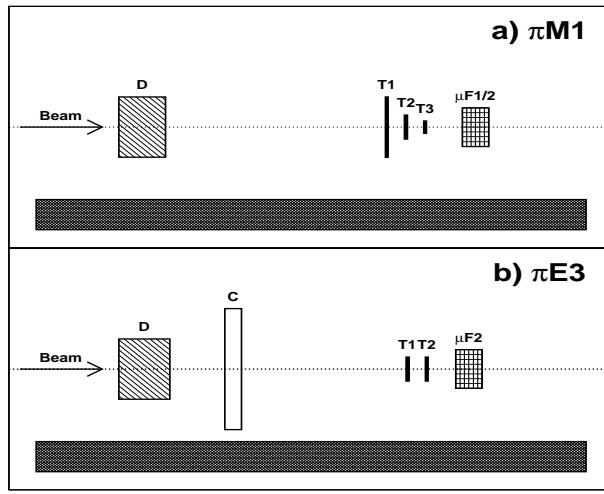
Fig. 3. : Sketch of the beam setups for a.) quantitative studies of the performance of  $\mu$ FAST I and II, b.) irradiation D : degrader, T1-T3: trigger counter, C: wire chamber.

The concept has been tested in a low intensity positive charged particle beam of the  $\pi M1$  area at PSI which is expected to contain mainly pions. The beam momentum was selected to be 146 MeV/c. The setup is shown schematically in fig 3a. Beam particles first cross a 8.5 cm thick lucite degrader (D) then a beam trigger system of three plastic scintillators (T1-T3) of 0.5 cm thickness each and hit finally the planes of the detectors  $\mu$ FAST I or II perpendicularly. Using  $\mu$ FAST I half a million triggers have been recorded for radiation hardness studies with a data rate of about 100 Hz.

A high intense charged pion beam of the area  $\pi E3$  of PSI has been used for a passive irradiation of the  $\mu FAST$  II scintillator block selecting the same momentum of 146 MeV/c as in  $\pi M1$ . The corresponding arrangement is sketched in fig. 3b. The beam crosses a 9.0 cm thick lucite degrader (D). The beam profile is measured using a transparent wire chamber (C). The beam rate is monitored by two 0.5 cm thick scintillation counters (T1-T2). Finally particles enter the detector which was surrounded by a lead shield otherwise.

- Fig. 3 : Sketch of the beam setups for a.) quantitative studies of the performance of  $\mu$ FAST I and II, b.) irradiation, D : degrader, T1-T3: trigger counter, C: wire chamber.

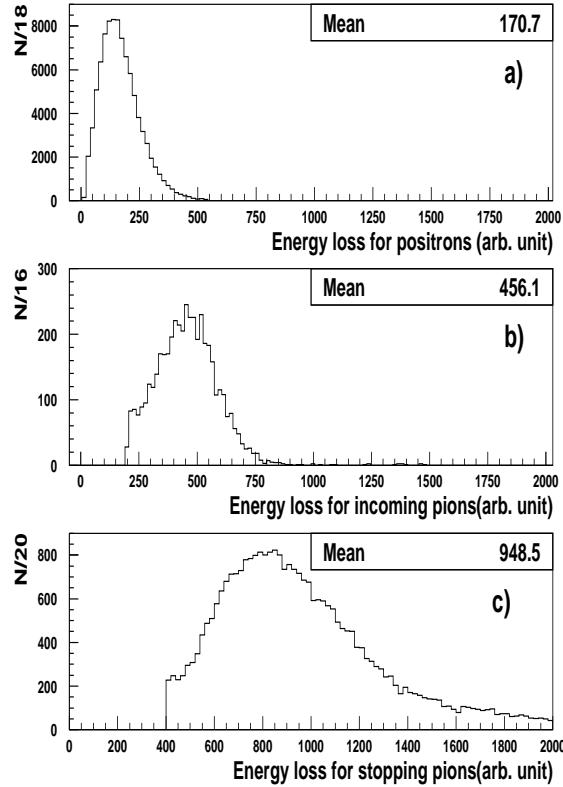
Fig. 4. Energy loss distributions for a.) positrons crossing  $\mu$ FAST I, b.) pions in the first plane, c.) pions in the stopping point

As came out later 80 % of all triggers were due to minimum ionizing particles (positrons) crossing all detector planes. These triggers were used to calibrate the 12 photomultipliers to give the same signals for any plane. The corresponding energy loss spectrum is shown in fig. 4a.

Pions entering the detector were already non-relativistic and gave rise to larger energy losses (fig. 4b) increasing to the stopping point (fig. 4c). Comparing the average values of the three distributions a ratio of 1.0/2.7/5.6 is found. As required, the pions stop dominantly in the center of the detector (see fig. 5).

- Fig. 4 : Energy loss distributions for a.) positrons crossing  $\mu$ FAST I, b.) pions in the first plane, c.) pions in the stopping point.
- Fig. 5 : Distribution of pion stoppings per detector plane of  $\mu$ FAST I.

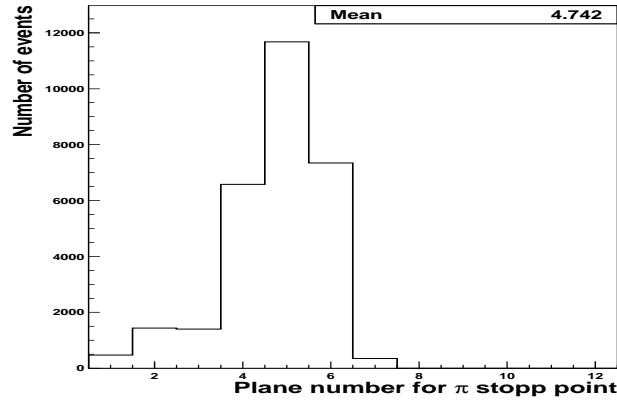
Fig. 5. Distribution of pion stoppings per detector plane of  $\mu$ FAST I.

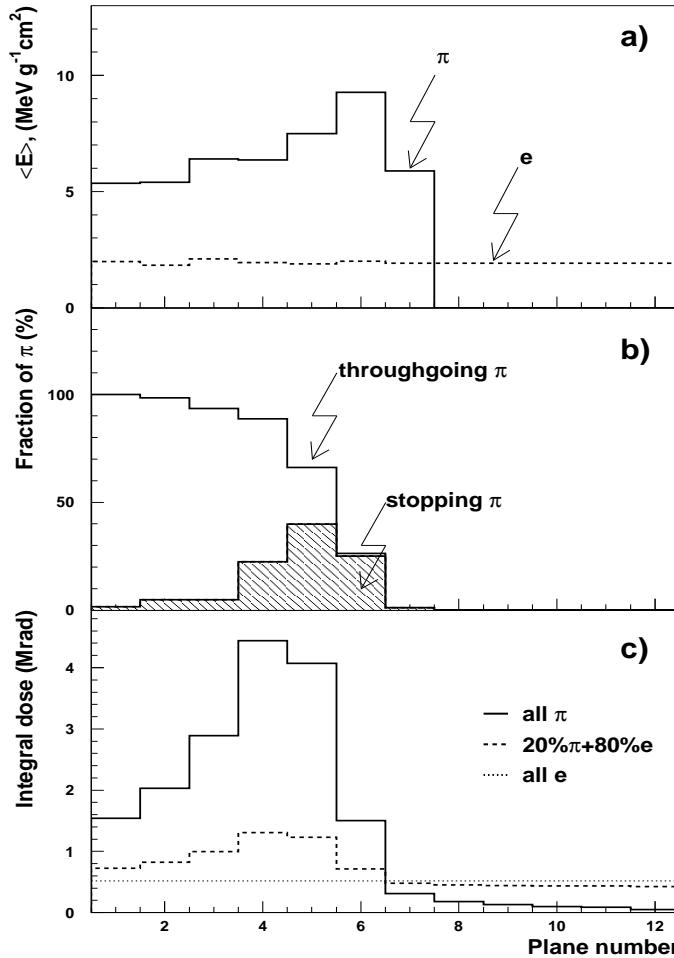
Fig. 6. a.) average energy loss as measured for pions and positrons per plane of  $\mu$ FAST I, b.) corresponding fraction of crossing and stopping pions, c.) radiation dose placed per plane for different assumptions about the particle content of the incoming beam.

In fig. 6a the average energy loss in the detector planes as measured with  $\mu FASTI$  in  $\pi M1$  is distributed for pions and positrons. Fig. 6b shows the part of incoming pions crossing a detector plane or stopping there. Together with the total particle flux this numbers allow to estimate the integral irradiation dose per detector plane. To do that a GEANT-based Monte Carlo was used to simulate the experimental conditions and fit the pion stopping distributions in figs. 6b. The corresponding Monte Carlo result for the dose per plane is displayed in fig. 6c if the beam consists only of pions or positrons and for the particle mixture found for the measurement in  $\pi M1$ . Planes 4 and 5 have been irradiated correspondingly with a dose between 1 - 4 Mrad.

- Fig. 6 : a.) average energy loss as measured for pions and positrons per plane of  $\mu$ FAST I, b.) corresponding fraction of crossing and stopping pions, c.) results of a GEANT based Monte Carlo calculation of the radiation dose placed per plane for different assumptions about the particle content of the incoming beam.

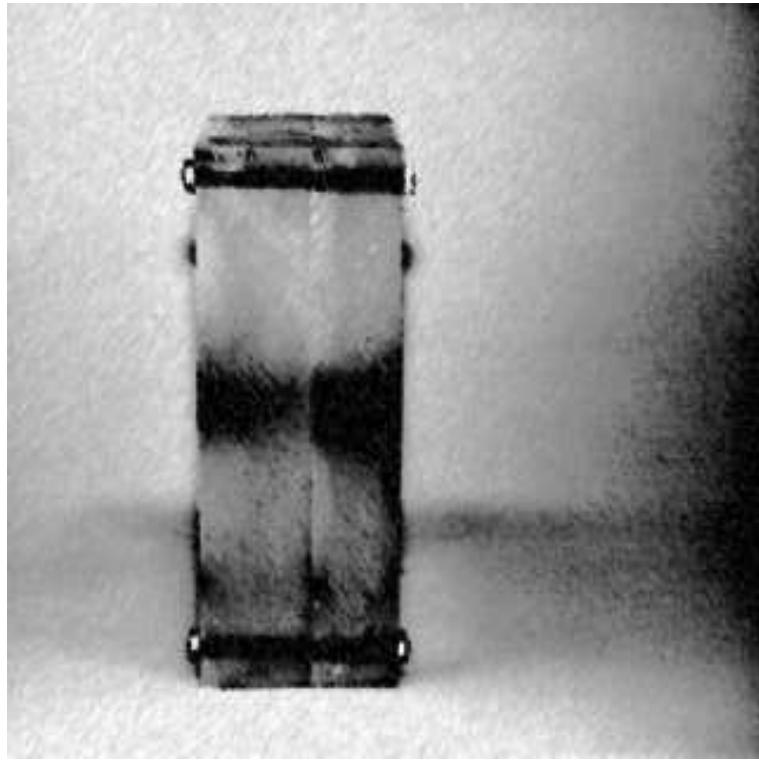
Fig. 7. Photo of the side view of the degrader after irradiation with clearly visible damage in the irradiation region. The beam particles are entering from the left.

As visible in fig. 7 the degrader showed a clear damage in the region where the

intense beam was crossing. The degrader is made out of two blocks pressed strongly together with screws. Both blocks arise from the same piece of lucite of 5 cm thickness. The second one was machined down to 4 cm a few hours before the irradiation started. During that procedure the block was warmed up considerably. This circumstance seems to be reflected in an interesting way in the damage profile. Beam particle hitting the blocks from left produce in the first one a brown zone which becomes smaller and weaker near to its end. At the entrance of the second block however a kind of phase transition seems to happen. Much stronger browning is observed. The widening of the profile is due to increasing multiple scattering of pions slowing down. The damage seems to be irreversible. After three months no change of the transparency has been observed.

- Fig. 7 : Photo of the side view of the degrader after irradiation with clearly visible damage in the irradiation region. The beam particles are entering from the left.

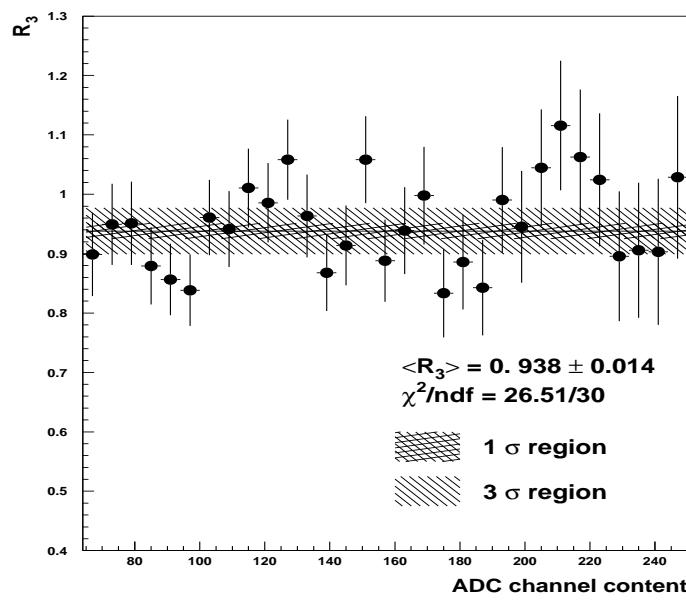
Fig. 8. Ratio of the sum of ADC-spectra for planes 2-5 of  $\mu$ FAST II after and before irradiation.

The ratio  $R_2$  of the average values of ADC-spectra measured with  $\mu$ FAST II after and before the irradiation is also shown in the table. It comes out to be near to unity, demonstrating that no clear radiation damage is appearing for the considered detector region. One would, however, like to prove whether the shape of the corresponding spectra remains unchanged too. That is shown in fig. 8, where the ratio  $R_3$  of the two sum spectra is distributed for the region of reasonable statistics of the data. All values are consistent with one within their errors, giving an average  $\langle R_3 \rangle$  which allows a decrease of the observed light signal of less than 10 % due to irradiation.

- Fig. 8 : Ratio of the sum of ADC-spectra for planes 2-5 of  $\mu$ FAST II after and before irradiation.
- Fig. 9 : Mean ADC-values as measured for cosmic ray particle crossing a pixel of a certain plane of  $\mu$ FAST II

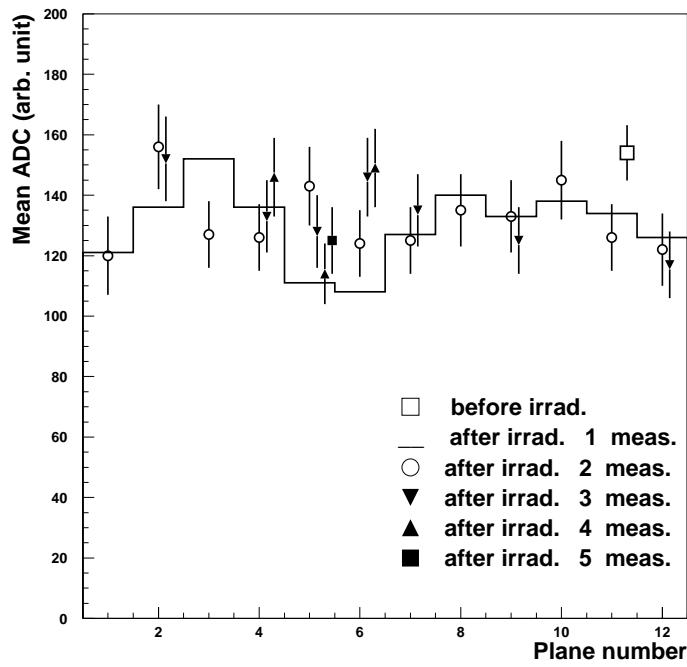
Fig. 9. Mean ADC-values as measured for cosmic ray particle crossing a pixel of a certain plane of  $\mu$ FAST II

In fig. 9 the results of all measurements are distributed versus the plane number and a rough order in time. In contrast to the impression from the first measurement no dependence on the plane number is observed. As can be seen from fig. 10 all data points follow a gaussian distribution.

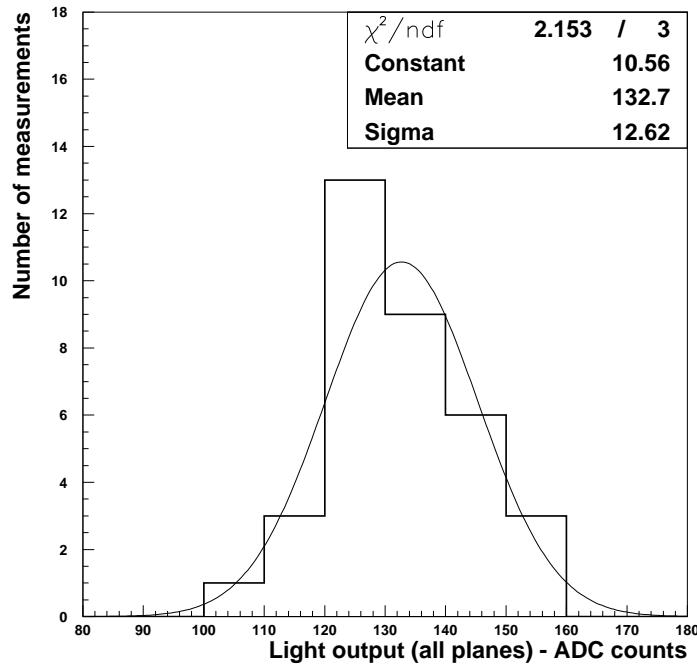
Fig. 10. Number distribution of measurements displayed in fig. 9 versus the measured variable.

Due to lack of time, only a single measurement has been done before irradiation in plane 11. It fits to the gaussian behavior of all data.

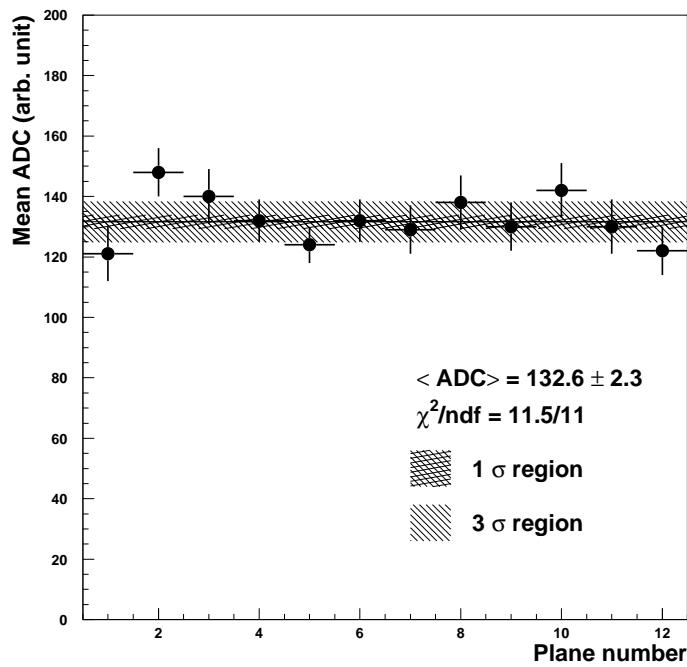
Fig. 11. Average of mean ADC-values for cosmic ray particle crossings per plane of  $\mu$ FAST II.

In fig. 11 the average values of the measurements per plane are shown together with a total average and its one and three sigma region. The single data point from before irradiation agrees with that average in  $1.4\ \sigma$ .
