Effect of Optical Coating and Surface Treatments on Mechanical Loss in Fused Silica

Andri M. Gretarsson, Gregory M. Harry, Steven D. Penn, Peter R. Saulson, John J. Schiller, and William J. Startin

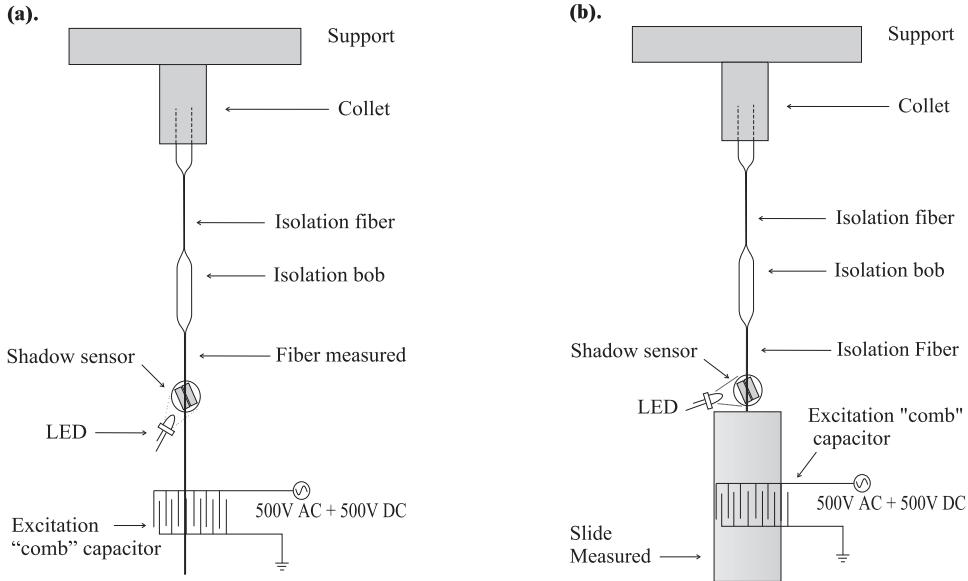
FIGURE 1. Schematic diagram of the experimental setups. (a). Setup for measuring fiber Q s. (b). Setup for measuring slide Q s. The isolation bobs and fibers prevent the measured sample Q from being degraded by rubbing in the clamp and from recoil in the lower Q support structure.

of dimensions $76 \text{ mm} \times 25 \text{ mm} \times 1 \text{ mm}$. The slides were suspended below a monolithic, fused-silica isolation system, as shown in Fig. 1b. The slides' vibration was monitored by positioning the LED and shadow sensor around the suspending fiber directly above the slide.

The coated Slide B was suspended from the center of one of its short edges, as shown in Fig. 1b. When the supporting fiber was connected to the slide using a hydrogen-oxygen torch the coating became visibly damaged. Where the flame from the torch contacted the coating, the coating took on a milky appearance. This occurred in a crescent shape approximately 3 mm across at the top of the slide. The high value of d_s for the second mode is believed to be due to this damage. To test this, the top 5 mm of this slide were immersed in a 50% solution (by weight) of HF and water for about 6 hours. Rinses with distilled water were applied periodically to remove flakes of the coating. The etch removed most of the damaged part of the

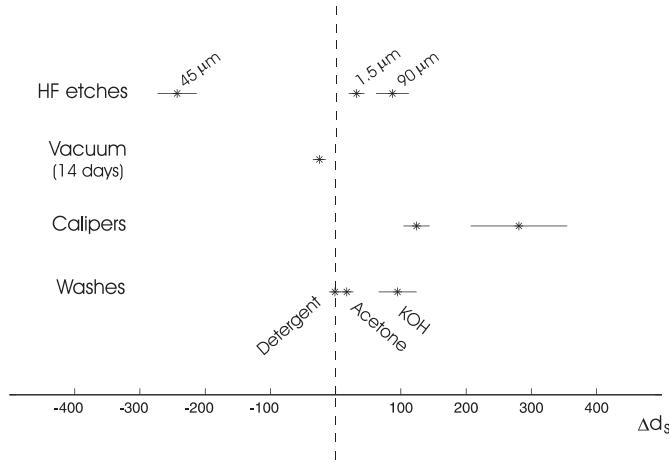
Figure 2 shows how strongly different treatments affected the surface of fibers. Most of the treatments either produced no change in the condition of the surface or they made it only slightly worse. However, pinching the surface at regular (1 cm) intervals with calipers significantly increased the dissipation depth, possibly due to small cracks formed by the mechanical contact. Similarly, the mechanically polished microscope slide had the highest measured d_s . It is interesting to note that the surface of Fiber I, after being significantly damaged by calipers, was restored to a condition better than as drawn (or perhaps more appropriately better than “as stored and handled”) by the $45 \mu\text{m}$ HF etch. The resulting dissipation depth agrees with the best as drawn case, having a value of about $100 \mu\text{m}$.

FIGURE 2. Change in the condition of fiber surfaces as compared to the initial surface as drawn, Δd_s vs treatment. Horizontal lines mark the uncertainty in Δd_s .
