Effect of Optical Coating and Surface Treatments on Mechanical Loss in Fused Silica

Andri M. Gretarsson, Gregory M. Harry, Steven D. Penn, Peter R. Saulson, John J. Schiller, and William J. Startin

Department of Physics, Syracuse University, Syracuse, NY 13244-1130, U.S.A.

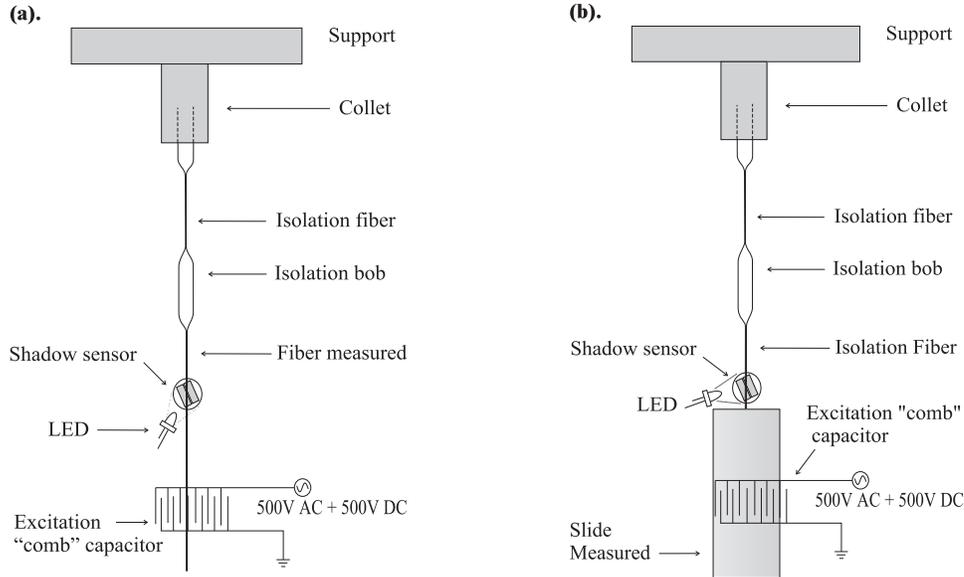
FIGURE 1. Schematic diagram of the experimental setups. (a). Setup for measuring fiber Q_s . (b). Setup for measuring slide Q_s . The isolation bobs and fibers prevent the measured sample Q from being degraded by rubbing in the clamp and from recoil in the lower Q support structure.

of dimensions $76 \text{ mm} \times 25 \text{ mm} \times 1 \text{ mm}$. The slides were suspended below a monolithic, fused-silica isolation system, as shown in Fig. 1b. The slides' vibration was monitored by positioning the LED and shadow sensor around the suspending fiber directly above the slide.

The coated Slide B was suspended from the center of one of its short edges, as shown in Fig. 1b. When the supporting fiber was connected to the slide using a hydrogen-oxygen torch the coating became visibly damaged. Where the flame from the torch contacted the coating, the coating took on a milky appearance. This occurred in a crescent shape approximately 3 mm across at the top of the slide. The high value of d_s for the second mode is believed to be due to this damage. To test this, the top 5 mm of this slide were immersed in a 50% solution (by weight) of HF and water for about 6 hours. Rinses with distilled water were applied periodically to remove flakes of the coating. The etch removed most of the damaged part of the coating and the Q was re-measured. The Q and dissipation depth of the second

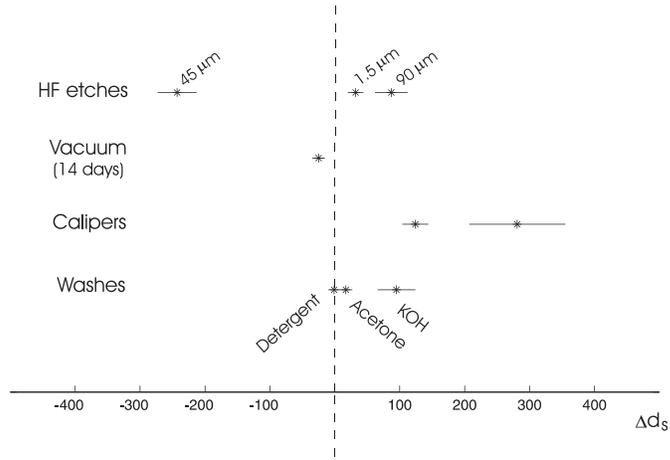
FIGURE 2. Change in the condition of fiber surfaces as compared to the initial surface as drawn, Δd_s vs treatment. Horizontal lines mark the uncertainty in Δd_s .

Figure 2 shows how strongly different treatments affected the surface of fibers. Most of the treatments either produced no change in the condition of the surface or they made it only slightly worse. However, pinching the surface at regular (1 cm) intervals with calipers significantly increased the dissipation depth, possibly due to small cracks formed by the mechanical contact. Similarly, the mechanically polished microscope slide had the highest measured d_s . It is interesting to note that the surface of Fiber I, after being significantly damaged by calipers, was restored to a condition better than as drawn (or perhaps more appropriately better than “as stored and handled”) by the $45 \mu\text{m}$ HF etch. The resulting dissipation depth agrees with the best as drawn case, having a value of about $100 \mu\text{m}$.
