# Autopsy on an RF-Processed X-band Travelling Wave Structure

F. Le Pimpec, S. Harvey, R.E. Kirby, F. Marcelja  
 SLAC, 2575 Sand Hill Road, Menlo Park CA 94025 , USA

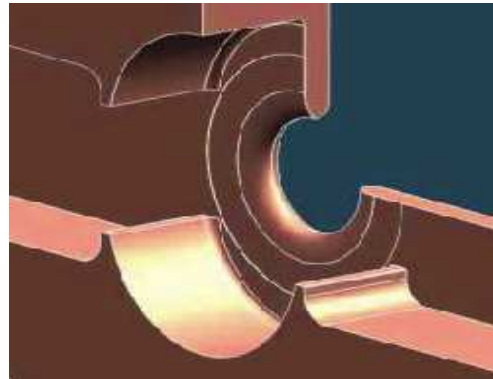
The breakdown pattern localization Fig.2 reveals that most of the breakdown are occurring in the input coupler (IC) of the TW. In Fig.3 we can see that the input coupler is divided into two parts the waveguide section, left side of the picture and the cell side in the center. The feature separating the waveguide side and the cell side is denominated "horns". The gap between the top and bottom horn is  $\sim 9$ mm.

Figure 3: Input coupler design. The center is the cavity side with the first iris
