Investigation of quasi-cleavage in a hydrogen charged maraging stainless steel

Investigation of quasi-cleavage in hydrogen charged aeronautical maraging stainless steel

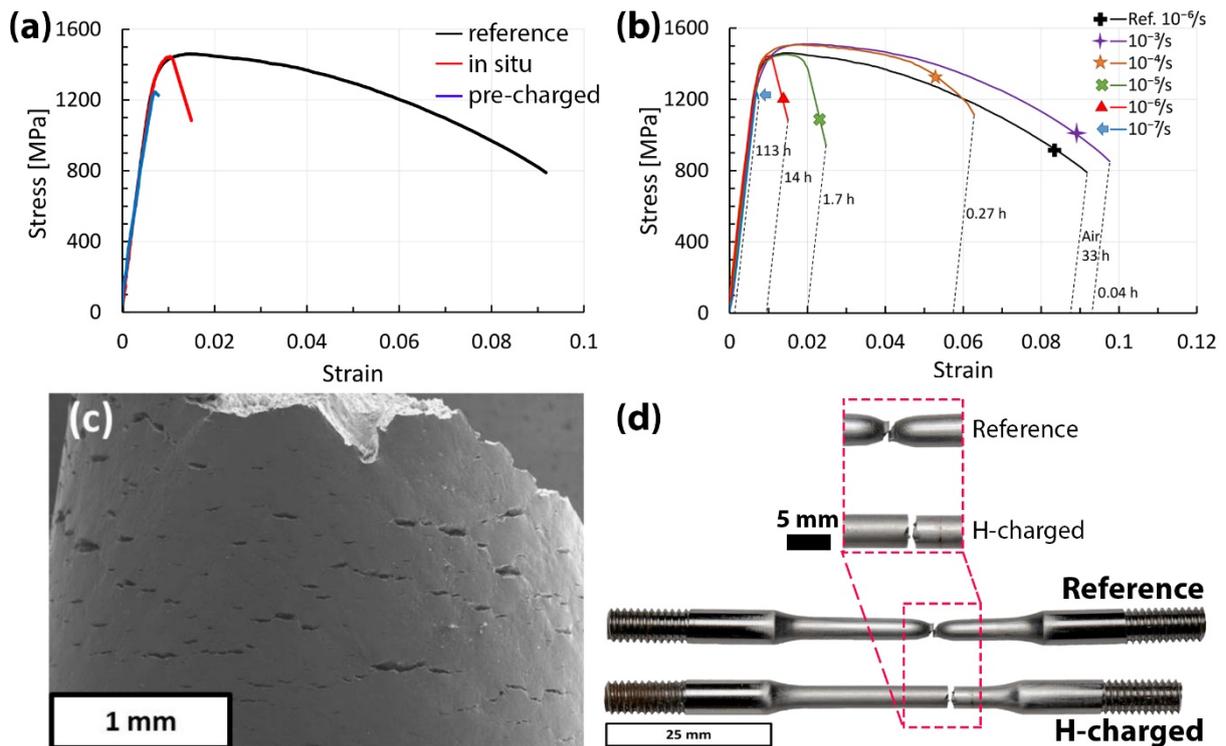
Fig.1. Tensile test results. (a) Stress-strain curves of PH13-8Mo (10^{-6} s^{-1} strain rate). The results obtained for tensile testing during cathodic charging (*in situ* condition, red curve) and for tensile testing in air after 120h of cathodic charging (pre-charged condition, blue curve) are compared to the reference test in air (black curve). (b) Influence of the strain rate on stress-strain curves during SSRT (*in situ* conditions). Note that higher flow stresses are observed at 10^{-3} s^{-1} and 10^{-4} s^{-1} experiments under H than at 10^{-6} s^{-1} under air. This is most probably an effect of strain rate rather than an effect of hydrogen. (c) Secondary electron side view of the sample tested at 10^{-4} s^{-1} with *in situ* H-charging, showing considerable secondary cracking. (d) Optical images taken of the reference and the *in situ* H-charged samples after SSRT at 10^{-6} s^{-1} .

Stress-strain ($\sigma - \epsilon$) curves obtained at 10^{-6} s^{-1} are shown in Fig. 1a. The yield strength and elongation at fracture for the reference specimen tested in air are $\sim 1400 \text{ MPa}$ and 9% respectively. It should be noted that the material shows very limited work hardening, as the ultimate tensile strength does not exceed 1430 MPa . The optical image of the reference sample after fracture (Fig. 1d) reveals significant necking, which is consistent with the progressive reduction in load visible on the tensile curve (black curve in Fig. 1a and b).

Fig. 1a shows considerable reduction of the elongation at fracture at 10^{-6} s^{-1} due to hydrogen in both *in situ* and pre-charged conditions. The optical image of the *in situ* H-charged sample after fracture (Fig. 1d) reveals no necking at all. The strain rate sensitivity of the *in situ* H-charged material was further investigated. In Fig. 1b, several *in situ* $\sigma - \epsilon$ curves are simultaneously plotted, including the reference curve deformed at 10^{-6} s^{-1} in air. The sensitivity to hydrogen embrittlement is shown to increase significantly with decreasing strain rate. Only at the strain rate of 10^{-3} s^{-1} , the H-charged sample could sustain similar elongation as the

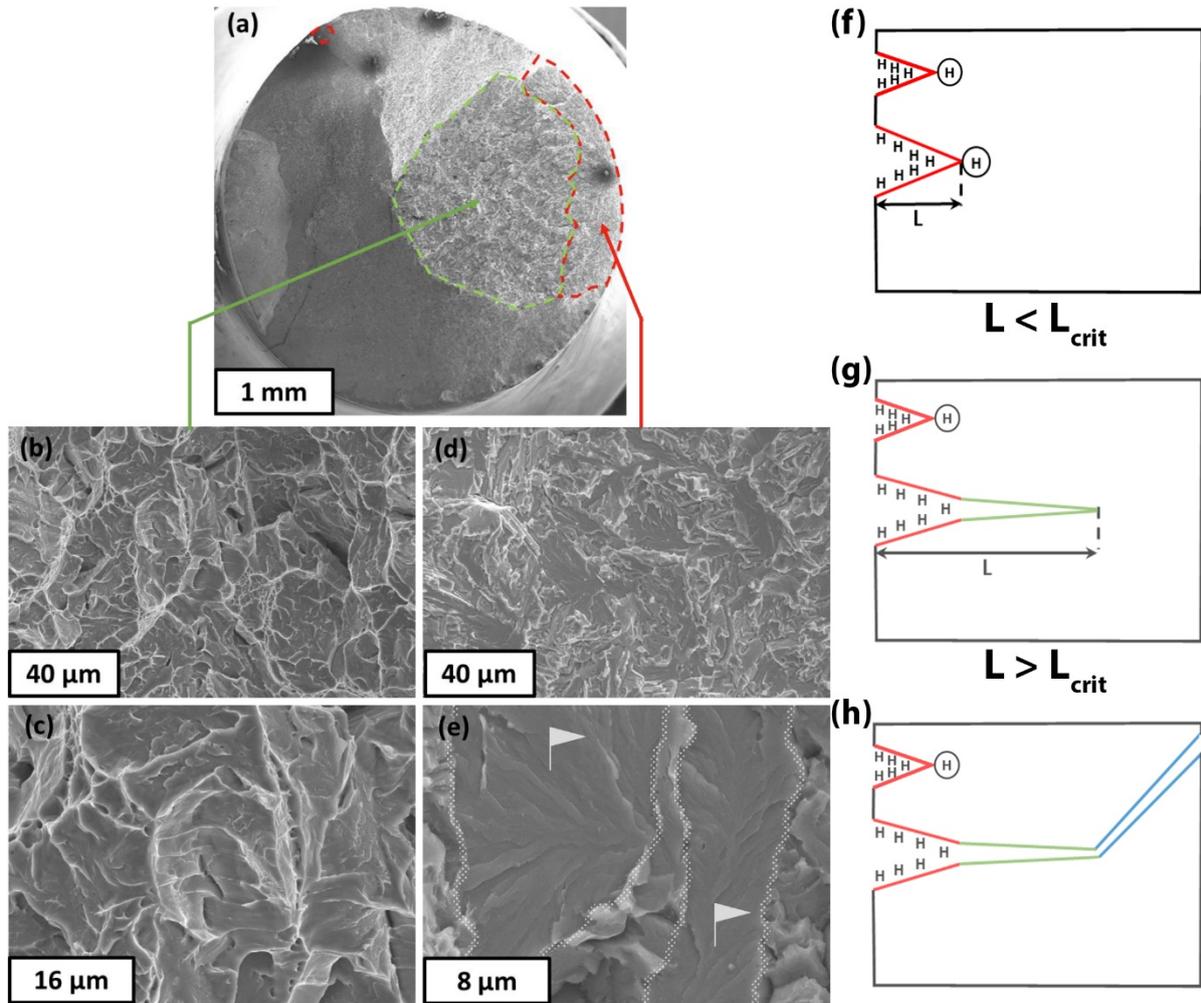
Fig. 2. Fracture surface morphologies. (a) Fracture surface of the sample tested *in situ* at 10^{-6} s^{-1} . The green region corresponds to ductile cracking (DC), associated with critical cracking. Higher magnification pictures of the DC region are presented in (b) and (c). The red region corresponds to quasi-cleavage (QC) cracking, associated with sub-critical cracking. Higher magnification pictures of the QC region are presented in (d) and (e). The rest of the fracture surface is composed of shear lips. (f-h) **Schematic representation of the sequence leading to the failure of a SSRT specimen in *in situ* H-charging condition.** (f) Slow propagation of a sub-critical crack assisted by hydrogen, which is adsorbed on crack surfaces and accumulates ahead of the crack tip. (g) Fast propagation of a critical crack after the sub-critical crack reached a critical length L_{crit} . The high crack growth rate most probably prevents any hydrogen/crack interaction. (h) Shearing leading to the final failure of the sample.

Fig. 2 shows the fractographic observations conducted on the sample tested *in situ* at 10^{-6} s^{-1} . The overall fracture surface can be divided into three distinct regions. In the region closest to the edge of the sample, the crack presents a quasi-cleavage (QC) morphology (red area in Fig. 2a). The QC surface (Fig. 2d) consists of flat facets with river patterns and of other rougher areas. Fig. 2e is a higher magnification image of two flat facets (marked with white flags), clearly showing some river patterns, surrounded by rougher areas.

The second part of the crack corresponds to the green area in Fig. 2a and is located deeper in the sample. The fracture surface in this part of the crack appears to be different from the QC region, including more curved and embossed patterns (Fig. 2b). The existence of small dimples is presented in Fig. 2c, that are not apparent in the QC region. Moreover, cleavage rivers are hardly ever observed in this inner part of the crack. Therefore, due to the more ductile aspect, we refer to this crack morphology as ductile cracking (DC).

Looking at the morphologies of fracture surfaces obtained at a strain rate of $\sim 10^{-6} \text{ s}^{-1}$ (Fig. 2a-e), the following hypothesis can be made on the sequence that led to the failure of the sample. In a first stage (Fig. 2f), hydrogen-assisted cracks initiated and propagated subcritically under the effect of hydrogen towards the centre of the sample, following a QC propagation mode. In a second stage (Fig. 2g), one of the QC cracks reached a critical length for which the stress intensity factor at the crack tip exceeded the fracture toughness value of the material. Consequently, the crack propagation shifted from sub-critical to critical. The critical crack propagated at a very high rate, which leaves insufficient time for any hydrogen to diffuse and allow embrittlement to take place. This critical crack propagation is therefore most probably uncorrelated with the presence of hydrogen and corresponds to the DC morphology. In a third stage (Fig. 2h), the final failure of the sample was obtained by shearing of the remaining ligament, corresponding to the shear lips on the fracture surface.

Given this mechanism, quasi-cleavage in the material investigated here can be rationalised as a discontinuous process involving i) actual cleavage cracks propagated along {100} type planes across single martensite blocks, and ii) ductile connections between cleavage cracks. This leads to the aspect of quasi-cleavage shown in Figs 2d and 2e, where flat and rougher areas correspond to cleavage facets and ductile connections, respectively.

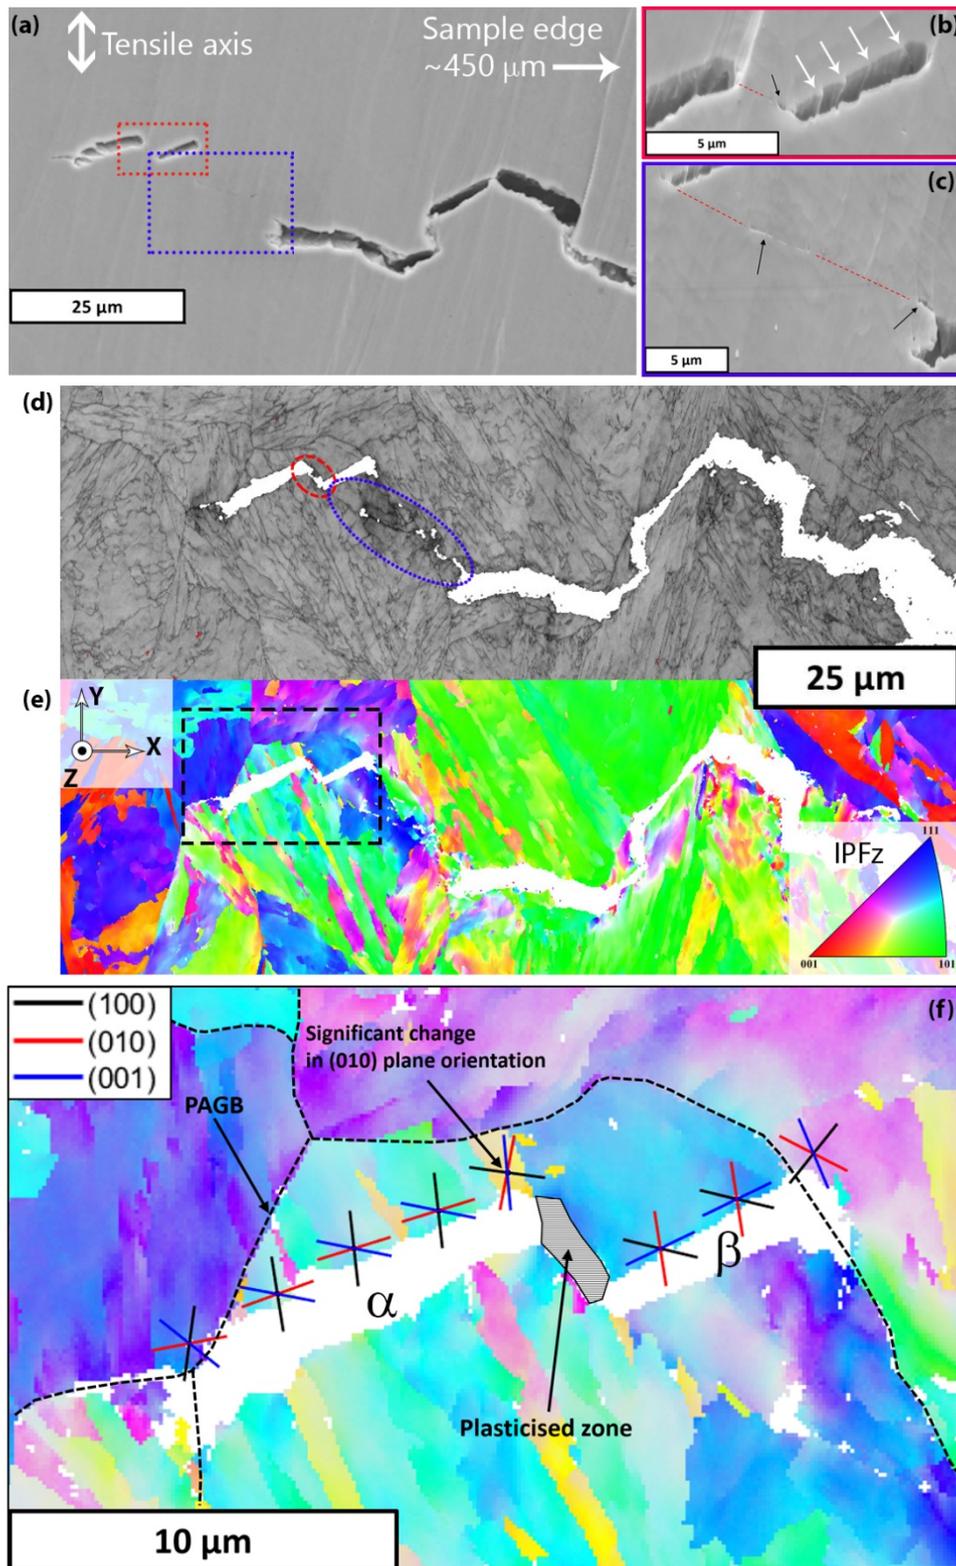
Fig.3. **EBSD results.** (a) Cross-sectional scanning electron micrograph of the secondary crack obtained *in situ* at 10^{-5} s^{-1} . (b) Higher magnification of the two internal cracks. (c) Higher magnification of the ligament between the main crack tip and one of the internal cracks. (d) EBSD band contrast map. Low-indexation plasticised zones are highlighted with circles. (e) The corresponding IPF map. (f) Higher magnification IPF map corresponding to the area indicated in (e) with a black dashed rectangle. The traces of $\{100\}$ type planes are indicated as well as the presence of plasticised zone.

Fig. 3 shows the secondary electron observations and the EBSD analysis of the crack tip region. The tensile axis corresponds to the vertical direction. Note that only the crack tip region (located at 450 μm from the specimen edge) was studied. The crack has a segmented aspect and shows many bifurcations (Fig. 3a). It is noticeable that two small cracks (α and β) are present ahead the main crack tip. These two cracks are apparently disconnected from the main crack (however since we can only get information from a 2D section of a 3D fracture structure, the discontinuity cannot be fully supported by one measurement). The two small cracks are separated by a small, uncracked ligament. Each of these two cracks is relatively straight (no bifurcation is present). However, steps are clearly visible in Fig. 3b on the cracked surfaces (highlighted by white arrows). Defects are observed (black arrows) between the two small cracks (Fig. 3b) and in the uncracked ligament separating the two small cracks from the main crack tip (Fig. 3c). Furthermore, the later area appears darker in the EBSD band contrast map (Fig. 3d), which is a first indication of locally intense plastic deformation.

The band contrast and inverse pole figure (IPF) maps shown in Fig. 3d and e show that the cracks are transgranular, i.e. they do not seem to follow prior austenite grain boundaries (PAGBs), or any other type of boundaries. Fig. 3f is a higher magnification IPF map focusing on the two small cracks located ahead the main crack tip. The dotted lines show the PAGBs. Each crack goes through *one entire* martensite block. In other words, the cracks stop at PAGBs or block boundaries. A highly plasticized zone is present between the two cracks, where EBSD indexation rate was found to be lower. To assess if those cracks follow a specific crystallographic plane, the traces of $\{100\}$ type planes are shown. Traces of $\{110\}$ -type planes are also shown in Suppl. Fig. S4. The crack directions observed here are consistent with a propagation along $\{100\}$ type planes. Suppl. Fig. S5 and S6 show complementary trace analysis of a secondary internal crack extracted from a pre-charged specimen tested at 10^{-5} s^{-1} .

boundaries. However, the lath boundaries cannot be clearly observed here because of their low misorientation. Nevertheless, it is known that inside a block, the lath boundaries are almost parallel with each other and with the block boundaries. The EBSD band contrast map in Fig. 3d seems to indicate that the two internal cracks are connected with each other, which is not the case, as previously shown in Fig. 1e-g. In the same manner, the connection between the internal cracks and the main crack tip seems more developed on the band contrast map than it really is according to the SEM observation. The reason is that the material is significantly deformed in these regions. It makes the EBSD indexation more difficult (due to blurred diffraction patterns), resulting in numerous not-indexed points that can be confused with effective cracks. The method used for the sample preparation prevented any material deformation. Therefore, it seems that it is the formation of the connections between cracks that involve significant plastic deformation.

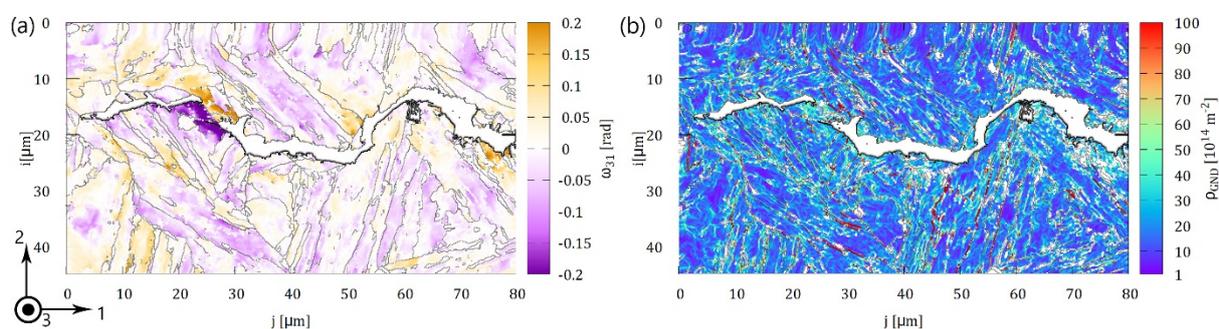
Fig.4. **HR-EBSD results.** (a) ω_{31} rotation tensor and (b) GND density map. Black lines highlight the high-angle grain boundaries (misorientation $>10^\circ$).

Fig. 3d suggests intense plastic deformation concentrated between cracks. To study these plastic zones, HR-EBSD was applied to calculate the lattice rotation tensor elements (ω_{ij}) and geometrically necessary dislocation (GND) density (ρ_{GND}) using the BLGVantage CrossCourt v4.0 software (Fig. 4). HR-EBSD is an image cross correlation technique utilized on the raw EBSD patterns [17], where a reference diffraction pattern is chosen at each grain to relate the state of each other pixel within that grain to this point. The results given by this technique are therefore relative to the reference patterns, that should ideally be selected at the minimal / zero stress state. In the absence of such references in our sample, HR-EBSD provide only a relative / qualitative support to the microstructure analysis to highlight the increased plastic zones around the cracks. More information about the HR-EBSD experiments are provided in the Suppl. Materials.

Increased ω_{31} values (Fig. 4a) were found around the plasticised zone located between the main crack and the two internal cracks, indicating large lattice rotations in this area. This confirms the local intense plastic activity suggested by the band contrast map of Fig. 3d. The concentration of plastic deformation between the cracks suggests that this plastic deformation results from the mechanical interaction between cracks under tensile loading. This would imply that the cracks were formed first and the locally intense plastic deformation occurred later. Further components of the ω_{ij} tensor can be seen in Suppl. Fig. S7.

The estimated ρ_{GND} map (Fig 4b) shows an overall high dislocation density (of the order of 10^{15} m^{-2}), comparable to other measurements in similar materials [19, 20]. The dislocations are mainly concentrated along lath boundaries, typical to martensitic steels [19]. On the other hand, no significant local increase of the dislocation density is measured in the plasticized zone located between the cracks. This can be related to the quasi-absence of work-hardening in this material, where plastic deformation is obtained from movements of the already existing dislocations, rather than by dislocation multiplication.

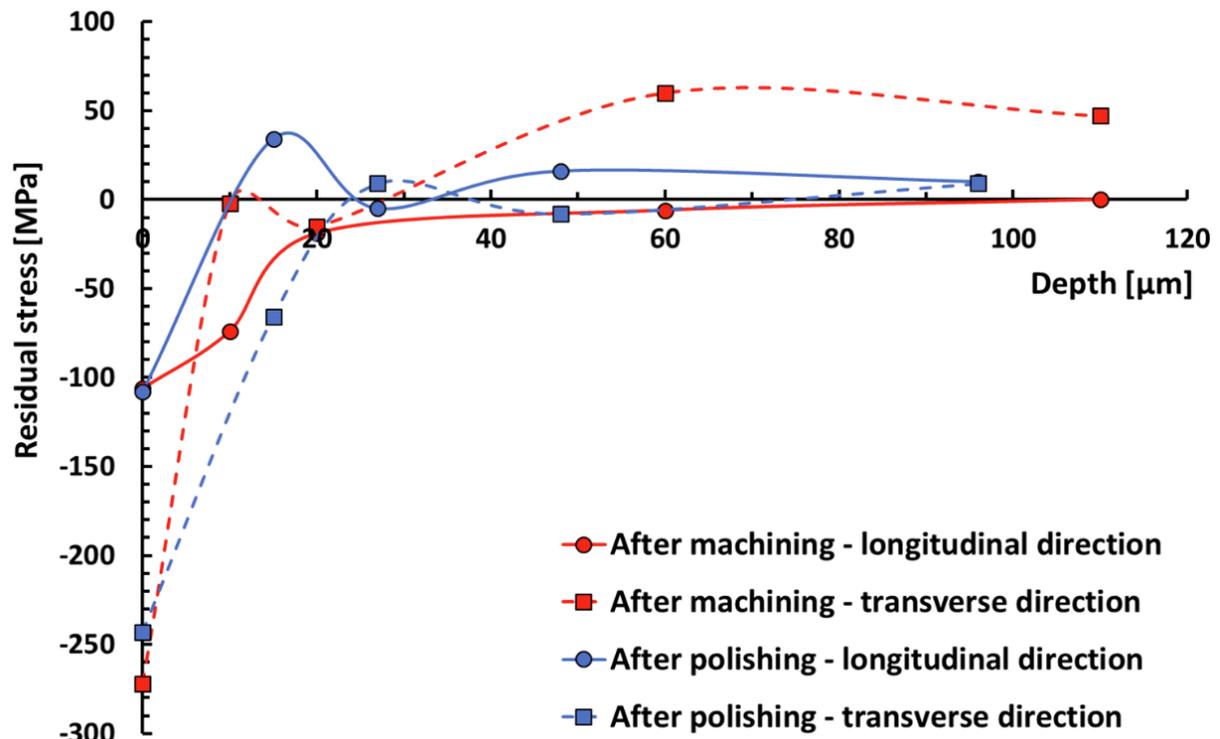
Suppl. Fig. S1. Residual stress measurements (by XRD) at the surface and subsurface of a SSRT sample after machining and after polishing.

The polishing of samples has the dual purpose of reducing uncontrolled surface defects that can act as initiation sites for cracks and removing the material thickness affected by residual stresses. In order to assess the effect of polishing on residual stresses, measurements were conducted using X-ray diffraction (XRD) and electrochemical grinding in order to obtain a depth profile of residual stresses. These studies were performed on two SSRT specimens: one was in the as-machined state and the other one was polished after machining. The residual stresses were determined in the longitudinal and transverse directions. The spot size of these X-ray measurements is of the order of 1 mm in diameter. The results are presented in Suppl. Fig. 1. It can be seen that residual stresses are mainly found in the transverse direction, and are mainly located at the surface. It also appears that the polishing step had a very limited effect on the residual stress, probably because the layer of material removed during polishing is too thin (it was measured to be about 5 μ m). However, the residual stresses appear to be mainly compression stresses in both machined and polished samples, which is supposed to mitigate cracks initiation. In addition, the stress level measured is far below the yield strength of the material in any case.

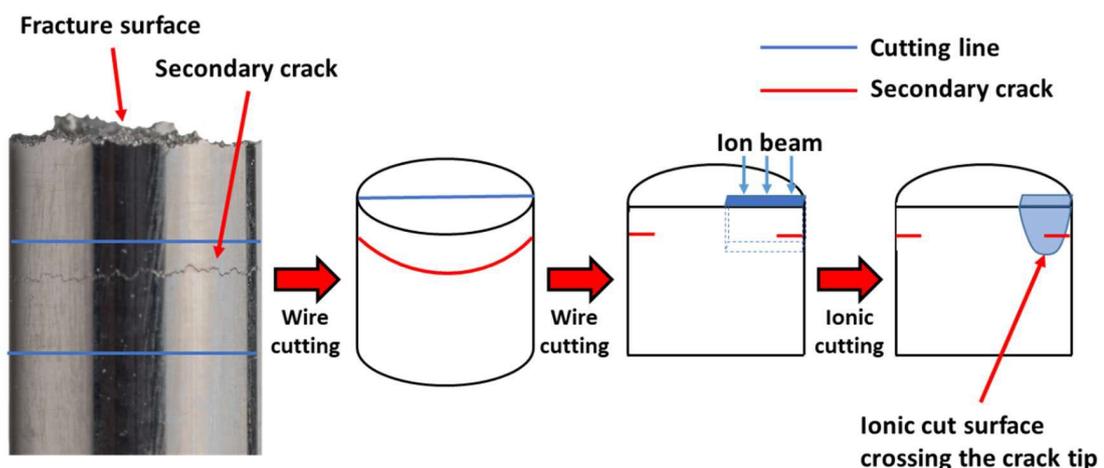
Suppl. Fig. S2. Schematic representation of the procedure used to extract and prepare the sample in order to study the crack path. The ionic cut surface, containing the crack tip can be directly analysed by EBSD.

The secondary crack was extracted from the bulk sample by wire cutting, then Ar ion cross-polishing was applied on the surface (JEOL IB-19530CP).

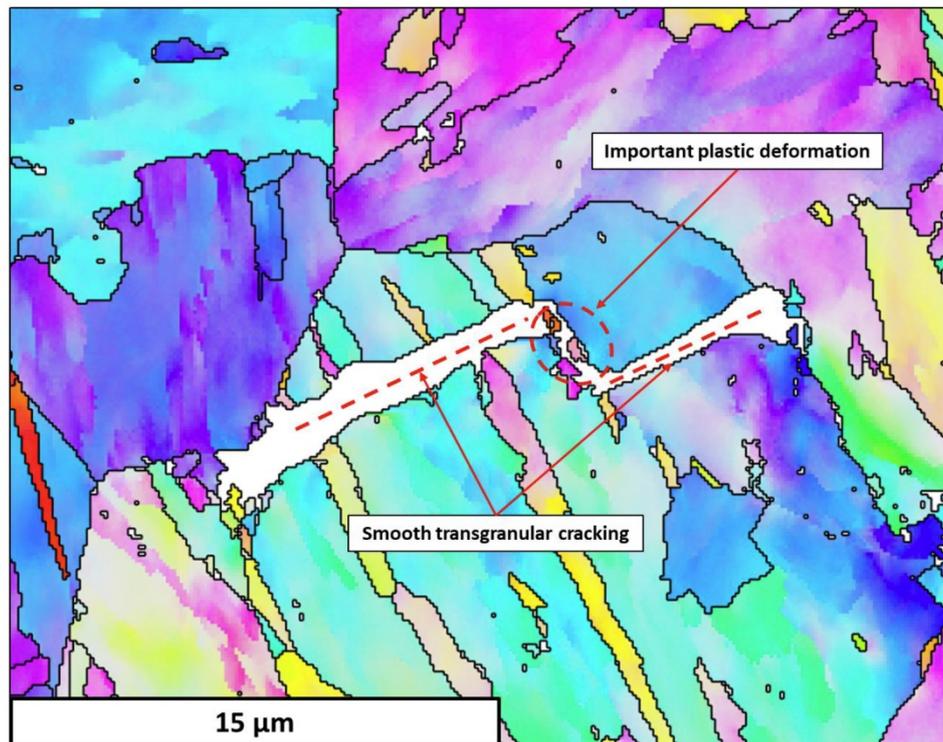
Suppl. Fig. S3. Magnification of EBSD IPF map on the internal cracks region. Detected boundaries ($>3^\circ$) have been plotted with black lines. The two smooth sections seem to be transgranular. What seems to be a connection between the two smooth sections is in fact a heavily plasticised zone, resulting in low indexation.

Boundaries are marked with black lines in Suppl. Fig. S3, which correspond to PAGBs, packet and block boundaries. At first sight it does not seem that the crack is propagating along these

The secondary phase austenite in maraging stainless steels mainly consists of thin layers of reverted austenite, located at the boundaries of the martensitic structure [S1, S2, S3]. However, it is evidenced here (Suppl. Fig. S3) that the QC cracks in this material do not follow grain boundaries. It is therefore not expected that the secondary austenitic phase interacts significantly with the hydrogen-assisted cracks.

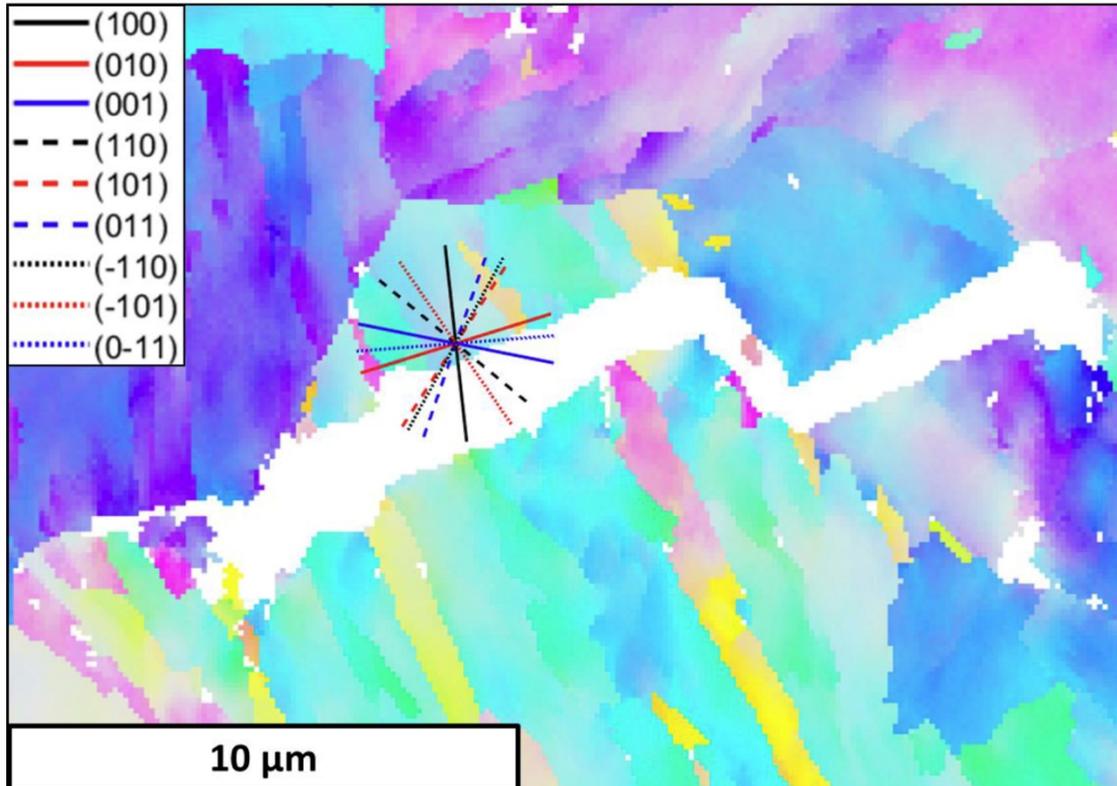
Suppl. Fig. S4. EBSD IPF map displaying local traces of the $\{100\}$ and $\{110\}$ planes close to the crack edge.

In Suppl. Fig. S4, the traces of $\{100\}$ and $\{110\}$ type planes are shown. The $\{100\}$ planes are the cleavage planes in BCC iron, and the $\{110\}$ planes are the martensitic laths habit planes. We remind the Reader that the martensitic matrix of the studied alloys presents a BCC structure (not tetragonal), mainly because of its very low carbon content. Thus, transgranular cleavage cracks should follow $\{100\}$ planes and intergranular cracks that propagate along lath boundaries (or parallel block boundaries) should follow $\{110\}$ planes. It can be seen that the only trace lying parallel to the crack edge corresponds to the (010) plane. As a consequence, it is likely that the crack locally follows a (010) cleavage plane.

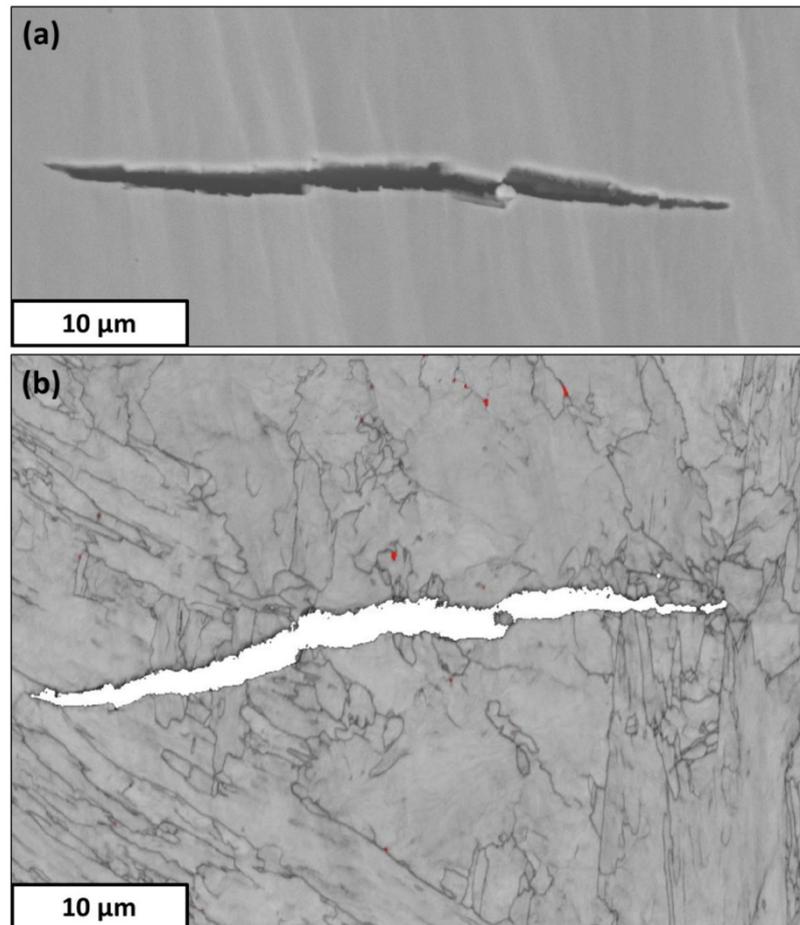
Suppl. Fig. S5. Internal crack in a sample tested at 10^{-5} s^{-1} in H-pre-charged condition. (a) Cross-sectional SEM micrograph of the area selected for EBSD analysis and (b) EBSD band contrast map.

In pre-charged condition, the cracks form internally, and rarely connect the side surface of the sample. As a consequence, it is challenging to cut through a crack, as it cannot be located before cutting. We only managed to cut through small secondary cracks, the largest one being investigated here, and we did not observe connections between cracks. Suppl. Fig. S5 presents a SEM observation and an EBSD band contrast map of a secondary crack after testing in pre-charged condition at a strain rate of 10^{-5} s^{-1} . According to the band contrast map, the internal crack presented here seems to follow a transgranular path.

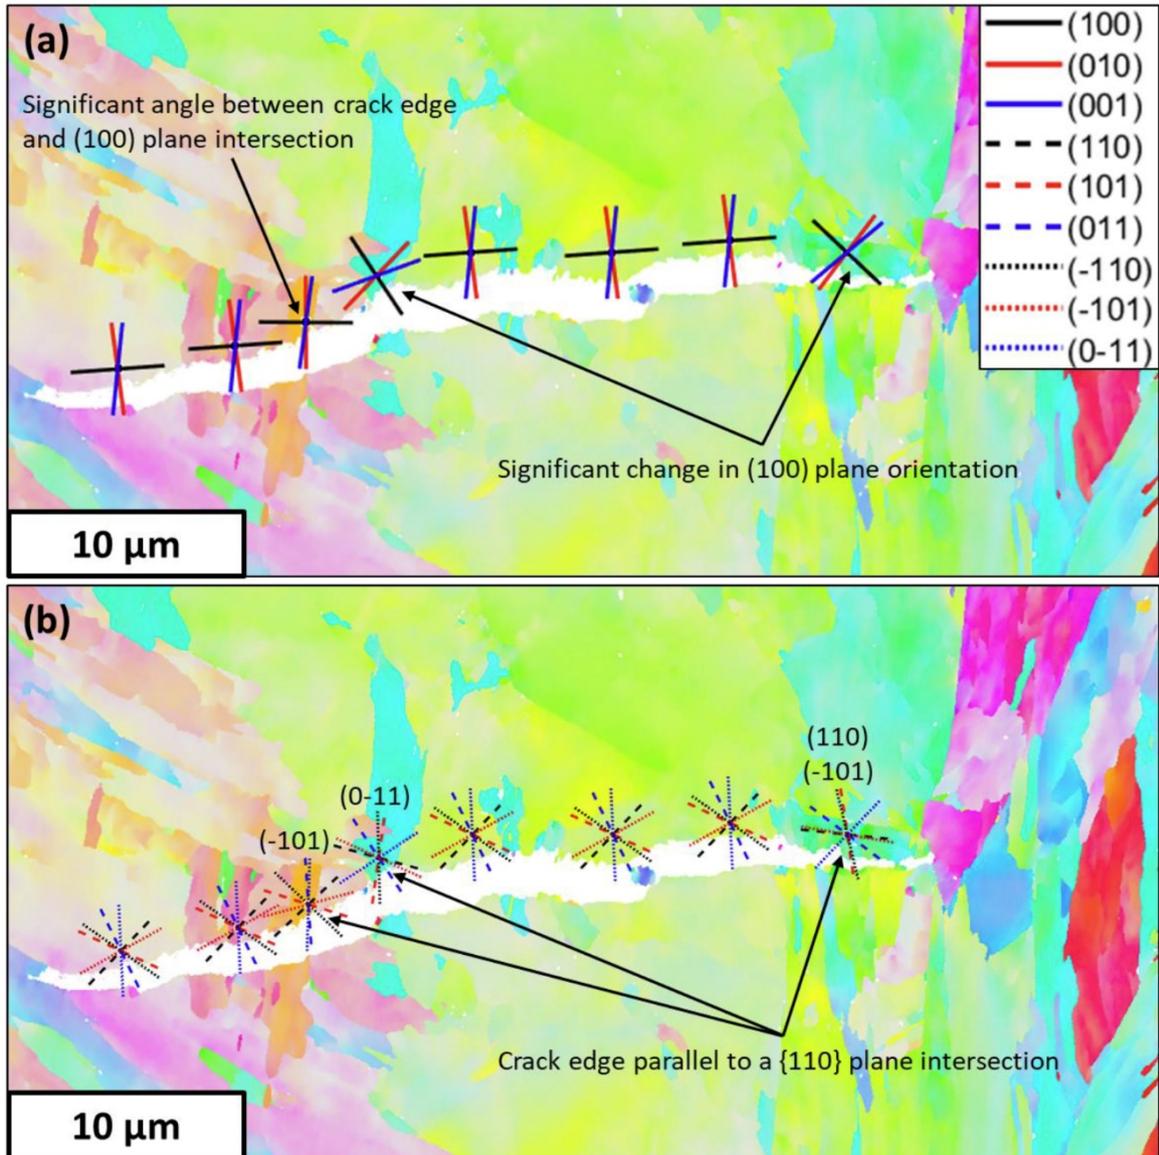
Suppl. Fig. S6. Internal crack in a sample tested at 10^{-5} s^{-1} in H-pre-charged condition. EBSD IPF map showing traces of (a) $\{100\}$ planes and (b) $\{110\}$ planes. Overall, the crack seems to follow $\{100\}$ cleavage planes, although better agreement is found with $\{110\}$ planes in some part of the crack.

The traces of the $\{100\}$ cleavage planes are presented in Suppl. Fig. S6a. It can be seen that the crack globally seems to follow $\{100\}$ cleavage planes. This observation was made in the previous analysed cracks as well. However, traces of the $\{110\}$ planes presented in Suppl. Fig. S6b show that some part of the crack better align with $\{110\}$ planes.

In summary, the QC cracking in pre-charged samples seems to consist in transgranular cleavage failure along $\{100\}$ planes. It appears that the crack can also follow $\{110\}$ planes, which are the habit planes of martensitic laths. Even though it suggests a failure along the lath boundaries, the EBSD map presented in Suppl. Fig. S6b indicates that the cracking occurred across the blocks. Therefore, it is unlikely that the crack followed lath boundaries, which are almost parallel to the block boundaries. However, the $\{110\}$ planes are also slip planes in BCC iron, and transgranular hydrogen-assisted cracking along these planes has already been reported in the literature [12]. Thus, it appears that hydrogen-assisted cracking along $\{110\}$ slip planes is possible in PH13-8Mo in the testing conditions of this study, despite not being the preferential cracking path.

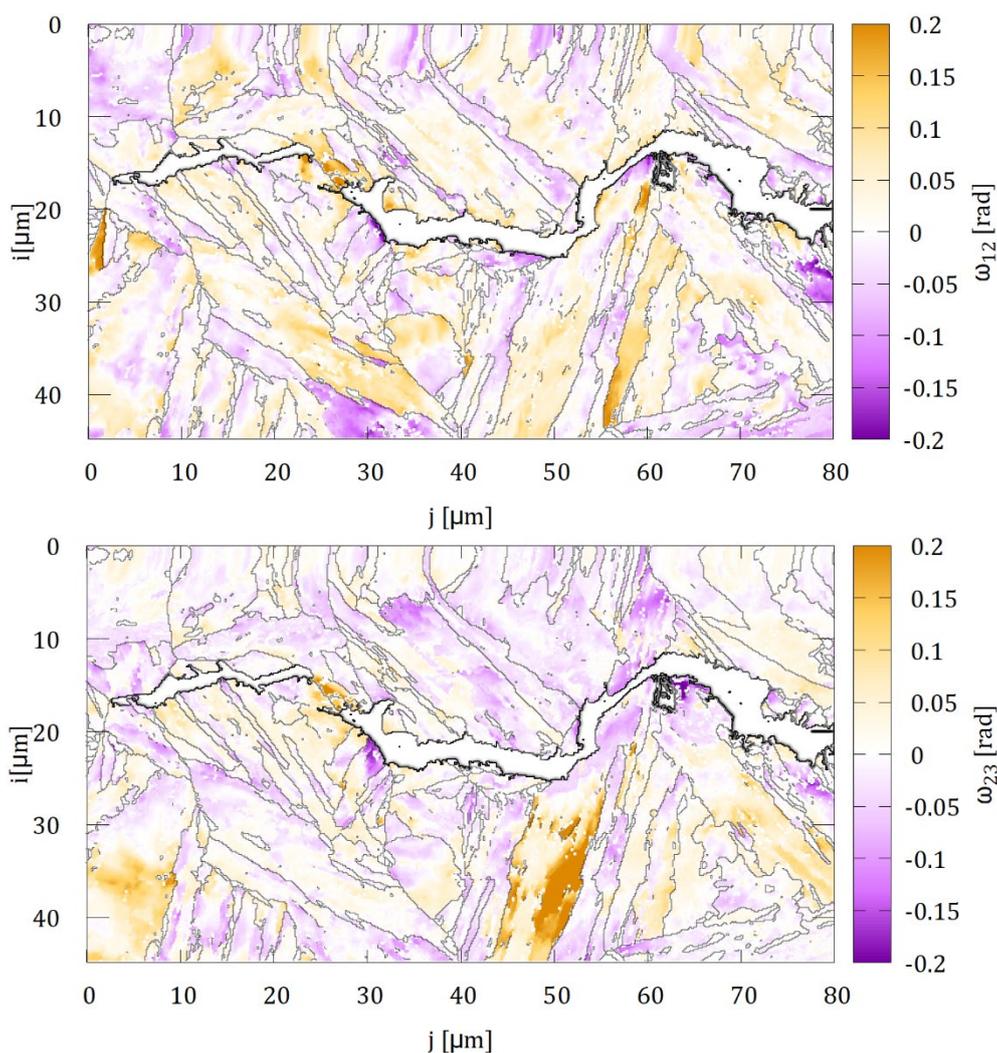
Suppl. Fig. S7. HR-EBSD rotation tensor components ω_{12} and ω_{23} .

For the HR-EBSD evaluation, the sample's surface was re-polished with Ar ions (3 kV, 15 min) to remove the oxidised layer that has formed after some storage time in air. The patterns were recorded with a 2×2 binning (672×512 px² resolution) with a step size of 150 nm and frame averaging of 6, using a 20 kV high current electron beam. Small grains containing less than 50 measurement points were excluded from the evaluation, along with the pixels with low quality diffraction patterns (i.e. data recorded at the crack). Fig. S7 shows the ω_{12} and ω_{23} rotation tensor components (the ω_{31} is shown in Fig.4).
