Wear and corrosion properties of Mg(OH)₂ compound layer formed on magnesium alloy in superheated water vapor

Abstract: The wear resistance of magnesium and its alloys is very poor due to their inherent low hardness and poor tribological properties. Improving the wear resistance of magnesium and its alloys plays a significant role in expanding their application range. Various surface treatments have been used to produce protective coatings or layers for solving this problem. In this work, the Mg(OH)₂ layer with a thickness about 25 μm was directly formed on AZ91 magnesium alloy by oxidizing in superheated water vapor. SEM and XRD were employed to characterize the microstructure and phase composition of oxidized layer. The effect of oxidized layer on the friction and wear properties of magnesium alloy against the bearing steel ball were evaluated by using a reciprocating friction and wear test apparatus. The results showed that layer exhibited low friction coefficients and extremely small wear loss compared to the untreated substrate.

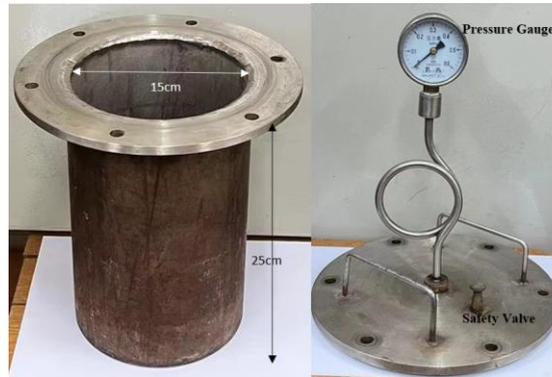
Fig.1 Photograph of the container used to prepare Mg(OH)₂ on magnesium alloy.

The magnesium alloy used in this study is AZ91D, with a chemical composition (wt.%) of Al (8.3-9.7), Zn (0.35-1.0), Mn (0.15-0.5) and Mg (balance). Specimens with a thickness of 5 mm were cut from a bar with a diameter of 12 mm. Prior to treatment, the samples surfaces were mechanically abraded using silicon carbide papers (400-1200grit). Figure 1 illustrates the container utilized for processing the magnesium alloy. The vessel is constructed from stainless steel, with a total volume of 4.4 liters. The magnesium alloy samples were placed on a sample holder within the container. An appropriate amount of tap water was added to the container, ensuring that the all water could be converted into vapor at the selected heating temperature without excessively increasing the pressure inside the container, thus avoiding any potential hazards. The container was then sealed, heated to reach a required temperature of 200oC and held at this temperature for 4 h. Apart from the sandpaper abrasion, no any additional

pretreatments were required for the samples. The process of layer formation consumed only electrical energy and a very little amount of water, with no other consumables or emissions.

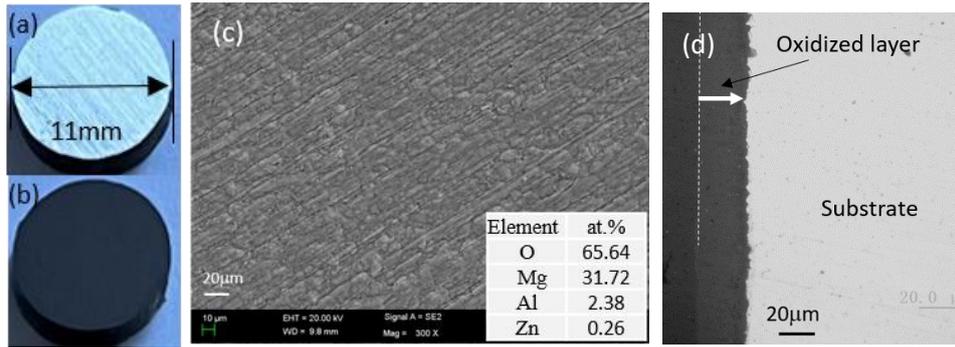
Fig. 2. Appearances of magnesium alloy samples: (a) original, (b) oxidized, (c) surface and (d) cross-section microstructure of $\text{Mg}(\text{OH})_2$ layer.

Fig. 2 shows appearances of original and oxidized magnesium alloy samples and polished cross-sections of Mg(OH)₂ layer formed on AZ91.

From Fig. 2 (a) and (b), the appearance of untreated magnesium alloy sample, when viewed by the naked eye, displayed a typical metallic luster on their surface. However, following oxidation treatment, the surface assumed a uniform deep black coloration. Fig. 2 (c) shows the surface morphology of the oxidized layer by SEM and the composition provided by EDX analysis. It can be observed that the atomic ratio between oxygen and magnesium in the layer is very close to 2:1, confirming that a layer composed of magnesium hydroxide has been obtained after oxidation in water vapor following the reaction $\text{Mg} + 2\text{H}_2\text{O} \rightarrow \text{Mg}(\text{OH})_2 + \text{H}_2$. From Fig. 2 (d), it can be seen that the oxidized layer was also black observed under the optical microscope. The layer was dense and homogeneous without evident defects. Therefore, it is very easy to measure the thickness of the layer. The thickness of the layer is about 25 μm . There was no any problem for adhesion between layer and matrix due to forming the layer through oxidization of magnesium.

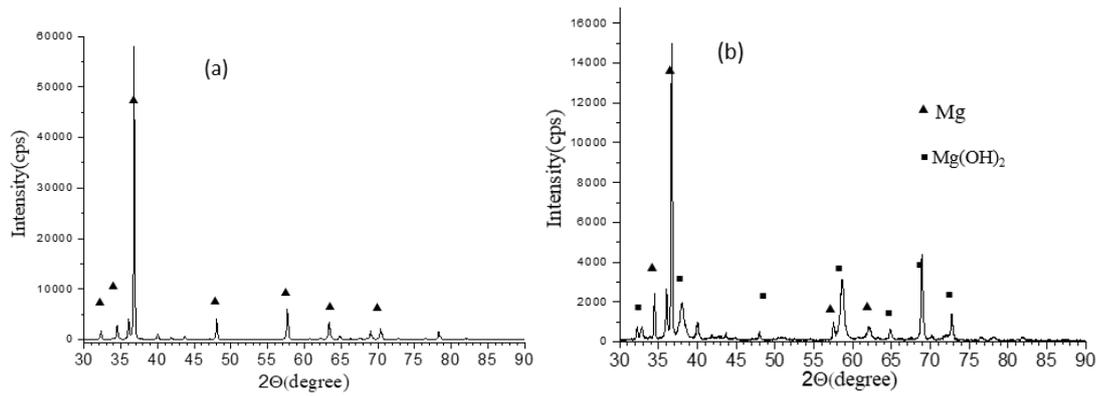
Fig. 3. XRD analysis of AZ91 alloy samples: (a) untreated, (b) treated in 200°C superheated water vapor for 2 h.

Fig. 3 presents the XRD patterns of untreated and oxidized AZ91 magnesium alloy. The untreated AZ91 alloy mainly composed of hexagonal Mg phase. After oxidation treatment, the diffraction peak intensities corresponding to Mg all weakened relatively. Distinct diffraction peaks emerged at 32.8° , 38.1° , 58.7° , 62.2° , and 68.9° , which are attributed to the diffraction generated by the (100), (101), (110), (111), and (200) crystallographic planes of $\text{Mg}(\text{OH})_2$, respectively. Despite the thickness of the layer reaching about 25 μm , the diffraction peaks originating from the substrate maintained a significant level of intensity. The reason is that the constituent elements magnesium and oxygen in the layer have low mass absorption coefficients for X-rays, especially oxygen, which has a mass absorption coefficient for Cu radiation of less than one-third that of copper. Therefore, diffraction peaks originating from the substrate still retain considerable intensity.

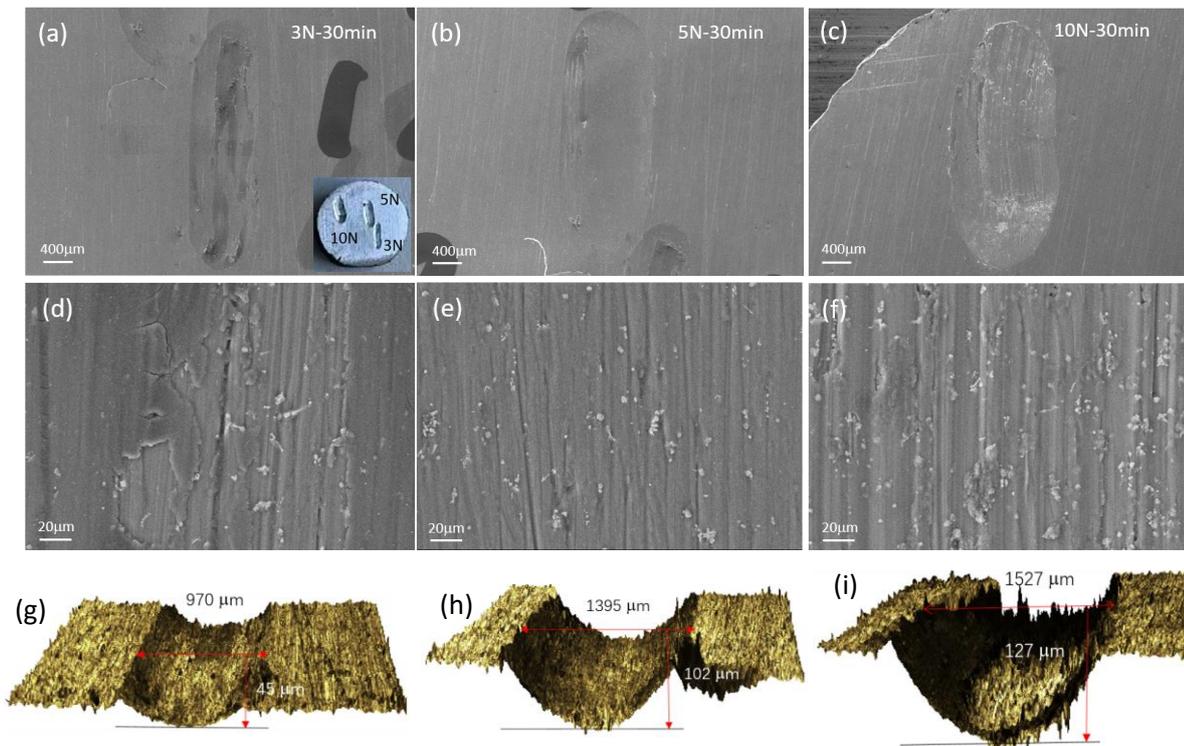
Fig. 4. The micrograph of wear tracks of the untreated AZ91 magnesium alloy under different loads: (a, d, g) for 3 N, (b, e, h) for 5 N and (c, f, i) for 10 N.

The wear scars of untreated sample after sliding 30 min under a load of 3, 5 and 10 N were observed by SEM and illustrated in Fig. 4.

SEM and 3D morphologies of wear track with different magnifications after sliding 30 min under 3 N load are displayed in Fig. 4 (a, d, g). It is observed that after wear test, the resultant wear track on the sample surface measured approximately 930~1000 μm in width. A detailed examination revealed that the evident oxide adhesion and scratches were visible in the enlarged wear track areas. The depth of wear scar reached about 45 μm . At a load of 5N, a marked

increase in the width of the wear track is observed, reaching 1320~1400 μm with the wear tracks predominantly characterized by grooves and minimal oxide deposits. The depth of wear scar increased to about 102 μm . With the load increasing to 10 N, the wear track generated is distinctly different from those produced by 3N and 5N loads. In addition to the further increase in wear track width to 1520~1600 μm , the worn region exhibited severe plastic deformation, as well as signs of adhesion and tearing accompanied by with evident furrows. The wear scar had a depth reaching about 127 μm . These results indicate that the load had a significant impact on the tribological properties of magnesium alloys. At lower load conditions, the dominant wear mechanisms are oxidation and ploughing. However, with the increase in load, a combination of ploughing, plastic deformation and adhesion was the wear mechanism.

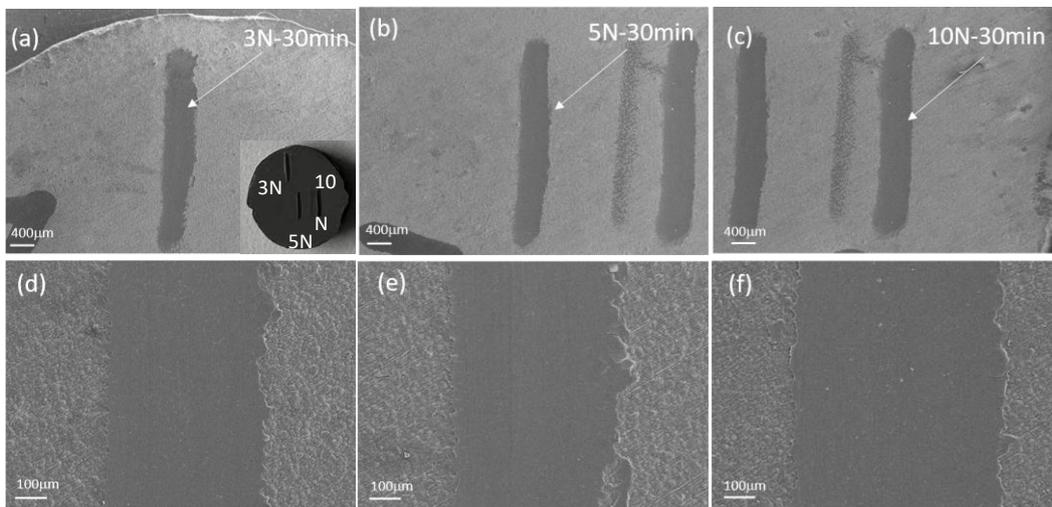
Fig. 5. SEM images of wear scar on treated AZ91 magnesium alloy after test under three loads.

The SEM morphologies of wear tracks created on the oxidized sample surface under three different loads are presented in Fig. 5. Compared to the untreated samples, under the same wear conditions, there is no obvious difference in the morphology of the wear tracks obtained for three loads. The width of the wear tracks ranges from about 500 to 600 μm under the three loads after sliding for 30 min. The wear track areas are very smooth and level, with no observable scratches, resembling a polished appearance. After 30 minutes of wear, in addition to the clearly visible wear tracks on the sample surface, no signs of scratches, adhesion, or plastic deformation were observed. The wear mechanism appears to be in the form of grinding and polishing. The results show that significant improvements in the wear resistance of AZ91 magnesium alloy can be achieved by treatment in superheated water vapor.

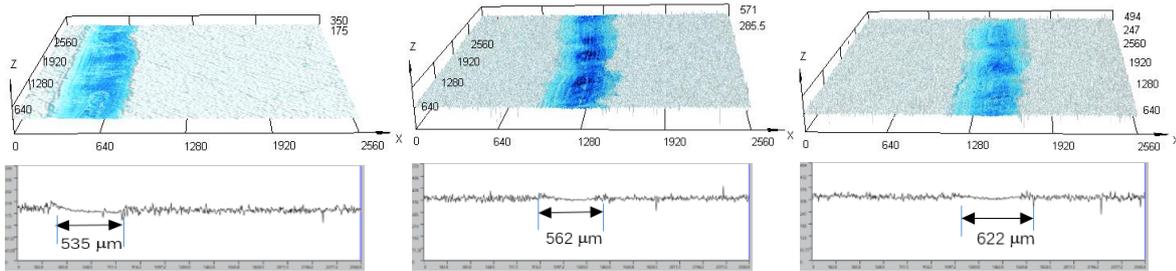
Fig. 6. Three and two dimensional profilometry of wear tracks left on the oxidized sample after sliding wear for 30 min at 3 N, 5 N and 10 N respectively.

3 and 2 D profilometry of wear tracks left on the oxidized sample are presented in Fig. 6. The width of the wear tracks left on the surface of the oxidized samples was significantly reduced compared to the untreated samples, measuring 535, 562 and 622 μm for 3N, 5N and 10 N load, respectively. Additionally, the depth of the wear tracks was also significantly reduced to about 5, 7 and 12 μm for 3, 5 and 10 N load respectively. The narrow and shallow wear track of oxidized sample also indicated that the wear loss was dramatically reduced.

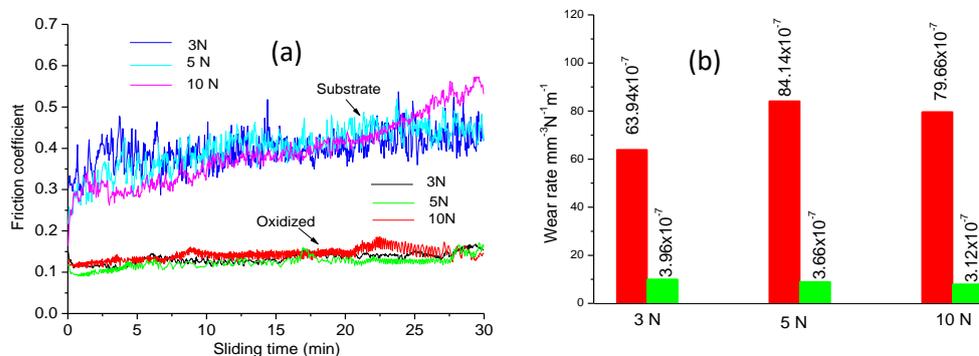
Fig. 7. The curves of friction coefficient (a) and wear rate (b) of untreated and treated AZ91 magnesium alloy after sliding for 30 min under different loads.

The friction coefficient and wear rate for untreated and treated samples underwent sliding for 30 min under a load of 3, 5 and 10 N are shown in Fig. 7.

For the untreated magnesium alloy sample, the friction coefficient quickly rose to about 0.4 once the test started, then fluctuated between 0.35 and 0.45 under 3 N and 5 N loads. In contrast, as the load increased to 10 N, the friction coefficient displayed a progressive increase until the end of the test, rising from an initial value of around 0.3 to about 0.55, albeit with a slightly diminished amplitude of fluctuation. Compared to the untreated sample, the friction coefficients of the oxidized sample significantly decreased under the action of all three loads. The coefficients remained predominantly within the range of 0.12 to 0.17. The fluctuation was also

evidently decreased within a very narrow scope. These results suggested that the magnesium hydroxide layer formed on the surface of magnesium alloy by oxidation possessed superior tribological characteristics. The wear rate of untreated sample was $63.95 \times 10^{-7} \text{ mm}^3\text{N}^{-1}.\text{m}^{-1}$ for 3 N, $84.14 \times 10^{-7} \text{ mm}^3\text{N}^{-1}.\text{m}^{-1}$ for 5 N and $79.66 \times 10^{-7} \text{ mm}^3\text{N}^{-1}.\text{m}^{-1}$ for 10 N. For oxidized sample, the wear rate was $3.96 \times 10^{-7} \text{ mm}^3\text{N}^{-1}.\text{m}^{-1}$ for 3 N, $3.62 \times 10^{-7} \text{ mm}^3\text{N}^{-1}.\text{m}^{-1}$ for 5N and $3.12 \times 10^{-7} \text{ mm}^3\text{N}^{-1}.\text{m}^{-1}$ for 10 N. Compared to the untreated samples, the wear rates are reduced by approximately 16, 23, and 25 times, respectively. Low friction coefficient and wear rate meant that the tribological properties of magnesium alloy were greatly improved by forming a $\text{Mg}(\text{OH})_2$ layer in water vapor. The wear resistance of magnesium alloy was improved by depositing Ti-DLC monolayer and Ti/Ti-DLC multilayer films with filter cathodic vacuum arc deposition technology. Under a load of 5 N and a frequency of 1 HZ, the friction coefficient of all coatings was below 0.12, the wear rate was 2–3 orders of magnitude lower than that of uncoated the magnesium alloy [17]. Das et al., reported a high wear resistant TiC/Co/Y₂O₃ composite coating which was synthesized on the surface of AZ91D Mg alloy by plasma transferred arc coating process. The wear rate was reduced about seven times as compared to AZ91D Mg [18]. Chen et al. used ultrasonic impact treatment to simultaneously fabricate surface Ti-MoS₂ self-lubricating coatings on AZ91Dmagnesium alloy. The coated samples exhibited superior anti-wear properties. Compared to untreated samples, the wear volume at 5 N, 15 N, and 25 N loads was reduced by 89.78 %, 84.23 %, and 43.88 %, respectively [8]. To achieve superior corrosion and wear resistance, Wang et al. prepared a Ni–WC/Al–Ni functionally graded coating on AZ91D Mg alloy. The wear resistance of the coating was 5–8 times that of the substrate [19]. Ding et al. produced a novel Nb₂O₅/Mg gradient coating on AZ31 magnesium alloy substrate by using a sputtering deposition process. The wear rate was reduced by more than an order of magnitude [20]. DLC films show a stable and relatively low friction coefficient under dry conditions at room temperature, in comparison with uncoated AZ91magnesium alloy [21]. Aluminum matrix composite coatings reinforced with SiCp were deposited using oxyacetylene thermal spraying on ZE41 magnesium alloy substrates. The incorporation of SiCp to the spraying mixture increased wear resistance up to 2 times more than the initial ZE41 substrates [22].

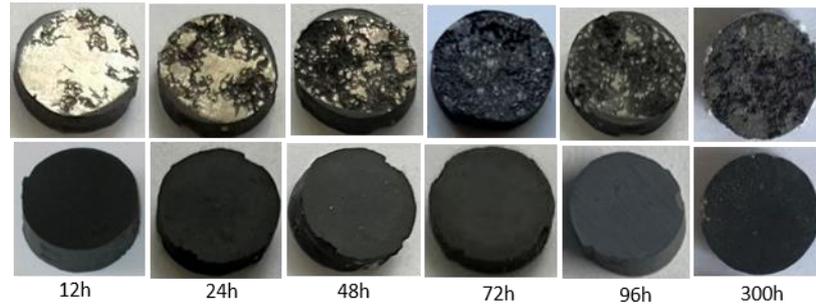
Fig. 8. Appearances of untreated and oxidized magnesium alloy immersed in a 3.5% NaCl solution for various times.

Corrosive immersion test was carried out to evaluate corrosion resistance of untreated and treated samples. Surface morphologies of two samples after being immersed in a 3.5% NaCl solution for different times are shown in Fig. 8. As illustrated, following a 12 h immersion period, localized areas on the sample surface exhibited signs of corrosion, with distinct corrosion byproducts becoming evident upon examination. As the duration of immersion increased, the area of corrosion progressively expanded, and the quantity of corrosion products continuously accumulated. After 48 h of immersion, a significant portion of the sample surface was covered by corrosion products. Upon reaching 72 h of immersion, the entire sample surface exhibited severe corrosion. After 300 h of immersion, in addition to the surface, parts of the sample had completely corroded away. In contrast, the surface of the oxidized sample exhibited negligible alterations over the duration of the immersion period. Even after 300 h of immersion, the sample surface remained largely unchanged, and no corrosion products were observed on the surface. Clearly, the magnesium hydroxide film layer on the surface of magnesium alloys can effectively enhance their corrosion resistance through mitigating the onset and progression of corrosion processes.
