Design, construction, commissioning and long term operational experience with the D0 Uranium/Liquid Argon calorimeter

The D0 experiment was designed in the mid 1980s and ran at the Fermilab $p\bar{p}$ collider from 1992 through 2011. I describe the uranium-liquid argon calorimeter and its readout electronic which was upgraded in the late 1990s to handle the higher luminosity of the upgraded Tevatron during its second running period from 2001-2011. I summarize maintaining the calorimeter for 20 years of data taking. I further describe a few issues that arose during that time, including different types of noise and the anomalous high voltage currents seen only in the central calorimeter.

*Calorimetry for High Energy Frontiers - CHEF 2013,
April 22-25, 2013
Paris, France*

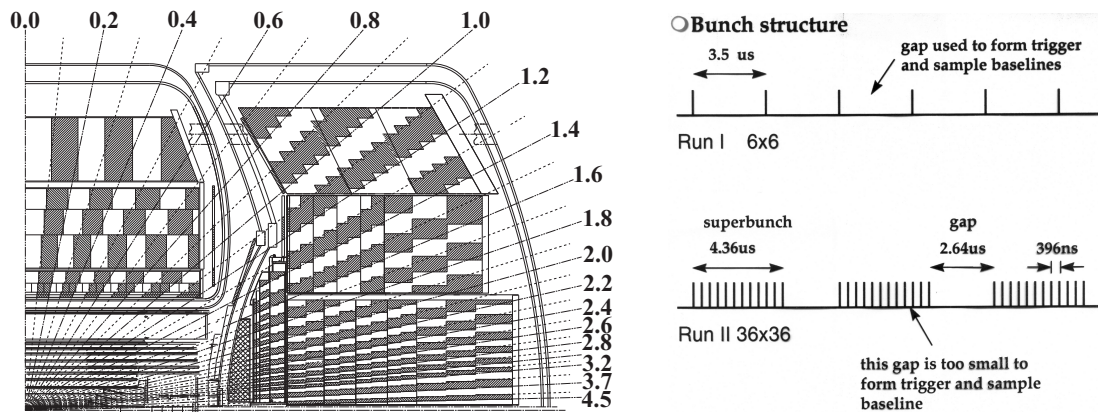
Figure 1: (left) Side view of one quarter of the D0 calorimeter system, showing segmentation and tower definitions. The lines extending from the center of the calorimeter denote the η coverage of the cells and projected towers. The Run II solenoid and tracking detectors are also shown in the inner part of the detector. (right) Tevatron bunch structure for Run I and Run II.

The D0 calorimeter consisted of three cryostats, the central calorimeter (CC) which covers the pseudorapidity $|\eta| < 1.1$ and two end calorimeters (EC) which extend the coverage to $|\eta| < 4.5$, where $\eta = -\ln \tan(\theta/2)$. The CC is segmented into 8 layers while the ECs have 9 layers. The first four layers are used primarily to measure the energy of photons and electrons and are collectively called the electromagnetic (EM) calorimeter. The remaining layers (three or four fine hadronic (FH) and one course hadronic (CH) layers), along with the EM section, are used to measure the energy of hadrons. Most layers are segmented into 0.1×0.1 regions (cells) in (η, ϕ) space. The third layer of the EM calorimeter is segmented into 0.05×0.05 regions. Figure 1(left) shows a cross sectional $r-z$ view of one quarter of the D0 calorimeter system.

The main difference affecting the readout electronics between Run I and Run II was the number and spacing of the beam crossings. All beam structure at the Tevatron was based on the 53.1046 MHz RF accelerator clock. It took 1113 clock cycles or about 21 μ seconds for the beam bunches to travel around the ring. Figure 1(right) shows the beam structure for both Run I and Run II. In Run I there were six bunches with a beam spacing of ≈ 3.5 μ seconds which allowed time to ship information to the trigger system and get back the results before the next crossing occurred. Only two sample and holds per channel were needed. The first sampled the baseline just before the crossing and the second sampled about 2.2 μ seconds later when the signal from that crossing was at its maximum. A third sample and hold was used to store the difference of the two samples when an L1 accept was received, allowing for an essentially dead timeless readout of the calorimeter at the Run I L1 accept rates. In Run II there were thirty six bunches organized in three trains of twelve bunches. The closest spacing between bunches was 396 nanoseconds which required the use of a switched capacitor array (SCA) as the analog memory to hold forty one samples taken every 132 nanoseconds while waiting for the L1 decision. Because the SCA pedestals and noise were not adequate for 15 bits of dynamic range, we stored two gain paths in different SCA channels every 132 nanoseconds for each cell and chose the gain path to use only after the L1 accept was sent. The shaping of the signals was also changed to minimize the pileup while still using about two thirds of the total charge in the 2.3 mm Argon gap. In Run II there was a second level (L2) trigger system to reduce the rate of data sent to the farm of computers used to further filter the events sent to tape. This necessitated an additional L2 SCA storage element where the baseline subtracted value was held until an L2 confirmation was sent, before the signal was digitized. The analog cable drivers and digitization system for the precision readout were not upgraded for Run II.

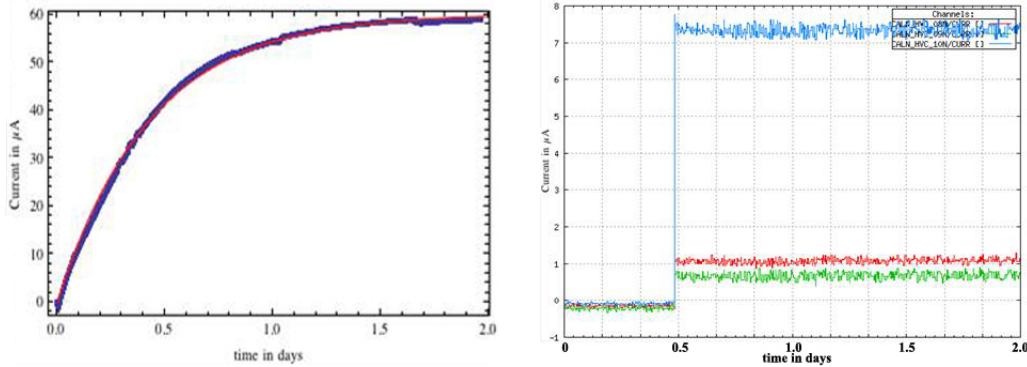
Figure 2: (*left*) Current for one CC HV channel as a function of time. (*right*) Current for three EC HV channel as a function of time.

evidence of sharp (50 to 100 seconds) current discharges with a roughly constant frequency. Both the average current and the number and frequency of the discharges changed over time and/or integrated luminosity. Figure 2 shows the currents for the initial turn-on of the HV for a channel in both the CC and EC. Note the 2 days to reach equilibrium on the CC channel, while the EC reaches equilibrium within the 5 minute sampling interval.

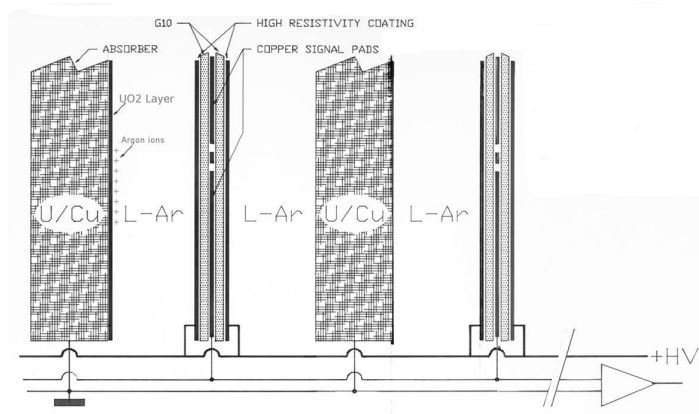
Figure 3: Basic D0 calorimeter readout cell structure.

It has been known for over 60 years [4, 5] that a thin layer of high resistivity oxide on a metal surface in the presence of an electric field can cause positive ions to collect on the oxide layer. Under the proper conditions the field created by the ions can extract electrons from the metal and allow them to drift in the field. In the US this is referred to as Malter currents, a common problem in gaseous drift chambers. While the D0 calorimeter has liquid as the drift media, the same effect can occur (see Figure 3). Two distinct effects can occur. As positive ions collect on the insulating surface of the UO_2 , the field across the thin oxide layer builds up, until electrons are extracted from the metal and are ejected into the gap. Some of the electrons neutralize the ions on the surface, while most drift across the gap and produce a continuous current. When the rate of neutralized argon ions is in balance with the new ions entering the region of Malter currents, the overall current is stable. If the field produced by the ions builds up sufficiently, the UO_2 insulator eventually breaks down and the current increases significantly, creating a Malter discharge. The discharge

neutralizes a localized area of the insulator [6] as well as increasing the current across the gap. After the discharge the continuous current is lower than just before the discharge until the local positive ion density can build up enough that the discharges can occur again. Both Malter currents and discharges are seen in the CC calorimeter.
