Comparison of long-term natural aging to artificial aging in Duralumin.

Abstract: The understanding of long-term aging of aeronautical materials, in particular aluminium alloys used in the fuselage and structure of aircraft is of extreme importance for airline fleets. In this work, a plate from an old aircraft (Breguet) was retrieved and studied in terms of microstructure and mechanical properties. A comparison was made between this naturally-aged alloy and a modern alloy on which different artificial aging conditions were applied. The old alloy exhibits a precipitation of θ -Al₂Cu at grain boundaries and of Ω -Al₂Cu on dispersoids. This non-expected nanostructure for an alloy in T4 state was attributed to the heat that the plate experienced during the aircraft cycles. However, it is shown that this aging is reversible (after a solution treatment). Moreover, the very long time of outdoors exposure seems to have caused intergranular corrosion causing the early failure during tensile tests on some of the specimens. The artificial aging (low temperature, 100°C for up to 10,000h) applied on the modern 2017A alloy did not allow to reproduce the nanostructure of the old plate, meaning t

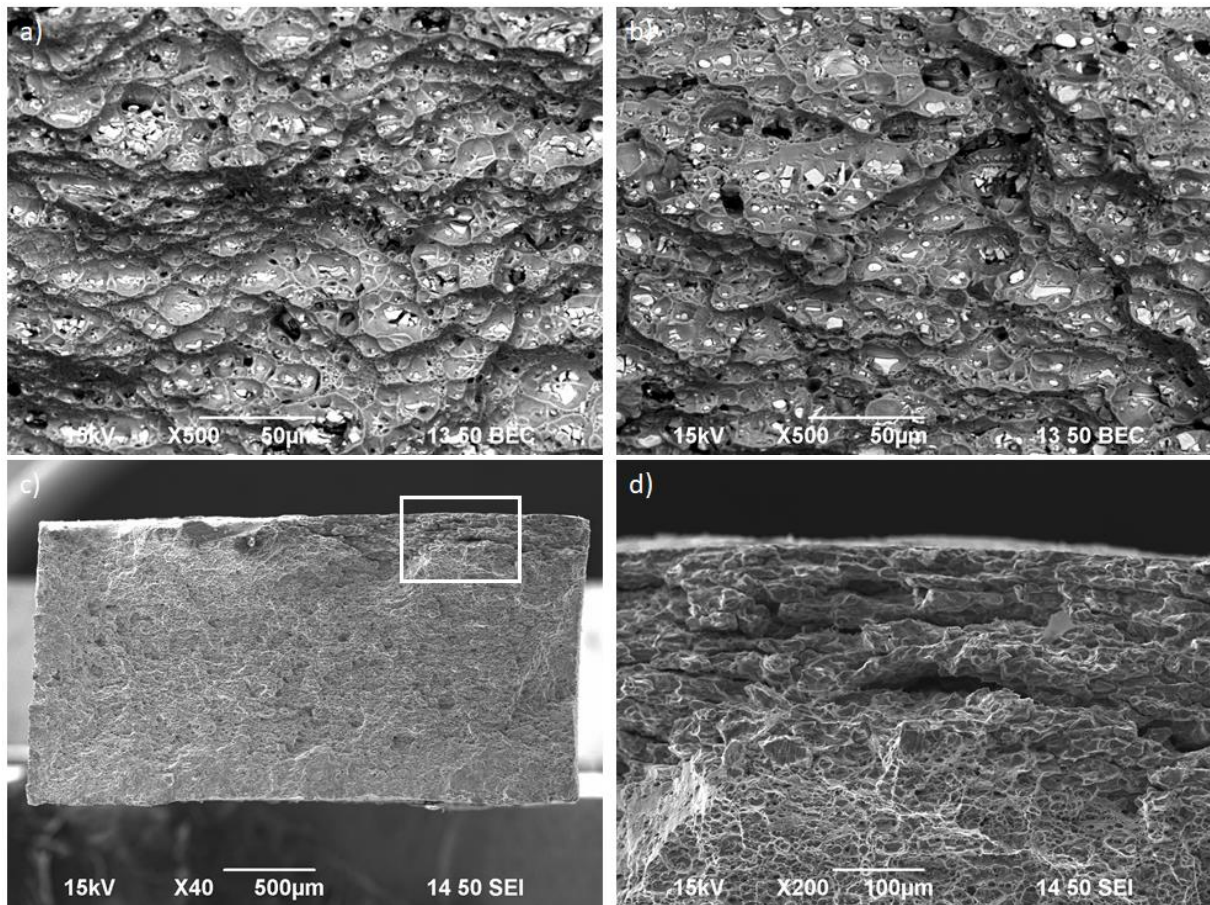
Fracture surface analysis was carried out by SEM on post-mortem specimens. Figure 2 presents images representative of each alloy. On both alloys, equiaxed dimples were observed, typically present for ductile fracture caused by uniaxial tensile load. This type of fracture processes by microvoid coalescence. Microvoids nucleate at particles such as precipitates. After nucleation, the voids grow in the direction of the applied tensile stress. The dimples caused by coarse intermetallics are clearly visible in the microstructure of both alloys. Coarse intermetallics in 2017A-type alloys are well-identified: AlMnFeSi mostly (large, grey particles with faceted morphology) together with Al_2Cu (round and bright) and Mg_2Si (dark). They are quite numerous in both samples. Extremely small dimples were also present which could be caused by intragranular precipitation.

In the old alloy (L8), on all the early-failed specimens occurring mainly in the transverse direction, decohesive fracture along grain boundaries were observed (see framed area in Figure 2c and d.). Intergranular corrosion, unspotted before testing on the specimens, seems to be the main cause of this rupture mode. It is known that alloys of the 2xxx series are susceptible to stress-corrosion cracking and that the sensitivity depends strongly on the grain orientation. The transverse direction is thus the most susceptible to cracking, which is observed here.

Fig. 2. SEM photographs of fracture surface in back-electron scattering mode for a) 2017A-AR, b) L8-AR. Images c) and d) in secondary electron mode, show fracture due to intergranular corrosion on L8-AR in the transverse direction.

L8 plate exhibits a peculiar mechanical behaviour and microstructure in the AR conditions, i.e. after 10 years of service and 50 years in outdoor environment. Limited elongation (or early failure) was explained by intergranular rupture mode due most probably to intergranular corrosion present in the plate. Precipitation at grain boundaries (Al_2Cu) was indeed observed on the AR plate by TEM. This is clearly the sign of a heat exposure during the aircraft life-time.

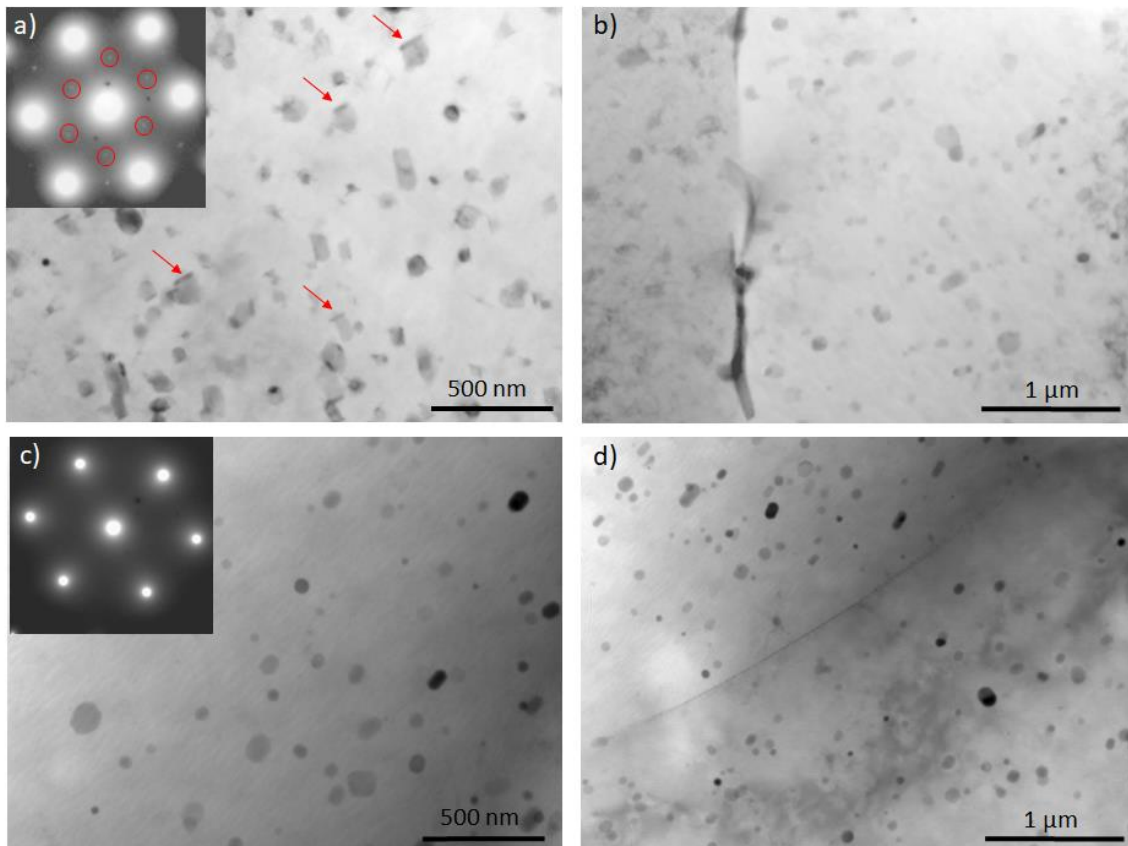
On L8-AR, TEM observations (see Figure 4.a and 4.b) reveal a precipitation at grain boundaries and the presence of a precipitation on dispersoids. The precipitation is marked by arrows in BF-TEM image (Figure 4a) and circles in the corresponding selected area diffraction (SAD) pattern. This phase corresponds to Ω -Al₂Cu phase, as identified in [13] on similar Duralumin. No other precipitation is observed in this sample by TEM but it was verified by small angle X-ray scattering (SAXS) that GPZ/clusters are present in this state (see Figure 5). The results show indeed two main contributions: one in the low q-range ($0.002 < q < 0.1 \text{ \AA}^{-1}$) with a q^{-4} contribution, attributed to large precipitates (dispersoids) and one at high q-range ($0.1 < q < 1 \text{ \AA}^{-1}$), a plateau attributed to GPZ or small clusters in the alloy matrix.

At grain boundaries, the precipitation nature is Al₂Cu. Precipitation on dispersoids and at grain boundaries could be the sign of the heat experienced by the plate during its life-time. After solution treatment (ST), precipitation on dispersoids and at grain boundaries has disappeared: see Figure 4.c and 4.d.

Fig. 4. BF-TEM images in $[110]_{Al}$ zone axis with corresponding SAD patterns of a) and b) L8-AR; c) and d) L8-ST.

This precipitation induces a fragilization of the material upon exposure to environment (50 years outdoors). Another precipitation was observed in L8-AR: the Ω -Al₂Cu phase, which grows on dispersoids. But this precipitation has no hardening effect on the alloy in the AR state: overall L8-AR exhibits a similar hardness as 2017A. Upon artificial treatment (180°C/8h), hardness of the old plate did not reach a maximum, as opposed to the modern alloy 2017A, although hardening precipitation was observed inside the grains by TEM. We believe that microhardness is thus affected by precipitation at grain boundaries. In the AR-state, the high dislocation density observed in L8 is the sign of work hardening that compensates for the loss of hardness due to intergranular precipitation. However, this intergranular precipitation decreases the potential for further hardening in the old plate upon aging.

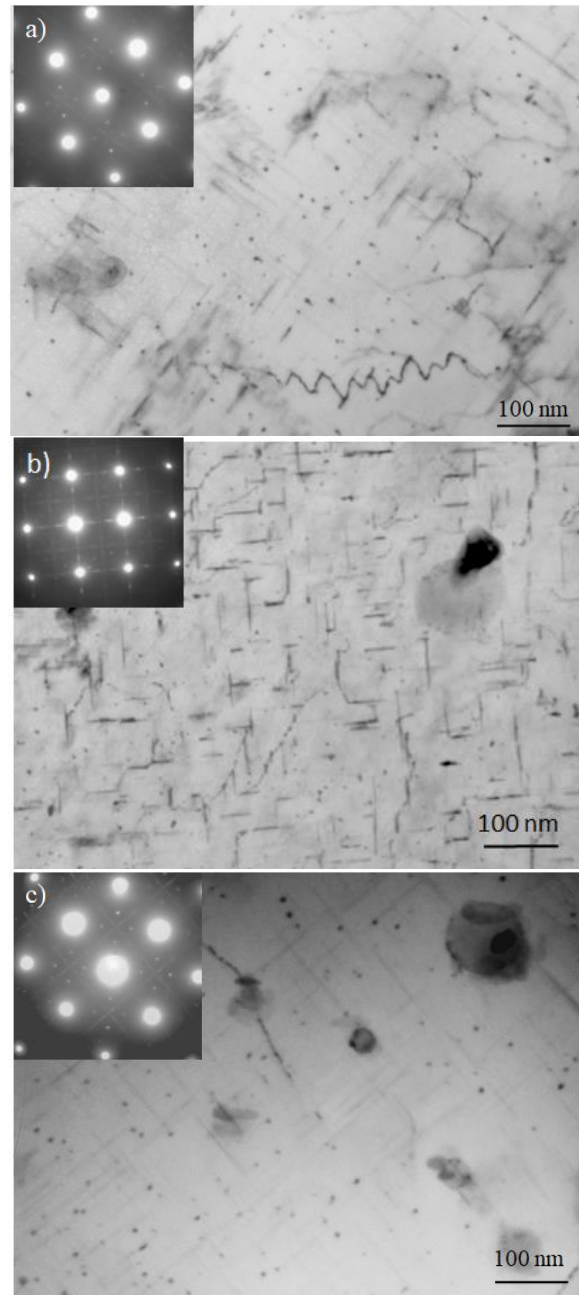
The nanostructure is then observed for 2017A and L8 after treatment at 180°C for 8h corresponding to peak hardening. It is shown in Figure 6. The observations of the old plate (Figure 6.a) reveals the presence of a variety of phases:

- the hardening θ'' -Al₃Cu phase identified in the SAD patterns thanks to the discontinuous streaks along [200]_{Al} [16],
- the θ' -Al₂Cu phase (platelets) identified thanks to faint spots (110)_{θ'} at 1/2 of (220)_{Al},
- the Q'(Q)-AlCuMgSi phase which are rods observed end-on in the [100]_{Al} direction in the BF images,
- the Ω -Al₂Cu phase with diffraction spots at 1/3 and 2/3 of the [022]_{Al} orientation.

This precipitates zoology is equivalent to the one found in the modern 2017A alloy in the same aging conditions (Figure 6.b and [13]). Measurements of the hardening precipitates (θ'' -Al₃Cu and θ' -Al₂Cu platelets) are reported in Table 3. On average, platelets are 86 ± 29 nm long for L8_180°C/8h and 60 ± 15 nm long for 2017A_180°C/8h. The difference is not significant enough to conclude. However, a much higher number of dislocations are found in the old plate indicating some work-hardening of the L8 plate during its shaping or during its lifespan.

After ST followed by aging at 180°C for 8h, the nanostructure is observed again: see Figure 6.c. The platelets are measured: in the old plate, they are 65 ± 18 nm, and dislocations have disappeared.

Fig. 6. BF TEM images in [110]_{Al} zone axis a) L8_180°C/8h; b) 2017A_180°C/8h; c) L8_ST-180°C/8h

These results show that hardening precipitation occurs after artificial aging (180°C-8h) in L8, in a similar manner as the 2017A alloy whether in the as-received

state or after solution treatment. This means that the peculiar behaviour of the L8 in hardness during thermal aging (observed in Figure 2) is not due to a lack of hardening precipitation. The reason for the hardness stagnation on the old plate is thus suspected to be found at microscale.

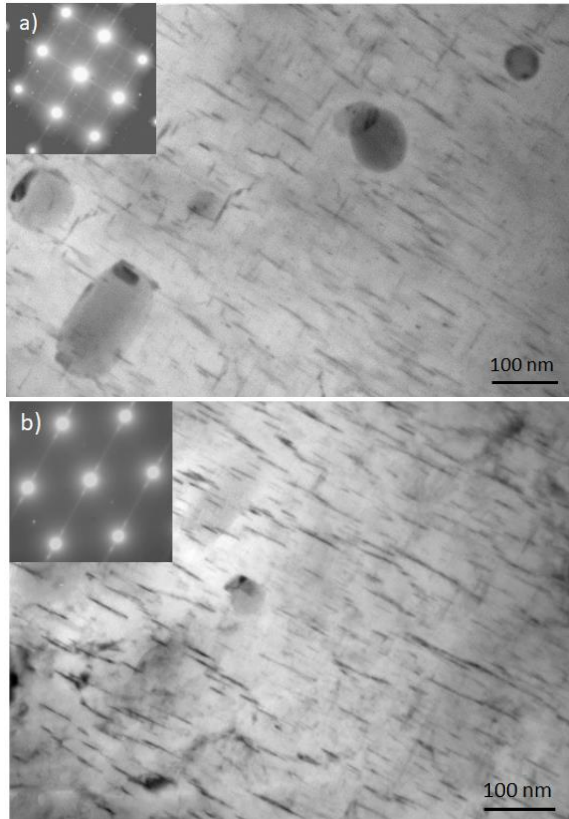
The microstructure corresponding to an aging time of 10 000h at 100°C is shown in Figure 7 and the one for 5h at 180°C in Figure 8.

Fig. 7. BF-TEM images of 2017A alloy thermally aged at 100°C for 10,000h in a) $[100]_{Al}$ zone axis and b) in $[110]_{Al}$ zone axis.

In the SAD patterns in two zone axes ($[100]_{Al}$ and $[110]_{Al}$), for the 2017A alloy heat treated at 100°C for 10,000h, we observe discontinuous streaks along $[200]_{Al}$ with maximum intensities at $(100)_{Al}$ corresponding to the θ'' - Al_3Cu phase. The θ' - Al_2Cu precipitates, if present, have a low volume density. The $Q'(Q)$ - $AlCuMgSi$ phase was observed in the BF images (rods seen end-on oriented along $[001]_{Al}$ direction) but the precipitates are also very few. The diffraction patterns, similar as the ones seen in [16], indicate that the alloy is just before peak hardening. Figure 8 provides the confirmation of a nanostructure very close to the one previously presented (for 8h at 180°C). The length of the hardening precipitates in the two aging conditions, is of the same order of magnitude (see Table 4). A major difference can be found for the Ω - Al_2Cu phase: this phase was hardly seen in the 2017A alloy aged at 100°C for 10,000h: diffraction spots are not visible in the SAD patterns (inserts of Figure 7.a and 7.b). However, the phase can be seen on dispersoids in BF-TEM images. It is concluded that the phase is present but in very little quantities and with no significant influence.

Artificial aging at low temperature (100°C) was applied on 2017A alloy to simulate natural aging. If time-temperature equivalence based on Arrhenius law is used, 10,000h at 100°C should correspond to 5h at 180°C. However, differences in hardness and in microstructure can be noticed between these two aging conditions.

Another difference is noted between the two aging conditions: the presence of Ω -Al₂Cu phase was very rarely spotted after aging at low temperature (100°C). In AA2519 alloy (Al-5.6Cu-0.3Mn-0.3Mg-0.15Zr wt.%), Zuiko and Kaibyshev [19] showed that the
