Experimental study on the gradual fracture of layers in multi-layer laminated glass plates under low-velocity impact

Alena Zemanová, Petr Konrád, Petr Hála, Radoslav Sovják,
Radim Hlužek, Jan Zeman, Michal Šejnoha
Czech Technical University in Prague, Czech Republic

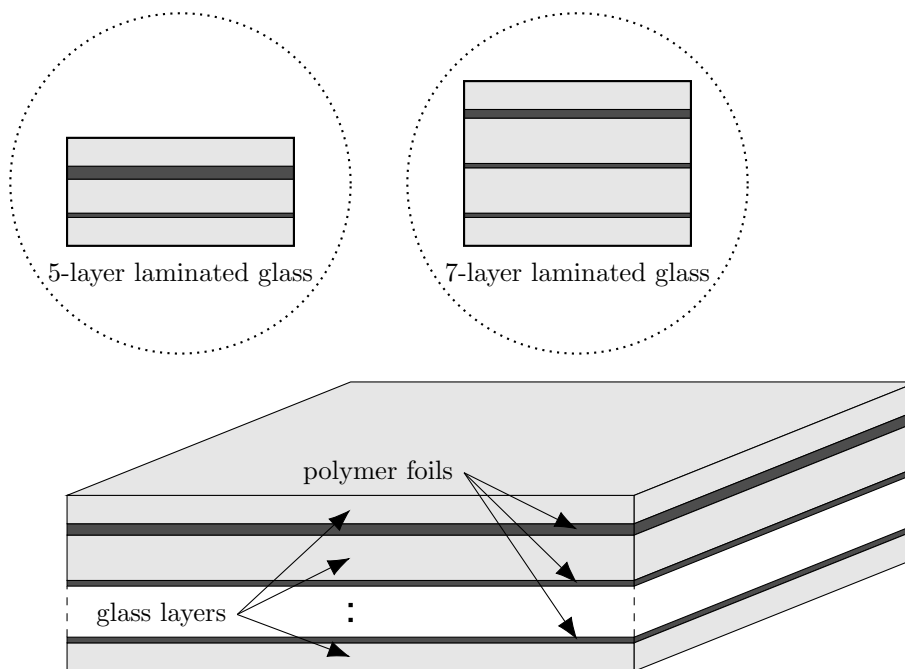
Figure 1: Scheme of multi-layer laminated glass plates.

Non-destructive and destructive impact tests were carried out on laminated glass units, where two different geometries (Figure 1) were selected for the experimental campaign, i.e., 5-layer laminated glass (5LG) containing three glass plies and two interlayers and 7-layer laminated glass (7LG) made from four glass plies connected with three interlayers.

Motivated by the sacrificial-glass-ply concept [34] and the key role of the middle glass layer [37], we designed the thicknesses of both external glass layers to be thinner, whereas the inner selected glass layer/s in tested samples were slightly thicker. This setup might be also convenient for the post-fracture response of laminated samples because the thicker glass layers are protected by a polymer foil and an additional glass layer. Therefore, fewer micro-defects due to the transport and manipulation before the impact tests should occur

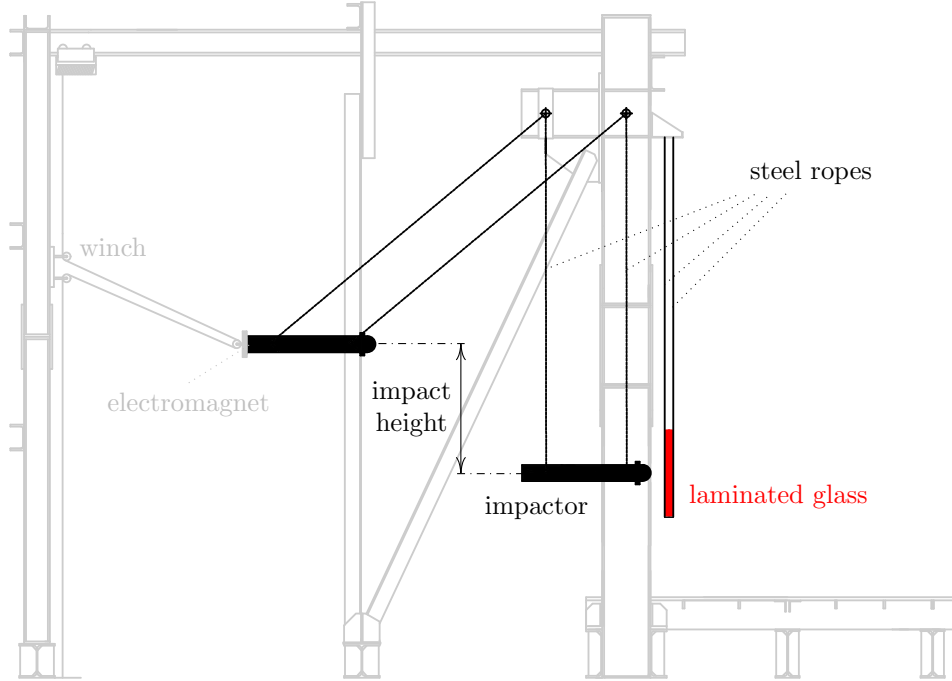
Figure 2: Side view of the pendulum impactor device.

The low-velocity impact was induced by a pendulum device, which works on the principle of a free-falling weight following a circular path (Figure 2). The sample of the laminated glass was suspended on a pair of steel ropes placed along the vertical sides of the glass sample with both sides approximately 50 mm from the vertical edges of the sample. In this way, steel ropes were wrapped around the bottom edge of the sample (Figure 3). Such type of supports is utilised in experimental modal or other dynamic analysis of structures to approximate the free boundary conditions [19].

The impactor had the shape of a cylinder with a hemispherical nose with a radius of 50 mm and 800 mm in length. The impact was carried out by lifting the 48.2 kg impactor to the prescribed height with a winch and an electromagnet and then releasing it onto a glass sample. After the impact, the sample started to move in the direction of the impulse along the circular path where it was captured to prevent multiple impacts.

The vertical distance between the impactor’s axis of symmetry and the centre of a sample (impact height) was initially 5 cm. After each test, this distance was increased by 5 cm.

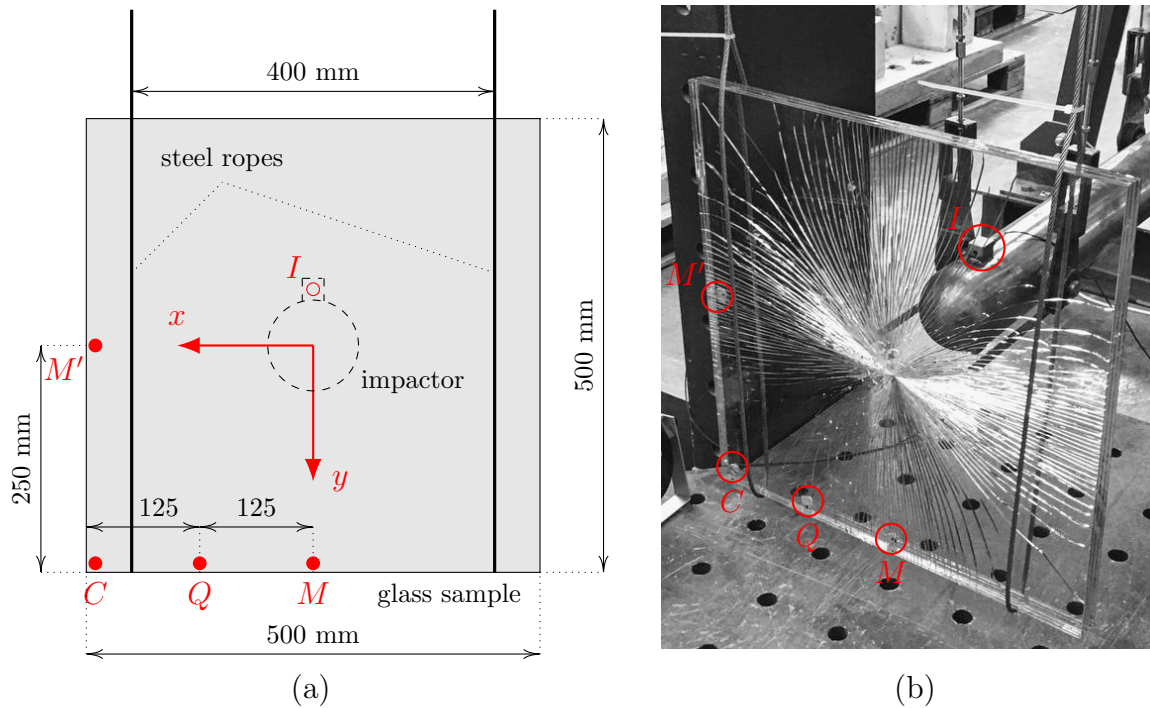
Figure 3: Positions of sensors: (a) scheme of the positions of four sensors C , Q , M , and M' on the impacted surface of a sample together with one sensor I on the impactor behind, (b) photo of an experimental setup with all sensors highlighted.

Five accelerometers with integral electronics (Model 350B04 Shear ICP® Shock Sensor, PCB Piezotronics) recorded the response of a laminated glass sample. Four of them were glued on the back face (the non-impacted outer surface) of each laminated sample (Figure 3), and one additional sensor was bolted to the impactor (Figure 3 (b)) to monitor the contact

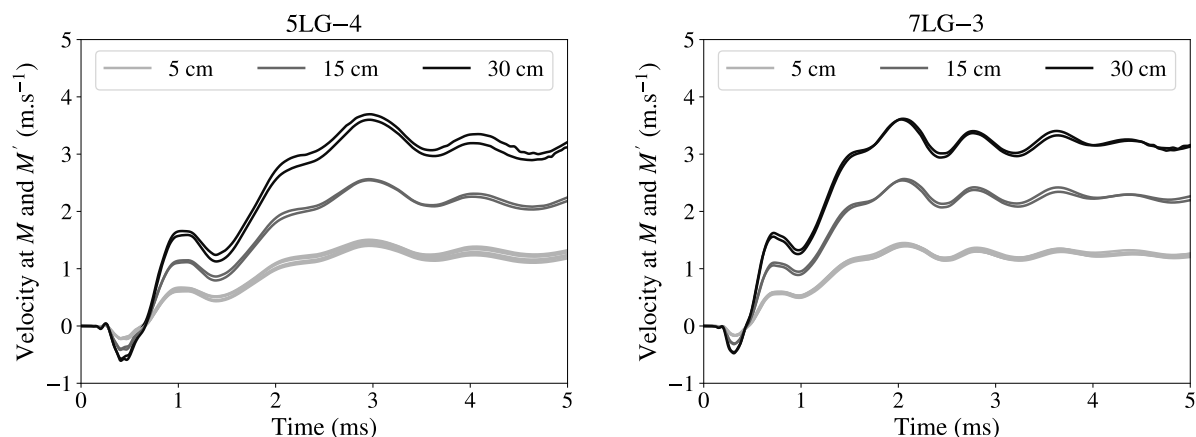
Figure 4: Comparison of velocities at positions M (0, 250, 0) mm and M' (250, 0, 0) mm derived from the corresponding sensors located in the middle of bottom and left edge (Figure 3) for a 5LG-sample and a 7LG-sample and three impact heights (5 cm, 15 cm, and 30 cm).

To analyse the response of samples, we derived velocities from measured accelerations using their time integration. For this purpose, we employed the classical Newmark scheme [47] in the form corresponding to the constant average acceleration method. Figure 4 compares the velocities at positions M and M' (Figure 3) that are located symmetrically about the diagonal axis. The response is plotted for three different impact heights (5 cm, 15 cm, and 30 cm) and two samples (with no visible failure for the selected impact heights) representing both geometries. The time axis range is set to cover the contact duration. The comparison of velocities from both sensors indicates that the steel ropes did not effect significantly the response during the contact because the differences were small and can more likely be attributed to other experimental uncertainties.

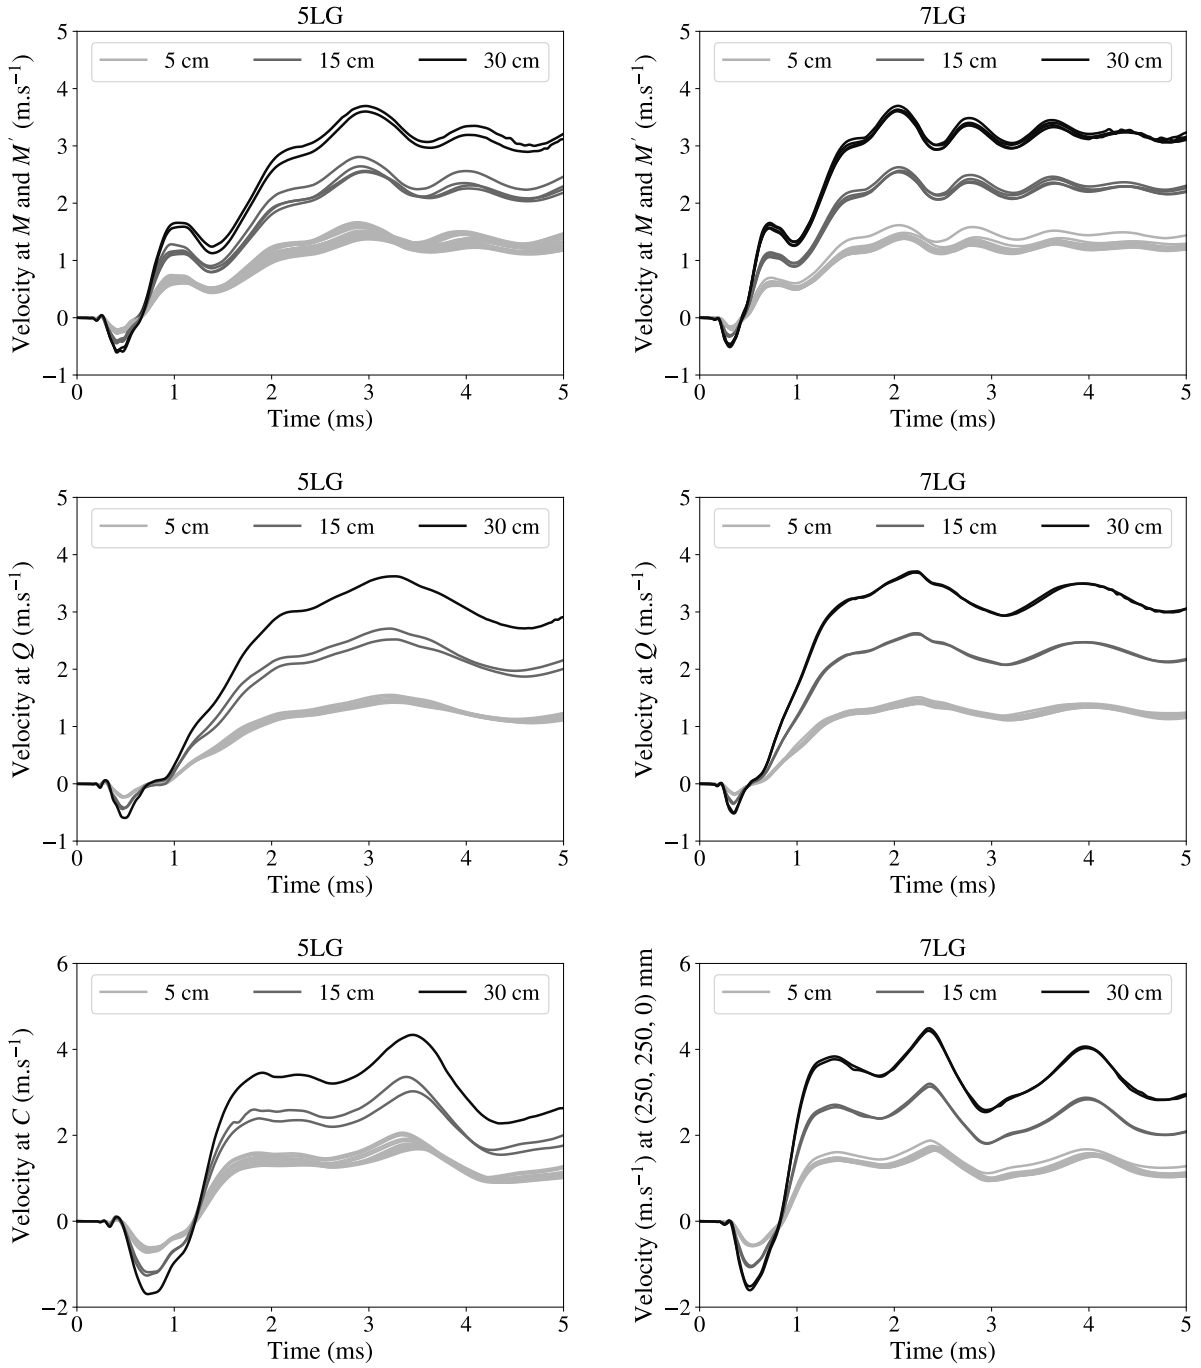
Figure 5: Assessment of the impact test repeatability by comparison of velocities for all non-destructive tests, samples, measured locations (Figure 3), and three impact heights (5 cm, 15 cm, and 30 cm).

Figure 5 summarises the velocities for all samples and non-destructive tests at three positions (midpoints of edges M and M' were plotted together) and three impact heights of 5, 15, and 30 cm. As can be seen, the testing method provides consistent responses for the same conditions. The uncertainties related to the experimental measurements are caused by a slightly eccentric impact (see ahead to Figure 23) and partially by imperfections in sample dimensions or positions of sensors. The oscillations of velocities, evident from Figures 4 and 5, correspond to vibrations of samples induced by the impact. Their frequencies were obtained from the fast Fourier transform (FFT) analyses of signals recorded from the impact test similarly to [37]. Before the FFT analysis, the initial and final part of the data from accelerometers on glass samples were eliminated in accordance with the instructions in [48] to have a sufficiently regular signal. We eliminated the initial data before the largest amplitudes (approximately 0.3–0.4 ms of a signal) and the final part (after 20 ms) with small oscillations affected significantly by the experimental noise (Figure 6).

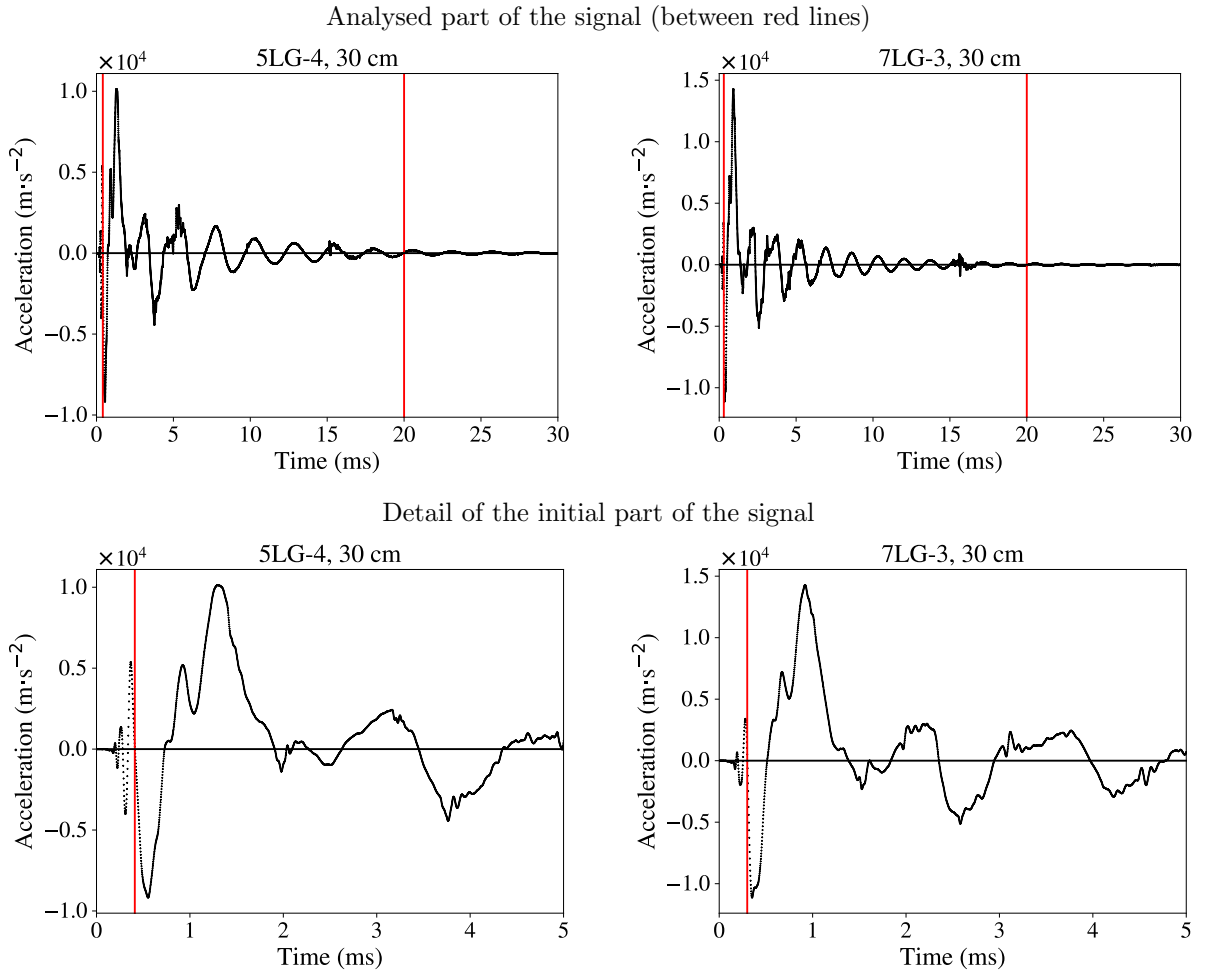
Figure 6: Accelerations recorded by the corner sensors C attached to the laminated glass samples; red lines define the part of the signals employed in the FFT analysis.

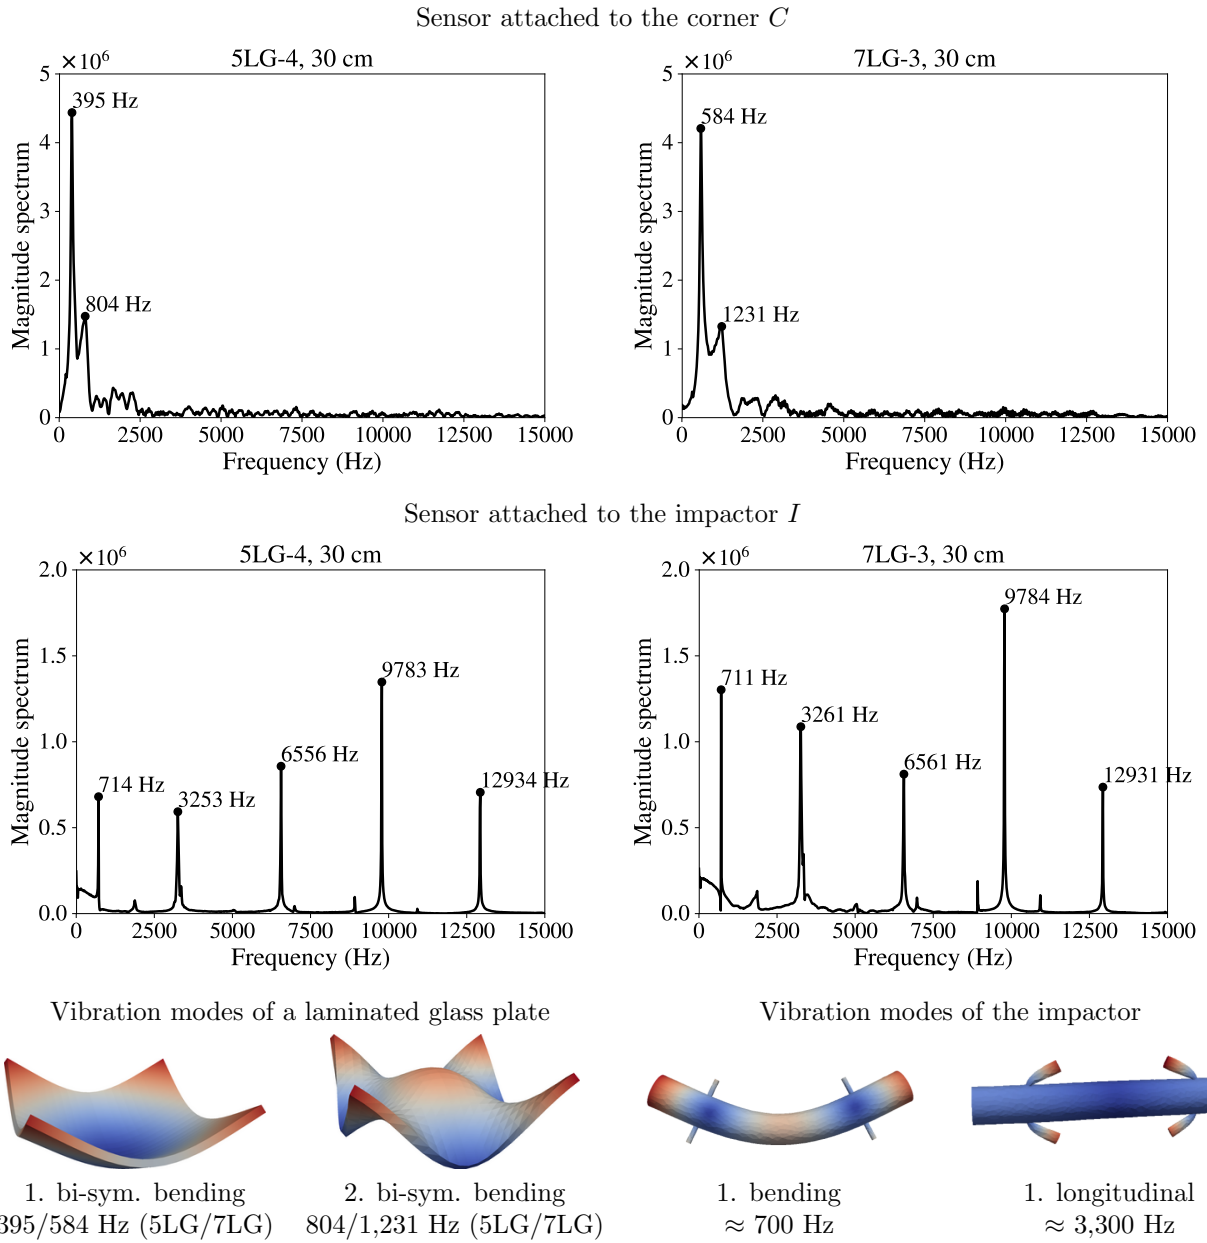
Figure 7: FFT-based signal analysis of accelerations recorded by sensors attached to laminated glass samples (C) and to the impactor (I) complemented with relevant vibration modes.

The natural frequencies of laminated glass plates were derived from the corner sensor and were compared with those of the impactor (Figure 7). The two dominant frequencies of samples correspond to the first bi-symmetric vibration modes excited by the impact. The numerical simulation of modal response of the impactor explained that the modes excited by the impact corresponded to the first and higher bending and longitudinal modes. We employed a standard material parameters of steel (Young’s modulus of 210 GPa, Poisson ratio of 0.3, and density of $7,800 \text{ kg}\cdot\text{m}^{-3}$).

For the evaluation of contact forces, a sensor was attached to the impactor (Figure 3), and the recorded accelerations were multiplied by its mass (48.2 kg). The FFT analysis combined with the modal analysis for the impactor revealed that the signals included also the impactor’s vibrations, and thus the corresponding frequencies had to be eliminated. Figure 8 shows the comparison of contact forces derived from raw and filtered data. The frequency corresponding to the most significant amplitudes observed for the non-filtered data matches that of the longitudinal vibration of the impactor (approximately 3,300 Hz), and the motion presumably corresponds to local oscillations of the sensor and not to the contact force (Figure 7). Thus, the signal was filtered with an 8th-pole Butterworth low-pass filter ($2\times$ CFC 1000 filter with the cut-off frequency of 1,650 Hz) to completely eliminate these undesired vibrations. The selected cut-off frequency is above dominant natural frequencies detected for glass samples (Figure 7).

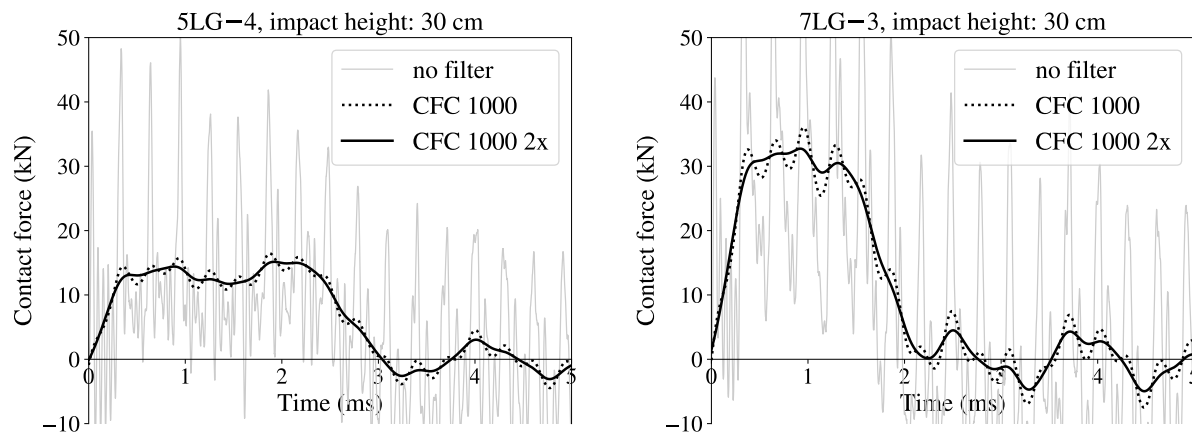
Figure 8: Comparison of contact forces derived from non-filtered and filtered accelerations for two non-destructive tests representing both types of samples.

As visible from the filtered evolution of contact forces (Figure 8), the acceleration of the impactor did not drop to zero after the contact, but some level of oscillations can be seen even after the impact. These vibrations correspond to the acceleration of the sensor due to the impactor’s bending and the sensor’s off-axis position (Figure 3). If we omit this additional vibration, the impacts resulted in 3 ms contact for 5LG-samples and 2 ms contact for the 7LG-samples. However, the first bending frequency of the impactor (approximately 700 Hz) is in the range of frequencies excited on laminated plates, and so their elimination is undesired. This impactor ringing must be kept in mind when validating numerical sim-

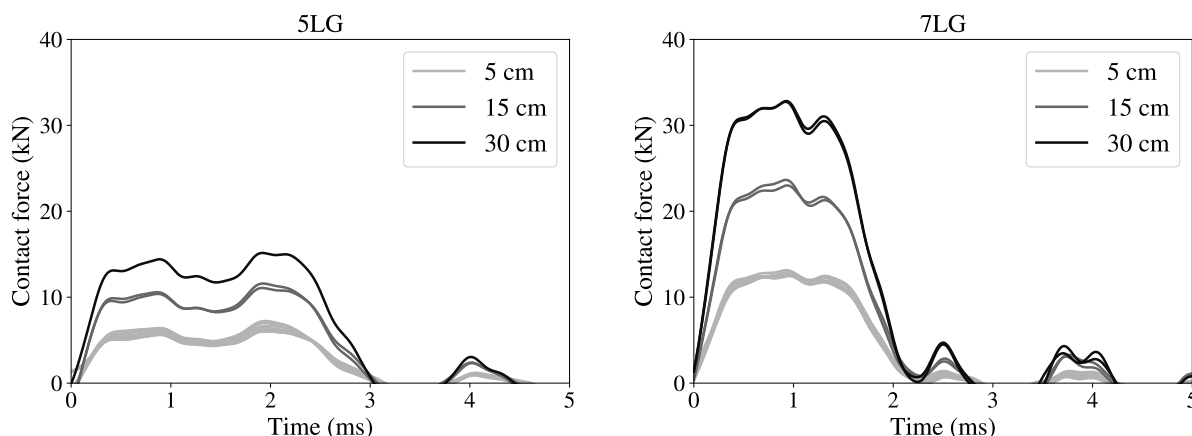
Figure 9: Comparison of contact forces ($2\times$ filter CFC 1000) for all non-destructive tests, samples, and three impact heights.

Figure 9 compares the contact forces for all unfractured samples (both geometries) and three impact heights. The contact duration was consistent and longer for the 5LG-samples, whereas the impact from the same height resulted in more than twice higher contact force for 7LG-samples. This observation highlights that an assessment of the impact resistance for different types of laminated glass based on the level of impact energy or height can be misleading for this type of boundary conditions, and the resultant contact force has to be evaluated as well.

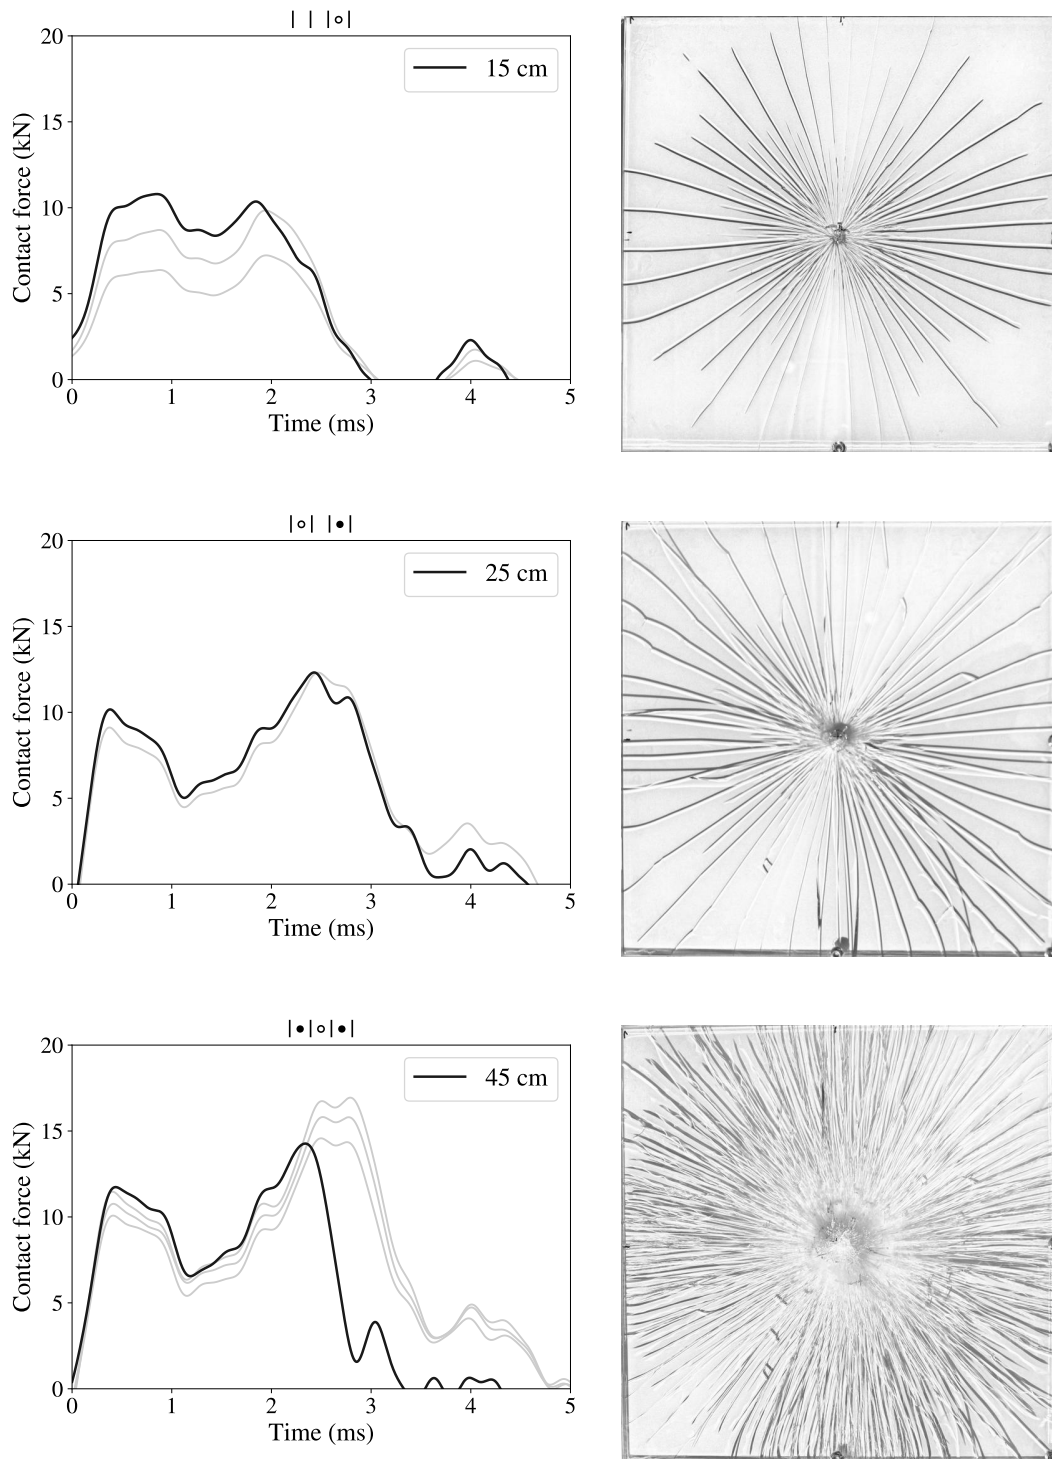
Figure 10: Evolution of contact forces ($2\times$ filter CFC 1000) and corresponding fracture patterns for 5LG-1. Black lines denote the contact forces during the destructive tests, whereas the grey ones correspond to the previous sequence of impact events at lower impact heights (increased by 5 cm for each following impact event).

The same strategy as in the previous section was employed to determine the contact forces during the destructive tests. We plot the results of this analysis in terms of contact forces for each sample independently (Figures 10–20) and complement them with distinctive fracture patterns. Recall that the evolution of contact forces exhibits the same trend for all non-destructive tests, their magnitudes only differ with an increasing impact height (Figure 9). When a previously intact glass layer fractured, the contact force deviates from the formerly consistent path. Then, a new shape of contact force can be observed, and its trend is again consistent for the increasing impact heights until the subsequent fracture of another glass layer(s). The contact duration was longer for samples with fractured layers as their modal response had changed.

The typical fracture pattern consisted of several radial cracks of different lengths, in some samples seldomly connected by a short parts of secondary cracks (e.g., Figures 10, 15, 18, or 20). The area under the impact point was often covered by a finer net of cracks especially on the impacted glass layer (see ahead to Figures 22 and 23). As expected, the density of fracture pattern increased with the impact energy.

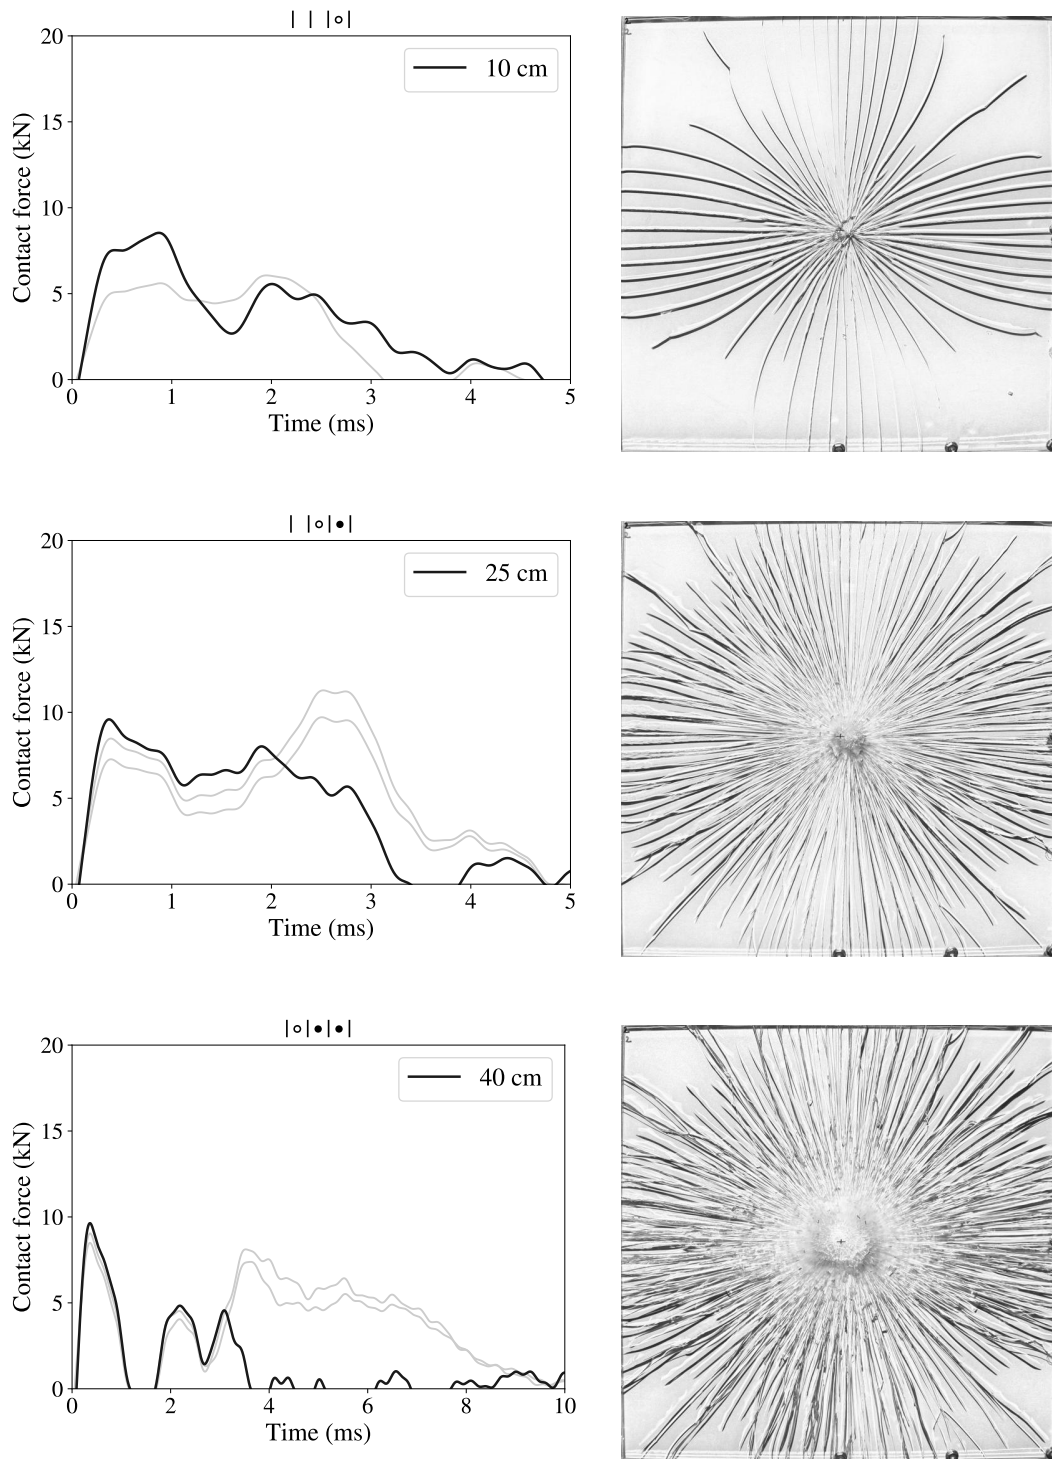
Figure 11: Evolution of contact forces (2× filter CFC 1000) and corresponding fracture patterns for 5LG-2. Black lines denote the contact forces during the destructive tests, whereas the grey ones correspond to the previous sequence of impact events at lower impact heights (increased by 5 cm for each following impact event).

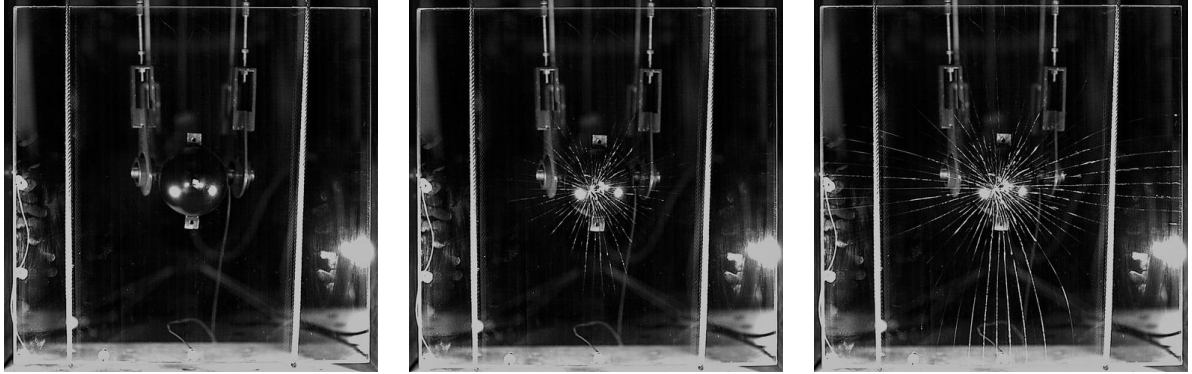
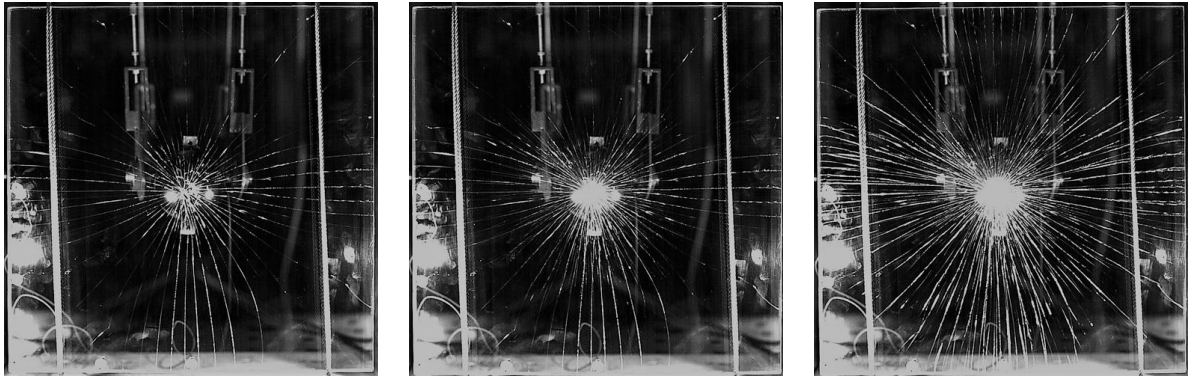
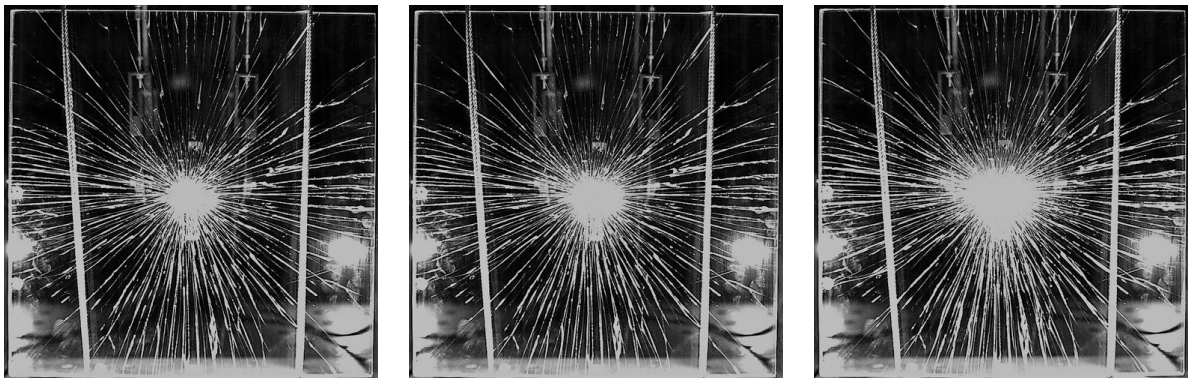
Figure 12: Evolution of cracks in 5LG-2 sample (frame rate 5,000 frames per second, i.e., time step 0.2 ms between two adjacent photos in a row).

For four samples (two per the same geometry), the evolution of fracture pattern was captured by a high-speed camera (Figures 12, 14, 19, and 21) with a 0.2 ms time intervals between two successive frames. The visibility of cracks depended on their opening during the vibration of a laminated glass plate. Therefore, we encourage the reader to compare the high-speed camera photos with the final fracture patterns captured on a white background after the impacts to detect all cracks (via their shadows) that developed during the contact.

The high-speed camera investigation also revealed that cracks spread quickly on the outer non-impacted surface and reached the edges within less than 0.4 ms (Figure 12 or 14). If the impacted layer fractured first, the cracks were mostly localised around the impact point and spread only occasionally towards edges (Figure 20). In many structural applications, the outer glass layers in multi-layer laminated glass are made of tempered glass due to its surface compressive stresses developed during the tempering process. This treatment leads to higher tensile strength, but it also modifies the fracture pattern of a glass sample that breaks into many small pieces. This behaviour is undesirable for the post-critical resistance because the fine net of crack would not remain localised under the impact point.

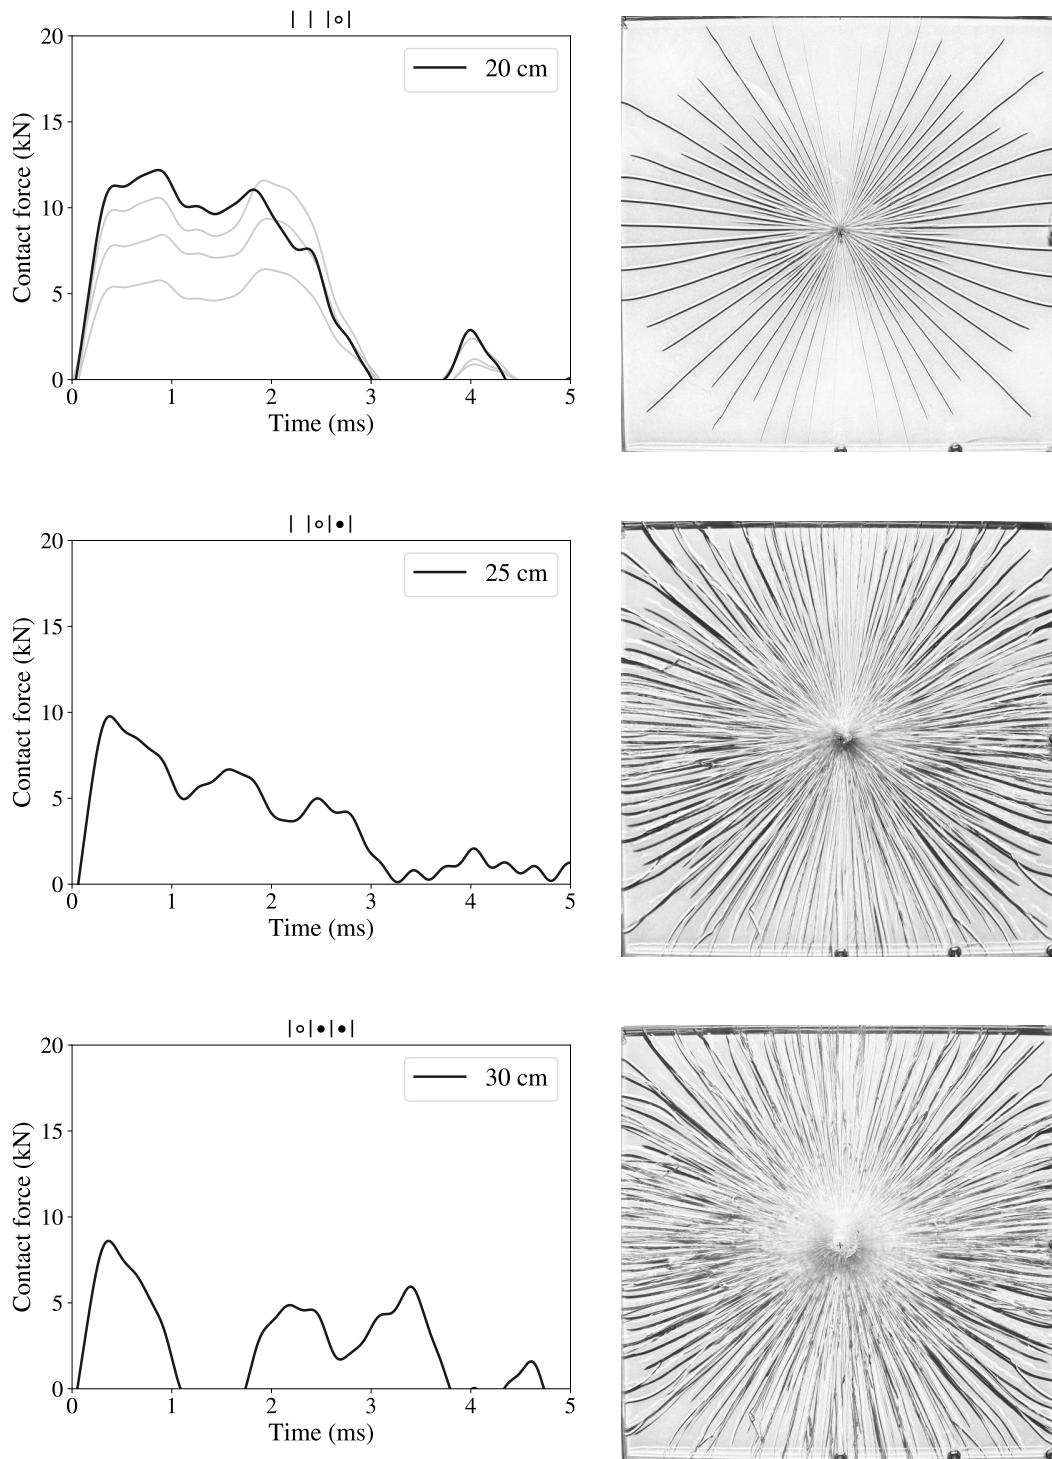
Figure 13: Evolution of contact forces ($2\times$ filter CFC 1000) and corresponding fracture patterns for 5LG-3. Black lines denote the contact forces during the destructive tests, whereas the grey ones correspond to the previous sequence of impact events at lower impact heights (increased by 5 cm for each following impact event).

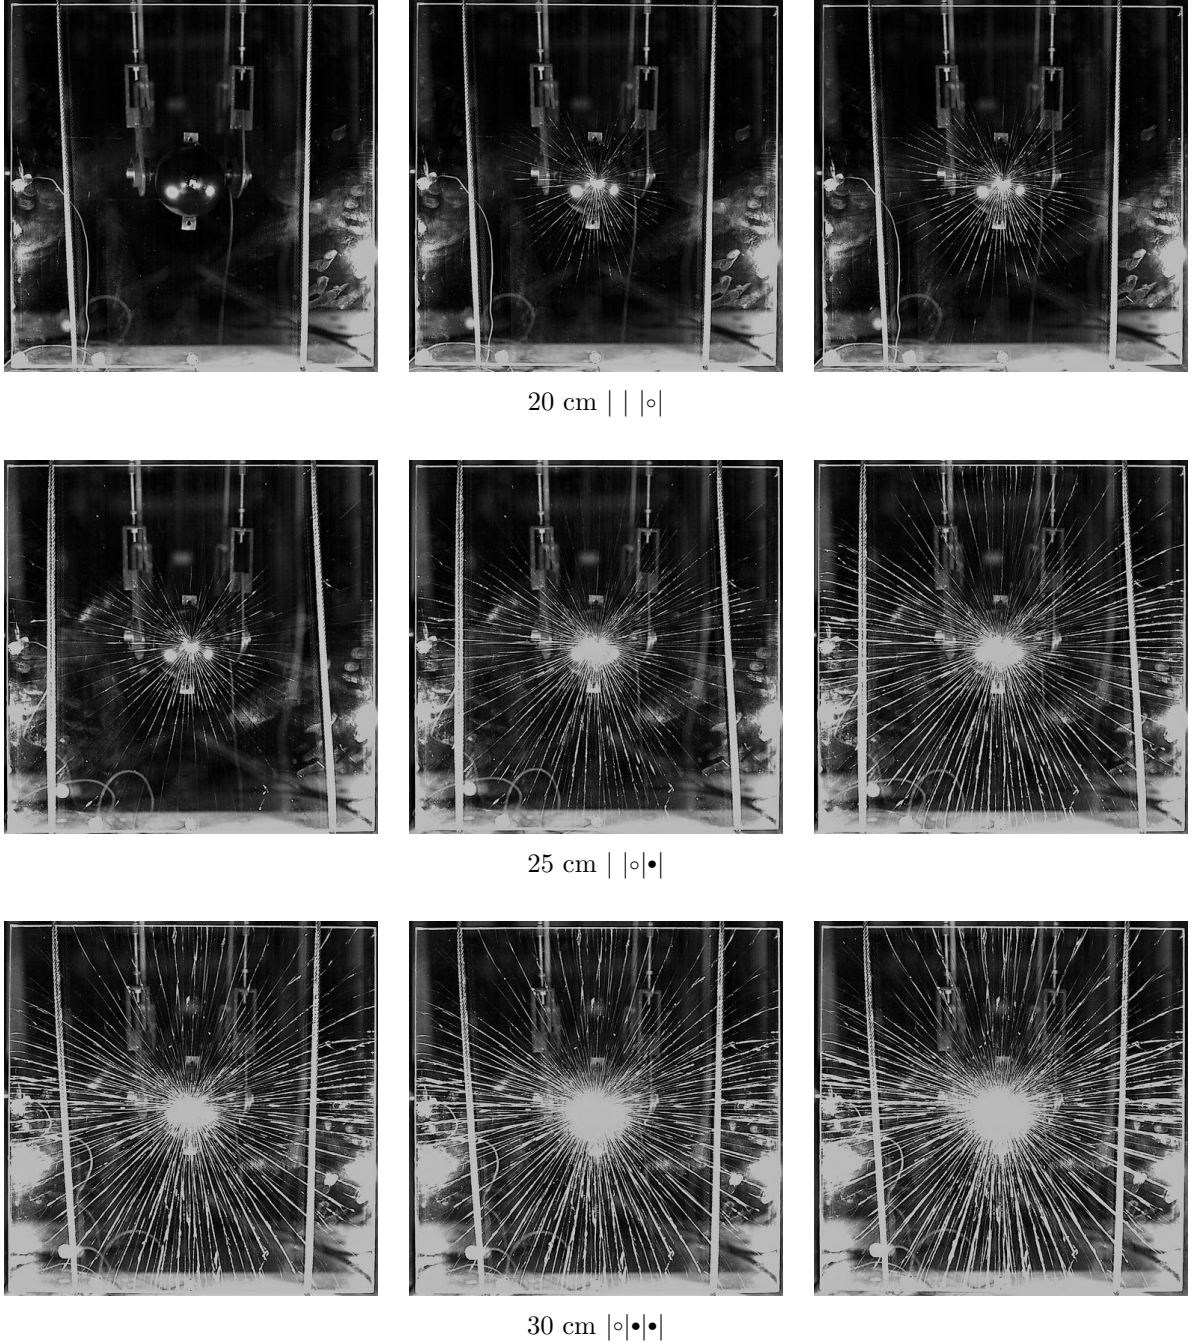
Figure 14: Evolution of cracks in 5LG-3 sample (frame rate 5,000 frames per second, i.e., time step 0.2 ms between two adjacent photos in a row).

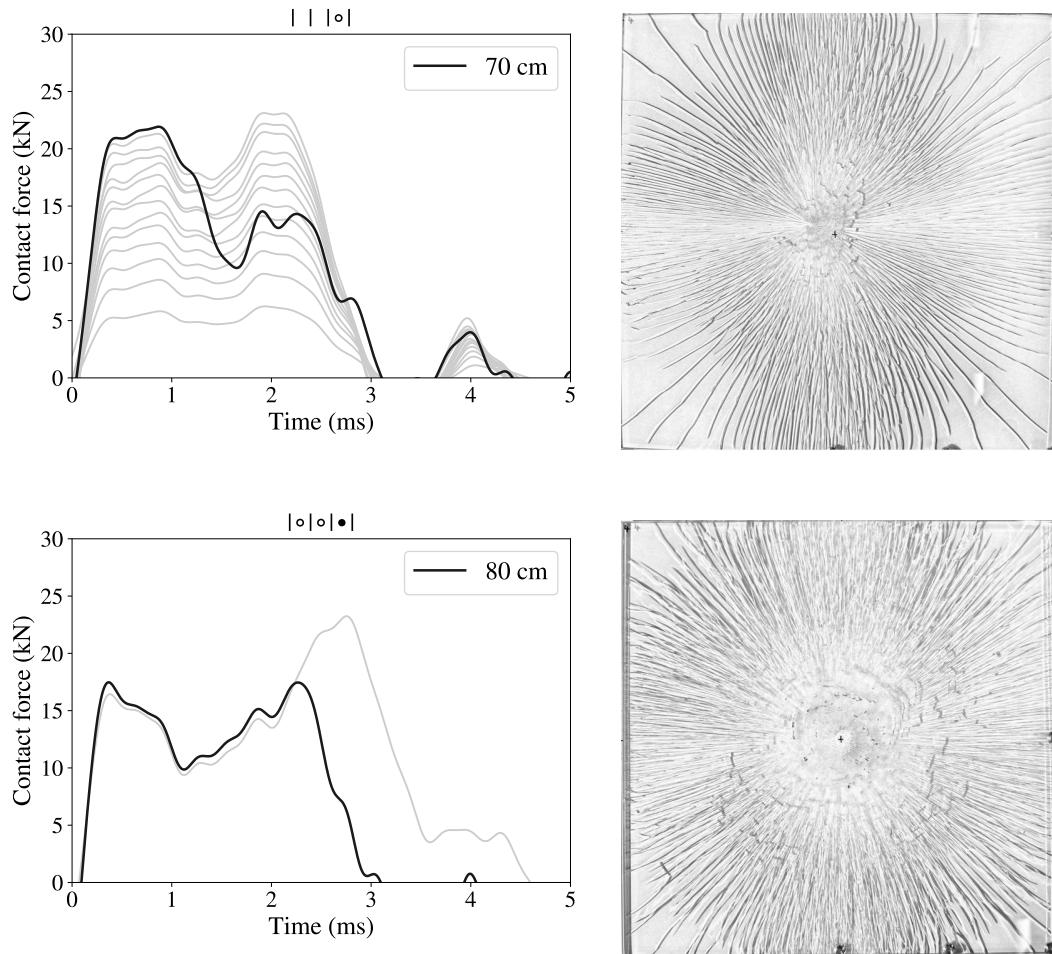
Figure 15: Evolution of contact forces ($2\times$ filter CFC 1000) and corresponding fracture patterns for 5LG-4. Black lines denote the contact forces during the destructive tests, whereas the grey ones correspond to the previous sequence of impact events at lower impact heights (increased by 5 cm for each following impact event).

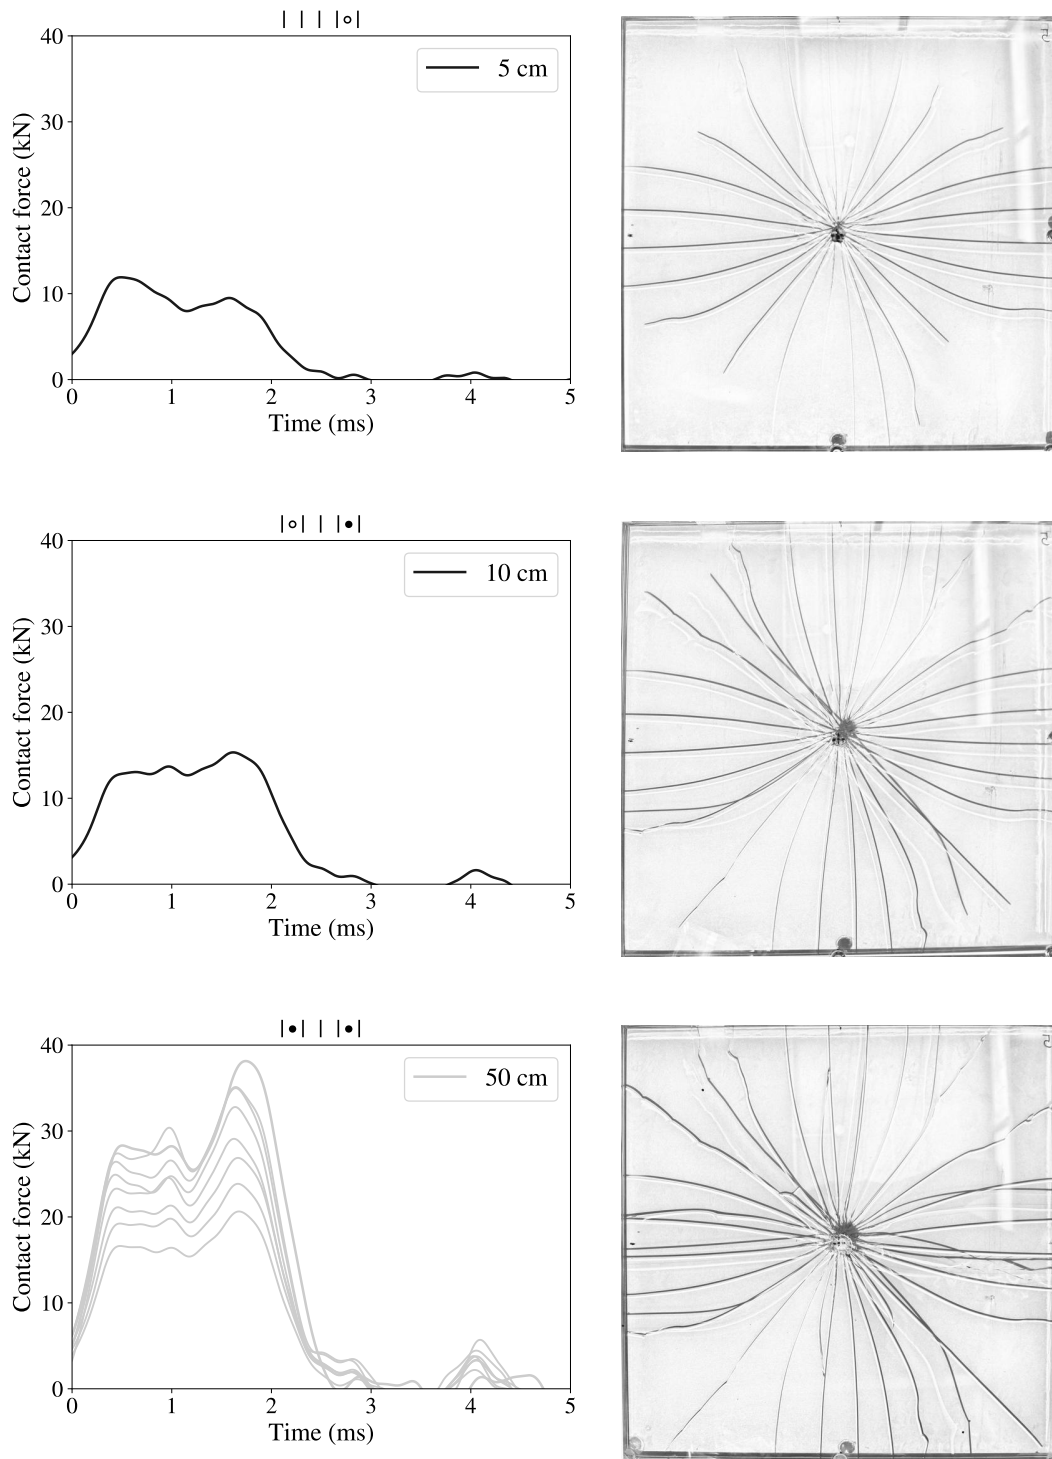
Figure 16: Evolution of contact forces ($2\times$ filter CFC 1000) and corresponding fracture patterns for 7LG-1. Black lines denote the contact forces during the destructive tests, whereas the grey ones correspond to the previous sequence of impact events at lower impact heights (increased by 5 cm for each following impact event).
