Experimental study on the gradual fracture of layers in multi-layer laminated glass plates under low-velocity impact

Alena Zemanová, Petr Konrád, Petr Hála, Radoslav Sovják,
Radim Hlužek, Jan Zeman, Michal Šejnoha
Czech Technical University in Prague, Czech Republic

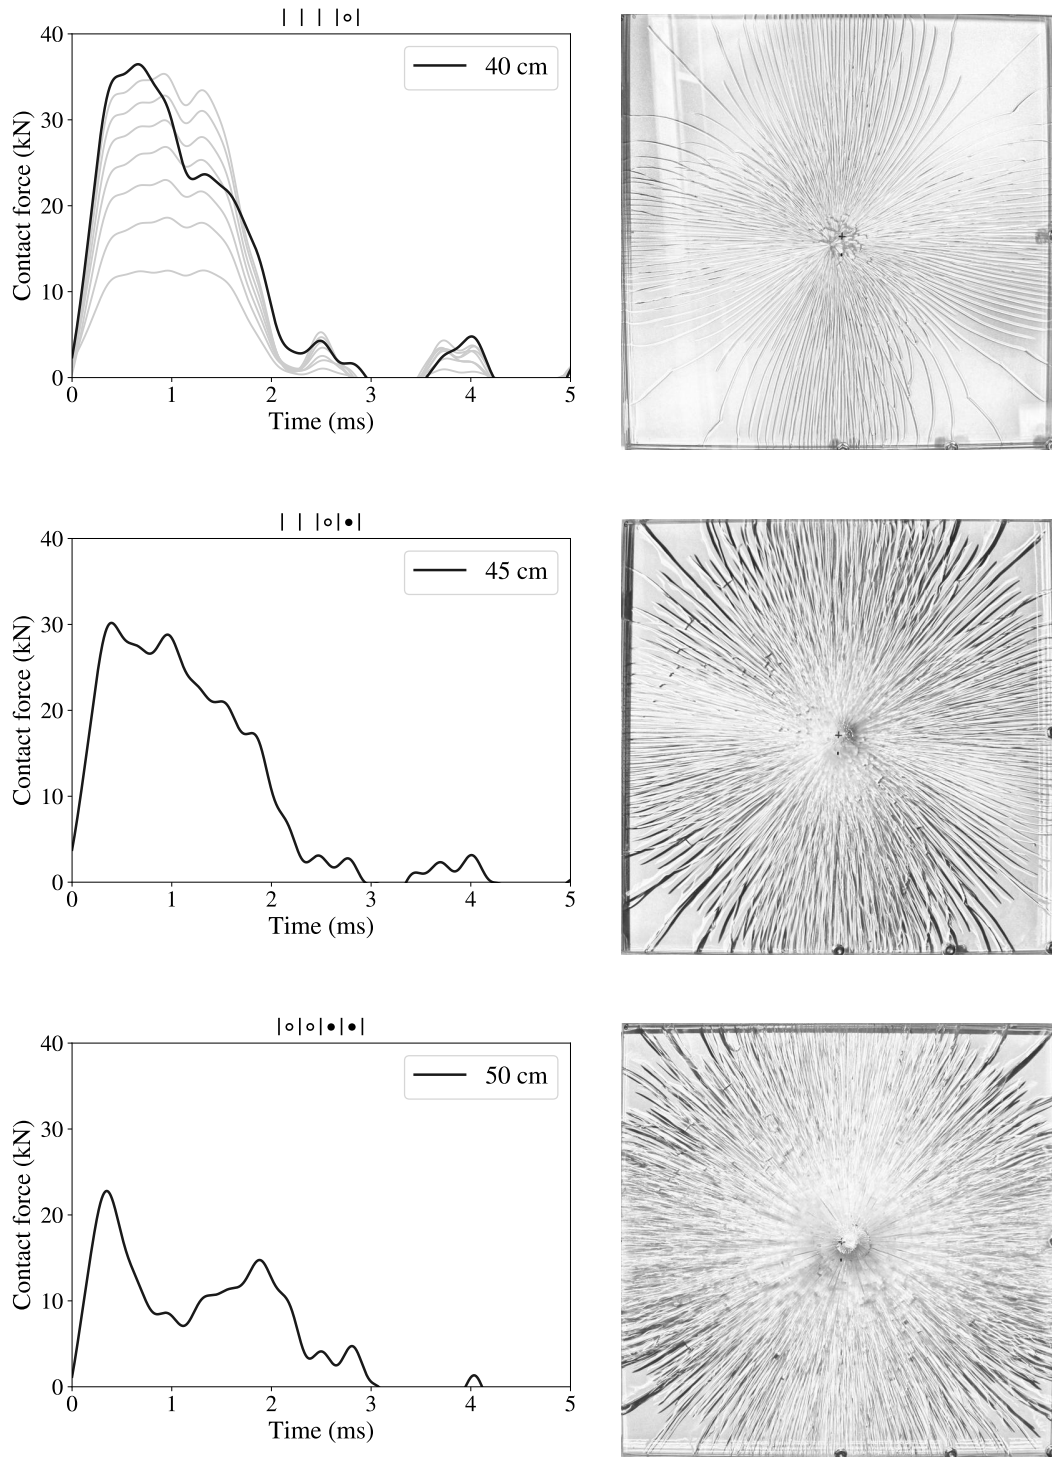
Figure 17: Evolution of contact forces ($2\times$ filter CFC 1000) and corresponding fracture patterns for 7LG-2. Black lines denote the contact forces during the destructive tests, whereas the grey ones correspond to the previous sequence of impact events at lower impact heights (increased by 5 cm for each following impact event).

The same strategy as in the previous section was employed to determine the contact forces during the destructive tests. We plot the results of this analysis in terms of contact forces for each sample independently (Figures 10–20) and complement them with distinctive fracture patterns. Recall that the evolution of contact forces exhibits the same trend for all non-destructive tests, their magnitudes only differ with an increasing impact height (Figure 9). When a previously intact glass layer fractured, the contact force deviates from the formerly consistent path. Then, a new shape of contact force can be observed, and its trend is again consistent for the increasing impact heights until the subsequent fracture of another glass layer(s). The contact duration was longer for samples with fractured layers as their modal response had changed.

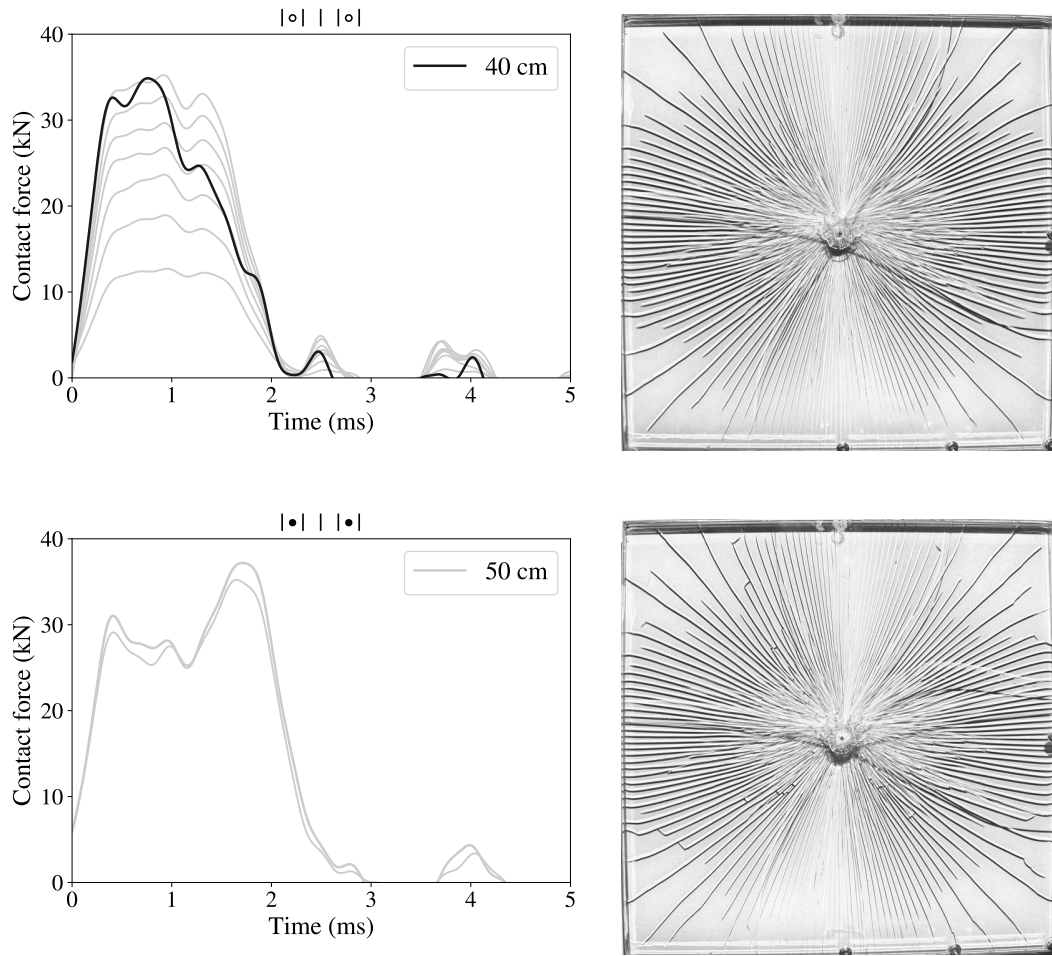
Figure 18: Evolution of contact forces ($2\times$ filter CFC 1000) and corresponding fracture patterns for 7LG-3. Black lines denote the contact forces during the destructive tests, whereas the grey ones correspond to the previous sequence of impact events at lower impact heights (increased by 5 cm for each following impact event).

The typical fracture pattern consisted of several radial cracks of different lengths, in some samples seldomly connected by a short parts of secondary cracks (e.g., Figures 10, 15, 18, or 20). The area under the impact point was often covered by a finer net of cracks especially on the impacted glass layer (see ahead to Figures 22 and 23). As expected, the density of fracture pattern increased with the impact energy.

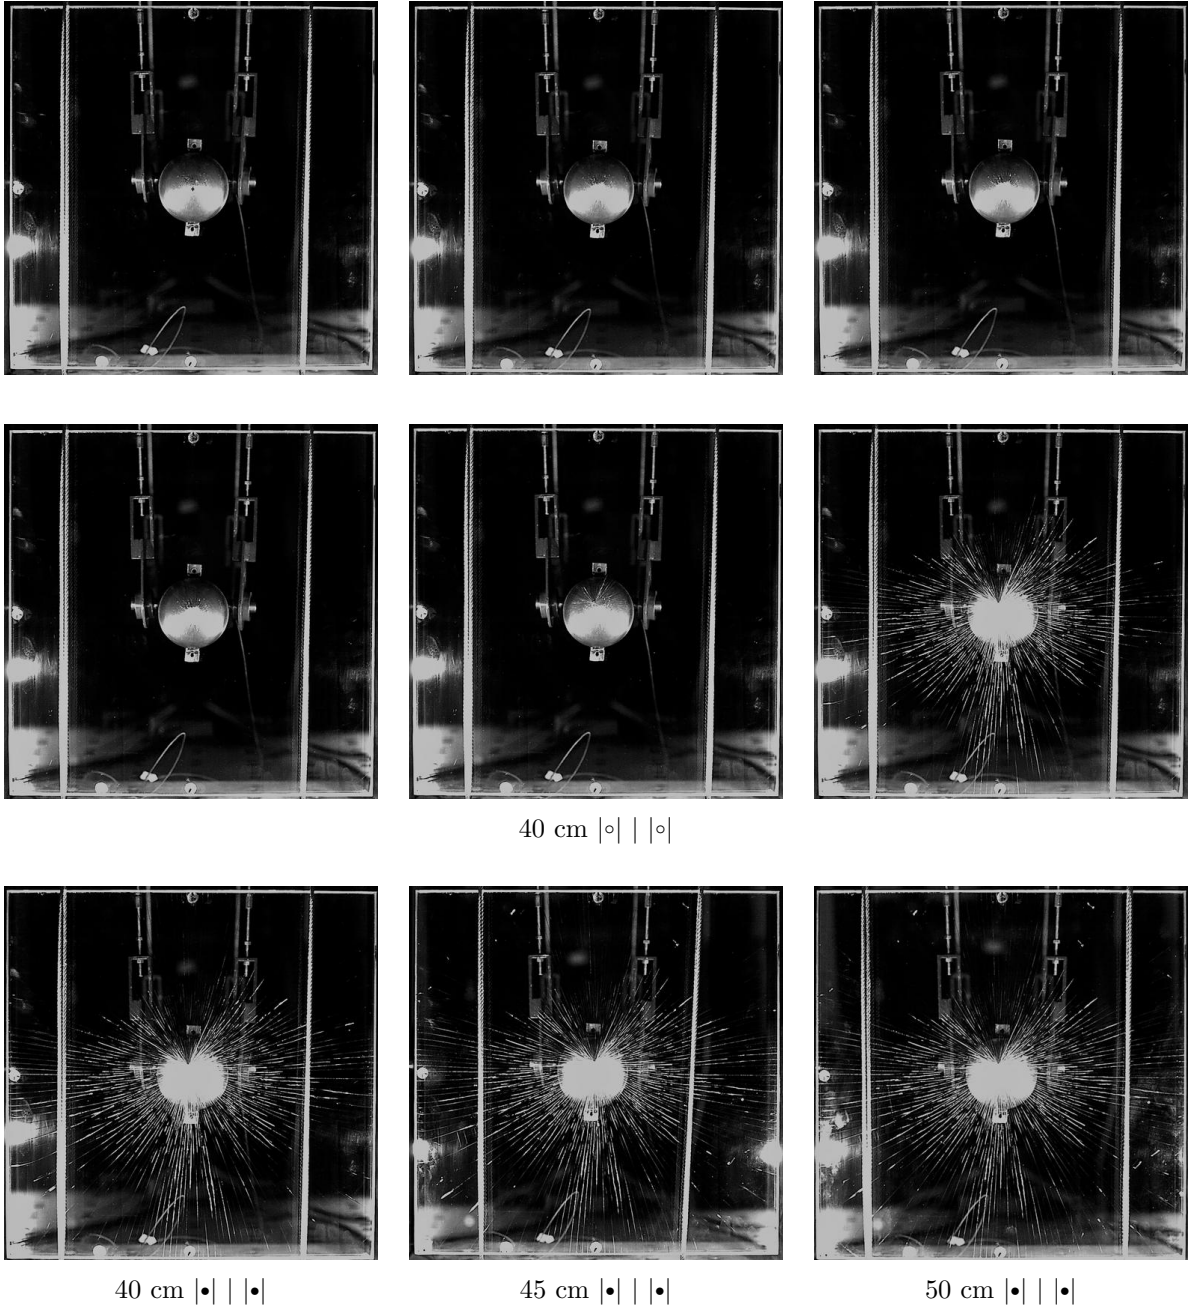
Figure 19: Evolution of cracks in 7LG-3 sample (frame rate 5,000 frames per second, i.e., time step 0.2 ms between two adjacent photos in a row).

For four samples (two per the same geometry), the evolution of fracture pattern was captured by a high-speed camera (Figures 12, 14, 19, and 21) with a 0.2 ms time intervals between two successive frames. The visibility of cracks depended on their opening during the vibration of a laminated glass plate. Therefore, we encourage the reader to compare the high-speed camera photos with the final fracture patterns captured on a white background after the impacts to detect all cracks (via their shadows) that developed during the contact.

The major changes in crack patterns occurred when the first glass layer(s) fractured. Further, the growth of cracks under consecutive impacts was small until the fracture of next glass layer; compare, e.g., fracture patterns for different impact heights but the same scheme of cracked layers (Figure 19). A visual comparison of patterns for the impact height of 50 cm shows that the fewest cracks appeared in the 7LG-1 sample where both outer glass layers fractured at relatively low impact energies. This suggests that the density of cracks is given by the initial power of the impact leading to fracture, and the additional impacts did not change the density of cracks significantly.

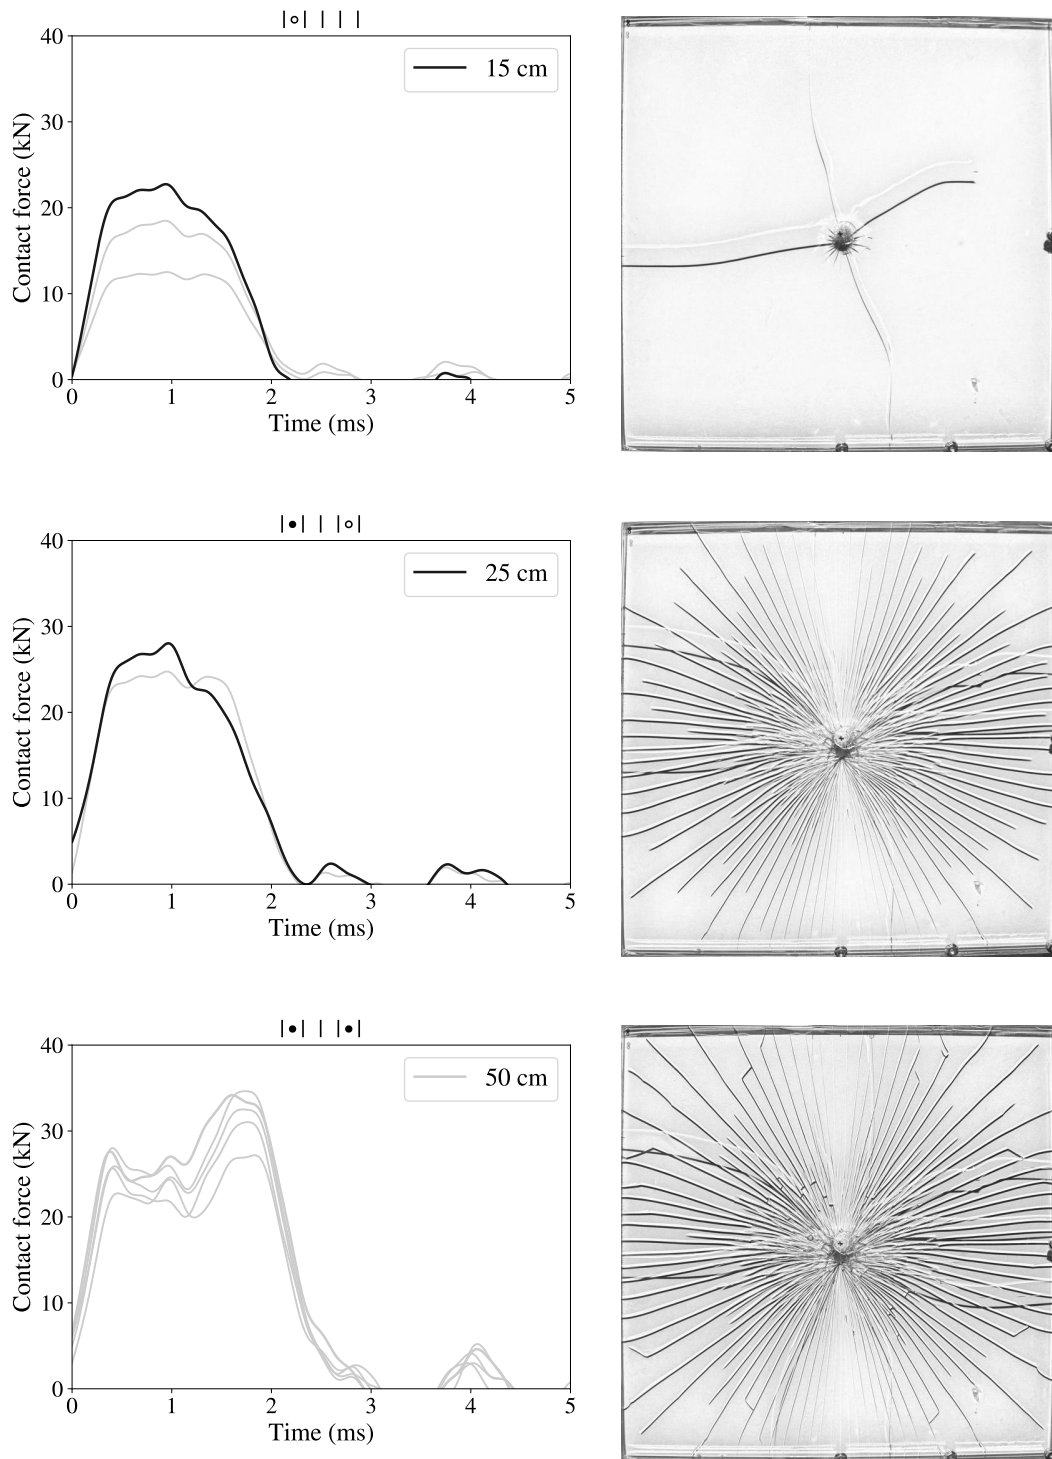
Figure 20: Evolution of contact forces ($2\times$ filter CFC 1000) and corresponding fracture patterns for 7LG-4. Black lines denote the contact forces during the destructive tests, whereas the grey ones correspond to the previous sequence of impact events at lower impact heights (increased by 5 cm for each following impact event).

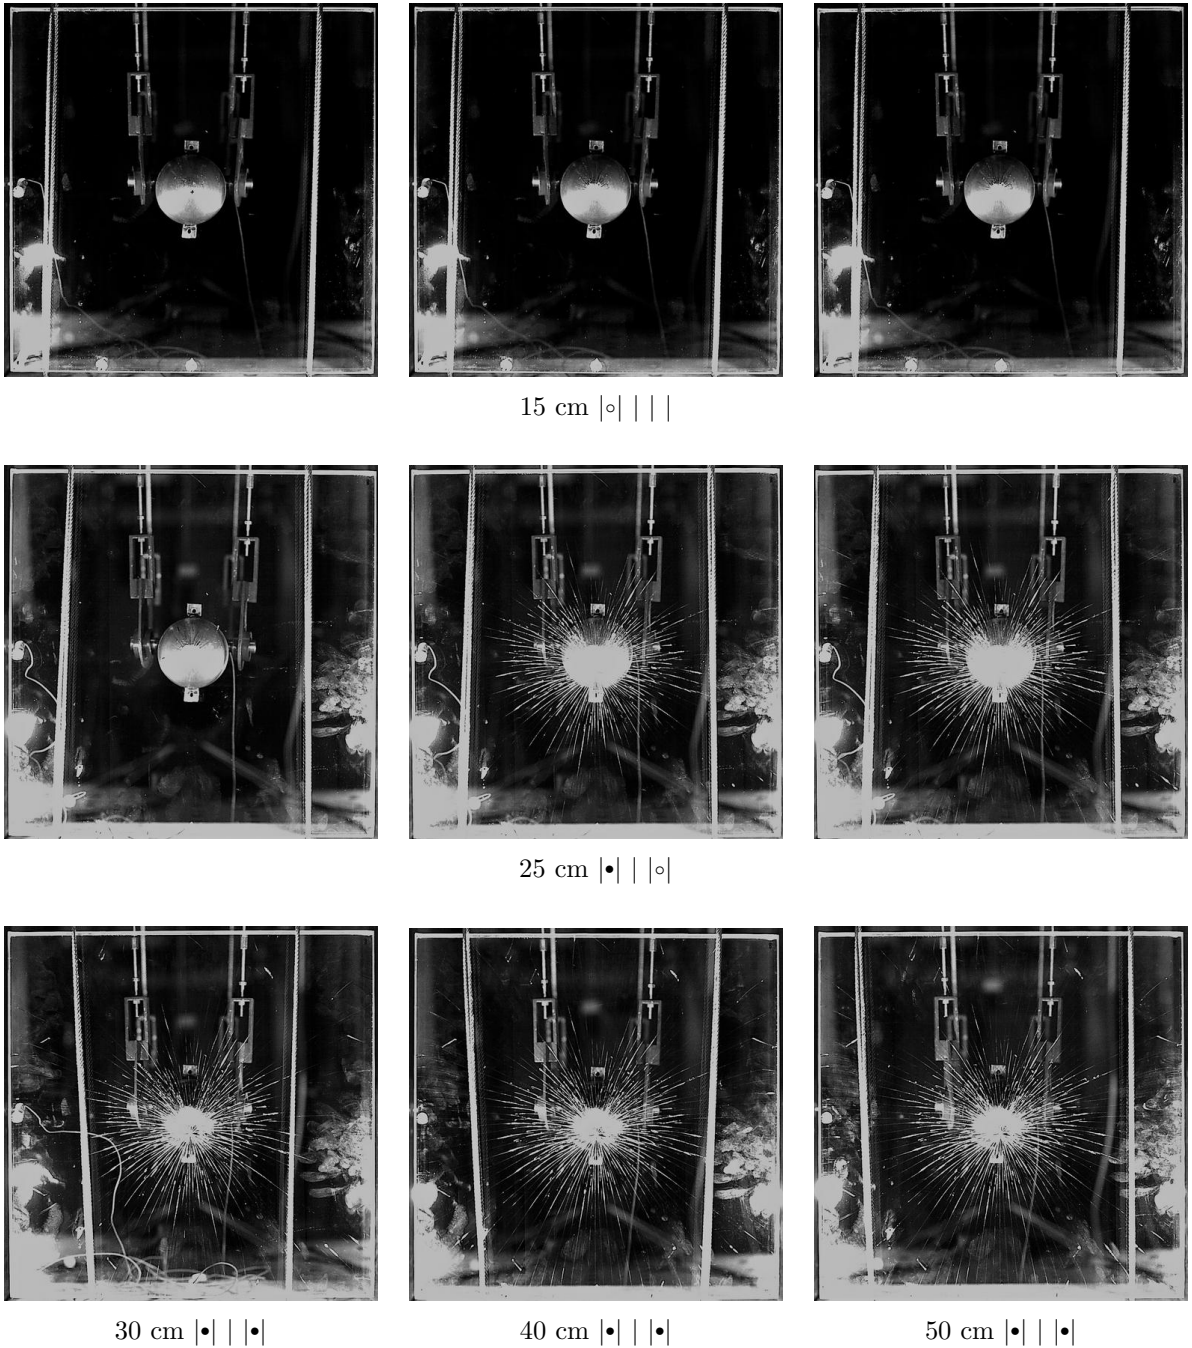
Figure 21: Evolution of cracks in 7LG-4 sample (frame rate 5,000 frames per second, i.e., time step 0.2 ms between two adjacent photos in a row).

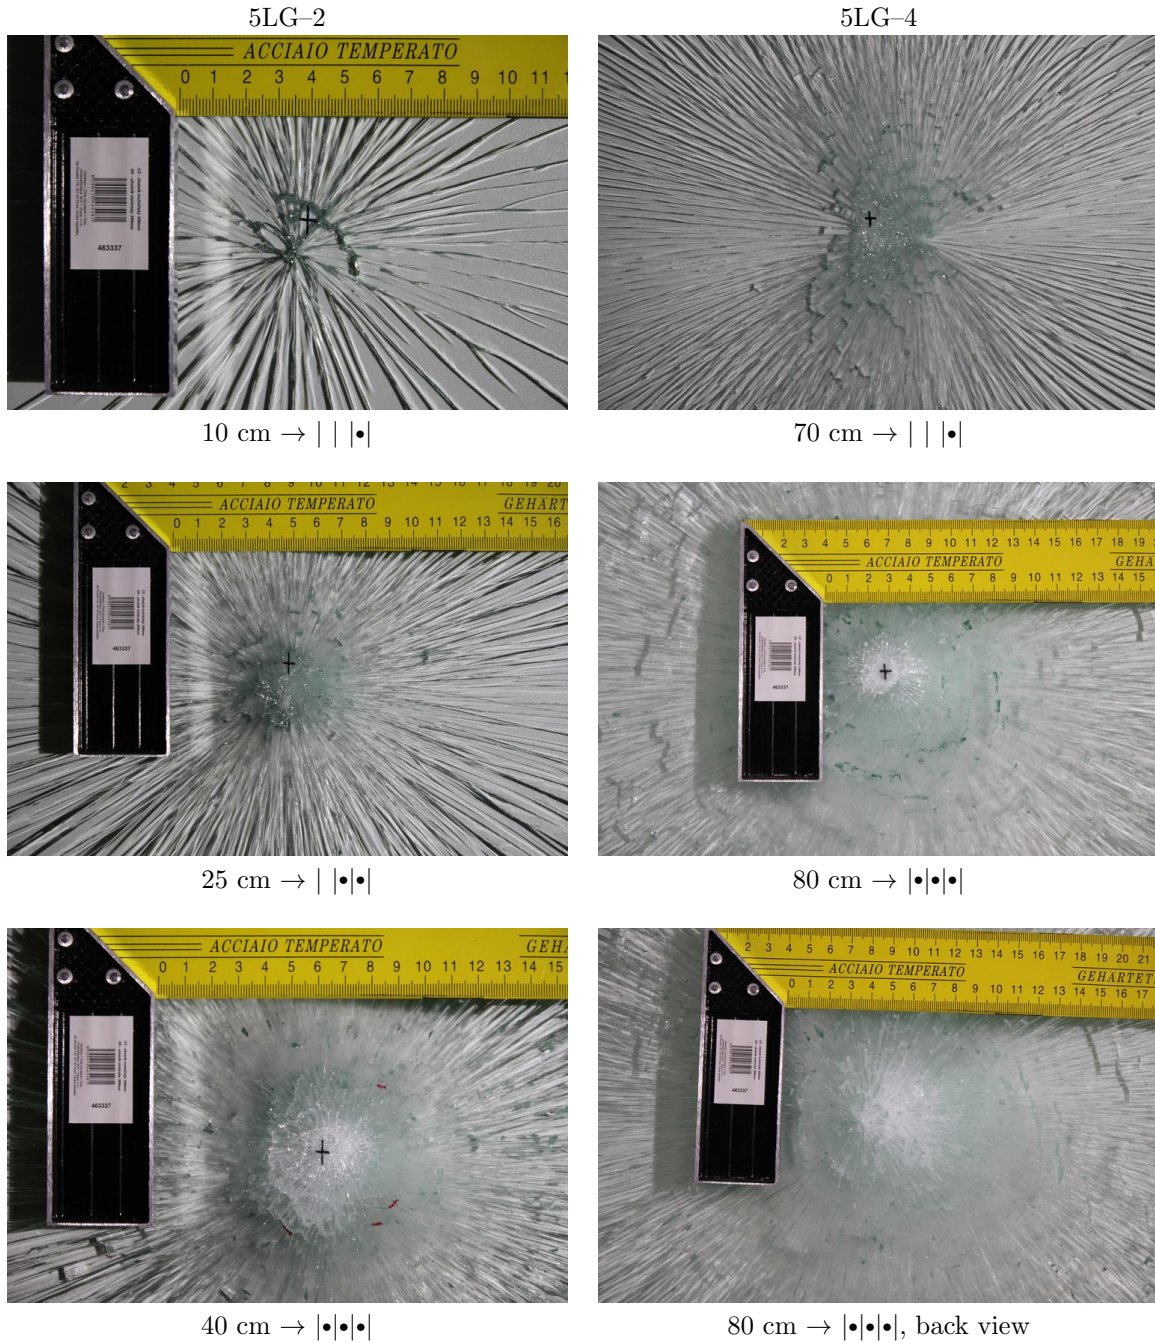
Figure 22: Details of crack patterns under the impact points for 5LG-samples seen from the impacted (no label) or non-impacted side (referred to as back view).

The details of starburst crack patterns under the impact point are summarised for four samples in Figures 22 and 23. We can observe that the centres of crack patterns in non-impacted glass layers do not coincide with the intended impact point (area) whereas the origins of the crack patterns in the impacted layers are significantly closer to this point (Figures 22 and 23). A sequence of images (Figure 19) also confirms that despite the impactor hit the centre of the plate with the tolerance less than 0.5 cm, the origin of the pattern in the back glass layer is located approximately 1.5 cm from the centre (Figure 23). Therefore, the reason is not the eccentric impact but more likely some invisible microflaw on the surface under tension. The changes in crack patterns under the impactor were minor as highlighted for some cracks and consecutive impact tests by different colours or marks in Figure 23.

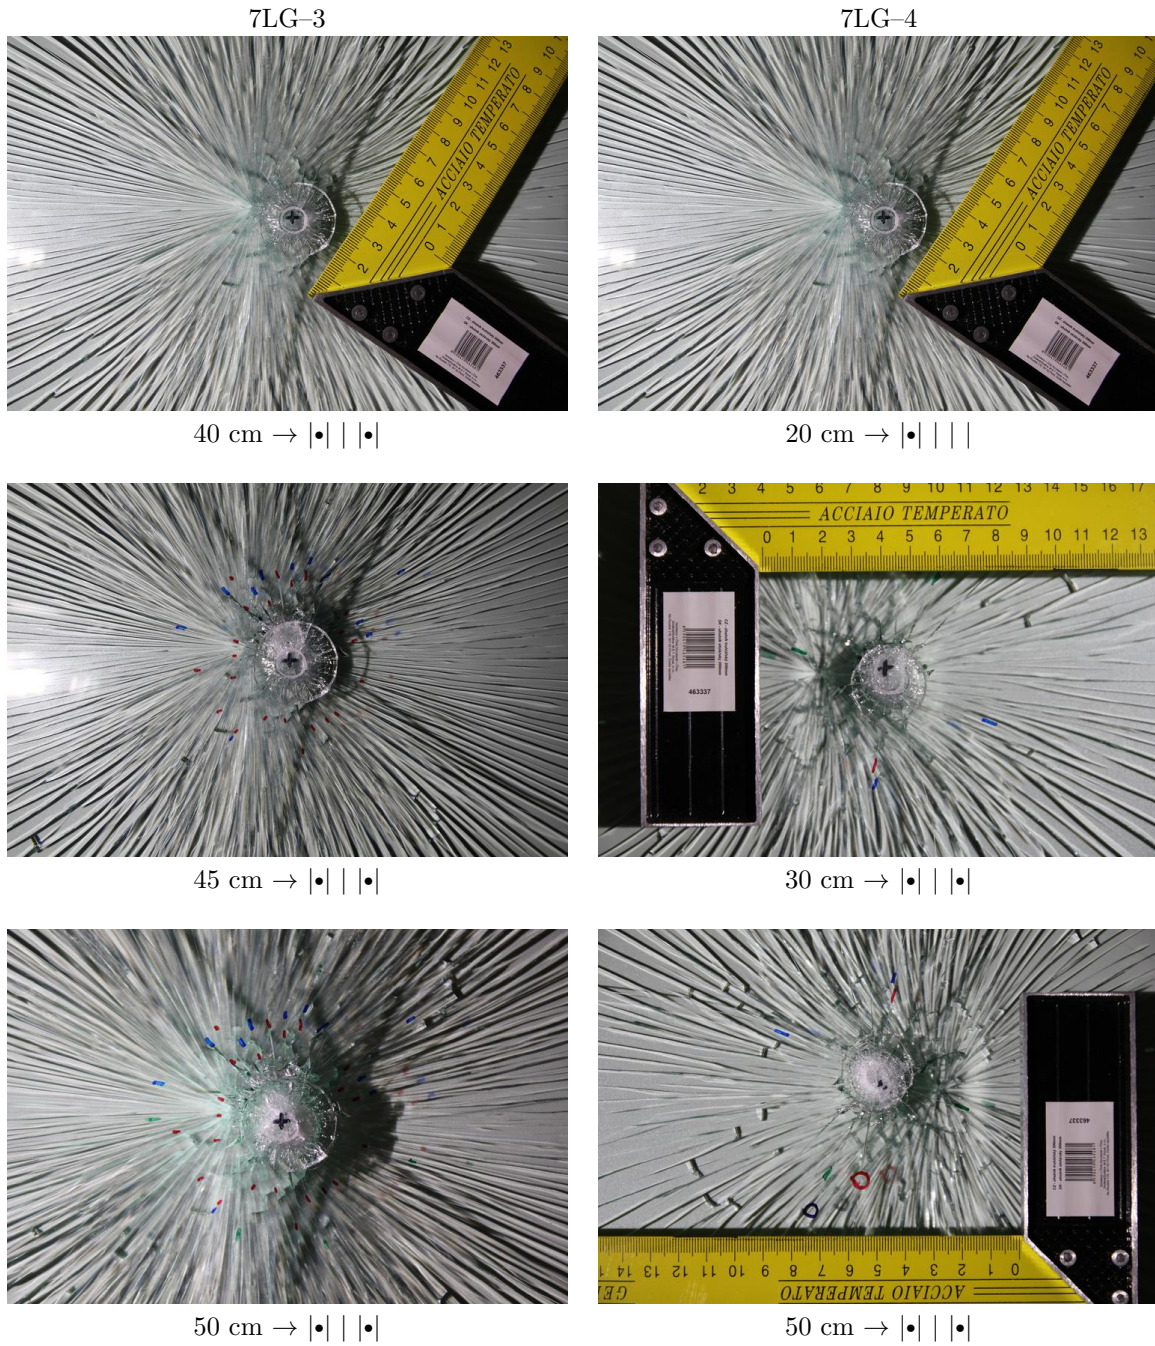
Figure 23: Details of crack patterns under the impact points for 7LG-samples seen from the impacted side.

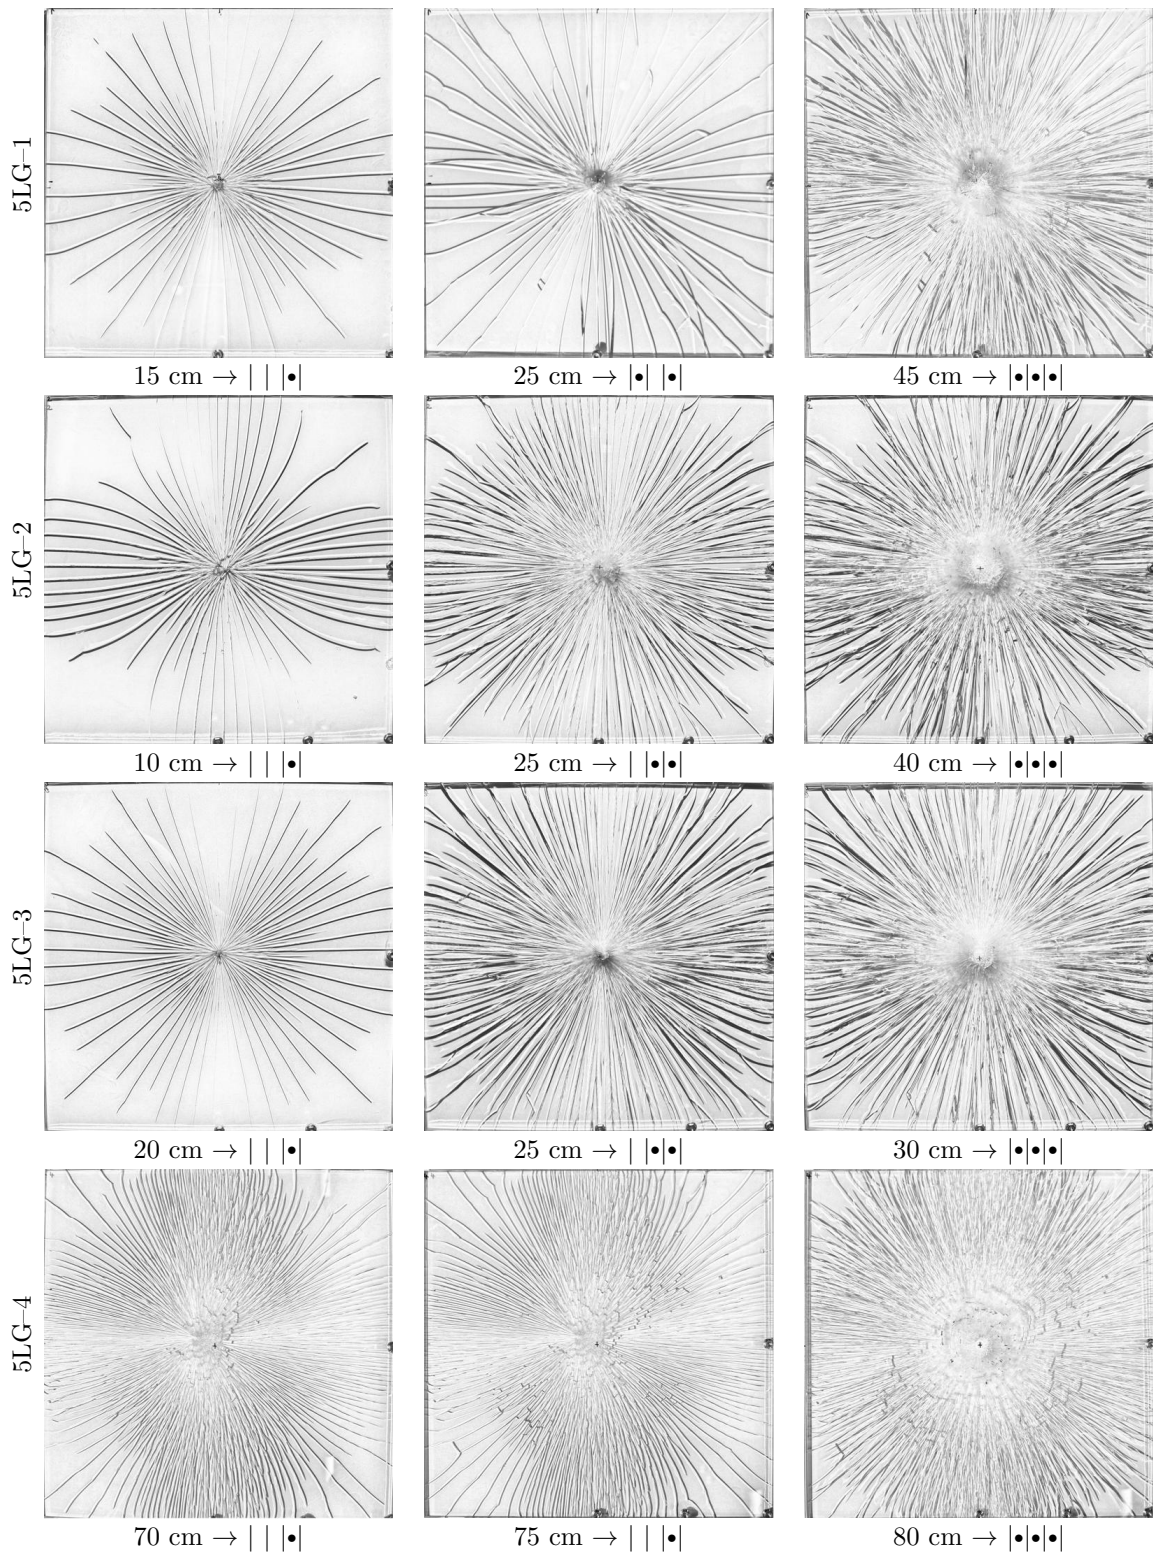
Figure 24: Fracture patterns for 5LG-samples corresponding to different impact heights complemented with the scheme of the cross-section with fractured layers marked by •. Photos are taken from the impacted side.

For both types of laminated glass, Figures 24 and 25 summarise all fracture patterns corresponding to the subsequent fracture of glass layers. The back layer fractured first for all 5LG-samples and the density of the radial cracks was comparable for three tested samples that fractured under the impact heights of 10, 15, and 20 cm. A significantly finer crack pattern on 5LG-4 corresponded to a more powerful impact. For 7LG-samples, the back glass layer fractured first in two cases and the front one in other two cases. Corresponding fracture patterns differ (first column in Figure 25) which indicates that the way of cracking was different in both outer glass layers.

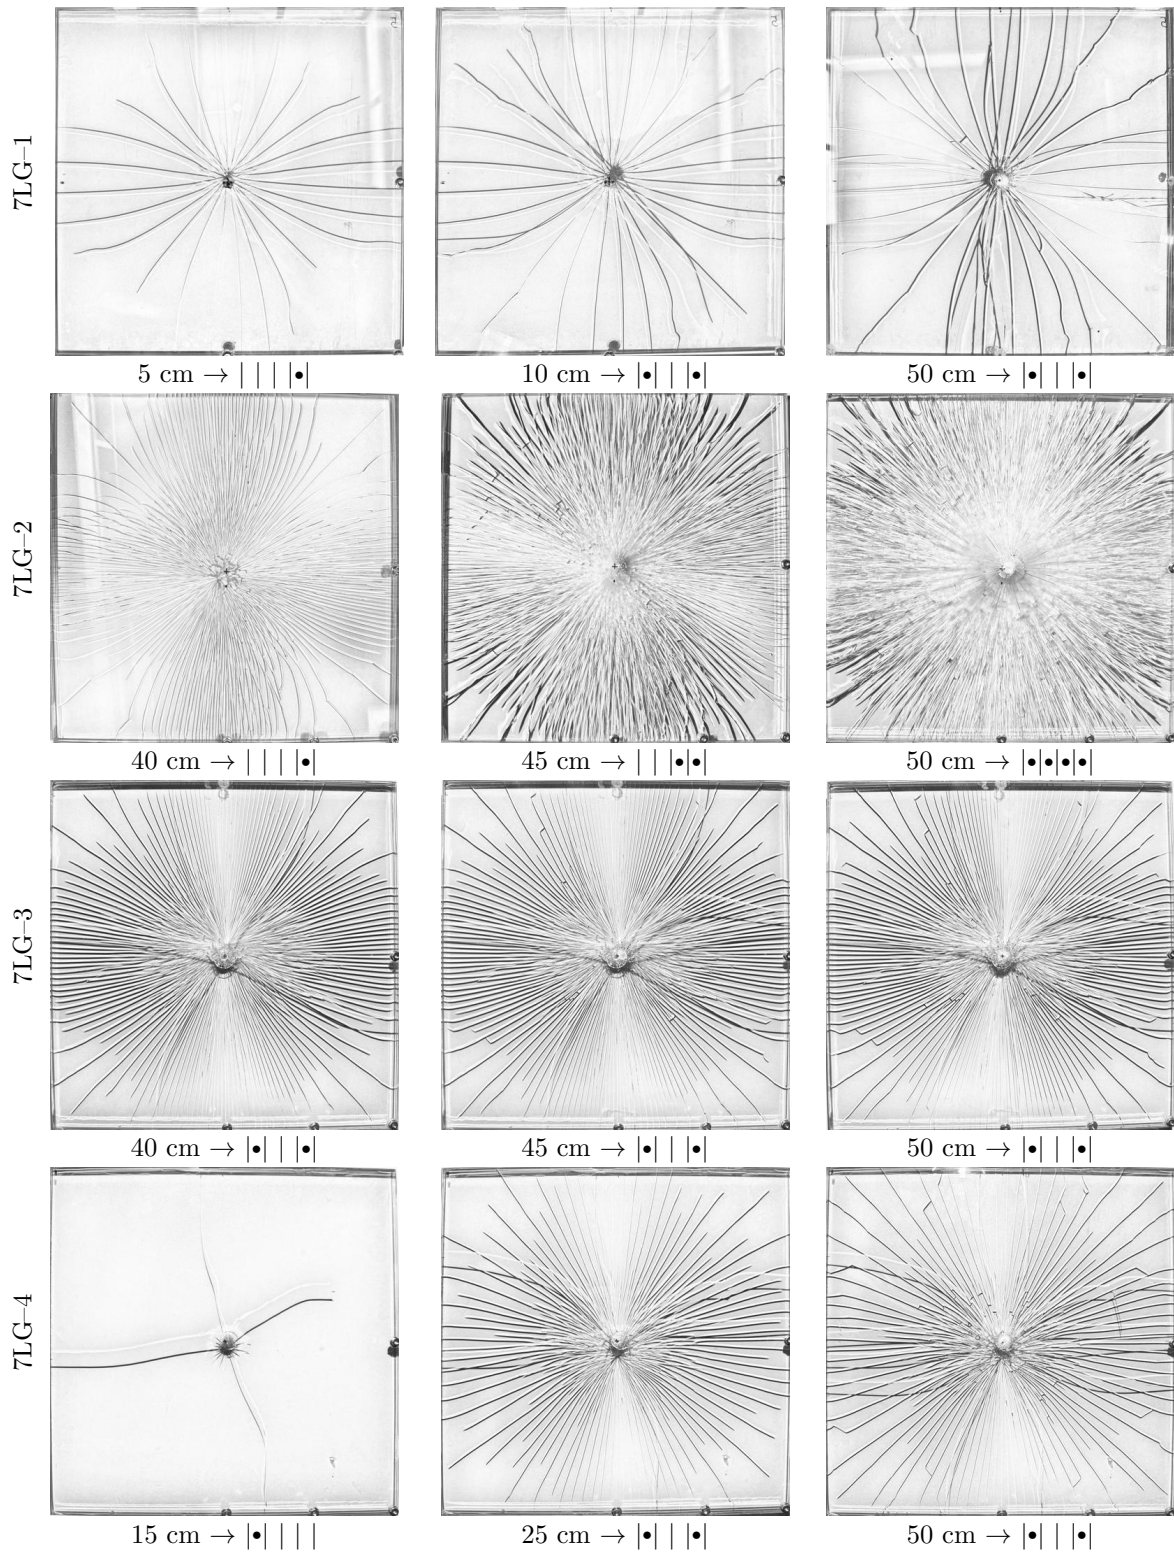
Figure 25: Fracture patterns for 7LG-samples corresponding to different impact heights complemented with the scheme of the cross-section with fractured layers marked by •. Photos are taken from the impacted side.

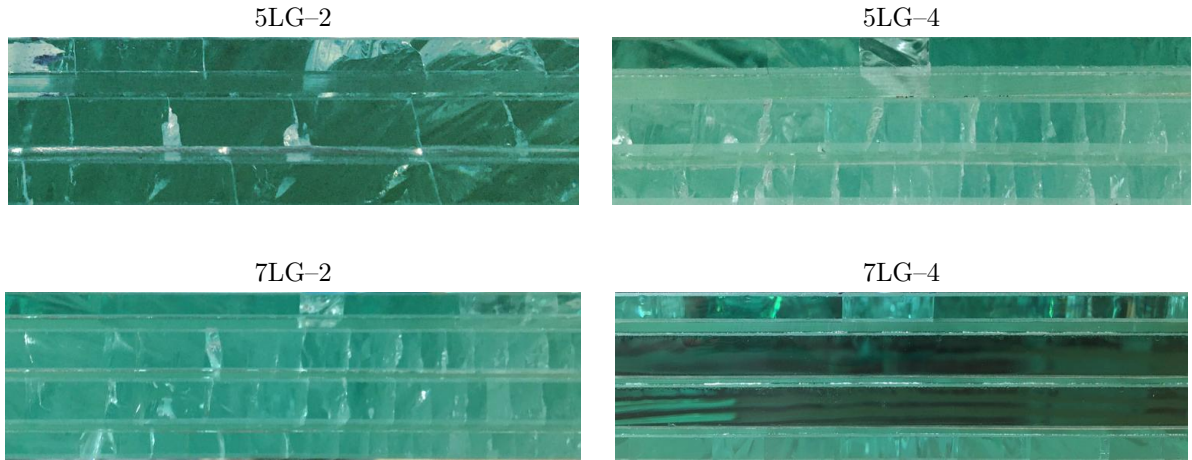
Figure 26: Side views of the final fracture patterns visible on samples' edges after all impact tests (the top glass layer is the impacted one).

The driving mechanisms of cracking for three-layer laminated glass was studied in [49]. The authors observed that the radial cracks initiated in the supported glass layer, and after a short time interval, the cracks propagated at the same in-plane locations in the impacted glass layer. In our impact tests, all glass layers did not generally fracture at one impact event, so the cracks did not completely propagate across the layers as can be seen in the side views on samples' edges (Figure 26). The more significant differences can be observed for the crack patterns on the impacted glass layer, which was underlied by a thicker PVB foil and where the cracks stayed mostly localised around the impact point (clearly visible, e.g., for 7LG-4 in Figures 20 and 26). The crack patterns partly differed also for the samples where glass layers fractured consecutively in the direction from the non-impacted surface to the impacted one (e.g., 5LG-2, 5LG-4, 7LG-2 in Figure 26).

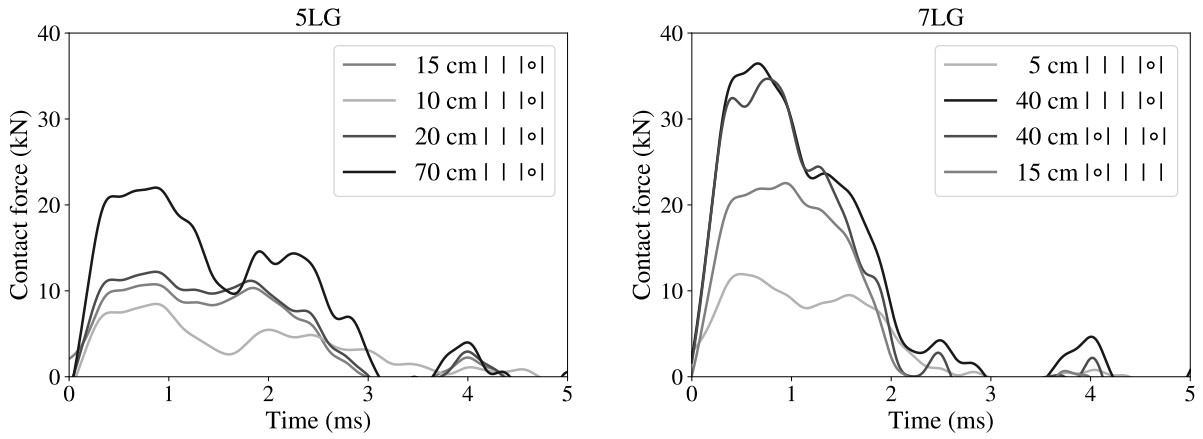
Contact forces corresponding to the first glass layer(s) fracture

Figure 27: Comparison of contact forces ($2\times$ filter CFC 1000) corresponding to different stages of glass fracture.

The overview of breakage forces (presented in Figure 27) indicates that the 7LG-samples resisted mostly higher contact forces than the 5LG-sample. For both types of laminated glass, the scatter of forces is substantial due to the stochastic nature of tensile strength of glass. For 5LG-samples, the lowest peak value leading to the first glass layer fracture was less than 10 kN, whereas the largest value was over 20 kN. For 7LG-samples, the breakage force reached the value over 35 kN for two samples but was less than 15 kN in another case. Similar differences can be also seen for the peak contact forces leading to the fracture of subsequent glass layers.

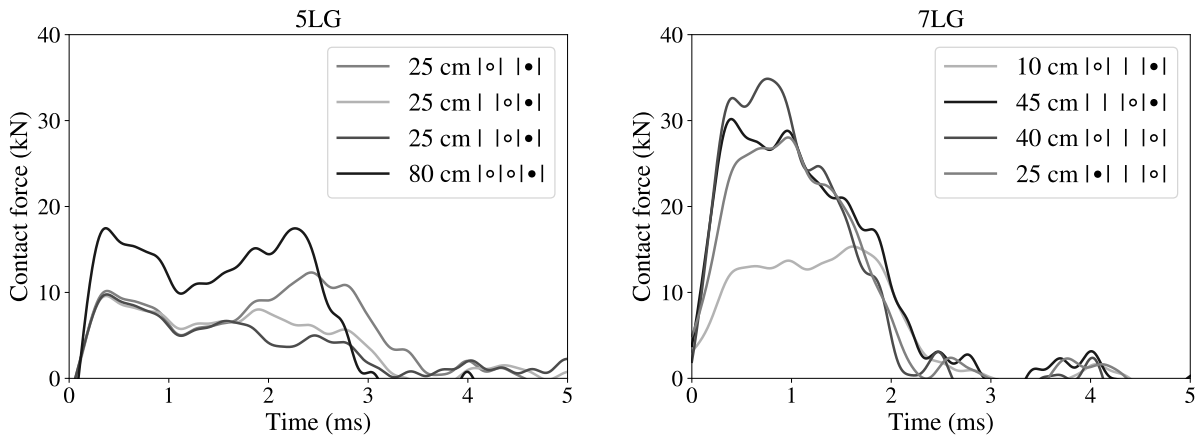
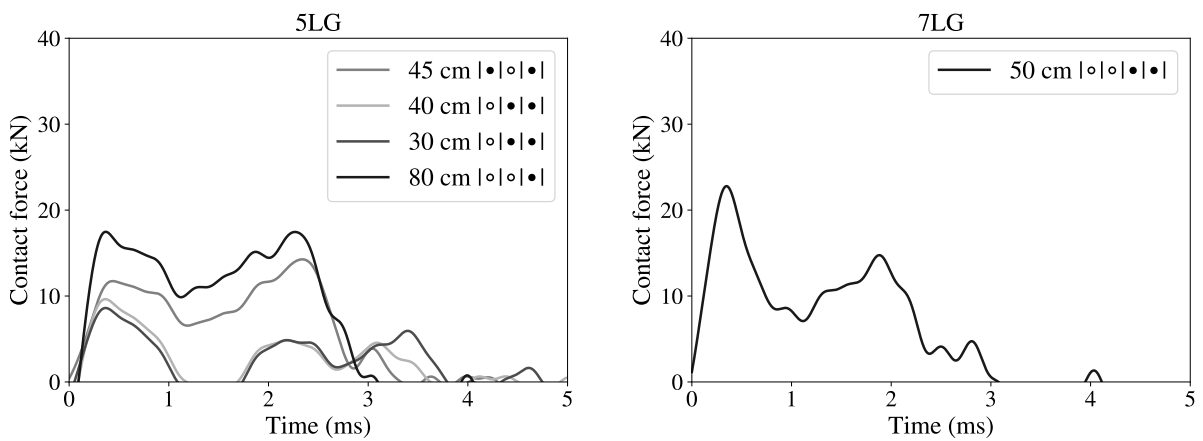
Contact forces corresponding to a subsequent fracture of different glass layer(s)

Contact forces corresponding to the fracture of all glass layers

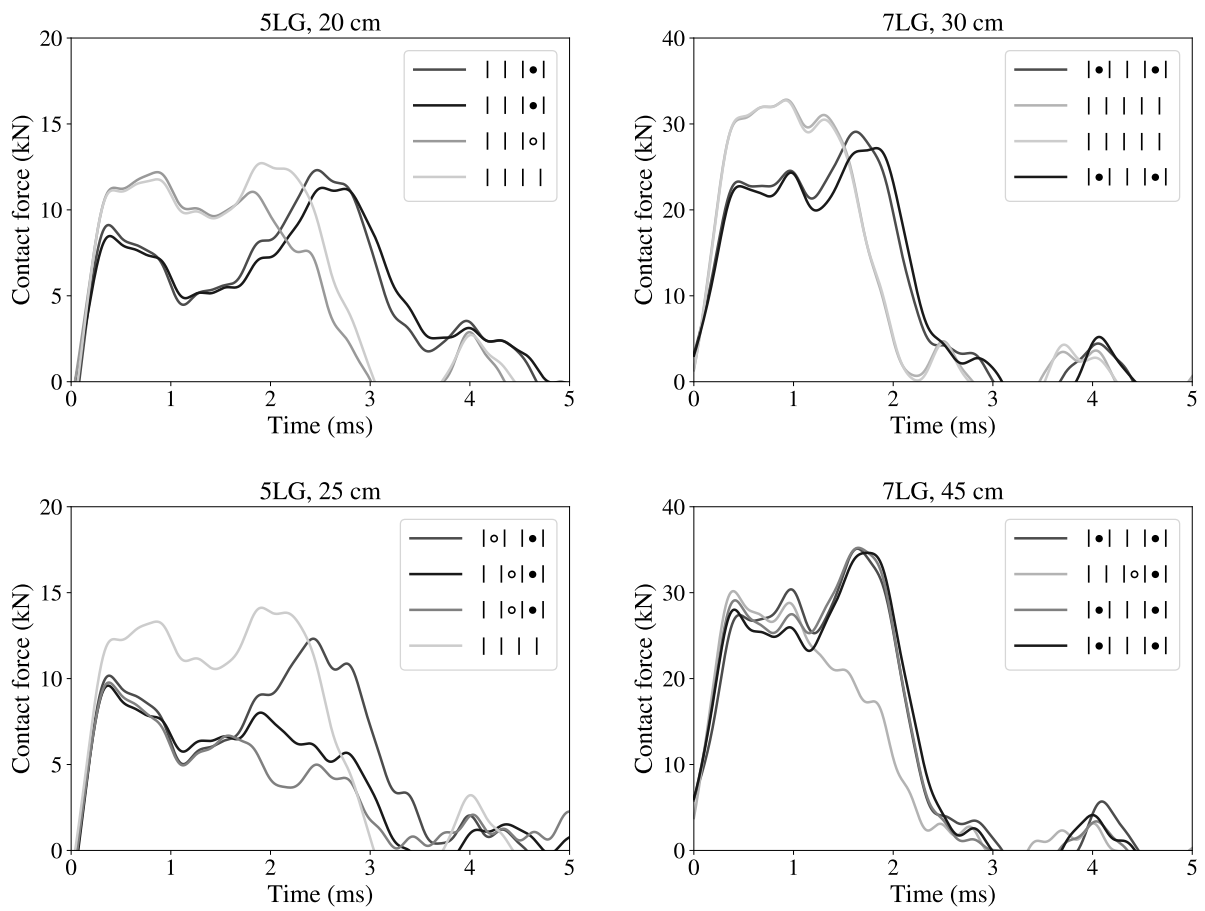
Figure 28: Comparison of contact forces ($2\times$ filter CFC 1000) for two different schemes of cracked layers in laminated glass samples.

Further, we tested if the same scheme of cracked layers provided the same evolution of contact forces. The very good level of conformity in the evolution of contact forces could already be seen for the post-fracture response of individual laminated glass samples (Figures 10–20). The comparison of contact forces acting on different samples (Figure 28) proves that the contact forces were consistent not only for non-destructive tests, but very similar evolutions developed also for the same scheme of fractured layers. For 5LG-samples

and the impact height of 20 cm, the contact forces differed only slightly, and the impact event resulted in approximately the same length of the contact and a similar peak value of the contact force. When the impact height was increased to 25 cm, the evolution of contact force followed initially the same path for three samples with the same scheme of cracked layers until the fracture of another glass layer. Almost identical contact forces can be also found for the 7LG-samples with both outer glass layers fractured (Figure 28).

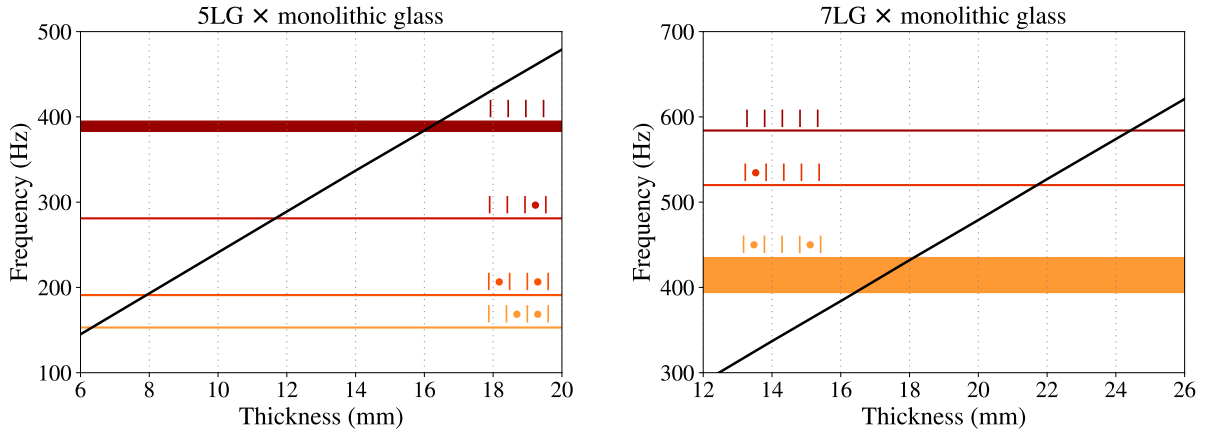
Figure 29: Comparison of the natural frequencies corresponding to the first bi-symmetric mode shape derived from FFT-based analysis for laminated glass samples against numerical predictions for monolithic glass plate (black line; Young’s modulus of glass 72 GPa, Poisson’s ratio 0.22, density $2,500 \text{ kg}\cdot\text{m}^{-3}$).

Next, the thicknesses of equivalent monolithic glass plates (with the same first natural frequencies) can be obtained from Figure 29. The natural frequencies of monolithic glass plates were derived numerically (employing the Young’s modulus of glass 72 GPa, Poisson’s ratio 0.22, and density $2,500 \text{ kg}\cdot\text{m}^{-3}$). The 5LG-samples vibrated similarly to a 16 mm-thick glass ply (the sum of the nominal thicknesses of glass layers together). If the back glass layer fractured in 5LG-samples, the natural frequencies corresponded to a monolithic glass plate thicker than 11 mm (the sum of nominal thicknesses of both unfractured layers). A difference in the first natural frequencies can be seen for 5LG-samples with only undamaged middle or front (impacted) glass layer. The first scheme provided the response comparable to an 8 mm-thick glass plate (the middle layer was 6 mm thick), whereas the second one to an approximately 6 mm-thick glass sample (the impacted layer was 5 mm thick).

For the undamaged 7LG-samples, the dynamic response corresponded to a 24.5 mm-thick glass plate (less than 26 mm—the nominal thicknesses of glass layers in a 7LG-sample together). If the impacted glass layer fractured, the response was comparable to a 21.5 mm-thick glass plate (the total thickness of unfractured glass layers was 21 mm). A wider range of obtained natural frequencies can be seen in Figure 29 for 7LG-samples with both outer glass layer damaged, when their modal response corresponded to a monolithic glass with the thickness of 16–18 mm.
