#### Effect of Graded Bias Voltage on the Microstructure of arc-PVD CrN Films and its Response in Electrochemical & Mechanical Behavior

The effect of graded or constant bias voltages (-40 V, -80 V and -40/60/80 V) on size grain and surface defects of arc PVD deposited CrN films was investigated. Corrosion resistance evaluated using electrochemical impedance spectroscopy (EIS) and potentiodynamic curves (Tafel) and the mechanical behavior evaluated by means of instrumented nanoindentation and scratch testing was correlated with the microstructural changes. It was found that the bias voltage variation affects corrosion behavior due to the presence of defects (i.e. open voids, droplets) which also affects the failure mechanisms and increasing spallation. High bias voltage (-80 V) increases nano-hardness and the elastic modulus due to the dense microstructure of the CrN coating.

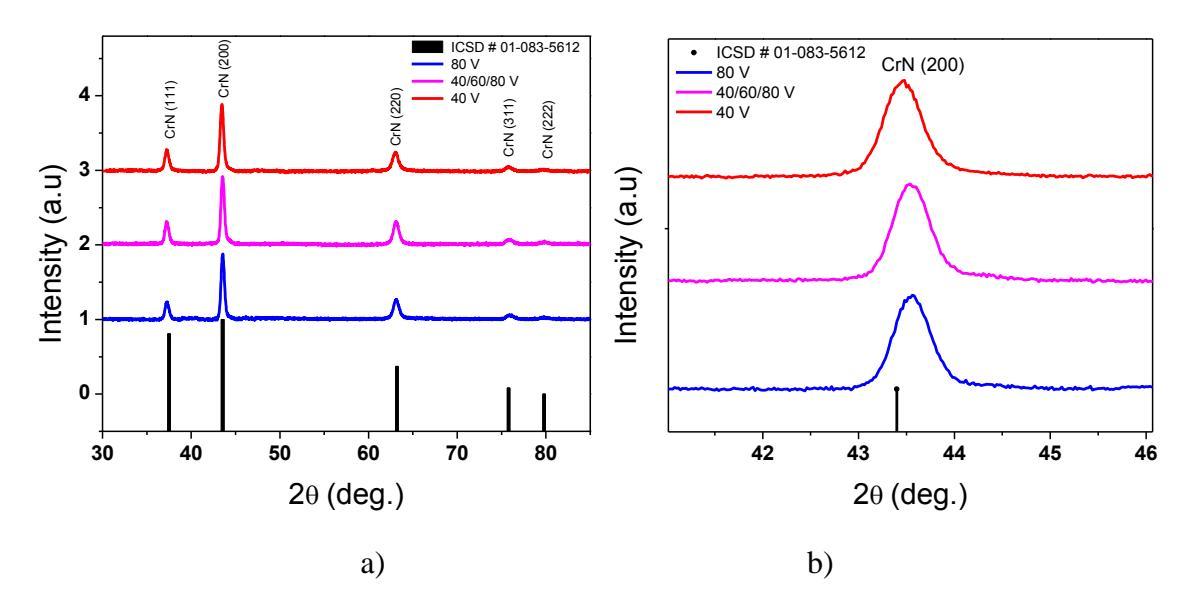
Figure 1. XRD patterns of CrN films: a) at 40  $V_b$ , 40/60/80  $V_b$  and 80  $V_b$ , and b) zoom in of (200) peak.

Figure 1 shows XRD patterns of CrN coatings which exhibit diffraction peaks corresponding to the B1 type structure of CrN phase (ICSD card # 01-083-5612, in figure 1a) with strong reflection in (200), as can be seen in figure 1b. The samples were compared with previously reported of unstrained CrN and they are presented in table I. A compressive stress state are present in the samples under study which are according to the shifting (200) peak to higher angles observed for  $40V_b$ ,  $40/60/80V_b$ , and  $80V_b$  samples. This behavior is related to the residual stresses due to atomic peening effect (APE) during the film growth [13].

A higher lattice strain was found from the 80Vb specimen caused by APE that promotes changes in nucleation and growth kinetics. Table I shows that crystallite size increases with the corresponding increment of the bias voltage. It is due to the enhanced mobility of adatoms on the surface and hence the growth and coalescence of nuclei were accelerated [14]. Likewise, it was observed a correlation between Bias Voltage and coating thickness finding a less thickness and major density of the coating for  $80V_b$  [15].

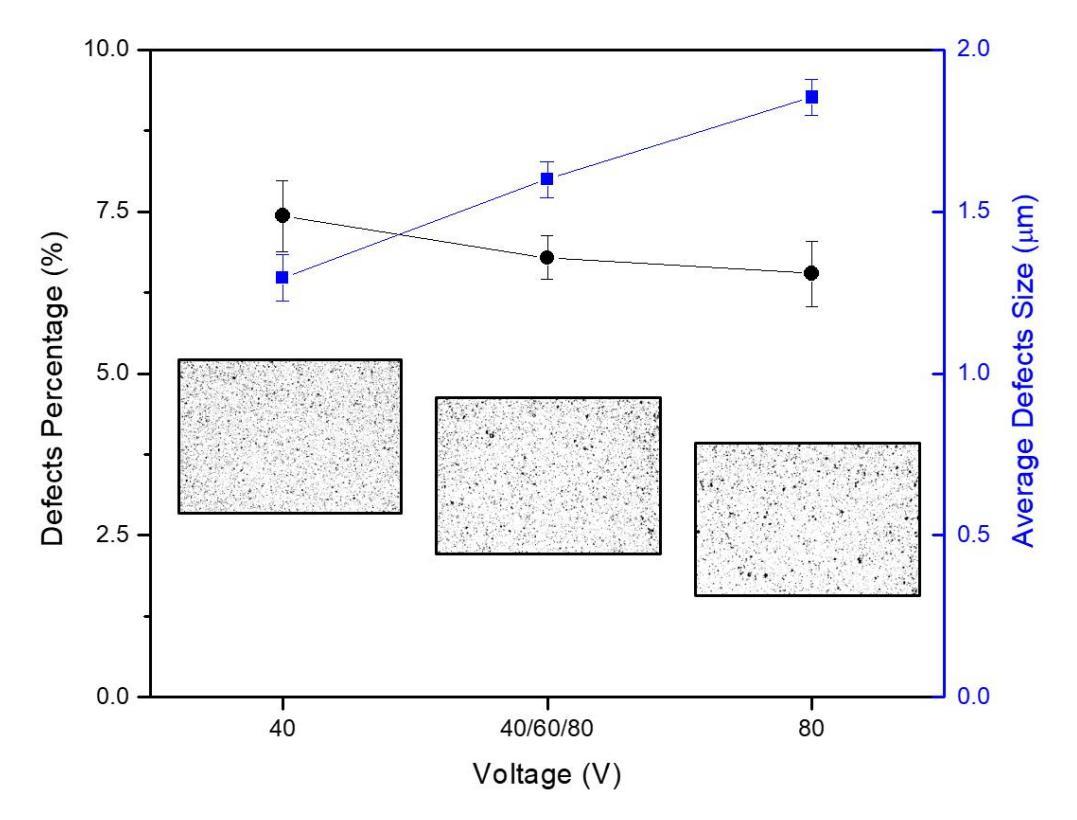
Figure 2. Relationship between size and defects percentage with the bias voltage.

Figure 2 shows the roughness values obtained by profilometry. The films roughness and defects percent have a clear tendency to be reduced for coatings obtained with a higher bias voltage; such as is previously reported by Warcholinski *et al.* who found a decrease of the microparticles density when the bias voltage increase [17]. However, we found an increase in the particle average size that could be related to higher arcs formation during the process.

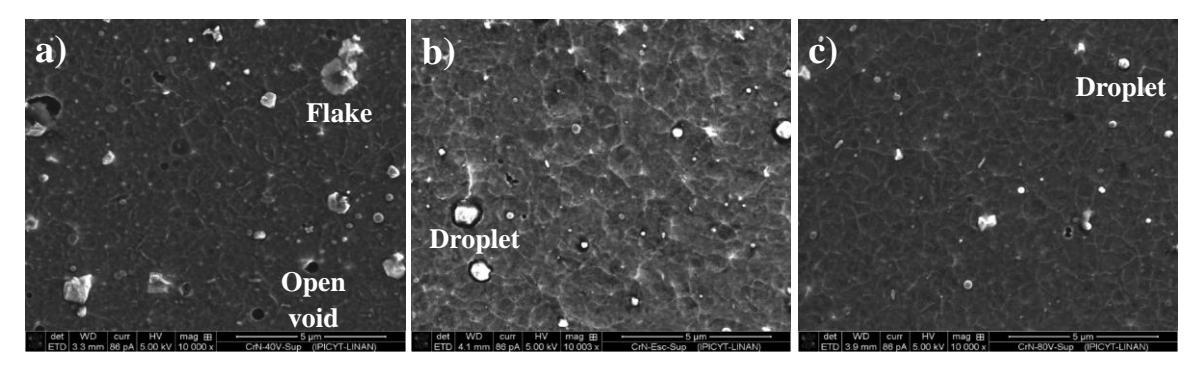
Figure 3. SEM micrographs of CrN coatings: a) 40V<sub>b</sub>, b) 40/60/80 V<sub>b</sub>, and c) 80 V<sub>b</sub>.

A detailed analysis of the SEM micrographs show a honeycomb structure at CrN films surface, a similar behavior was found by some authors for CrN coatings deposited by arc-PVD (see Figure 3) [17,19]. The honeycomb structure is more defined in the 40/60/80Vb coating due to the gradual acceleration and momentum that suffer the ions and particles during the deposit process. On the other hand, flakes-like defects were observed that could arise from particles detachment of the chamber walls. Additionally, open void defects were found in all samples. This kind of defects are widely known and it is mainly due to a droplets removal or others particles deposited on the substrate surface. [20].

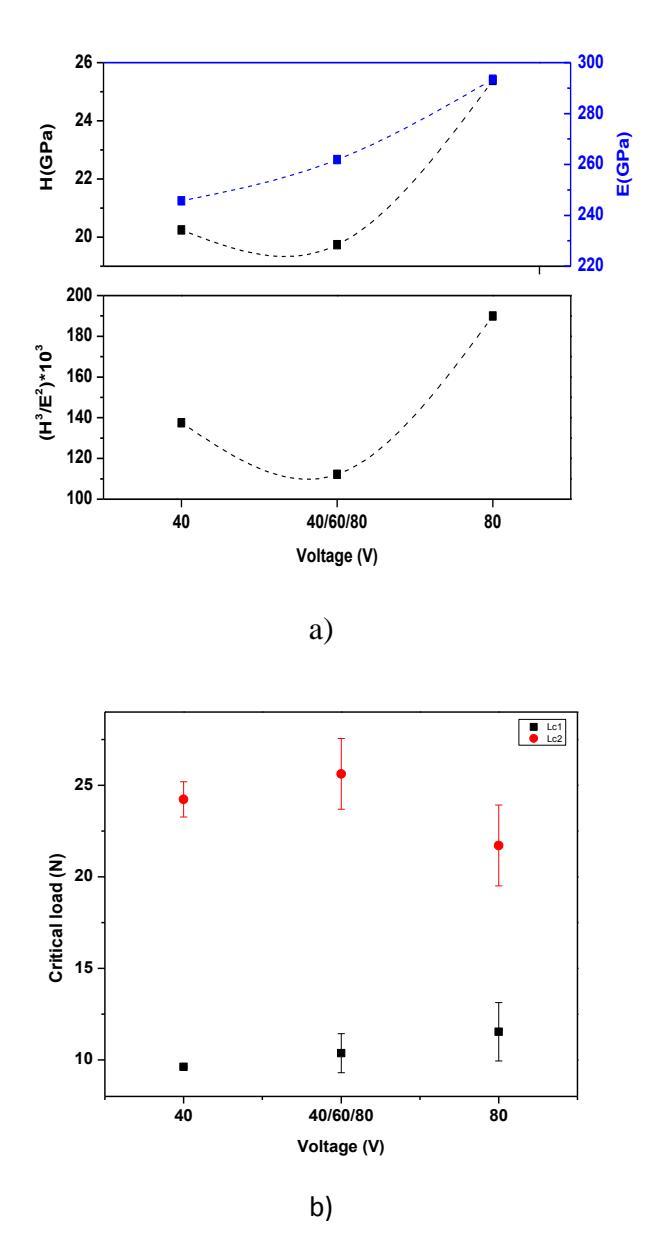
Figure 4. Effect of bias voltage on mechanical properties of CrN coatings: a) H, E and  $H^{3}/E^{2}$ ; b) Critical loads obtained by scratch tester.

Figure 3 show hardness (H), reduce elastic modulus (E), and the  $H^3/E^2$  ratio of the CrN coatings. An increase 19.74 GPa to 25.38 GPa in hardness and 245.66 GPa to 293.41 GPa in the reduced elastic modulus was reached when bias voltage shift from 40 to 80 V. Values higher obtained to 80 V can be attributed to more dense microstructure and major lattice strain, which indicates compressive stresses that enhance the mechanical resistance of the system [21][22][23][24]. On the other hand, intermediate values of H and E were obtained with 40/60/80 V due to a combination of mechanical properties between 40Vb and 80V. Additionally, It is important to consider that the values found have been higher to reported by Tan [12], who obtained a hardness between 7 GPa to 15 Gpa with CrN coatings deposited with a graded bias voltage (from -20 V to -200 V with intervals of 5V, 10V, and 60V).

Besides, figure 3a shows the  $H^3/E^2$  ratio of CrN coatings deposited at various voltages. This ratio represents the plastic deformation resistance of the coatings, which is related to the contact behavior of films. Higher values indicate the ability of the coating to absorb more energy. The behavior found is similar to the obtained with the hardness, in this case, the  $H^3/E^2$  shows a growth from 113.45 GPa to 189.96 GPa with increasing of V, thus, this coating should be more rigid to the contact compare with the others.

Figure 4b shows the critical loads cohesive Lc1 (black) and adhesive Lc2 (red) related with resistances to initiation of cracks and to delamination. LC1 is influenced by  $H^3/E^2$  ratio, thus, its behavior is similar to figure 3, where higher values were obtained with coatings deposited to 80 V. However, different behavior was found with LC2, in this case, the 40/60/80 V presents major interfacial resistance followed by coatings of 40 V and 80 V respectively. The phenomenon is related to the residual stresses observed by DRX, due to the high compressive stress in coatings with 80 V, the adhesion of the system of substrate/coating is reduces

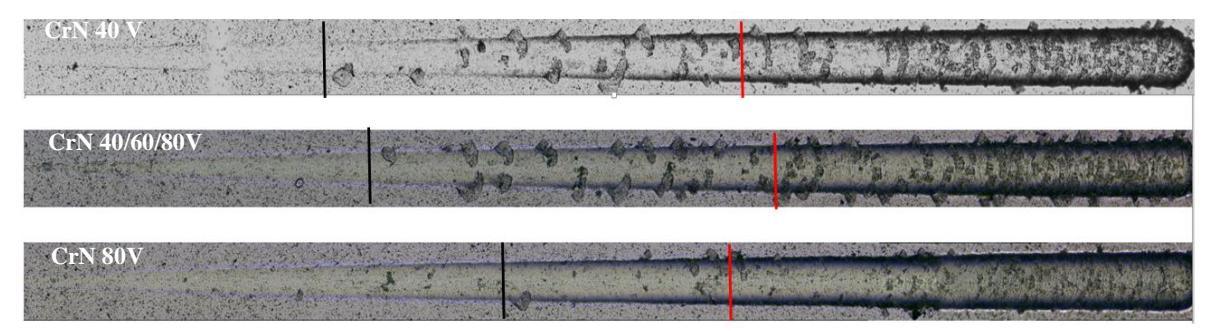
Figure 5. Scratch tracks of the coatings. LC1-Black line; LC2- Red line

Figure 5 shows the scratch tracks of the coatings. It was observed that at a load lower than LC1 the scratch track presents lateral cracks, corresponding to cohesive failures. When the load slightly overpasses LC1, recovery spallation at the border of the scratch crack and arc tensile cracks are formed, which are more marked by the increase of the load. After the Lc2 load, the scratch track shows buckling spallation. The buckling spallation is more severe 40/60/80V coatings likely by their honeycomb structure more pronounced.

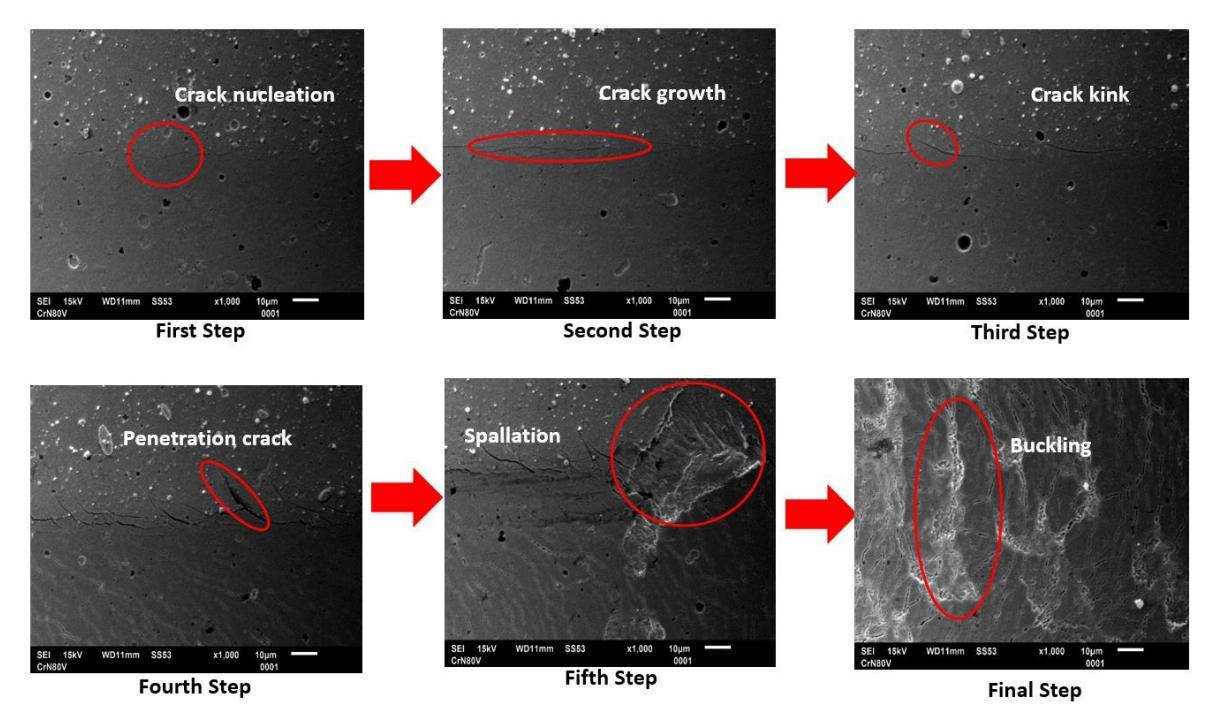
Figure 6. Failure mechanism of the coatings (CrN 80V).

Figure 6 shows the failure mechanism of the coatings. It can be seen that cohesive failures start with lateral cracks, which bordered droplets and they cross defects as voids and adhered weak particles. These cracks increase the depth when the load is rising up and they can interact with each other for originating recovery spallation at the border of the scratch crack (with values majors or equal to LC1), which act as cluster start point of buckling spallation. On the other hand, arc tensile cracks which are simultaneously generated with recovery spallation can aid to crack proliferation at end of the scratch track; this phenomenon is more notable when the honeycomb structure is more pronounced (40/60/80V). Additionally, the mechanism of failure depends on the  $H^3/E^2$  ratio and the residual stress of films. For that reasons, at the scratch track end, the films deposited with 80 V has minor amount spallations.

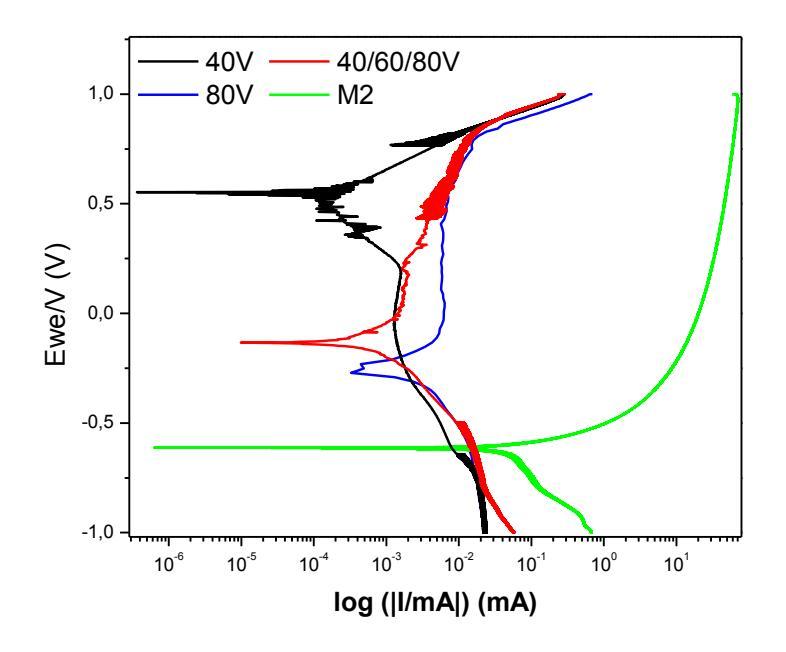
Figure 7. Polarization curves of un-coating and coating steel.

Figure 7 shows the potentiodynamic polarization curves of M2 steel without and with the coating, in presence of chlorides and at room temperature. The electrochemical parameters obtained by Tafel analysis are detailed in Table II.

It was observed that M2 steel presents potential and corrosion current values of -619.87 mV and 48.55  $\mu$ A respectively. In the anodic zone, its active region in the increases fasts with the applied potential until 0.3 V in which starting the formation of unstable and un-protective iron oxide layer, which allows the dissolution of the metal to continue taking place.

On the other hand, the CrN improves the corrosion resistance of M2 steel, and this is higher when reducing the bias voltage. That is showed with the increase in the corrosion potential and corrosion current lower values that were obtained with CrN 40Vb. In all cases coated

CrN coatings obtained to 40/60/80 V and 80 V have passive zones between potentials of - 0.077 and 0.69 V derivated of the formation of protective oxide of Cr<sub>2</sub>O<sub>3</sub>. Besides, to potentials a little lower than transpassive potentials there are fluctuations in current due to an increase of dissolution points generated by pitting corrosion that the steel experiments when defects are removed of the coating. In films obtained to 40 V the pitting potential was not observed, only one active region could be identified. However, these films present the lower corrosion currents and the higher corrosion potentials, that indicated that this coating improves greater the corrosion resistance of M2 steel.

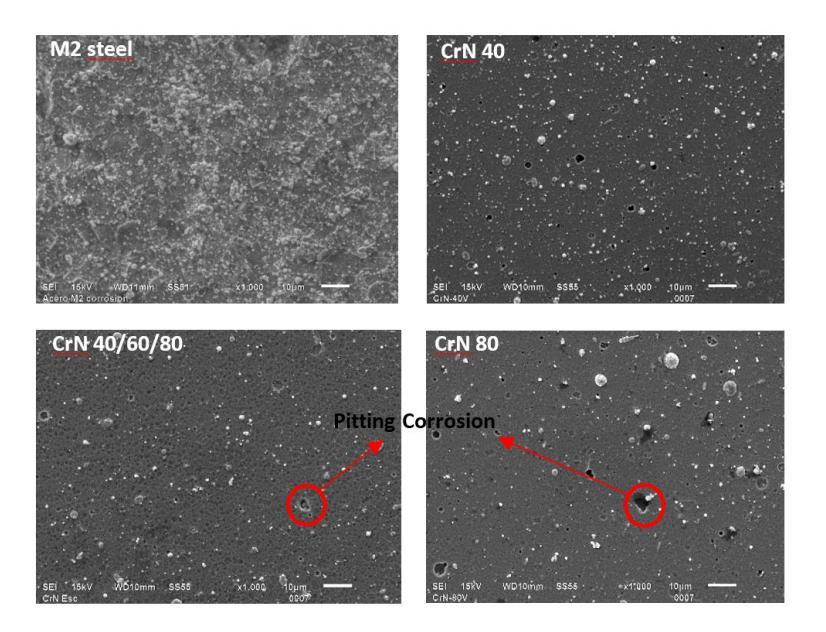
Figure 8. SEM images of the surface after corrosion test.

Scanning electron microscope was used to analyze the surface of the specimens after the corrosion process. It was observed that the specimens are susceptible to medium chloride and present corrosion. A lower damage was observed in coated-steel. Figure 8 shows that M2 steel basically presents uniform corrosion, while that in coated-steel the localized corrosion is prevalent. In coated samples, the corrosion process is dependent on the voltage. As shown in figure 6 coatings deposited at 80 V had larger pitting and higher iron dissolution, while the corrosion process of CrN 40 V and CrN 40/60/80 V as was slower.

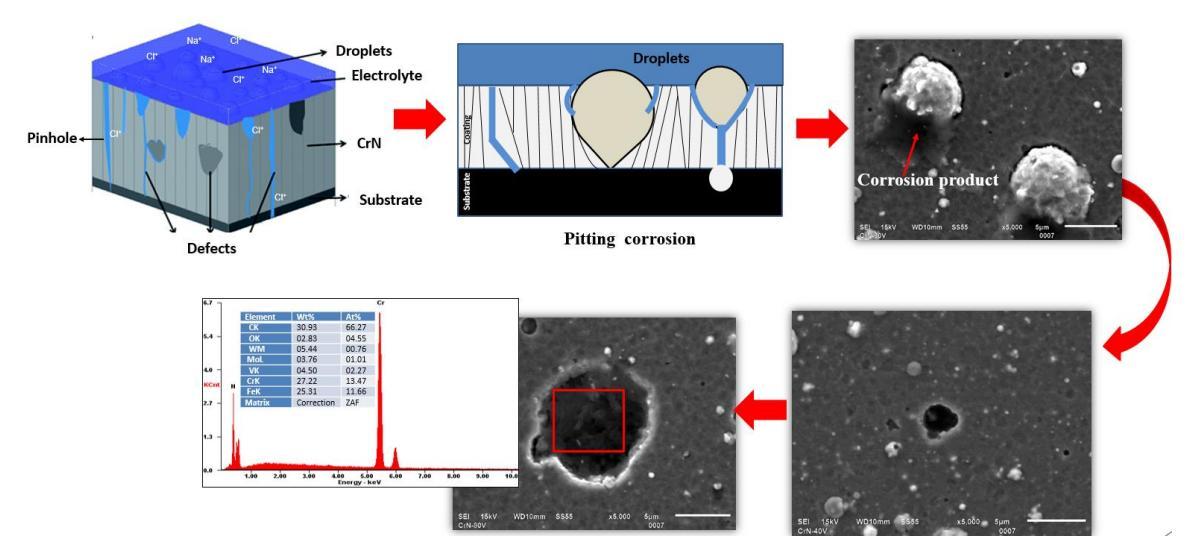
Figure 9. Corrosion mechanism of the coatings.

The corrosion phenomenon is triggered by the diffusion of the electrolyte in the porosities of the film, derived from defects formed during the deposition process. Pinholes can act as routes of diffusion of corrosive media towards the substrate. We found that the size of the droplets related to the corrosion mechanism, larger sizes generate a poor adhesion of the particle with the coating and can increase the residual stresses in the film favoring the separation of this inside the coating and subsequently the generation of spaces through which the electrolyte can penetrate, as shown in the figure 9. For that reason, CrN 80 V presented the lowest corrosion resistance.

Besides, with the increase of the potential, the droplet detachment is produced and pore formation. The pores provide the direct diffusion ways for electrolyte and generate pitting corrosion.
