PSD12: 12TH INTERNATIONAL CONFERENCE ON POSITION SENSITIVE DETECTORS 12–17 Sep 2021 University of Birmingham, Birmingham (United Kingdom)

# CMS Phase-1 pixel detector refurbishment during LS2 and readiness towards the LHC Run 3

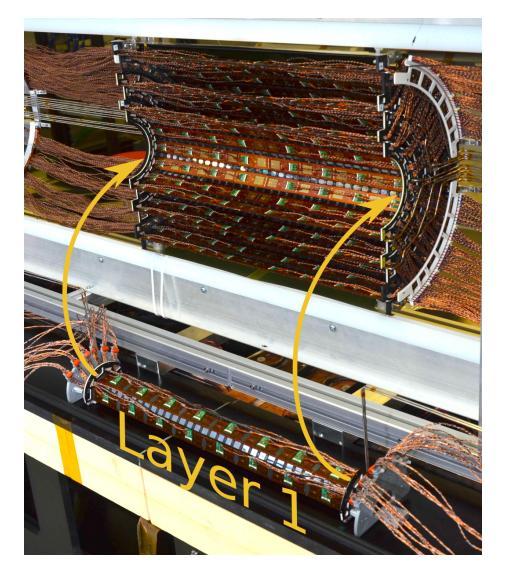
**Figure 1**. This picture shows one half of BPix just before the first pixel layer was installed. L1 rests ready for installation in front of layers 2 through 4.

in the past caused timing errors and thus loss of data synchronization. The old TBM suffered from a vulnerability for a specific single event upset (SEU) which required a power cycle of the TBM to recover. The new TBM is guarded against this SEU phenomena. In addition, L1 is equipped with new high voltage cables with better insulation. With the new cables and upgraded power supplies, the reverse bias voltage can be ramped up to over 800 V, compared to 450 V in Run 2. A greater range for the high voltage in combination with a lower noise level helps to operate the modules at a very high efficiency [5] through Run 3. Prior to the L1 installation, the inner modules of the second layer (L2) were easily accessible. Thus, defect inner L2 modules were replaced. Figure 1 shows one half of BPix prepared for the installation of the new first pixel layer.
