Copper coated carbon fiber reinforced plastics for high and ultra high vacuum applications

We have used copper-coated carbon fiber reinforced plastic (CuCFRP) for the construction of high and ultra-high vacuum recipients. The vacuum performance is found to be comparable to typical stainless steel used for this purpose. In test recipients we have reached pressures of 2×10^{-8} mbar and measured a desorption rate of 1×10^{-11} mbar·liter/s/cm²; no degradation over time (2 years) has been found. Suitability for baking has been found to depend on the CFRP production process, presumably on the temperature of the autoclave curing. Together with other unique properties of CuCFRP such as low weight and being nearly non-magnetic, this makes it an ideal material for many high-end vacuum applications.

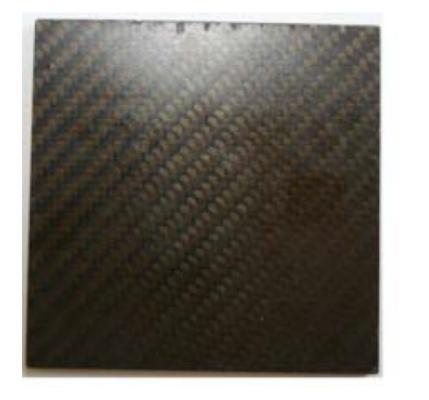
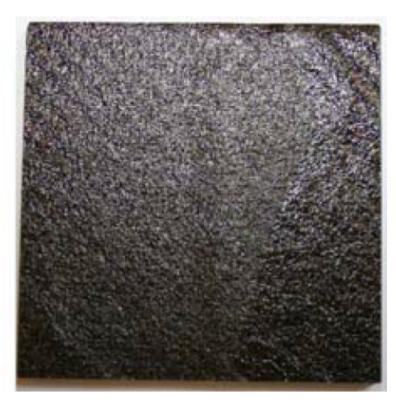
(a) CFRP sample before coating (front and backside).

Figure 1: Three different test pieces were used to investigate the vacuum properties of copper-coated CFRP. The square CFRP sample (a) was first characterized without coating, later with. A custom made model (b) of a possible later application was made using one aluminum negative to make two half shells. A standard, "off-the-shelf", CRFP tube (c) was fitted with two custom made ISO K DN160 flanges to demonstrate that the technology can be used to produce standard vacuum parts.

Carbon fiber reinforced plastics are known to have excellent mechanical properties and can be tailored to design. This allows to reduce weight and still excel in strength of shape. Three different samples (Fig. 1) were produced to investigate the properties of copper-coated CFRP: A quadratic plate ($100 \times 100 \times 5 \text{ mm}^3$), a custom designed and tailored vacuum recipient made from high performance CFRP, and a standard vacuum tube made from lower grade CFRP with inside diameter 150 mm¹ with two ISOK DN160 flange².

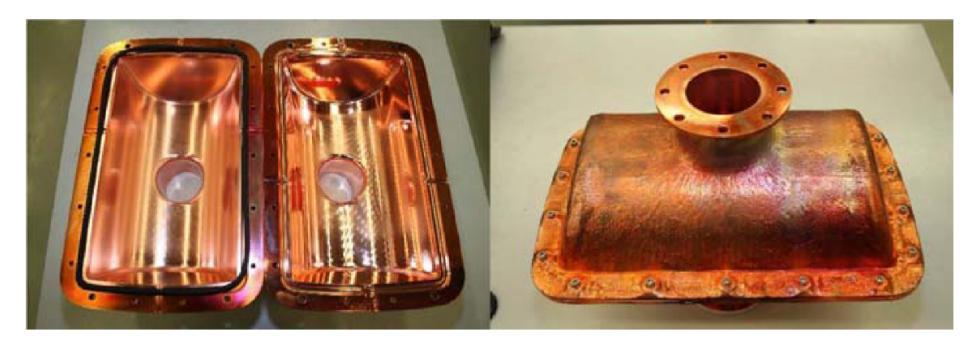
(b) Cu coated CFRP vacuum recipient.

The second test piece was a custom design of a scaled down model of a possible vacuum recipient for our experiment, shown in Fig. 1b. The size $(420 \times 270 \times 300 \text{ mm}^3)$ was chosen such that the half shells could fit into available galvanization test baths. On each half shell an ISO K DN63 flange was attached to demonstrate that a connectivity to standard vacuum parts can be accomplished. The recipient was produced by Pauco Plast² in an autoclave at 200 °C using a negative mold made from aluminum. Both half

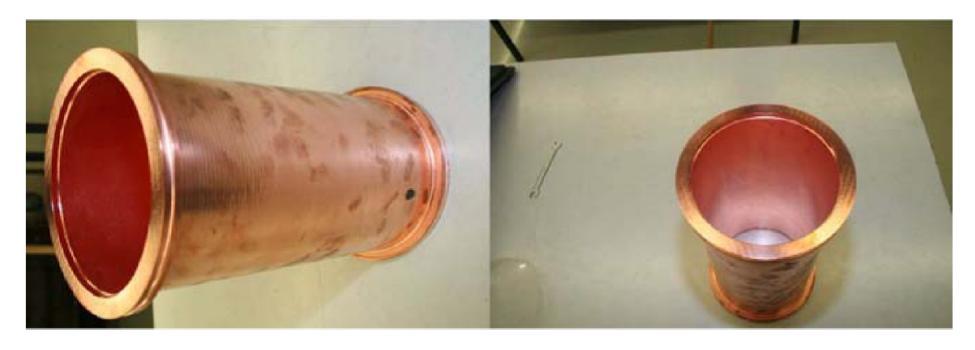
(c) Cu coated CFRP vacuum tube.

The third test sample was an "off-the-shelf" CFRP tube¹ glued to two ISO K DN160 end flanges produced by Pauco Plast² entirely made of CFRP, and later copper-coated by Galvanic Wädenswil⁴, shown in Fig. 1c. The

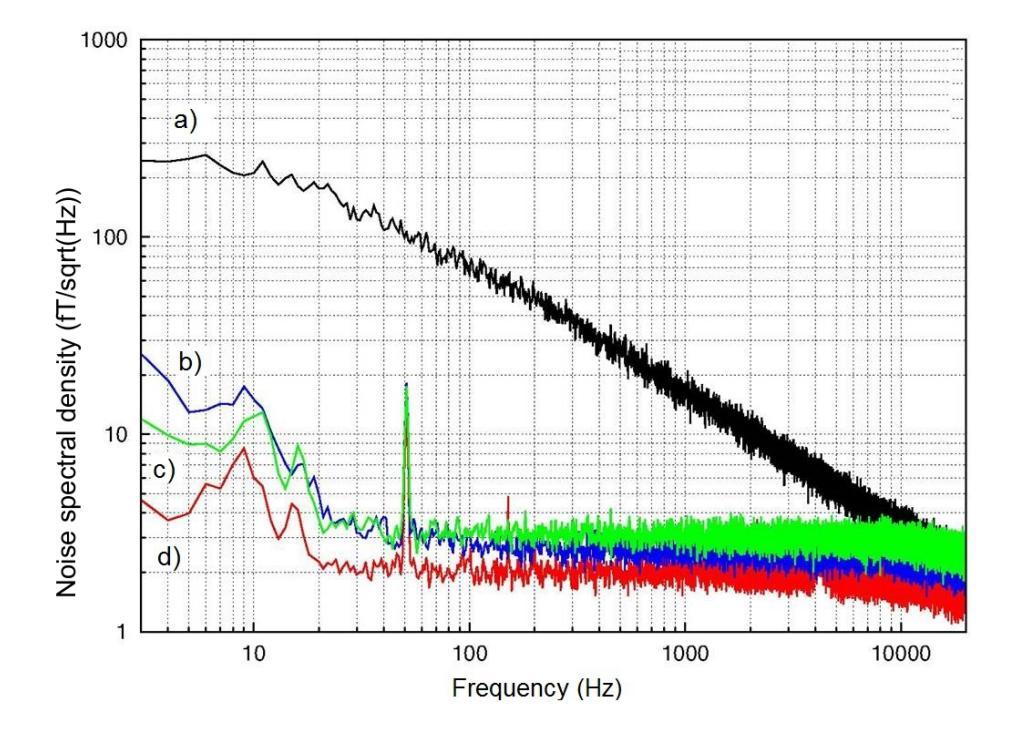
Figure 2: Comparison of spectral noise measurements using an array of SQUIDS at PTB [4]. The noise spectrum of the actually used Al electrode (thickness 30 mm (a) was an order of magnitude larger than of both CFRP samples: b) uncoated CFRP, c) 500 nm Cu on CFRP. The system noise (d) is shown as reference. Note, that this CuCFRP sample was produced using magnetron sputtering; galvanically coated CFRP typically has a Cu-layer thickness of $\sim 20 \,\mu\text{m}$ and hence a slightly higher noise spectrum.

The suitability of the material with respect to its magnetic properties was shown in the BMSR-II of the PTB in Berlin [3]. Figure 2 compares the noise spectrum of a CFRP plate, a copper-coated CFRP plate, and an aluminum electrode. Both CFRP samples showed no dipole structure and a peak to peak magnetic field of $B < 40 \,\mathrm{pT}$ in a distance of $\sim 3 \,\mathrm{cm}$ even after magnetization with a strong permanent magnet. We consider the material suitable for our magnetic requirements and will concentrate on the vacuum properties in this article.

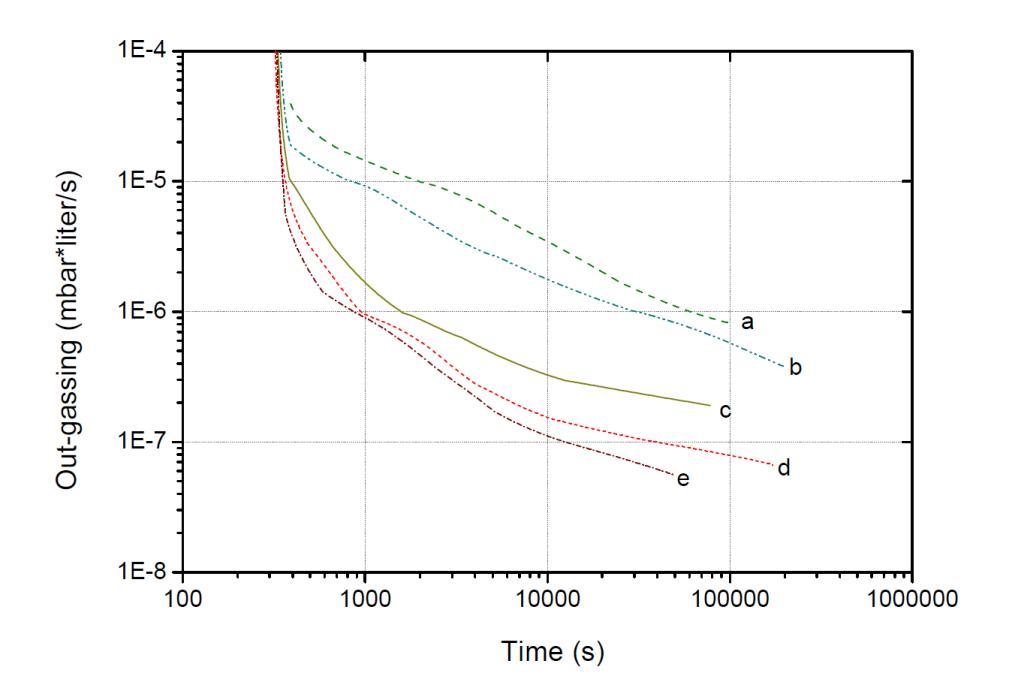
Figure 3: Out-gassing of a $10 \times 10 \text{ cm}^2$ CFRP sample in a test vacuum recipient. a) First vacuum pumping after cleaning in purified benzine; b) second vacuum pumping after leaving sample in air for 24 hours; c) after baking for 24 hours at 100 °C and exposing to air for 1 min. The last two curves have been measured after coating the sample galvanically with 20 µm of copper: d) First vacuum pumping after coating, e) second after baking the sample at 100 °C and exposing it to air for 2 hours.

pure benzine. Then the out-gassing rate was measured in a vacuum recipient, connected to a turbo pump (TPH 330) and roughing pump (Leybold SC5) with a pump speed of 200 liter/s. The pressure, which in our geometry using a $10 \times 10 \,\mathrm{cm}^2$ (~ $200 \,\mathrm{cm}^2$ surface) sample easily relates to the out-gassing rate, was measured using an ionization gauge (TPG 300/IKR 020, Balzers). Figure 3 shows three measured curves for the uncoated CFRP plate: (a) sample directly after cleaning, (b) after a first vacuum pump down and subsequent exposure to air for 24 h, and (c) after baking for 24 h and 1 min exposure to air. We note here that baking improved the surface properties of all Cu coated pieces considerably making them more resistant, e.g. against finger prints. We also characterized the composition of the rest gas in case (a) using a quadrupole mass spectrometer PRISMA³ (see Fig. 4), which is dominated by over 90 % of water. Next the sample was coated by Galvanic Wädenswil⁴ using a proprietary galvanic procedure. This unique technique avoids any aggressive or implantation preparation processes, guaranteeing the conservation of the surface quality and maintaining the non-magnetic properties of the sample. The coating decreased the out-gassing by a factor of ten which further improved by a factor of two after baking the sample. We also studied the helium permeability in a dedicated setup. For this purpose the CuCFRP plate was clamped directly onto a flange of a vacuum leak detector using a fluoroelastomer sealing. The flange, clamps, and plate were then put into a tightly closed plastic bag filled with helium. The integral leakage rate did not increase from the regular background rate of the leak detector when blind flanged with a fluoroelastomer sealing $(1 \times 10^{-7} \text{ mbar} \cdot \text{liter/s})$. Hence, no permeability was detected for the CuCFRP plate, instead the leakage rate of

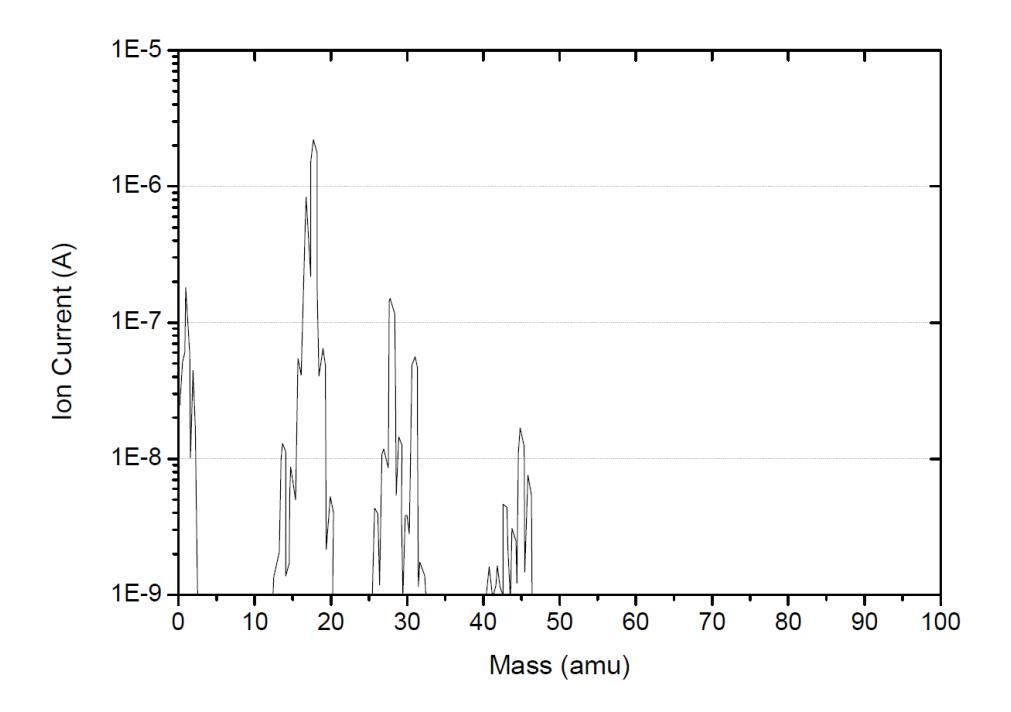
Figure 4: Residual gas composition of CFRP sample measured with a Pfeiffer PRISMA quadrupole mass spectrometer. More than 90% is water, all other peaks are typical for rest gas. Note that no masses above ethanol (46) were found.

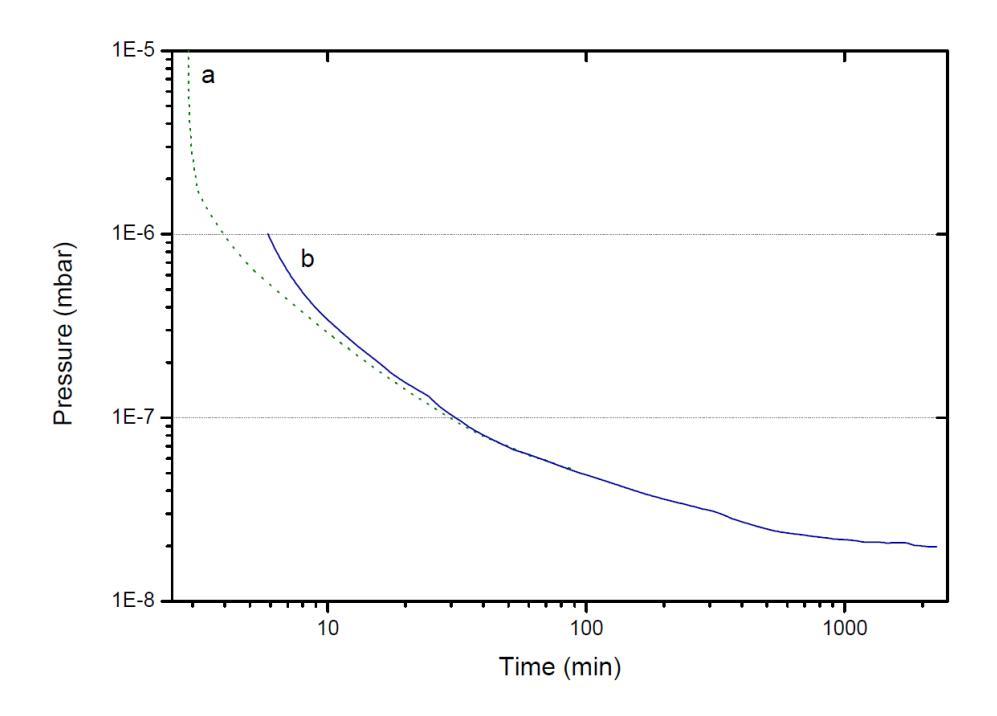
Figure 5: Evacuation curve of the custom made CuCFRP vacuum recipient (Fig1b). (a) After baking a pressure of 5×10^{-8} mbar was reached after 1.5 hours; (b) after 2 hours venting a second evacuation resulted in a nearly identical curve with a final pressure of 2×10^{-8} mbar reached after one day of pumping.

The total pressure after cool down was identical to pressures reached by identical pumps blind flanged using fluoroelastomer seals. Figure 5 shows two subsequent evacuation curves. A final pressures of 5×10^{-8} mbar was reached after baking and 100 min of pumping. A second pumping curve, recorded after venting and exposure to air for 2 hour, coincides with the first curve after 90 min. The final pressure reached was 2×10^{-8} mbar.

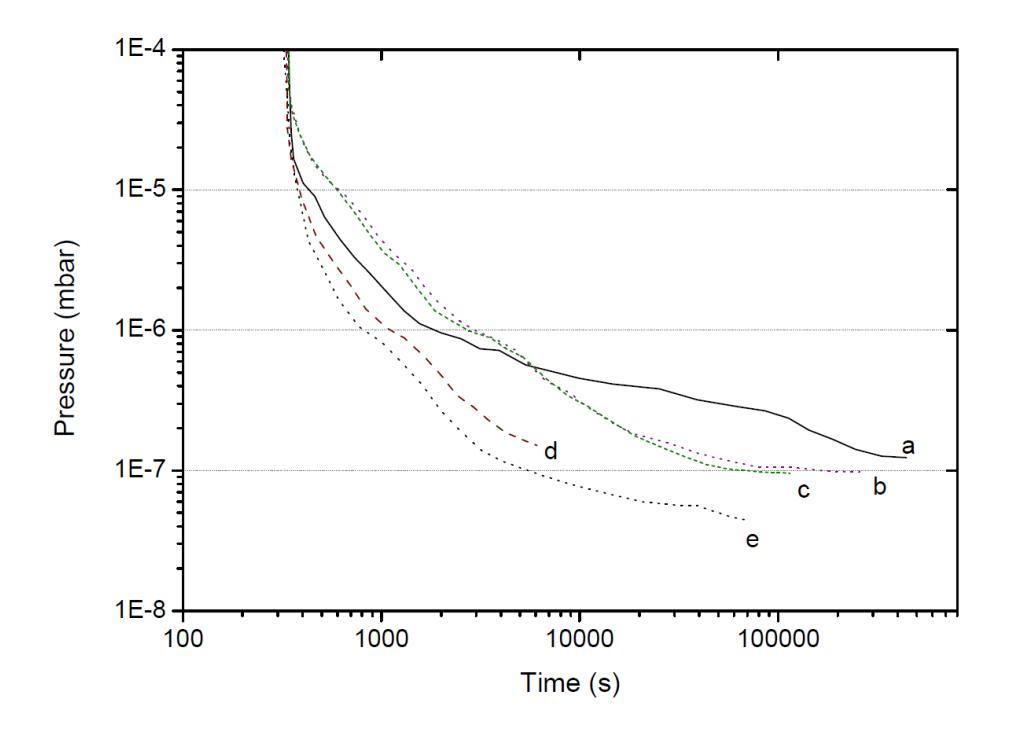
Figure 6: Evacuation curves of the tube made of copper-coated CFRP compared to a stainless steel tube (c). Evacuation curve without recipient (e); with CuCFRP tube before cleaning (a); CuCFRP tube cleaned with alcohol (b); second evacuation of cleaned CuCFRP tube after 10 min venting (d).

tube was cleaned with a cotton cloth and purified ethanol before evacuation. Vacuum tightness and He-permeability of the ISO K DN160 flange sealed with an fluorelastomer seal was tested with a leak tester (HLT560, Pfeiffer). Only a very small permeability through the gasket of $< 10^{-8}$ mbar·liter/s could be measured. The tube was then attached with a locking collar to a turbo molecular pump (TPH 330, Pfeiffer) backed by a Leybold SC 15 scroll pump with a total pumping speed of 200 liter/s. Several evacuation runs have been performed. For comparison an identical tube made from stainless steel (316L) was also evacuated. Figure 6 shows the pressure curves over time of these vacuum tests. It was remarkable that after cleaning with ethanol the CuCFRP tube behaved similar to the standard stainless steel tube.

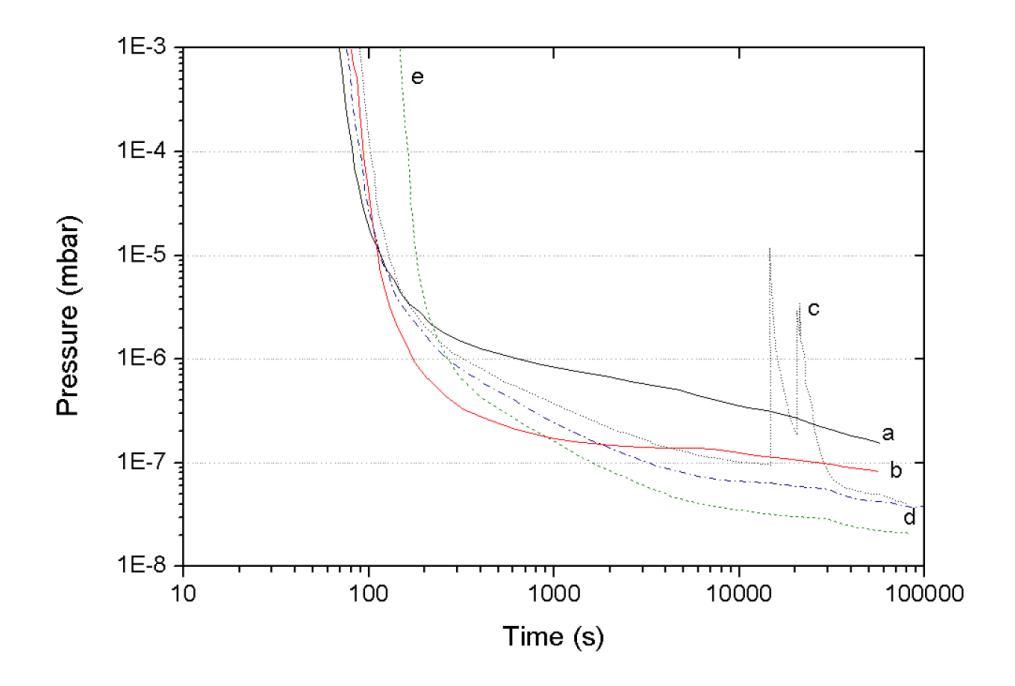
Figure 7: Evacuation curves of CuCFRP tube after two years storage in air. First evacuation of tube after storage (a); second evacuation after venting with N_2 (b); after baking the stainless steel flanges (see Fig. 8) with a hot air gun (c); fourth evacuation after baking end flange and venting with air (d); evacuation without CuCFRP tube only with flange and pressure gauge (e).

Two years after initial characterization, storing the tube at air, we remeasured the evacuation behavior (see Fig. 7) of the CuCFRP tube using a turbo molecular pump (TMH521, Pfeiffer) backed by a Leybold EcoDry 15 m³ with a pumping speed of 500 liter/s. After baking the stainless steel end flanges a end pressure of less then 4×10^{-8} mbar was reached. A desorption rate of about 10^{-11} mbar·liter/s/cm² for the CuCRRP tube was deduced by subtracting the measured desorption rates of the pump alone and pump and tube.

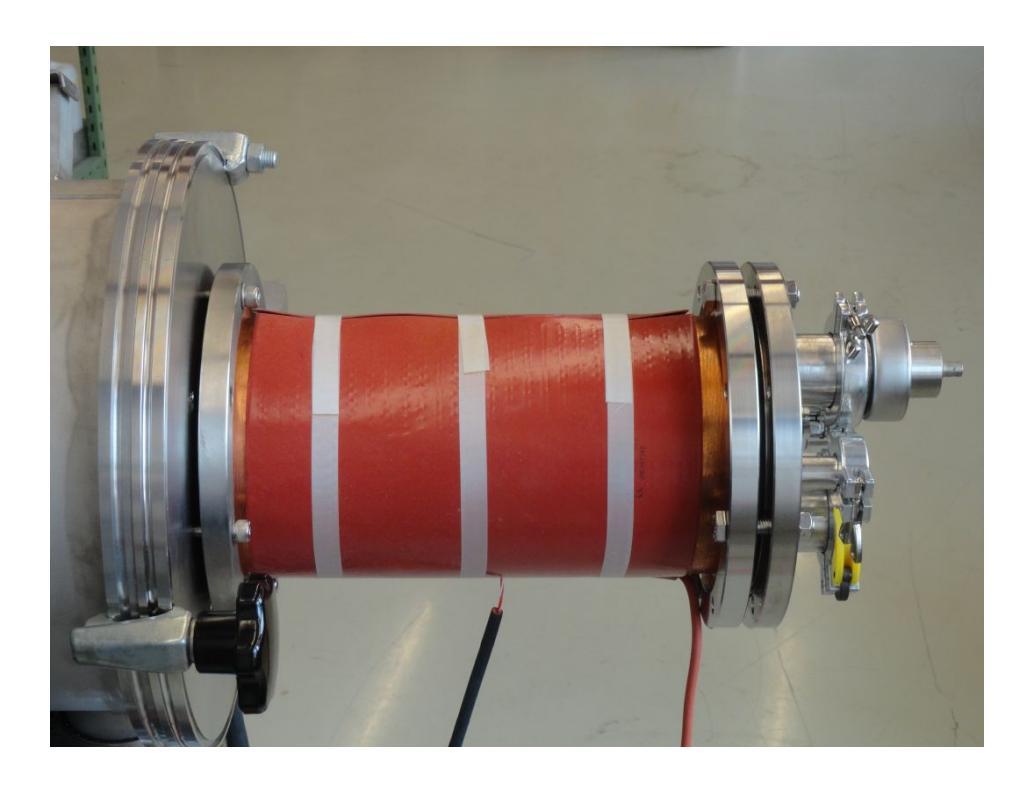
Figure 8: Photograph of the setup with thermal insulation removed. One can see that the heating blanket does not extend all the way to the end flanges but leaves about 1 to 2 cm of open space.

i) The tube was flanged to a stainless steel vessel with a volume of 40.2 liter pumped by a turbo pump (Pfeiffer TMH 071 Y P) and closed with a stainless steel end flange with a connected vacuum gauge. We estimated the pumping speed at the connection as about 30 liter/s. As sealing we used fluoroelastomar O-rings. The tube (excluding the end flanges) was completely covered by a heatable blanket which could be controlled at a preset temperature via a PT 100 sensor. Figure 8 shows a picture of the setup. One can see that the heating blanket did not extend all the way to the end flanges but left about 1 to 2 cm of open space. Since both end flanges were not heated - and the overall thermal insulation enclosing the whole setup (not shown in Fig. 8) was inefficient - this meant that we had considerable temperature gradients over the regions near the end flanges. Which in turn transformed into mechanical stress in these regions.

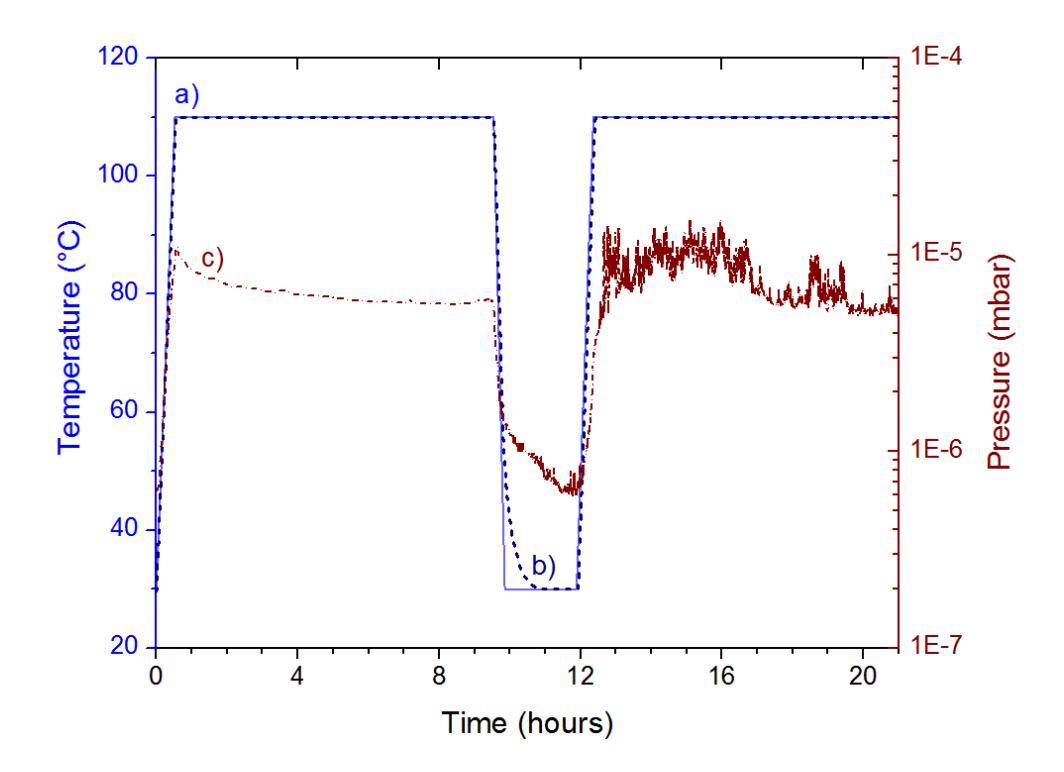
Figure 9: Evolution of temperature (a) set temperature, b) measured temperature) and pressure (c) as a function of time for the first two heating cycles. Due to the small heat capacity of the tube the temperature of the tube closely reflected the heating pattern while the internal pressure lagged behind by about 30 min. The occasionally visible pressure 'spikes' were interpreted as small internal leaks, when tiny cracks opened in the Cu-coating and a small amount of nitrogen from the previous flushing with nitrogen (as verified by a quadrupole mass spectrometer) was released.

Thermal cycling was started after two weeks of pumping at room temperature at an initial pressure of 2.9×10^{-7} mbar. The tube was heated to 110 °C within 30 min and kept there for about 10 hours. Cooling to 30 °C was effected within 30 min and the lower temperature was kept then for 2 h until the next cycle started. Figure 9 shows the evolution of pressure and temperature as a function of time. Due to the small heat capacity of the tube the temperature of the tube as well as the internal pressure closely reflected the heating pattern. A total of 23 cycles was performed. Two days after the last heating the pressure read 2.2×10^{-7} mbar, slightly lower than at the beginning of the heat test. Afterwards, the test tube was disconnected and the stainless steel vessel was pumped alone to a marginal lower pressure of 2.0×10^{-7} mbar.

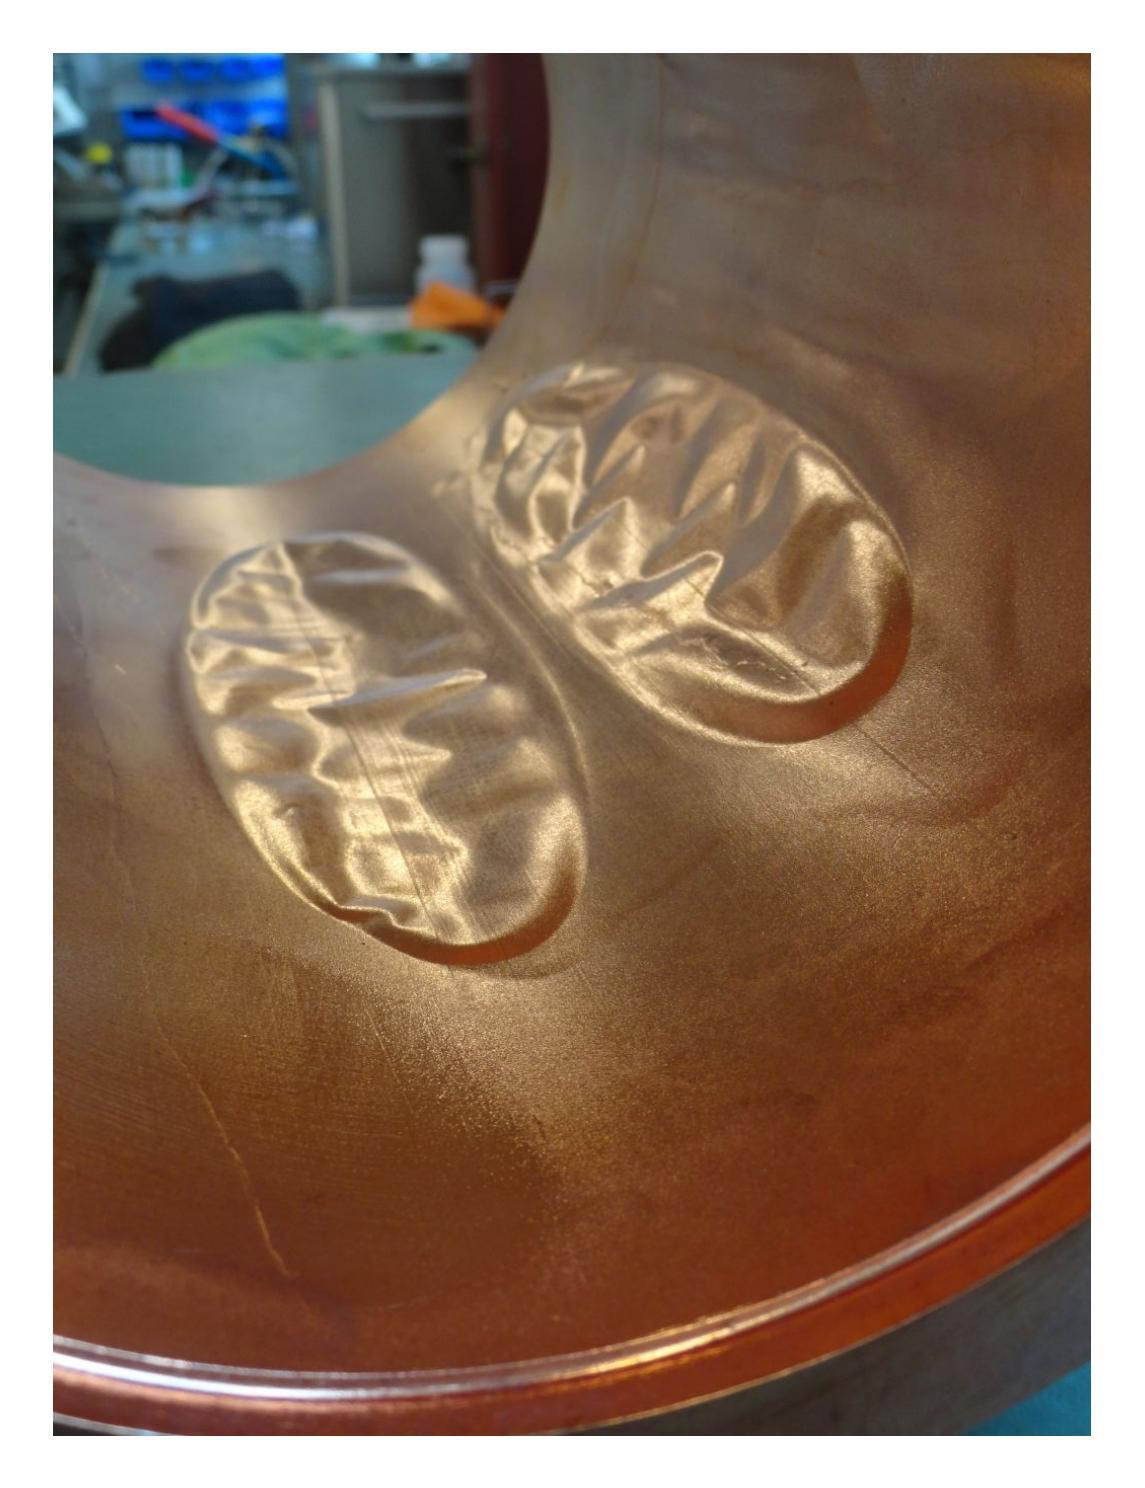
Figure 10: Photograph of the tube's internal surface after opening. Two 'blisters' had developed over a combined area of $\sim 150\,{\rm cm^2}.$

After opening the system we observed two large 'blisters' in the coating, see Fig. 10, with an overall area of about 150 cm^2 . The de-laminated Culayer was still intact and robust; no obvious cracks or holes were visible. From the pressure evolution we had indications that some de-lamination may have happened already during the second heating cycle. Based on this we speculate that the pressure spikes discussed in connection with Fig. 9 could represent a stepwise further enlargement of the blisters.

from off-the-shelf CFRP tubes and our recipients showed no measurable deformation when evacuated. Even after two years of exposure to air the vacuum performance was comparable to stainless steel. That the coating had de-laminated over a specific area points to locally insufficient CFRP surface conditions necessary for coating which might be a direct result of the production method. The custom made sample (fig. 1b) had a much smoother inner surface before coating. The adhesion of the copper coating might depend directly on the surface quality of the mold and the temperature during the autoclave CFRP production process. This assumption is supported by the observation that the custom made recipient, which was heated to 200°C during production, did not show any degradation during baking at
