Abstract

Project Overview

Design and Implementation using Computer Vision

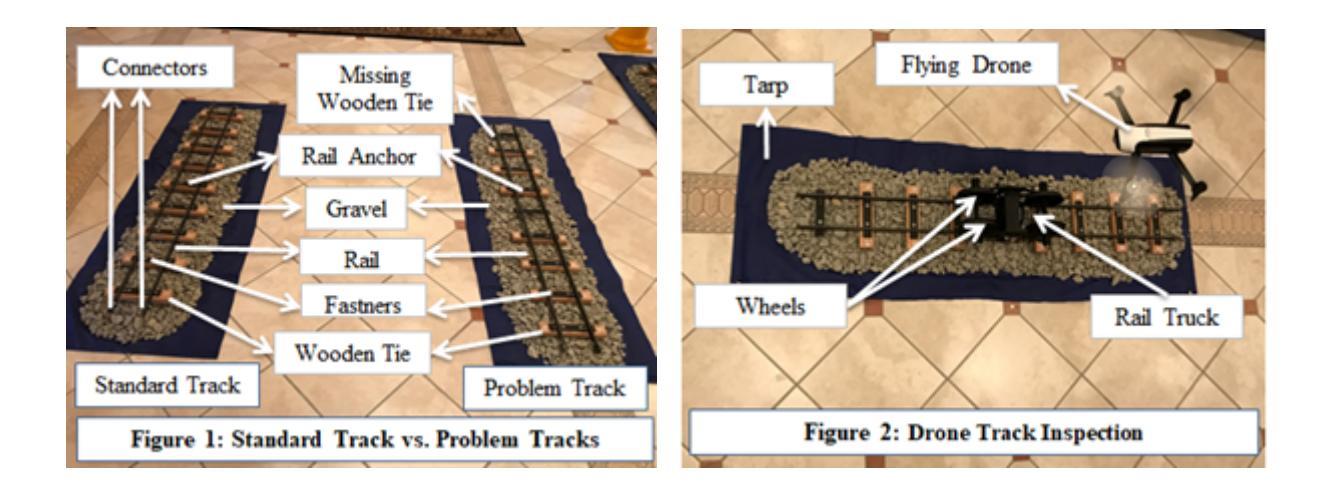
We started with a 3D modeling of rail track using a 3D printer from the lab and then created simulated rail tracks using wooden blocks to represent the wooden ties and cast-iron metal to represent the rail. We soldered the rail to the rail anchors and then drilled holes in these anchors to hold the wooden blocks. The wooden blocks were then riveted to these rail anchors using screws and washers (representing fasteners). Finally, the connectors were prepared to represent rail extension anchors and were placed on these tracks at the end points. We prepared 4 such rail tracks. One was considered as standard track (state of good repairs, control) that was used to compare with another track with simulated defects (problem track, variable). The other two tracks were connected, and a rail truck was placed on it (prepared for the project using wheels, spring, bearings and brackets to simulate real-life rail system). The blue tarp was placed on the floor and gravel were laid to simulate rail track system. The Figures 1 and 2 illustrate the train tracks along with the flying drone to demonstrate the intricacies of the project.

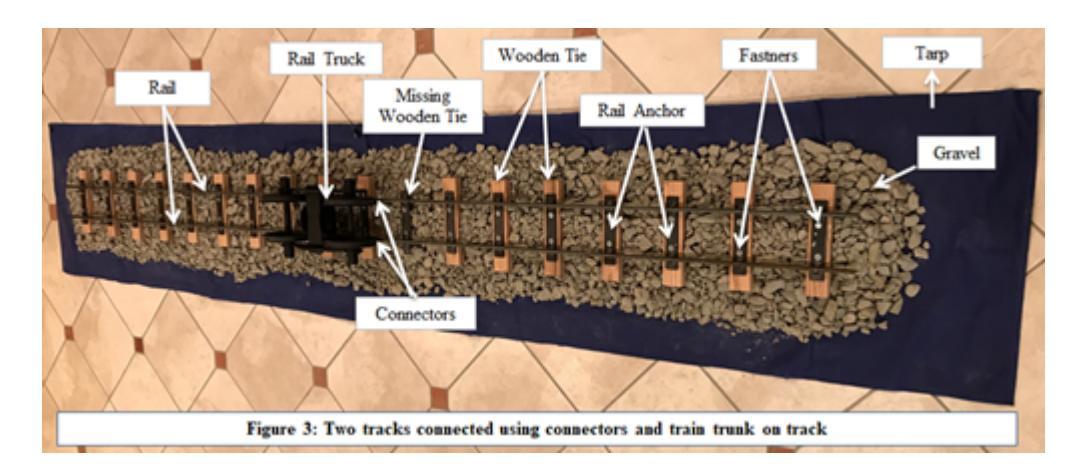
The following procedures were followed to perform the visual inspection of rail track system with the standard track with no defects: 3.1) The simulated track was placed on the gravel; 3.2) The drone was made to fly over rail track system five times with prescribed coordinates (starting point, height, length and ending point); 3.3) Video and still images were taken from drones were downloaded with proper labels. The same steps were followed, and drone was run over 5 times for all problem track cases. These cases were labelled from 02 - 15 and tabulated in table 1 and 2 listed in the results section.

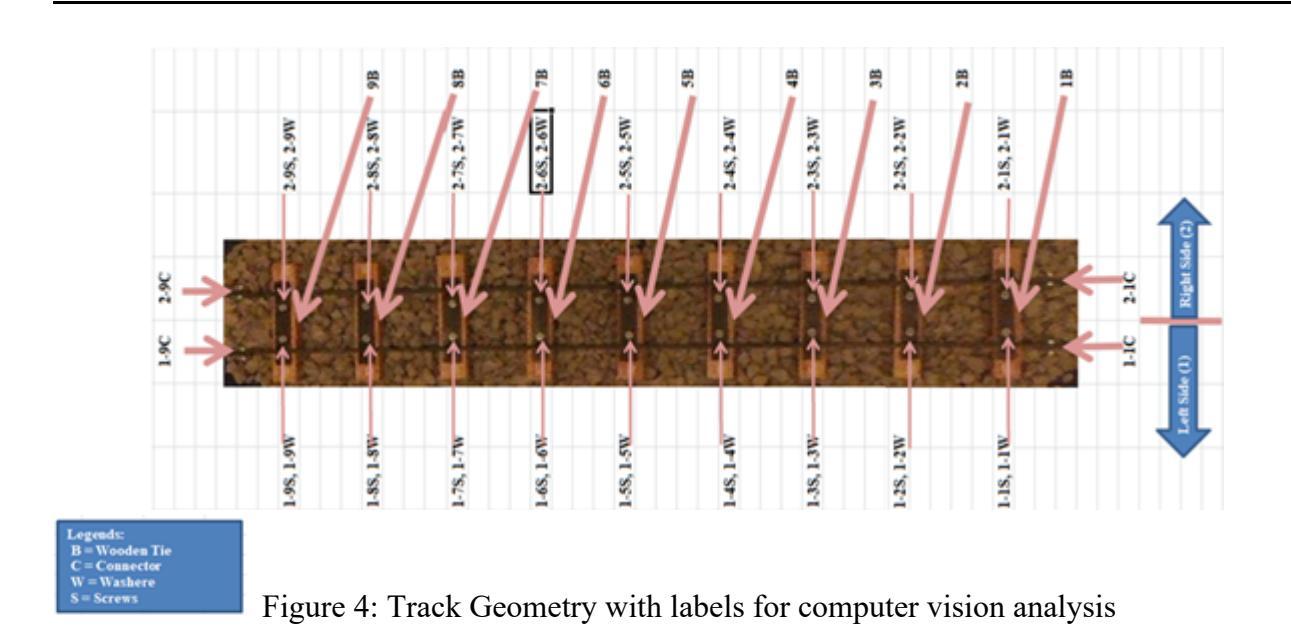
The track geometry was labeled so that computer vision algorithms can analyze the problem track image and compare with the standard track image for false positive and false negative results. Figure 4 illustrates the labeled track components considered for defect detection.

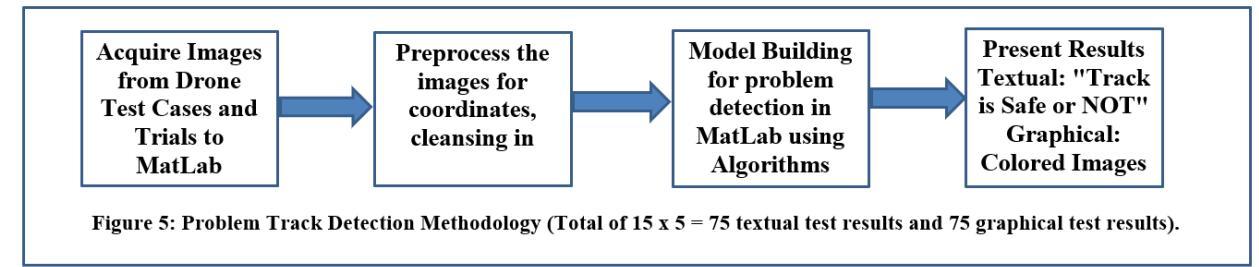
The MATLAB Software for image processing and computer vision was used to acquire these images, preprocessed and modeled for final results. Figure 5 shows the experimental design process flow.

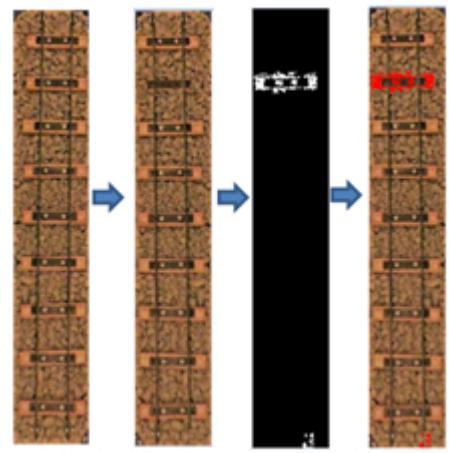
The same test result in graphical representation is shown below in Figure 7 where the final picture shows that the track is not safe and has the following problems: 1-8S, 2-8S, 1-8W, 2-8W, 8B and 2-1C missing (S for Screws, W for Washer, C for Connector and B for Block – see methods section for more details). The 1st frame is standard track and the 2nd frame is problem track. After the MATLAB program modeling, the gray scale analysis shows the problem area which was finally presented in RGB scale for track quality.

Figure 7: Graphical Test Result displays actual problem spots

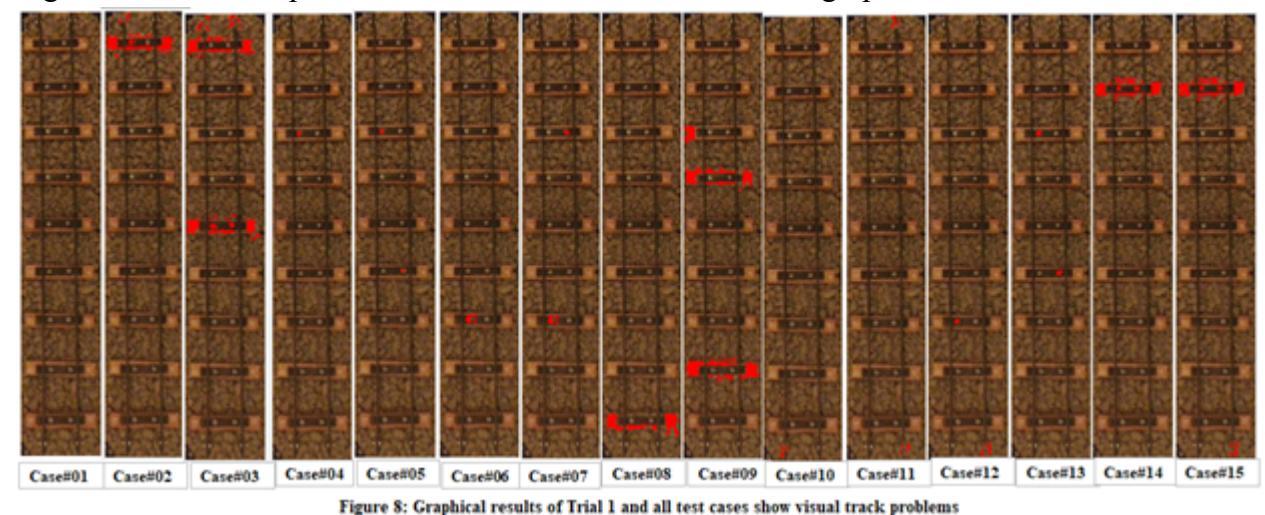
Figure 8 below attempts to illustrate some of the test results in graphical form:

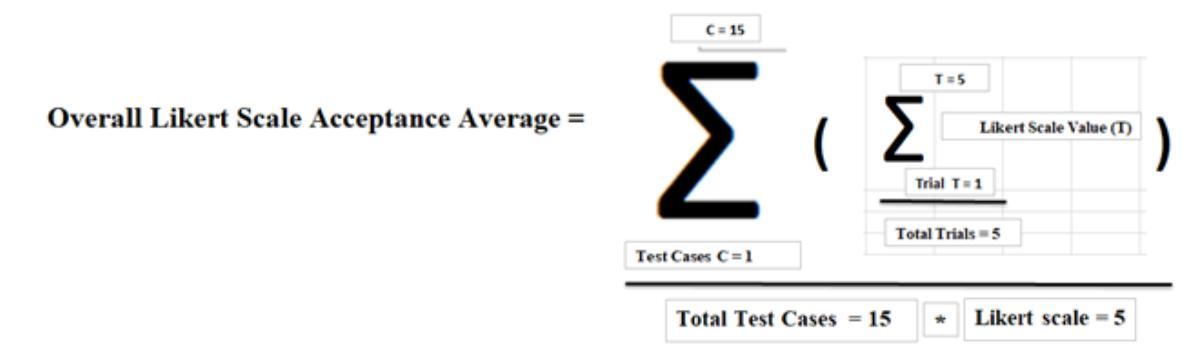
The test results, both textual and graphical, were manually reviewed to assess the testing results on 1-5 Likert scale according to parameters given by Mogey (1999) and Table 5 shows the overall average success rate of 96.09% in identifying track defects. This average value was computed for each test case for all the trials and then averaged for all test cases' average value and the formula is shown below (the test results' variability is between 4 and 5 and hence average options was selected over Kruskal Wallis test (Mogey, 1999):

Figure 10: Likert scale formula

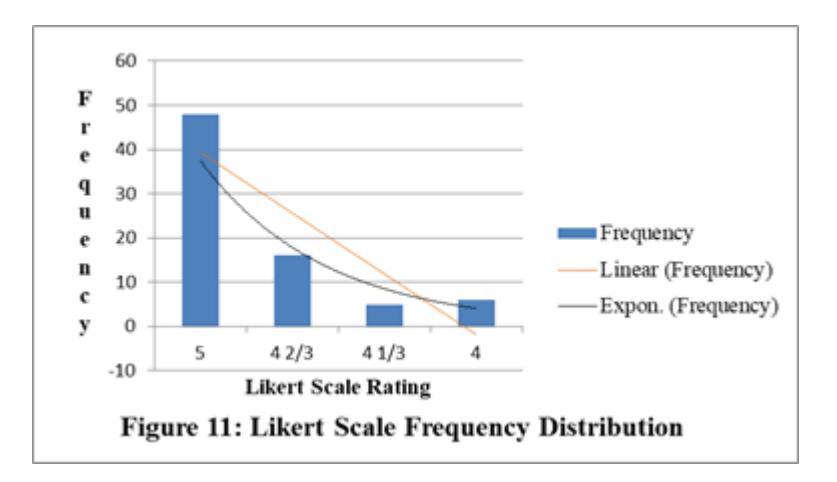
The frequency distribution of Likert scale suggests that the Likert scale rating occurrence range between 4 and 5 with maximum frequency of 5 dominates indicating higher success rate identifying track defects, supported by the frequency regression lines' downward trend and is shown in Figure 11:

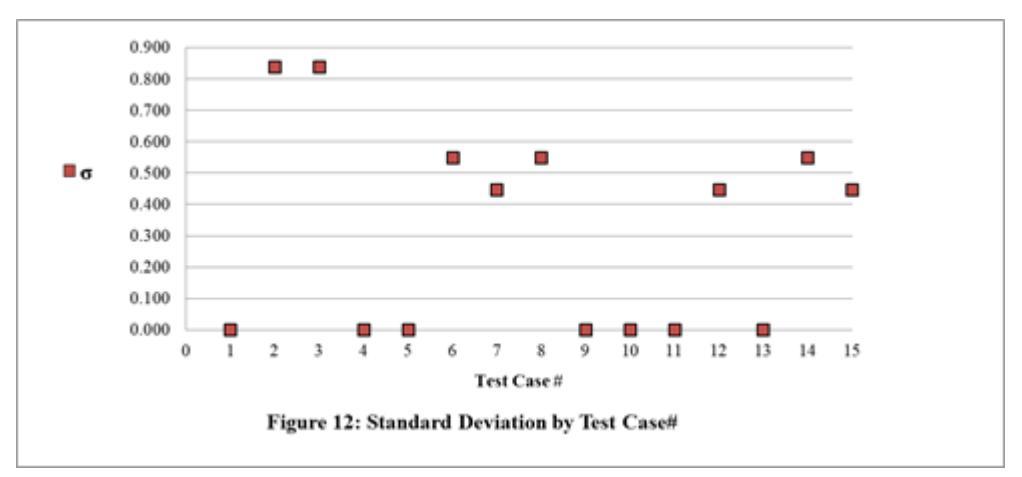
The graphical representation of Standard Deviation of the test case results of identifying the track defects is shown in Figure 12. The graph suggests that in many test cases the results were acceptable but in several test cases the standard deviation was high leaving a standard deviation of 0.311 for the experiment as a whole. This indicates further refinement is necessary in the experimental design to have better standard deviation and less variance.

The graphical representation of standard deviation of the test case results of identifying the track defects (figure 12) suggests test results have a high standard deviation and have a high acceptable rate and deviation.

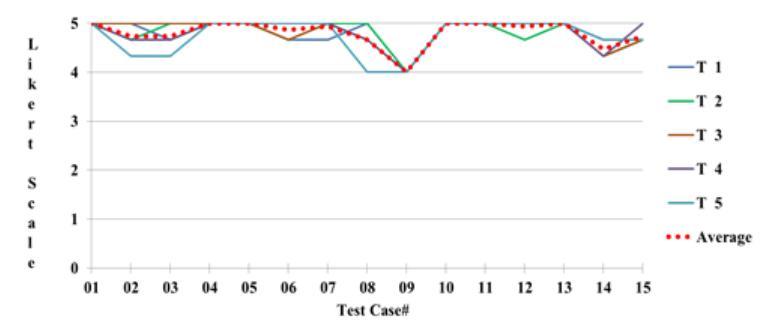
The false positives using Likert scale (figure 13) also suggests high acceptable rate of 5 and hence the approach is feasible.

Figure 13. False Positive by Track Estimated Using Likert Scale

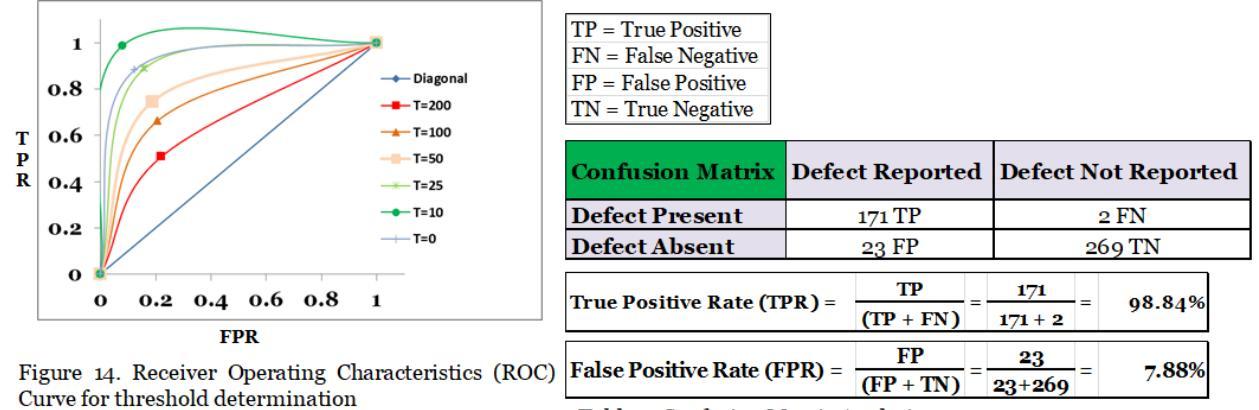
The confusion matrix in Table 4 demonstrates a high acceptable TPR of 98.84% indicating the success of this project. However, the FPR value of 7.88% indicates some scope for improvement. The figure 14 demonstrates the ROC analysis for threshold determination indicating a very high acceptance rate with threshold of 10 during the computer vision analysis.

Table 4. Confusion Matrix Analysis

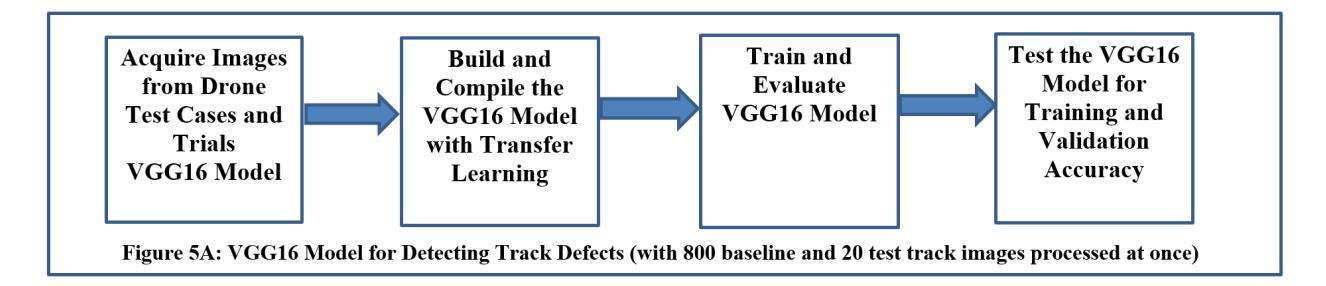
Next, a model was acquired for VGG16, an existing model used to classify images into a thousand objects that won the ImageNet Large Scale Visual Recognition Challenge in 2014 (to identify cats/dogs). This model was adapted to detect track defects based on the images that were classified earlier in the first step, the concept called transfer learning. These steps are shown in Figure 5A.

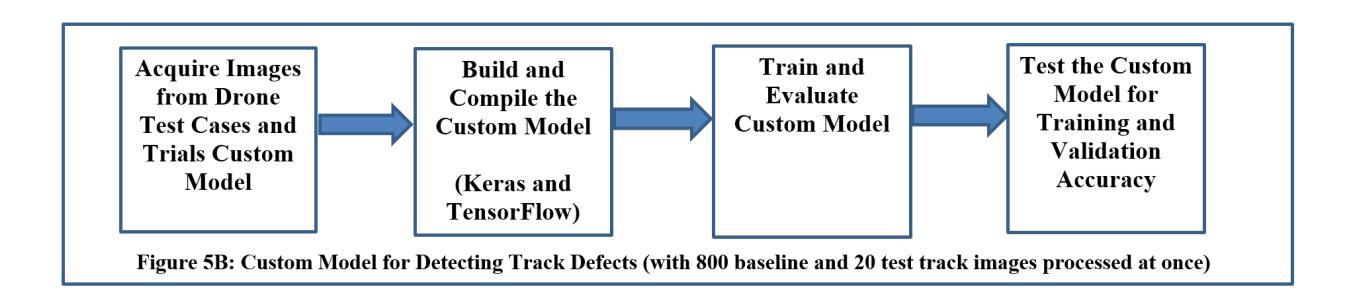
In addition, this project built a custom model using the Keras neural network API in python along with a TensorFlow backend to support track defect detection. Keras is an open-source neural network library and TensorFlow is Google's open source library for large-scale machine learning and computation. For this custom model, we used three collated 'blocks' of Convolution, Activation, and Pooling layers, followed by Flatten and Dense layers to reduce the dimension of the output to 2 options (safe and defective). Initial layers were used to help the model detect smaller shapes, such as lines or curves, while the later layers to identify more complex structures, with the final layer making the ultimate decision. The compilation was performed using the optimizer, which determines whether the model is learning (Adam). The loss function, which was used to calculate the extent of the gap between predicted and actual classifications (Categorical Cross Entropy), and the metrics for training accuracy (decimal representation of the fraction of training set predictions that were correct). These steps are shown in Figure 5B.

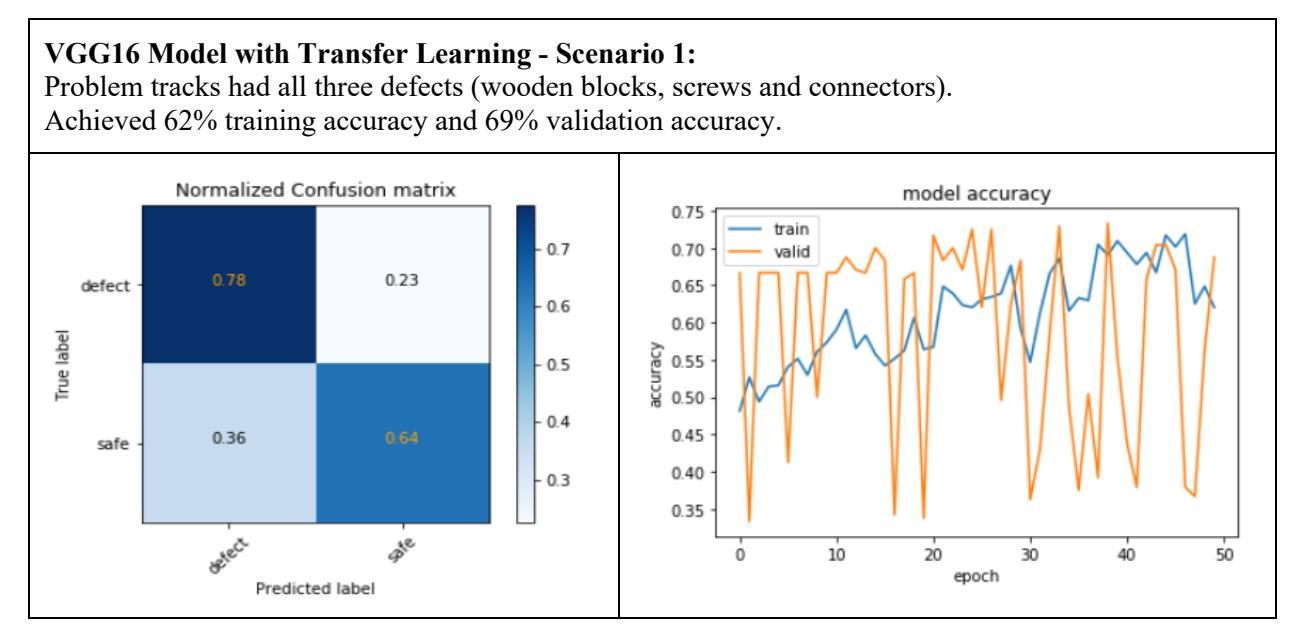
The testing results for the VGG16 model on defective tracks with all types of defects provided a confusion matrix which indicated a moderate false negative (23%) and high false positive (36%) in identifying the track defects. This model provided a 62% training accuracy and 69% validation accuracy. In addition, the validation accuracy wildly fluctuated, returning highly inconsistent results, demonstrating the unsuitability of this approach. The results are shown in Figure 15.

Figure 15: Scenario 1 - VGG Model Results (Confusion Matrix and Model Accuracy)

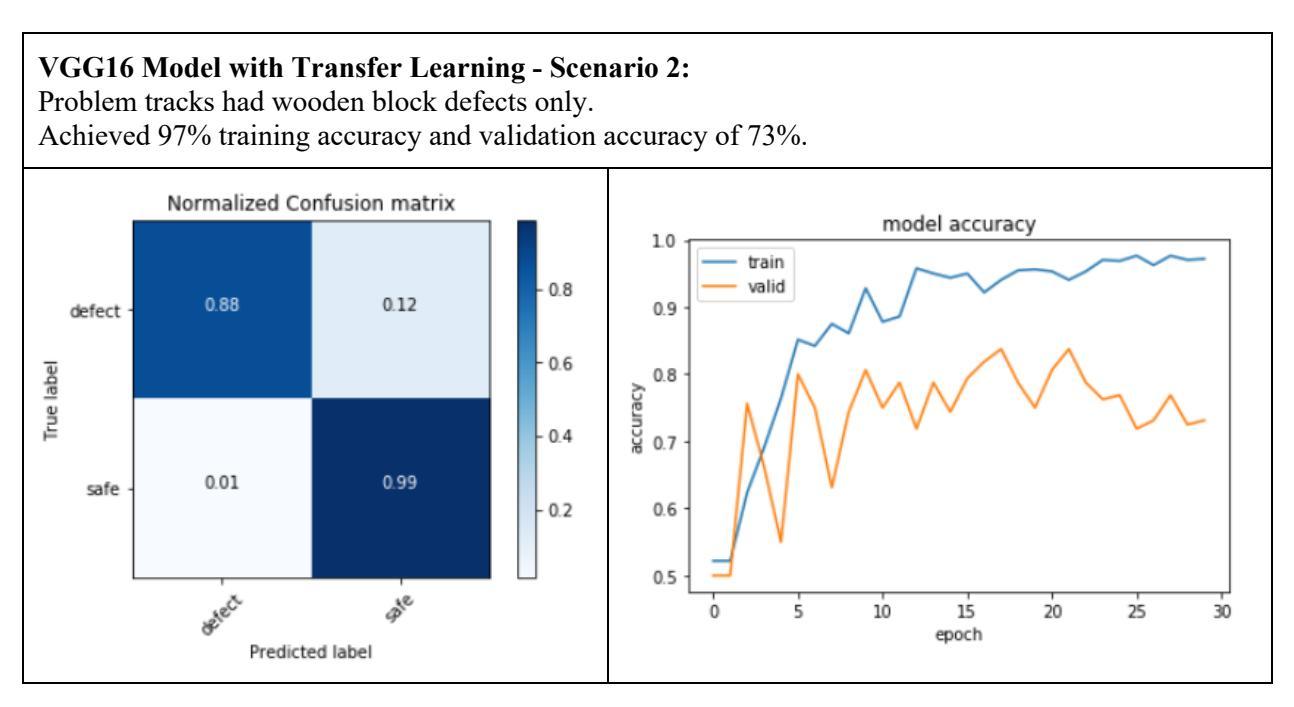
This resulted in conducting additional scenarios to further analyze if the VGG16 model would be viable if only one defect were to be introduced during our testing (missing wooden blocks). The results are shown below suggests that the model achieved 97% training accuracy and validation accuracy of 73%. As the confusion matrix indicates the number of false negatives was small while the number of false positives was negligible. The poor validation accuracy combined with the high training accuracy suggest a problem of overfitting, when the model does not learn to identify key features and instead memorizes the input dataset to a degree. These results are shown in Figure 16.

Figure 16: Scenario 2 - VGG Model Results (Confusion Matrix and Model Accuracy)

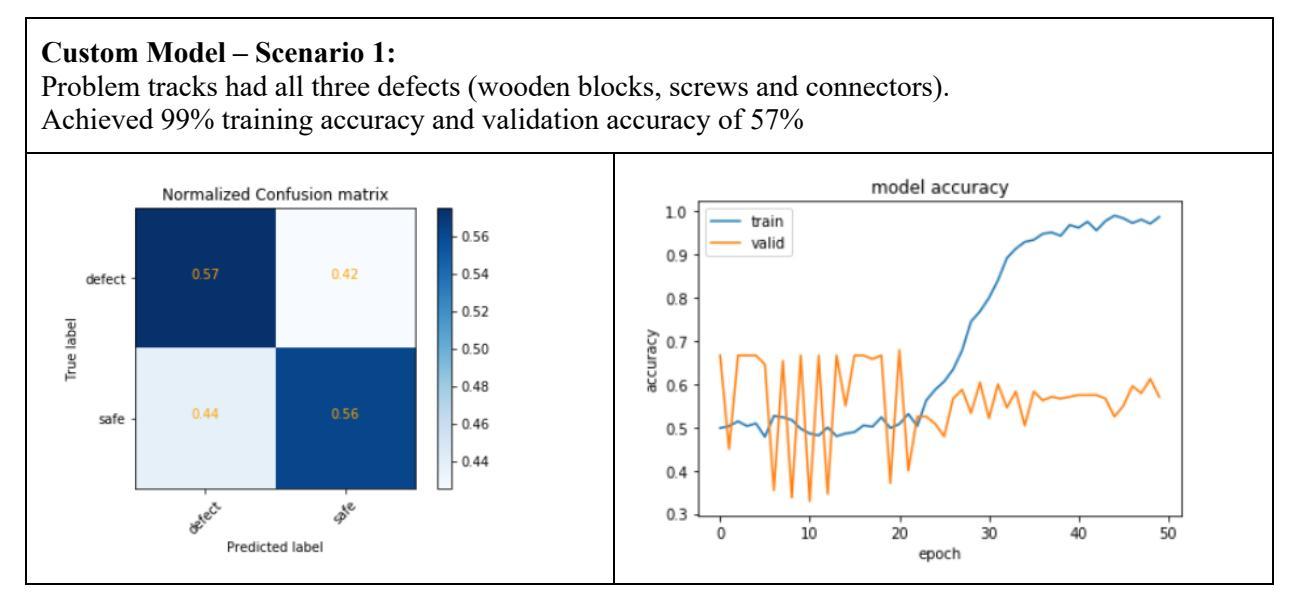
The testing results with the custom model on defective tracks with all types of defects provided a confusion matrix indicating a high false negative (42%) and high false positive (44%) in identifying the track defects. This model provided a very high 99% training accuracy and a very low 57% validation accuracy (which the project considered unacceptable). This model showed an even greater case of overfitting, in which the model was only able to memorize the input data (resulting in an extremely high training accuracy) but was not able to actually learn anything (resulting in an extremely low validation accuracy). The results are shown in Figure 17.

Figure 17: Scenario 1 - Custom Model Results (Confusion Matrix and Model Accuracy)

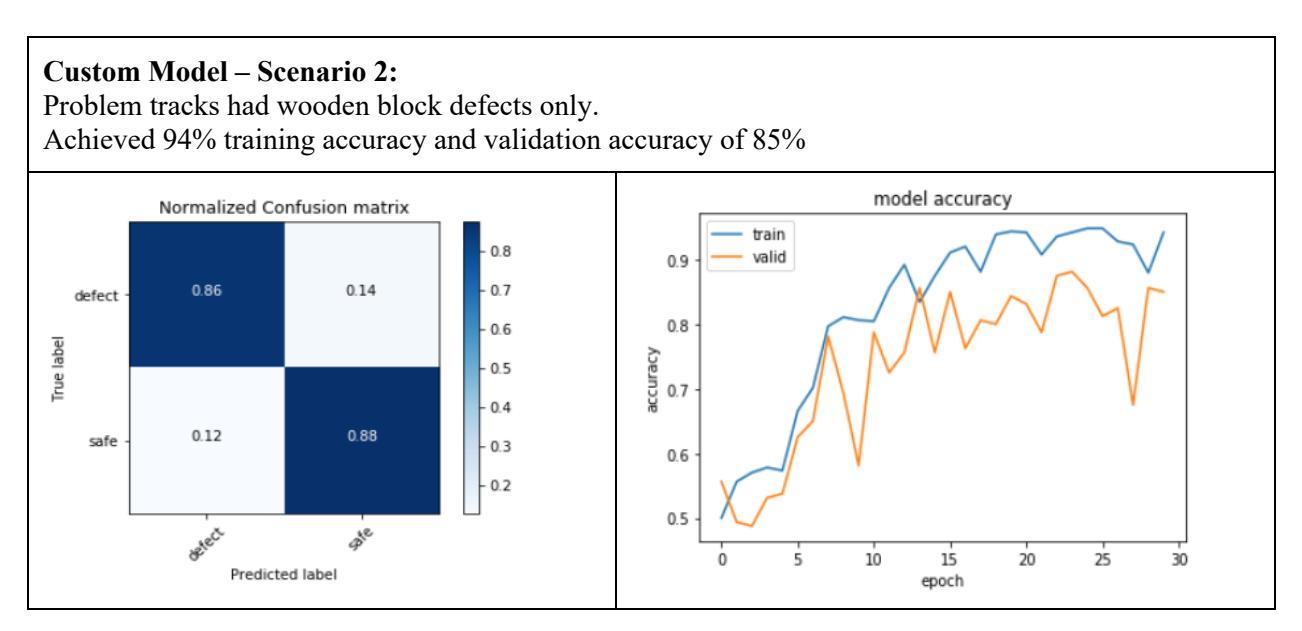
This resulted in conducting an additional scenario to further analyze if the custom model would be viable if only one defect was introduced during our testing (missing wooden block). The results show that the model achieved 94% training accuracy and validation accuracy of 85%. As the confusion matrix indicates the number of false negatives was low (14%) with slightly fewer false positives (12%). The test results are shown in Figure 18.

Figure 18: Scenario 2 - Custom Model Results (Confusion Matrix and Model Accuracy)

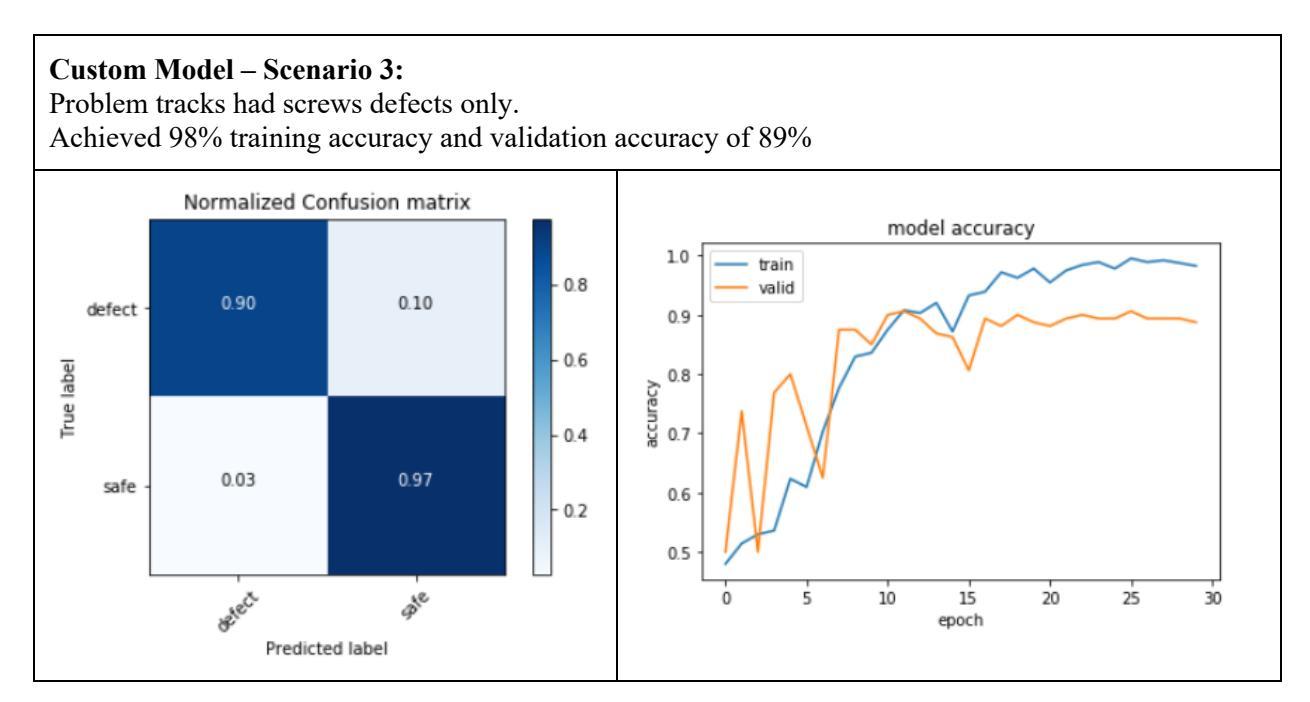
We conducted an additional scenario to further analyze if the custom model is still viable if a different type of defect was used during our testing instead (missing screws). The results show that the model achieved a 98% training accuracy and a validation accuracy of 89%. As the confusion matrix indicates, the false negatives were low at 10% with a minimal number of false positives. The test results are shown in Figure 19.

Figure 19: Scenario 3 - Custom Model Results (Confusion Matrix and Model Accuracy)
