"Cryogenic In-situ clamped beam testing of Sn96"

Abstract

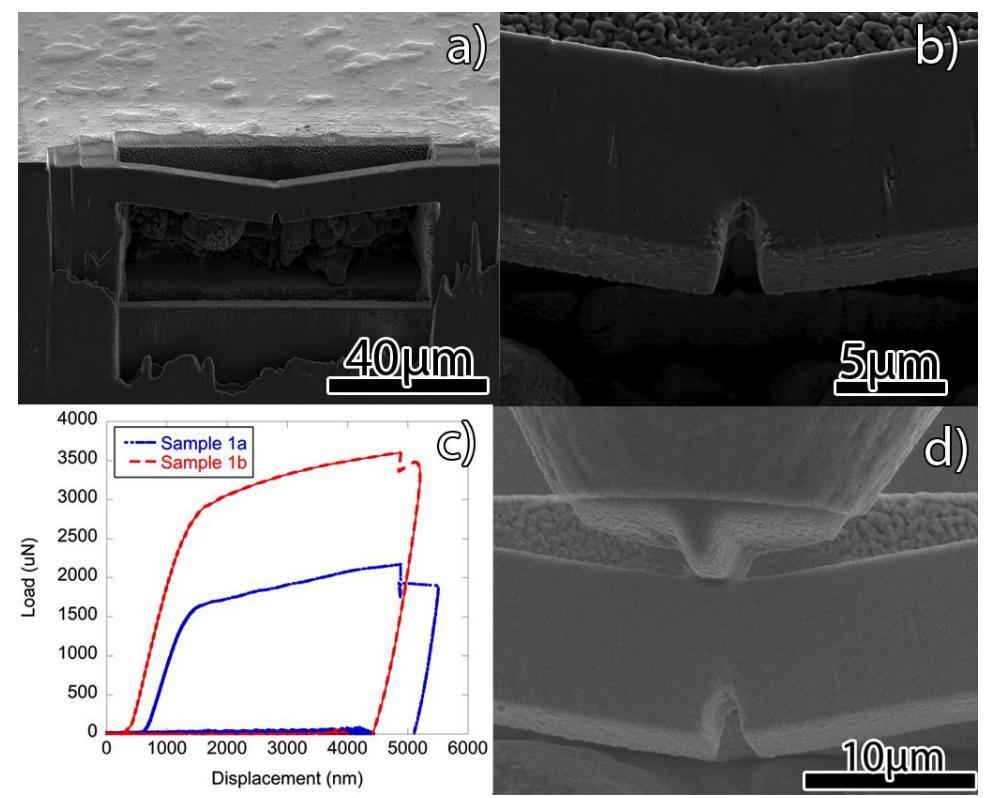
Figure 1: (a) SEM image of sample 1 after completing the bend test, (b) higher resolution image of the crack in sample, (c) the load and displacement curves for sample 1 after the first (1a) and second (1b) load cycle. (d) The position of the diamond wedge with respect to sample 1 during bending.

Figure 1 summarizes the mechanical response of sample 1, which did not contain any intermetallic particles ahead of the crack tip. Sample 1 was loaded twice as during the first load-controlled test there was no significant opening of the crack tip, deformation was primary accommodated along the outer edges of the beam. Whereas after the second load test (Figure 1b) there was considerable opening of the crack tip. Figure 1d shows the position of the diamond wedge tip with respect to the sample and Figure 1a shows the resulting deformation in sample 1.

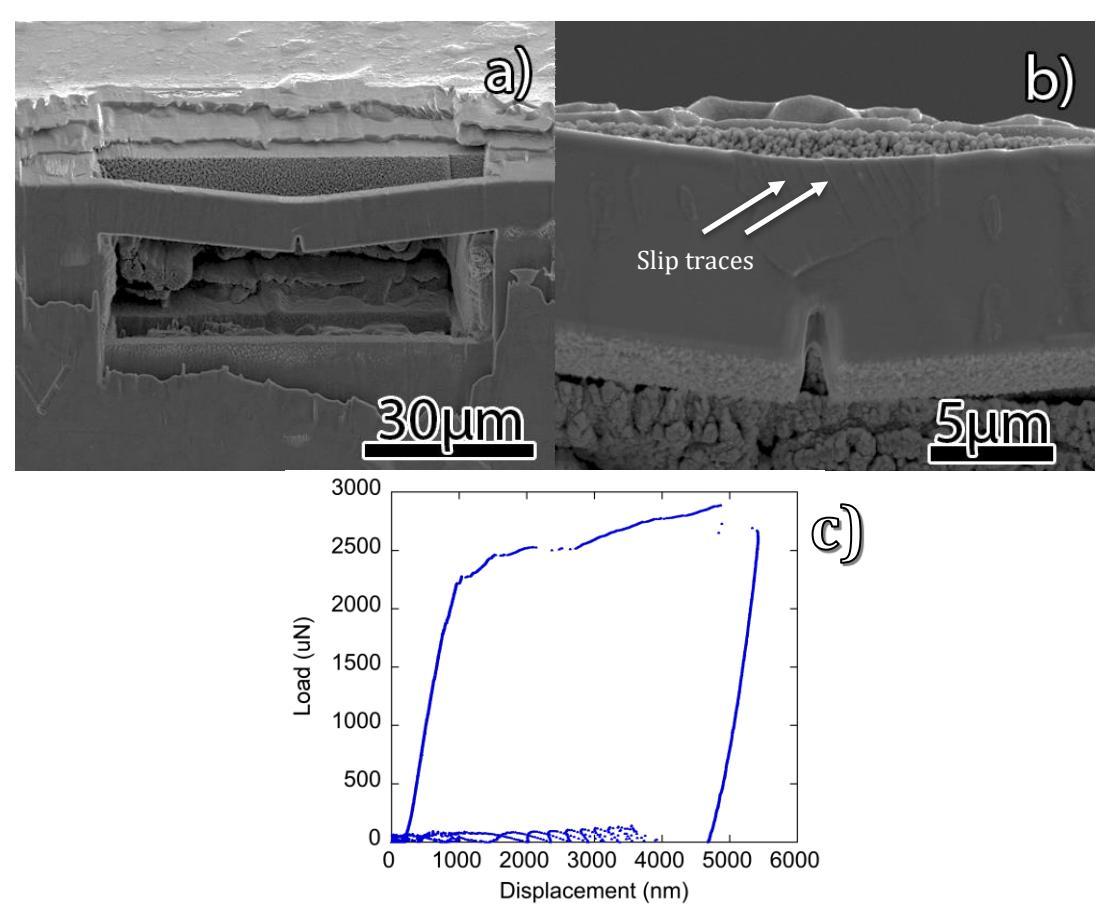
Figure 2: SEM image of sample 2 after completing the bend test (a), higher resolution image of the crack in sample 2 (b), and the load and displacement curves for sample 2 (c).

The mechanical response of sample 2 is shown in Figure 2. Sample 2 contained an intermetallic particle ahead of the crack tip. The intermetallic particle was both larger then the diamond wedge tip and in direct contact with the tip upon loading. Figure 2 shows the resulting deformation of sample 2. In addition to the crack tip opening upon loading, slip traces can also be seen within the intermetallic particle (Figure 2b) and will be shown in more detail in the following section.

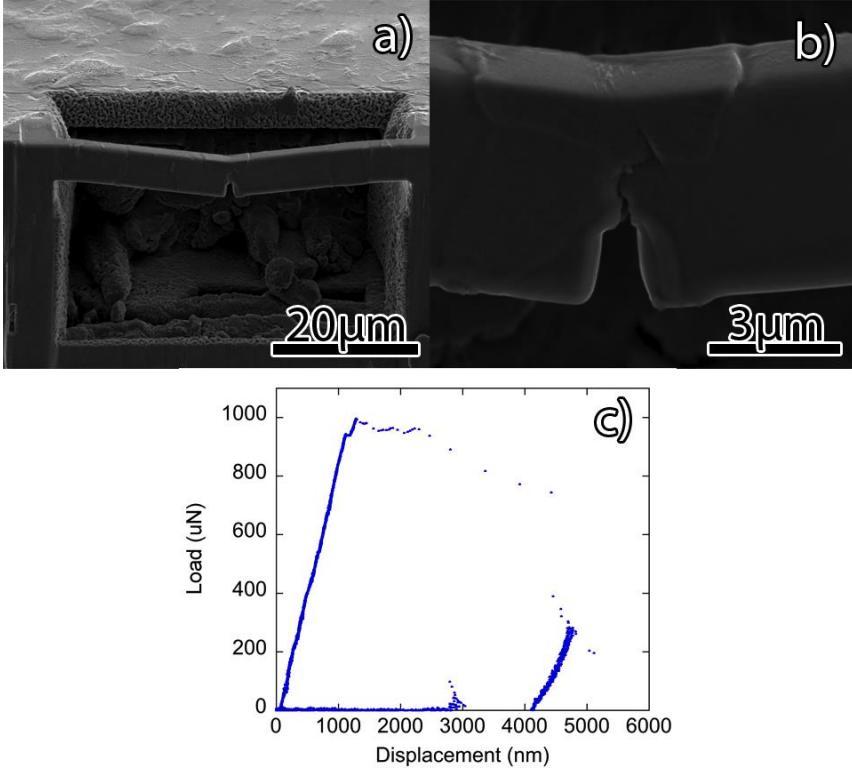
Figure 3: SEM image of sample 3 after completing the bend test (a), higher resolution image of the crack in sample 3 (b), and the load and displacement curves for sample 3 (c).

The mechanical response of sample 3 is shown in Figure 3. Sample 3 is similar to sample 2 with the exception that the intermetallic particle in sample 3 is smaller than the particle in sample 2. Figure 3b shows the resulting deformation of sample 3, which shows the crack running directly into the intermetallic particle and then continuing along the intermetallic boundary. Compared to the load/displacement curve of sample 2, sample 3 appears to only accommodate deformation through the opening of the crack tip, as the load significantly drops once the crack tip opens.

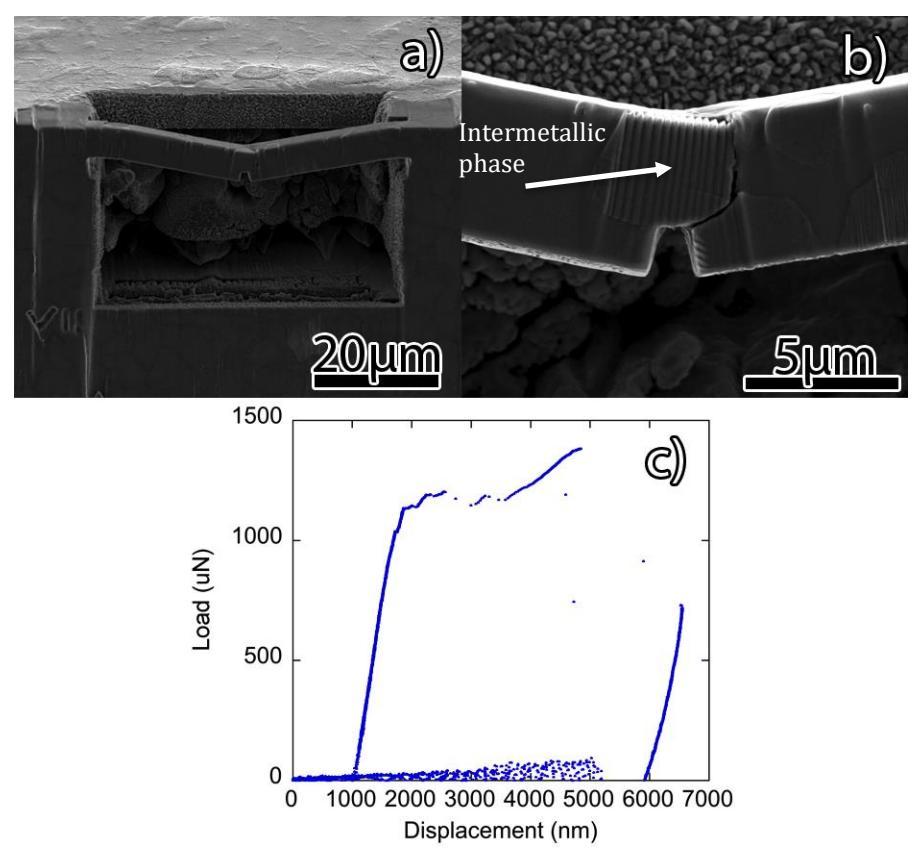
Figure 4: SEM image of sample 4 after completing the bend test (a), higher resolution image of the crack in sample 4 (b), and the load and displacement curves for sample 4 (c).

The mechanical response of sample 4 is shown in Figure 4. Unlike the previous samples where the crack was initiated within the Sn matrix, in this case the crack tip is initiated within the intermetallic phase. Directly above the intermetallic particle where the crack was initiated, was another intermetallic particle as shown in Figure 4a and 4b (annotated with arrows in Figure 4b). Upon deformation and crack tip opening, the crack progressed along the boundary between the two intermetallic particles rather then through the particle. This suggests that in the presence of the intermetallic phase, intergranular fracture is preferred and can contribute to the brittle behavior observed in Sn96 below the DBTT.

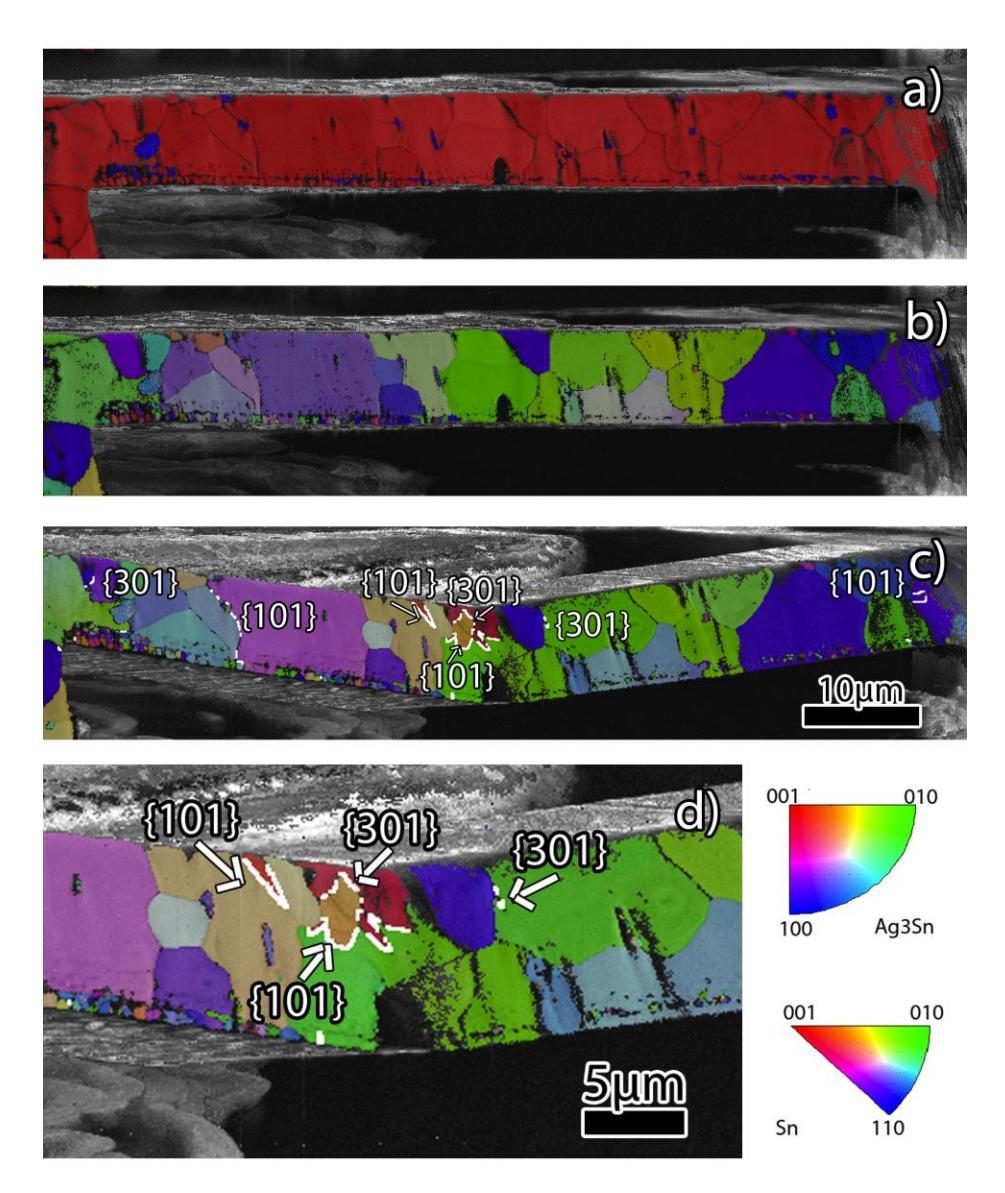
Figure 5: Clamped beam geometry sample 1 (a) phase map, (b) IPF Y map prior to bending, (c) IPF Y post bending and (d) IPF Y map of the crack tip post bending.

All of the microbeams were examined with EBSD prior to and directly after mechanical testing. Figure 5 shows the EBSD scans for sample 1 where part (a) shows the phase map where red represents the Sn matrix and blue represents the Ag₃Sn intermetallic, part (b) shows the IPF Y map prior to testing and part (c) shows the IPF Y map directly after testing and part (d) shows an IPF Y map of the crack tip after loading. Prior to bending, sample 1 did not show any evidence of twinning, however as can be seen in Figure 5c, after bending below the DBTT, twins are present both ahead of the crack tip and at the edges of the beam. Twin boundaries are highlighted in white in the EBSD map. This is in agreement with twins forming in regions of highest stress concentration within the beam. Figure 5d shows the twin boundaries ahead of the crack tip in more detail. Similar to the twins previously observed in the pure Sn micropillars¹, twinning behavior is consistent with the formation of the {301} and {101} twin in Sn^{17,18}.

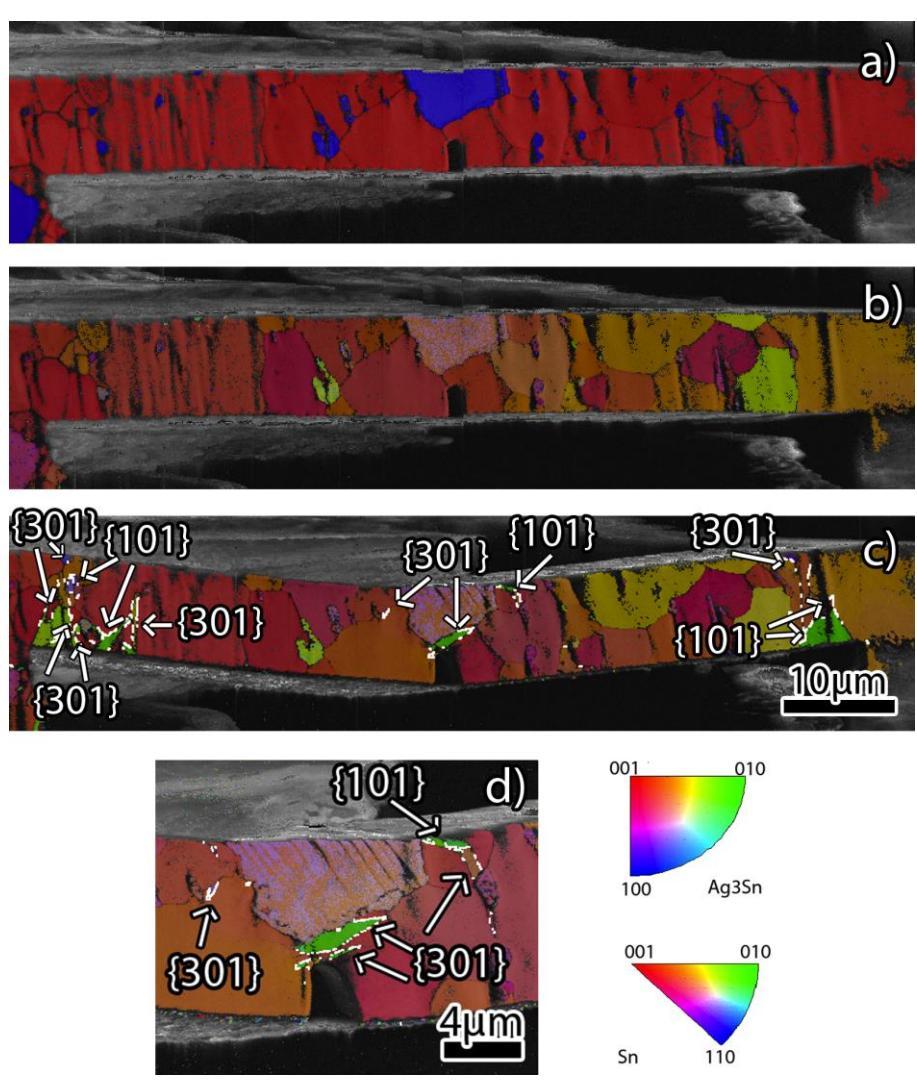
Figure 6: Clamped beam geometry sample 2 (a) phase map, (b) IPF X map prior to bending, (c) IPF X post bending and (d) IPF X map of the crack tip post bending.

The EBSD scans for sample 2 are shown in Figure 6. As can be seen in Figure 6c twins also formed ahead of the crack tip and along the edges of the beam at the points of highest stress concentration. Figure 6d shows the deformation ahead of the crack tip in more detail where both {101} and {301} twins are observed. This suggests that the primary deformation mechanism ahead of the crack tip is deformation twinning and the required stress for the nucleation of dislocations at the crack tip is larger than the stress required to nucleate twins. Deformation is also accommodated within the intermetallic phase itself. Figure 6d also shows slip traces within the intermetallic phase that were not present prior to bending. While dislocations are not favorable in the BCT Sn matrix, it appears that they are still able to form and accommodate slip within the orthorhombic intermetallic phase.

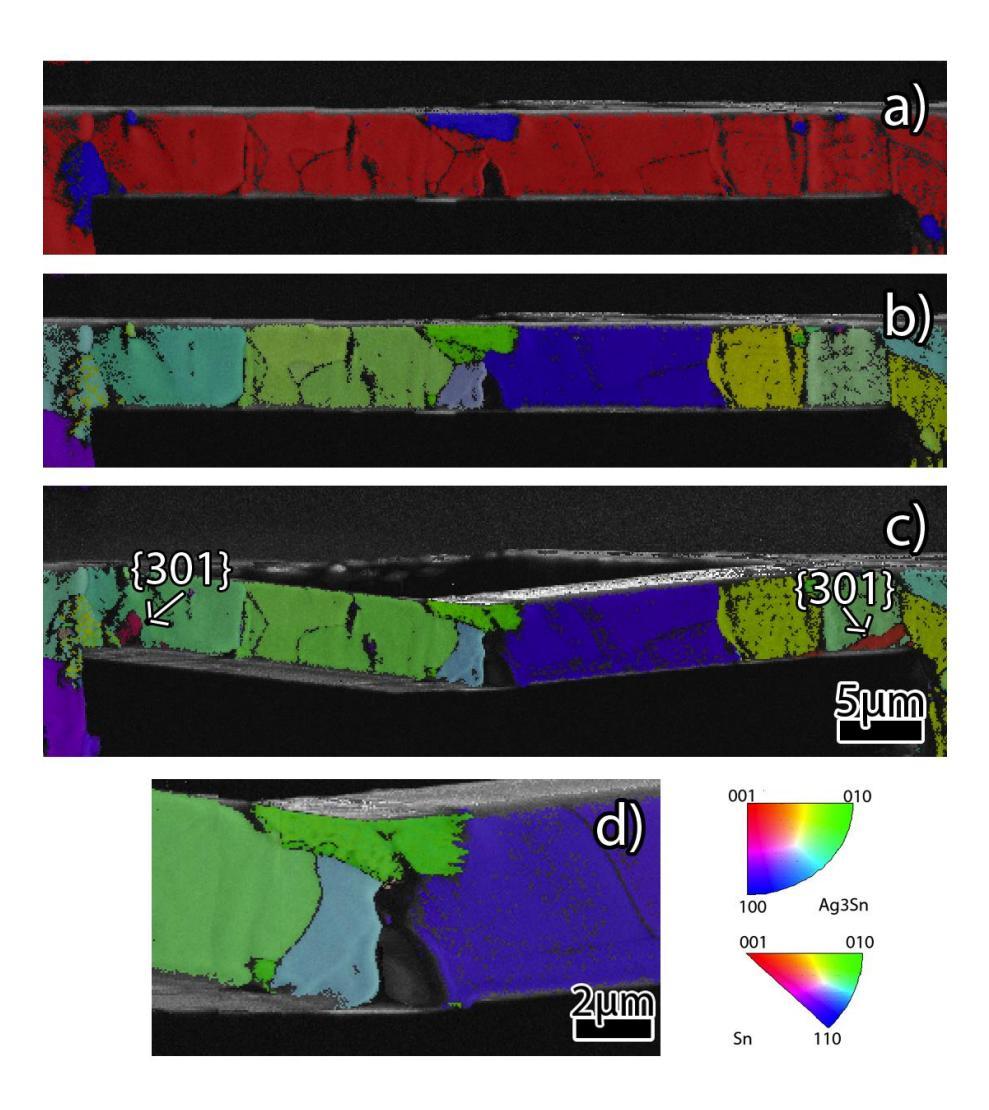
Figure 7: Clamped beam geometry sample 3 (a) phase map, (b) IPF Y map prior to bending, (c) IPF Y post bending and (d) IPF Y map of the crack tip post bending.

The EBSD scans for sample 3 are shown in Figure 7. Sample 3 is similar to sample 2 in that the crack tip is initiated within the Sn matrix and ahead of the intermetallic phase. However unlike sample 2, sample 3 does not show any twinning ahead of the crack tip. Instead, deformation is accommodated through a small grain rotation as can be seen in Figure 7c and d. In this case the crack propagates initially along the second phase boundary and then stops at a slip step in the intermetallic phase. Twinning is observed in sample 3 along the beam edges, both being {301} twins as shown in Figure 7c.

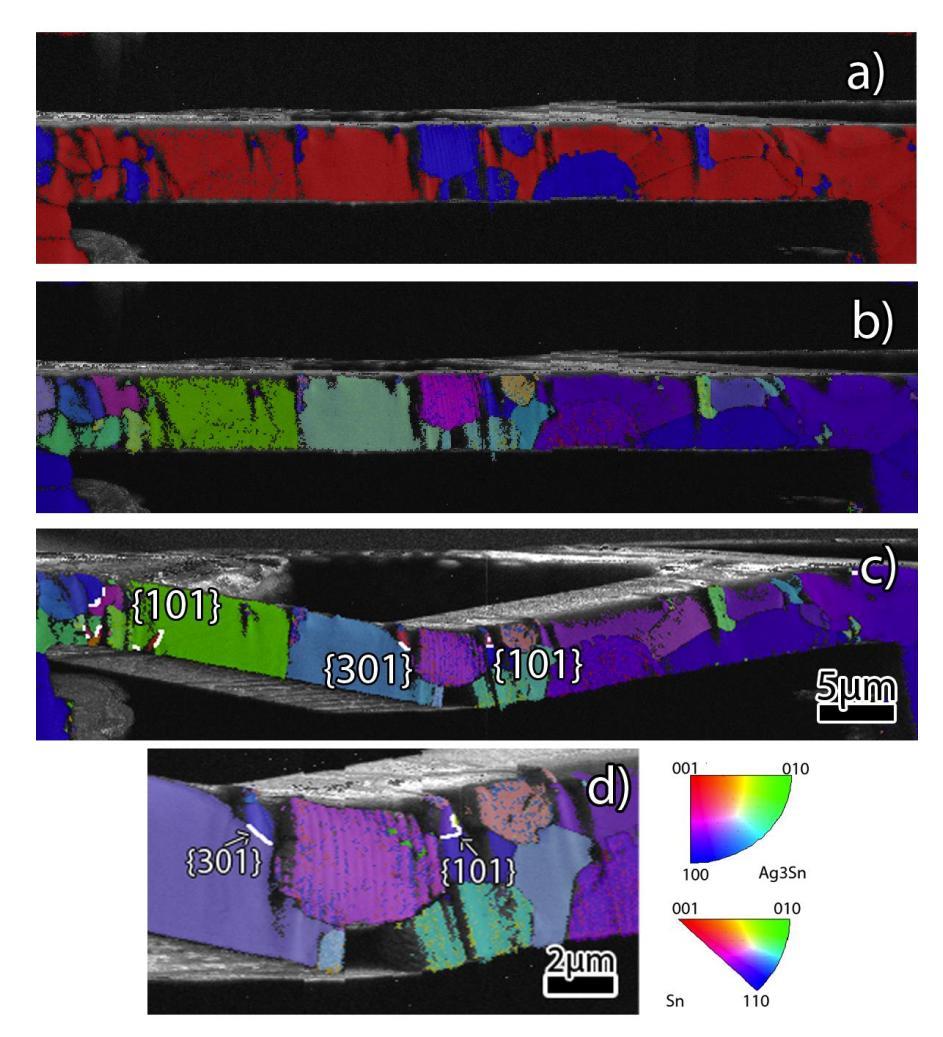
Figure 8: Clamped beam geometry sample 4 (a) phase map, (b) IPF Y map prior to bending, (c) IPF Y post bending and (d) IPF Y map of the crack tip post bending.

The EBSD scans of sample 4 are shown in Figure 8. Figure 8a clearly shows where the crack was initiated within the intermetallic phase, which is ahead of a second intermetallic particle of a different orientation (Figure 8b). Upon bending, the crack propagated to the second intermetallic particle boundary and continued to progress along the boundary between the two particles (Figure 8 c and d). This suggests that intergranular fracture, in particular between second phase particles, contributes to the brittle behavior of the Sn96 alloy below the DBTT. Twins were also observed in the neighboring Sn matrix grains that were directly next to the intermetallic particles as well as at the edges of the beam, which was observed in all four samples. The occurrence of twins in the surrounding Sn matrix suggests that the limited dislocation plasticity and deformation primarily through twinning is also a contributing factor to the brittle nature of the alloy. The twins observed, both the {301} and {101} are consistent with twins observed in pure Sn.
