# GPT-4V as Traffic Assistant: An In-depth Look at Vision Language Model on Complex Traffic Events

Xingcheng Zhou<sup>®</sup>,<sup>1,\*</sup> and Alois C. Knoll<sup>®1</sup>

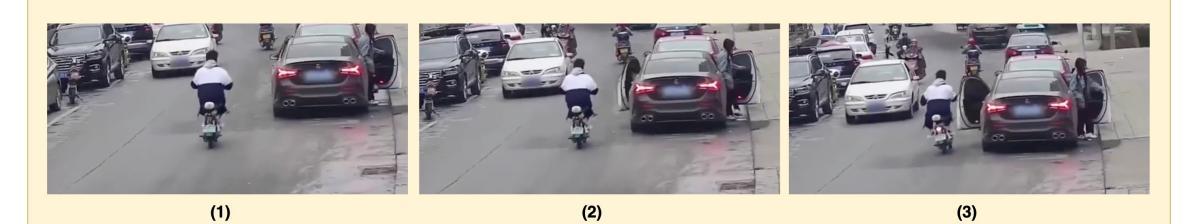
Figure 1: Dooring Part 1

As shown in figure 1 and 2, we observe that GPT-4V can correctly recognize the car accident depicted in the images and accurately identify it as 'dooring'. This indicates that GPT-4V aligns the text semantic feature of 'dooring' accidents with semantic context captured in multiple images. It can also provide an overall accurate description of the accident, only except for the misidentifying of another red vehicle as the car opens the door. This demonstrates the feasibility of generating accident reports based on keyframes, and provides a good example of vision-based traffic report generation.

1. The first image shows a person riding a motorbike down a street with several cars parked on the right side. The road is wet, which could indicate recent rain, making the surface potentially slippery.

2. In the second image, the car door of a parked vehicle on the right side begins to open as the motorbike approaches.

3. The third image shows the car door further open, and the motorbike is very close to the car, indicating an imminent collision.

The fourth image captures the moment of impact where the person on the motorbike appears to collide with the open car door.
 The fifth image shows the aftermath of the collision, with the person and the motorbike on the ground, suggesting they have been knocked over by the impact with the car door.

6. The final image shows the person lying on the ground, separated from the motorbike, indicating they have fallen as a result of the accident.

Based on the precise understanding and description of accidents, we delved into the model's high-level reasoning and inductive capabilities. By querying the causes of accidents, we assessed its casual inference ability within the given scenario. The answer shows it can include specific accident contexts, such as 'wet road surface,' to provide possible reasons applicable to the 'dooring' accident type. Additionally, GPT-4V attributes the primary responsibility of the accident to the act of opening the car door which is consistent with common traffic regulations. Through the prompt regarding required necessary emergency measures, we aimed to evaluate the model's decision-making ability. It turns out that the generated decisions are relatively general and applicable to almost all types of accident scenarios. This generality may be attributed to the limited information available from the provided images, causing the model to lean towards offering a correct yet non-specific answer. When analyzing the severity of accidents, the model provides a broad range of assessments, which aligns with what humans can infer based on the given images.

In summary, GPT-4V demonstrates a high level of accuracy in recognizing and comprehending this case. It exhibits the capability to make reasonable analyses, conclusions, and decisions based on the provided image information. Its analytical skills in this particular case are comparable to those of humans.

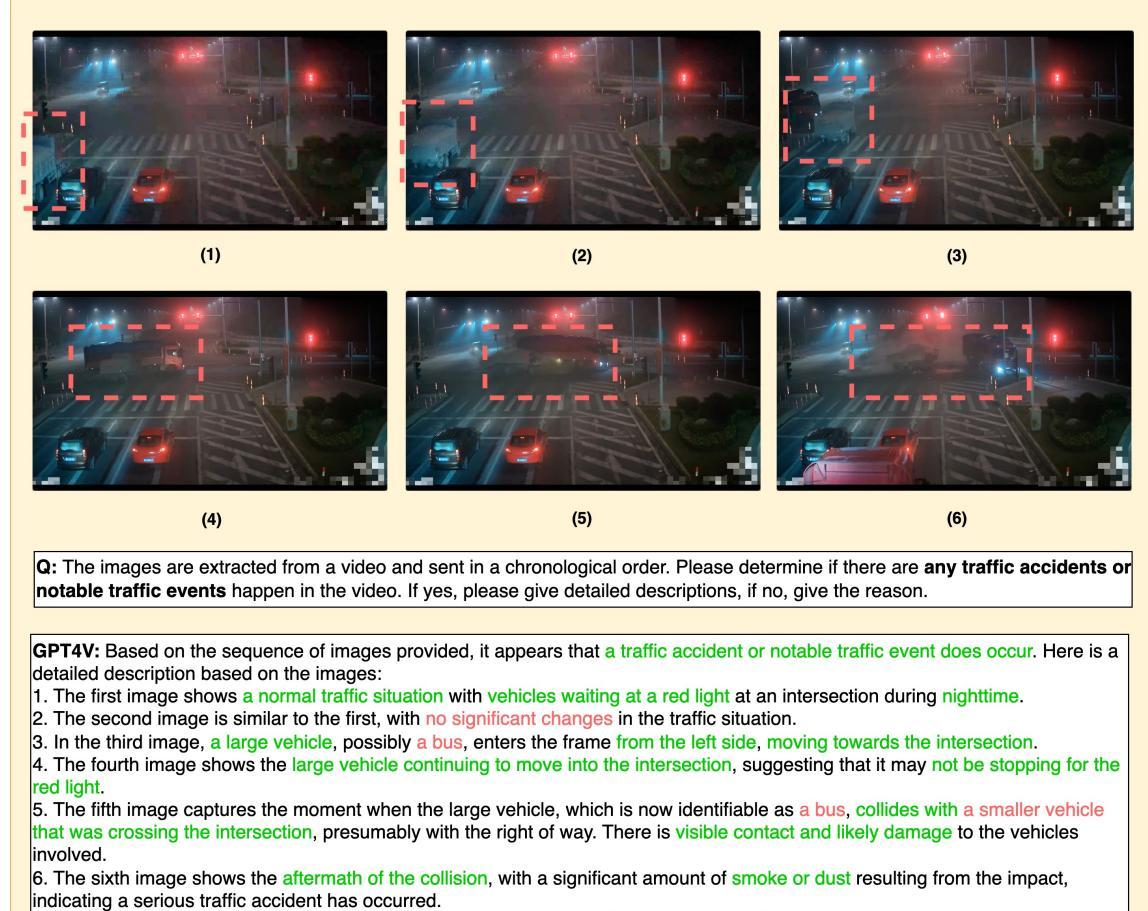
Figure 3: Run the Red Light at Night Part 1

Running red lights is one of the most common traffic violations. The recognition of this traffic event solely from video is challenging. The model needs to first recognize the status of the traffic light and the layout of the traffic scene. Based on the common sense that vehicles should stop and wait at red lights, the model identifies whether there is a vehicle traveling in the corresponding lane at the red light and then reaches a conclusion. The frames shown in figure 3 and 4 are extracted from the video in dataset [15]. There is a blue truck dragging a full load of dirt on the lower left side of the image, which continues to move forward at a red light and hits another large red semi-trailer truck that is moving normally. This ultimately caused the dust from the blue truck to spill into the air and caused the red semi-trailer truck to veer off course.

From these images, it is clear that a traffic accident took place at the intersection, involving at least a bus and a smaller vehicle.

As the sequence progresses, a large vehicle, which appears to be a bus, enters the frame from the left side of the image. The bus is moving towards the intersection, and it becomes apparent that it is not slowing down despite the red traffic light. The bus continues to approach the intersection at speed, indicating a failure to adhere to the traffic signal. Other vehicles remain stationary, obeying the red light.

reasoning, and has difficulties in recognizing the class and attributions of small objects, especially for such a nighttime scene. However, despite the imprecise description of the vehicle type and appearance, the model can still include common sense for causal inference and determine that the primary responsibility for this crash is from the vehicle running the red light. While analyzing the severity of the crash, the model infers that it brings significant impact based on indicators such as "substantial damage" and "smoke or dust," which is reasonable. The emergency measures taken for the crash are still relatively general as in section II-A.

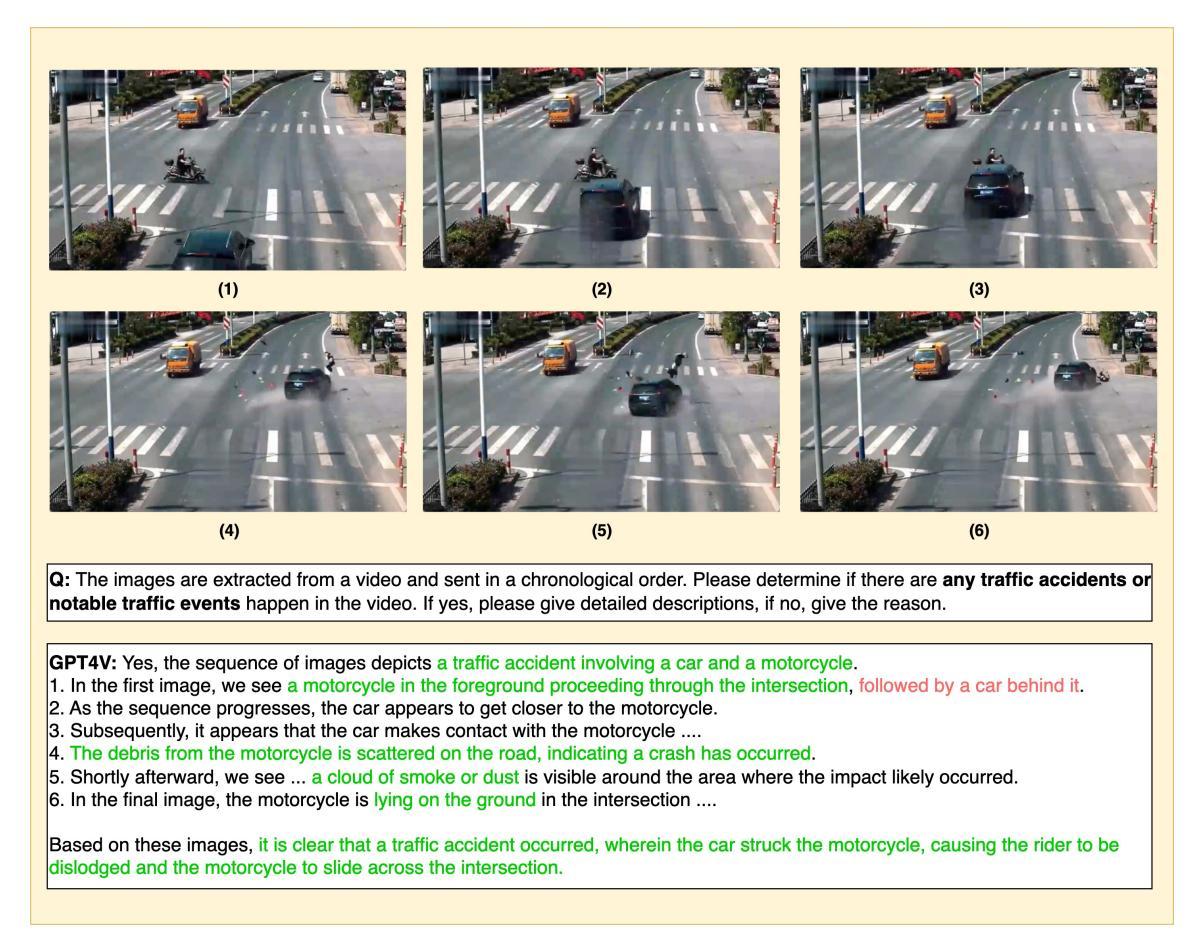
Figure 5: Motorcycle Car Collision Part 1

Collisions between cars and two-wheel vehicles are also common traffic accidents. These collisions can cause varying degrees of injury to both parties depending on their driving speed at the time of the incident, the traffic environment, and whether the two-wheel driver wears a helmet. As shown in figure 5, resourced from the video in dataset [15], a motorcyclist is traveling straight on the road and is hit by a black sedan. Since both of them are traveling at high speeds, the motorcyclist is knocked down, flies into the air, and then falls to the ground. Due to the camera's restricted observation perspective, the images do not fully reveal the situation of the traffic signal and surrounding details, but the accident was in fact caused by the motorcyclist using his cell phone while driving and running a red light.

GPT4V: Based on the given images, a detailed description of the traffic accident can be provided as follows: 1. \*\*Initial Conditions\*\*: The intersection is shown with clear weather conditions and good visibility. A motorcycle is seen in the middle of the intersection, followed by a blue car. A yellow bus is seen on the side road, but it does not appear to be involved in the incident.

By prompting the model to specify the recognized traffic participant's appearance and trajectory, we discover that although the model can identify the major vehicles, there are still some deviations in the details, such as the motorcyclist actually not wearing a helmet. Regarding the description of vehicle trajectory, GPT-4V interprets it more from the image's perspective, even though it is still not completely accurate for their location descriptions. In the analysis of the severity of the accident, the model recognizes it as "significant" via some scene contexts, such as the rider being thrown from the bike, and the visible cloud of smoke or dust, etc. These indicators have also been taken into account when deciding the required emergency measures.

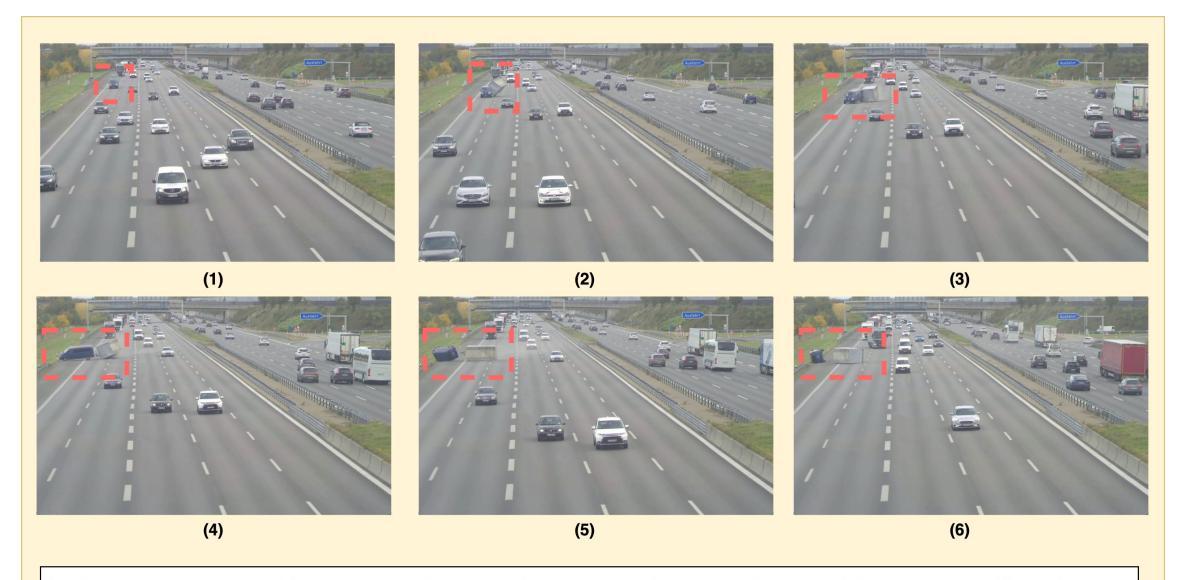
The images in Figure 7 are selected and extracted in a video from **Providentia++** project [7]. As shown in the images, there is a blue van towing a trailer box highlighted with the red dashed line. This vehicle was moving at high speed when the trailer box attached to it tipped over and landed on the side. Since the blue van was connected to the trailer box, its own trajectory was also affected and thus rolled over and fell to the ground, ultimately causing the accident.

GPT4V: ..., it appears that there is a notable traffic event occurring. In the third image, we can see a vehicle that has tipped over onto its side in the median area between the opposing lanes of traffic. This suggests that there has been a traffic accident involving at least this one vehicle. The subsequent images show the same scene from different moments in time, with the overturned vehicle remaining in the same position ....

demonstrates the powerful reasoning and causal inference abilities of GPT-4V. By combining a series of contextual information including environment, weather, vehicles involved, traffic conditions, etc., the model characterizes the level of the accident as severe. It provides emergency measures to be taken including dispatching police, fire service, and emergency medical services. Most of these measures do appear in the subsequent rescue after the accident, which can prove that the model has the ability to make similar decisions when reacting to emergent traffic situations as a human being.

However, GPT-4V again fails to make accurate statements when it comes to spatial reasoning. For example, the accident was not in the median area between the opposing lane of traffic, but on the side of the highway. And the vehicle was not traveling in the same direction as the camera's point of view, but on the opposite side of the camera before it flipped over. The vehicle was also not light-colored but a dark-colored van with a trailer box. From these descriptions, we can tell that the model, while being able to recognize the rollover of the vehicle and reasoning in the context of the recognized environmental information, did not succeed in recognizing the type and driving condition of the vehicle itself. This leads to the inability to make correct and specific determinations when carrying out a cause analysis.

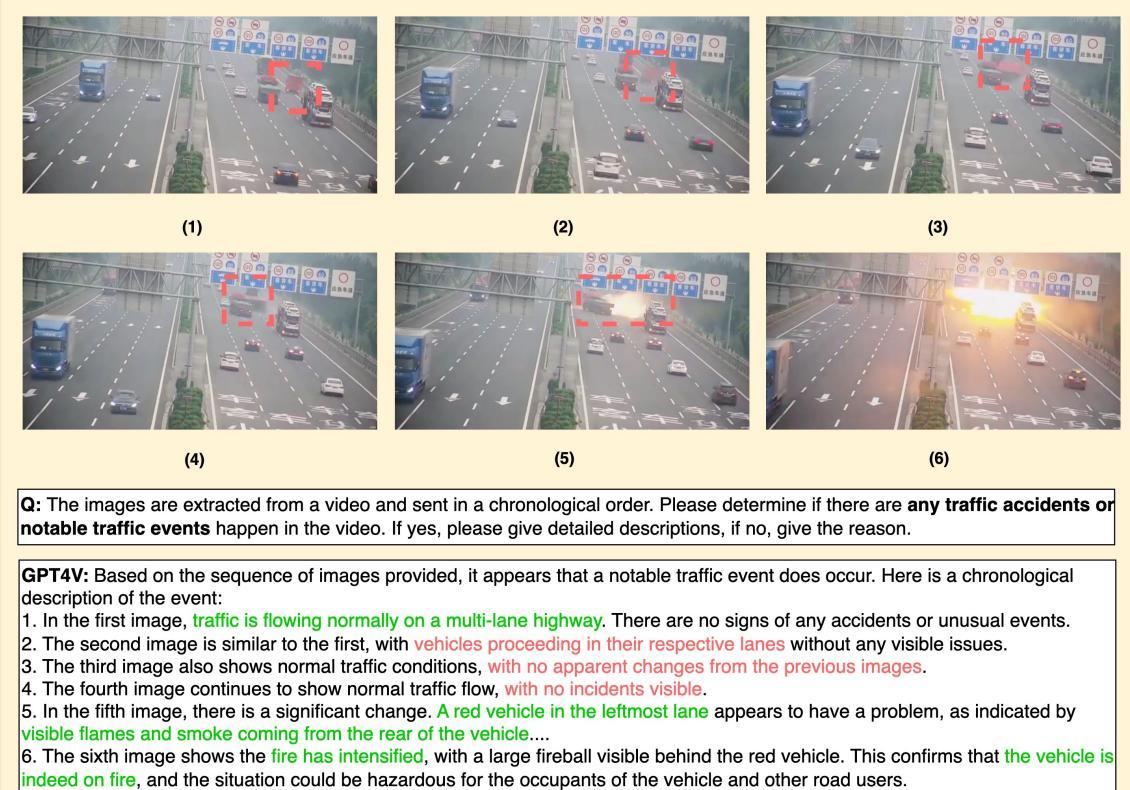
Figure 9: Fires and Explosion Part 1

Vehicle explosions are a relatively uncommon but extremely dangerous type of traffic accident. It is usually caused by some issues such as severe collisions, fuel leaks, or overheating of electric vehicle batteries. These accidents are usually accompanied by loud noises and flames, resulting in significant injuries and property damage. The video shown in figure 9 and 10 is resourced from [12]. The captured keyframe shows a red truck traveling on the highway, which overturned due to a lane change while in motion at high speed. And due to its fast traveling velocity, the cargo it carries rubs violently against the road surface, resulting in an explosion accompanied by bright flames. Since it is difficult to distinguish between an explosion as well as a sole fire without providing acoustic information, we regard this as a successful case as the model is able to recognize the flame from the vehicle as a notable traffic event.

From these images, it is clear that a vehicle fire has occurred on the highway, which is a notable traffic event....

As shown in Figures 9 and 10, GPT-4V is able to identify the abnormalities in the fifth and sixth images through image-level analysis, i.e., there is a visible flame which later on becomes larger. According to the first question prompted in figure 10, it is obvious that the model has not been able to successfully recognize the driving lane changes of the vehicles displayed in the 2nd, 3rd, and 4th images, which result in the inability to provide the corresponding attribution analysis and causal link. Therefore, in the analysis of the causes of the accident, some correct but more general answers are presented. In terms of the emergency measures taken for this accident, the model proposes to try putting out the fire safely with fire extinguishers if possible before the fire department arrives. It shows that the model is able to provide rational decisions according to the types of accidents.

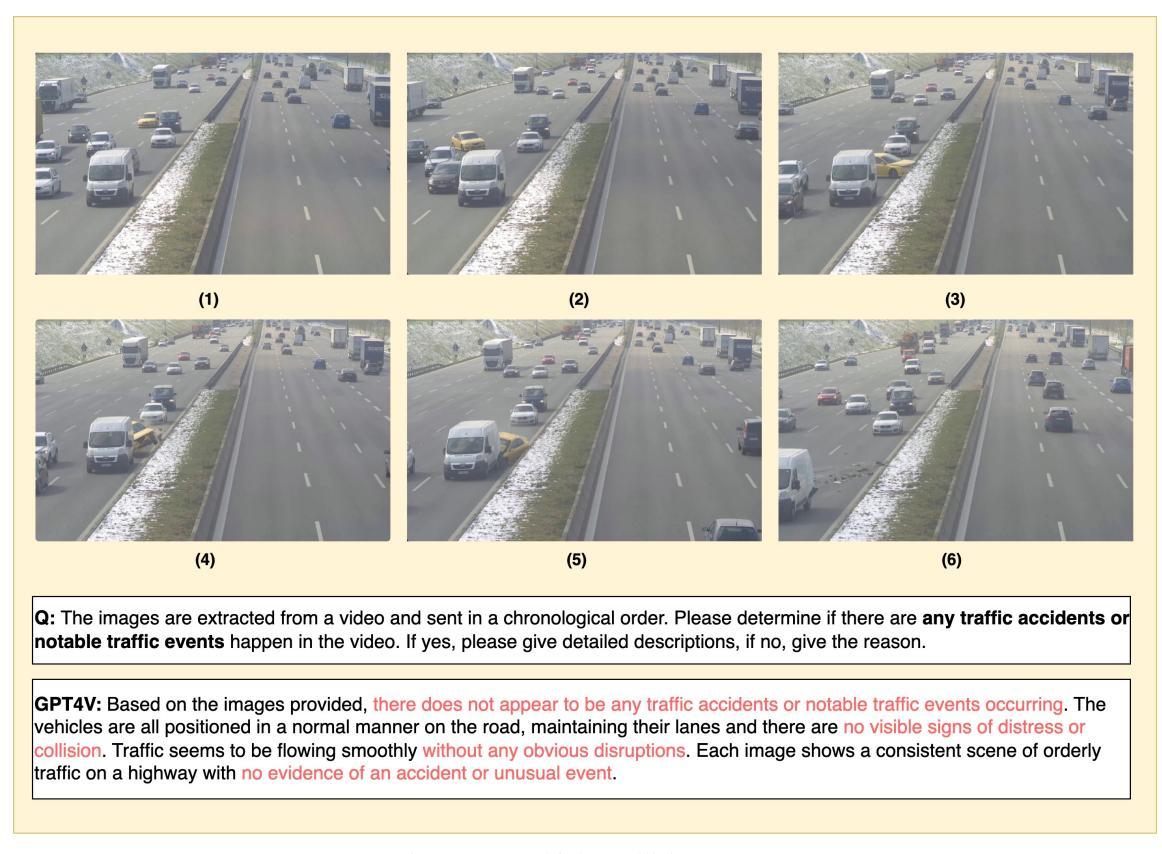
Figure 11: Vehicle Collision Part 1

Figure 11 shows a vehicle collision accident, resourced from **Providentia++** Project. The images depict a yellow car traveling on a multi-lane highway when a white van in front of it suddenly stops on the highway lane. In order to avoid the vehicle in front of it that slows down, the yellow car makes a sharp turn, which yet still hits the guardrail in the middle of the highway due to its excessive speed, and later hits the stopped white van. Although there are similar accident scenarios with two vehicles colliding in this video as in section II-B, the number of vehicles present in this video is far larger and the causes are more complex, with multiple vehicles interconnected with each other. And due to the limitation of view angle, the obvious collision between the yellow car and the white van cannot be directly observed either, which can probably only be confirmed through comprehending context information.

As shown in figure 11 GPT-4V fails to recognize either the accident or notable traffic events within the provided keyframes. Although it is obvious for human beings to identify the abnormality in the images, the model still describes it as having "no evidence of an accident or unusual event". Based on the previous evidence that, the model can recognize vehicle collisions, as well as recognize the debris, we hypothesize the failure of recognition happens due to the excessive number of vehicles displayed in the picture. The excessive number of vehicles leads to the inability of the model to focus attention on the behavioral recognition of all the vehicles, which results in the missing of the obvious accidental vehicles. Based

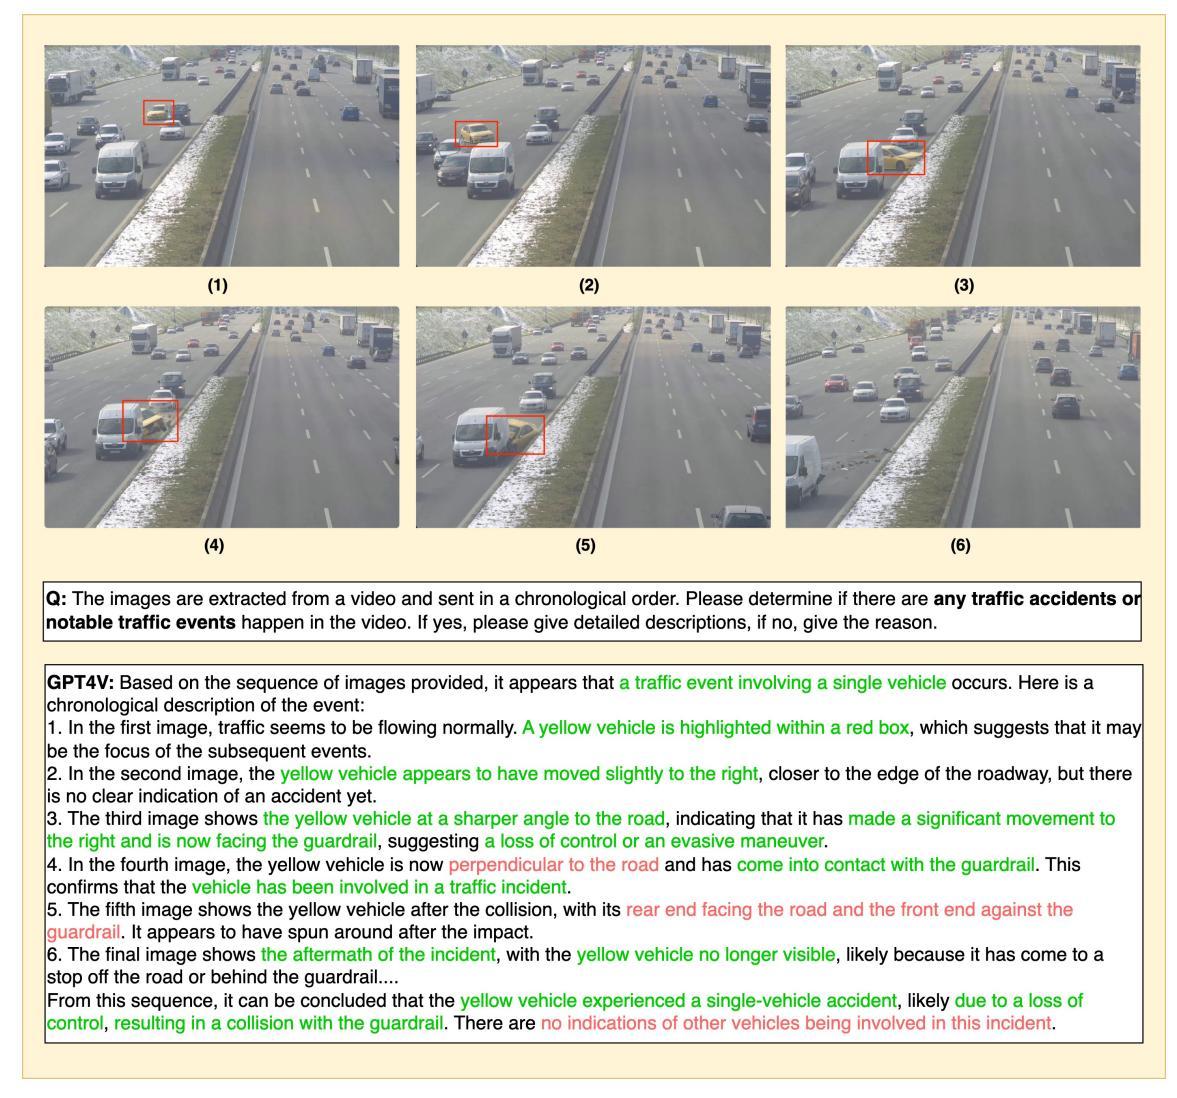
Figure 12: Vehicle Collision (Highlighted) Part 1

on this assumption, we manually highlight the accident vehicles in the images and conduct the analysis again.

However, the model still fails to completely analyze the cause of the accident and fails to identify the collision with the stopped white van. In addition to the previously discussed failing reasons including restricted camera view, lack of spatial reasoning, and lack of temporal and acoustic information, another possible reason might be that, the model assigns less attention to the remaining vehicles after highlighting the target vehicle. This then leads to the failure to capture the causal link between the stopped white vehicle and the result of the accident.

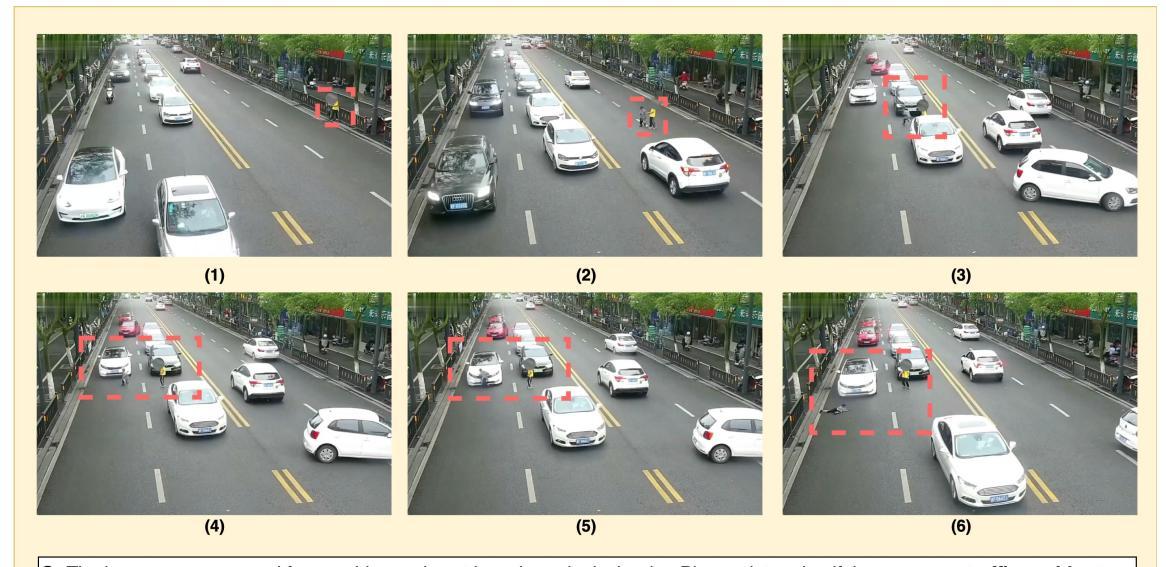
Jaywalking is a typical and common example of traffic rule violation, usually referring to the act of pedestrians crossing roads where there are no crosswalks or traffic signals. This behavior poses a traffic safety hazard, especially when jaywalking across roads with high traffic volumes and high speeds, as pedestrians are vulnerable traffic participants and can easily lead to traffic accidents. The video in figure 14, resourced from dataset [15] displays a scene with two pedestrians jaywalking across a multi-lane street. To protect the privacy of the pedestrian, their faces are been anonymized.

- 1. The first image shows normal traffic flow with vehicles in their respective lanes.
- 2. In the second image, a pedestrian appears to be crossing the street while traffic is moving, which could potentially be unsafe.
- 3. The third image shows the pedestrian has safely reached the median strip, and traffic continues to flow normally.
- 4. The fourth image reveals that the pedestrian has left a wheeled bag in the middle of the road, which could pose a hazard to oncoming traffic.

In the fifth image, a driver has stopped their car and is stepping out, presumably to remove the bag from the road.
 The final image shows the driver picking up the bag from the road, likely to prevent any accidents or disruptions in traffic.
 From these images, it appears that there was a potential traffic hazard due to a bag left on the road. However, a driver took initiative to remove the bag, likely preventing any accidents or notable traffic events from occurring.

The evaluation result in figure 14 and figure 15 shows that GPT-4V fails to recognize two pedestrians crossing the road, but only recognized one of them and viewed the other pedestrian as a wheeled bag. And due to the illusory effect of the Large Language Model, the whole story was refined into a scenario in which a pedestrian lost his wheeled bag on the road while crossing the road and avoided a traffic accident due to the timely stopping of the driver. Nevertheless, GPT-4V can still reason that this traffic violation behavior is jaywalking based on the traffic environment in the images and based on the context that one recognized pedestrian crossing the road there.

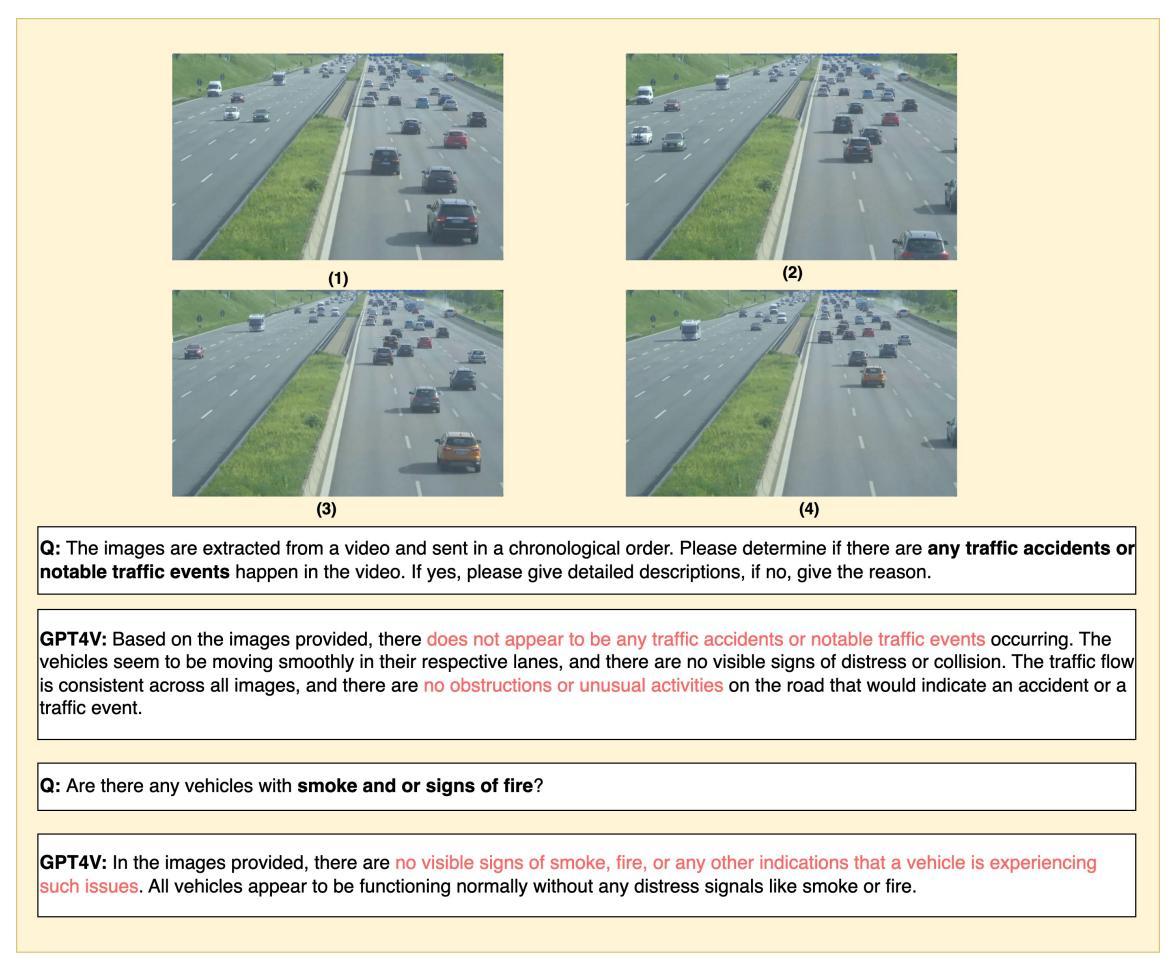
Figure 16: Vehicle Smoke Part 1

Vehicle smoke is usually a serious sign of damage to the vehicle, which indicates that the vehicle is defective. For safety reasons, people should immediately move the vehicle to a safe place if it begins to smoke so that the situation does not escalate further, such as to a fire or even a vehicle explosion. The images in figure 16 and figure 17 are from the video recorded by **Porivdentia++** Project. On the upper right side of the image is a white vehicle parked in the emergency lane with visible white smoke streaming from it. The rest of the vehicles were traveling normally on the road and were not affected.

Figure 16 demonstrates that GPT-4V cannot recognize the abnormality of the image, nor can it recognize the car that is emitting white smoke, which means that the model fails to capture the corresponding visual semantic features despite the explicit prompts of "whether there's smoke or a sign of fire in the images". In figure 17, we apply the same highlight operations to the images as we do in figure 12, and we input the same question with even more explicit prompts. However, the model still could not identify any signs of smoke and fire. One possible reason could be that the distance of the white vehicle is too far from the camera, and the image resolution is not clear enough so that the visual features can not be well extracted and utilized. Another possible explanation is that GPT-4V still does not achieve a well-performed semantic alignment of vehicle smoking visual features and text features, especially for this distant, dense and noisy scenario.

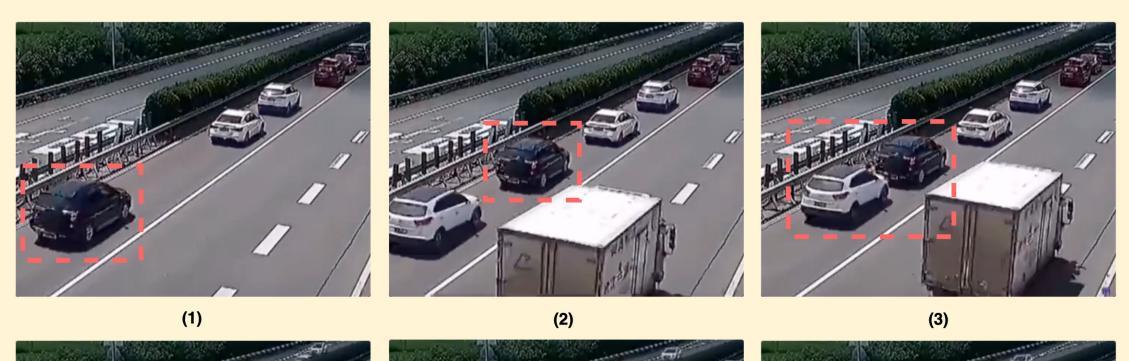
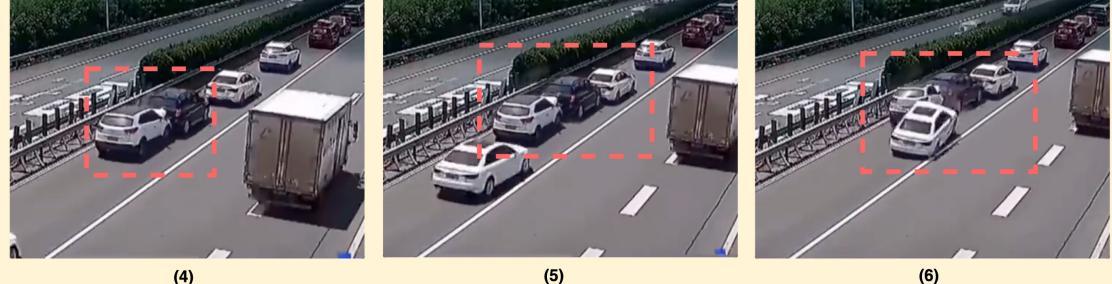
The images in figure 18, resourced from [4], shows a case of four vehicle collisions. It demonstrates a scene of a traffic jam on a multi-lane road where a small black SUV, highlighted with the dotted line,

slows down after approaching the vehicle in front of it. As can be observed in images 2, 3, and 4, the black SUV was followed closely by a white car. Due to its excessive velocity and the insufficient distance, the white car was unable to stop within a safe braking distance, and thus crashed into the black SUV in front of it. Image 4 and 5 show the collision of these two vehicles. In image 5, a new white car appears behind the white sedan, which also fails to brake in time for the same reason, and crashes head-on into the vehicle in front of it. The collisions, the position of the black SUV was shifted forward and also then rear-ended the vehicle in front of it. This leads to the eventual collision of the four vehicles shown in image 6. In summary, this accident involved 4 vehicles, associated with 3 consecutive collisions.

Based on these observations, we can deduce that the possible reasons for this failure can be as follows. First, in order to make the generated textual description of the traffic event logically self-consistent, the model somewhat neglects the semantic associations with visual features, thus creating an illusory effect. Secondly, the image-level vehicle recognition is not accurate enough, and there are many false positive and false negative detections. For the third, model fails to associate the corresponding vehicles across images when performing multi-object tracking, which may be because the appearances between the vehicles are similar, e.g. the colors, and performing multiple vehicle associations solely utilizing visual features while ignoring spatial features can be difficult. Lastly, the image-level vehicle collision detection is still not accurate enough, since it is clear that there are multiple vehicles involved in the collision in image 6, which are not mentioned in the answers.
