Understanding the role of threading dislocations on 4H-SiC MOSFET breakdown under high temperature reverse bias stress

Abstract

The origin of dielectric breakdown was studied on 4H-SiC MOSFETs that failed after three months of high temperature reverse bias (HTRB) stress. A local inspection of the failed devices demonstrated the presence of a threading dislocation (TD) at the breakdown location. The nanoscale origin of the dielectric breakdown was highlighted with advanced high-spatial-resolution scanning probe microscopy (SPM) techniques. In particular, SPM revealed the conductive nature of the TD and a local increase of the minority carrier concentration close to the defect. Numerical simulations estimated a hole concentration 13 orders of magnitude larger than in the ideal 4H-SiC crystal. The hole injection in specific regions of the device explained the failure of the gate oxide under stress. In this way, the key role of the TD in the dielectric breakdown of 4H-SiC MOSFET was unambiguously demonstrated.

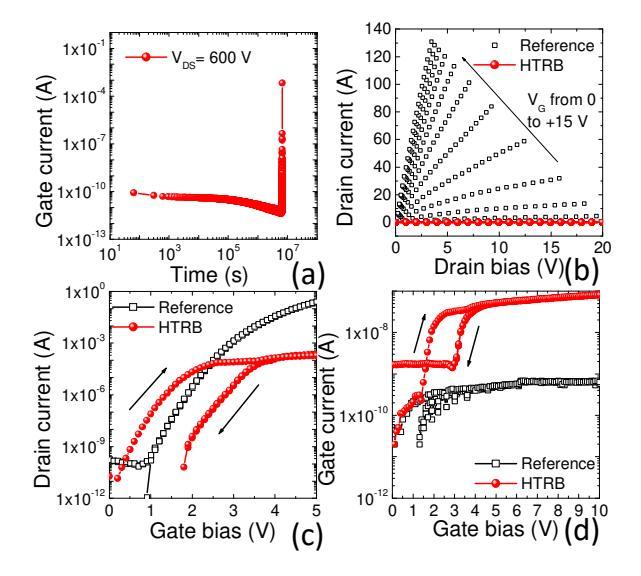
Fig. 1a reports the gate current as a function of the HTRB stress time at 140 °C and V_{DS} =600 V, showing the abrupt increase of the current at the breakdown. Fig. 1b compares the I_D-V_D characteristic of the failed device with that of a reference device survived to the HTRB test. As can be seen, the failed device shows a degradation of the output characteristics, as the drain current cannot be modulated by the gate bias after the HTRB. By repeating three times the I_D-V_G (V_{DS} = 0.5 V) transfer characteristics (Fig. 1c), the failed device shows a shift of the transfer characteristics, indicating the occurrence of a charge trapping. The presence of charge trapping is also responsible for the behaviour of the I_G-V_G characteristic shown in Fig. 1d, where a significant increase of the gate current is observed at V_G>2V for the failed device. It is worth noting that during the HTRB some trapping phenomena occurred. In fact, the gate current at fixed bias (Fig. 1a) decreases with increasing the HTRB time, thus indicating the occurrence of holes trapping in the oxide layer until the hard breakdown occurs. In particular, during HTRB holes are accumulated at the SiO₂/4H-SiC interface and they can be injected in the oxide via Fowler-Nordheim tunnelling [17].

Fig. 1: (a) MOSFET gate current vs time under HTRB at $V_{DS} = 600$ V at 140 °C. (b) Comparison of the I_D - V_D collected on a fresh reference device and a failed HTRB device. (c) Comparison of hysteresis loop of the I_D - V_G ($V_{DS} = 0.5$ V) collected on a fresh reference device and a failed HTRB device. (d) Comparison of hysteresis loop of the I_G - V_G collected on a fresh reference device and a failed HTRB device.

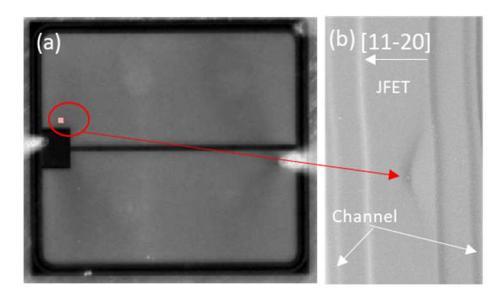
After the HTRB test, the breakdown spot was identified by EMMI (Fig. 2a) and marked with a FIB cut. After the complete device delayering, the bare 4H-SiC surface in the FIB mark was investigated by SEM, revealing the presence of a triangular features having the vertex in the centre of the JFET region (Fig. 2b).

Fig. 2: (a) EMMI micrograph showing the location of the breakdown (BD) event. (b) SEM micrograph showing the delayered MOSFET, revealing the presence of epitaxial defect in the JFET region.

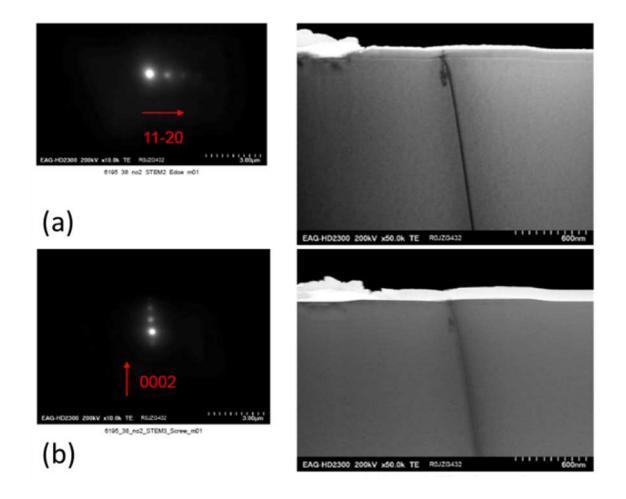
The nature of the defect found at the breakdown spot was clarified by means of TEM analysis. In fact, TEM in cross section (Fig. 3) allowed to identify a threading dislocation (TD) running along the epitaxial layer. The TEM dual beam investigation – along the directions [11-20] and [0002], shown in Figs. 3a and 3b, demonstrated the presence of a mixed dislocation. In fact, the dislocation shows up with the [11-20] spot (edge) and with the [0002] spot (screw).

Fig. 3: (a) Cross section transmission electron microscopy in 2-beams configuration [11-20] (b) Cross section TEM in 2-beams configuration [0002]

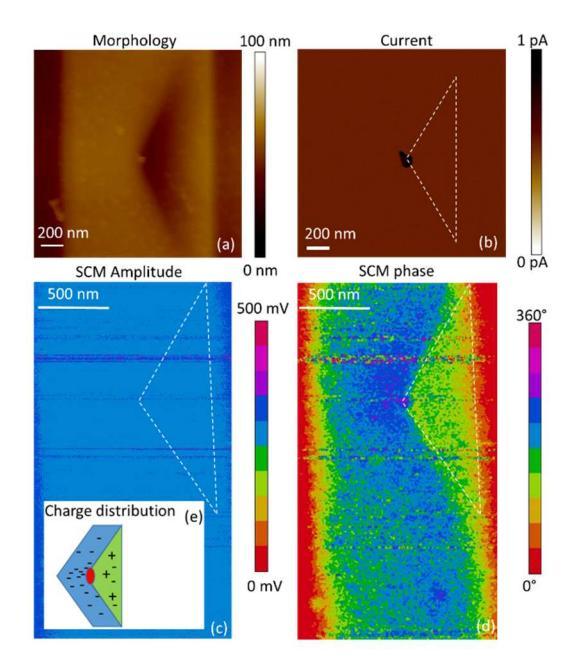
To explore the electrical behaviour of the TD, a nanoscale electrical characterization was carried out using the conductive atomic force microscopy (C-AFM) [18]. In particular, C-AFM allowed determining the morphological shape of the surface (Fig. 4a) – a triangle with the vertex in the [11-20] direction – about 25 nm deeper than the surface of the JFET region where it is located. Even in the triangular region (highlighted with a dashed line), the surface conductivity is rather homogeneous (Fig. 4b). Noteworthy, the current is at least two orders of magnitude larger on the isosceles triangle vertex, i.e., where the TD is reaching the surface (Fig. 4b). Hence, the electronic transport properties close to the TD (radius < 100 nm) are significantly different from the surrounding material.

Then, local capacitance mapping [19] was performed using the SCM. During the surface scan with the metal tip, a modulating bias with amplitude ΔV at 100 kHz frequency is applied to the sample and the capacitance variation ΔC in response to this modulation is recorded with the SCM sensor. Besides the SCM signal amplitude $|\Delta C|$, which is related to the net active dopants concentration (N_A-N_D) in the semiconductor underneath the tip, also the phase signal is recorded, which is very sensitive to the type of majority carriers in the region underneath the tip. Fig. 4c and d show the maps of the ΔC amplitude and phase measured in the same region where the C-AFM (Fig. 4b) was collected. The amplitude is not affected by the presence of the defect, thus indicating no significant variation of dopants concentration in the defect region. On the other hand, a difference in the in the phase map is observed between the triangular region and the rest of the n-type doped JFET area. As discussed in the following, this change in the phase signal can be ascribed to an increase of the density of minority carriers (holes) in this region.

Fig. 4: (a) Atomic force microscopy morphology in the JFET region (b) C-AFM Current map showing the increased conduction in the TD. SCM amplitude (c) and phase (d) showing a spatial charge variation in the triangular defect region. Schematic of the local distribution of minority carriers (e).

Using the *Read's model* [20], *Chung et al* [21] considered the TD in the JFET n-type semiconductor region as a core containing acceptor-type states capable of trapping electrons, leading to a negatively charged dislocation core. They supposed the charge screened by a positive space charge in a cylindrical configuration of ionized donors. However, according with the SCM experimental data, the real scenario seems to be more complex. Fig. 4e schematically describes the non-cylindrical space charge distribution found in the TD region. On the left side – in the centre of the JFET region – an electron accumulation (blue colour) is demonstrated. On the other hand, inside the triangular region (green colour), a hole (minority carrier) accumulation produces a SCM phase variation that maintains

the charge neutrality. Clearly, the TD produces a variation in the local electronic structure of the JFET region of the MOSFET.

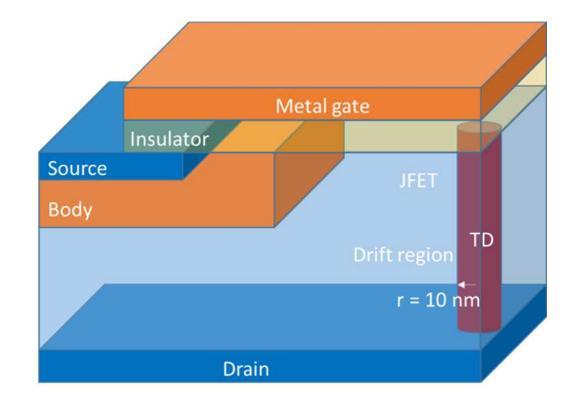
Fig. 5: Schematic 3D of the elementary cell of the MOSFET including the treading dislocation (TD) in the centre of the JFET region.

Fig. 5 shows the 3D schematic of a power MOSFET having a cylindrical TD of radius 10 nm in the centre of the JFET region. The band gap of the TD is assumed to be 2.3 eV with a common E_C value but with a E_V 1 eV higher than the defect-free 4H-SiC. Fig. 6a shows the cross-section on the electric field distribution inside the MOSFET unitary cell in HTRB configuration (at $V_{DS} = 600$ V), calculated using TCAD simulations. A cross section on the SiO₂ gate insulator at 25 nm from the physical interface (Fig. 6b) shows that the oxide electric field increases from the channel region toward the JFET region reaching its maximum (~ 4.6 MV/cm) at the edge of the unitary cell. To understand the

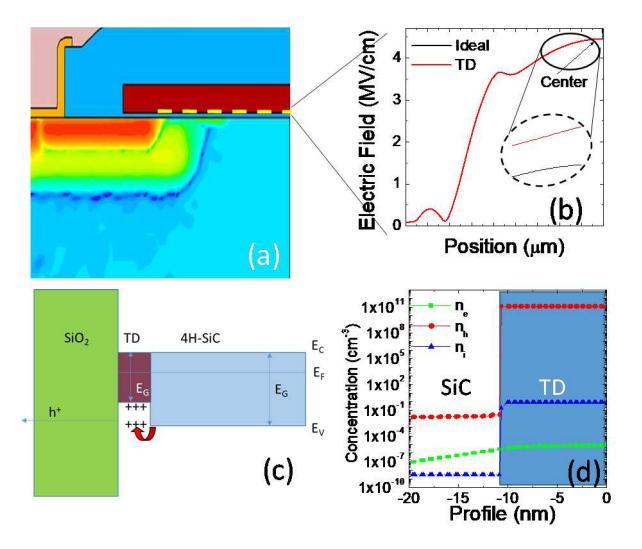
TD behaviour inside the JFET region, the oxide electric field was calculated in both the ideal (reference) structure and in the structure containing the TD. A zoom in the centre of the JFET region reveals an increase of the oxide electric field of about 0.3% with respect to the reference ideal structure (inset in Fig. 6b). The higher valence band offset and the lateral confinement of the TD produces the creation of a quantum well. Considering the ideal conduction contribution – i.e., the ideal Fowler-Nordheim (FN) tunnelling [24] and the quantum confinement that inhibits the FN tunnelling from the bottom of the quantum well [25] – the oxide electric field produces a minor increase of the hole current through the insulator layer. Besides the calculated increase of the electric field due to the TD band gap narrowing, also the surface morphology plays a role [26]. However, this local increase of the oxide electric should not be prominent, as an acceleration of the breakdown kinetics would result in the MOSFET failure in a short time.

The band gap narrowing produces a quantum well for holes ("hot spot") that are collected from the surrounding 4H-SiC material (Fig. 6c). Hence, TD quantum well becomes a source for hot holes injection into the insulator (Fig. 6c). In fact, the calculated intrinsic carrier concentration (n_i) and holes concertation (n_h) increase in the TD of several orders of magnitude. Fig. 6d shows that the electron density (n_e) increases in the MOSFET profile following the electric field profile (Fig. 6b) while an abrupt increase of 13 and 9 orders of magnitude for n_h and n_i respectively is found. The local holes confinement can accelerate the oxide degradation. This demonstrates that the premature BD is not due to an intrinsic insulator weakness but the local variation of the semiconductor electronic properties in the presence of the TD in the JFET region.

Fig. 6: (a) Cross section of the computed (SILVACO) MOSFET elementary cell. (b) Electric field profile in the middle of the gate insulator (dashed yellow line in Fig. 6a). (c) Schematic band diagram showing the holes accumulation in the TD and the injection in the SiO₂. (d) Carrier concentration profile across the TD and the ideal 4H-SiC.
