Photocathode Behavior During High Current Running in the Cornell ERL Photoinjector

Abstract

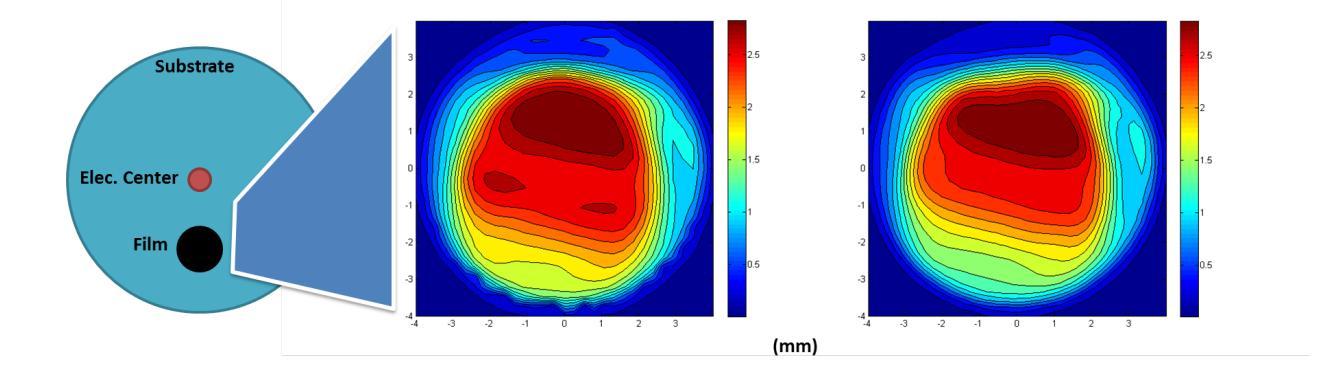
FIG. 1: A schematic of the photocathode substrate and film is shown at left. The QE (%) map of the photocathode is shown before running (middle) and after (right).

One of the samples, having a diameter of about 8 mm, was grown approximately 6 mm off-center with respect to the puck symmetry axis, done in anticipation of the damage to the electrostatic center. After the growth, the puck and photocathode were transferred by means of a dedicated UHV suitcase to the load lock chamber of the ERL prototype DC gun [5]. The QE map of the photocathode was measured with a small DC laser at 532 nm once in the load lock chamber, and before insertion into the gun, and is shown in Fig. (1).

The QE peak (3%) as well as the QE uniformity were deemed non-ideal, likely due to misalignment of the evaporating sources within the deposition chamber. The poor uniformity was verified with XRF measurements performed at the F3 line at the Cornell High Energy Synchrotron Source (CHESS). The F3 station used a 10 keV X-ray beam with approximately 10 μ m diameter, incident upon the sample surface with a coincidence angle of 45 degrees. An energy dispersive Vortex ME4 silicon drift detector fabricated by SII Nanotechnology measured X-ray fluorescence from the sample, which is generally capable detecting trace elements down to the parts per million level. The sample was scanned with the use of a 2D translation stage, yielding 2D maps of the atomic areal density, and thus ultimately the chemical composition. In order to calibrate the fluorescent flux incident on the detector to yield the atomic areal density, we prepared thin film test samples on Si substrates for Sb, K, and Cs. Rutherford backscattering measurements were then used to determine the areal density of the thin film test samples, and these test samples were then run under XRF prior to analyzing the actual photocathode sample. The XRF maps are plotted in Fig. (2). Several causes contribute to a large systematic uncertainty is inherent in these measurements. First, the RBS beam scatters off a small area of the substrate, and the test films analyzed for calibration also include the large variations in surface concentration. Second, these measurements were performed in air after the cathode's use in the injector, and it is unknown how interaction with air will affect the areal density of the film constituents. Finally, in the case of the potassium test film, it was seen that the potassium RBS scattering peak lies too close to that of Si to allow a precise determination of the areal density. Thus, the values quoted for potassium should be viewed only as lower bounds; it is possible that the stoichiometry is closer to the expected value of K_2CsSb .

After an approximate run time of 8 hours, and a total charge delivered of about 575 Coulombs, the photocathode puck was retracted into the UHV preparation chamber for visual inspection and QE measurement. It should be noted that the QE, as determined by the delivered laser power (data not available), showed no apparent degradation and did not limit the length of the run; the run ended at the preference of the operators. The post-run QE map in Fig.(1, right) shows a small, nonuniform decrease, with more significant damage toward the gun electrostatic center, which in the above maps is upward.

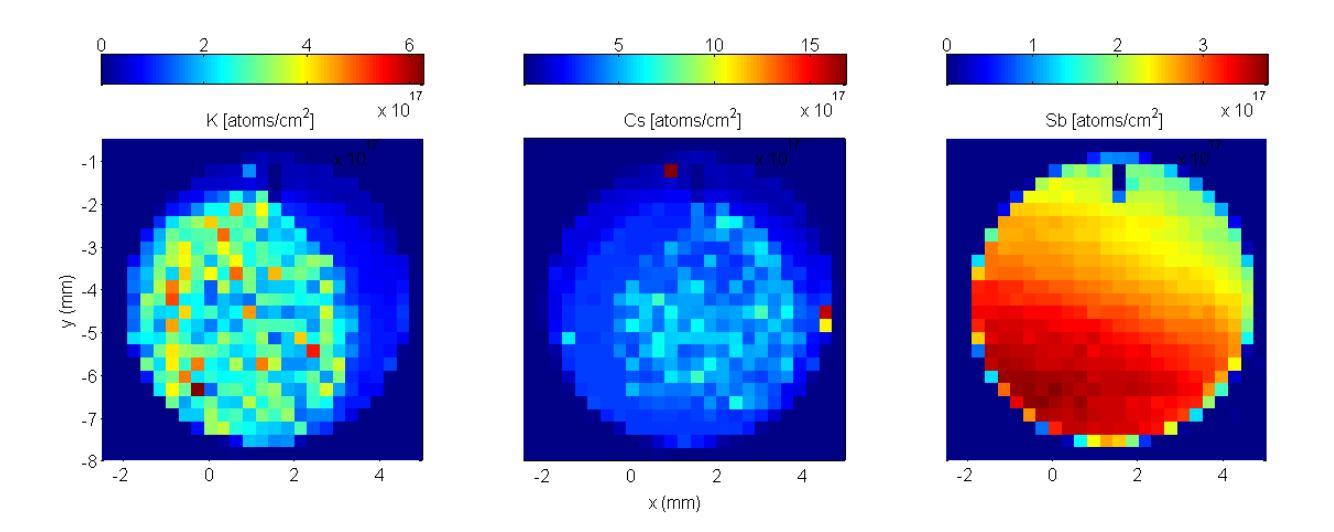
FIG. 2: XRF maps for K (left), Cs (middle), and Sb (right). A notch had been scribed in the sample for orientation purposes. The stoichiometry, normalized to the Sb areal density, averaged over the active area was found to be $K_{0.8}Cs_{1.29}Sb$, where the values for the potassium areal density should be treated as a lower bound on the actual value (see text).

The atomic areal density maps clearly show a non-uniform distribution of the metallic species, implying some misalignment of the substrate with the evaporative sources, and thereby creating a nonuniform QE distribution. Nevertheless, this photocathode had sufficiently high QE to be operated as a first test for delivering mA level current, and to investigate its ruggedness with respect to long operation times. It is interesting to note that though clearly visible to the naked eye (see below), the features of damage from use are not evident in the XRF maps.

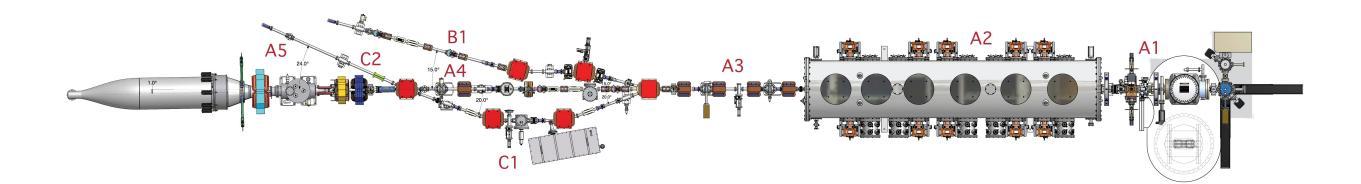
FIG. 3: A schematic of the Cornell ERL photoinjector. Beam travels from right to left.

A schematic of the Cornell ERL photoinjector is shown in Fig. (3), and is described in [6]. The photocathode is inserted directly into the electrostatic center of the Pierce electrode structure of a DC gun operating at 250 kV, and the photocathode is illuminated by a 1.3 GHz repetition rate laser operating at 520 nm. The 250 keV electrons pass through two emittance compensation solenoids and a normal-conducting buncher cavity before entering the 5 two-cell SRF cavity cryomodule, which boosts the energy to about 5 MeV. The average current as a function of time for this run is plotted in Fig. (4).

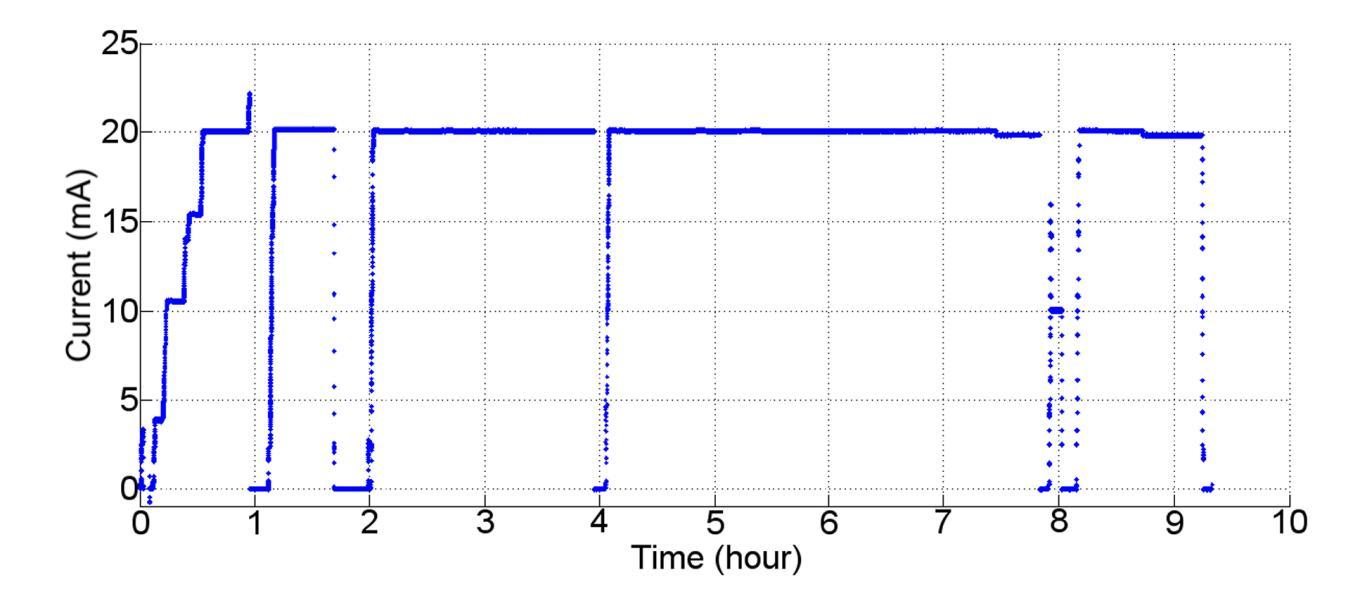
FIG. 4: Current as a function of time for the run in question.

varies the laser power on the cathode via a Pockels cell, to account for variations in upstream laser power, as well as gradual degradation of cathode quantum efficiency. As visible in Fig. (4), during injector operation, a number of vacuum burst events triggered the fast shutdown safety system. After each trip, the beam current was successfully restored to 20 mA.

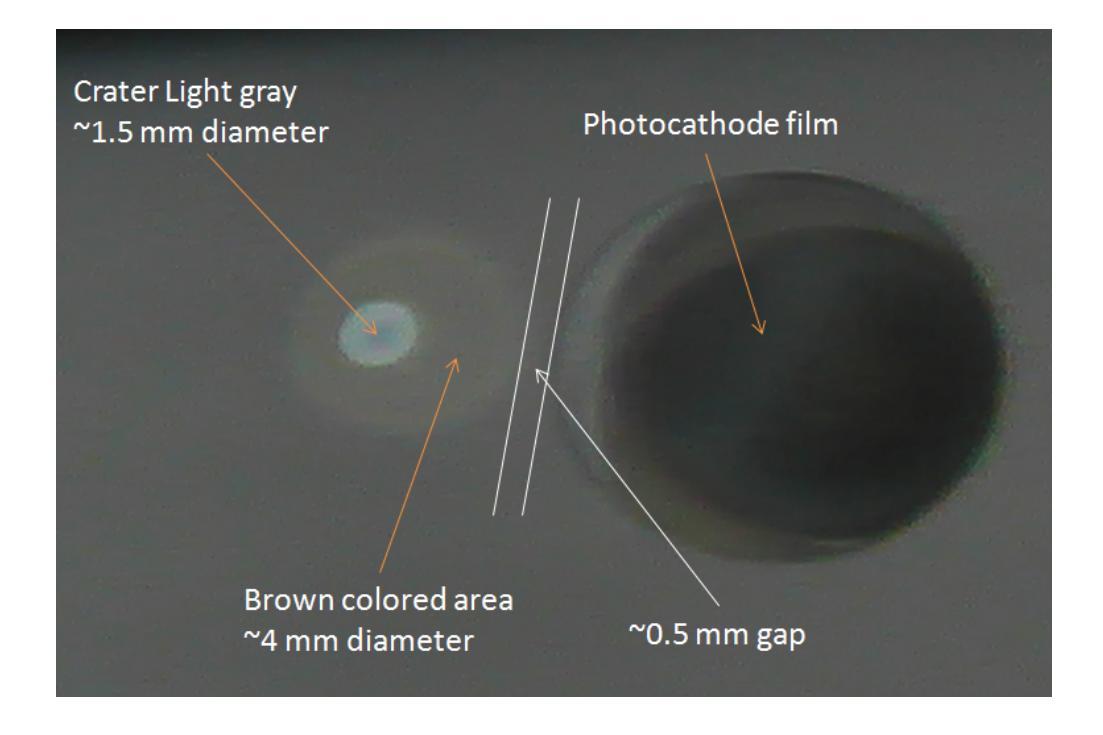
FIG. 5: A close-up photo of the photocathode film and substrate after use.

- *The Photocathode Film:* The three non-concentric rings of the bi-alkali film indicate the poor alignment of the substrate with the evaporative alkali sources. This, along with the XRF species maps, supports the hypothesis that the poor QE performance is due in part to poor alignment.
- *The Central Damage:* Located roughly at the electrostatic center of the puck, approximately 7 mm from the center of the photocathode film, this region has a well defined circular shape. Naked eye inspection suggests extreme surface roughening due to the loss of the typical mirror-finish of the polished Si substrate.
- *The Brownish Area:* This area asymmetrically surrounds the central damage area, and presents a brownish color and loss of mirror-finish. The centroid of this region is shifted towards the site of electron emission.

The most salient feature of the photocathode appearance upon removal from the gun was the presence of a highly damaged area approximately at the electrostatic center of the gun. A photograph taken in air of the sample after removal from the gun is found in Fig. (5). Naked eye inspection of the surface reveals different regions with well defined characteristics:

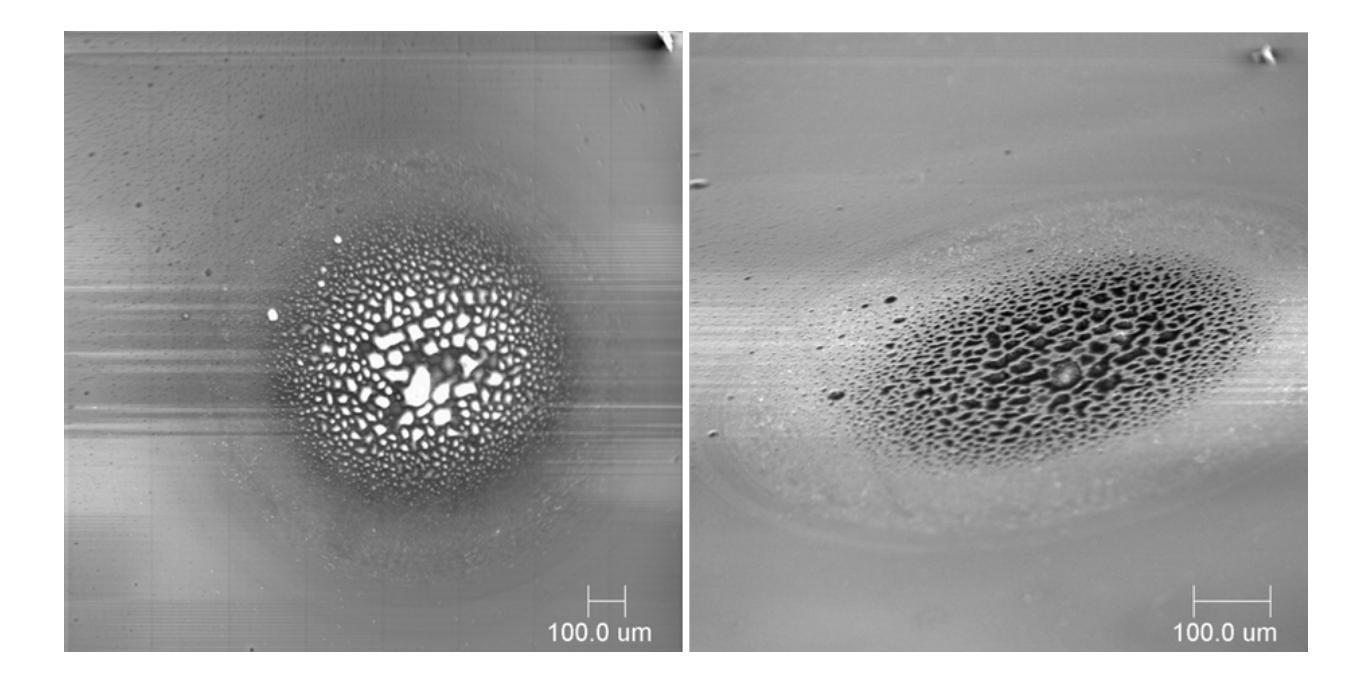
FIG. 6: SEM micrographs of the central damage area at different substrate inclination angles.

SEM micrographs of the central damage area are shown in Fig.(6). According to previously reported work on GaAs and GaAsP we believe that the central damage area has been caused, at least in part, by the back-bombardment of residual gas ionized by the beam [7, 8]. The ions in question are likely created between the photocathode and the entrance to the first SRF cavity, and upon entering the gun's accelerating field, can impact the surface with up to 250 keV of energy.

Furthermore, given that the central damage is predominantly at the electrostatic center, it is likely that the majority of the ions are produced once the beam has been aligned on its symmetry axis, which is done with corrector magnets after the exit of the gun. It is of interest to note that both the height and size of the microstructures increase as you approach the electrostatic center of the sample. This distribution of microstructures should be due to some nontrivial combination of the ion beam transverse profile with the integrated ion dose.

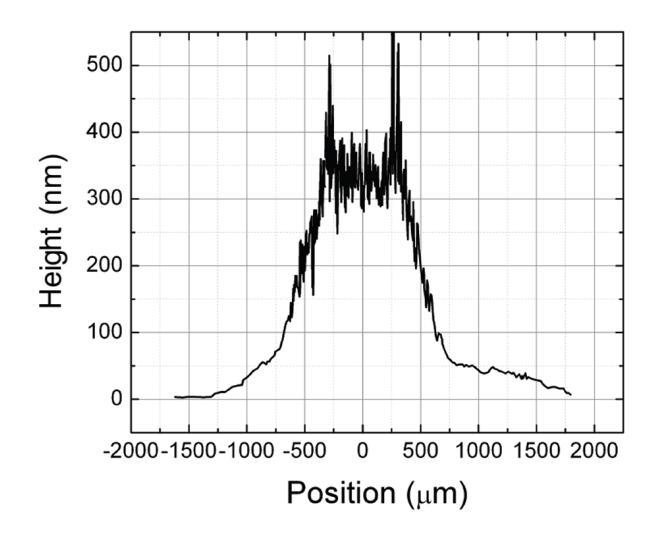
The surface profile from contact profilometry is shown in Fig.(7). While intuition suggested that the central damage area was a crater due to ion sputtering of material, the surface profilometry suggests that the damage site is raised (or simply roughened) with respect to the ordered substrate crystal. It is likely that the thickness of the tip obscures the fast oscillations of the surface roughening, and thus the average height of 350 nm should be interpreted as an average of surface maxima.

FIG. 7: Surface profilometry of the central damage area, indicates the presence of significant surface roughening. Due to the large tip size, the profile data should be interpreted as sampling the local maxima of the surface profile.

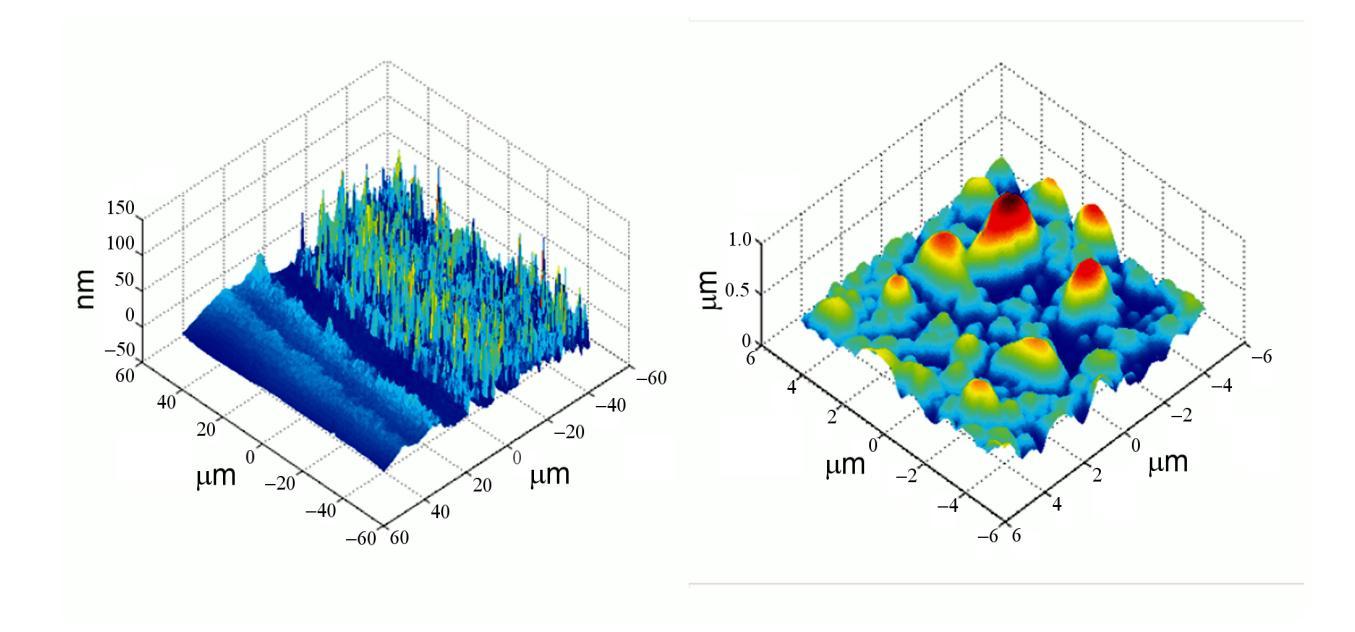
Atomic force microscopy was carried out over an area of $100 \times 100 \ \mu m^2$ near the edge of the central damage, see Fig.(8, left). In these images the fast oscillations of the surface roughening are apparent. Moving from the border to the central part of the damage, the surface becomes more and more rough, but the resolution of this scan was unable to reveal details of the surface in the central part of the damage. Thus, we also performed surface scans with a smaller resolution over an area of $10 \times 10 \ \mu m^2$ in an intermediate position between the edge and center of the central damage site, shown in Fig.(8, right). From this scan, we see that the surface exhibits no sharp point-like peaks, and has an rms surface roughness of about 100 nm.

FIG. 8: Atomic force micrographs of the central damage area. Left: $100 \times 100 \ \mu m^2$ scan at the interface of the brownish area and the central damage site. Right: $10 \times 10 \ \mu m^2$ scan at the mean distance between the center and edge of the central damage site.

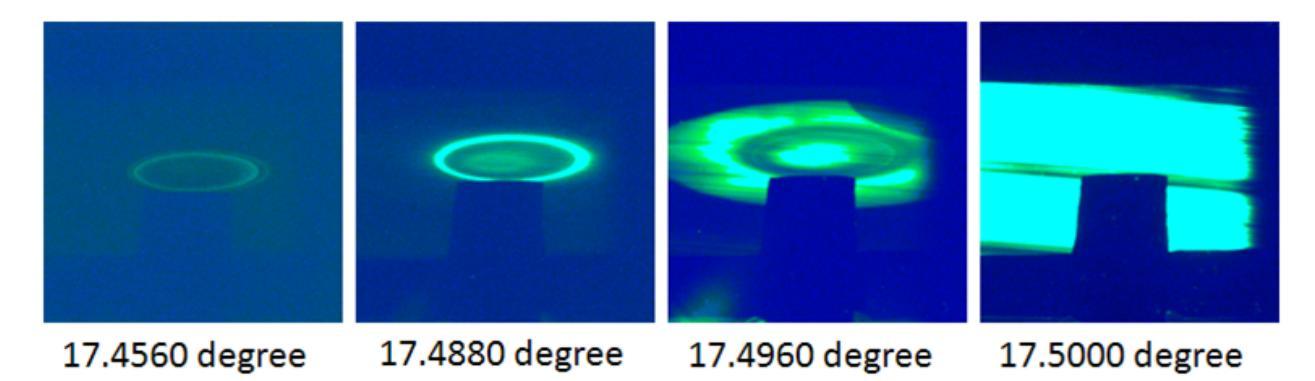
FIG. 9: False color photographs from the XRD CCD camera at various diffraction angles, illustrating the variation in lattice spacing as a function of distance from the central damage spot.

Fig.(9) shows a false color image taken with the XRD CCD at various substrate inclination angles, indicating a nearly radial distribution of lattice spacing, measured from the center of

the damage site. As the diffraction angle, θ , approaches that of the Si(004) diffraction peak (see $\theta = 17.4960^{\circ}$), a round area with well defined edges emerges in the upper right corner of the image, which was the location of the bi-alkali film, indicating lattice damage overlaps with the active area of the cathode. A rectangular lead stripe of thickness 2.1 mm was overlaid on the sample for length calibration; Fig.(10) reports the approximate diameters for the different areas of diffraction peaks.

The smallest diffraction angle corresponds to the region of largest atomic spacing. The annular region that first diffracts (at left in Fig. 9) appears to be the region of largest damage. It appears unlikely from a beam dynamics perspective that the backstreaming ion distribution should be annular (see section below). Thus, the surface region inside the

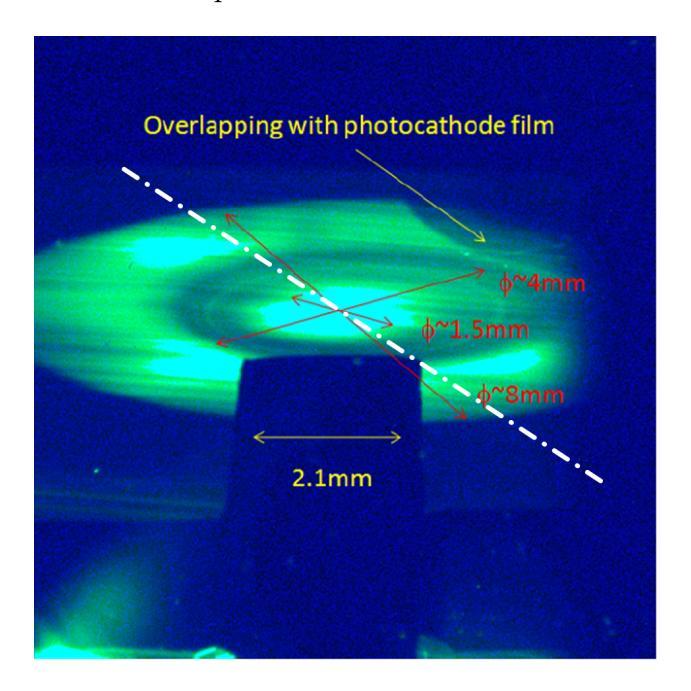
FIG. 10: Various diameters of the regions of interest from the XRD CCD snapshots. The white dotted line is the diameter over which data was sampled for Fig. (11).

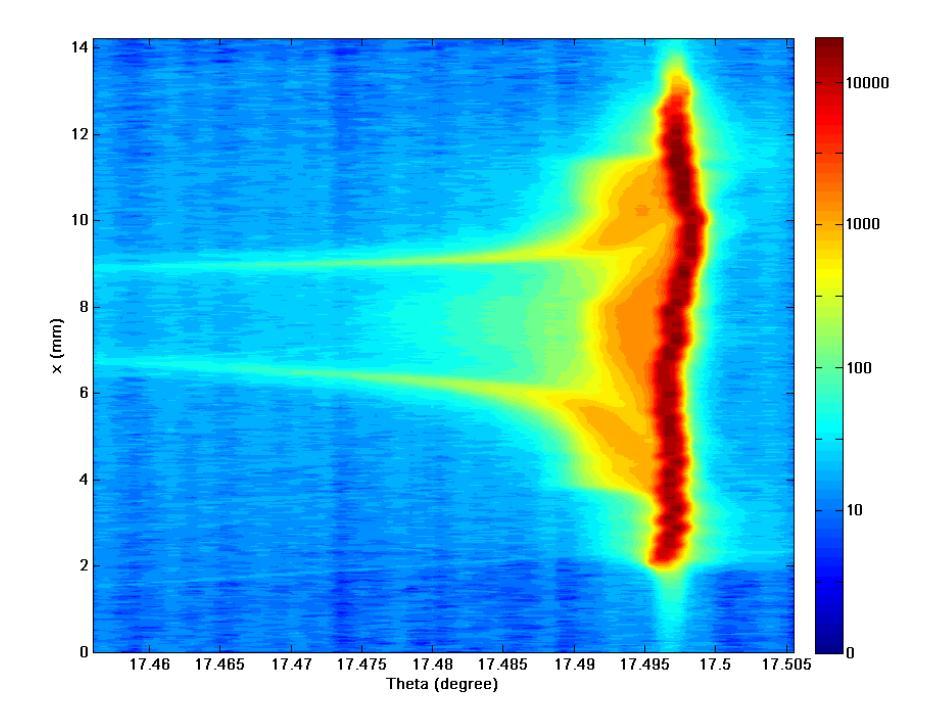
Given that the distribution of crystal strain regions is radial, we can collapse the spatial data down to one dimension, and plot the number of counts on the CCD detector as a function of both position along the diameter of the damage region and diffraction angle. This is shown in Fig.(11). The induced crystal strain is proportional to the deviation of the diffraction angle from the Si(004) peak (rightmost red region). The crystal strain is symmetric about the damage site center, and is sharply peaked on either side of the electrostatic center (here at $x \sim 8$ mm).

FIG. 11: Counts on the CCD detector as a function of the position along a diameter of the circular damage region (x, vertical axis) and the diffraction angle.

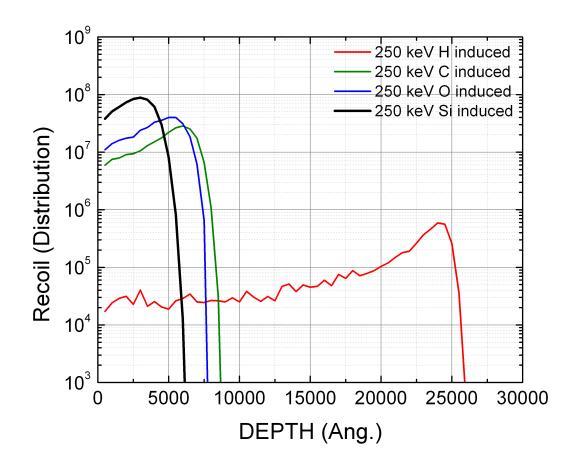
The results of the TRIM simulations were performed in *Surface Sputtering and Monolayer Collision* mode, and are shown in Fig.(12). It shows the number of atomic recoils for each species as a function of the ion penetration. It is clear from the TRIM data that the effect of hydrogen ions on the surface film is likely to be very small in comparison to that of carbon or

FIG. 12: The number of atomic recoils as a function of penetration depth for a variety of implanted ions.

oxygen, given both the small number of recoils and the relatively large penetration depth. Also, we conclude that we are well justified in applying results from Si self implantation literature, as the integrated number of atomic recoils of both carbon, oxygen, and hydrogen are comparable to that of Si. TRIM also reports the sputtering yield from the various implantation species; hydrogen was found to have a negligible sputtering yield, whereas carbon and oxygen ions at 250 keV have 0.16 and 0.18 sputtering yield, respectively, which alone appear to be inadequate to describe the features of the damage area.

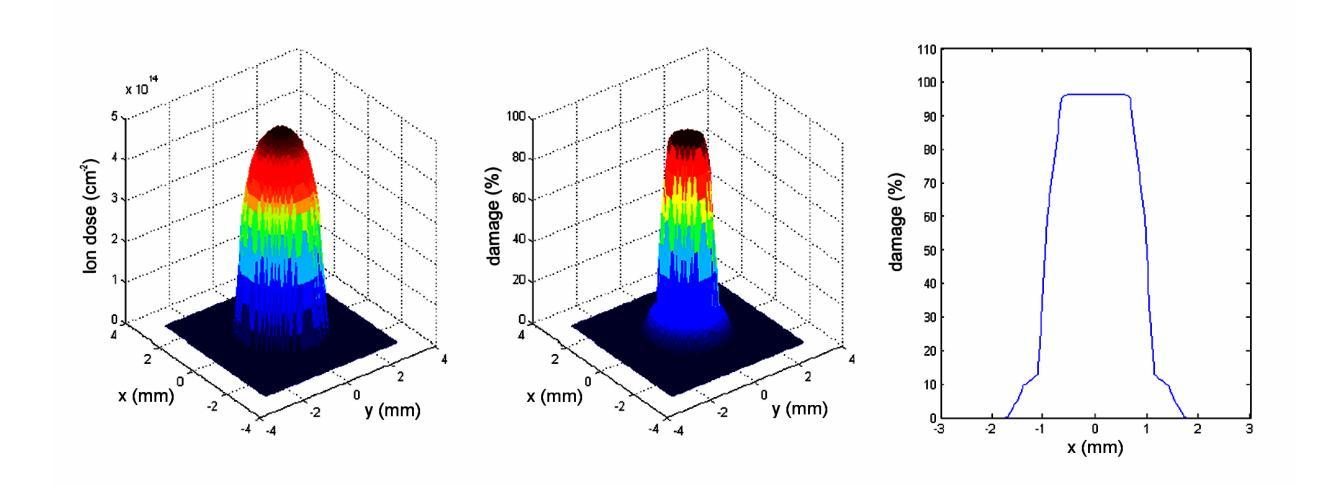
beam profile, along with the partial pressure and ionization cross section, yields the 2D ion dose distribution, which is plotted in Fig.(13, left).

Using this information, a threshold dosage of 4×10^{14} ions/cm², and the same damage vs. dose slope as in [12], we calculate the damage profile shown in Fig.(13, middle, right). The sharp increase in the damage is due to the superlinear response of the amorphization. We should note that in order to reach the onset of the superlinear damage, we used a number of ions only 10 times larger than the lower bound estimate, according to the rationale above. Upon inspection of the XRD data in Fig.(11), the sharp decrease in the number of counts for large angular offsets from the Si(004) peak near the center of the damage site may be due to

FIG. 13: Left: The 2D dose distribution of ions, calculated from the simulated electron beam profile at the DC gun anode. Middle: The damage profile, or percent amorphization of the Si using the ion beam profile and a superlinear model. Right: a cross section of the damage profile.

the complete amorphization of the Si substrate surface, thereby suppressing the diffraction in that region, due to the onset of the superlinear damage regime. Thus, there is good qualitative agreement between the ion back-bombardment calculated damage profile and both the profilometric and XRD maps.

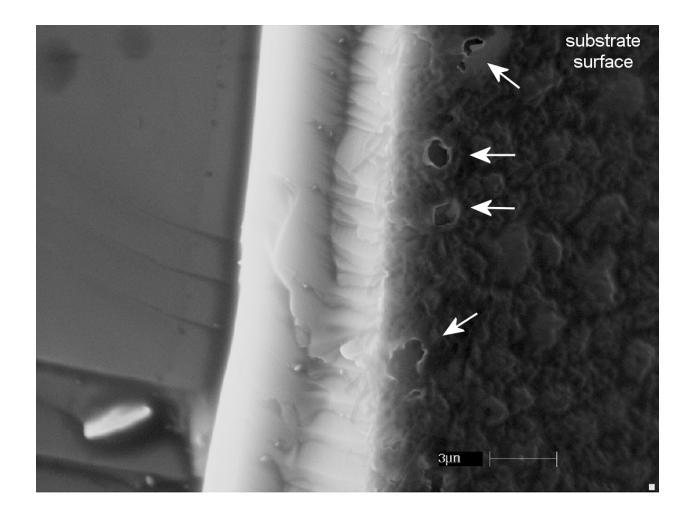
In order to investigate possible means of the formation of the surface roughening/protrusions, the sample was hand-cleaved through the center of the damage area, and a high-resolution SEM micrograph was taken of the substrate cross section near the surface. These micrographs are shown in Fig. (14) and Fig. (15). Fig. (14) indicates the presence of pore structures below the Si substrate. Similar pore production has been reported in literature as a consequence of ion implantation with doses several orders of magnitude larger than the ones we calculate incident upon our photocathode [13], which suggests that our estimate of the total ion dose may be far lower than the actual value. Furthermore, Fig. (15) indicates the presence of bubble-like regions 10's of μ m deep (deeper than the expected penetration of 250 keV ions), which are present only below the damage region, and not below hand-cleaved pristine Si. The nature of these structures is still currently under investigation.

FIG. 14: SEM micrograph of the substrate cross section, beneath the damage site. The surface of the substrate is towards the right. Pore structures are indicated by arrows.

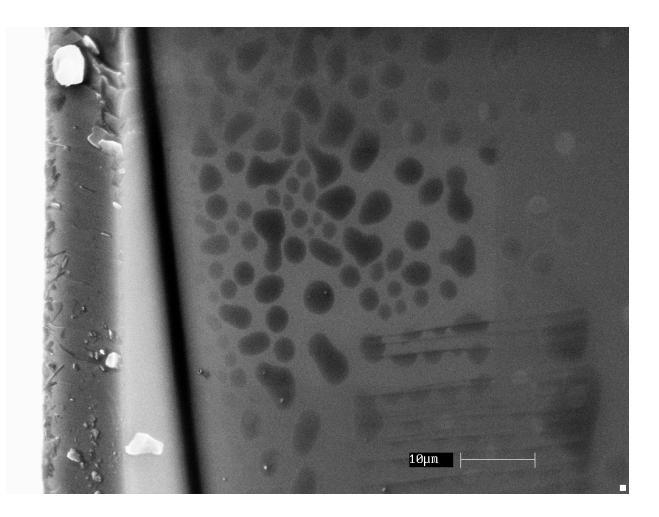
FIG. 15: A lower resolution, larger scan range SEM micrograph beneath the damage site. The surface of the substrate is towards the right.
