Failure of refractory masonry material under monotonic and cyclic loading – crack propagation analysis

K. Andreev^{1,2}, Y. Yin², B. Luchini¹, I. Sabirov³

1 – Ceramics Research Centre, Tata Steel, 1951MD, Velsen Noord, The Netherlands

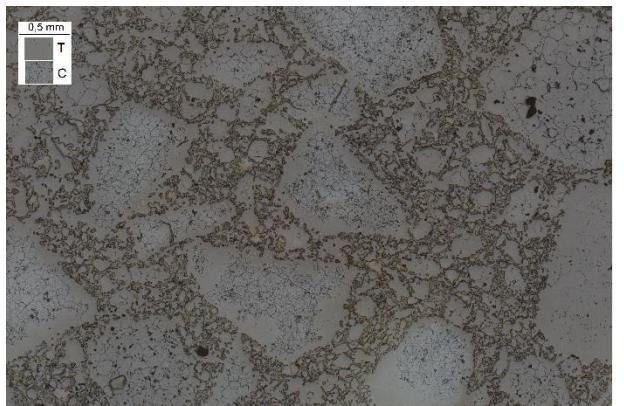
Fig. 1 Typical microstructure of the studied material: C is cristobalite, T is tridymite.

Commercially available silica bricks standardly used for construction of coke ovens were studied (Fig. 1). The bricks are pressed from quartzite grains using calcium hydroxide solution and sintered at temperatures of 1500°C. The density of the aqueous Ca(OH)₂ solution was 1200–1320 kg/m³. The amount added was 7–8 wt.%. The chemical and physical properties of the studied silica brick were broadly discussed in a previous publication, where it was referred to as SB2 [7]. Typical chemical composition features 96.0 wt.% of SiO₂, 2.5 % of CaO, 1.0 % of Al₂O₃, and 0.5 % of Fe₂O₃. The mineralogical composition features 63-66 % of tridymite, 28-31 % of cristobalite, less than 1 % of quartz, and 3-5 % of pseudo-wollastonite. Tridymite forms the grains of the matrix and the rims of larger grains [7]. Cristobalite is predominantly found in the large grains (Fig. 1). In Fig. 1, the dark fields and lines are pores and their boundaries in the matrix, respectively. The grain size distribution, as indicated by the supplier, is as follows: 1–2 mm grains are 2 wt.%, 0.5–1 mm grains make up13 wt.%, and 0.1–0.5 mm grains comprise 29 wt.%; the rest of the grains are finer than 0.088 mm. The bulk and true density of the brick are 1.84 g/cm³ and 2.35 g/cm³, respectively. The apparent porosity is 19.6 %. The pore size distribution obtained by Hg-porosimetry shows three peaks corresponding with the pore diameters of 0.5 µm, 10 µm, and >100 µm. The compressive strength at RT and at 1400 °C is 40–50 MPa and 10–15 MPa, respectively.

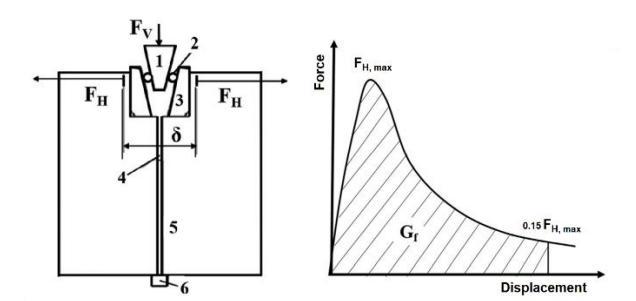
Fig. 2 Schematic representation of the wedge splitting test with a typical force-displacement curve used to calculate the fracture energy [22]: 1 – wedge, 2 – rolls, 3 – load transmission pieces, 4 - crack starting notch, 5 – side notch, 6 – support, F_V – vertical force, F_H – horizontal force, δ - horizontal load-point displacement.

Monotonic and cyclic wedge splitting tests (WST) [20] were performed at room temperature (Fig. 2). WST set-up was used as it allows stable crack propagation and enables the development of the FPZ [21]. WST is closely related to the compact tension (CT) test. In both test set-ups, the stable crack propagation is promoted by the low ratio of the sample volume to the surface of the crack. The test procedure and the data analysis algorithms were discussed in previous publications [8, 22]. Material properties calculated from the force-displacement parameters of WST are notched strength (SIG-NT), fracture energy (G_f) and their ratio [22]. G_f and strength were calculated from horizontal forces and displacements. Gf is calculated as the ratio of the surface under the force-displacement curve to the projection of the crack surface. The ratio of G_t/SIG-NT is the measure of brittleness at failure [11, 22]. The higher the ratio, the lower the brittleness. Refractories of low brittleness are often referred to as "flexible". WST were done in the frame by Shen Zhen Wance Testing Machine Co. The load cell capacity is 100 kN. The error of the force measurement is within 0.5 N. Estimated error of the displacement measurement is 0.5 % of the measured range. The horizontal displacements were validated by mechanical extensometers. The error of the extensometer is 0.2 µm. Samples were cut with a circular blade saw. From one brick two samples could be extracted. The width, depth, and height of the samples were 100 mm, 65 mm and 100 mm, respectively. Due to notches, the failed cross-section had the width and height of 55 mm and 66 mm, respectively. Tests were conducted with the constant vertical wedge displacement rate of 0.5 mm/min. According to established practices of testing of refractories, the loading stopped at

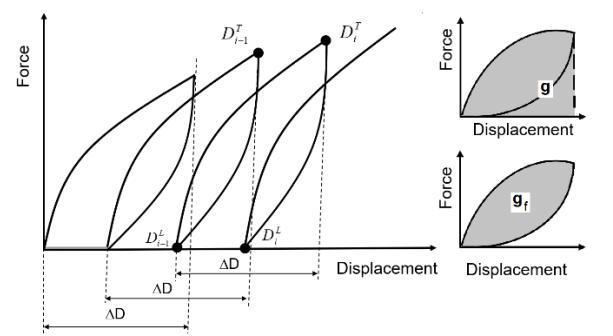
The cyclic tests were performed according to a loading protocol featuring constant effective loading displacement (Fig. 3) [12]. The loading protocol is as follows:

$$\begin{cases} D_i^T = D_{i-1}^L + \Delta D \\ D_{i-1}^L = D(F = 0) \\ \Delta D = const \end{cases}$$
(1)

where D_{i-1}^{L} is the lowest displacement during the unloading in the previous (i-1) cycle, D_{i}^{T} is the highest displacements during the loading in the current cycle, ΔD is the displacement amplitude. F is the force. $D_{(F=0)}$ is the displacement when force is zero. As it is shown in Formula 1 and Fig. 3, the amplitude of the loading part of the cycle is constant. The unloading stops upon reaching the minimal force level. The next loading starts where the previous unloading stopped. Such cyclic loading protocol is seen as more representative of the in-service failure of refractories, where the loading is often induced by thermal strains [12]. Due to constant displacement amplitude, the test can be seen as a fatigue test. All cyclic tests were performed with the same amplitude, which is 90 % of the average displacement at failure (displacement

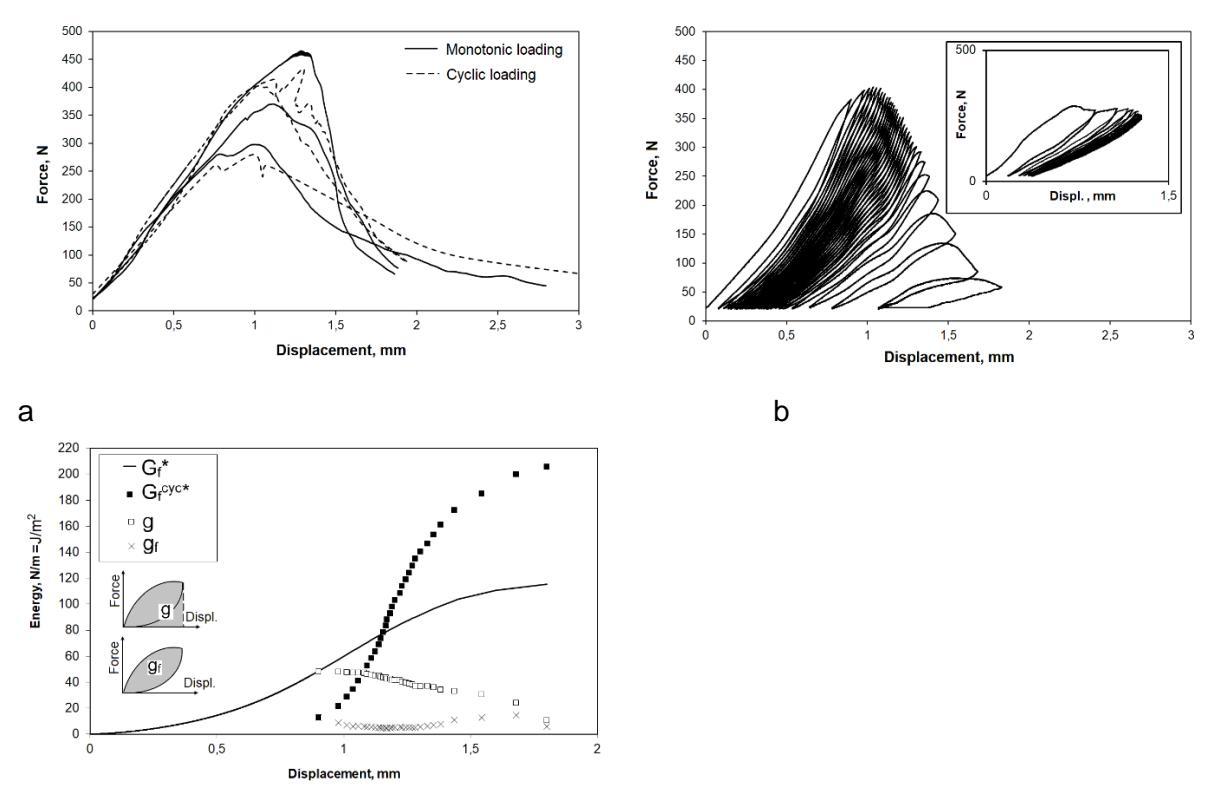
Fig. 4 WST curves of vertical force and displacement, (a) curves of samples subjected to microstructural analysis, (b) typical cyclic fatigue curve for SC1 and SC7 (insert), (c) energy development for the sample SC1.

Typical WST force-displacement curves are presented in Fig. 4. The stiffness is approximately similar for all samples. Within both groups of samples, the strength and the strain-softening differ significantly. The samples of both loading modes show increasing brittleness (lower Gf/SIG-NT ratio) with increasing strength (Fig. 5). If the fracture energy is normalized by the ratio L2/L1, the trend becomes less significant.

The average strength is similar for SM (5.5 MPa) and SC (5.4 MPa) (Table 1). In SC, the strain softening is somewhat more gradual than in SM (Fig. 4). The fracture energy (G_f) and the ratio G_f /SIG-NT are in average 15–20 % higher in SC samples. The difference is even higher if the fracture energy obtained from individual cycles (G_f^{cyc}) is considered for SC. The coefficients of variation of strength and energy of both loading modes are quite similar.

In SC, the loading–unloading loops of individual cycles have an overlap. The loops are wide and are spread along displacement axis in the beginning and especially the end of the loading protocol. In the middle phase, the cycle loops are close to each other. The shape and the size of a loop is related to the energy balance of crack propagation. For individual cycles, the energy developed during the loading part of the cycle (g) and the dissipated energy (g_f) are shown (Fig. 4.c). In the beginning and middle phases of the test, the energy dissipated per cycle is much lower than the energy accumulated during the loading phase of the cycle. Only at the end of the loading program those values become close. At the same loading displacement, for all cycles after the first, g is lower than the envelope energy G^{f*}. The curves representing the partial energies consumed since the beginning of the test, Gf* and Gf^{cyc*}, have a sigmoidal shape (Fig. 4.c). In the beginning phase of the test, the cyclic energy (G_f^{cyc*}) is lower than the envelope energy G_f^{*}. However, during the middle phase, a significant build-up of G_f^{cyc*} occurs. On average for all cyclic samples, fracture energy calculated from the curve envelope (G_f) is some 30-60 % lower than that calculated from the energies dissipated in individual cycles $(G_{f^{cyc}})$. These findings are important for understanding the differences in the cracks of different modes. They will be treated in detail in the Discussion section of the paper.

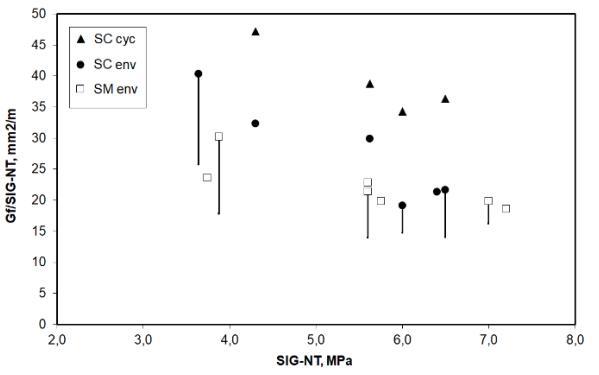
Fig. 5 Relationship between the notched strength and brittleness for individual samples. The vertical lines show the effect of the correction for L2/L1.

Within each group of samples, the strength is related to the crack non-linearity (Fig. 14.a) and to the through the grain failure (Fig. 13). Higher stress at failure typically means higher elastic energy built-up before the crack initiation. This should explain the fact that cracks in samples of higher strength have lower non-linearity L2/L1 (Fig. 14.a). Such cracks deviate less from the flat crack plane (straight fracture line) (Fig. 7) and have higher portion of the through the grain failure (Fig 13.b). The cracks propagating with less energy available are possibly less sensitive to the main cracking direction and deviate towards local defects. As an example, one should refer to SC3, which due to the deviation of the crack, sustained significantly more loading cycles than other SC samples. Higher fracture surface (higher L2/L1) of the lower strength samples also promotes energy dissipation. This reduces the brittleness even further. The illustration of the latter effect can be seen in the flatter trends between the strength and G_t/SIG-NT when the latter is corrected by L2/L1 (Fig. 5).

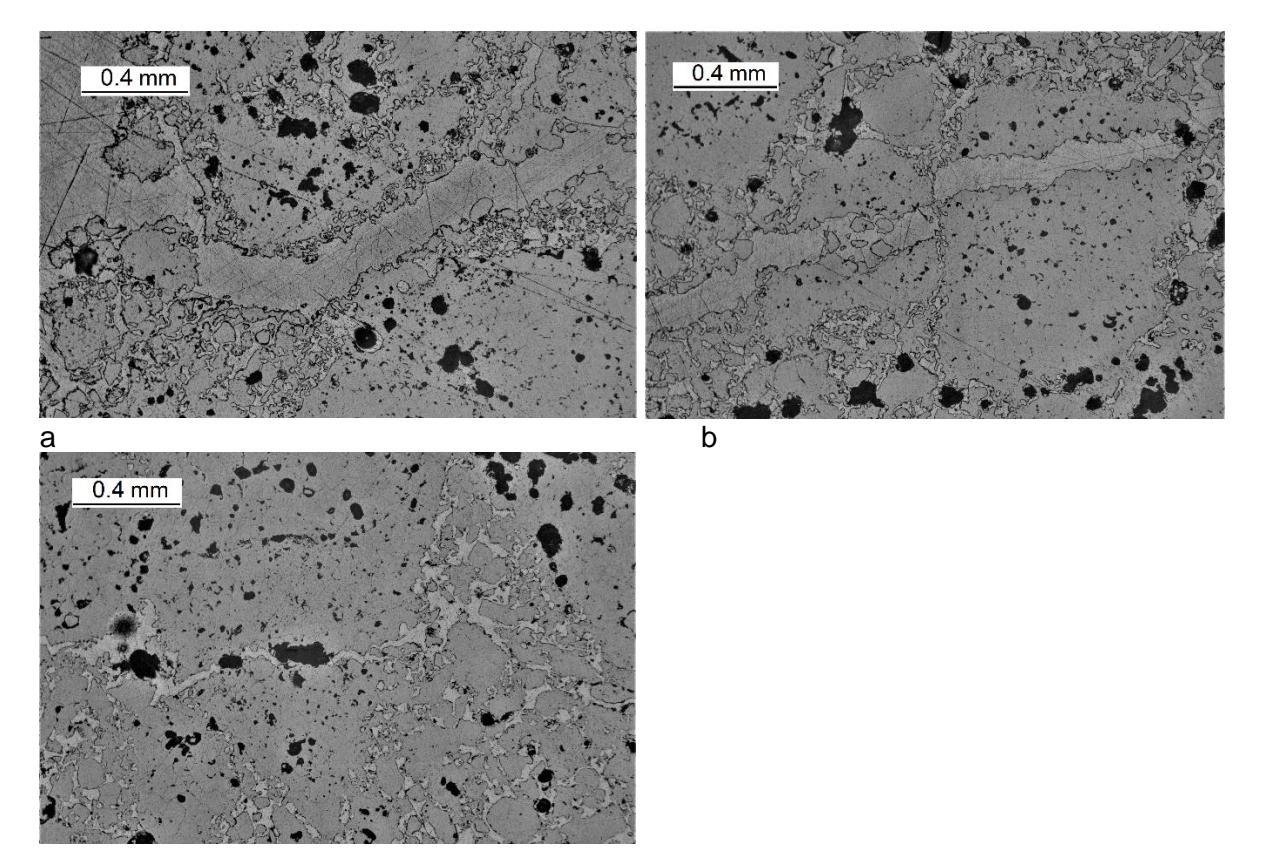
Fig. 6 The mouth (a), middle (b) and the tip (c) of the crack developed in SC1.

The fracture in the samples 1, 2, and 3 in each group was studied by microstructural analysis (Fig. 6, 7). The crack profiles show a single major crack. From the micrographs, typical crack width is estimated to be 0.2 mm at the mouth and several micrometres at the tip. Occasional occurrences of minor crack branching are seen. In cases when an alternative crack is branched off at a higher angle, it stops quickly (e.g., SM2, SM3, Fig. 7). If the angle between the branching cracks is small, the cracks propagate for some distance almost in parallel and then re-unite (e.g., SM3, SC2). For both loading modes, the samples with cracks of highest waviness and branching (SM3, SC3, Fig. 7) are those of lowest strength (Table 1). The sample SC3 also has the lowest brittleness and needs the highest number of cycles to fail. In the crack path (Fig. 6.c, 7), there are interruptions when the crack path blends with irregularities of the microstructure. In Fig. 5, the lines with two arrowheads mark the parts of the cracks featuring frequent interruptions. In these parts the crack between the two interruptions is not significantly longer than the interruption itself. The zones of frequent crack interruptions in the tip of the crack are typically longer in SC, where they can span some 30–40 % of the crack trajectory.

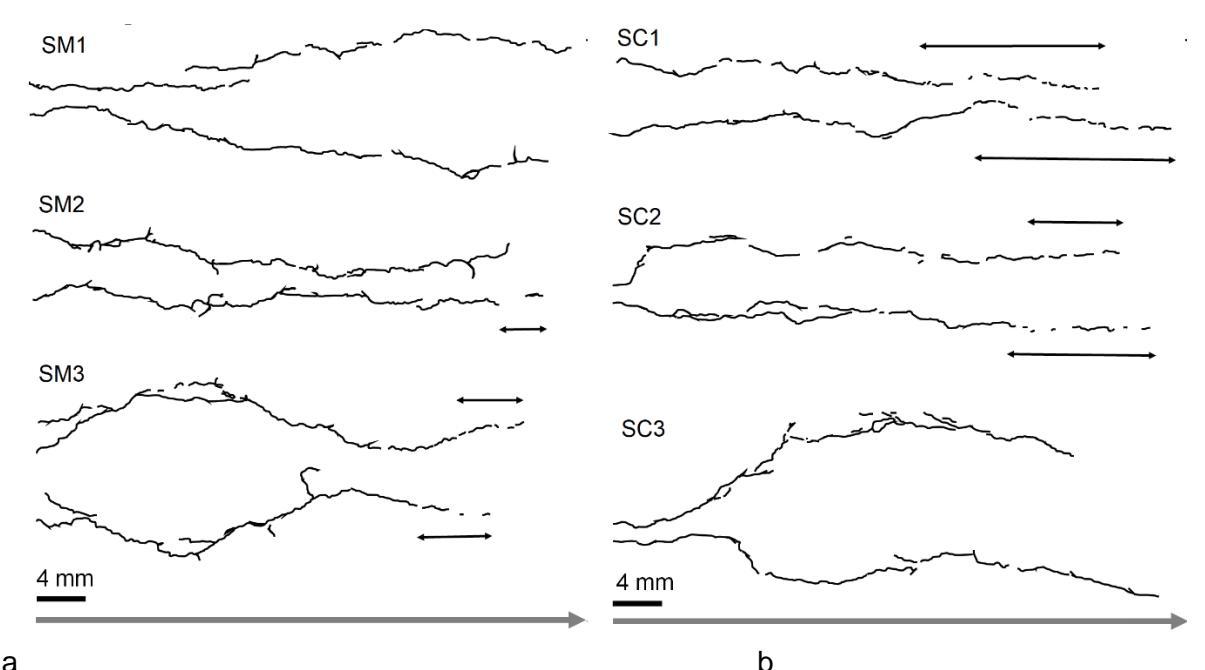
Fig. 7 Crack trajectories. The black lines with two arrowheads indicate the part of the crack featuring frequent interruptions. The grey arrow under the scale bar shows the direction of the crack propagation. Its length equals to the ligament length of the sample.

Longer fracture process zone shows itself in SC as a part of the crack featuring frequent interruptions. In Fig. 7, this part is marked by the lines with two arrowheads. The absence of branching in the process zone is due to the brittle nature of silica refractories. This results from the strong cohesion between the grains and the lack of mismatch in the properties in the constituents of the microstructure [7].

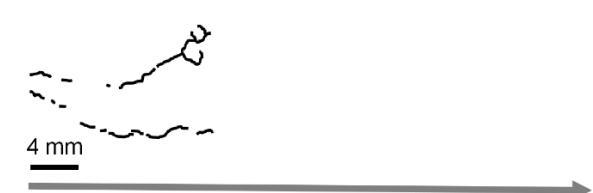
Fig. 8 Crack trajectories for SC7. The meaning of the grey arrow is as in Fig. 5.

The cross-sections of the sample SC7 (Fig. 4.b insert), whose loading was stopped after the initial 15 cycles during the middle phase of the degradation, demonstrate the presence of cracks (Fig. 8). The crack length is approximately 30-40 % of the cracks seen in the samples, which sustained full loading program. The crack path in SC7 is frequently interrupted.

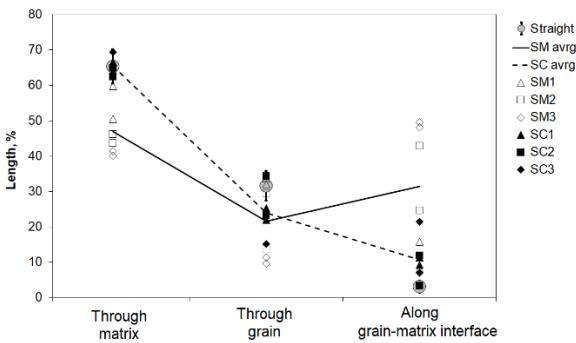
Fig. 9 Crack propagation through different constituents of the microstructure compared with the results for the random straight reference lines through un-cracked material (marked "straight").

SM have higher portion of the crack propagating along the grain-matrix interface than SC and in the reference straight lines (Fig. 9). The crack portions through the grain and especially through the matrix are lower in SM. In SC, the portion of crack propagation through the matrix is as high as in the reference straight lines. The average portion of through the grain cracking in SM, SC, and in the reference straight lines is 21.6±11.2 %, 23.9±6.2 %, and 31.6±4.2 %, respectively. The average portion for through the matrix cracking in SM, SC, and in the straight lines is 46.9±7.3 %, 65.4±2.5 %, and 65.4±4.9 %, respectively.

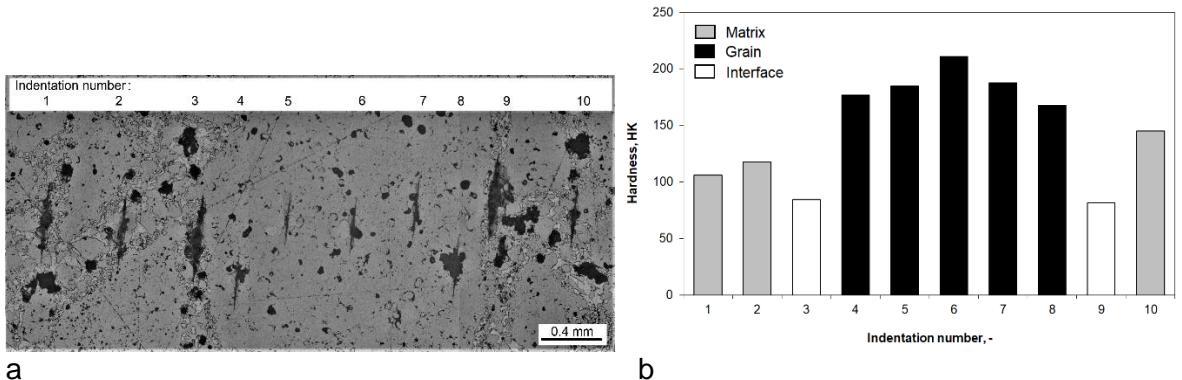
Fig. 10 Representative results of Knoop hardness tests in SC1, (a) indentation imprints in different microstructural constituents, (b) corresponding Knoop hardness values.

Among the constituents of the microstructure, the hardness increases in order from interface to matrix to the large grain (Fig. 14, Table 2). The coefficient of variation for the hardness in the matrix and the interface is above 20 %. For the grain, this value is almost twice as low. The distribution of hardness in the grain is aligned with the gradient mineralogical composition featuring higher content of tridymite and cristobalite in the rims and in the centre of the grains, respectively. Hardness of all the constituents of microstructure is significantly higher than that of the epoxy resin, used to prepare the polished section. The hardness of the epoxy resin is 5 HK.

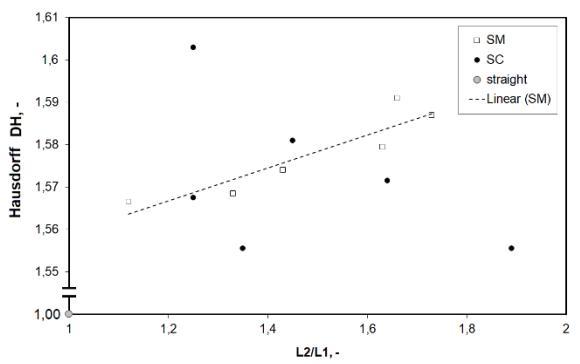
Fig. 11 Relationship between the Hausdorff constant and the ratio L2/L1.

For individual crack trajectories, roughness parameters are compared with the crack nonlinearity L2/L1 and with the microstructural indexes of crack propagation PA and PBA. Considered roughness parameters include Rq of two cut-off limits and Hausdorff dimension DH. With L2/L1, no significant correlations are seen. The exception is the correlation between DH and L2/L1 for monotonic loading (Fig. 11). With PA and PBA, no correlations are seen for DH and R_q for the cut-off of 8 mm. However, correlations are observed for Rq for the cut-off of 2.5 mm (Fig. 12). The following can be observed from those correlations. Both for PA and PBA, the data of two loading modes form common trends. For PA, the trend has an exponential form. The data of SC occupy the flatter part of the trend, where PA does not change significantly with roughness (Fig. 12.a). For PBA, a non-linear decreasing trend is observed.

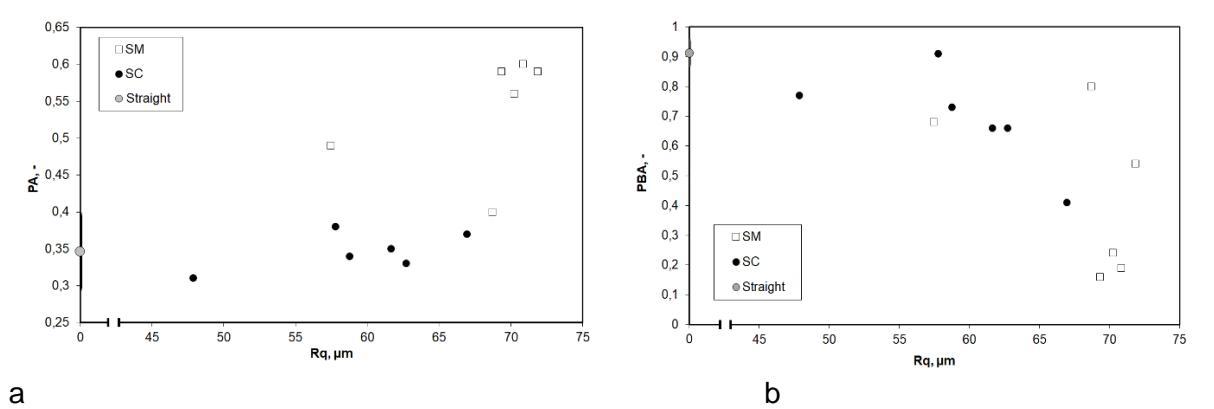
Fig. 12 Relationship between the ratios PA (a) and PBA (b) and the toughness Rq for the cut-off limit of 2.5 mm. "Straight" refers to the values for the reference straight lines.

cracks. This is supported by the fact that the roughness increases with higher portion of either through or around the grain fracture (higher PA) and that it decreases with higher portion of through the grain failure (higher PBA) (Fig. 12). Smaller difference between the loading modes is seen for the roughness with the waviness cut-off threshold of 8 mm. With a higher cut-off, both waviness of lower wavelength and the roughness are counted as roughness. As the size of larger grains is 1–2 mm, the waviness cut-off threshold of 2,5 mm seems to be more appropriate.

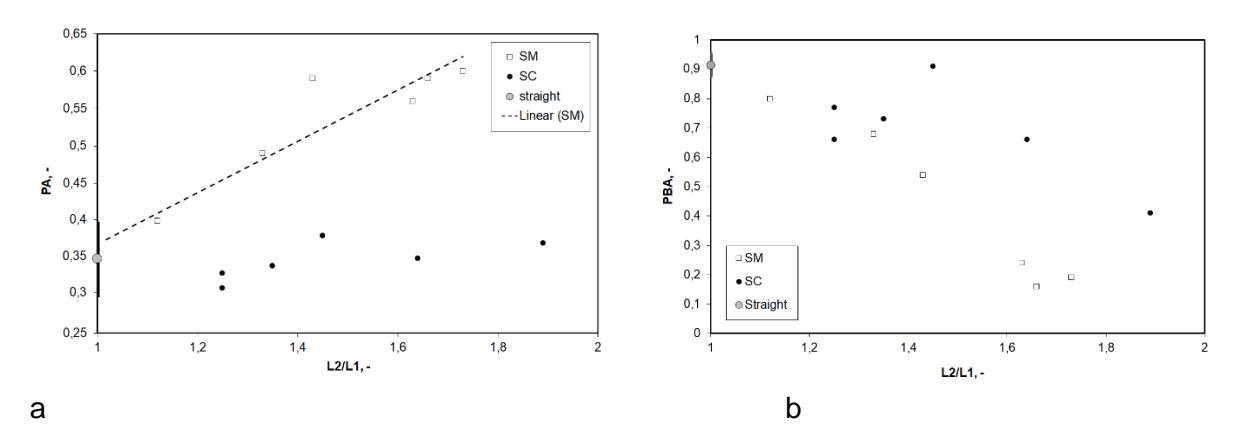
Fig. 13 Relationship between the ratios PA (a) and PBA (b) and the ratio L2/L1. The fit in (a) is discussed in the text.

When L2/L1 is compared for PA and PBA, clear trends are observed(Fig. 13). With growing L2/L1, the PA of monotonic samples linearly increases. PA of cyclic samples does not change with L2/L1. PBA of both loading modes decreases with increasing L2/L1. However, the sensitivity to the changing L2/L1 is lower for CS (flatter trend). All the trends can be extrapolated to the parameters specific for the reference straight lines (Fig. 12, 13).

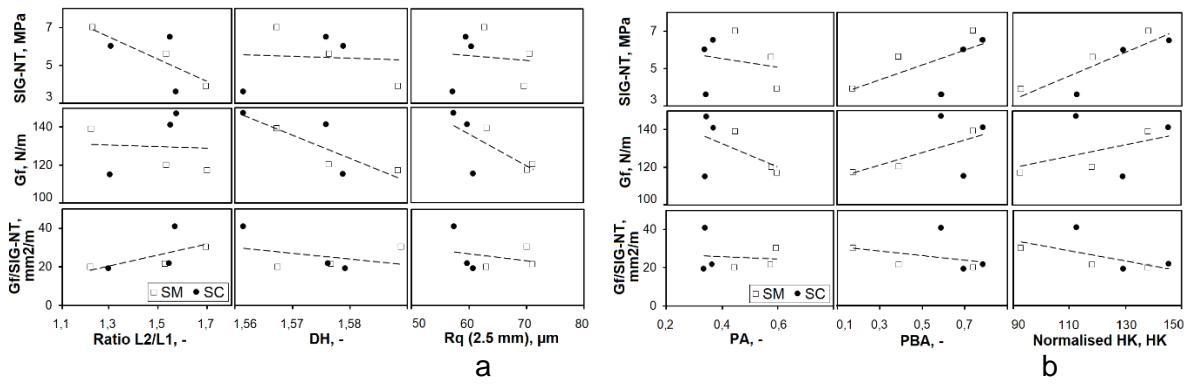
Fig. 14 Relations of the average crack trajectory parameters of a sample with its stressstrain parameters.

The correlation between the stress–strain parameters and the crack trajectory specific parameters is shown in Fig. 14. Data of only three samples with known crack propagation parameters is available per loading mode. Due to this, the attempted correlations are general for both loading modes. No statistically robust correlations are seen. Among the stress–strain parameters, G_f has fewer flat trends and thus is the most sensitive to the micro-structural parameters. Gf has a positive correlation with PBA. Gf has negative correlations with DH, Rq and PA. A certain relationship of falling strength with growing L2/L1 is seen. It seems that data of monotonic tests form more obvious trends than the cyclic ones.

Normalized hardness for cracks of both loading modes shows certain trends regarding all the stress–strain parameters (Fig. 14.b). The normalized hardness is obtained regarding the average hardness values of the constituents of the microstructure in the specific sample and their portion in the respective crack trajectory. For the positive correlation between the normalized hardness and SIG-NT, the coefficient of determination (R²) is 0.76. This is the only correlation among those of Fig. 11 that has an R² value of above 0.7. This renders it a statistically robust correlation. As the strengths in both modes are similar, the correlation observed is attributed to the variation of the microstructural characteristics of the samples within each mode of loading. The hardness has positive and negative trends with the fracture energy and the brittleness ratio, respectively (Fig. 14.b). Normalised hardness has good correlation with PBA.
