# Airborne Sound Analysis for the Detection of Bearing Faults in Railway Vehicles with Real-World Data

**Abstract**—In this paper, we address the challenging problem of detecting bearing faults in railway vehicles by analyzing acoustic signals recorded during regular operation. For this, we introduce Mel Frequency Cepstral Coefficients (MFCCs) as features, which form the input to a simple Multi-Layer Perceptron classifier. The proposed method is evaluated with real-world data that was obtained for state-of-the-art commuter railway vehicles in a measurement campaign. The experiments show that bearing faults can be reliably detected with the chosen MFCC features even for bearing damages that were not included in training.

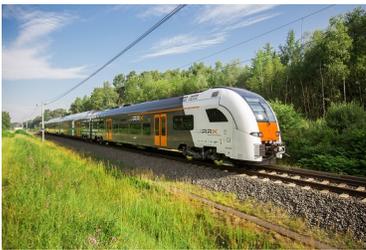
Fig. 1. Photograph of the commuter rail vehicle of the type Desiro HC RRR that was equipped with measurement equipment to obtain the real-world data.

In order to obtain realistic bearing fault data, a state-of-the-art commuter railway vehicle of the type Desiro HC RRR (Rhein-Ruhr-Express) [16] as shown in Fig. 1 was equipped with damaged bearings and a multitude of sensors was mounted on two cars. Two test trips with a duration of approximately 4 hours each were conducted. The railway vehicle was commuting between two cities to simulate normal operation. Two of the four train cars (cf. Fig. 2), i.e., Car A and Car B, were equipped with measurement equipment, i.e., acceleration sensors, temperature sensors, microphones, etc. In this paper, only the microphone data is considered. A drivetrain, comprising a motor and a gearbox, is located at each of the four axles of a car (cf. Fig. 2 and Fig. 4). The axles of Car B are denoted as  $B_i$  with  $i \in \{1, 2, 3, 4\}$ , while the axles of Car A are denoted as  $A_i$  with  $i \in \{1, 2, 3, 4\}$ . At Car B, solely healthy bearings are installed and therefore the measurements of Car B serve as a reference for the healthy state of a bearing. However, Car A is equipped with damaged bearings, which will be described in Sec. II-C.

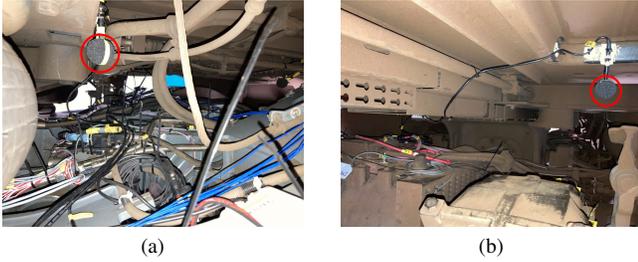
Fig. 3. Placement of the microphones (◦) on the rail vehicle. A single microphone is placed above each drivetrain component by attaching it to the bottom of the railway car. Subfigure (a) depicts the microphone above the motor and Subfigure (b) shows the microphone above the gearbox.

Only the first two drivetrains of each car were equipped with microphones. As shown in Fig. 3, a microphone was placed above every drivetrain component by attaching it to the bottom of the railway car. Thus, the distance between drivetrain component and microphone is  $\approx 30$  cm. The locations of the microphones (depicted as ■ and ■) can also be inferred from Fig. 4, which shows a schematic view of Car A. Due to their position, the microphones do not only capture the sounds that are emitted by the bearings, but they additionally capture noise that is caused by the railway tracks and other components in the train bogie, e.g., brakes, dampeners, etc. Please note that in the following the microphones depicted as ■ are considered for classification tasks at the motor and that the microphones depicted as ■ are considered for classification tasks at the gearbox.

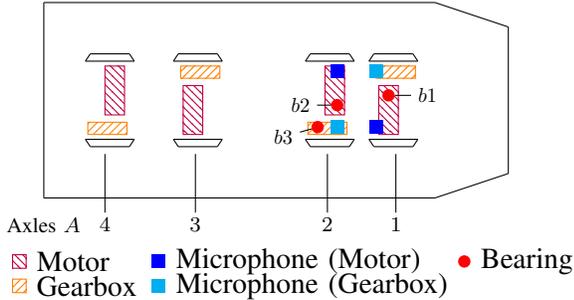
Fig. 4. Schematic view of Car A. The first two drivetrains, i.e., motor and gearbox, are equipped with acoustic sensors. A microphone is placed at a central position above each drivetrain component at Axle A1 and Axle A2. The microphones above the motors are depicted as ■ and the microphones above the gearboxes are depicted as ■. The positions of the damaged bearings are indicated by red circles (●). The microphone setup at Car B is identical.

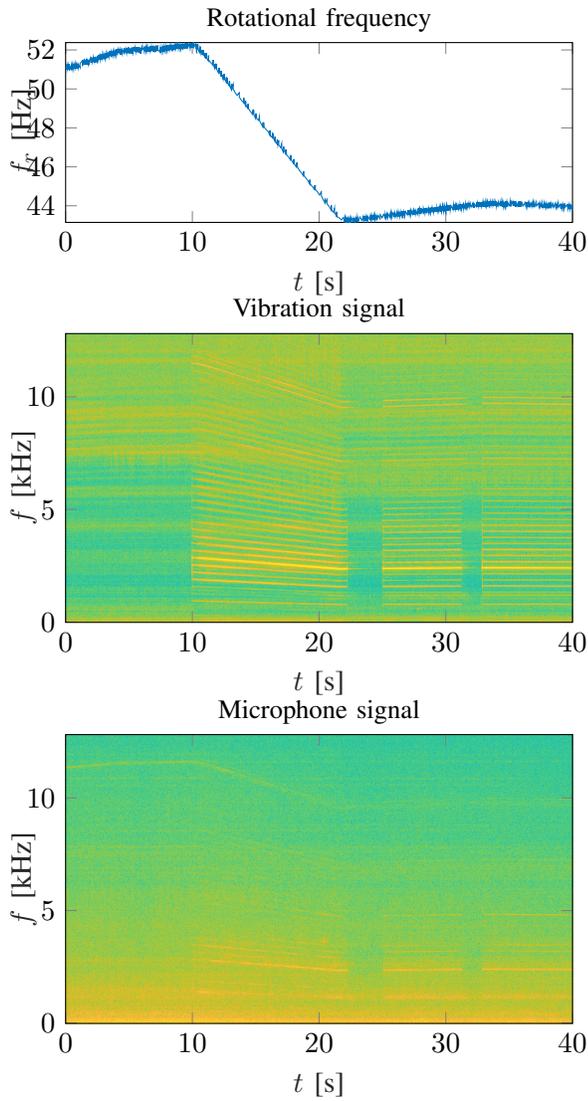
Fig. 5. Rotational frequency (top), spectrogram of the vibration signal (center) and spectrogram of the microphone signal (bottom) of a healthy bearing.

At first, we want to illustrate the suitability of airborne sound for the task of fault detection by comparing spectrograms obtained from airborne and structure-borne sound signals. Fig. 5 shows a rotational frequency curve (top figure) and the corresponding spectrograms for the structure-borne sound measured directly on the housing of the motor of Axle  $B1$  at Car B (center figure) and the spectrogram for the airborne sound (bottom figure) that was captured by the microphone located at the motor at the same axle and at the same car, i.e.,  $B1\_b1$ . The considered signal shows a period of an almost constant rotational speed which is followed by another period of constant rotational speed after a deceleration period of approximately 10s. The spectrogram of a vibration signal is dominated by harmonics of the rotational frequency. These harmonics can be clearly observed in the spectrum over the entire frequency range for time periods when torque is applied. If we now compare this to the spectrogram of the microphone signal, a similar structure

can be observed, although much less pronounced. While for the vibration signal the harmonics of the rotational frequency could be observed as sharp horizontal lines over the whole frequency range, for the microphone signal only a few harmonics can be faintly recognized and only in the frequency region below 5 kHz. Thus, it can be stated that spectrograms computed for airborne sound signals exhibit a similar structure as the spectrograms for structure-borne sound signals, although the components that are linked to periodic events in the motor are represented incompletely and less pronounced. Consequently, harmonics from bearings are recognizable in the sound signal that is captured in its proximity and thus changes w.r.t the condition of bearing should be

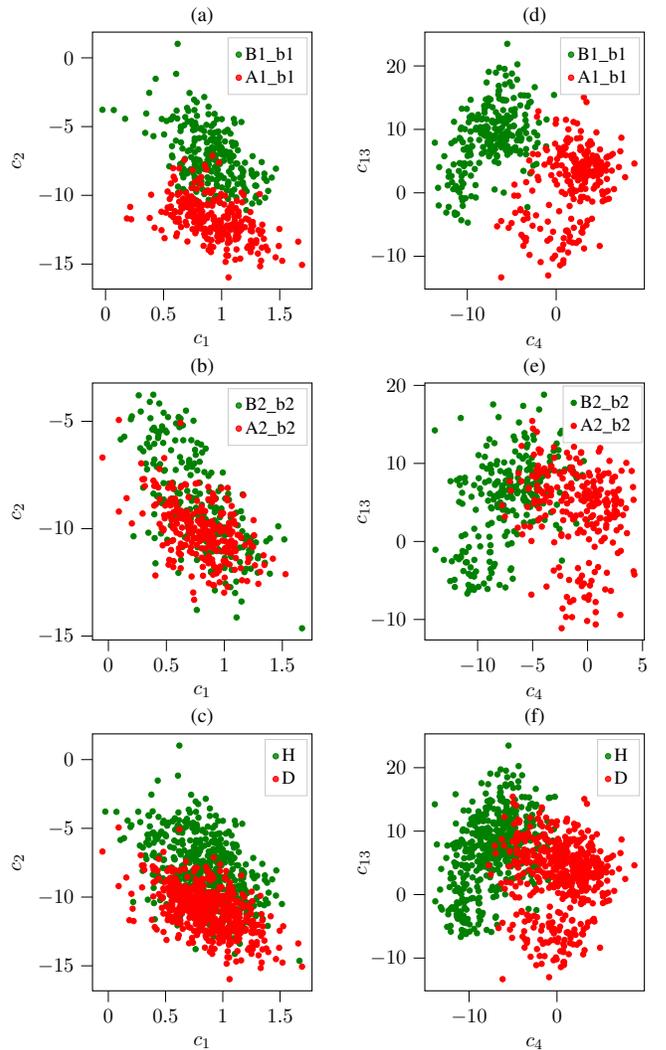
Fig. 6. MFCC scatter plots for the microphone data of the motor. Figures (a)-(c) show scatter plots for the values the first MFCC, i.e.,  $c_1$ , on the x-axis and the values for the 2nd MFCC, i.e.,  $c_2$ , on y-axis, whereas Figures (d)-(f) show scatter plots for 4th MFCC, i.e.,  $c_4$ , and the 13th MFCC, i.e.,  $c_{13}$ . For figures (c) and (f) the data points for  $B1\_b1$  and  $B2\_b2$  and  $A2\_b2$  and  $A1\_b1$  were combined to H and D, respectively.

Motivated by the results for structure-borne sound, we investigate in this paper whether Mel Frequency Cepstral Coefficient (MFCC) are also useful features for the classification bearing faults by analyzing airborne sound. An indication of their appropriateness is given by the following example: Fig. 6 shows two-dimensional scatter plots for two exemplary combinations of MFCCs. Subfigures (a) - (c) in Fig. 6 depict scatter plots in which the values of the first MFCC, i.e.,  $c_1$ , are shown along the x-axis and the values for the second MFCC,

i.e.,  $c_2$ , are shown on the y-axis. Subfigure (a) shows the data points for the healthy bearing  $B1\_b1$  and the damaged bearing  $A1\_b1$ , respectively, whereas Subfigure (b) shows the data points for  $B2\_b2$  and  $A2\_b2$ .  $B1\_b1$  and  $B2\_b2$  denote the data that was obtained from the microphones above the motors at Axle  $B1$  and Axle  $B2$  of Car B, respectively (cf. Fig. 2). For Subfigure (c) the data points for  $B1\_b1$  and  $B2\_b2$  and  $A2\_b2$  and  $A1\_b1$  are combined for the labels H (Healthy) and D (Damaged), respectively. For Subfigures (d) - (f) a different combination of MFCCs is used: the values for the fourth MFCC, i.e.,  $c_4$ , are given along the x-axis and the values of the thirteenth MFCC, i.e.,  $c_{13}$ , are plotted on the y-axis. Again, the data points for  $B1\_b1$  and  $B2\_b2$  and  $A1\_b1$  and  $A2\_b2$  are combined for the labels H and D, respectively, in Subfigure (f). Subfigures (a)-(f) in Fig. 6 show that the point clouds for the two classes, Healthy (H) and Damaged (D), do only overlap to a small extent in these two exemplary 2-dimensional subspaces. Since it is already possible to roughly discriminate between healthy and damaged samples in these 2-dimensional subspaces, it is reasonable to assume that the point clouds in the 13-dimensional subspace that is spanned by all 13 MFCCs are more distant.

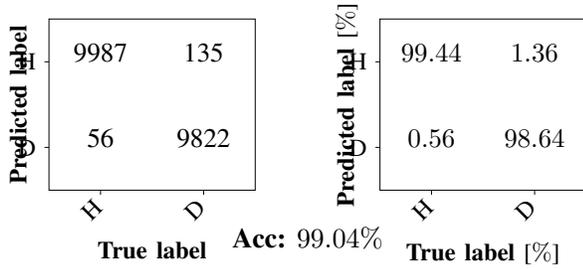
Fig. 7. Confusion matrix for a binary classification problem at the motor with seen damages.

datasets of sizes 80000 and 20000 samples, respectively. The classifier is trained for 20 epochs with a learning rate of  $\lambda = 0.001$  and a batch size of 32. The results are summarized in Fig. 7. It can be observed that the bearing faults can be very well detected with a True Positive Rate (TPR) of 98.64%, while the probability of false alarms is negligibly small with 0.56%. Note that for the computation of True Positive Rate (TPR) and True Negative Rate (TNR) the class label H refers to the positive class and D to the negative class.

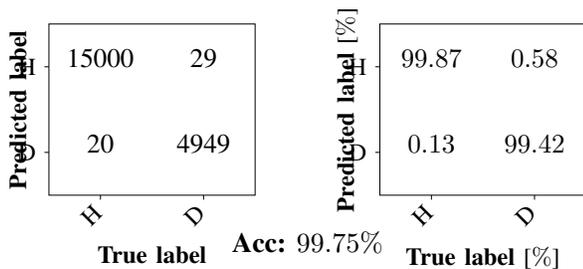
Fig. 8. Confusion matrix for a binary classification problem at the gearbox with seen damages.

2) *Binary Classification for Bearing Damages at the Gearbox*: A similar experiment is conducted for the gearbox. Since only a single bearing damage, i.e.,  $A2\_b3$ , for the gearbox is available, the data which is obtained for the healthy gearboxes at the three remaining axles, i.e., axles  $B1$ ,  $B2$  and  $A1$  are labelled as Healthy (H). The size of the test set and training set are identical to the previous experiment. The obtained confusion matrices are shown in Fig. 8. Again, an almost perfect classification result can be achieved with an accuracy of 99.75%. However, it has to be stated at this point that it cannot be ruled out that the bearing fault at the motor  $A2\_b2$  affects the microphone signal that is recorded at the microphone above the gearbox.

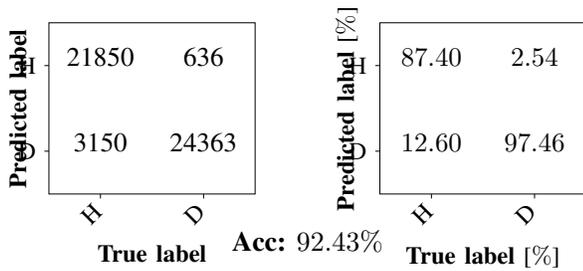
Fig. 9. Confusion matrix for a binary classification problem with the unseen Bearing Damage A2\_b2 in the test set.

Since the previous experiments have demonstrated that the detection of bearing faults works very well for seen data, it is now examined how well this classifier performs for unseen data. To this end, the classifier is trained with data from one of the two damaged bearings at the motor, either  $A1\_b1$  or  $A2\_b2$ , and data from the corresponding axle at Car B, i.e.,  $B1\_b1$  or  $B2\_b2$ , and tested with data from the remaining damaged bearing and its corresponding healthy reference. Hence, if the classifier is trained with  $A1\_b1$  and  $B1\_b1$ , it is tested with  $A2\_b2$  and  $B2\_b2$  and vice-versa. The results are shown in Figs. 9-10. Here, the training set and the test set contained 50000 samples each. It can be observed that the overall accuracy drops below 93% in both scenarios. It is notable that an almost inverse behavior of TPR and TNR can be observed when Fig. 9 and Fig. 10 are compared: While a TPR of 87.40% and a TNR of 97.46% are obtained when the classifier is tested with data from  $A1\_b1$  and its healthy reference, a TPR of 98.62% and a TNR of 87.22% is obtained when the classifier is tested with data from  $A2\_b2$  and its healthy reference. A possible explanation for this is that while Bearing  $A2\_b2$  represents a fault in a developed stage,  $A1\_b1$  represents a bearing in a very early stage. Hence, it is somehow plausible that, when the classifier was only trained with a developed fault, the number of undetected faults increases when it is tested with data from a less severe fault. The experiments with unseen data support the claim that the features are indeed fault-related and not axle-related, since the bearing faults at the motor could still be reliably detected although the faults are positioned at different axles.

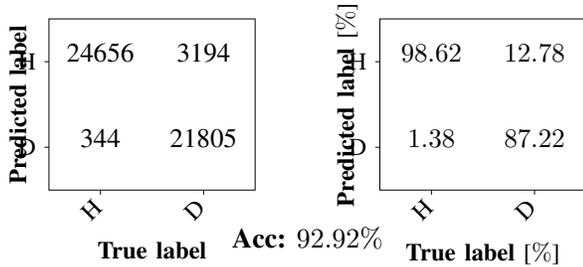
Fig. 10. Confusion matrix for a binary classification problem with the unseen Bearing Damage A1\_b1 in the test set.
