Flow Induced Corrosion in 6061-T6 Aluminum Pipes in De-Ionized Water Environments

Abhishek Deshpande[†] and Erik Voirin
Fermi National Accelerator Laboratory
Kirk Rd. and Pine St.
Batavia, Illinois 60510
USA

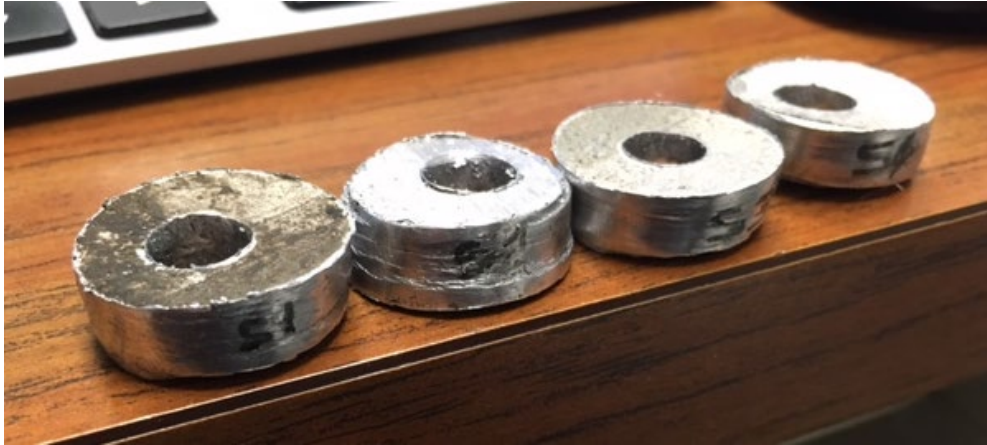
filtration. The average operation temperature, pressure, and resistivity are 90 °F, 160 Psig, and 10 MOhm-cm, respectively. Samples shown in Fig 1 were cut out from a decommissioned header's 90-degree elbow of the system. This section of the header operated for over 40-years at the above conditions. Sample thicknesses are highlighted in Table 2:

Fig 1: Samples cut from the supply header of the Main Ring LCW cooling system.

Sample ID	Min thickness, in	Nominal Sch40 pipe wall thickness, in.	Material loss or gain, in.
S1	0.254	0.258	-0.0040
S2	0.2545	0.258	-0.0035
S3	0.2515	0.258	-0.0065
S4	0.262	0.258	0.0040

The above table shows that the wall thickness has changed minimally over 40-years of operations.

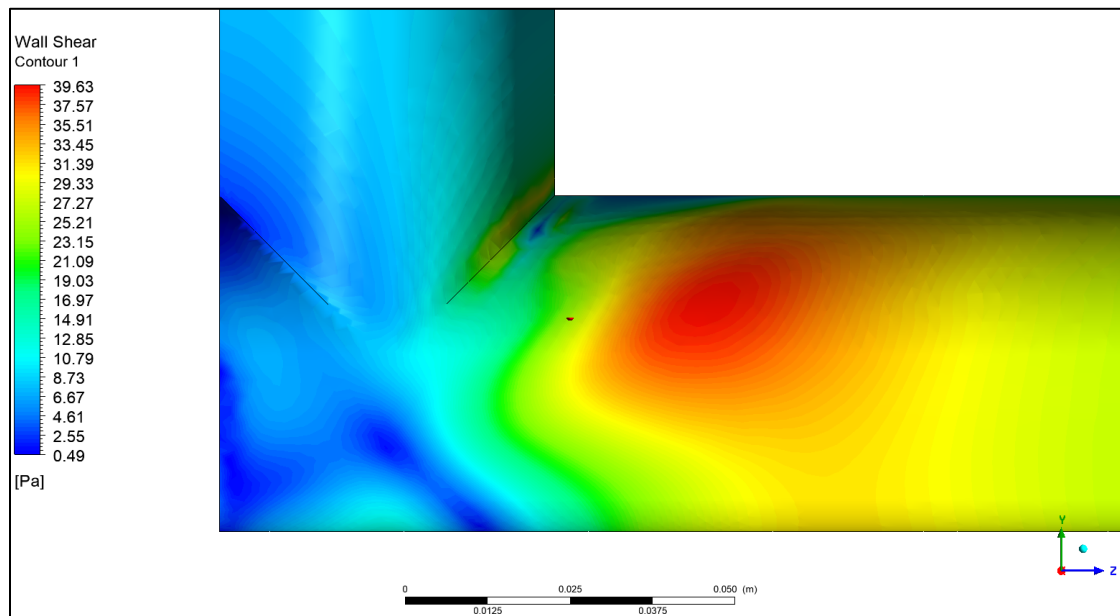
A CFD simulation was performed to determine the wall shear stress on the miter elbows, which are present on the inlet and outlet ports of each core block, at water velocity and temperature of 8 ft/s and 130 °F, respectively. A maximum wall shear stress of 40 Pa was simulated for a condition

where flow exits the elbow from the top, Fig 2. Flow at the inlet has a maximum shear stress of 50 Pa, however, since the water at the outlet would be warmer, this is considered the worst case. Investigating why wall shear stress would be indicative of corrosion, literature sources suggest high shear stresses bring more of the corrosive components contained in the fluid through the fluid boundary layer and into contact with the wall. The physics behind corrosion/erosion may be understood as a convective mass transfer coefficient at the fluid solid interface, which is analogous to a convective heat transfer coefficient, acting alongside shear stress. It may be theorized that mass transfer is the variable of interest for corrosion, not purely wall shear stress, and this is validated with references.³ Fick's equations for mass transfer and the Fourier heat equation are analogous differential equations and of the same form. Heat and mass transfer are captured by the Lewis number, which is the ratio of Schmidt number over the Prandtl number. Both heat and mass transfer can be simulated using commercial computational dynamics code, however, in this study, only shear stress is compared as it seems to be the more common variable used in corrosion studies.

Fig 2: Shear stress in elbow at outlet of cooling block, where water will be hotter, (with more corrosion potential.) Water is flowing from the top, down then to the right in this image.

CFD simulations revealed that the worst-case shear stress on the aluminum components of the LBNF absorber is very low, 50 Pa. Parameters derived from two experimental setups were used to estimate the material loss in aluminum alloys owing to flow induced corrosion/erosion. The loss of material in both cases over 35-years was minimal. The material lost in one case was much higher than in the other. This may be attributed to the entrained sand present in the first case. From the above study one can expect minimal erosion/corrosion in the aluminum components of the LBNF absorber during its ~35-year operational life.
