# Radiation Hardness Studies of RPC Based on Diamond-Like Carbon Electrodes for MEG II Experiment

## Abstract

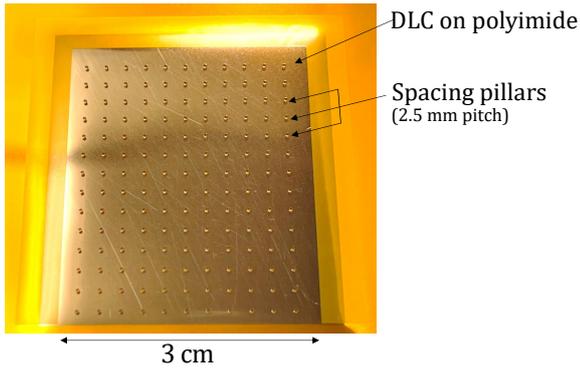
**Figure 1:** Small prototype electrode of the DLC-RPC. The DLC is sputtered on polyimide and spacing pillars are formed on the DLC.

Performance studies of the DLC-RPC with a 2 cm-size prototype are presented in Ref. [2]. This prototype demonstrated a low-material design using high-resistivity electrodes (Fig. 1) made of DLC-coated polyimide films (50  $\mu$ m thick) and 30 nm thick aluminum readout strips. The use of these materials will allow an RPC of up to four layers within a material budget of 0.1 %  $X_0$  —

In this test, a small prototype electrode of the DLC-RPC shown in Fig. 1 was used. As mentioned in Sect. 1, a polyimide film is coated with DLC, and spacing pillars are formed on DLC at a 2.5 mm pitch by photolithographic technology. The surface resistivity of the DLC of this prototype is about 40  $\text{M}\Omega/\text{sq}$ .

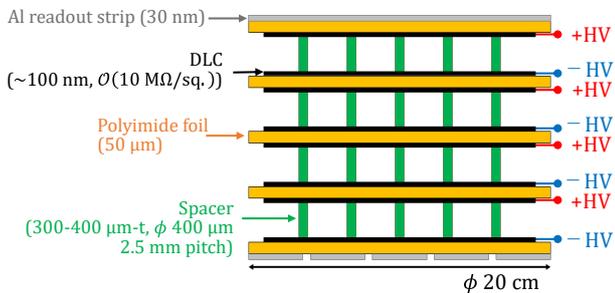
**Figure 2:** Concept of the full-scale DLC-RPC

the overall material budget can be suppressed to 0.095 %  $X_0$  with the design as shown in Fig. 2. For gas gap, on the other hand, 384  $\mu\text{m}$  high spacing pillars are formed on the DLC surface by photolithographic processing. The performances of this prototype detector presented in Ref. [2] are encouraging; 42 % single-layer efficiency for MIP particles and 180 ps timing resolution were achieved under a 1  $\text{MHz}/\text{cm}^2$  low-momentum muon beam. When the efficiency of a four-layer RPC is concerned, 42 % single-layer efficiency is close to the goal of 90 % four-layer efficiency. In addition to the above measurements, Ref. [2] finally proposed a further improved detector design, which will give higher rate capability and full scalability of the detector. The proposed design improvement is underway in parallel with this study to realize a 20 cm size detector.

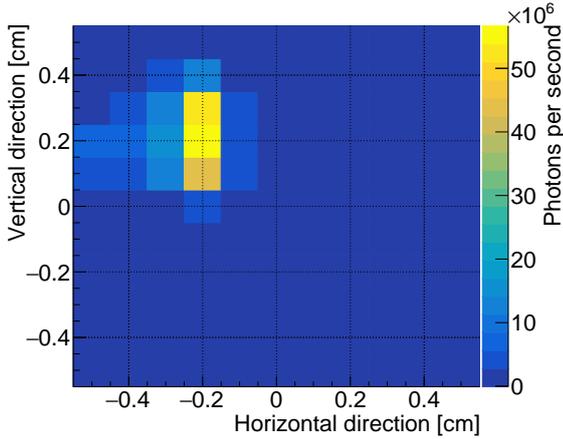
**Figure 3:** Measured profile of X-ray beams

This X-ray generator has a copper target and a monochromator. Therefore, the characteristic X-ray of copper is output, and the energy of the X-ray beam is about 8.04 keV. The profile of the X-ray beam was measured using an X-ray monitoring device (ionization chamber) as shown in Fig. 3. X-rays were quite localized to an area of about 1 mm  $\times$  3 mm. It is locally equivalent to  $\sim 5.7 \times 10^9$  counts/ $\text{cm}^2$  of radiation intensity.

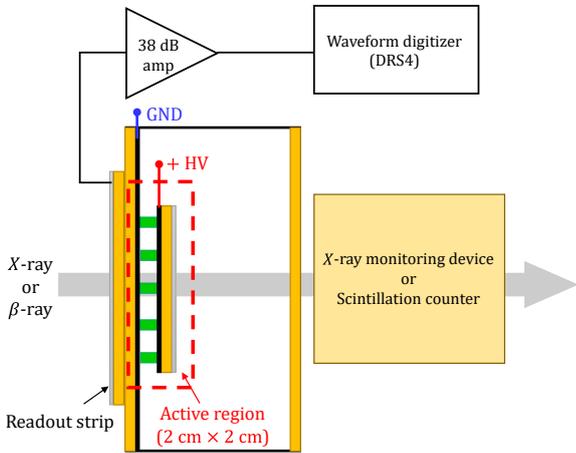
**Figure 4:** Experimental setup

Figure 4 shows the scheme of the experimental setup. The DLC-RPC electrode shown in Fig. 1 was placed on the chamber window, which is a polyimide film with sputtered DLC and works

as a cathode electrode of the DLC-RPC. The surface resistivity of the cathode-side DLC is about  $15 \text{ M}\Omega/\text{sq}$ . The chamber was filled with  $\text{C}_2\text{H}_2\text{F}_4/\text{SF}_6/\text{iC}_4\text{H}_{10}$  (94:1:5). The signal readout was performed on an aluminum strip, placed on the outer front of the chamber. The induced signal on the readout strip was amplified by 38 dB amplifiers, and fed into a DRS4 waveform digitizer [3]. The X-ray monitoring device was placed behind the chamber to monitor the X-ray beam during X-ray irradiation. To evaluate changes in the DLC-RPC performance, the response to  $\beta$ -ray emitted from  $^{90}\text{Sr}$  source was measured before and after X-ray irradiation. The monitoring device was replaced with a scintillation counter for a reference counter during the  $\beta$ -ray measurements.

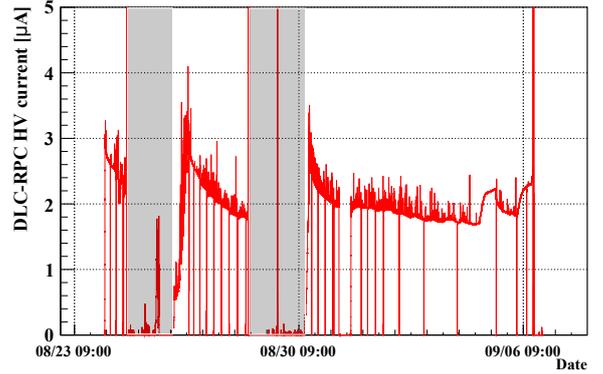
**Figure 5:** The DLC-RPC HV current. The chamber was opened in shaded periods due to discharge problems.

The DLC-RPC was operated at 2.8 kV of high voltage supply during X-ray irradiation. The current values of the high-voltage module were continuously recorded to evaluate the accumulated charge. The history plot of the DLC-RPC HV current is shown in Fig. 5. The operation was interrupted twice because of discharges, which are shown as the shaded region in Fig 5. The chamber was opened and the DLC-RPC electrode was cleaned during these periods for removal of dust that caused discharges via spacers as discussed in Sect. 5.5.

As shown in Fig. 5, the DLC-RPC HV current decreased during X-ray irradiation. This means the decrease in the DLC-RPC gas gain because the HV current was considered proportional to the gas gain. The X-ray intensity did not change according to the output of the X-ray monitoring device. Comparison of the pulse height spectra for  $\beta$ -ray measured before and after the test shows

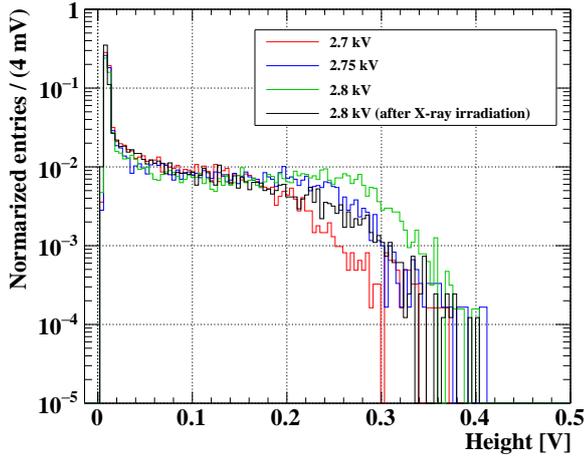
**Figure 6:** Comparison of the pulse height spectrum for  $\beta$ -ray

that the effective voltage was reduced by 50 – 100 V (Fig. 6).

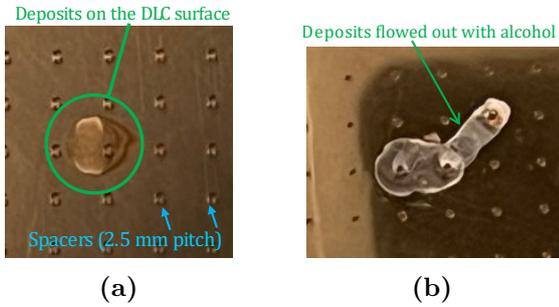
**Figure 7:** Deposits on the DLC surface. (a) Deposits in the discolored position. (b) Deposits are being removed by alcohol.

After X-ray irradiation, deposits on the DLC surface were observed as shown in Fig. 7. The resistivity of the DLC was significantly increased in this region ( $> 500 \text{ M}\Omega/\text{sq}$ ). After the removal of the deposits, the resistivity of the DLC and the DLC-RPC gas gain were fully recovered. We concluded that deposits formed insulators on the DLC surface, causing a decrease in DLC-RPC gas gain.

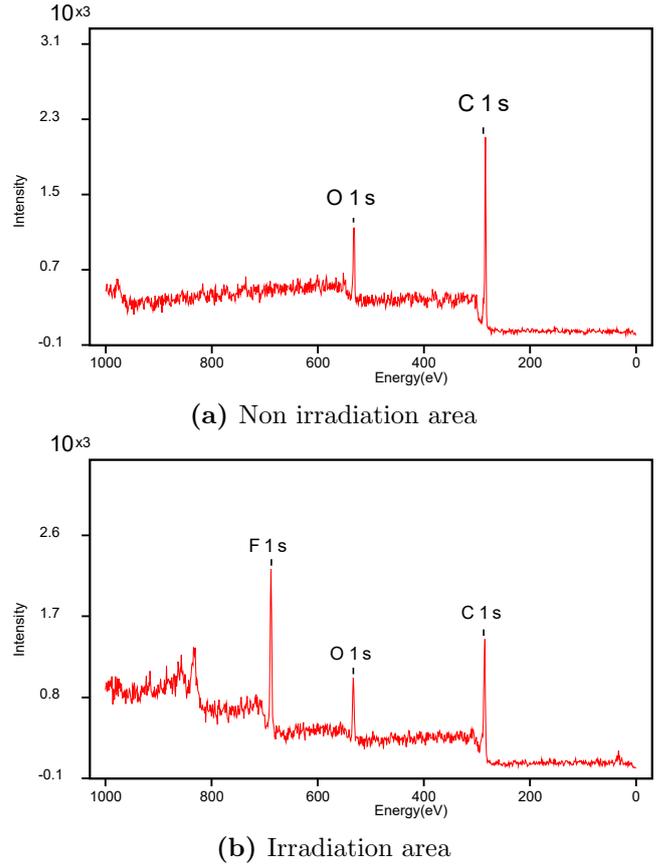
**Figure 8:** Results of the electrode surface analysis

spectroscopy (PHI X-tool, ULVAC-PHI INC. [4]). The results are shown in Fig. 8 and Tab. 1. Carbon and oxygen were detected in the non-irradiated area. (Fig. 8a). Carbon is a component of the DLC and oxygen is assumed to be detected by oxidation of DLC. On the other hand, the fluorine component appeared in the X-ray irradiated area (Fig. 8b). This fluorine component is understood to be produced during the irradiation through the following reaction [5]:

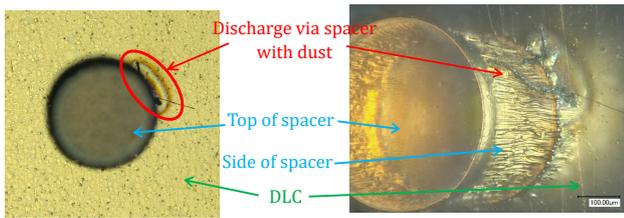
(a) Top view of the spacer (b) Oblique view of the spacer

**Figure 10:** Discharge via a pillar.

Twice discharges during the X-ray irradiation (Fig. 5) occurred via the spacing pillars. There is discoloration from discharge at the base of the pillar, and dust on the side of the pillar is presumed to have served as a discharge path as shown in Fig. 10. Such discharges occurred repeatedly at the same pillar. In this test, no further discharge was observed because the relevant pillar was removed after the second discharge.

Discharge via the pillar is a significant problem for the stable operation of the DLC-RPC. Therefore, it is necessary to establish a mechanism to suppress discharges and a system that enables remote recovery from outside the chamber in the event of a discharge.
