UV Degradation of the Optical Properties of Acrylic for Neutrino and Dark Matter Experiments

ABSTRACT: UV-transmitting (UVT) acrylic is a commonly used light-propagating material in neutrino and dark matter detectors as it has low intrinsic radioactivity and exhibits low absorption in the detectors' light producing regions, from 350 nm to 500 nm. Degradation of optical transmittance in this region lowers light yields in the detector, which can affect energy reconstruction, resolution, and experimental sensitivities. We examine transmittance loss as a result of short- and long-term UV exposure for a variety of UVT acrylic samples from a number of acrylic manufacturers. Significant degradation peaking at 343 nm was observed in some UVT acrylics with as little as three hours of direct sunlight, while others exhibited softer degradation peaking at 310 nm over many days of exposure to sunlight. Based on their measured degradation results, safe time limits for indoor and outdoor UV exposure of UVT acrylic are formulated.

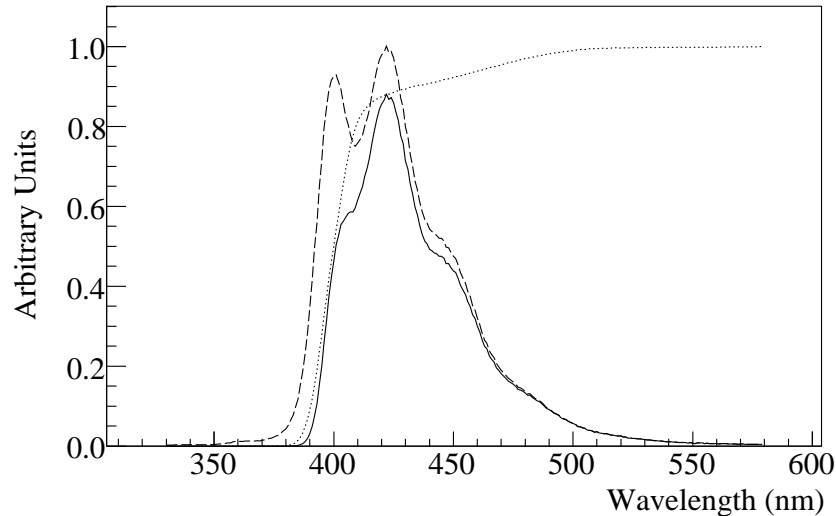
Figure 1. A sample Daya Bay liquid scintillator emission spectrum (dashed); transmittance spectrum of 1 cm non-UVT acrylic (dotted); light yield based on these two values (solid). The peak values of the two input spectra have been normalized to 1. Sample emission spectrum information provided by [12].

light collection. A sample liquid scintillator emission spectrum from Daya Bay is shown in Figure 1; the product of this spectrum and a non-UVT acrylic transmittance spectrum reveals about 21% light loss in traversing 1 cm of acrylic. If UVT acrylic is used, light loss due to acrylic traversal will be less than a few percent.

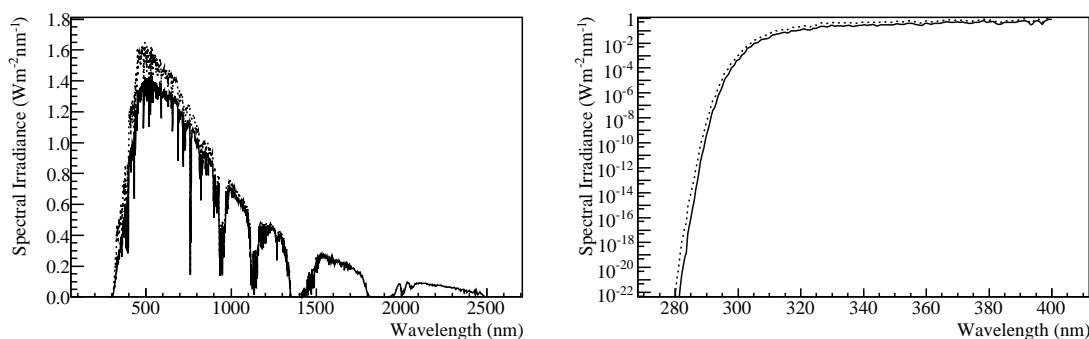
Figure 2. Left: total solar UV/VIS/NIR spectrum according to ASTM standard G173-03 [21]. Right: total solar UV spectrum. Spectra are given for hemispherical terrestrial measurements (dotted), and direct solar plus circumsolar measurements (solid).

UV exposure was achieved via outdoor solar irradiance. The total solar emission spectrum can be seen in Figure 2, along with solar UV emission. During exposure, samples were mounted on a flat, untilted, non-reflective surface and then exposed to the sun in Madison, Wisconsin for either short-term or long-term testing. Short-term exposures were 3-4 hours in length and were repeated for up to 24 hours. Long-term exposures ranged from 5-13 days in length. Tests were performed in the period between August 14 and September 15, 2008. Short-term exposures were achieved during sunny or mostly sunny weather conditions. Long-term exposures included periods of rain, clouds, sun, and night.

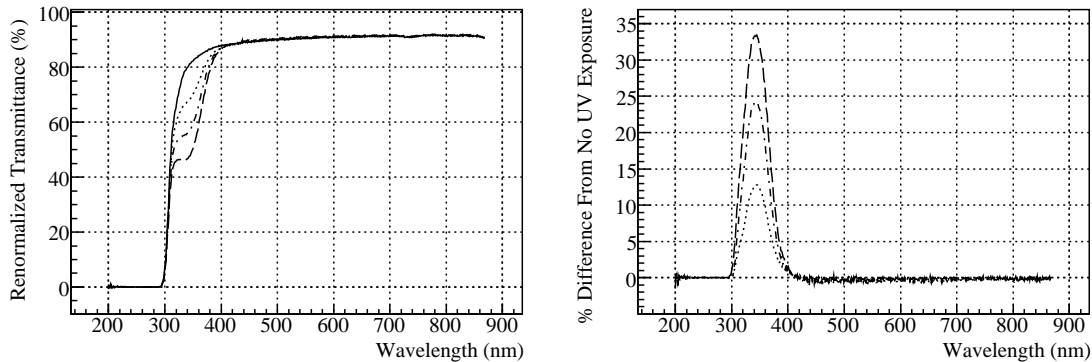
Figure 3. Left: transmittance spectrum for Reynolds sample #17. Right: Difference in transmittance of sample before and after UV exposure. Solid - No Exposure; Dotted - $32.9\ \text{J}/\text{cm}^2$; Dot-Dashed - $66.8\ \text{J}/\text{cm}^2$; Dashed - $115\ \text{J}/\text{cm}^2$.

Short-term tests consist of samples undergoing single or repeated exposures of 4 hours or less. The results of short-term exposure studies are summarized in Table 2. The Reynolds #17 sample was submitted to 7 exposures of 3-4 hours and received the highest UV dosage of any sample in the short-term test. After exposure, the sample showed no signs of coloration, crazing, or surface degradation. The transmittance spectrum of the Reynolds #17 acrylic sample for selected UV dosages can be seen in Figure 3. In this sample, significant degradation of specular transmittance can be seen in the near-UV range for the lowest dosage level, $32.9\ \text{J}/\text{cm}^2$. The difference between exposed and unexposed transmittances, hereafter referred to as transmittance degradation, as plotted in Figure 3, clearly exhibits a single peak of increasing amplitude. A gaussian fit gives this peak a mean value of 343 nm and a half-width of 20.3 nm. The mean value remains consistent with increasing dosage while σ increases on the order of a few nm.

The degradation at 360 nm as a function of UV dosage is shown in Figure 4. As suggested by Figure 3, transmittance at 360 nm continues to degrade with increasing UV dosage, although the pace of degradation slows. The data fits an exponential decay with an exposure constant on the order of $220\ \text{J}/\text{cm}^2$, with a horizontal asymptote at 20% transmittance. The uncertainty in exposure is the result of a $1\ \text{mW}/\text{cm}^2$ uncertainty in maximum solar luminosity, a $0.6\ \text{mW}/\text{cm}^2$ uncertainty during shaded exposure, both very conservative values, and a 5-minute period of uncertainty in luminosity for every 30 minutes of full sunlight to account for periods of brief cloud cover. To allow

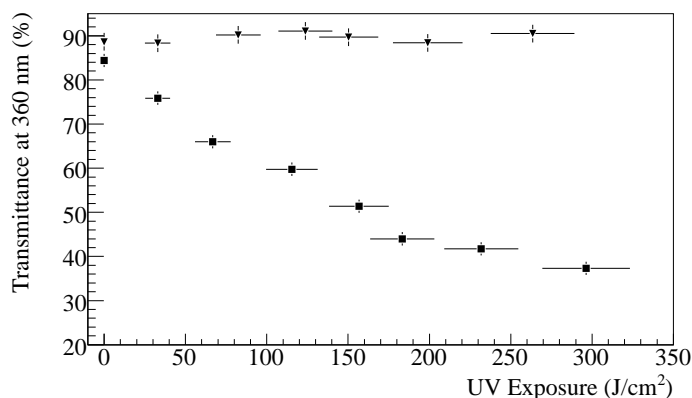
Figure 4. Transmittance at 360 nm plotted versus UV dosage. Triangles - Polycast #18; Squares - Reynolds #17. Vertical error bars indicate transmittance measurement uncertainty from sample surface imperfections and imperfect light collection, while the horizontal error bars show the uncertainty in UV exposure resulting from varying weather conditions.

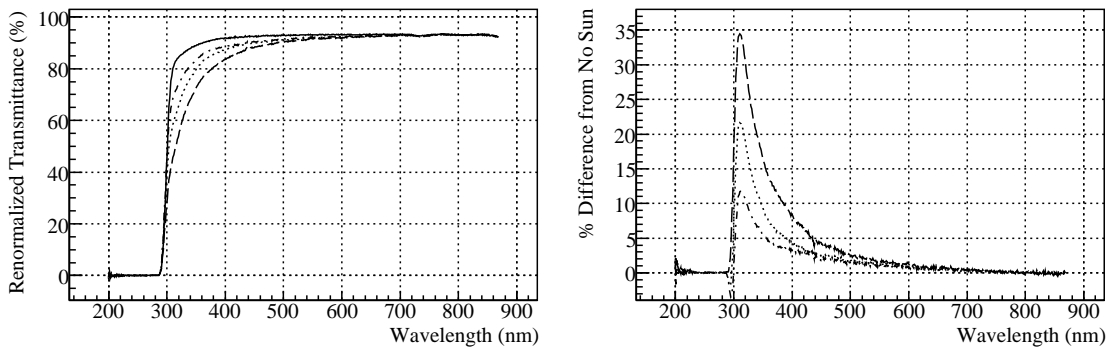
Figure 5. Right: transmittance spectrum for Polycast sample #7. Left: Difference in transmittance of sample before and after UV exposure. Solid - No Exposure; Dotted - 752 J/cm²; Dot-Dashed - 1211 J/cm²; Dashed - 2192 J/cm².

The effect of long-term exposures of up to 24 days of solar irradiation on acrylic was also studied. Long-term exposure results are summarized in Table 3. The Polycast #7 sample received the greatest long-term UV dosage; its transmittance spectra for increasing dosage levels is shown in Figure 5. The change in transmittance over the spectrum is not gaussian, but shows instead a sharp peak at 310 nm, followed by a long tail extending out past 450 nm. Change in transmittance remains above 5% until about 435 nm for maximum UV dosage. The YenNan #20 sample's transmittance change is similar, with a broader peak at around 305 nm. Neither sample showed any visible signs of yellowing or degradation.

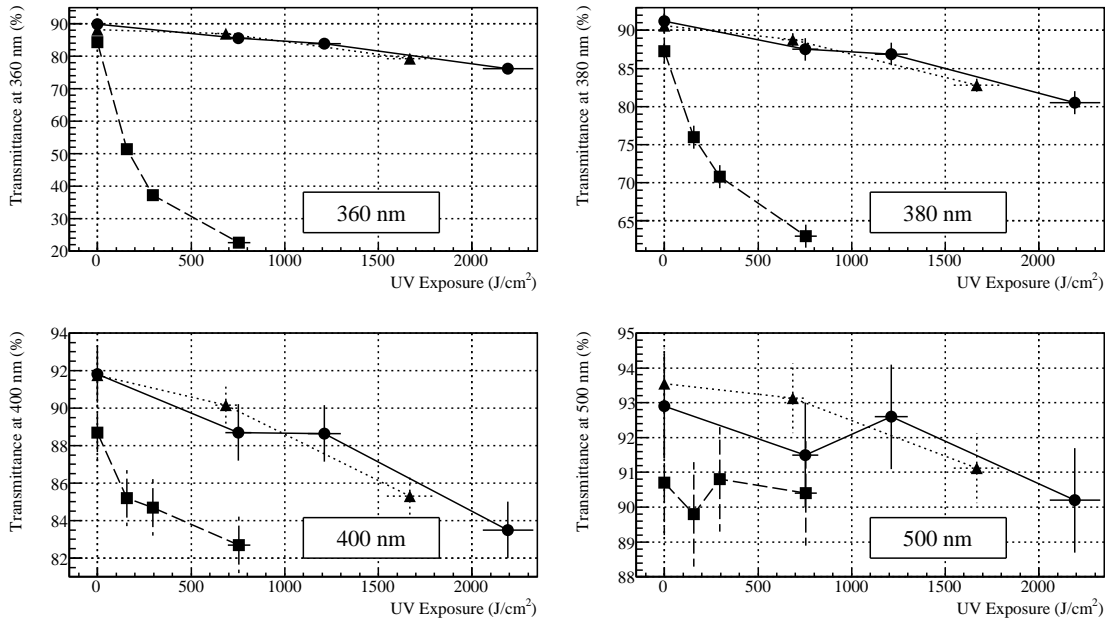
Figure 6. Transmittance plotted versus UV dosage for four wavelengths. Circles - YenNan #20; Triangles - Polycast #7; Squares - Reynolds #17. Vertical error bars indicate transmittance measurement uncertainty from sample surface imperfections and imperfect light collection, while the horizontal error bars show the uncertainty in UV exposure resulting from varying weather conditions.

Rate of long-term degradation of Polycast and YenNan samples can be examined by plotting transmittance at 360 nm versus total UV dosage, as was done with short-term exposure data. In Figure 6, one can see the difference in degradation rate between Reynolds #17 and the Polycast and YenNan samples. A linear fit to the Polycast and YenNan samples yields a degradation rate of 6.2 cm²/kJ and 5.5 cm²/kJ, respectively. The units on this rate are percent loss in transmittance over exposure in kJ/cm². At this rate, a Polycast sample would need around 50 times more UV exposure than a Reynolds #17 sample to degrade transmittance to 90% of its initial value at 360 nm.
