# Tensile material properties of human rib cortical bone under quasi-static and dynamic failure loading and influence of the bone microstructure on failure characteristics

Damien Subit<sup>a,\*</sup>, Eduardo del Pozo de Dios<sup>b</sup>, Juan Velázquez-Ameijide<sup>c</sup>, Carlos Arregui-Dalmases<sup>a,d</sup>, Jeff Crandall<sup>a</sup>

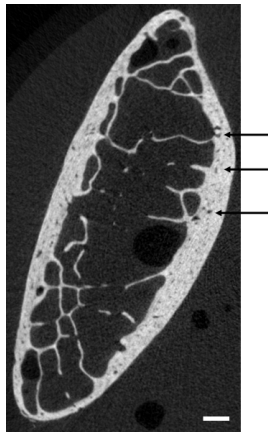
Figure 1: Cross-section of the left 6<sup>th</sup> from the antero-lateral aspect, from micro-computed tomography. The arrows indicate voids. The bar scale is 1 mm long.

The ribs were first cut into five 60-mm long pieces named A (most anterior piece) to E (most posterior piece). Isotropic images similar to figure 1 were obtained with a micro-computed tomograph (Scanco Medical Viva CT40, Brüttisellen, Switzerland) at a resolution of 30  $\mu\text{m}/\text{pixel}$  and used to determine where the bone coupons could be machined based on the curvature and the thickness of the cortical shell (Figure 2-a). Next, the periosteum was removed, and the sample was shortened with a small abrasive band saw equipped with a diamond blade (Diamond bone band saw, Mar-med

(figure 1): the cortical shell in the rib has pores, and the transition from the cortical to the trabecular bone can be somewhat blurred. Rather than using a two-part model for bone, a gradient approach may prove more accurate to predict the actual deformation modes and fracture locations under dynamic loading. Rib bone material properties need to be refined to include a more precise model for fracture prediction, such as stress concentration caused by the presence of pores or by the connection between the trabeculae and the cortical shell. Micromechanics approaches such as the cohesive zone models (Subit et al., 2009) would be worth evaluating as they can predict the onset of a crack based on the local microstructure.

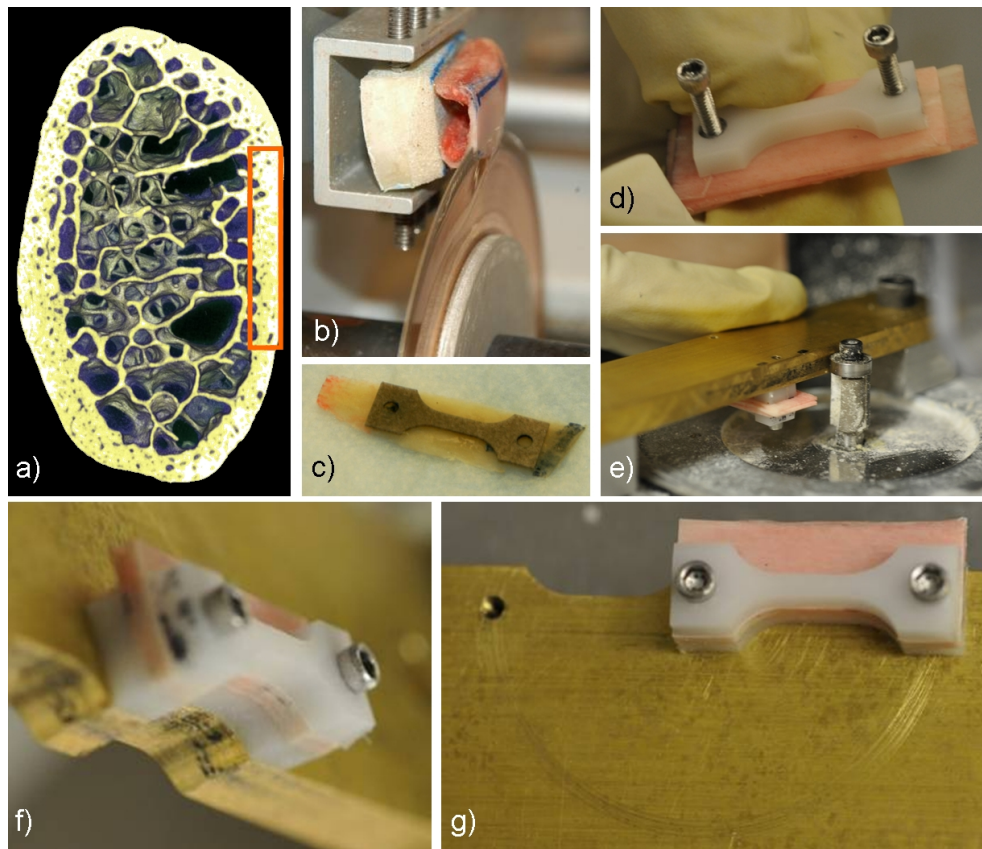
Figure 2: Machining of bone coupons.

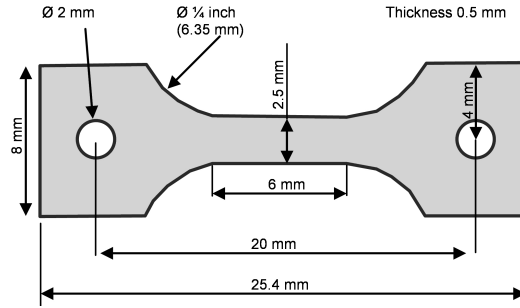
Figure 3: Dimensions of the bone coupons. The 2 holes are used only for references for machining and testing, and do not carry any load.

inc., Cleveland, OH, USA). The next cuts were performed with a low speed diamond saw (IsoMet low speed saw, Buehler Ltd, Lake Bluff, IL, USA, equipped with a 15HC Diamond blade) that can execute parallel cuts with micrometric accuracy. The sample was glued to a piece of hard foam that was then clamped in the sample holder in the desired orientation thanks to screws with spear tips (Figure 2-b). This step was critical in the machining process: the orientation of the bone slab had to be adjusted so that the cut performed with the low speed diamond saw would be entirely in the cortical shell. A first cut was made to generate the outermost flat surface. From there, an other cut was made parallel to the first one to create a flat piece of cortical bone (referred to as wafer) that was 0.5 mm thick (Figure 2-c). Next the two holes used to reference the position of the bone coupon (figure 3) were drilled in the wafer.

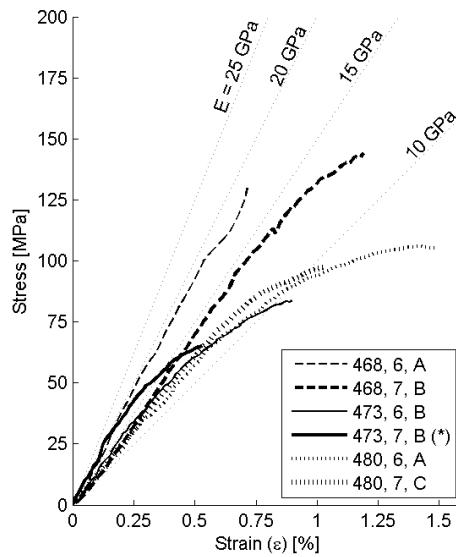
Figure 7: Strain-stress curves for the quasi-static tests. \*: sample fractured in the clamp.

Strain-stress curves were plotted for all the quasi-static tests (figure 7). The material properties were determined by assuming a linear elastic model between 0 and 0.5 % of tensile strain (table 3). Young's modulus ranged from 11.4 to 18.5 GPa, failure stress from 83.4 to 143.9 MPa, and failure strain from 0.71 to 1.49 % in quasi-static, and failure stress ranged from 94.7 to 155.9 MPa in dynamic.

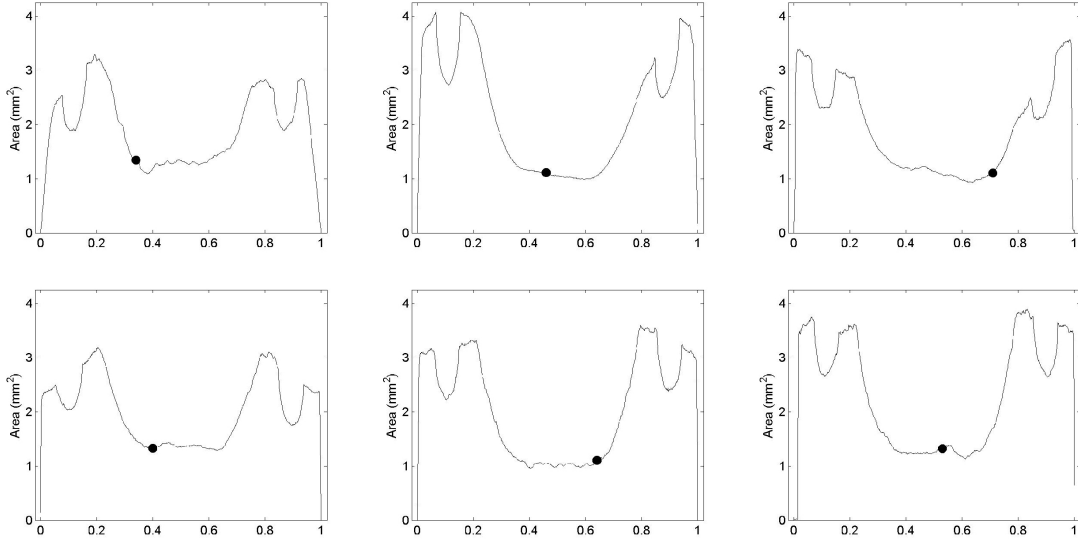
Figure 8: Variation of the cross-section (quasi-static tests). The fracture location is indicated by the dot. Zero is the anterior end of the coupon, and one is its posterior end.

The coupons machined in the human cortical bone are heterogeneous (Appendix A), and the actual cross-sections (determined by taking into account the presence of the voids) were smaller than the target of  $1.25 \text{ mm}^2$  (figures 8 and 9). When compared to the material parameters determined for the human femur (table 4), rib bone exhibits a lower Young's modulus, but the failure stress and failure strain are in the same range. Although the strains were not measured using the same methods for all these studies (extensometer or non contact optical measurements), it makes sense that the effective modulus appears smaller for the rib bones. The voids in the rib bone microstructure are not accounted for in the measurement of the cross-sectional area as the coupon cross-section is assumed to be rectangular and its area is approximated by measuring its thickness and width. With the femur cortical bone being denser than the rib cortical bone, coupons made of femur bone or rib bone with the same external dimensions would appear to have the same cross-sectional area, whereas the actual cross-section of the rib bone coupon will be smaller because of the voids.

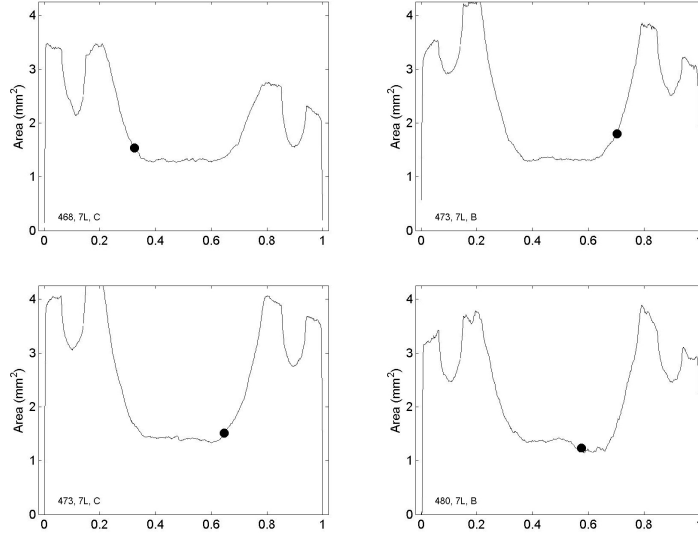
Figure 9: Variation of the cross-section (dynamic tests). The fracture location is indicated by the dot. Zero is the anterior end of the coupon, and 1 is its posterior end.

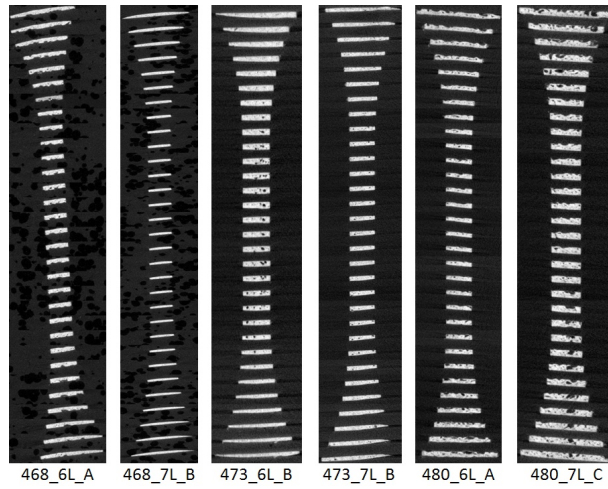
Figure A.10: Images of the cross-section obtained from micro-computed tomography (coupons tested under quasi-static loading). Only one every ten images is included.

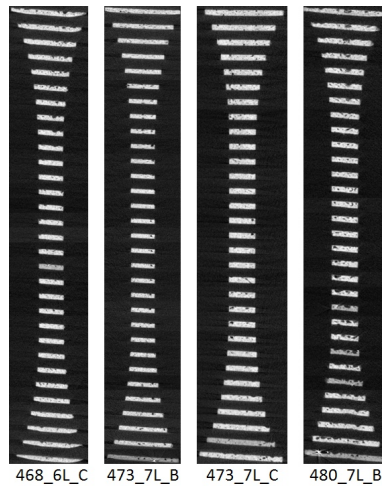
Figure A.11: Images of the cross-section obtained from micro-computed tomography (coupons tested under dynamic loading). Only one every ten images is included.
