# Polyurethane spray coating of aluminum wire bonds to prevent corrosion and suppress resonant oscillations

**ABSTRACT:** Unencapsulated aluminum wedge wire bonds are common in particle physics pixel and strip detectors. Industry-favored bulk encapsulation is eschewed due to the range of operating temperatures and radiation. Wire bond failures are a persistent source of tracking-detector failure. Unencapsulated bonds are vulnerable to condensation-induced corrosion, particularly when halides are present. Oscillations from periodic Lorentz forces are documented as another source of wire bond failure. Spray application of polyurethane coatings, performance of polyurethane-coated wire bonds after climate chamber exposure, and resonant properties of polyurethane-coated wire bonds and their resistance to periodic Lorentz forces are under study for use in a future High Luminosity Large Hadron Collider detector such as the ATLAS Inner Tracker upgrade.

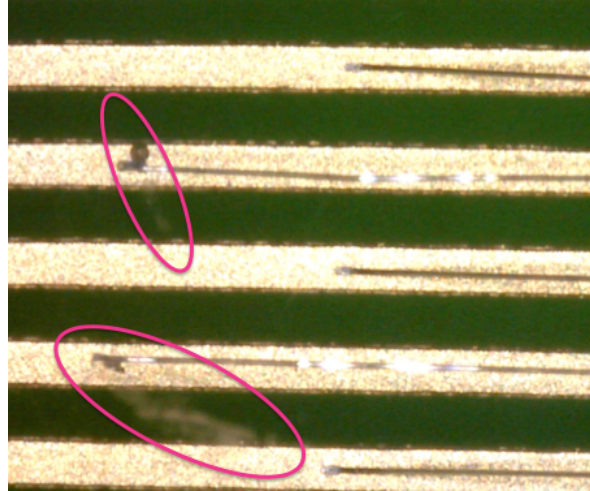
Fig. 1. Aluminum wire bonds in deionized water. Hydrogen plumes and a larger bubble emanate from wire bond heels.

The second wire bond vulnerability is corrosion. In the presence of liquid water, aluminum corrodes via the reaction:  $\text{Al} + 3\text{H}_2\text{O} \rightarrow \text{Al}(\text{OH})_3 + 3\text{H}_2\uparrow$ . The reaction is catalyzed when halide ions are present in solution, and galvanic corrosion can contribute to corrosion when gold and aluminum are both present. Corrosion typically starts at the heel of a wire bond where the protective alumina layer on the outer surface of aluminum and the crystal structure of the aluminum are disrupted during the bonding process. In Fig. 1, two streams of hydrogen bubbles and one larger bubble are visible emanating from the heel of wire bonds that are shown immersed in deionized water. The printed circuit traces were plated with the ENIG process. A forensic signature of a wire-bound corrosion attack on a dry board is a white aluminum hydroxide residue such as those shown in Fig. 2. Aluminum hydroxide residues are best imaged with oblique lighting. The staff of CERN's QART Lab carried out a survey of printed circuit boards from an assortment of CERN experiments and labs. They were able to provoke corrosion with deionized water in six of eight boards that were tested.[5]

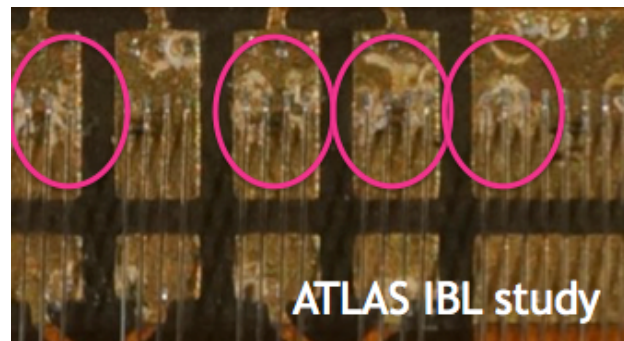
Fig. 2. White residues produced by corrosion .

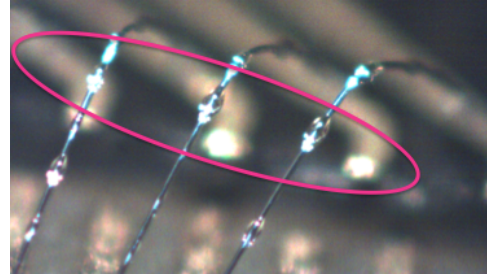
Fig. 3. Polyurethane coatings from a spray can.

Cellpack D 9201 polyurethane is sold in spray cans and as a liquid. Previous attempts to apply a coating with a spray can yielded non-uniform coatings [3] with droplets coalescing on wire bonds such as shown in Fig. 3. Satisfactory coatings were achieved with Cellpack liquid applied using a Paasche Talon Dual Action Airbrush TG2L and a 0.65mm needle and nozzle designed for spraying more viscous paints. Control of droplet size with air pressure and flow rate is crucial. When droplets are too fine, they become tacky en route to the wire (Fig. 4a). If the spray is too heavy, droplets coalesce on wires, just as if they had been applied with a spray can (Fig. 4c). In the Goldilocks zone, uniform coatings are achieved (Fig. 4b).

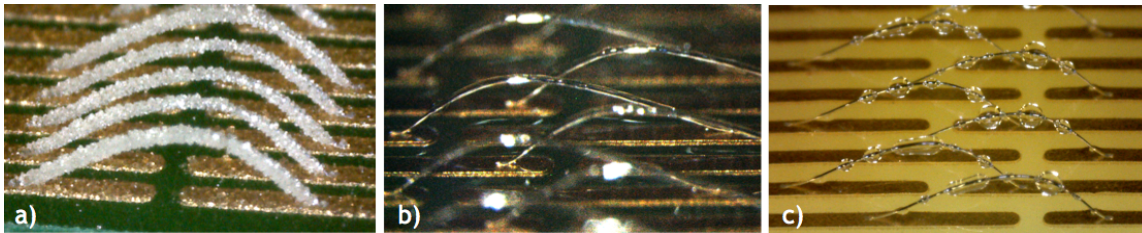
Fig. 4. Examples of polyurethane spraying: a) Spray too fine. Droplets dry before reaching wire. b) Hermetic coatings result when spray is just right. c) Spray too heavy. Droplets coalesce.

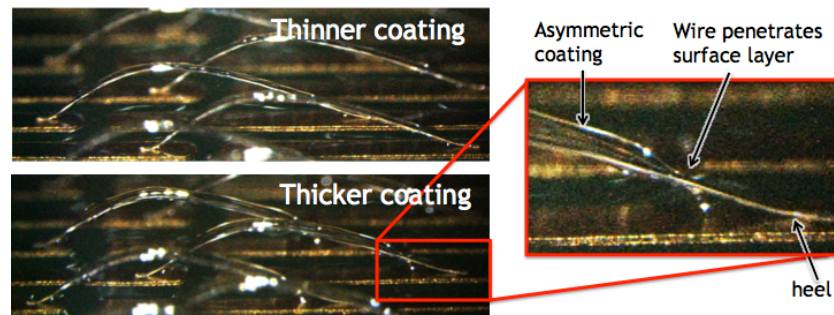
Fig. 5. Multiple spray passes build up the desired coating thickness.

The polyurethane coating thickness is built up by passing the spray over the sample many (tens) of times with just a few seconds between spray passes. Coatings with an outer diameter from  $35\mu$  to  $100\mu$  on a  $25\mu$  diameter wire have been obtained. Wires bonds are hermetically coated, but the coating is asymmetrically deposited on the side of the wire facing the spray (Fig. 5). The wires were sprayed from each end of the bond to ensure coverage of both “ankle” regions above the wire bond feet. The polyurethane that is deposited over the feet and heels of a wire bond blends into the layer that covers the circuit board.

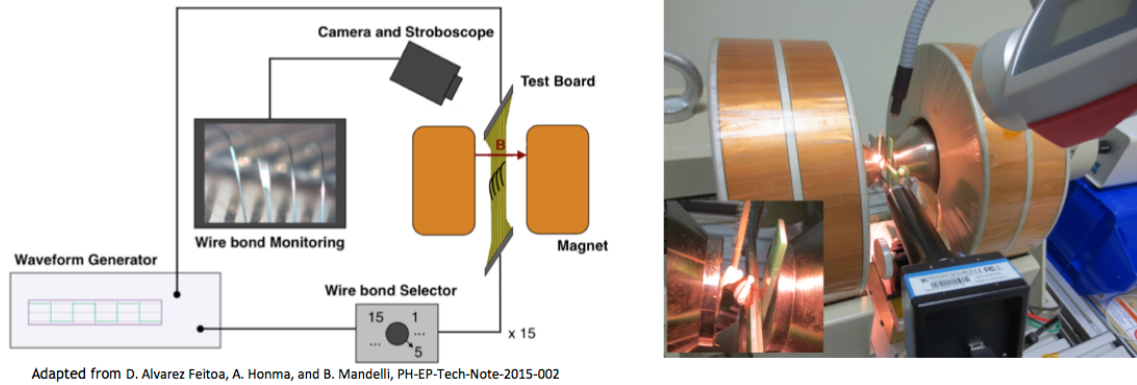
Fig. 6. Test set-up for measuring wire bond resonance properties.

Resonant oscillation testing of wire bonds is carried out within the apparatus depicted in Fig. 6. A water-cooled magnet produces a horizontal magnetic field of up to 1.7 T to simulate ATLAS' 2T solenoidal field. A test board with wire bonds is oriented with its normal parallel to the field to simulate the ITK disk/endcap geometry. A waveform generator sends a 50% duty cycle square-wave current of up to 180 mA p-p through one wire bond. The Lorentz force on a 180 mA current in a 1.7 T field is 50% greater than the worst-case force anticipated on an ITK FE-I4 voltage regulator supply wire bond. The transverse periodic Lorentz force drives a guitar-like oscillation. Wire bonds are imaged with a microscope camera, and the details of wire bond motion are visualized with an LED strobe.

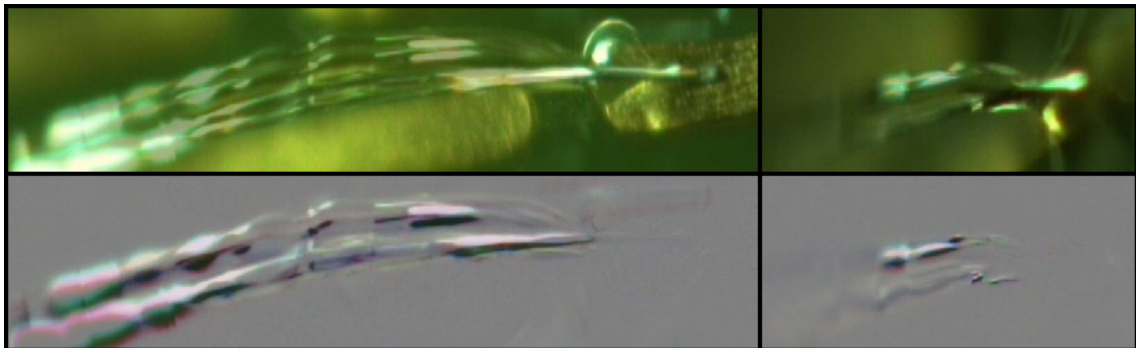
Fig. 7. Video frames have been added (top) and subtracted (bottom) to show regions of movement (light and dark) and the fixed regions (gray) that include the wire bond heel.

Video recordings reveal that the surface layer of polyurethane surrounding and covering the wire bond foot and ankle regions keeps the most vulnerable regions immobilized. Flexing occurs higher along the wire shaft where the coated wire emerges from the surface layer. The immobilization of the wire bond foot in Fig. 7 is demonstrated by the addition and subtraction of video frames. In subtracted frames, locations that are not moving appear as a neutral gray,

whereas displaced images are dark or light. Polyurethane coatings achieve the same foot immobilization as potted wire bond feet, but resonance studies suggest an additional protection mechanism.

A small number of wire bonds were tested to destruction. As the current is increased in increments, and resonance frequency trends gently downward as expected. The generator frequency was adjusted at each current step to the resonance frequency. A dramatic decrease in resonance frequency signals the approach of the elastic limit of a wire bond. Once the elastic limit is reached, a bond sometimes breaks during the search for the new resonance frequency, so only a current range can be quoted in Table 1. The ability to withstand larger peak-to-peak currents is anticorrelated with Q-value. Uncoated wire bonds break easily with a peak-to-peak current of a few mA at their resonance frequency. At the other end of the spectrum, four heavily-coated wires were bullet-proof; they withstood a square wave at their resonance frequencies corresponding to a peak-to-peak current 50% greater than the maximum expected for the ITK for at least an hour. The bond wire in Fig. 7 withstood that current for 38.5 hours!
