Detection of Equipment Faults Before Beam Loss

J. Galambos

ORNL, Oak Ridge, TN, USA

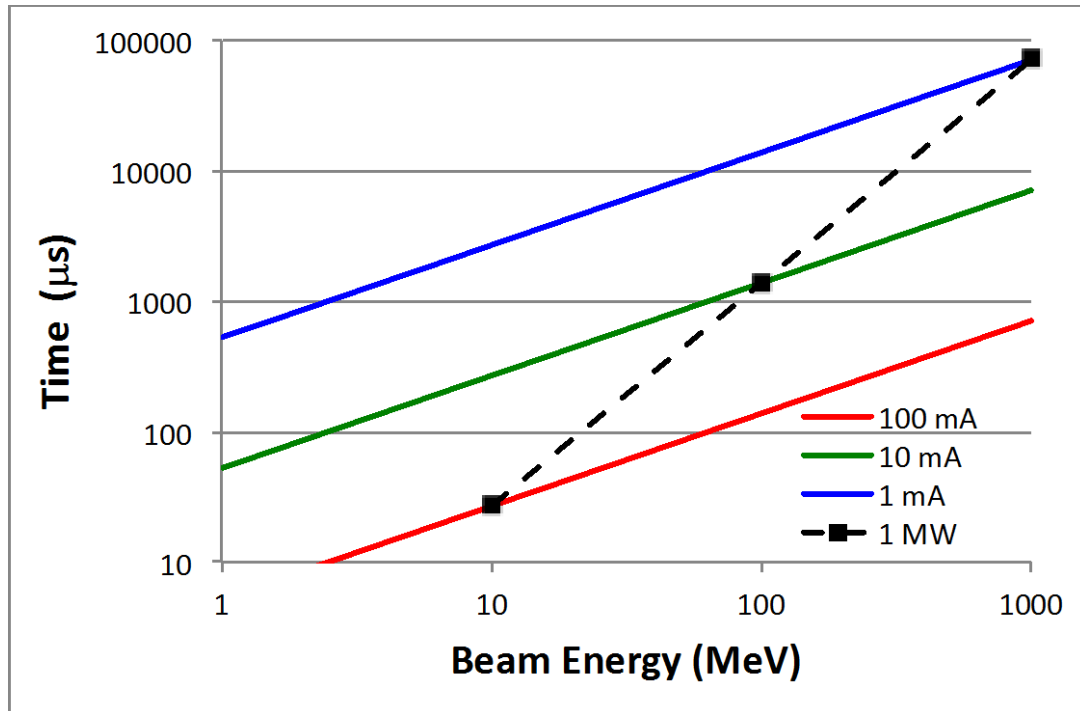
Fig 1: Time required for temperature of Cu to increase by 100°C when subjected to a 1 mm² proton beam of varying average current and energy. The dashed line indicates the 1 MW beam contour.

Before discussing equipment failure precursors, it is useful to understand the reaction time-scales needed to protect equipment from gross beam loss. Figure 1 shows the time required for copper to increase in temperature by 100°C when subject to a 1 mm² cross-section proton beam of varying average current and energy. This can be thought of as a characteristic response time to protect the machine from catastrophic damage from the beam (or approaching the ‘melting metal’ stage). The reaction time is shorter at low energies, owing to the shorter beam penetration length. For average currents above 10 mA, the reaction time is generally less than 1 ms.

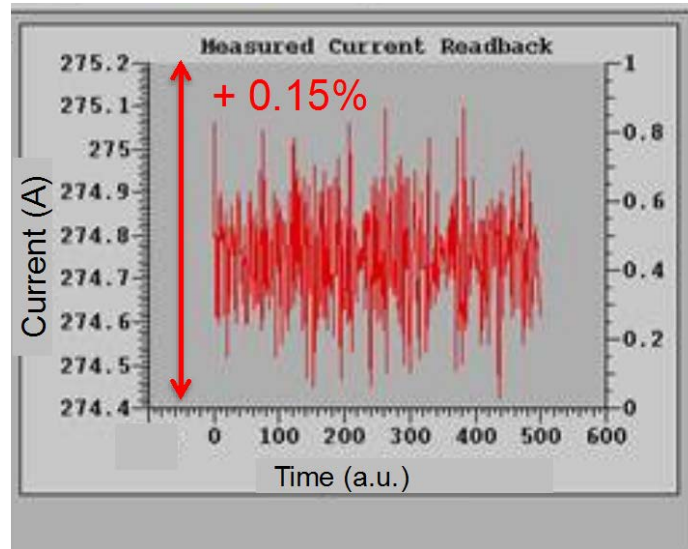
Fig. 2: Sample current fluctuation for a typical quadrupole power supply in a linac

It is relatively straightforward to measure the current in a power supply, and appropriate control capability is specified when the power supplies are ordered. It is a simple matter to adopt software that monitors the power supply output to ensure that the current is at the appropriate set-point. Figure 2 shows an example of a normal quadrupole power supply current fluctuating with time, for a d.c. application.

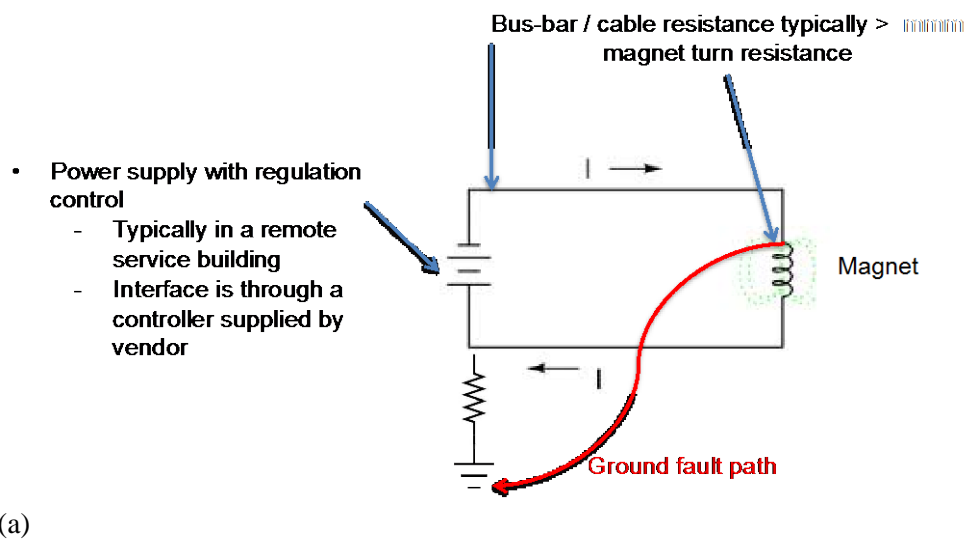
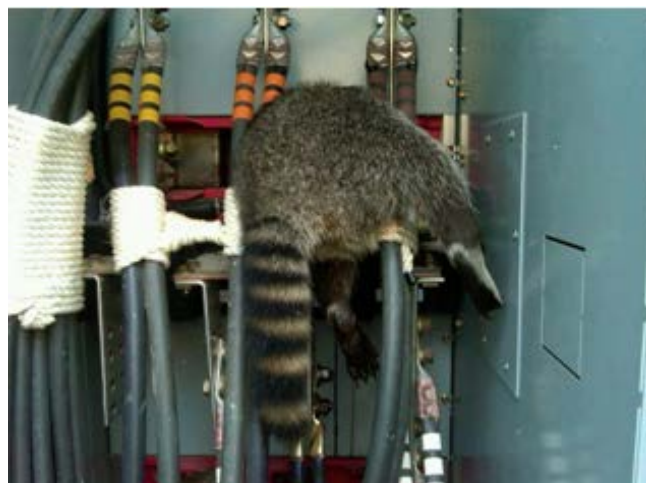
Fig 3: (a) Schematic of a ground fault that shunts part of the current around the desired path through a magnet. (b) Example cause of a ground fault interrupt.

It is possible for the current read-back to be acceptable, but for there still to be a problem in maintaining the desired magnetic field. This can happen if some of the current is accidentally shunted around the desired current path, for example, if there is a turn-to-turn short in a multiturn magnet, or if there is a partial short to ground, as illustrated schematically in Fig. 3(a) (Fig. 3(b) shows an example cause of a ground fault interrupt). The latter example is referred to as a ground fault, and power supplies typically have a protective component called a ground fault interrupt to prevent damage of the cable or power supplies. However, it may be possible for a small amount of current to short-circuit the desired path through the magnet, and still be within the acceptable range of the ground fault interrupt comparator.

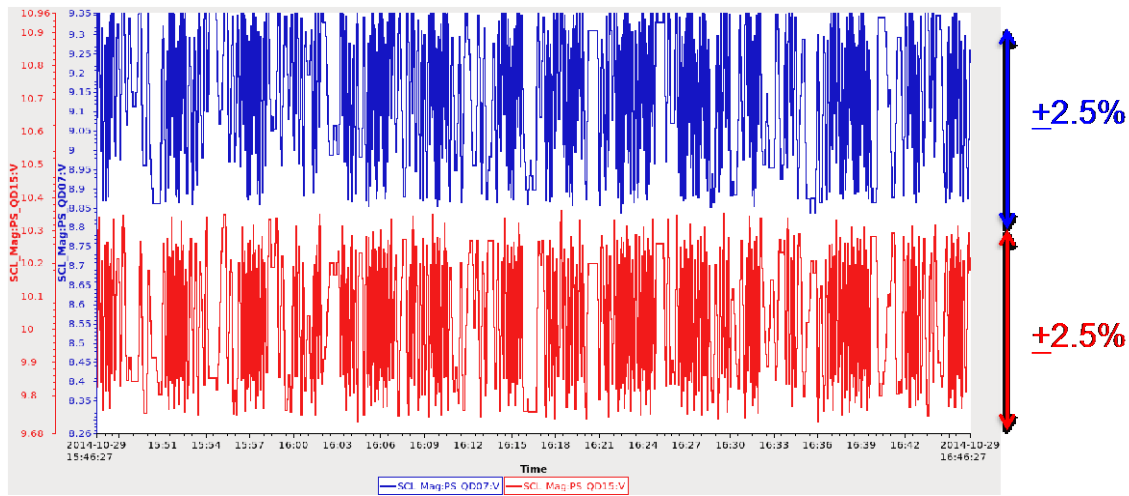
Fig 4: Time chart of the voltage read-back on two quadrupole power supplies (top and bottom plots) over ≈ 1 hour, indicating rather large noise fluctuations.

For particle accelerators, the magnet power supplies are typically of the current-controlled type. A particular current is specified (corresponding to the desired magnetic field level), and the voltage is adjusted to produce the specified current. It is also possible to measure and monitor the voltage required to maintain the specified current. For d.c. magnets, the voltage is ideally constant; for cycled accelerators, the voltage can be quite complicated, but it should still follow the same pattern each cycle. A partial turn-to-turn short will slightly change the resistance across the magnet and affect the voltage required for the power supply to maintain the same current. However, typically in large accelerators, the resistance change is small compared with the overall circuit resistance (or impedance), which includes the effects from cables to and from the tunnel, and multiple magnets driven by the same power supply. The voltage change caused by a turn-to-turn short may not be detectable. Also, magnet power supplies are often not required to have tight tolerance on voltage read-back. Figure 4 shows a typical voltage read-back for two quadrupole power supplies in the SNS superconducting linac section. There is a large level of noise ($>2\%$), which obviates the possibility of detecting small changes in the magnet coil resistance.

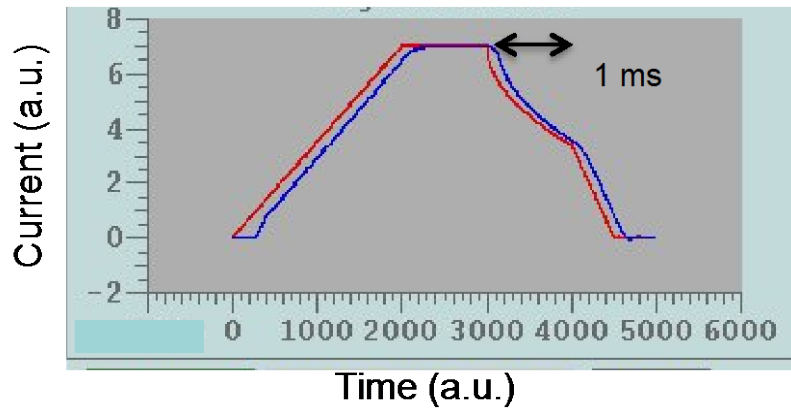
Fig. 5: Current waveforms for a pulsed dipole magnet, with a pre-set target waveform (red, initially leading curve) and actual read-back waveform (blue, initially trailing curve).

As mentioned already, cycled accelerators have repeatable patterns that magnets follow each cycle. While these may be complicated, there is typically a pattern goal for the magnet current over each cycle. Figure 5 indicates a dipole magnet current over one cycle. In this case, it is for an injection kicker in the SNS ring, and occurs over a period of a few milliseconds. Note that there are two curves: a target waveform (red), and the actual measured current waveform (blue). It is possible to compare the two waveforms electronically and report an error or alarm if the difference exceeds a pre-set value. This is the typical procedure for pulsed systems.

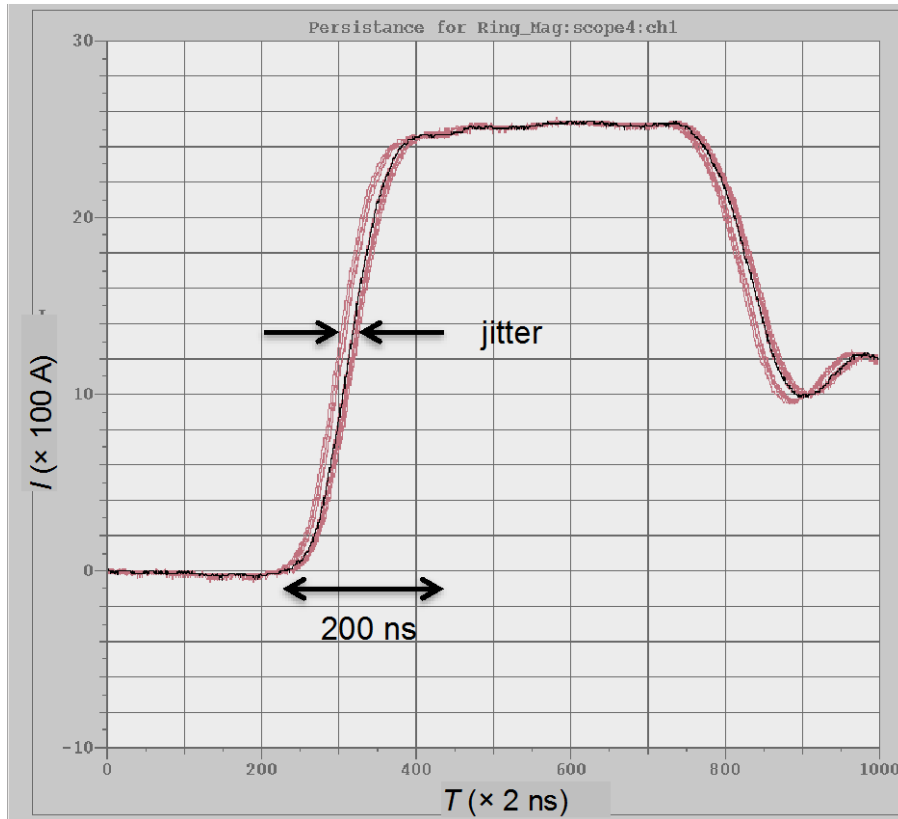
Fig. 6: A persistent display of a kicker waveform over many cycles, indicating a drift of the kicker firing

Another example of a pulsed magnet is a fast kicker system. In this case, magnets reach full field in a fraction of a turn within a ring (≈ 200 – 300 ns). The fields rise during a gap in the beam, so the precise waveform during the field rise is not important. The more critical issue in this case is the timing of the kicker firing, as premature or late firing results in the kicker affecting the beam, which is not in the gap. Figure 6 indicates a waveform display of a kicker in the SNS ring. There are actually ~ 6000 waveforms displayed on the plot, but they fall into two families, and appear as only two waveforms. The appearance of multiple traces indicates the initiation of some drift in the kicker firing, which can be a precursor of an emergent kicker problem. Persistent displays of this type are useful for illustrating a drift in time of a pulsed quantity.

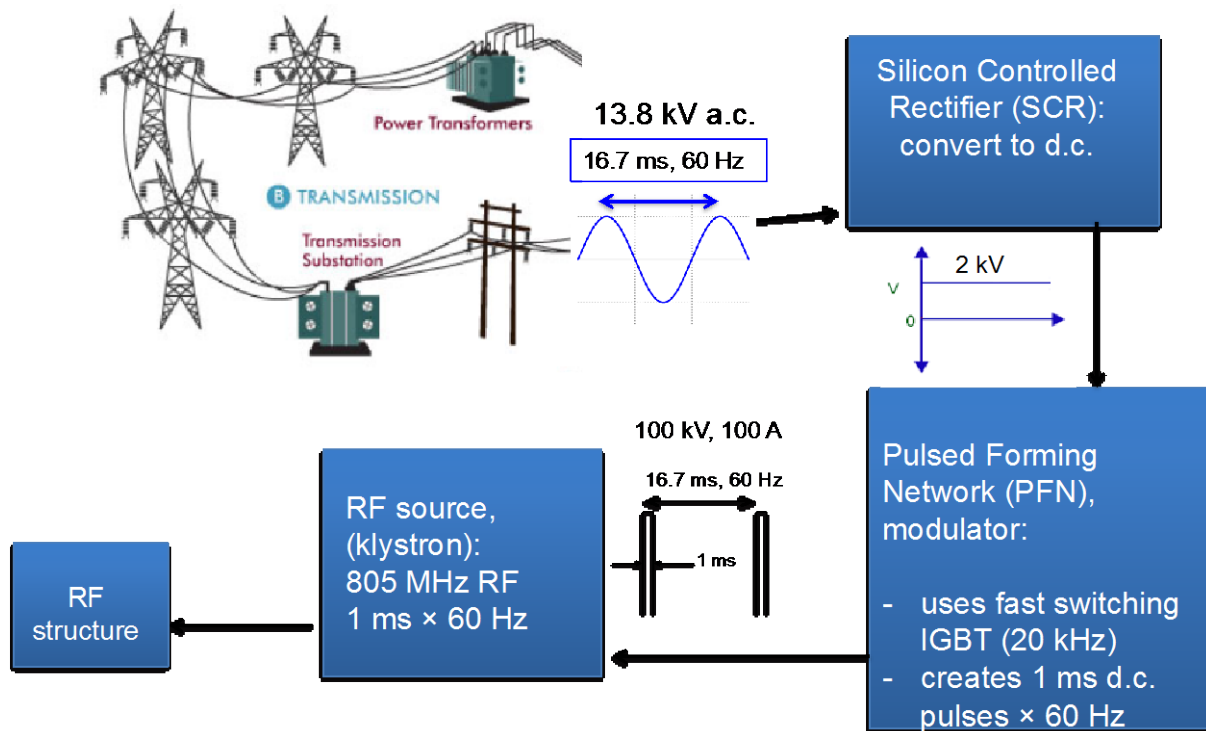
Fig. 7: Schematic of the components of a high-power RF installation

High-power RF systems are a major component of high-power accelerators. There are several linked subsystems within a pulsed high-power RF installation, as illustrated in Fig. 7. Power from the grid is converted from a.c. to high-voltage d.c. in a rectifier. For pulsed systems, the d.c. power is converted by some sort of a pulsed forming network to pulsed high-voltage d.c. waveforms, which are used to power an RF source. The RF power generated in the source is finally transported to the accelerating structure. A crucial part of the overall system is the low-level RF (LLRF) system, which coordinates the timing and amplitude control of the delivered RF power very precisely with the beam in the structure. Any variation or drift in the equipment of these components can cause beam loss. Some examples of identifying causes of beam loss due to RF equipment issues are shown here.

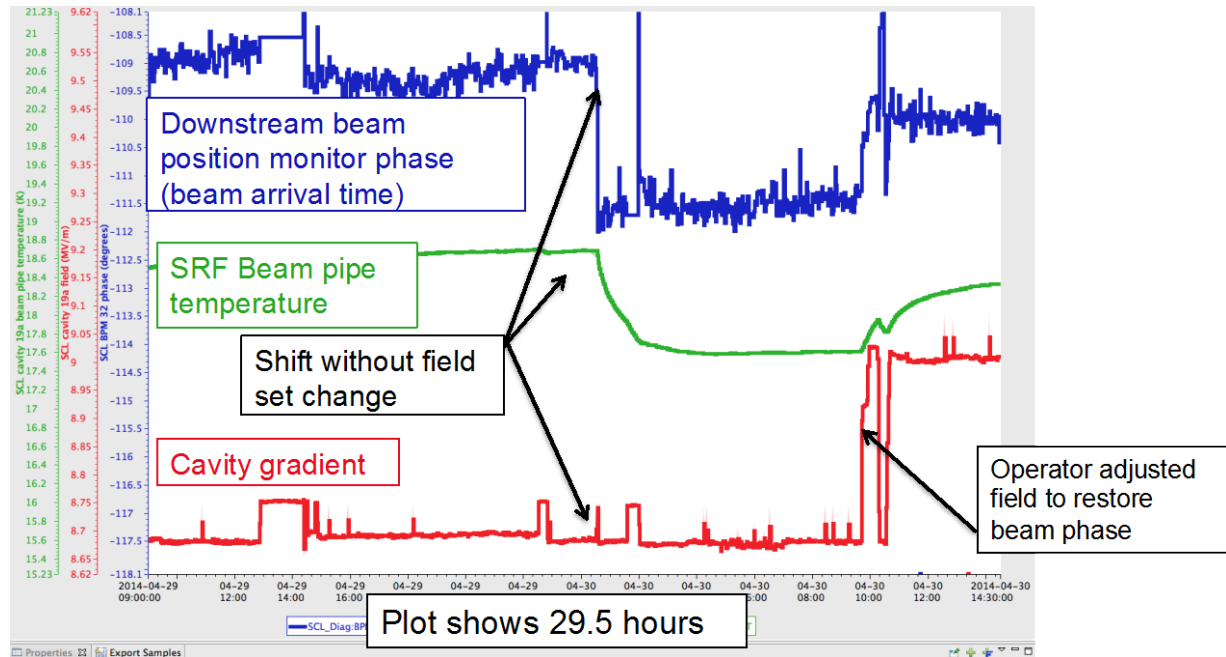
Fig. 8: Timeline indicating a shift in LLRF performance. The bottom curve is the cavity gradient, the middle curve is the beam pipe temperature, and the top curve is a downstream loss monitor signal. The entire time span shown is 29.5 hours.

Figure 8 indicates a time history over ≈ 30 hours of: (1) the field gradient in a superconducting linac cavity (red), (2) the temperature of a downstream cavity beam-pipe (green), and (3) the beam arrival time in a downstream beam position monitor (blue). Near the middle of the time period, there is a sudden change in the beam-pipe temperature and arrival time of the beam, indicating a change in the beam acceleration. The beam loss monitors along the linac did not report a meaningful increase in beam loss, so the beam kept running. About 4 hours later, an operator noticed the change in the downstream beam arrival time and artificially increased the cavity gradient to restore the beam arrival time to the previous value. Subsequently, the beam-pipe temperature also returned to its previous level. In this case, the root cause of the observed changes was an electronic component failure in the LLRF system, resulting in a change in the field regulation, which the operator compensated for. The cavity gradient change was small (a few percent) so it was possible to continue running, but this was an indication of an equipment issue, which needed addressing. The elevated beam-pipe temperature was due to elevated beam loss, even though it was not detectable on loss monitors in this case.

This issue was diagnosed by correlating different signal changes along a timeline. Control systems have tools to perform this task, with both live streaming and archived data. This is a common technique for diagnosing previously unseen issues.

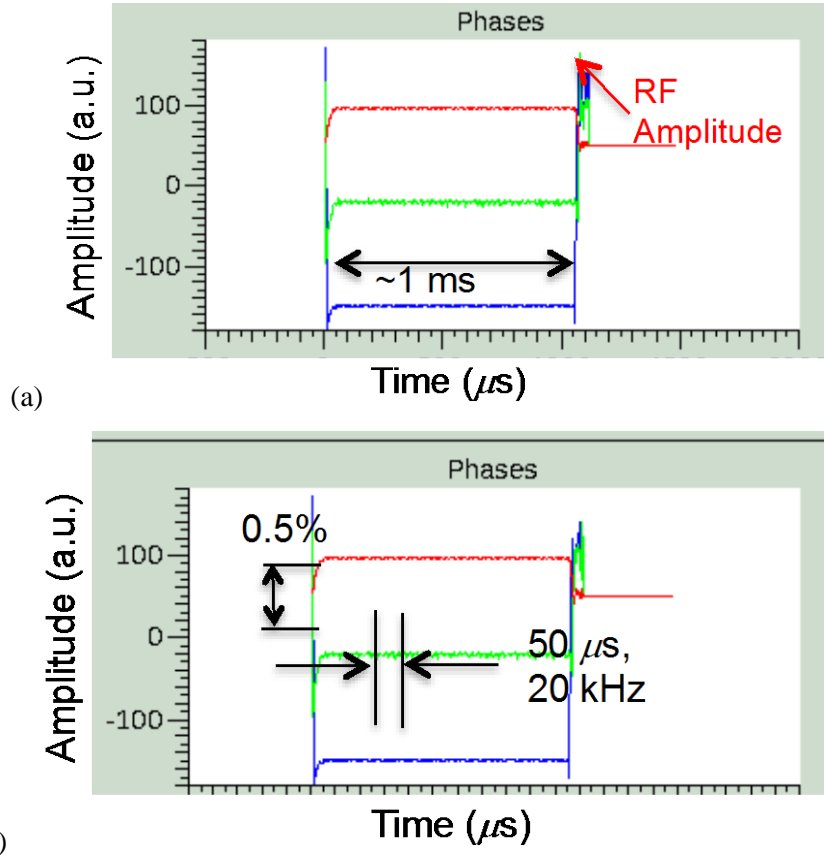
Fig. 9: (a) A waveform display of the RF amplitude (top curve in (a)) of a copper structure cavity. (b) Enlargement of the same trace, revealing 20 kHz noise.

Another technique for diagnosing RF system equipment issues is that of monitoring fast time-scale waveforms of the RF system. Figure 9(a) shows the LLRF amplitude waveform output for a 1 ms pulse in a copper cavity structure. Figure 9(b) shows a zoomed-in view of the amplitude axis. While the zoomed-out view indicates a fairly nice looking waveform, the zoomed-in image shows some amplitude noise at about the 0.5% level. This jitter is within the acceptable control margin, and is not, in itself, a concern. Analysis of the structure of the amplitude noise reveals a 20 kHz frequency component. It turns out that the pulse-forming network (PFN) uses 20 kHz solid-state switching technology to provide the high-voltage drive for the klystrons powering this cavity.

This amplitude fluctuation is an indicator of the PFN health, and can be monitored. If this ripple increases, it could become a source of beam loss, so maintenance or adjustment of the PFN unit can be identified from the downstream LLRF measurement. It is useful to have automated systems to monitor the quality of the RF waveforms and report cavities that exceed a permissible threshold of amplitude or phase variation.

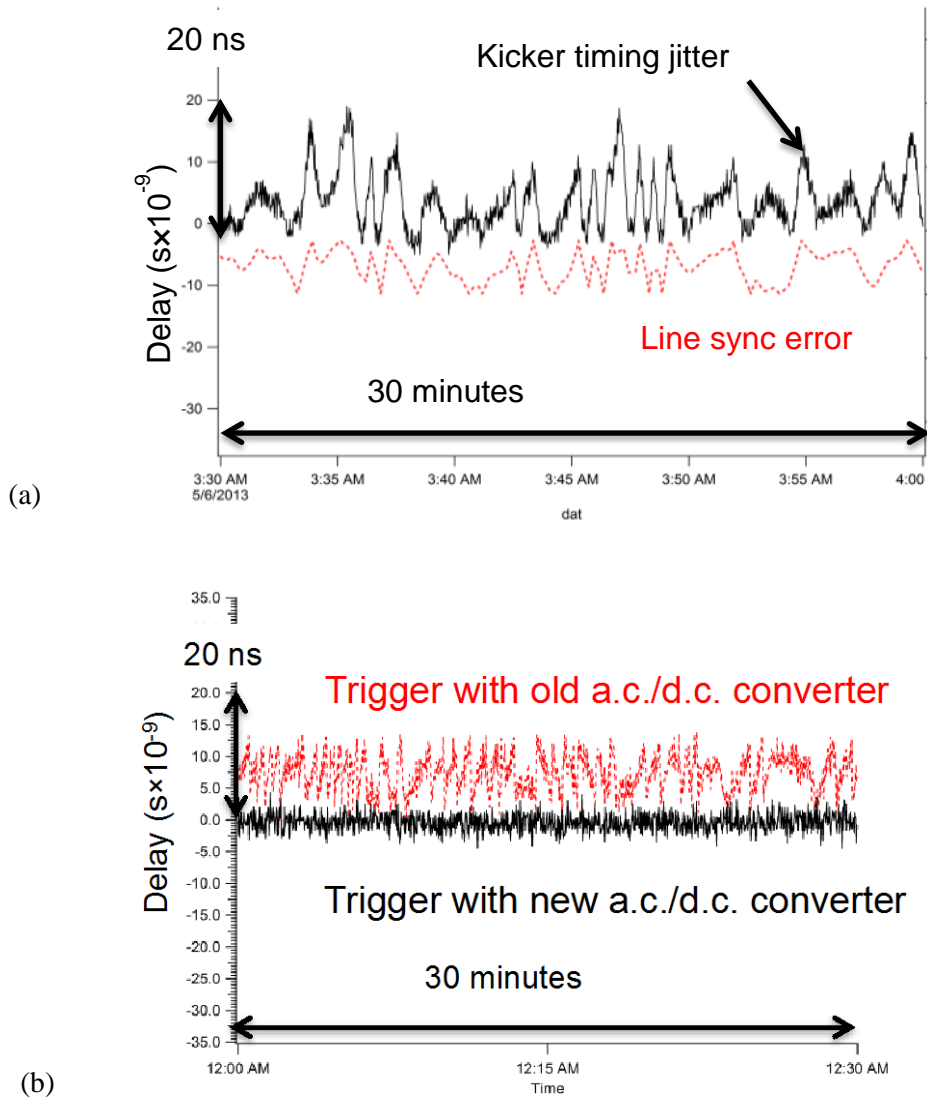
Fig. 10: (a) Jitter in the timing signal of a kicker magnet (black) with a correlation in the line-synch phase variation (red). (b) Jitter in the timing signal with the faulty a.c.–d.c. convertor (red) and with a replaced unit (black).

High-power accelerators are large electrical power consumers. Historically, pulsed accelerators were designed to run at harmonics of the electrical grid frequency, to be able to ‘ride along’ at a constant phase of the electrical grid a.c. power cycle. Although electrical grids are referred to as operating at 60 Hz, or 50 Hz, there are constant slight variations in the electrical power generation frequency to match the demand load. Previous-generation pulsed accelerators would adjust the beam pulse timing to follow the grid frequency, so as to maintain a constant phase offset from the peak of the voltage cycle. With the advent of solid-state fast switching technology to provide PFN capabilities, modern electrical systems are generally not sensitive to when the beam pulse occurs relative to the grid power cycle. This enables accelerators to run at constant frequency, and even at a frequency that is not a harmonic of the grid. However, there can be issues if the grid a.c. frequency effects ‘leak-through’ to the beam in unanticipated ways. An example is shown in Fig. 10(a), which shows jitter in a kicker timing signal (black trace) and the variation of the beam trigger with grid line cycle peak (red trace). There is a weak correlation in these traces, which led to the investigation of the kicker timing unit. Indeed, a low-cost a.c.–d.c. transformer was found to be performing below its specification (with an unacceptable a.c. component leading through to the d.c. signal). Although the beam loss was acceptable, if the issue progressed, it would become an issue. Figure 10(b) shows the improved-stability timing signal after replacement of the faulty a.c.–d.c. conversion unit.

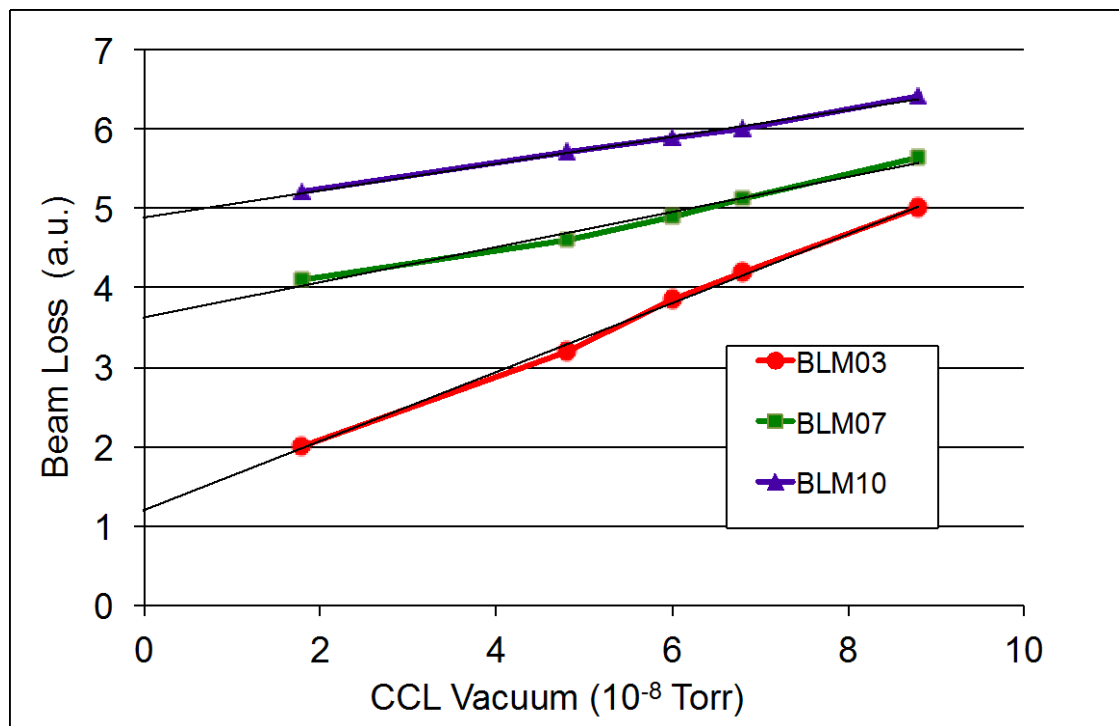
Fig. 11: Variation of downstream beam loss measurements with a purposeful variation of vacuum in an upstream region.

Most high-power accelerators require high vacuum to maintain low beam loss. Beam scattering and charge state changes (e.g. e-stripping) are examples of the loss mechanisms that cause beam loss [3]. Figure 11 indicates a clear response of downstream losses in a superconducting linac section, from a purposeful change in an upstream copper linac section vacuum level (caused by turning off vacuum pumps). While there is a clear dependence of loss on increasing vacuum levels, there is also another loss component. Monitoring the health of the vacuum systems is clearly an important part of preventing beam loss. Figure 12 shows the time history of the vacuum in a transport line of the SNS accelerator. There are fairly regular vacuum ‘spikes’ in the first half of the display, but these can be ignored. They happen regularly (e.g. related to beam trips and related loss). However, in the second half of the display, a sustained increase in vacuum baseline is observed, and is cause for implementing vacuum pump repair work. In this case, there was not a serious beam loss increase, but this is a precursor to more serious issues.

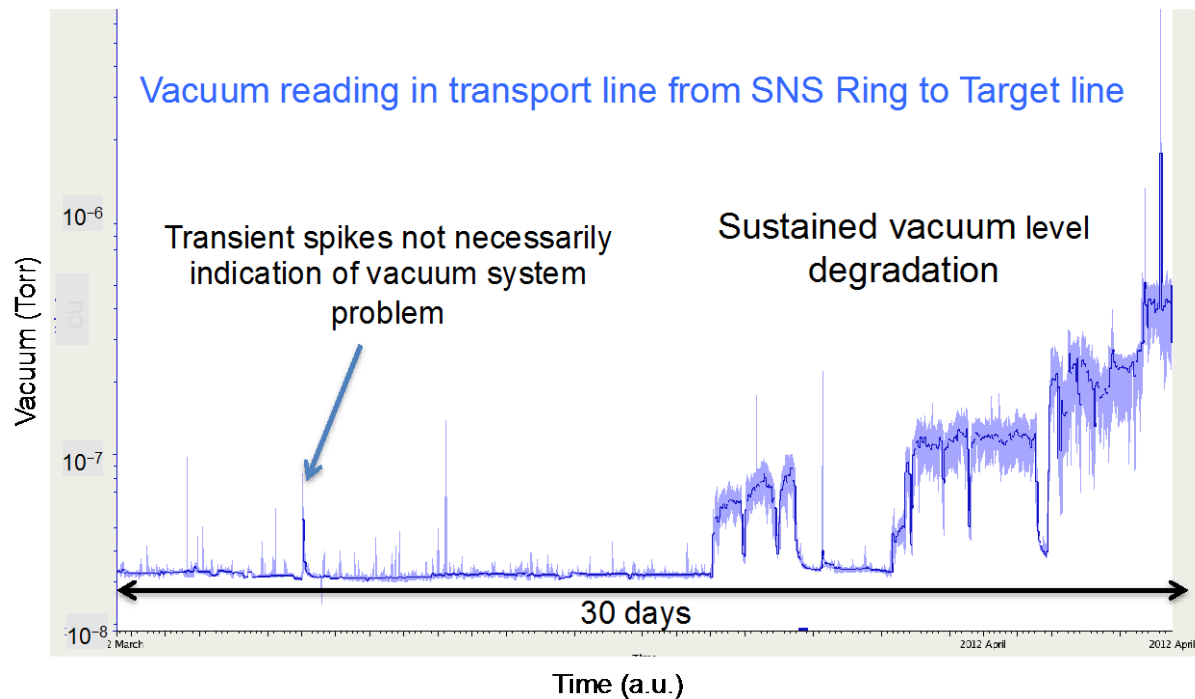
Fig. 12: One-month time history of the vacuum level in a transport line section, indicating a developing issue

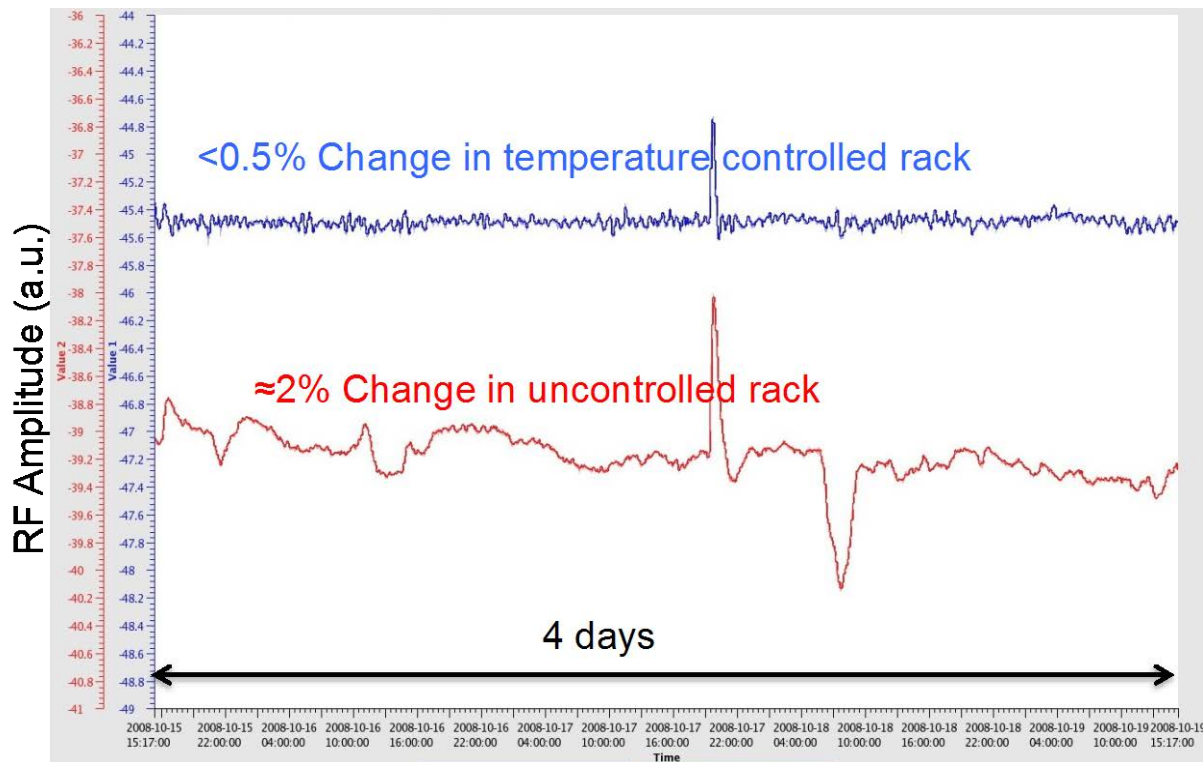
Fig. 13: Drifts in the RF field amplitude in a cavity with temperature-controlled LLRF electronics (blue) and in a cavity with similar LLRF electronics in a rack without temperature control (red).

variations in the thermal stability of the LLRF analogue front end board stability were measured, dependent on the particular electrical components used on the board. Figure 13 shows the RF field amplitude stability over several hours for two cavities with similar LLRF electronics. The unit in a rack with temperature control stabilization shows an acceptable drift in the field level, whereas the unit without temperature control shows an unacceptable drift. Temperature control stabilization in the racks was instituted to alleviate the drift, as indicated in Fig. 13. The better solution is to use electronic components that are not temperature sensitive, but this is not always possible.

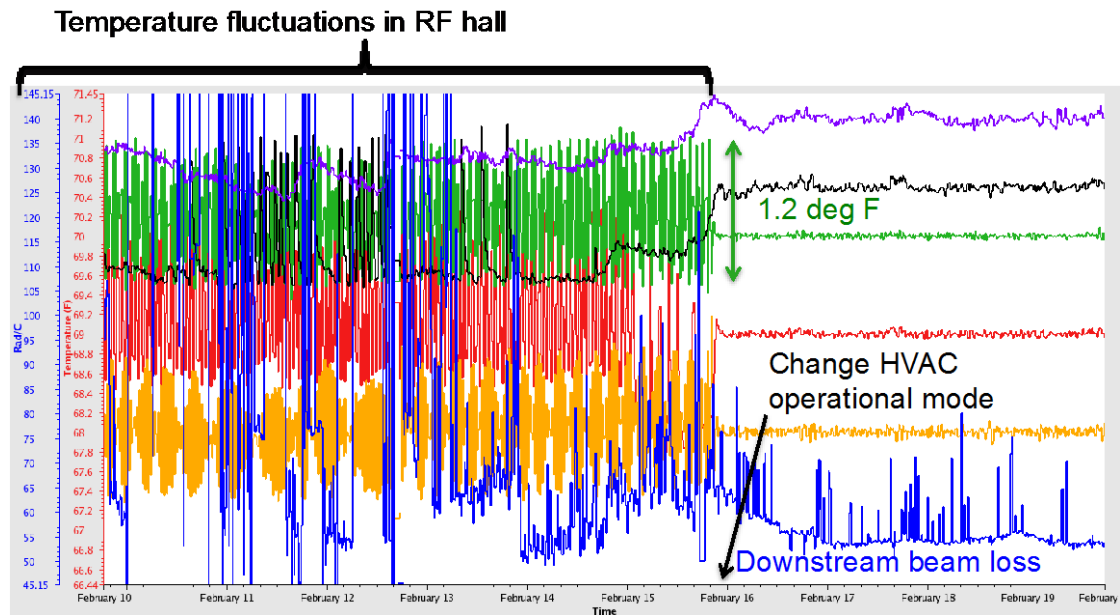
Fig. 14: Ten day period during which a new HVAC control mode was attempted, resulting in $\sim 1^\circ\text{F}$ fluctuations within the linac RF gallery [green (third curve from top), red (third curve from bottom), and orange (second curve from bottom) traces], causing unstable beam loss in the linac (bottom blue) trace.

Another temperature sensitivity of concern is the change in cable lengths with temperature. For some critical applications, such as RF reference lines, steps are taken to minimize this effect (temperature control of the reference line). But it is prohibitively expensive to control the temperature of all cables, and some beam instrumentation cables and LLRF cables can be many tens of metres long, and subject to slight length changes, which can cause changes of a few degrees Fahrenheit in the RF phase control for high frequency (~GHz) systems. As an example of this effect, Fig. 14 shows the SNS klystron gallery building temperature (measured at several locations) and a downstream linac beam loss, measured over about 10 days. For the first week of the display, a new heating ventilation and air conditioning (HVAC) operational mode was attempted, which resulted in continuous temperature fluctuations of $\sim 1^\circ\text{F}$ throughout the building (this is the building that houses the RF equipment). Finally, the old control mode was re-established, and both building air temperature fluctuations and unexplained beam loss fluctuations disappeared.

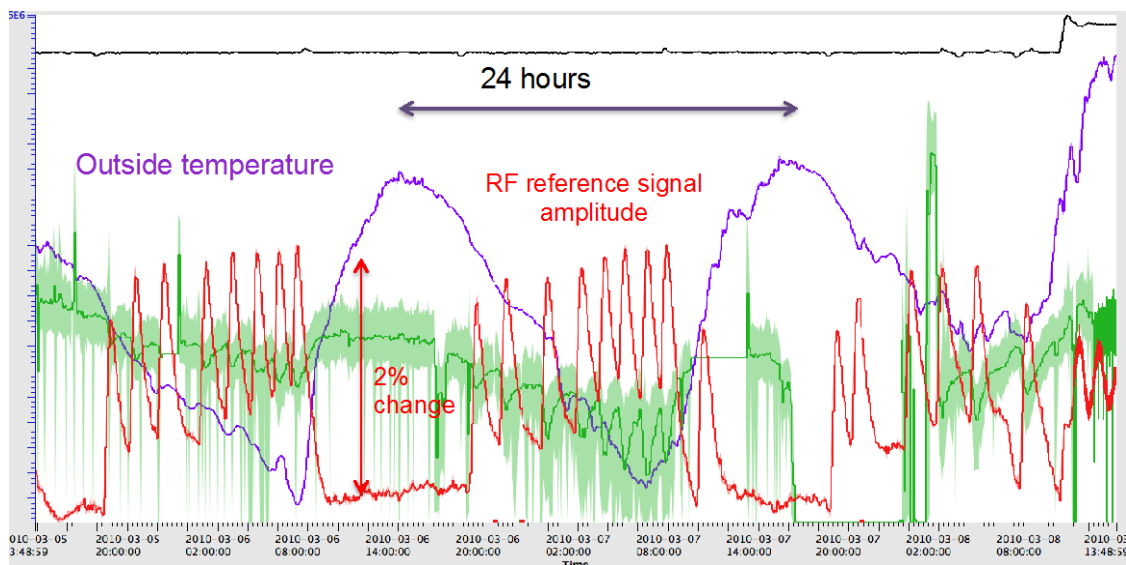
Fig. 15: Diurnal temperature variation leading to unexpected behaviour in RF reference line control and a related change in beam parameters.

Another example of a subtle temperature change affecting beam parameters is shown in Fig. 15, which shows parameter variations over ≈ 3 days. In this case, unexpected erratic behaviour was observed in the beam injection area of the SNS accumulator ring (green curve labelled 'beam missing foil'). An operator noticed a correlation of this parameter with the variation in amplitude of the linac RF reference signal (which should be constant). The erratic behaviour only occurred at night, when the building, which houses the reference line signal generator, was cooler. Replacing the reference line signal generator solved the issue, as it had developed a temperature sensitivity. This is another example of how searching for correlations helped identify the source of the equipment problem. The associated beam issues were never severe enough to stop beam operation in this case.

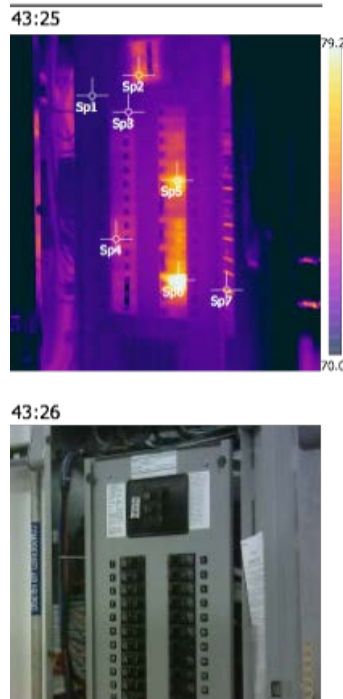
Fig. 16: Thermal (top) and visual (bottom) images of the same breaker panel. The thermal image shows hot spots (e.g. Sp2, Sp6, and Sp7) not seen in the visible spectrum image.

Finally, we should note that it is often useful to monitor equipment temperature directly, even if direct temperature sensors are not available. Infrared imaging is a useful technique to provide highly localized temperature information. An example is shown in Fig. 16. This technique is useful for periodic monitoring of circuit breakers and magnet cable connections, as loose connections generate heat, which leads to equipment degradation or failure.

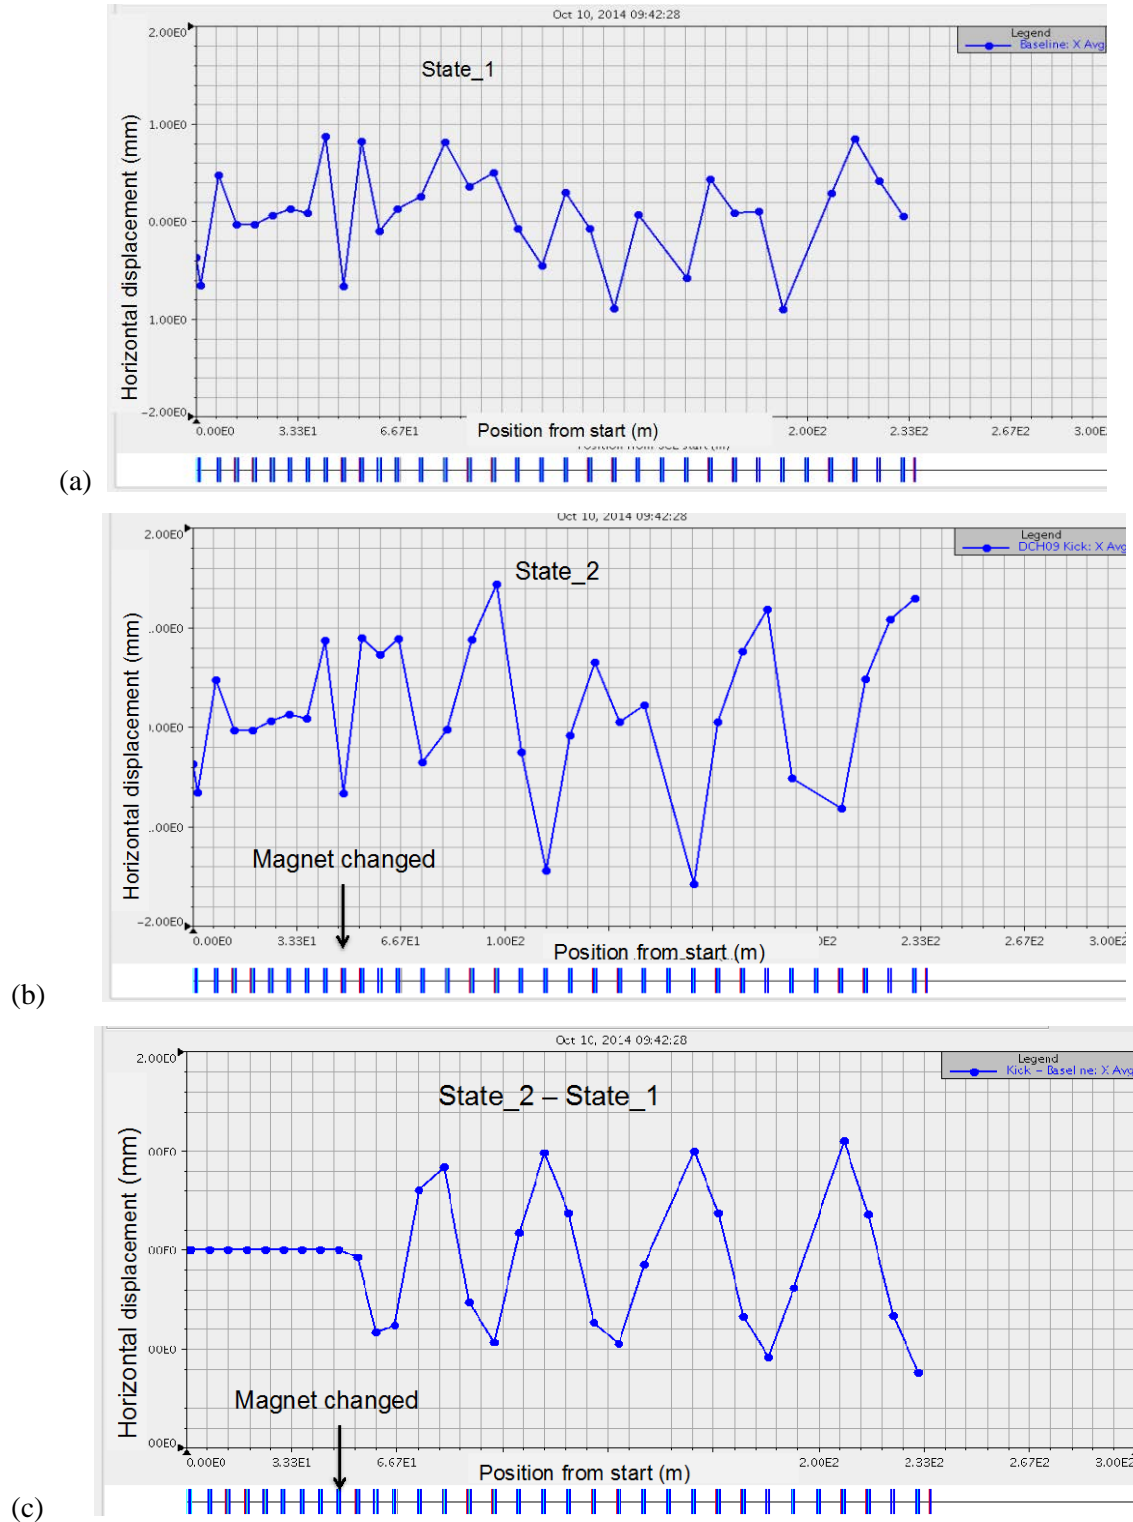
Fig. 17: (a) Original beam trajectory along the horizontal axis. (b) Trajectory after a change in the steering at the indicated location. (c) Difference between the trajectories of (b) and (a). (Magnets are displayed synoptically below the x-axis).

Measuring changes in the transverse beam position is the most direct method to detect issues with equipment that affect the transverse beam position (e.g. magnets and RF devices for hadron beams). Figure 17(a) shows a typical beam trajectory along a linac. Ideally the trajectory lies perfectly along the axis; however, there are typically slight imperfections. This trajectory is somewhat chaotic, but acceptable. Figure 17(b) indicates the same beam trajectory, with a slight change to a steerer at the location indicated. It is not obvious from this image alone where the trajectory change originated. However, a plot of the difference between the two trajectories indicates a wave in the beam motion beginning where the steering changed. Orbit (trajectory) difference techniques are powerful methods of identifying changes in steering magnets and RF or quadrupole elements if the beam is even slightly off axis. Sometimes, the settings of the magnet or RF may not have changed. For example, if a slight turn-to-turn short is developing, the applied magnetic field can change slightly, even though the magnet current settings have not been changed. Also, if the LLRF control is not working properly (e.g. as shown in Fig. 8), a trajectory change may be observable.

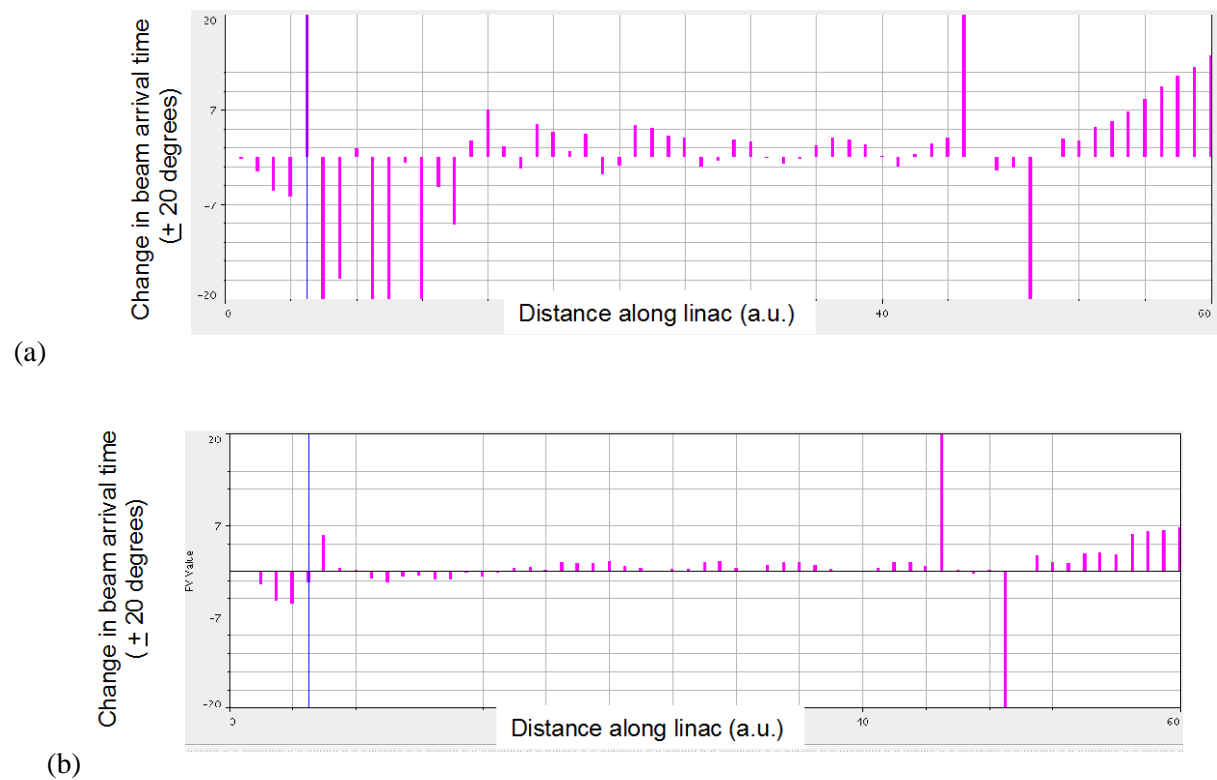
Fig. 18: (a) Change in beam arrival time along the SNS linac from beam set-up conditions. (b) Same plot as (a), after adjusting the phase of an RF structure at the start of the linac.

The method described in Section 4.1 can also be applied in the longitudinal direction. In the longitudinal plane, the longitudinal ‘position’ is typically recorded as the beam arrival time relative to a reference RF signal, often in units of ‘degrees’ of the reference RF signal. The measuring device may be a beam position monitor (if properly designed for this capability), or an RF resonator of some sort. Figure 18(a) displays the change in beam arrival time along the SNS linac from the saved beam set-up values. A wave is evident, starting from the beginning (the magnitude of the wave changes along the linac in this case, because the units of the arrival time change, and are not corrected here). This provided information as to where the problem originated, and an operator adjusted the phase of the first cavity in the linac, resulting in the difference plot shown in Fig. 18(b), which shows that the beam trajectory is much closer to the set-up conditions. This enabled continued beam running until a maintenance day, when a poor LLRF cable contact was discovered at the first cavity.
