**Characterization of Carbon-Contaminated B₄C-Coated Optics
after Chemically Selective Cleaning with Low-Pressure RF Plasma**

ABSTRACT

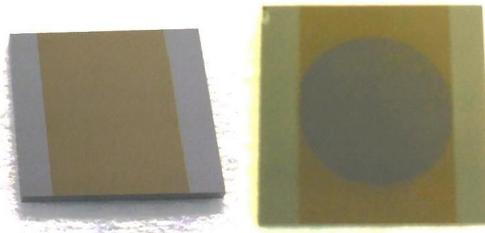
Fig. 1: Si(100) test wafers (10x10 mm² size) provided with a B₄C coating stripe (ocher color – see left hand side panel) plus a central amorphous carbon contamination spot (dark grey color – see right hand side panel) on top of the B₄C layer.

Si(100) wafer pieces, coated with an amorphous B₄C layer (see Fig. 1) were used in order to characterize changes in the B₄C surface chemistry as induced by the plasma treatment using x-ray photoemission spectroscopy (XPS). In addition, an energy-dispersive x-ray analysis (EDX) and/or scanning electron microscopy (SEM) analysis was performed on these Si test wafers in order to obtain information on the bulk versus surface chemical stoichiometry as well as changes in the surface morphology of the B₄C coatings. A partial/central amorphous carbon coating spot was applied in order to investigate the influence of the direct exposure of the plasma onto the B₄C coating (i.e., with or without the amorphous carbon top coating).

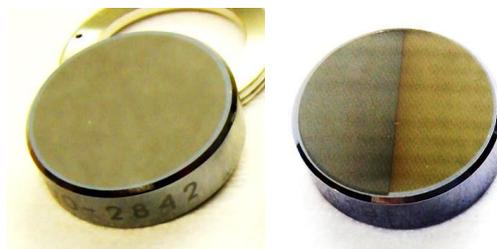
Fig. 2: Optically polished Si test mirrors with one inch diameter. The mirror on the left hand side shows a pristine B₄C coating, while the mirror on the right hand side exhibits one half of its surface (i.e., the darker part) coated with an additional amorphous carbon layer with 70 nm thickness.

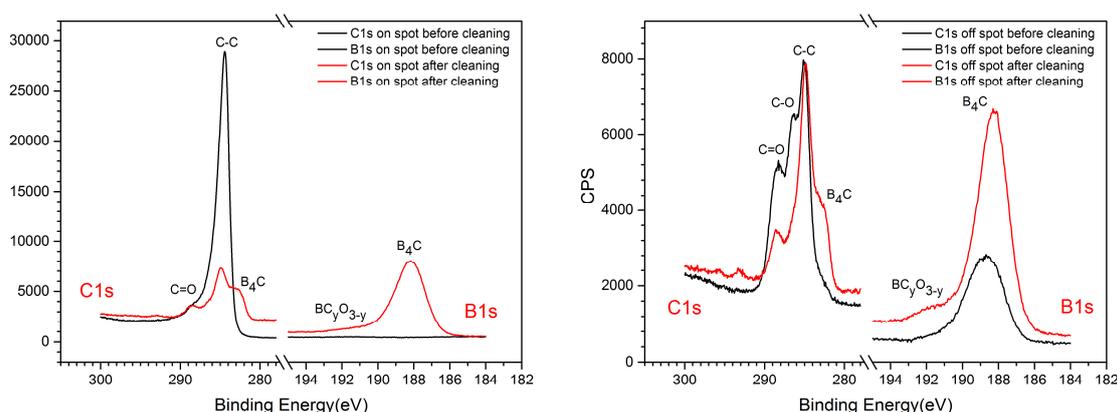
Fig. 3: High-resolution C1s and B1s XPS spectra of the B₄C-coated test wafer before (black solid lines) and after O₂/Ar RF plasma cleaning (red solid lines). Left panel: XPS data taken on the amorphous carbon contamination spot. Right panel: XPS data taken off the amorphous carbon contamination spot on the bare B₄C coating.

Fig. 3 shows the XPS high resolution spectra from the Si test wafers in Fig. S1, with the measurements being performed off as well as on the a-C spot before and after the O₂/Ar plasma cleaning. We first consider the “on spot” spectra before/after the plasma cleaning. Here, one can clearly distinguish the absence and the appearance of the B1s XPS line before and after the plasma processing, respectively, together with a significant reduction of the C1s core level line.

The cleaning efficiency becomes clear from the increase (reduction) of the B1s (C1s) lines for the “on spot” via the cleaning process, as well as from the overall similarity of the B1s and C1s lines between the “on spot” and “off spot” locations after cleaning. Taking a closer look at the spectra,

According to the XPS line assignments given in Table II, one can interpret the high resolution spectra in such a way that the O₂/Ar plasma surface treatment leads to:

- A substantial reduction of the C-C C1s peak (“on spot” and “off spot”) as well as the C-O and the C=O peaks (“off spot”), that are all related to adventitious or purposeful surface artifacts.
- The appearance of the B-B and B-C B1s line and the associated B-C peak in the C1s spectra (“off spot” and “on spot”) being due to B and C in bulk B₄C, respectively.
- A weak B1s peak at 191.4 eV B.E. due to the occurrence of boron oxy-carbide (BOC).

On the other hand, we observe for the post-treatment spectra that the spectral fingerprint of especially the C1s XPS lines *invariably* exhibits the three peaks associated with B₄C, C-C, and C=O (with some minor shoulder at 286.6 eV due to C-O). This indicates the existence of a chemically stable layer at the B₄C surface that is either resilient with respect to the plasma surface interaction and/or is a direct result from the latter. Similar results will be apparent from other plasma treatments with different feedstock gas combinations as will be shown in the next sections.

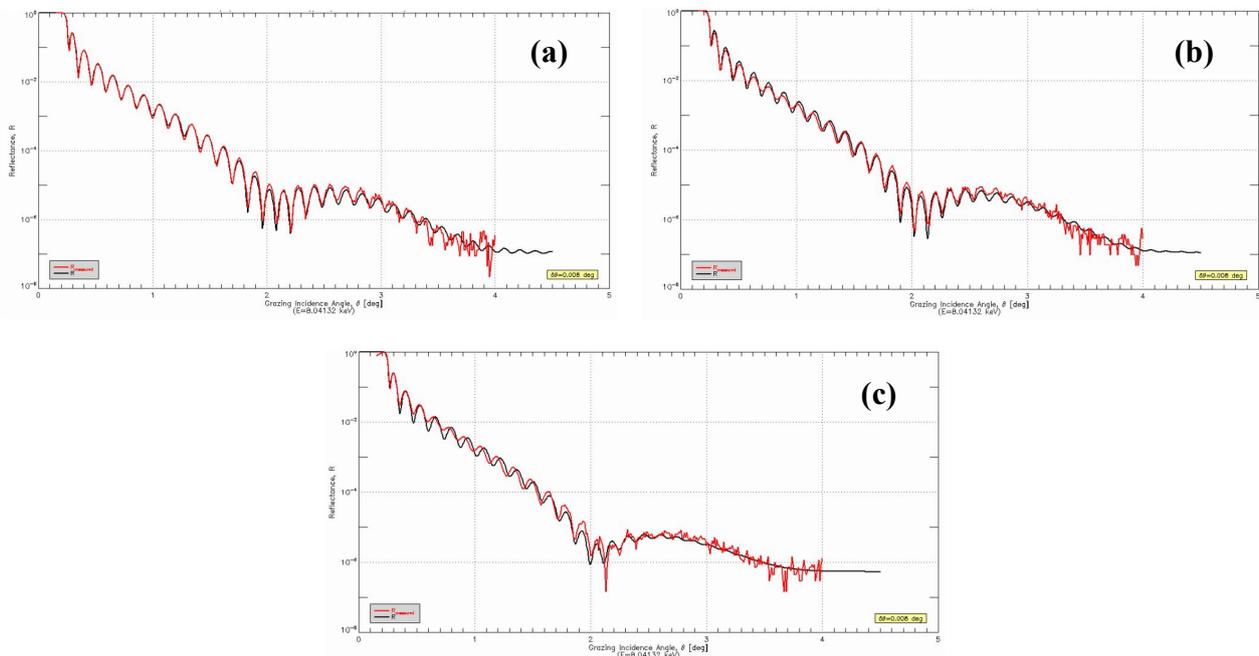
Fig. 4: XRR data from (a) pristine B₄C-coated Si test wafer right after B₄C deposition, (b) after 7 months of storage in air, and (c) after O₂/Ar plasma cleaning (red solid lines: experimental XRR data; black solid lines: IMD simulation)

In order to probe the effect of the O₂/Ar plasma treatment onto the integrity of the B₄C coating and the roughness of the B₄C/air interface, we have performed XRR measurements on both the Si wafer test coupons and the B₄C-coated test mirrors. The results from both types of test specimen are depicted in Figs. 4 and 5 and the parameters resulting from the IMD simulations of the experimental XRR data are given in Table III. All the XRR data simulation shown here include the Cr binding layer with about 2.2 nm thickness between the B₄C coating and the Si substrate.

Table III: Results from the IMD simulations of the XRR measurements as shown in Figs. 4 and 5.

When comparing the XRR results from the pristine Si test wafer (i.e., measured right after the B₄C deposition) with those from the Si wafer stored in air for 7 months, there is an apparent increase in B₄C layer thickness (i.e., 31.0 nm as compared to 29.9 nm). This is ascribed to the oxidation of the B₄C surface due to the exposure to atmospheric air, leading to the formation of BC₂O and BCO₂ together with the adsorption of adventitious carbon from atmospheric gases. Due to the limited

On the upside, the O₂/Ar plasma treatment of such a B₄C layer after such an extended exposure to atmospheric air results in the removal of the physisorbed surface contaminations together with a reduction of the B₄C layer thickness by 0.6 nm (i.e., 29.3 nm as compared to originally 29.9 nm). On the downside, the plasma treatment incurs an increase in rms surface roughness from 0.4 nm to 0.6 nm (see the upper part of Table III).

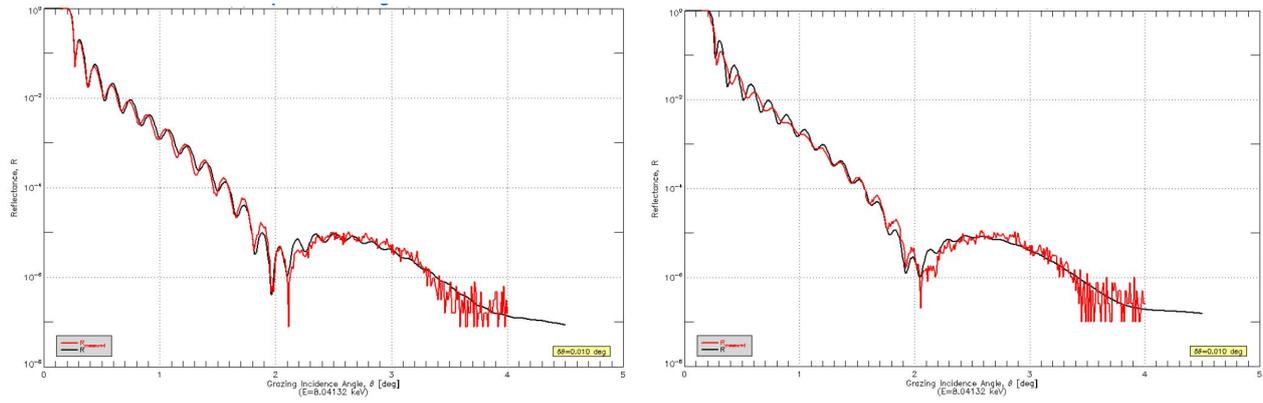
Fig. 5: XRR data from B₄C-coated test mirror right after O₂/Ar plasma cleaning. Left hand side: Non a-C coated part; right hand side: Formerly a-C coated part (red solid lines: experimental XRR data; black solid lines: IMD simulation)

The XRR analysis from the B₄C-coated mirror in the lower part of Table III basically conveys the same message: A reduction of the B₄C layer thickness between 0.9 and 0.1 nm (for the formerly C-coated and non C-coated part, respectively) together with an increase of rms surface roughness between 0.1 and 0.2 nm.

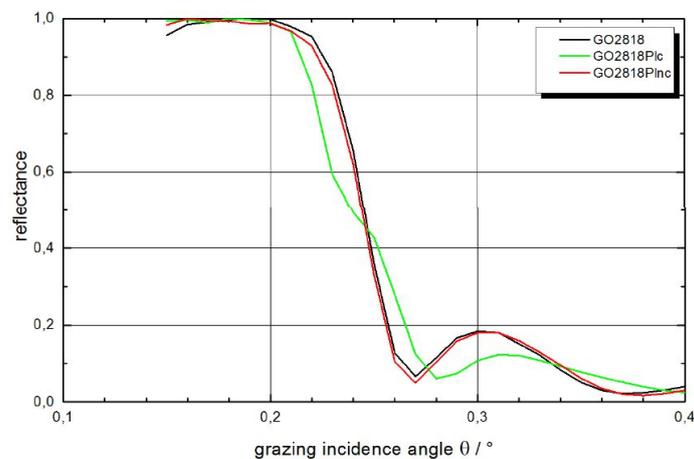
Fig. 6: Comparison of XRR total reflection data at low grazing angles for a pristine B₄C-coated test mirror (black line) and after a-C coating plus subsequent O₂/Ar plasma cleaning (green line: formerly a-C coated area; red line: non a-C coated area).

Additional information on the changes regarding especially the optical performance of the mirrors at Cu K α wavelength for correspondingly larger penetration depths (i.e., as compared to XPS) can be obtained by evaluating the total reflection part of the XRR data at low grazing incidence angles. In that respect, Fig. 6 gives evidence for an incomplete carbon cleaning of the mirror surface due to the deviation of the spectrum formerly a-C coated mirror surface (green line) at about 0.25 degree

grazing incidence as compared to the spectra for the pristine and non a-C coated samples (black and red lines, respectively). Also, the further discrepancies around 0.3 degree grazing incidence corroborate the changes in B₄C layer thickness mentioned above. The results from the surface roughness measurements via interference microscopy give – although being quantitatively lower than the XRR data – the same increase in terms of surface roughness by the plasma treatment (see Table III). Especially the deviations of the reflectivity edge of the formerly a-C coated material as compared to the pristine reflectivity are far from acceptable in terms of the expected optical performance.

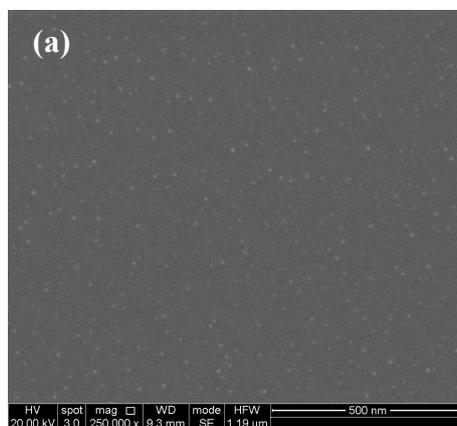
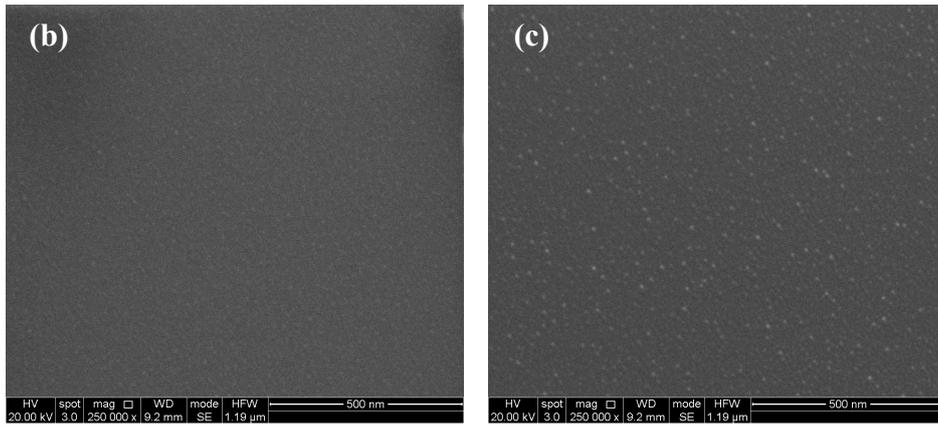
Fig. 7: SEM images of B₄C-coated test wafers taken at 20 kV electron acceleration voltage with a 250 000-fold magnification: (a) Pristine B₄C-coated test wafer, (b) O₂/Ar-plasma cleaned – formerly a-C coated part, and (c) O₂/Ar-plasma cleaned – non a-C coated part

The B₄C surface morphology of the Si test wafers in the SEM images shown in Fig. 7 give a visual account for the increase in rms surface roughness: Starting from the pristine test wafer in Fig. 7(a), one can distinguish small bright spots of about 10 nm diameter that are distributed across the surface in an irregular manner. Similar “hillocks” – but of micrometric size - have been observed in other studies [12] where they were attributed to crystalline B₄C intergrowths in a B-doped pyrolytic carbon matrix formed during the post-growth heat treatment of B₄C thin films as grown by CVD. After a-C contamination and subsequent O₂/Ar plasma treatment of the Si test wafer, there is a clear increase regarding the density of these hillocks in the SEM image in the non a-C coated part (see Fig. 7(c)) that obviously leads to an increase of the surface roughness observed in the XRR data. Regarding Fig. 7(b), the residual carbon interface layer (see Fig. S1) apparently leads to lower density of these hillocks as compared to the formerly non a-C coated counterpart in Fig. 7(c). We attribute these hillocks to the formation of boron oxy-carbides that are actually more prominent in the case of B₄C coatings treated with an Ar/H₂ plasma that will be discussed in a later section.

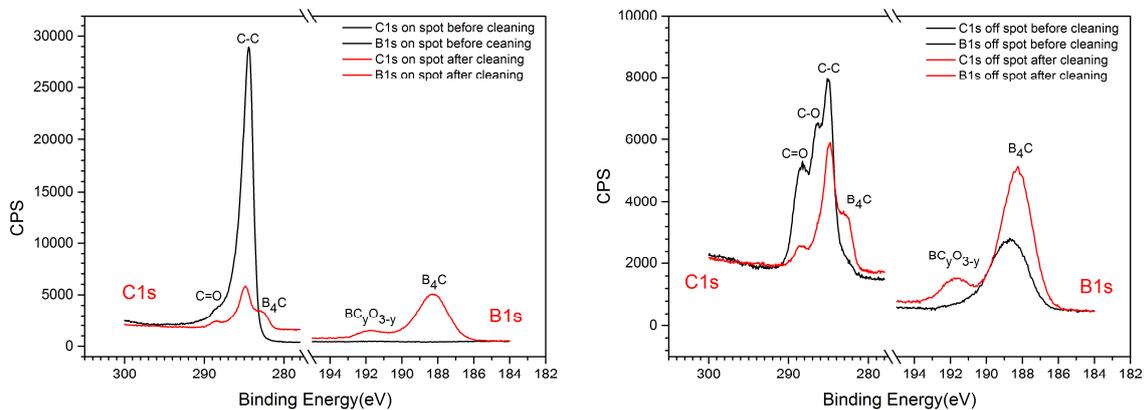
Fig. 8: High-resolution C1s and B1s XPS spectra of the B₄C-coated test wafer before (black solid lines) and after H₂/Ar RF plasma cleaning (red solid lines). Left panel: XPS data taken on the amorphous carbon contamination spot. Right panel: XPS data taken off the amorphous carbon contamination spot on the bare B₄C coating.

The high resolution XPS spectra in Fig. 8 yield the same results as their O₂/Ar analogues in Fig. 3: An almost complete removal of the a-C contamination, including a persistent three peak structure in the C1s XPS range. However, we note that in this specific case a significant increase of the B1s peak at 191.6 eV B.E. occurs that we relate to boron oxy-carbides.

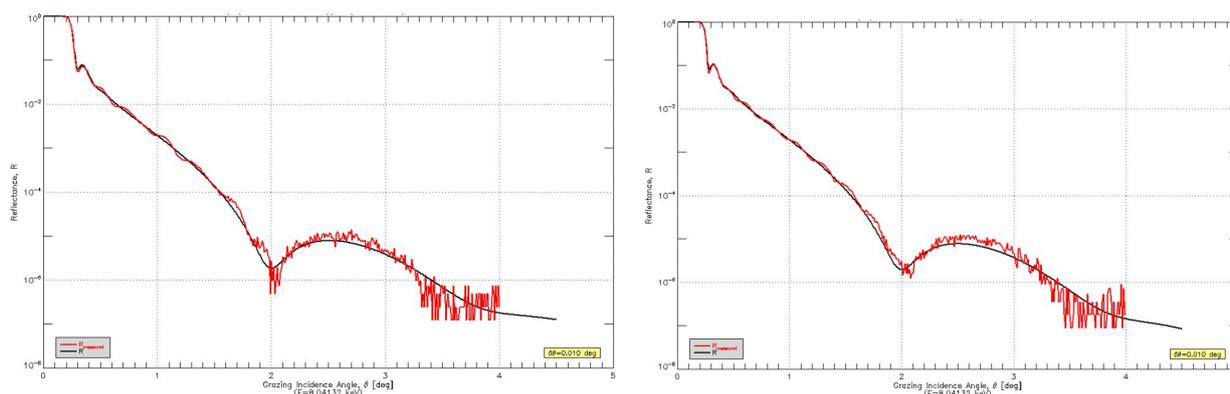
Fig. 9: XRR data from B₄C-coated test mirror right after H₂/Ar plasma cleaning. Left hand side: Non a-C coated part; right hand side: Formerly a-C coated part (red solid lines: experimental XRR data; black solid lines: IMD simulation)

The significant drawbacks from the H₂/Ar plasma cleaning become apparent from the XRR measurements presented in Fig. 9. As is already obvious from the data, there is an almost complete loss of Kiessig fringes throughout the complete angular range, which applies to both the non a-C coated and the formerly a-C coated part. Taking a closer look at the results from the IMD simulations in Table IV, one can conclude that there has been a substantial reduction of the B₄C layer thickness between about 8 and 4 nm for the non a-C coated and the formerly a-C coated part, respectively, together with a large increase of the B₄C/air interface roughness beyond 3 nm rms. These latter large numbers are probably partly due to some sample non-uniformities that may well contribute to the surface roughness. Nevertheless, the contribution from surface roughness itself is still substantial.

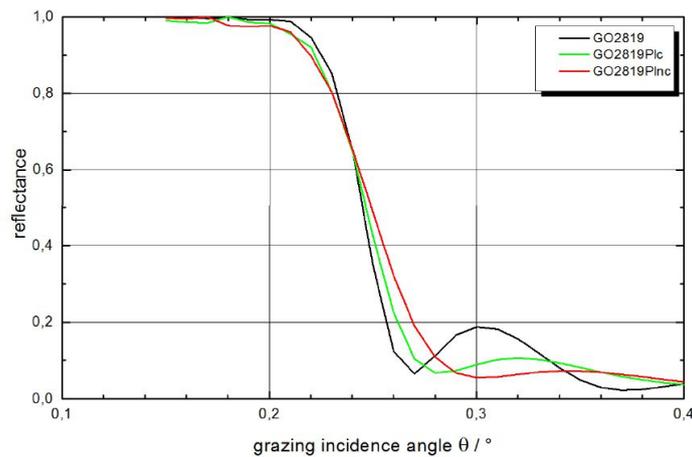
Fig. 10: Comparison of XRR total reflection data at low grazing angles for a pristine B₄C-coated test mirror (black line) and after a-C coating plus subsequent H₂/Ar plasma cleaning (green line: formerly a-C coated area; red line: non a-C coated area).

The total reflection data shown in Fig. 10 again indicate the structural changes for the B₄C layer at angles beyond 0.26 degree, while from the chemical perspective the deviation in the XRR data at about 0.25 degree indicate a satisfactory cleaning, which does not come as a surprise taking into account the loss of B₄C layer thickness mentioned above. Nevertheless, the clearly observable changes in the reflectivity edge for the plasma treated samples as compared to the pristine samples (i.e., distinct changes of the edges slope plus the occurrence of additional steps at about 0.18 degree grazing angle) indicate a severe and presumably unacceptable change of the optical performance of the B₄C coating due to, e.g., a chemical residue from the plasma cleaning, a change of the B₄C density, and/or B₄C surface roughness.

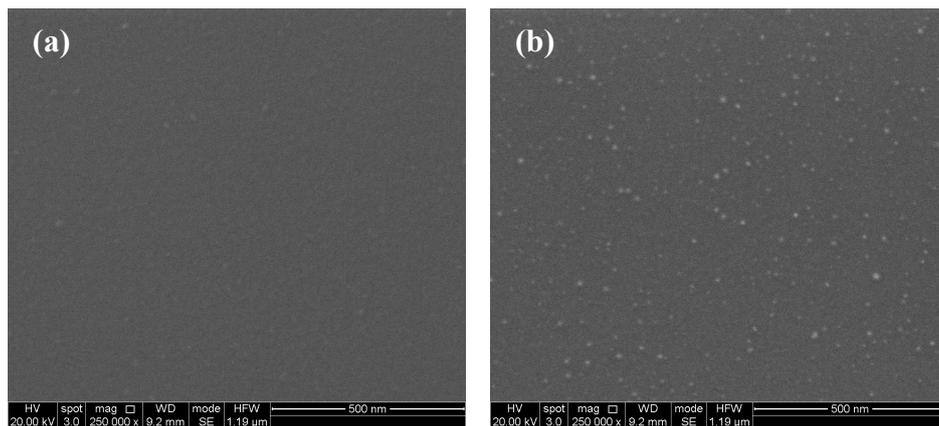
Fig. 11: SEM images of B₄C-coated test wafers taken at 20 kV electron acceleration voltage with a 250000-fold magnification after cleaning with H₂/Ar plasma: (a) Formerly a-C coated part, and (b) non a-C coated part

The SEM results from a H₂/Ar -cleaned B₄C-coated test coupon are depicted in Fig. 11. Comparing these results with their analogues from the O₂/Ar plasma cleaning in Fig. 7, the images taken in the formerly a-C coated part appear to be very similar (i.e., visually indicating a carbonaceous residue on the samples surface), whereas the non a-C coated part of the H₂/Ar-cleaned B₄C-coated test coupon exhibits fewer, but more distinct/larger hillocks that we attribute to the boron oxycarbides that appears more strongly in the B1s XPS line in Fig. 8 (“off spot” after cleaning). It is obviously somewhat surprising that these hillocks can still be observed after a reducing H₂/Ar plasma process, but our XPS depth profile analysis shows that the B₄C bulk material within the layers include quite some boron oxide phase that emerges to the surface during the sputtering by the Ar species within the plasma. Thus, we presume that there is a plasma-induced formation of boron oxy-carbide hillocks that are created by the interaction of the plasma with the B₂O₃ phases and B₄C phases emerging at the sample surface.

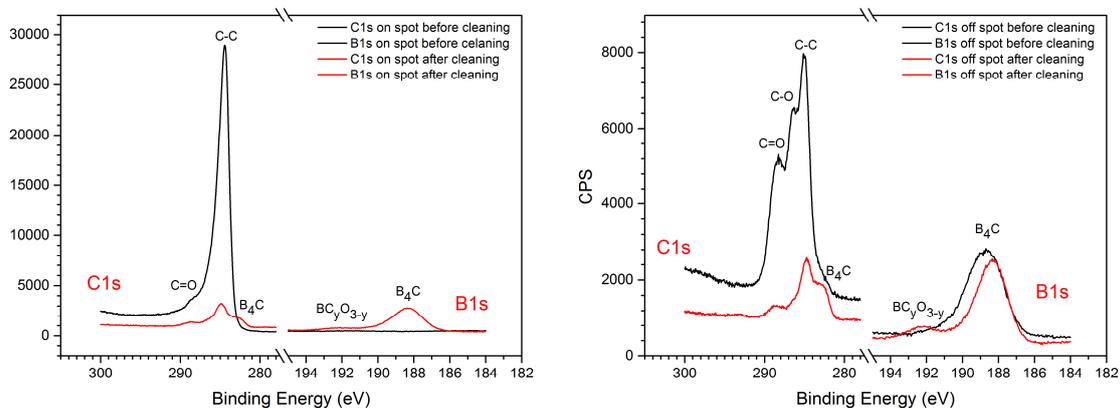
Fig. 12: High-resolution C1s and B1s XPS spectra of the B₄C-coated test wafer before (black solid lines) and after pure O₂ RF plasma cleaning (red solid lines). Left panel: XPS data taken on the amorphous carbon contamination spot. Right panel: XPS data taken off the amorphous carbon contamination spot on the bare B₄C coating.

In Fig. 12, we show the high resolution C1s and B1s XPS spectra taken off as well as on the a-C spot before and after the pure O₂ plasma cleaning. As can be observed from the C1s spectra, there is a strong reduction of the C1s lines related to C=O, C-O, and C-C species for both the “off spot” and the “on spot” spectra due to the plasma cleaning process, whereas the B1s line to 188.3 eV B.E. related to B₄C shows up after the plasma treatment. In the case of the B1s spectra, the “off spot” spectra exhibit a shift of the B1s line to lower B.E. (plus a decrease of the line width) and the appearance of a small additional peak at about 192.2 eV, that we attribute to oxidized boron and boron oxy-carbides, respectively.

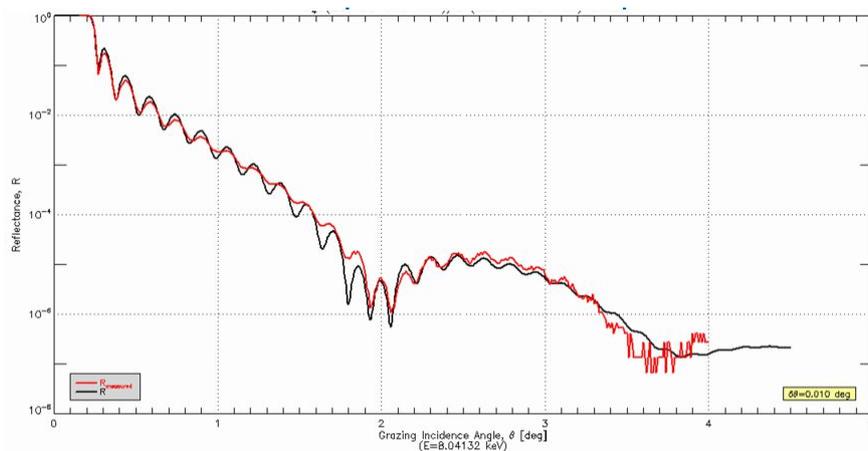
Fig. 13: XRR data from B₄C-coated test mirror after cleaning with pure O₂ plasma cleaning. (red solid lines: experimental XRR data; black solid lines: IMD simulation)

The measured XRR data in Fig. 13 together with the results from the IMD simulations given in Table V fully corroborate the results from the visual impression by the photographs in Fig. S3. As can be seen from the measured data, the Kiessig fringes throughout the full angular range are maintained and the parameters resulting from the pertinent IMD simulations yield a slight reduction of the B₄C coating thickness (i.e., 25.5 nm as compared to 26.0 nm) together with an unaltered B₄C/air interface roughness of 0.5 nm rms.

On the other hand, the micro-roughness data from interference microscopy show a substantial increase from 0.10 to 0.26 nm rms, which is at variance with the results from XRR. We attribute

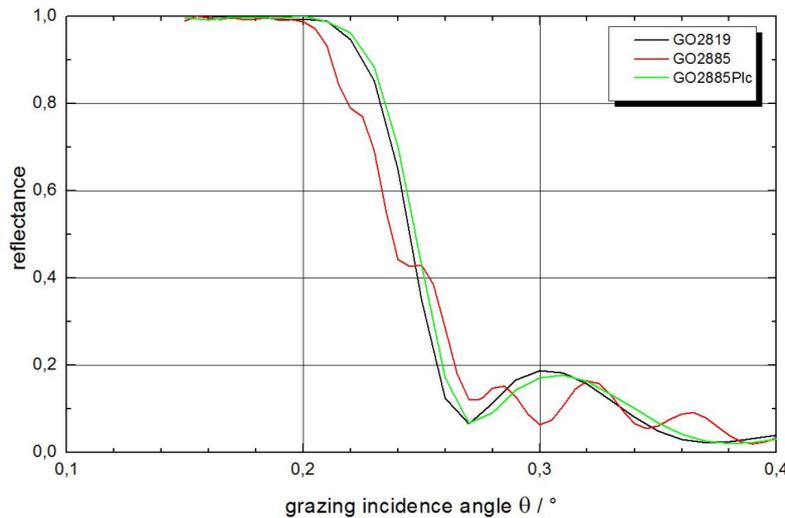
Fig. 14: Comparison of XRR total reflection data for a pristine B₄C-coated test mirror (black line), after a-C coating (red line), and after subsequent cleaning with pure O₂ plasma (green line).

The XRR total reflection data from a B₄C-coated test mirror in Fig. 14 give further support for a full recovery of the B₄C surface at negligible losses regarding the integrity of the B₄C layer. The spectrum for the a-C coated (i.e., non plasma-cleaned) mirror surface shows the expected chemical and structural deviations in the range from 0.2 to 0.26 degree and beyond 0.26 degree, respectively, due to the additional a-C top layer. On the other hand, the spectrum of the subsequently plasma cleaned sample nicely overlaps with the spectrum from the pristine untreated mirror in terms of the shape and slope of the reflectivity edge, beside a small shift regarding the edge position to slightly higher angular values. This leads to the conclusion for a full chemical and structural recovery of the test mirror from the perspective of Cu K α wavelengths and also applies to the optical performance of the fully processed mirror. Nevertheless, taking into account nowadays B₄C optical coating manufacturing technologies a rms roughness figure of 0.26 nm appears acceptable.

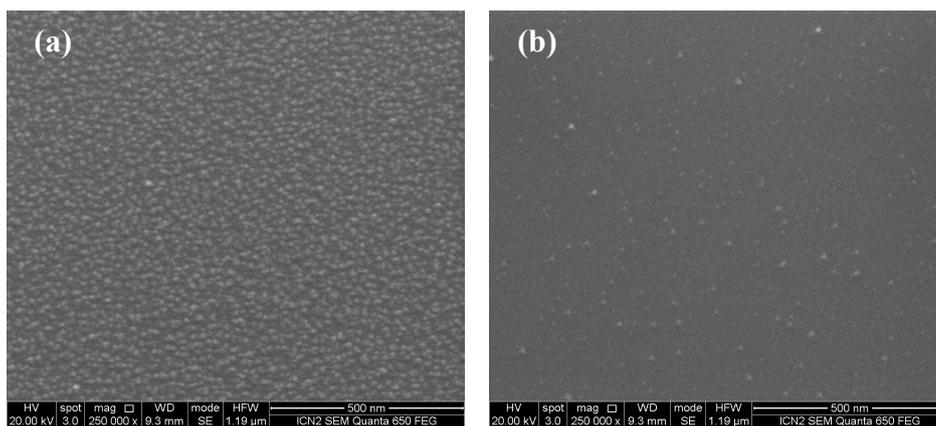
Fig. 15: SEM images of B₄C-coated test wafers taken at 20 kV electron acceleration voltage with a 250000-fold magnification after cleaning with pure O₂ plasma: (a) Formerly a-C coated part, and (b) non a-C coated part

In Fig. 15, we show the SEM images of a fully processed B₄C-coated test coupon that has been cleaned with pure O₂ plasma. What can be immediately concluded from the images is that whereas the appearance of the non a-C coated part in Fig. 15(b) is similar to that of the B₄C reference sample in Fig. 7(a) as well as the corresponding images from the other plasma processed samples in Figs. 7(c) and 11(b). In stark contrast to this, the image from the formerly a-C coated part in Fig. 15(a) exhibits a large density of small structures with diameters between 15 and 20 nm. As according the XPS results given in Fig. 12 the surface chemistry of the formerly a-C coated part is very similar to the ones from the O₂/Ar and H₂/Ar plasma treatment (see Figs. 3 and 8, respectively), we conclude that the surface modification in Fig. 15(a) is of a pure morphological nature, without apparently alternating the surface chemical characteristics that are basically given by the aforementioned plasma-induced conversion of the B₄C and B₂O₃ bulk phases into boron oxy-carbides.

As mentioned above, the B₄C/air interface roughness as measured with XRR remains unchanged (see Table V), whereas the interference microscopy gives an increase from 0.10 to 0.26 nm rms. Taking into account the rather enhanced density of hillocks in Fig. 15(a) - that almost equals a full surface coverage - together with the fact that XRR is measured at grazing incidence, it seems plausible that interference microscopy (close to normal incidence) gives the more reliable surface roughness information, consistent with the SEM results.
