Electrochemical and mechanical behaviors of dissimilar friction stir welding between 5086 and 6061 aluminum alloy

Abstract

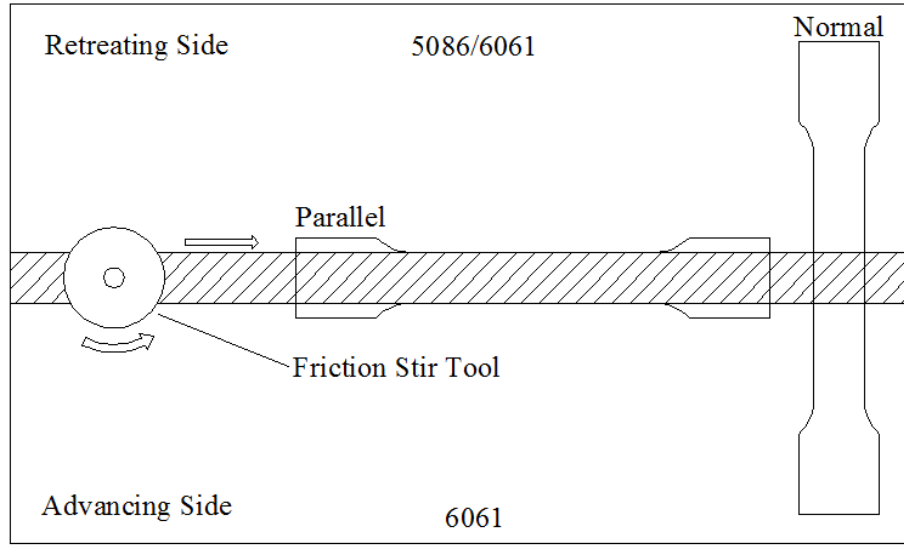
Fig. 1. Schematic showing the FSW joining process and the locations where tensile specimens were obtained.

AA5086-H32 (0.4% Si, 0.5% Fe, 0.1% Cu, 0.35% Mn, 4.0% Mg, 0.15% Cr, 0.25% Zn, 0.15% Ti, balance Al) and AA 6061-T6511 (0.4% Si, 0.7% Fe, 0.4% Cu, 0.15% Mn, 1.2% Mg, 0.35% Cr, 0.25% Zn, 0.15% Ti, balance Al) plates were friction stir welded vertical to the rolling direction with a travel speed, a rotational speed, and a shoulder diameter of 20 mm/min, 1000 rpm and 25 mm, respectively. The friction stir pin had a diameter of 8 mm and height of 6.35 mm. A simultaneous rotation and translation motion of the FSW tool generates the formation of an asymmetric weld. When the tool rotates in the direction of its translation, it refers to the advancing side (AS). When rotation and translation of the tool are in the opposite direction, it refers to the retreating side (RS) (Fig. 1). Fig. 2 shows the schematic view of the cross-section of the FSW joint of AA5086-AA6061.

Vickers microhardness testing (Wilson Rockwell, R5000) was performed across the welds using a 50 g load. The tensile tests were performed with a crosshead speed of 3 mm/min using an Instron-5500R testing machine. Two types of tensile specimens were machined from the FSW joints: parallel (longitudinal) and normal (transverse), as depicted in Fig. 1. An axial extensometer with a 25 mm gage length was attached to the specimens at the gauge section. The strain analysis of

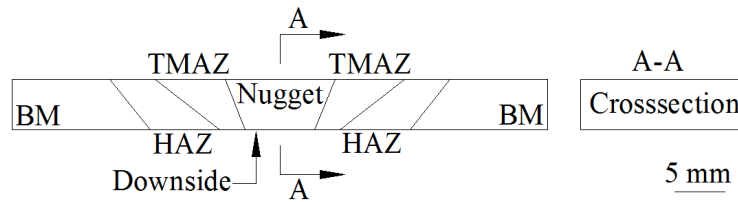
Fig. 2. Schematic view of the cross-section of the FSW joint of AA5086-AA6061.

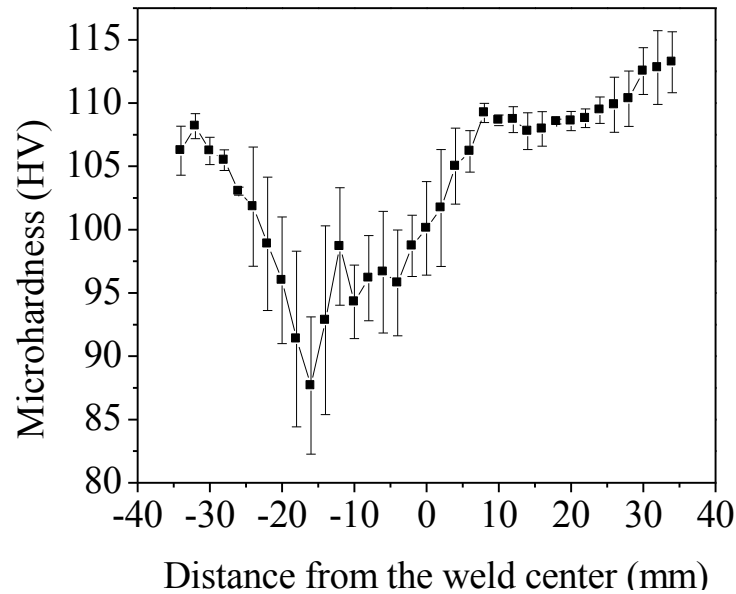
Fig. 3 shows the microhardness across the top surface of FSW AA5086-AA6061, which does not have a typical “W”-shaped hardness distribution characteristic. A minimum hardness of 88 HV is

obtained in the HAZ on the AA6061 side, which suggests that the tensile specimens are prone to fracture in this zone. The hardness distribution on the AA6061 side of the AA5086-AA6061 FSW joint is similar to that of the AA6061-AA6061 FSW joint [20]. However, the hardness distribution on the AA5086 side of the AA5086-AA6061 FSW joint does not resemble that of the AA5086-AA5086 FSW joint [21, 22]. For the AA5086 side, the hardness of BM was higher than that of the TMAZ/HAZ. In the NZ, the hardness increased from the AA6061 side to the AA5086 side.

Fig. 3. Microhardness distribution across the top surface of AA5086-AA6061 FSW joint measured with a 2 mm step.

From hardness results, we know that the hardness values of the NZ were lower than that of the BM, possibly explaining why the longitudinal tensile specimens of FSW joints decreased in both tensile and yield strength. The transverse tensile specimens contained all four zones (i.e., BM, HAZ, TMAZ and NZ). The observed ductility was measured as average strain over the gage length, including the various zones that have different resistances to deformation due to differences in grain size and precipitate distribution. When a tensile load was applied to the joint, failure occurred in the relatively weak regions of the joint [23]. The fracture of the transverse direction tensile specimens occurred in the HAZ.

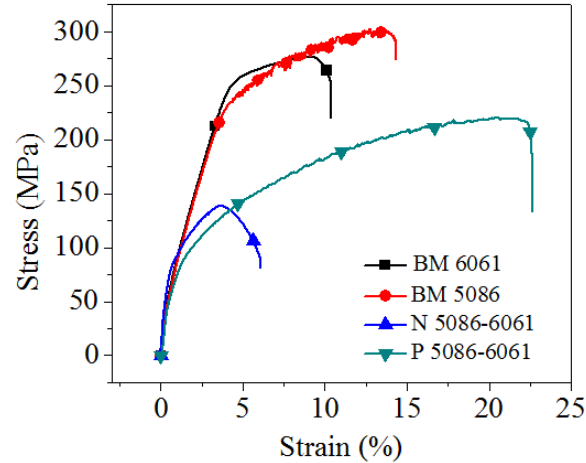
Fig. 4. Tensile test results of the AA5086-AA6061 FSW specimens as compared to those of base metals AA5086 and AA6061. N: normal, P: parallel.

Fig. 4 shows the tensile test results of specimens from the AA5086-AA6061 FSW joints, as compared to those of the base metals. Both FSW specimens (N and P) had lower tensile and yield strength than the base metals, indicating the negative effect of FSW process on the mechanical properties of the joints. In terms of ductility, the parallel FSW tensile specimen had a significantly increased ductility as compared to the base metals, while the normal FSW tensile specimen showed a much lower ductility than the base metals.

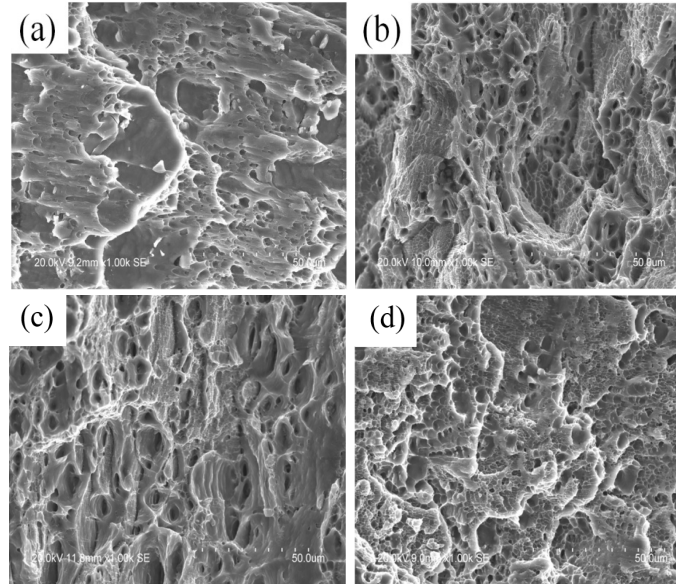
Fig. 5. SEM fractographs of BM and FSW specimens: (a) BM AA5086, (b) BM AA6061, (c) N AA5086-AA6061 FSW (failure occurred in HAZ on the AA6061 Side), and (d) P AA5086-AA6061 FSW (failure occurred in weld zone).

Most of the specimens had a 45° angle shear fractures along the tensile axis with the exception of BM AA6061 and N AA5086-AA6061 FSW specimens. Obvious necking/plastic deformation was observed on the FSW tensile specimens but not on BM AA5086 and BM AA6061 specimens. Fig. 5 presents SEM fractographs of the BM and FSW specimens. The fractographs reveal dimple fracture patterns with teared edges full of micropores. The dimples were of various sizes and shapes. The fracture surface of BM AA6061 has deeper dimples and thinner teared edges than the BM AA5086 specimen, which agrees with the fact that the BM AA5086 specimen exhibited better mechanical properties than the BM AA6061 specimen (Fig. 4). Fig. 5 also shows that the fracture surface of the N AA5086-AA6061 FSW specimen has much deeper dimples and thinner teared edges than the P AA5086-AA6061 FSW specimen, indicating that the P AA5086-AA6061 FSW specimen had better mechanical properties than the N AA5086-AA6061 FSW specimen.

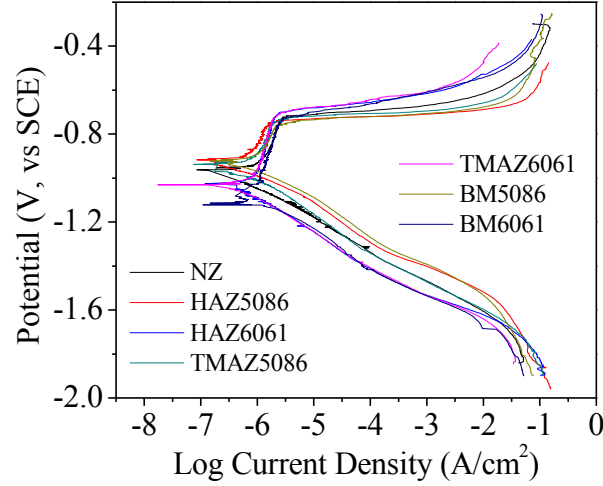
Fig. 6. Polarization curves of samples from different zones in the AA5086-AA6061 FSW joint in deaerated 3.15 wt.% NaCl solutions.

Fig. 6 shows polarization curves of samples from different zones in the AA5086-AA6061 FSW joint in deaerated 3.15 wt.% NaCl solutions. The passive regions of FSW AA5086-AA6061 coupons in AA6061 side (BM-AA6061, HAZ-AA6061, and TMAZ-AA6061) were larger than those of the AA5086 side. E_{corr} , I_{corr} and E_{pit} values of the different positions of FSW AA5086-AA6061 in deaerated 3.15 wt.% NaCl solutions are shown in Table 1. The E_{corr} values of downside (-944 mV_{SCE}) shifted to more anodic potentials from the BM-AA5086 (-953 mV_{SCE}) and BM-AA6061 (-1114 mV_{SCE}), while the E_{corr} value of the NZ was between the BM-AA5086 and BM-AA6061. The E_{corr} values of the HAZ-5086 (-917 mV_{SCE}) and the TMAZ-AA5086 (-937 mV_{SCE}) shifted to more positive potentials from those of the BM-AA5086 (-953 mV_{SCE}).

The same results occurred on the AA6061 side. The I_{corr} values decreased compared to the BM, as shown in Table 1. The E_{pit} values of downside (-749 mV_{SCE}) shifted to more negative potentials compared to those of the BM-AA5086 (-737 mV_{SCE}) and BM-AA6061 (-724 mV_{SCE}), while those of the NZ (-718 mV_{SCE}) shifted to more positive values. For the AA6061 side, the E_{pit} values of the HAZ-AA6061 (-705 mV_{SCE}) and the TMAZ-AA6061 (-714 mV_{SCE}) shifted to more positive values compared to those from the BM-AA6061 (-724 mV_{SCE}). The FSW improved corrosion resistance of the alloy mixtures compared to the AA5086 and AA6061 BM.

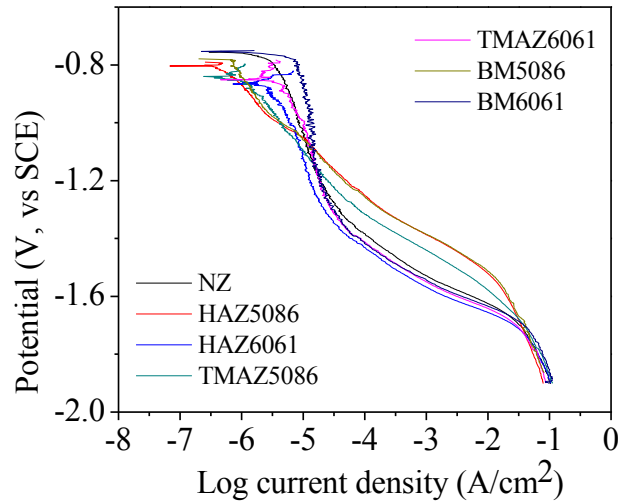
Fig. 7. Cathodic polarization diagram of different weld zones of FSW AA5086-AA6061 in aerated 3.15 wt% NaCl solutions.

Fig. 7 shows a cathodic polarization diagram of different weld zones of FSW AA5086-AA6061 in aerated 3.15 wt% NaCl solutions. In aerated 3.15 wt% NaCl the regions of HAZ-AA6061, TMAZ-AA6061, BM-AA6061, and upside show behavior of diffusion-limited oxygen reduction, while the regions of HAZ-AA5086, TMAZ-AA5086, and BM-AA5086 show Tafel behavior. Table 2 shows E_{corr} and I_{corr} values of the different weld zones of FSW AA5086-AA6061 in aerated 3.15 wt% NaCl solutions. The E_{corr} values of different weld zones of FSW AA5086-AA6061 shifted to more negative values than those of BM-AA5086 (-779 mV_{SCE}) and BM-AA6061 (-753 mV_{SCE}). Compared to the BM-AA6061 (8.57 $\mu\text{A}/\text{cm}^2$), the I_{corr} values of the HAZ-AA6061 (0.56 $\mu\text{A}/\text{cm}^2$), TMAZ-AA6061 (4.73 $\mu\text{A}/\text{cm}^2$), and NZ (1.44 $\mu\text{A}/\text{cm}^2$) decreased. Also, the I_{corr} values of HAZ-AA5086 (0.53 $\mu\text{A}/\text{cm}^2$), and TMAZ (0.87 $\mu\text{A}/\text{cm}^2$) decreased compared to those of BM-AA5086 (1.27 $\mu\text{A}/\text{cm}^2$).

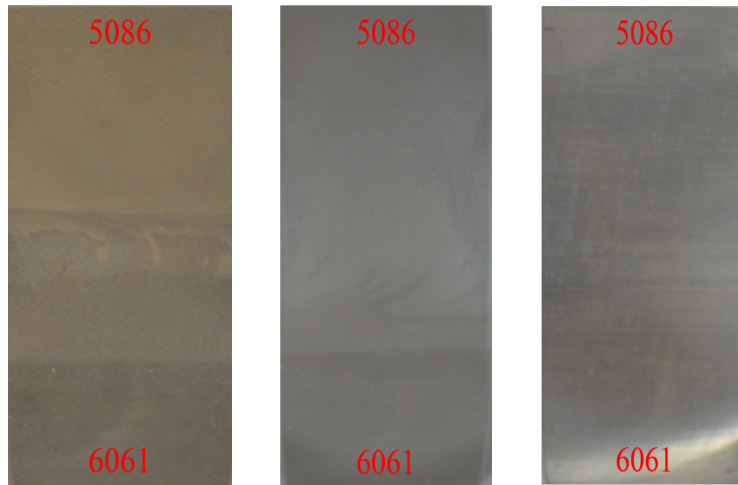
Fig. 8. FSW 5086-6061 samples immersed in (a) 3.15 wt.% NaCl, (b) ASTM seawater, and (c) 0.5 M Na₂SO₄ solution for 90 days.

Fig. 8 shows FSW AA5086-AA6061 coupons in 3.15 wt.% NaCl, ASTM seawater, and 0.5 M Na₂SO₄ solutions after 90 days. In 3.15 wt.% NaCl and ASTM seawater, the BM 6061 side was

much darker than the BM 5086 side, while the welded regions of those coupons were more complex. The NZ and adjacent regions contain a mixture of AA5086 and AA6061 due to solid-state mixing during the FSW process. Two colors indicate the different corrosion rates of AA5086 and AA6061. As shown in Fig. 8, there was almost no corrosion product on the surface of FSW AA5086-AA6061 coupons after 90 days immersion in 0.5 M Na₂SO₄ solution. After 120 days immersion in 0.5 M Na₂SO₄ solution, there was much more corrosion product on the BM 6061 side than on the BM 5086 side. There was almost no corrosion product on the BM 5086 side after immersion for 120 days in 0.5 M Na₂SO₄ solution.

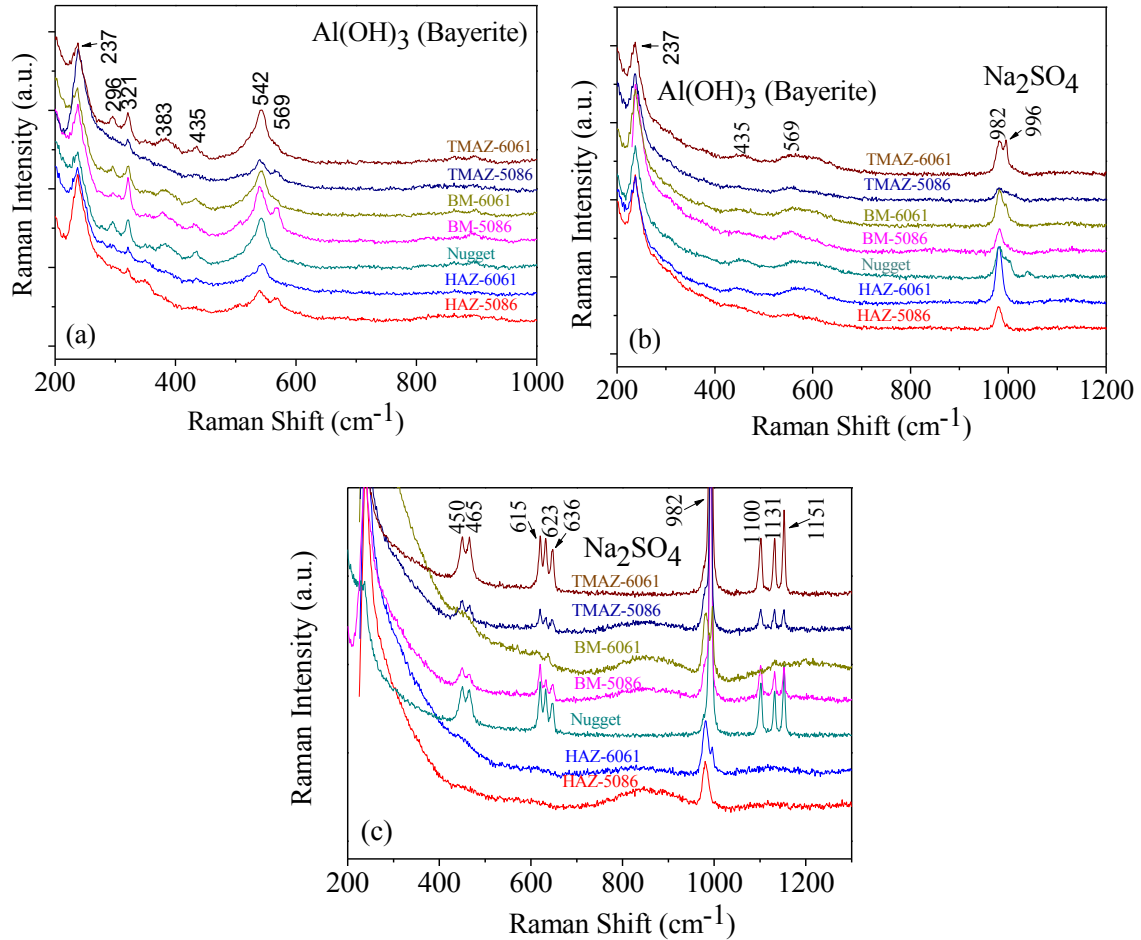
Fig. 9. Raman spectroscopy of distinct zones of FSW AA5086-AA6061 after 90 days immersion in: (a) 3.15 wt% NaCl, (b) ASTM seawater, and (c) 0.5 M Na₂SO₄ solution.

Fig. 9 and 10 show Raman spectra of distinct zones of FSW AA5086-AA6061 after 90 and 120 days immersed in 3.15 wt% NaCl, ASTM seawater, and 0.5 M Na₂SO₄ solution. We characterized both the AA5086 and AA6061 sides for NZ, TMAZ, BM, and HAZ via Raman spectroscopy. In Fig. 9 and Fig. 10a, characteristic bands of Al(OH)₃ (237, 296, 321, 383, 435, 542, and 569 cm⁻¹) were observed for distinct regions. TMAZ-AA5086, BM-AA5086, and HAZ-AA5086 had lower Raman intensity than the 6061 side, because there was less corrosion product on the AA5086 side, as shown in Fig. 8. In Fig. 9b and Fig. 10b, characteristic bands of Al(OH)₃ (237, 435, 569, and 636 cm⁻¹) and Na₂SO₄ (982, and 996 cm⁻¹) were observed for all regions of

FSW AA5086-AA6061 immersed in 0.5 M Na_2SO_4 solution. In Fig. 9c and Fig. 10c, characteristic bands of Na_2SO_4 were observed in TMAZ-AA6061, TMAZ-AA5086, BM-AA6061, BM-AA5086, and NZ. However, only bands of 982 and 996 cm^{-1} were found in the regions of HAZ-AA6061 and HAZ-AA5086. Raman data of $\text{Al}(\text{OH})_3$ bands for FSW AA5086-AA6061 coupons immersed in 0.5 M Na_2SO_4 solution were still missing, probably because there was insufficient corrosion product present. Notice that the strong Raman bands at 237 cm^{-1} might be partially from system noise [24-26].

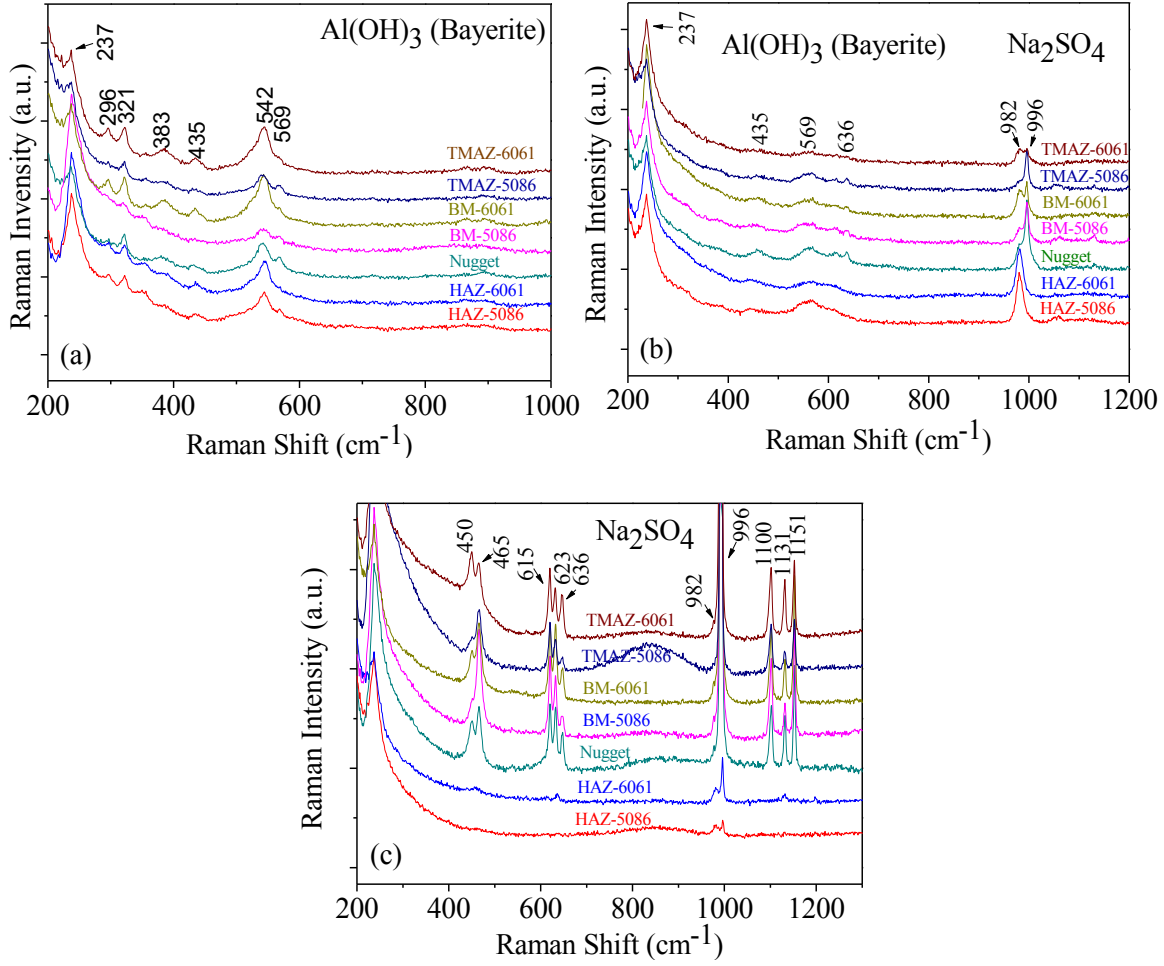
Fig. 10. Raman spectroscopy of distinct zones of FSW AA5086-AA6061 after 120 days immersion in: (a) 3.15 wt% NaCl, (b) ASTM seawater, and (c) 0.5 M Na₂SO₄ solution.

Fig. 12 shows SEM of NZ of FSW AA5086-AA6061 after 120 days immersion in 3.15 wt% NaCl, ASTM seawater, and 0.5 M Na₂SO₄ solution. The EDXA analysis depicted in Table 4 revealed corrosion product high in oxygen and aluminum. According to Raman analysis (Fig. 10), the corrosion products on the surface of the coupon immersed in 3.15 wt% NaCl and ASTM seawater was Al(OH)₃. A denser layer of corrosion products appeared to cover the coupon exposed in the NaCl solution as compared to the coupon exposed in the ASTM seawater. The oxygen concentration of the two locations shown in Fig. 12a (specimen previously exposed to

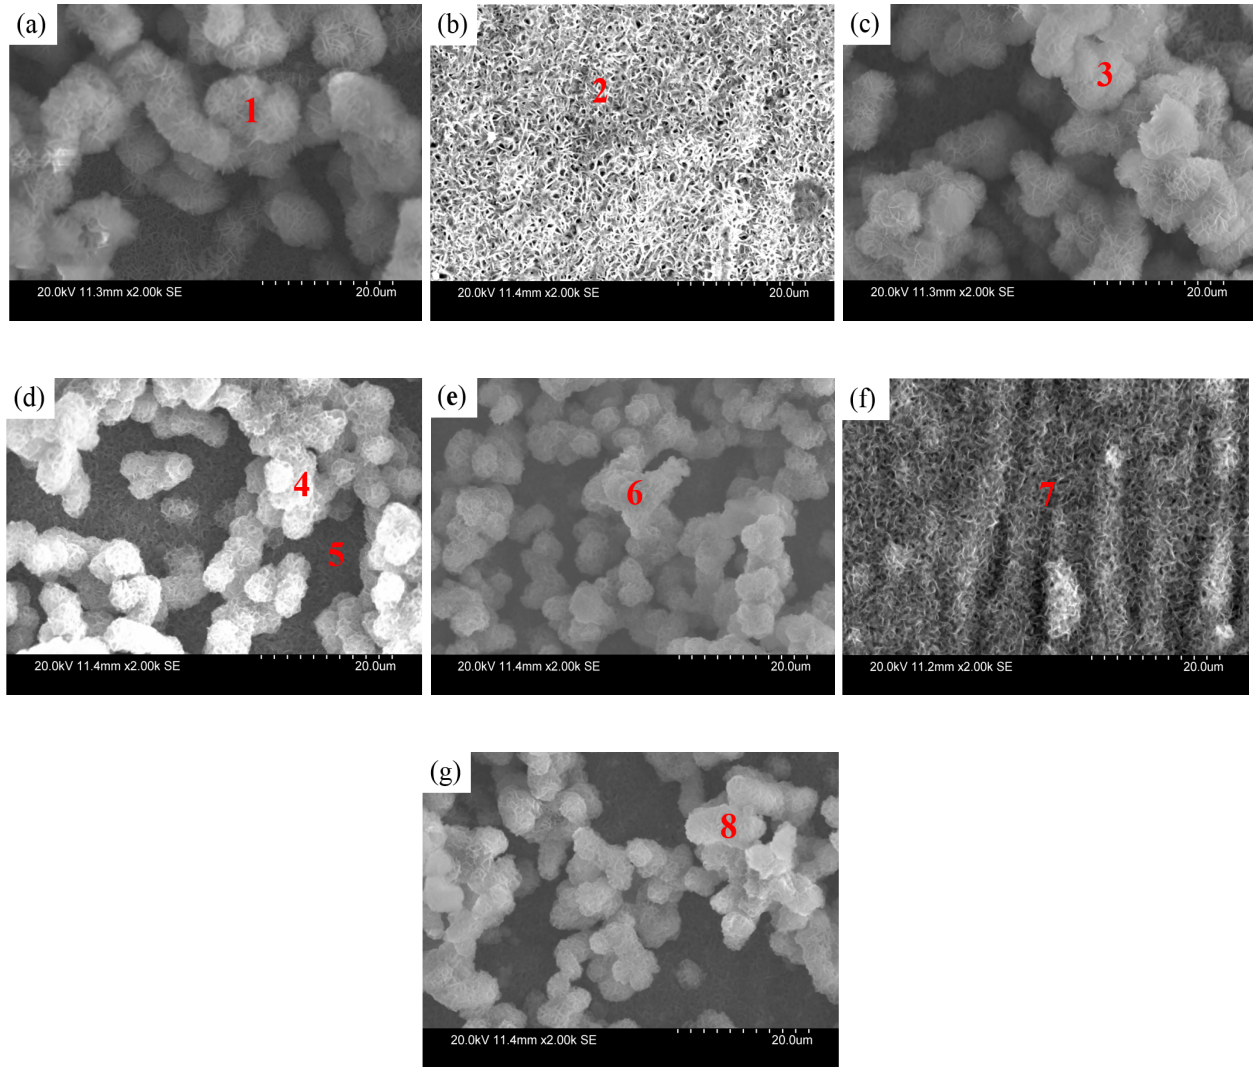
Fig. 11. Different zones (a) BM 5086 (b) HAZ 5086 (c) TMAZ 5086 (d) Nugget (e) TMAZ 6061 (f) HAZ 6061 (g) BM 6061 of FSW AA5086-AA6061 after 120 days immersion in ASTM seawater.

Fig. 11 shows the SEM of seven regions of FSW AA5086-AA6061 after 120 days immersion in ASTM seawater. There was more corrosion product on the surface of the BM 5086, TMAZ 5086, Nugget, BM 6061, and TMAZ 6061 than on the HAZ 5086 and HAZ 6061. EDXA quantification results in Table 3 reveal that the corrosion product was also high in oxygen and aluminum, which agrees with the Raman results Fig. 10b. The main corrosion product on the seven regions was $\text{Al}(\text{OH})_3$. The low corrosion on the downside of samples could be caused by the microstructure or the specimen orientation. Sulfur and magnesium came from the immersion solution (ASTM seawater), which must have remained on the coupons. The oxygen concentration of BM 6061, HAZ 6061, and TMAZ 6061 is higher than BM 5086, HAZ 5086, and TMAZ 5086, respectively. It indicates that AA6061 easily corroded than AA 5086, which agrees with immersion results in Fig. 8. Comparing oxygen concentration of point 4 and 5 in Fig. 11d, higher point 4 has more oxygen concentration than lower point 5. This is because corroded production (point 4) accumulated on sample surface (point 5). Low oxygen concentration appears in HAZ 5086 and HAZ 6061. Low oxygen concentration means high corrosion resistance, which also agrees with I_{corr} results in Table 2 and 3. Pits with different sizes were also

observed in the HAZ 5086 (Fig. 11b) and HAZ 6061 (Fig. 11f) regions. The pits around the constituent particles likely formed as a result of cathodic reduction [27]. Cathodic reduction on the constituent particles can increase the alkalinity in the surrounding solution, leading to the dissolution of the aluminum matrix.

Table 3. EDXA quantification results of six points in Fig. 11.

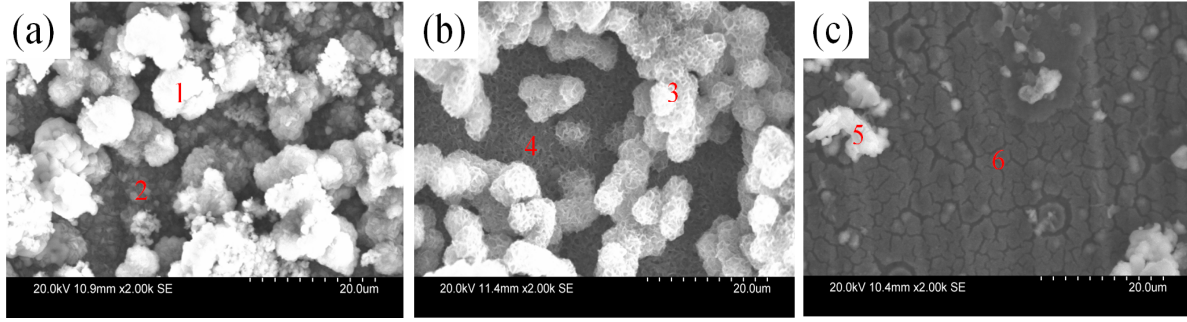
Fig. 12. SEM of NZ of FSW AA5086-AA6061 after 120 days immersion in (a) 3.15 wt% NaCl, (b) ASTM seawater, and (c) 0.5 M Na₂SO₄ solution.

NaCl solution) was also higher than in Fig. 12b (specimen previously exposed to the ASTM solution). As shown in Fig. 12c, cracking on the surface of the specimen exposed to the 0.5 M Na₂SO₄ solution was also found. The cracks are likely to be in the aluminum oxide corrosion layer.

Table 4. EDXA quantification results of six points in Fig. 12.

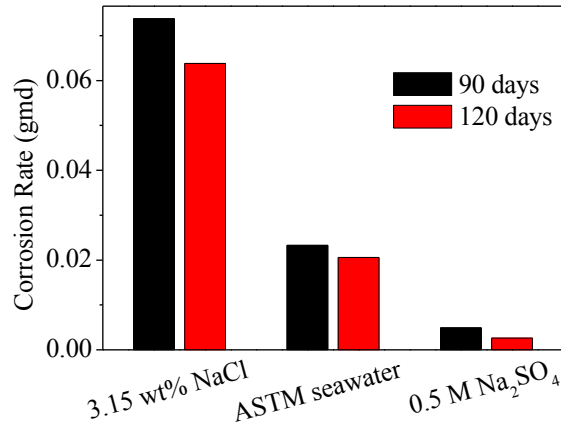
Fig. 13. Corrosion rate of specimens after 90 and 120 days immersion in 3.15 wt% NaCl, ASTM seawater, and 0.5 M Na₂SO₄ solution for FSW AA5086-AA6061.

The results of corrosion rate of FSW AA5086-AA6061 by weight measurement are shown in Fig. 13. The corrosion rate of FSW AA5086-AA6061 decreased from 90 days to 120 days in three solutions. The corrosion rate of FSW AA5086-AA6061 from highest to lowest for three solutions was as follows: 3.15 wt% NaCl > ASTM seawater > 0.5 M Na₂SO₄. The maximum value of corrosion rate was obtained from FSW AA5086-AA6061 in 3.15 wt% NaCl solution after 90 days immersion. The corrosion rates of FSW AA5086-AA6061 after 90 days immersion are higher than those from the 120 days immersion in three solutions. Therefore, the buildup of corrosion products slowed down the corrosion of the Al samples.
