Effects of neutron radiation on the optical and structural properties of blue and green emitting plastic scintillators

We report on the optical and structural properties of plastic scintillators irradiated with neutron beams produced by the IBR-2 reactor of the Frank Laboratory of Neutron Physics in JINR, Dubna. Blue UPS-923A and green plastic scintillators were irradiated with neutron fluence ranging from 10^{13} to 10^{17} n/cm². Discolouring in the plastic scintillators was observed after irradiation. The effects of radiation damage on the optical and structural properties of the samples were characterized by conducting light yield, light transmission, light fluorescence and Raman spectroscopy studies. The results showed that neutron radiation induced damage in the material. The disappearance of the Raman peak features in green scintillators at frequencies of 1165.8, 1574.7 and 1651.2 cm⁻¹ revealed significant structural alterations due to neutron bombardment. Losses in fluorescence intensity, light yield and light transmission in the plastic scintillators were observed.

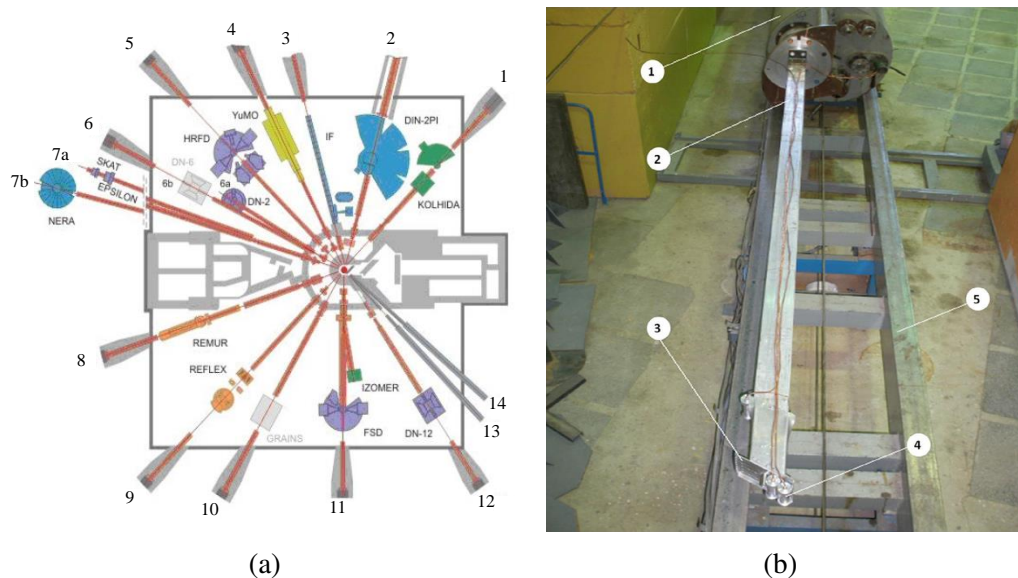
Figure 1: Layout of IBR-2 spectrometer complex (a), and the irradiation facility at the channel No. 3 of IBR-2 reactor experimental hall, the view from the external biological shield side: (1)-massive part of the irradiation facility, (2)-transport beam, (3)-metallic container for samples fastening, (4)-samples, (5)-rail way (b) [12].

Channel number 3 of the IBR-2 reactor, as schematically shown in Figure 1(b), located at the Frank Laboratory of Neutron Physics (FLNP) at the Joint Institute for Nuclear Physics (JINR) in Dubna, Russia was used to irradiate the samples [12, 13].

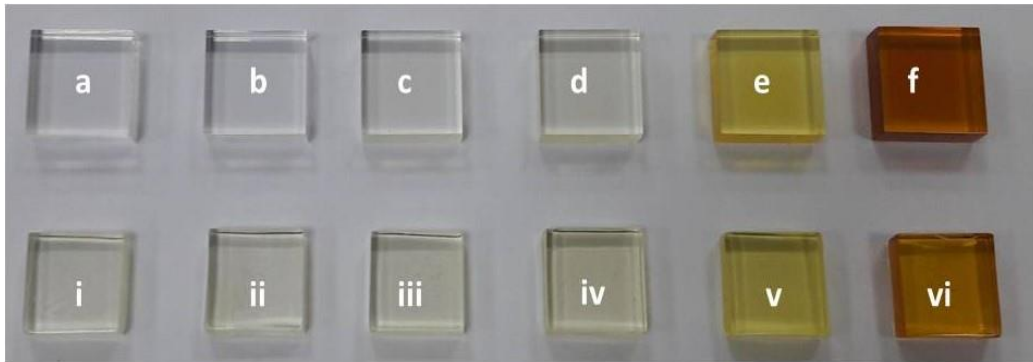
Figure 2: Neutron irradiated samples, Blue scintillators UPS-923A (a - f) and Green scintillators (i - vi). From the left column to right column: non-irradiated, 10^{13} , 10^{14} , 10^{15} , 10^{16} and 10^{17} n/cm².

The samples were subjected to a beam of neutrons for 432 hours, this was the duration of the reactor cycle during the October 2017 run (9 – 27 October 2017). The reactor operated at an average power of 1875 kW with the samples placed at various positions away from the reactor core to achieve various neutron fluences. The neutron fluence ranged approximately between $10^{13} - 10^{17}$ n/cm². However, during the irradiation only neutrons with energy $E > 1$ MeV were monitored. These neutrons account for about a quarter of the total flux. Hereafter we refer to number of fast neutrons with energy $E > 1$ MeV, although the actual amount of neutrons are a factor of four higher. As shown in Figure 2, the discolouration of the samples is evident after irradiation.

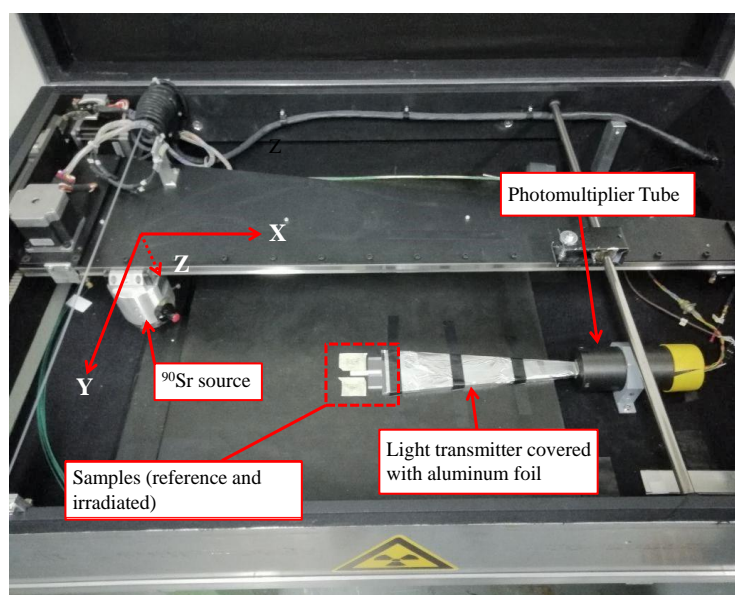
Figure 3: A photograph of light box set-up used to measure the light yield.

The light yield measurements were conducted at the European Organisation for Nuclear Research (ATLAS-experiment) using a light tight box set-up shown in Figure 3. The plastic scintillators were excited with β -electrons emitted by a ^{90}Sr source with average energies of 0.54 MeV and 2.28 MeV. The ^{90}Sr source

scanned over the sample in the X–Y direction whilst emitting radiation in the Z direction. The light emitted by plastic scintillators through fluorescence was detected by the photomultiplier tube (PMT). The signal generated by the PMT was further processed through electronics and digitized. To minimize background signals like those coming from the interaction of the β -electrons with the PMT, a light transmitter was used to transport the light produced by the scintillators to the cathode of the PMT. In addition, a light transmitter was covered with aluminum foil to impede β -electrons from the source.

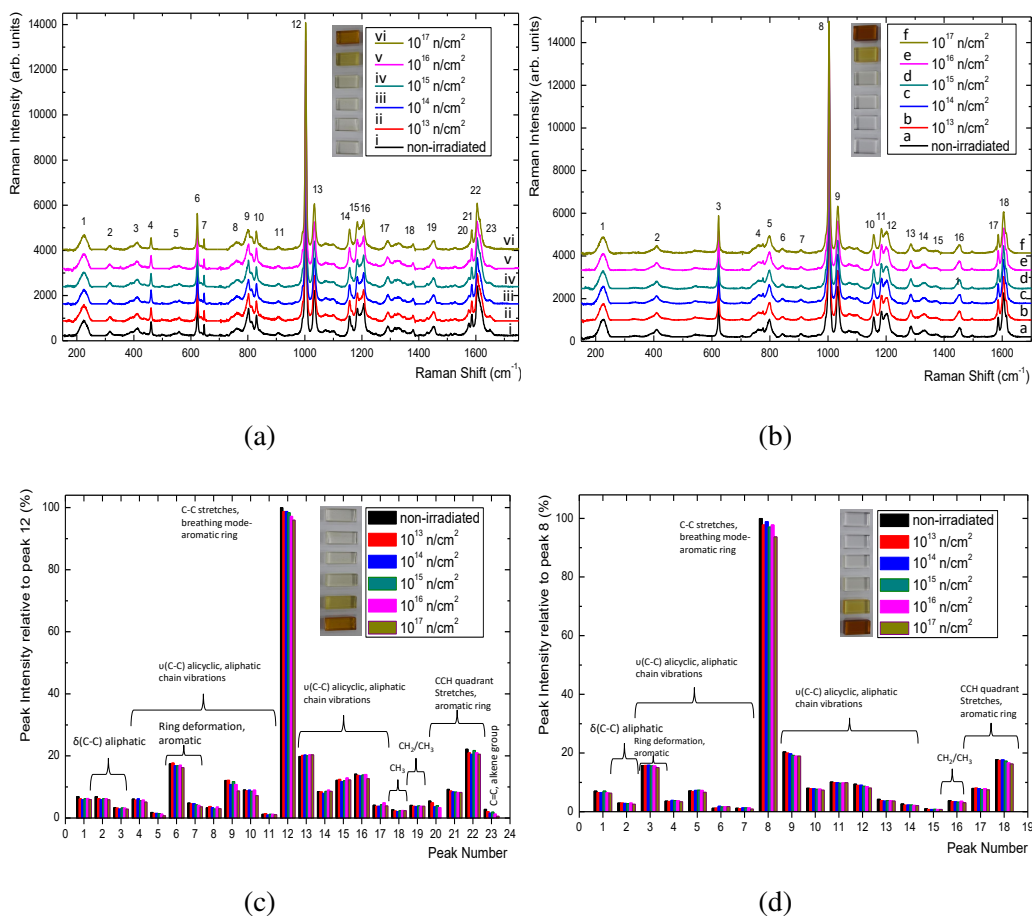
Figure 4: Background subtracted Raman spectra of irradiated and non-irradiated plastic scintillator samples for, (a) green plastic scintillators and (b) blue plastic scintillators UPS-923A. Plot of intensities of peaks relative to peak 12 (non-irradiated) for green (c) and peak 8 (non-irradiated) for blue scintillators (d). NB: The Raman spectra in (a) and (b) have been vertically offset for better visual presentation.

The only limitation of the 785 nm wavelength is that due to detector limitations on the instrument, Raman peaks can only be measured up to 2000 cm^{-1} . The -C-H and =C-H vibrational modes between 2800 and 3200 cm^{-1} could thus not be measured. Raman spectroscopy showed small changes in the structure, in comparison with non-irradiated and irradiated samples. Figure 4(a) and (b) reports the background subtracted Raman spectra of the green and blue emitting plastic scintillators .

Investigations were conducted in the quest of determining the radiation sensitive peaks. Intensities of the Raman peaks for both green and blue emitters were plotted relative to peak 12 and 8, respectively, in order to assess changes in the species present. Peak 12 and 8 typically represent aromatic ring structures, which influences the scintillation properties of the scintillator. The C-C bonds present in the structure give rise to a cloud of delocalized π -electrons that are prone to excitation by incident energetic particles. The results are shown in Figure 4(c) and (d). The ratio of most species found in the styrene backbone of samples to that found in the benzene ring shows a decrease after irradiation.

From the results shown in Figure 4(c) and (d), there is a significant decrease in the Raman intensities of aromatic breathing modes as well as alicyclic/aliphatic chain vibrations belonging to the aromatic benzene ring. These changes are more prominent in green emitting samples. It appears that the benzene ring structure undergoes a significant amount of damage. This could be a result of strong dehydrogenation due to the C-H bond breaking in the benzene ring and an emission of different C_xH_y groups with the absorbed neutron fluence as described by Torris, 2002 [16]. This causes a decline in the number of Raman active modes and hence could account for the observable effects. The Raman intensities of corresponding vibrational modes have been quantified and reported in Table 3 and 4 for green and blue emitting samples, respectively.

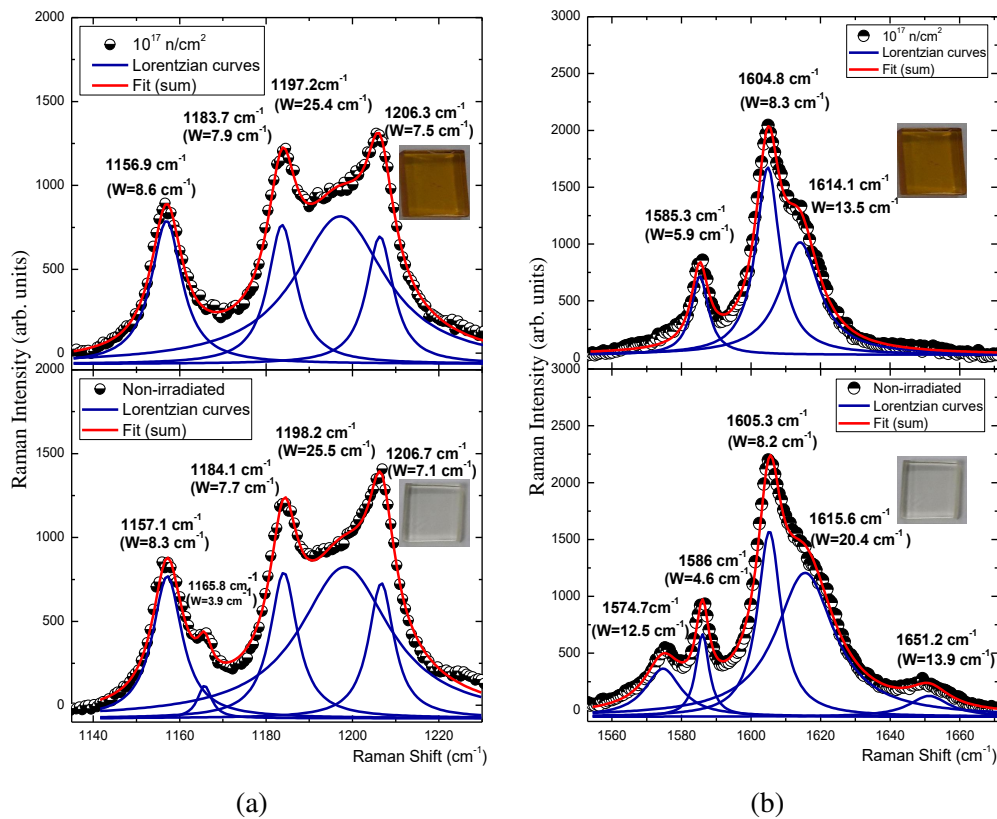
Figure 5: Lorentzian line-shape fitted function at regions 1140-1230 cm^{-1} (a) and 1560-1662 cm^{-1} (b), showing the disappearance of Raman modes at 1165.8, 1574.7 and 1651.2 cm^{-1} , which are present in the non-irradiated Raman spectrum of green scintillators.

It has been observed that, for green scintillators, Raman peak features at frequencies 1165.8, 1574.7 and 1651.2 cm^{-1} appear to be more sensitive to neutron radiation. These bands become less intense as the neutron fluence increases and finally disappear. They are most likely to be related to the fluor dopant 3HF (3-hydroxyflavone) [10, 11], although the primary peaks of 3HF do not match up that well with the peaks in the green scintillators spectrum [17]. It could be that the fluors are a “mix” of 3HF derivatives. Clearly the neutron irradiation does not have a major impact on the polystyrene since all the peaks are still present even for higher fluences. The corresponding Lorentzian fits of the non-irradiated and higher neutron fluence spectra are shown in Figure 5 and the peak intensity values are reported in Table 5.

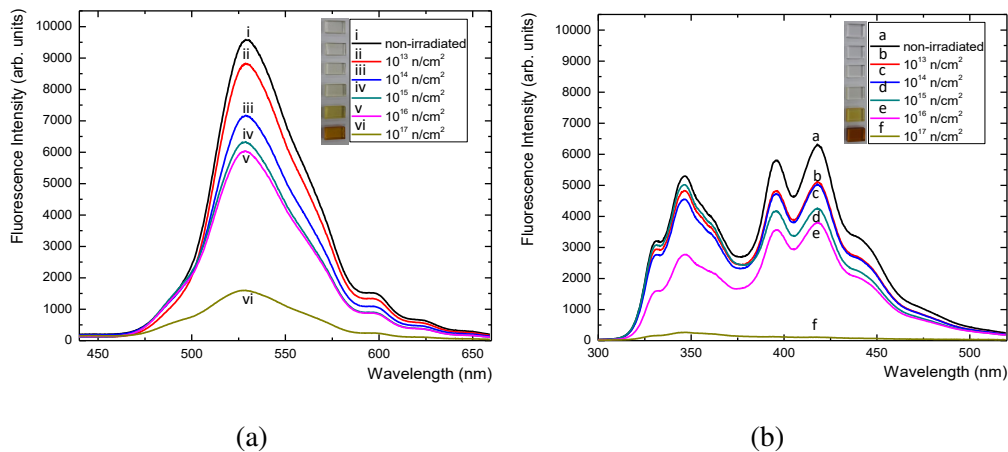
Figure 6: Fluorescence spectra for green scintillators (a) and blue UPS-923A scintillators (b).

Fluorescence spectra of plastic scintillator samples are shown in Figure 6. A two-peak feature in Figure 6(b) is observed for blue scintillators UPS-923A. Wavelength regions of 310-375 nm and 375-520 nm correlate with fluorescence of the polystyrene base and fluor dopants, respectively. The two-peak feature is observed since the fluorescence is predominantly from the benzene ring structures. However, the results for green emitting scintillators in Figure 6(a) reveal only a single fluorescence peak around 529 nm. For all samples, the decrease in fluorescence intensity is prominent as neutron fluence increases. There could be degradation of the aromatic benzene ring structures in the polymer base matrix and damage to the Förster energy transfer mechanisms due to C-H bond breaking within the benzene ring. These damages are reported in literature by Torrisi, 2002 [16], to be the cause of luminescence yield reduction. The results of Raman spectroscopy reported in Table 3 and 4 affirm these changes, and are consistent with the fluorescence results. Damage to the benzene ring directly affects the scintillation process in the material.

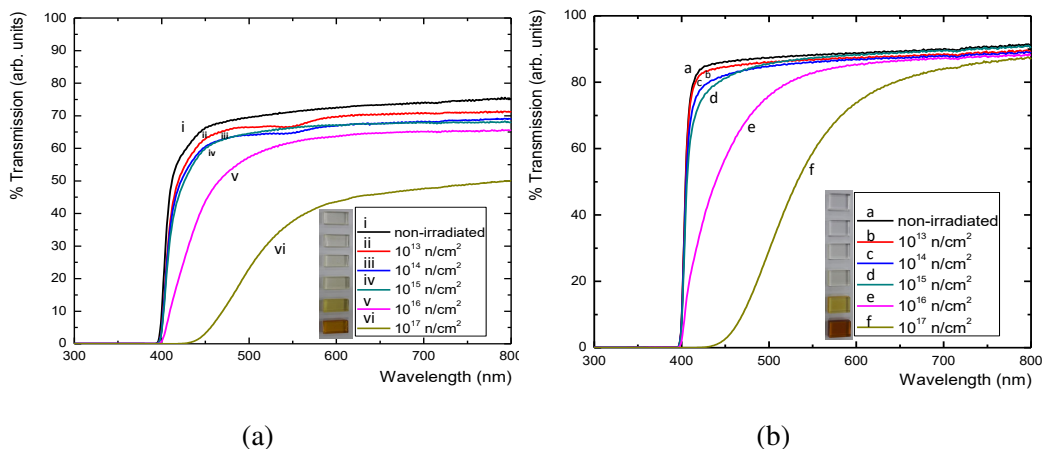
Figure 7: Light transmission spectra for green scintillators (a) and blue scintillators UPS-923A (b).

Transmission spectroscopy was conducted using the Varian Cary 500 spectrophotometer with the light transmission measured relative to transmission in air over a range of 300-800 nm. The results are shown in Figure 7. All the non-irradiated blue scintillators UPS-923A and green scintillators have an absorption

edge starting at 410 nm, which completely falls off at around 400 nm. The formation of an absorptive tint as neutron fluence increases is observed where the absorption edge drops and shifts to longer wavelengths. This effect is ascribed to the production of free radicals induced by radiation damage. These free radicals form absorption centers within the samples resulting in the light absorption competition and loss of transparency in scintillators.

From the light transmission plots, it is evident that blue scintillators UPS-923A possess the highest light transmission properties and appear to be most radiation tolerant as compared to green light emitters. The blue scintillator overall remains more transparent to all wavelengths, but becomes opaque to blue light after damage. Whereas, the green scintillators lose transmission in blue light region, but remain transparent in the 550+ nm region.

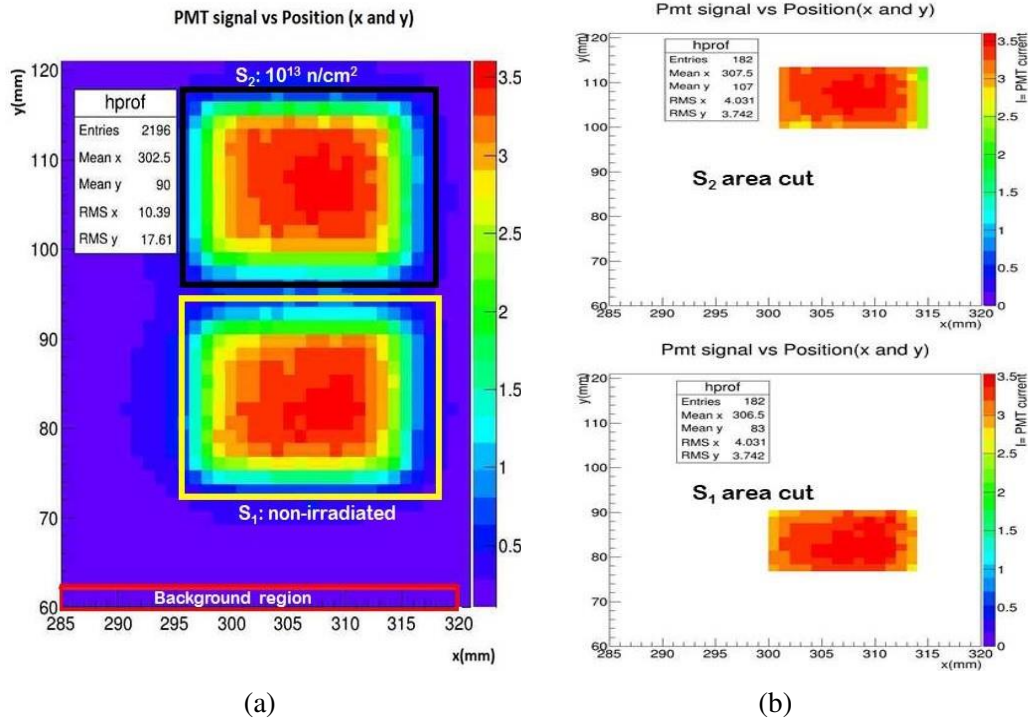
Figure 8: 2D mapping of the PMT signal with ⁹⁰Sr source position, indicating signal regions corresponding to regions on the experimental set-up (a) and plots of area cut with entries of high signal values (b) [color legend only available on electronic version].

The assessment of light yielded by irradiated plastic scintillator samples was performed by testing their response to a ^{90}Sr β -electron source. The signal generated by the PhotoMultiplier Tube was measured as a function of radiation source position. Figure 8(a) illustrates a 2D mapping of the signal measured in the X and Y direction over a pair of samples. The position of samples is approximated by the black and yellow boxes (color legend only available on electronic version), representing irradiated and non-irradiated samples, respectively.

Before analysis, the background was subtracted from the rest of the mappings. The background region marked with a red box on Figure 8(a) was selected on one of the 2D mapping surface with the signal not contaminated by the signal from the samples. A pair of irradiated (10^{13} n/cm²) blue test sample and the non-irradiated blue reference sample were used. The mean signal value of 0.1309 mean/entry over the selected area was used as a background value.

The area cuts plots shown in Figure 8(b) were selected from the 2D mappings with entries of high signal values. In order to analyse the light yield loss as a function of neutron fluence, the ratio of corrected signals from the reference and test samples were calculated and plotted against the neutron fluence as shown in Figure 9. The light yield loss in all irradiated samples is observed as neutron fluence increases. It is prominent at a fluence of 10^{17} n/cm². The light yield results are consistent with the fluorescence and light transmission results.

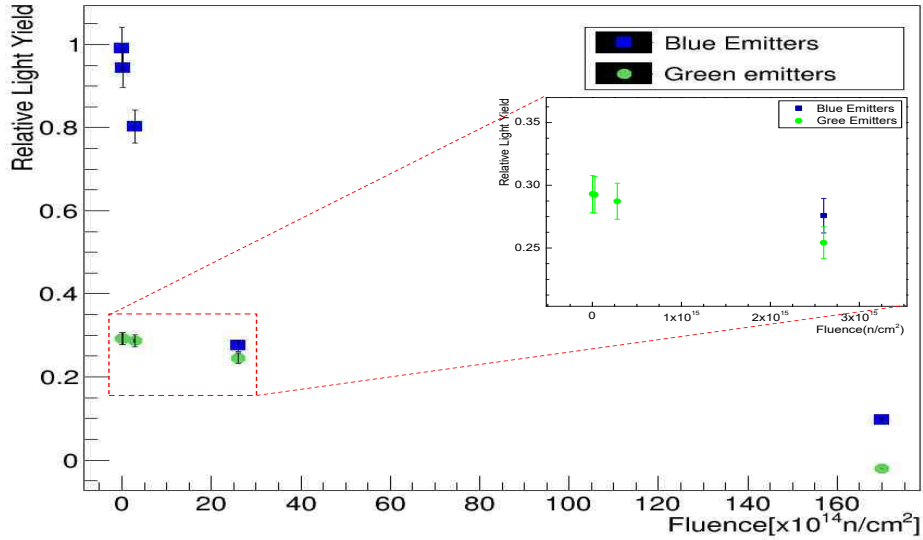
Figure 9: Light yield against neutron fluence for blue UPS-293A scintillator and green scintillator.
