AMBIENT VIBRATIONS OF AGE-OLD MASONRY TOWERS: RESULTS OF LONG-TERM DYNAMIC MONITORING IN THE HISTORIC CENTRE OF LUCCA.

The paper presents the results of an ambient vibration monitoring campaign conducted on so-called “Clock Tower” (Torre delle Ore), one the best known and most visited monuments in the historic centre of Lucca.

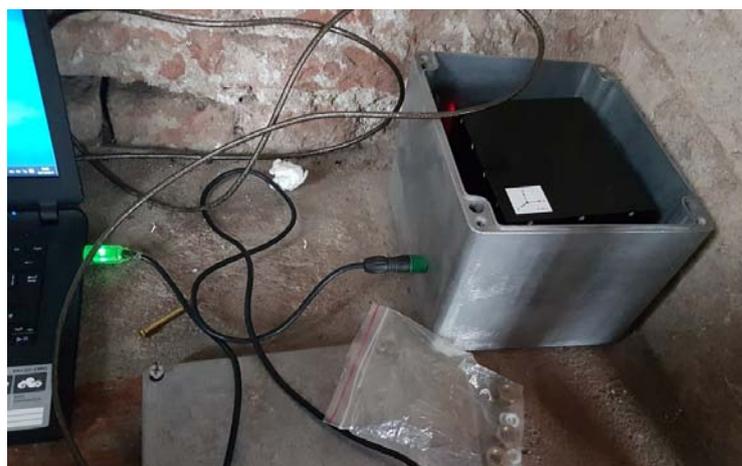
Figure 4. Sensor S.2 at level +37 m inside the tower.

In November 2017 a long-term ambient vibration monitoring experiment was begun with the fitting of six instruments along the tower's height: four Sara SS20 seismometric stations (tri-axial velocimeters, Fig. 3) from the INGV, named in the following S.942, S.943, S.944, S.945, and two tri-axial accelerometers (Fig. 4) provided by the firm Assist in Gravitation and Instrumentation (AGI S.r.l.), named in the following S.1 and S.2. The INGV sensors were coupled with a 24-bit digitizer and the signal was sampled at 100 sps. The AGI data were acquired by a laptop at a sampling frequency of 20 Hz using a 24-bit digitizer. With regard to the main characteristics of the instruments used in the monitoring campaign, the SS20 velocity transducers have a nominal sensitivity of 200 V/m/s, eigenfrequency of 2 Hz, and usable band from 0.1 to 250 Hz. The AGI accelerometers have an acceleration noise density of $2 \cdot 10^{-8} \text{ g}/\sqrt{\text{Hz}}$ and usable band from 10^{-5} to 50 Hz. It is worth noting that together the instruments can cover a very wide band of frequencies. The instrumentation was kept running on the tower up to March 2018. Figure 5 shows the layout of the sensors along the tower during the experiment: seismic station S.942 was placed at the base, collecting data from the ground, S.943 was at the height of 24 m above street level, the remaining two stations S.943 and S.944 were placed on the bell chamber, at about +42 m above street level. The AGI stations were both installed in the upper part of the structure, S.2 at +37 m and S.1 on the bell chamber level.

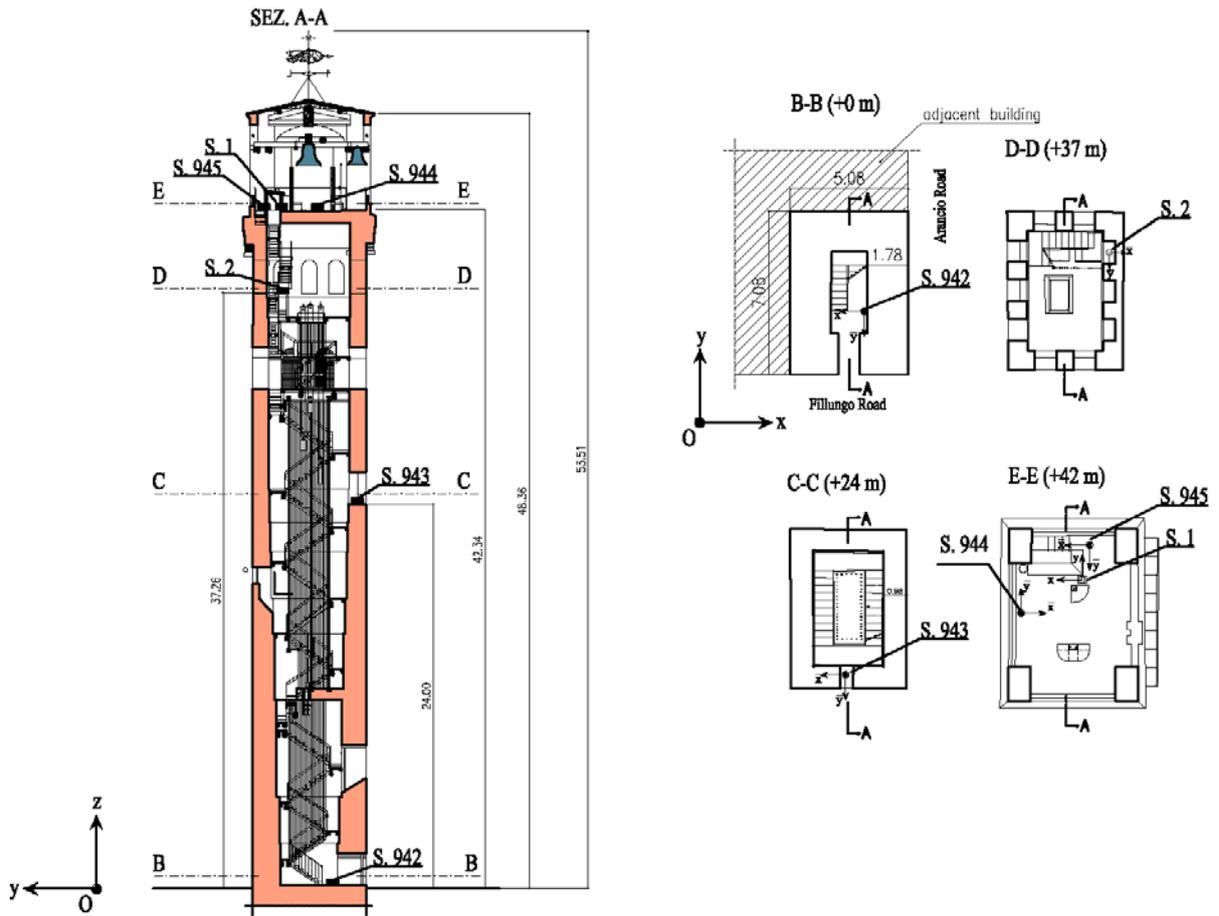
Figure 5. Sensor arrangement on the Clock tower: sensors S.942, S.943, S.944, S.945 (INGV), sensors S.1, S.2 (AGI).

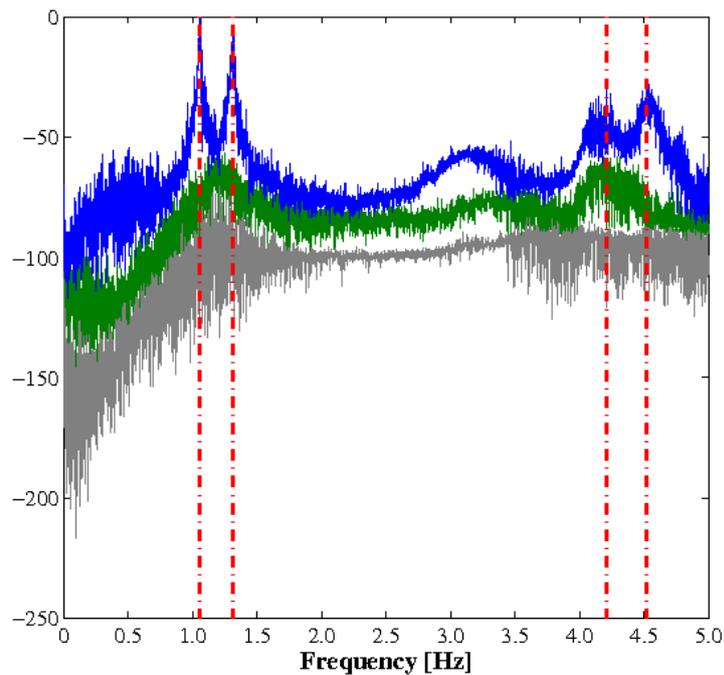
Figure 6. The three eigenvalues of the matrix $H[j\omega]^H H[j\omega]$ vs. the frequency on a log-magnitude scale.

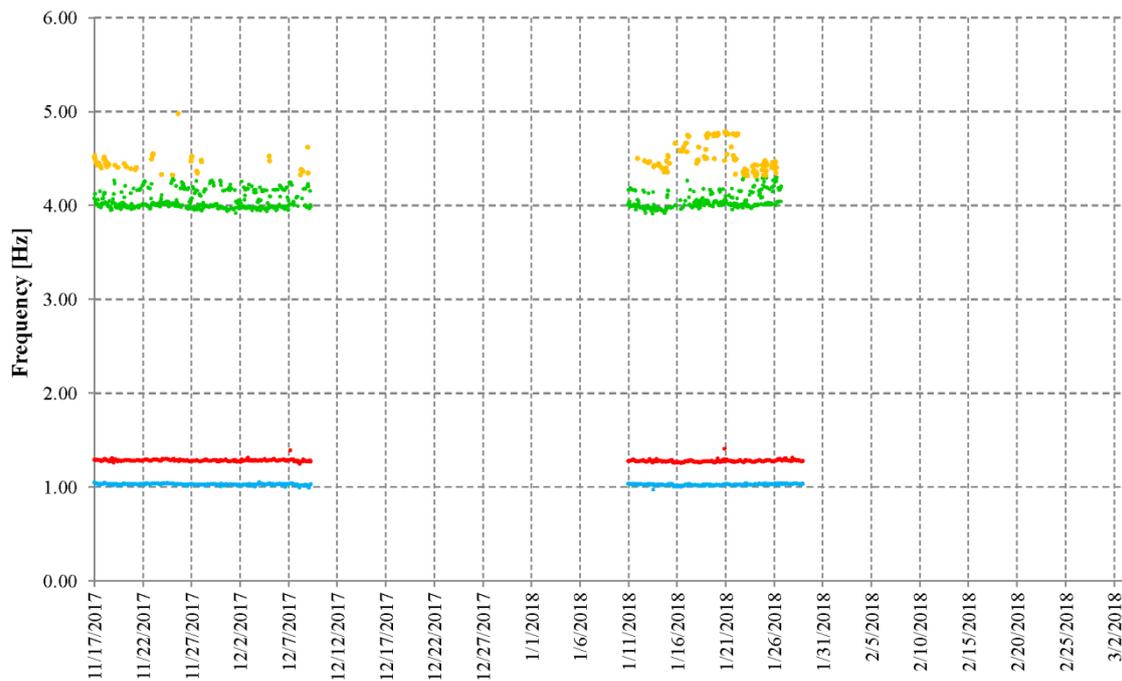
Figure 7. The tower's first four natural frequencies [Hz] detected by SS20 velocimeters during the monitoring period.

The tower's frequencies are reported in Table 1, where the mean values (evaluated over the entire monitoring period from November 2017 to March 2018) of the four frequencies are reported, together with their relative differences (evaluated on the 1st and 99th percentile) for the two different instruments. The frequencies values measured on the Clock Tower are in good agreement with those of other towers with similar geometries (Bartoli et al., 2017). The dataset from the SS20 seismic stations includes 970 hours of recordings, while the AGI instrumentation yielded 1110 hours of tower measurements. The frequency values vs. time are reported in Figures 7 and 8 for the SS20 and the AGI instruments, respectively. The mean values evaluated by the two instruments are in very good agreement. The first and the second frequencies were detected by the two instruments in all records, and the variation in the two frequencies is on the order of 3%. This variation is also in good agreement with the findings of another long-term dynamic monitoring conducted on the San Frediano bell tower in Lucca (Azzara et al., 2018a). The third frequency was also detected by the seismic stations in almost all records, while the fourth frequency only appears when the excitation level in the tower's structure was increased (it was detected in about the 30% of the records), and its values appear to be widely dispersed. A fifth frequency at about 5.7 Hz was also detected in about 30% of the records. With regard to the modal damping ratios, reported in Table 2, they are widely dispersed with variations on the order of hundreds of percentage points. Their values vary from 4% for the highest frequency, to 0.5% for the first. The values yielded by the seismic stations are generally higher than those from the accelerometers.

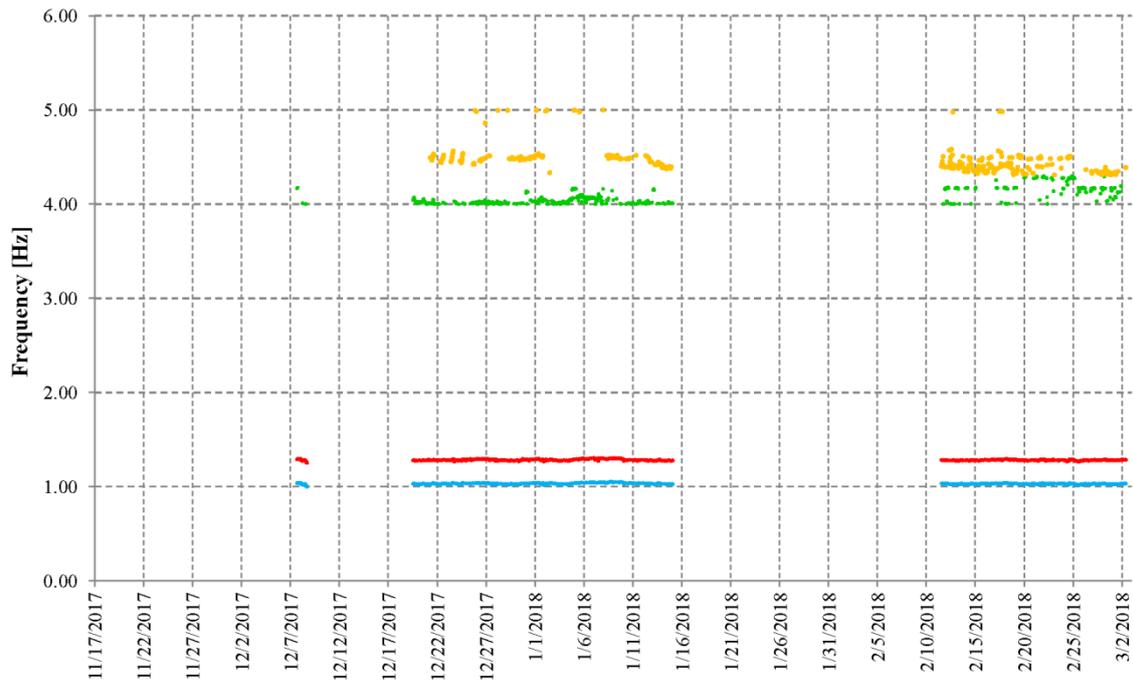
Figure 8. The tower's first four natural frequencies [Hz] detected by AGI accelerometers during the monitoring period.

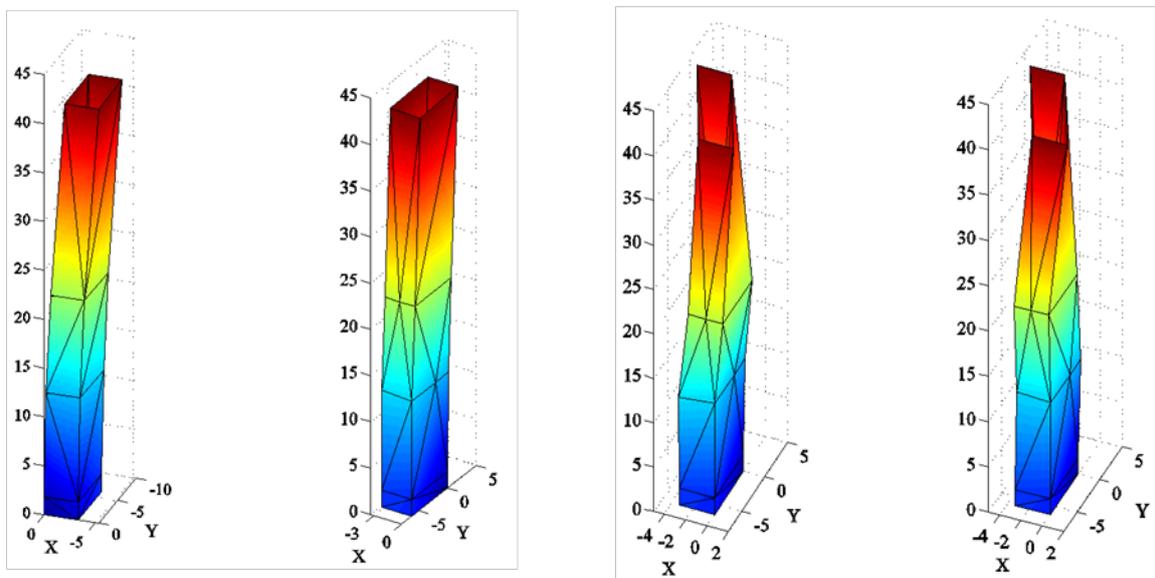
Figure 9. The tower's first four mode shapes [Hz] corresponding (from the left) to the frequencies f_1 , f_2 , f_3 , f_4 .

The mode shapes of the tower corresponding to the four frequencies f_1, f_2, f_3, f_4 are shown in Figure 9; these have been extracted from the data recorded in November 2016 by taking advantage of the different layouts used for mapping the tower's vibrations. The first two frequencies refer to bending modes along the x (first) and y (second) directions, while the third is a torsional mode and the fourth is a torsional-bending mode involving movements of the structure's upper parts.

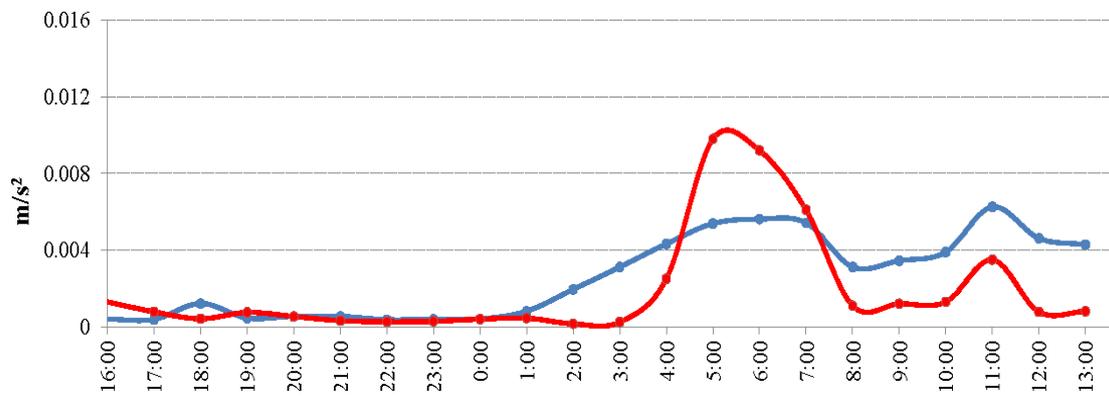
Figure 11. Maximum absolute accelerations recorded by the S.2 station (blue, +37 m) and the S. 945 station (red, +42 m) from 7 to 8 December 2017 (respectively at 16:00 and 13:00).

Figures 10 and 11 show further comparisons of the results obtained via the two instruments. In particular, Figure 10 shows the trend of the tower's fundamental frequency from 7 to 8 December 2017, extracted from the AGI (blue) and the SS20 (red) devices. The very good agreement between the two measurements indicates that the fluctuations exhibited in the frequency values do not depend on the instruments' functioning, but are rather due to environmental factors. Figure 11 shows a comparison of the hourly maximum accelerations (absolute values) recorded by the instruments during that same period. The differences between the amplitudes are mainly due to the different positions of the instruments, which were placed at slightly different levels along the tower. It is worth noting that maxima in the acceleration values correspond to minima in the frequency values. In fact, a look at the weather those days revealed very bad conditions, with strong wind velocities (see also Figure 15), thereby suggesting a connection between the frequency reduction shown in Figure 10 and the action of the wind, which due to the masonry's inability to withstand large tensile stresses, tends to decrease the tower's stiffness.

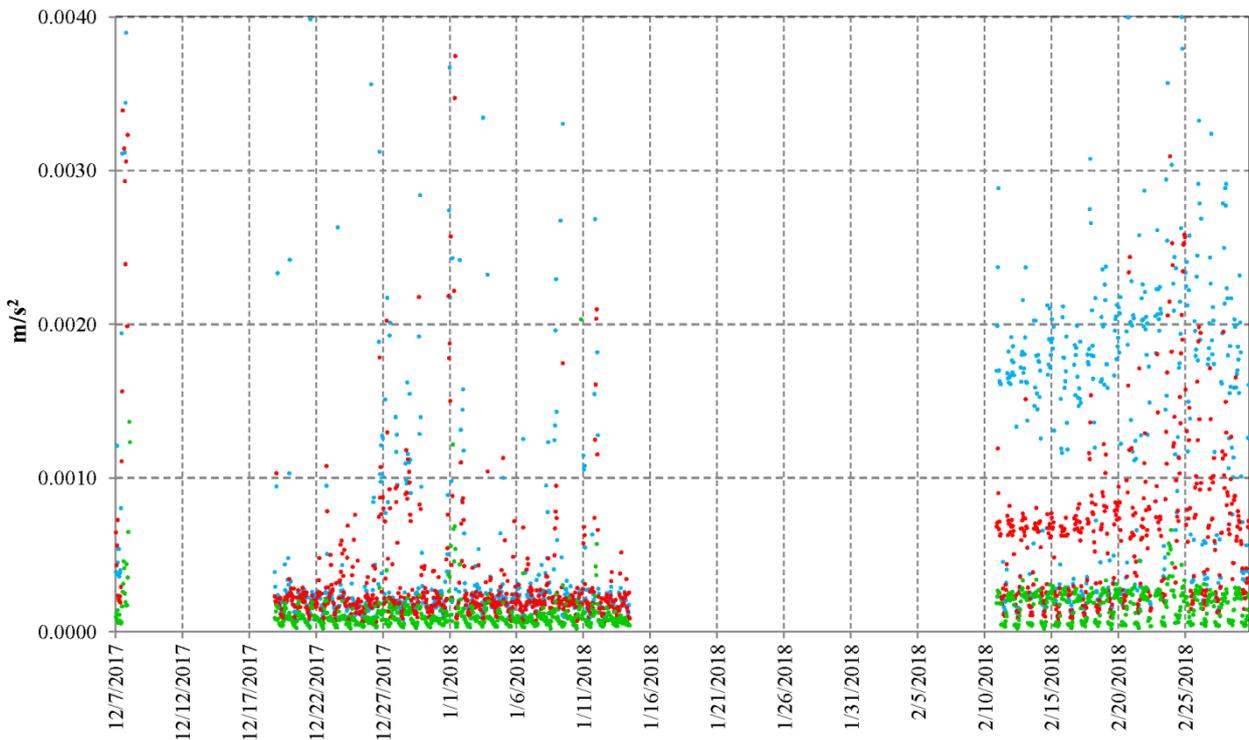
Figure 14. Maximum absolute values per hour of the accelerations recorded by AGI stations (S.2, +37 m) in the x (blue dots), y (red dots) and z (green dots) directions.

The trend over time of the maximum accelerations recorded by AGI sensors is shown in Figure 14. The vibration level in the tower is very low, generally under $2 \cdot 10^{-3} \text{ m/s}^2$, thanks to restrictions to vehicular traffic in force in the Lucca historic centre. The figure highlights an increase in the tower's vibration level during the Christmas holiday period (from 22 December to 1 January), connected to the increased pedestrian traffic in the historic centre, with a peak on New Year's Day. The figure also reveals a systematic increase in the accelerations, on average of one order of magnitude, from 9 February onward. This is due to the ringing of the tower bells, which had been suspended for restoration of the ancient clock and was restarted on 16 January 2018. The bell system is composed of three bronze bells, fixed at their supports and rung by hammers each quarter an hour in the x direction (along Via Fillungo). Indeed, Figure 14 shows significant amplification along x (blue dots).
