# Atomic defects of the hydrogen-terminated Silicon(100)-2x1 surface imaged with STM and nc-AFM

## Abstract

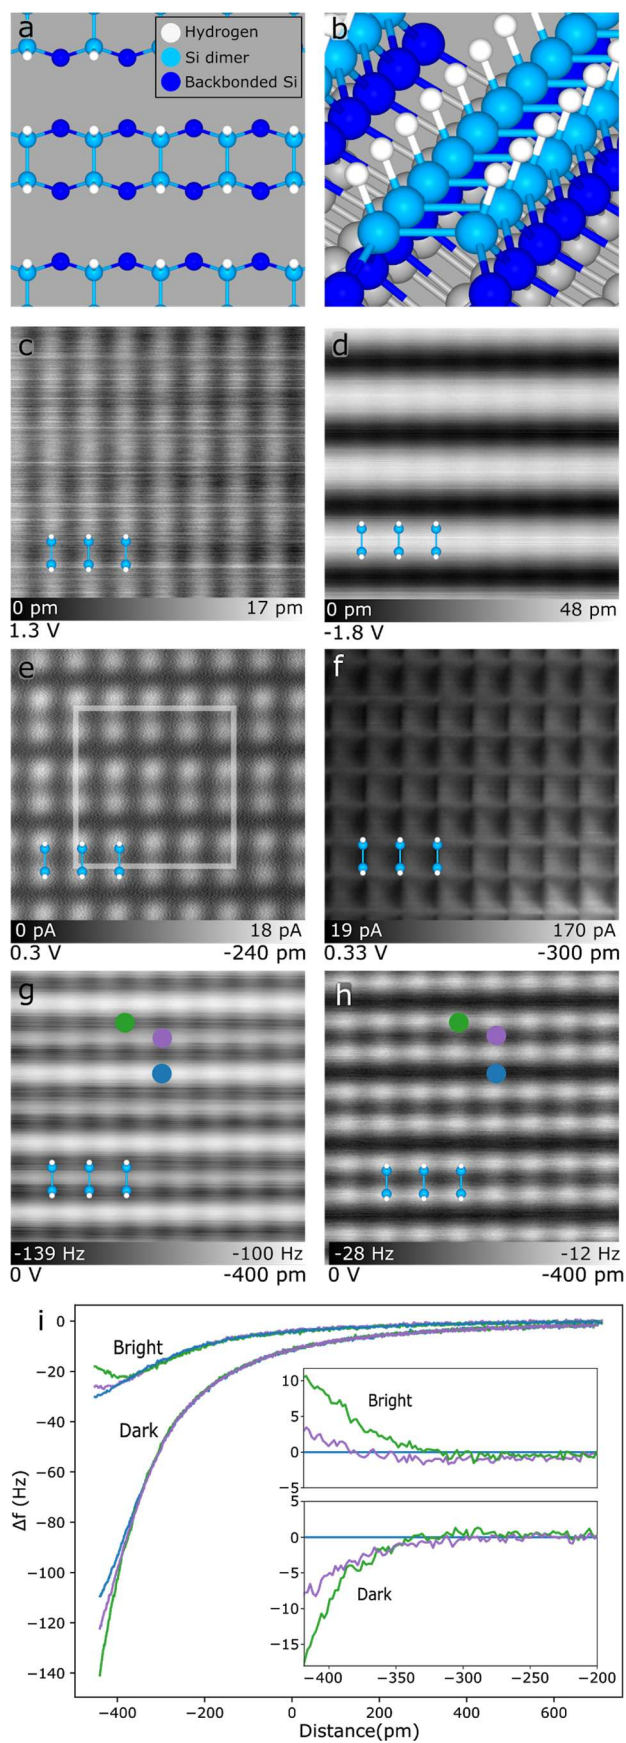
**Figure 1. Surface of H-terminated Si(100)-2x1 in different imaging modes.** (a) and (b) Top and side view of structural model, size of area shown in (a) indicated in (e). (c) and (d) Constant current ( $I=50\text{pA}$ ) STM topography of empty and filled states (bias voltages as indicated). (e) to (h) Constant height images of the same area as in (c), indicated height offset  $\Delta z$  initialized using tunneling setpoint parameters of  $I = 50\text{ pA}$  and  $V = -1.8\text{ V}$  over a H-Si/metallic STM tip (e), STHM (f), nc-AFM frequency shift in dark contrast (g), nc-AFM frequency shift in bright contrast (h). (i) Position-dependent frequency shift spectroscopy  $\Delta f(z)$  in bright and dark nc-AFM mode (positions indicated in (g) and (h)). The inset shows the calculated difference spectra in reference to the spectra taken between the dimer rows (blue position marker).

The variability of scanning probe imaging modes originates from the applied feedback mode, different tunneling parameters, or the functionalization of the probe tip. Figure 1 demonstrates various imaging modes for the defect-free H-Si(100)-2x1 surface. Figure 1a and 1b show a ball-and stick model of the surface reconstruction with the pairing of surface Si atoms into dimers and the termination of the residual dangling bonds with hydrogen (See Methods). For completeness, we start with the well-known STM topographies of empty and filled states (constant current imaging, sample bias as indicated, Figure 1c and 1d). Imaging both states allows for the assignment of dimer rows. Recent work has found that tip functionalization can determine the contrast sharpness and apparent atomic positions in empty state STM images of the H-Si(100) surface<sup>22</sup>. Three examples of this effect are displayed in Supplementary Information Figure S1, highlighting the necessity to include subtle surface features in the assignment of dimer position.

Further insights can be gained from constant height images. Figure 1e shows a constant height STM image of the surface at a sample bias which probes the onset of the conduction band (donor band) of our crystal<sup>9,17,24</sup>. Hydrogen-terminated silicon atoms within each dimer are identifiably without any significant convolution from bulk states. Figure 1f shows the final STM imaging method used, known as scanning tunneling hydrogen microscopy (STHM)<sup>25</sup>. The use of a flexible species at the apex of a metallic tip to provide enhanced contrast was first reported using CO-functionalized AFM tips to image the molecular structure of pentacene<sup>26</sup>. Other functionalizations of AFM tips have been explored including Cu-O tips<sup>27,28</sup> and Xe tips<sup>29,30</sup>. The use of  $\text{H}_2$ <sup>31,32</sup> and  $\text{D}_2$ <sup>25</sup> was the first successful demonstration of the enhanced imaging contrast using STHM. Rather than direct tip functionalization as done in AFM, STHM was routinely achieved by leaking in a background of molecular hydrogen ( $\sim 10^{-9}\text{ Torr}$ ) until an  $\text{H}_2$  molecule becomes trapped in the tip-sample junction. We are able to achieve STHM resolution by directly functionalizing the tip apex with hydrogen using voltage pulses over the H-Si surface, as discussed elsewhere<sup>22,33,34</sup>. Our ability to achieve STHM resolution using an H-functionalized tip aligns with recent theory that suggests the  $\text{H}_2$  molecule actually dissociates resulting in an H-functionalized tip<sup>35</sup>. In STHM imaging, the surface appears as a series of squares with each intersection correlating to a H-Si atom. The image's slight asymmetry is commonly attributed to the shape of the tip apex and the

A true force feedback can be visualized with frequency-shift maps generated by non-contact AFM. Based on the apparent contrast of the hydrogen atoms with the surrounding surface we denote the two different modes as bright and dark contrast AFM. Previous studies have identified these two contrasts when imaging the hydrogen-terminated Si(100)<sup>36</sup> surface, where the dark contrast image corresponds to a Si-terminated tip<sup>37</sup> and the bright contrast image corresponds to an H-terminated tip<sup>37</sup>. Figure 1i shows the height-dependent frequency shift  $\Delta f(z)$  that is governed by the interaction between tip and sample at selected positions on the surface. To highlight the termination-dependent reactivity we calculate the difference in frequency shift<sup>38</sup> compared to the “between dimer” position, where the least interaction is expected. The strongest repulsive component is clearly observed for the bright contrast tip on the H-atom, while the Si-terminated tip leads to the strongest attractive interaction at the same site (dark contrast).

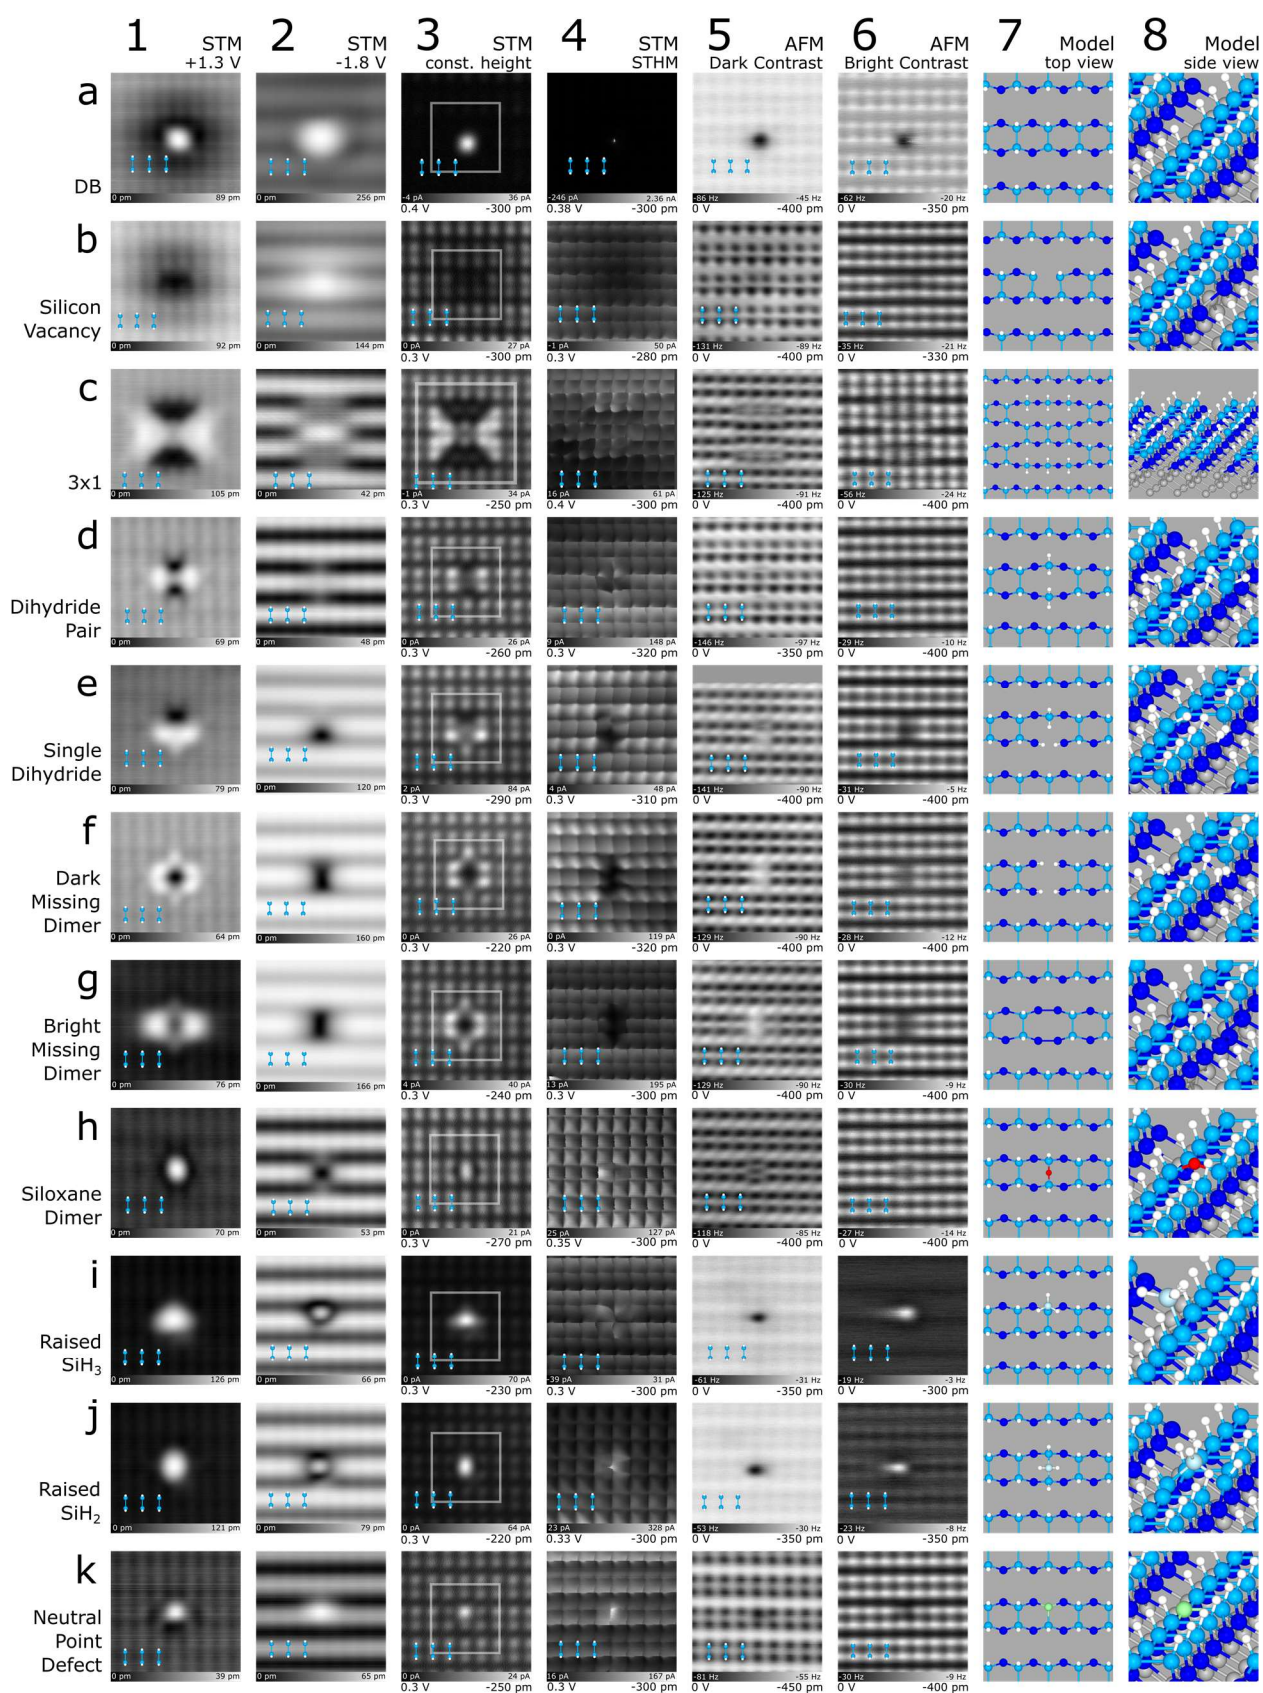
Figure 2. **Common features of the H-Si(100)-2x1 surface imaged using the indicated STM and nc-AFM imaging modes.** The dimer structure is shown as an overlay in each scan (lower left corners). The area of the structural models in columns 7 is indicated by the grey box surrounding the defect in column 3. Colours in the ball and stick models are: H - white, Si dimers - light blue, back-bonded Si - dark blue, O - red, raised Si - lightest blue, and unknown species - green.

Combining all six imaging modes allows for an in-depth characterization of the most common surface features and their local environment as shown in Fig. 2. While not an exhaustive list, it features defects routinely seen when the surface is prepared using the procedure outlined in the Methods section. To categorize the defects, one could focus on functional aspects (charged vs. neutral features)<sup>9</sup>, or structural aspects including missing or additional atoms. Here, we categorize the defects solely on structural commonalities, based on the number of affected atoms.

First, we list features that involve only one side of a dimer. These include a missing H atom that leaves the dangling bond (DB) of the underlying Si atom exposed (Fig 2a), a subsurface vacancy (Fig. 2b), the substitution of an H atom with SiH<sub>3</sub> (Fig. 2i), and an unidentified surface point defect (Fig. 2k). Second, defects affecting a whole dimer are: two missing H atoms creating a bare dimer (neutral, shown elsewhere<sup>39,40</sup>), two additional H atoms on a dimer to create a dihydride pair (Fig. 2d), a single added H atom forming a dihydride on one side of the dimer (Fig 2e) that in turn requires the neighboring Si atom to be missing (Fig 2e), the removal of the whole dimer (two missing Si atoms) accommodated by H-termination or dimer formation in the second layer (dark or bright, Figs. 2f and 2g). Alternatively, the dimer bond could be replaced by either a SiH<sub>2</sub> group (Fig. 2j) or an oxygen atom (siloxane bridge, Fig. 2h). Remaining larger features can be described as a combination of two or more of the smaller structures, like the 3x1 reconstruction which is a combination of dimer rows and dihydride atoms (Fig. 2c).

The most obvious deviation from the hydrogen-terminated surface are silicon DBs, well-understood un-terminated silicon atoms<sup>41–43</sup>. In STM, the centre of a DB is imaged as a bright protrusion indicating the highly conductive orbital which extends into vacuum. Due to the degenerate doping of our substrate (see Methods)<sup>6,42</sup>, DBs are usually negatively charged and the associated band bending leads to a halo around the DB in empty states imaging (Fig. 2a-1)<sup>42,44</sup>. The STM filled states image lacks the charge induced band bending around the DB due to competing electron emptying and filling rates rendering the DB neutral on average<sup>43,44</sup>. The constant height STM and STHM images in Figs. 2a-3 and 2a-4, also reveal the central protrusion but in addition, the STHM image shows a significant increase in tunneling current over a DB (36pA vs. 2.4nA). The reason is that the different tip functionalizations result in different tip-sample separations when the tip height is initialized using the tunneling setpoint (-1.8 V, 50 pA) as a fixed reference (direct comparison shown in Figure S2). Finally, AFM analysis in Figs. 2a-5 and 2a-6,

Figure 2b shows a suspected silicon vacancy (discussed in more detail in Figure 4) previously referred to as a type 2 (T2) defect<sup>45</sup>. Prior works have suggested this defect originates from many sources including a negatively charged As dopant<sup>45</sup>, Si-vacancy hydrogen complexes<sup>9</sup>, and B dopants<sup>46,47</sup>. Various types of crystal vacancies have previously been identified using scanning probe microscopy including Ga vacancies in GaAs<sup>48</sup>, As vacancies in GaAs<sup>49</sup>, and P vacancies in InP(110)<sup>50</sup> which exhibit similar imaging characteristics to the Si vacancy. From the STM empty states image in Figure 2b-1, it can be seen that the vacancy exists as a negatively charged species as evidenced by the reduction in brightness from charge induced band bending. Additionally, it lacks the bright centre found with the DB suggesting the defect does not contain any orbitals which extend into vacuum. This is further corroborated by the filled states STM image in Figure 2b-2 showing a diffuse bright protrusion similar to the DB, but of reduced conductivity. In 2b-3, a reduction of current due to charge induced band bending can be observed, along with a distortion of the density of states of the surface H-Si atoms above the sub-surface vacancy defect. 2b-5 and 2b-6 show similar distortions in the AFM frequency shift signal around the two H-Si atoms closest to the vacancy, suggesting a modification in their position or reactivity.

A silicon adatom replacing an H atom (on top of one of the dimer atoms) will be fully saturated and form a raised SiH<sub>3</sub> or silyl group (Fig. 2i)<sup>51</sup>. Larger clusters of these Si groups can subsequently bond and form islands<sup>21,52</sup>. The triangular shape of the defect as seen in the STM images demonstrates the tetrahedral bonding orientation at the Si, with the forth bond affixing it to the side of the dimer beneath. The raised nature of the silyl group dominates the current in constant height imaging which leads to extended distortions in STHM (Fig. 2i-4), partially due to the groups high flexibility, and gives rise to stronger frequency shifts in nc-AFM (Fig. 2i-5,6).

Instead of bonding with the neighbouring Si atom creating a dimer bond, the Si atom could bond with 2 H atoms, whereby a dihydride is created (Fig. 2e). Although not formally reported, it has been observed in the past (such as the top right of Figure 2 in Ref. [53]). The remaining Si atom of the dimer is either absent (Fig. 2e) or also bonds with 2 H atoms creating a pair of dihydrides (Fig 2d)<sup>20,53–55</sup>. Based on their appearance, the latter defect is commonly referred to as the “bow-tie” defect<sup>56</sup> or simply a dihydride. The concentration of dihydrides can be controlled by the annealing temperature during sample preparation<sup>18,57</sup>.

The H<sub>2</sub>-Si units appear as depressions in empty state topography (Figs. 2d-1 and 2e-1) and correspondingly as sites of lower current in the constant height imaging (Figs. 2d-3 and 2e-3), whereas neighboring dimers appear enhanced<sup>51</sup>. The concomitance of a depression and enhanced surrounding atoms in empty states imaging is a similarity that dihydrides share with missing dimers (Figs. 2f and 2g)<sup>13,58,59</sup>. The filled states imaging provides distinction with almost negligible variations of the dihydride sites (Fig 2d-2) compared to the distinct depression of missing atoms (Figs. 2e-2, 2f-2, and 2g-2). The STHM image of figure 2c-4 allows for a direct comparison between the dihydride and the missing atom.

The two variations of the missing dimer appear almost identical, except when comparing the relative height of the neighbouring dimers in constant current images of 2f-1 (dark) and 2g-1 (bright). The data were taken sequentially while continuously monitoring for tip changes, ensuring identical apex character. Similar to the unterminated surface<sup>60</sup>, the two varieties originate from different terminations of the exposed back-bonded silicon atoms. The formation of two dimer bonds—orthogonal compared to the top layer dimers (model in Fig. 2g-7)—corresponds to the bright variation (2g) and H-termination of all sites leads to the dark variation of the missing dimer (2f). The latter has been reported to cause less lattice strain<sup>61</sup>, matching our observation of less distortions in the STHM and nc-AFM images near the dark missing dimer (Figs. 2f-4,5,6 compared to Figs. 2g-4,5,6). This family of defects (dihydrides, missing dimers and combinations thereof) underlines the importance of combining several modes of SPM imaging to unambiguously assign the present structure.

Figure 2c explores a structure involving a larger number of dihydrides. During H-termination, a set of two silicon atoms will bond so that the center two atoms create a single dimer row (here 3 dimers long) leaving two lone Si atoms at either side which bond with two H atoms creating dihydrides. This is the motif of the 3x1 reconstruction shown here as a three unit patch (See Figure 2c-7)<sup>19,62,63</sup>. Figures 2c-1 and 2c-3 show the enhancement in current at dimers neighbouring the reconstruction and a reduction above the H<sub>2</sub>-Si atoms. Figure 2c-2 shows a dimer has been formed between two of the regular dimer rows, with Figure 2c-3 also highlighting this realignment. The dihydride features in the 3x1 reconstruction show similar features to the single dihydride structure mentioned above including the deviation in the STHM image (Figure 2c-4) and the splitting feature of the AFM image in Figure 2c-5. A direct comparison of the differences in nc-AFM dark mode imaging including the identification of individual H atoms at the dihydride sites is given in Figure 3.

Defects that we occasionally observe as substitutions that replace the dimer bond manifest themselves through the insertion of additional atoms between the dimer bond. We representatively show a SiH<sub>2</sub> group and an oxygen atom in such a position. The tetragonal bond orientation of the silicon atoms forces both substitutions into a raised height configuration (Figs. 2i-7 and 2j-7) compared to a regular dimer. The former represents a silicon adatom in the bridge position between two top layer silicon atoms compared to the already discussed SiH<sub>3</sub> group bonded to one side of the dimer. Both adatoms show similar apparent height in STM topography with their location with respect to the dimer easily discerned. In dark contrast AFM images the chemically reactive silicon tip strongly interacts with both

The bridging oxygen in Figure 2h forms a siloxane dimer (see structure in Fig 2h-7), sometimes described as a split dimer<sup>64,65</sup> or incorrectly identified as a dihydride<sup>2,66</sup>. STM imaging reveals a very localized defect with only subtle impact on neighboring dimers (Figs. 2h-1,2,3). Figure 2h-4 shows slight variation from the 2x1 dimer, with the positions of the atoms in the dimer further apart with a central bright feature present. This agrees with the AFM data in Figure 2h-5, showing the dimer contains a third atom in the middle. In bright mode AFM the attractive interaction between H-tip and the oxygen's non-bonding electron pairs leads to a slight depression in the centre and lets the dimer's H atoms appear pushed out (Fig. 2h-6). A defect of similar appearance was found on chlorine-terminated silicon<sup>67</sup>, and was associated with water contamination in the vacuum chamber (observed as H and OH bonded to the unterminated surface<sup>15,68,69</sup>) where a mild annealing followed by halogen termination allowed the oxygen to enter into the dimer bond. The authors comment that they expect this feature to also be present on hydrogen-terminated silicon.

Figure 2k shows an unknown neutral point defect. This defect is also observed in a negatively charged, H-decorated state. By removing the hydrogen from the structure via tip interactions (as discussed with Figs. 5, S5, and S6), the species transitions to the more stable, H-free, neutral variety. The observation that the H liberation occurs with tip interaction makes it difficult to obtain a full set of images of the H-decorated variety. The neutral variation exists very close to the surface both spatially and electronically as indicated by the height scales in the constant current images in Figure 2k-1 and 2k-2. It shows only a slight increase in conductivity in the constant height image of Figure 2k-3 localized to a single atomic site, suggesting it may exist in place of the Si atom on one side of the dimer. The AFM image of Figure 2k-5 confirms this localized nature, with the defect appearing as a slightly darker circular feature. Figure 2k-6 similarly shows a slightly darker feature, indicating additional reactivity with a hydrogen-terminated apex, but does not provide any further information on the structure.

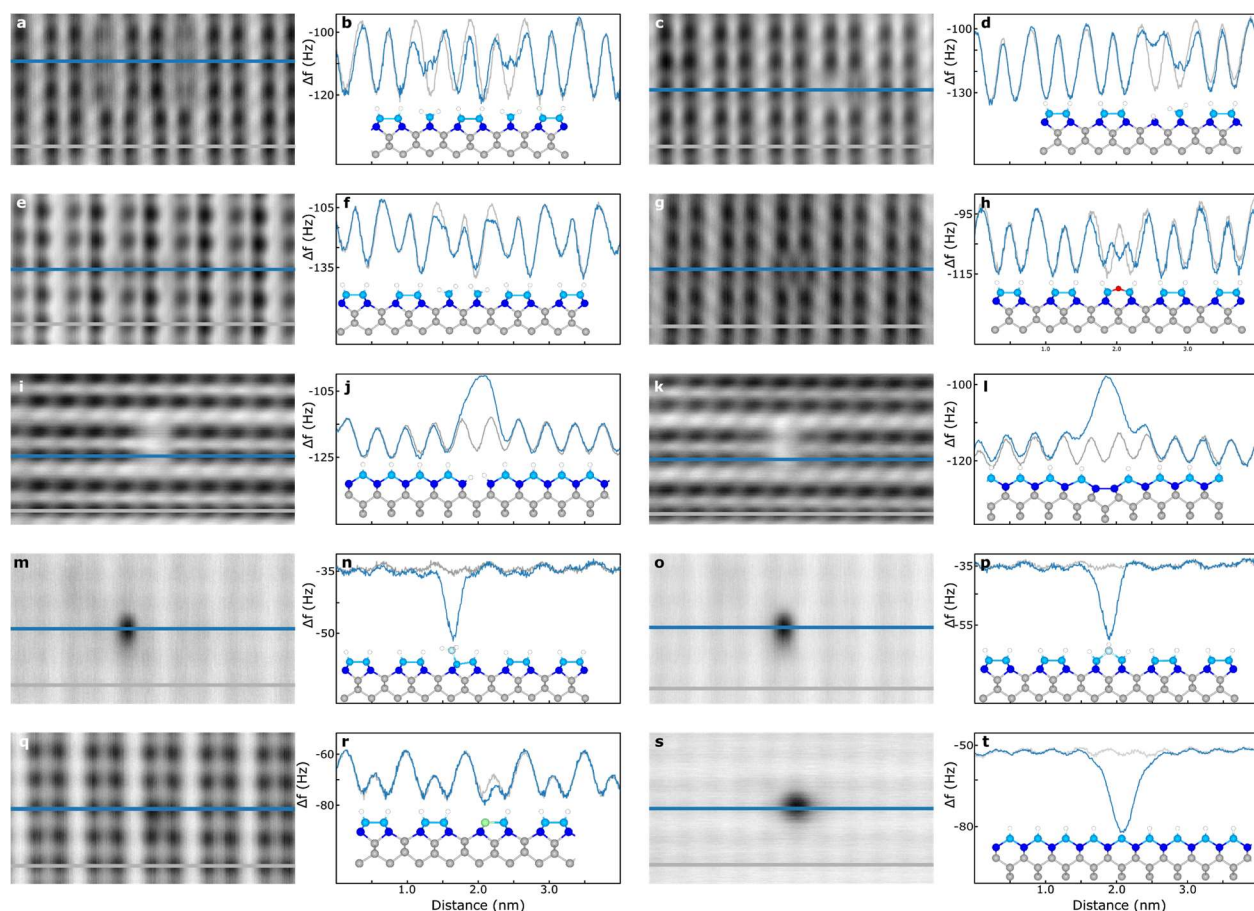
**Figure 3. Analysis of defects using dark-contrast AFM and line scan analysis.** Line cuts of the dark contrast AFM scans were performed by averaging over 6 adjacent lines, with the thickness of the line profile indicating this averaging. The defect profiles are indicated in blue, while the defect free 2x1 phase sample for each panel is in gray. The defects explored were (a,b) 3x1, (c,d) a single dihydride, (e,f) a dihydride pair, (g,h) a siloxane dimer, (i,j) a dark missing dimer, (k,l) a bright missing dimer, (m,n) a single raised SiH<sub>3</sub>, (o,p) a single raised SiH<sub>2</sub>, (q,r) a neutral point defect, and (s,t) a DB. See Figure 2 for the experimental image parameters.

The dark contrast AFM achieved the most striking resolution of all imaging modes presented in Fig. 2 presumably due to the Si-tip's greater chemical reactivity and apparent lack of apex flexibility. In the following we compare line profiles across the presented defect structures and a defect-free region with a simple structure model optimized by molecular dynamics calculations (Merck molecular force field 94, see Methods). Starting with dihydride based defects, Figure 3a,b shows an analysis of the 3x1 reconstruction. In Figure 3b the defect line profile (blue) is superimposed on a normal 2x1 phase line profile (gray), highlighting the reported splitting over the two dihydride-hosting atoms. The two central

Si atoms form a positionally shifted dimer in between the dihydrides, with the formed dimer bond reducing the distance between the constituent Si atoms. The 3x1 example can be compared to the case of a single dihydride in Figure 3c,d, showing a similar split over the location of the dihydride. A slight depression is seen above the missing Si atom but of reduced frequency shift when compared to the defect-free cross section, suggesting the tip cannot fully probe the vacancy due to the close proximity of the dihydride atoms. Examining the dihydride pair of Figure 3e,f, it interestingly appears very similar to the normal 2x1 phase with only slight variation at the position of the outermost H atoms. The lack of a hydrogen splitting feature, as with the other dihydride species, can be explained by looking at the calculated geometry of the two closely-spaced dihydride species in the dimer. Local repulsion between the two nearest hydrogen atoms results in a rotation of the dihydrides with respect to the surface. The position of the outer two hydrogens are now further away and much closer to the bulk atoms, making the feature less visible to the AFM tip.

Examining the siloxane dimer in Figure 3g,h shows three distinct minima in place of the dimer. The outer two peaks are spatially extended compared to a regular dimer due to the need to accommodate the oxygen atom bonded between the two Si atoms.

Figures 3i,j probe the dark missing dimer, with the hydrogen terminated second layer silicon atoms at the defect location presenting as less attractive to AFM probing due to increased distance (a frequency shift maxima in the middle). Figures 3k,l show the bright missing dimer. Examining the defect location in Figure 3l, two local minima “shoulders” are apparent on the sides of the central peak. These have a less negative frequency shift, with the minima pulled spatially towards the centre of the defect. This observation is a result of the second layer Si atoms bonding together at the defect location, introducing horizontal lattice strain. This pulls the neighboring atoms inwards more than in the dark missing dimer case, accounting for the shoulders in 3l which are absent in 3j. Importantly, these two defects were imaged in succession so any variations between the two are a consequence of their differing nature, not a tip change.

The two raised Si species in Figures 3m,n,o,p present an extra challenge to analyze because they must be imaged with a larger tip-sample separation to prevent tip-defect contact. As a result, the frequency shift of the surface is of smaller magnitude compared to the defect signal (compare blue and grey line traces in Figure 3n,p). Despite Figure 3n,p showing the defect as a mostly featureless peak in both cases, the position of the defect with respect to the lattice can still be extracted; comparing the two panels it can be confirmed that the  $\text{SiH}_3$  originates above one side of a dimer while the  $\text{SiH}_2$  is centered between the two atoms of a dimer. Additionally, the singly bonded  $\text{SiH}_3$  is a narrower peak (blue cross section of Figure 3n) than the doubly bonded  $\text{SiH}_2$  one (blue line Figure 3p), perhaps due to the extra degrees of freedom allowing the defect to bend more upon AFM examination.

The neutral point defect in Figure 3q,r displays as a slight decrease in the minima above the defect, suggesting a similarly coordinated substitutional species of enhanced electronegativity compared to a H-Si atom.

Lastly, a lone DB is shown in Figure 3s,t. As expected, the DB shows up as a localized feature of enhanced reactivity when compared to the surface. This reactivity extends spatially away from the DB location, generating a broad minimum that eclipses the signal from neighboring lattice sites.

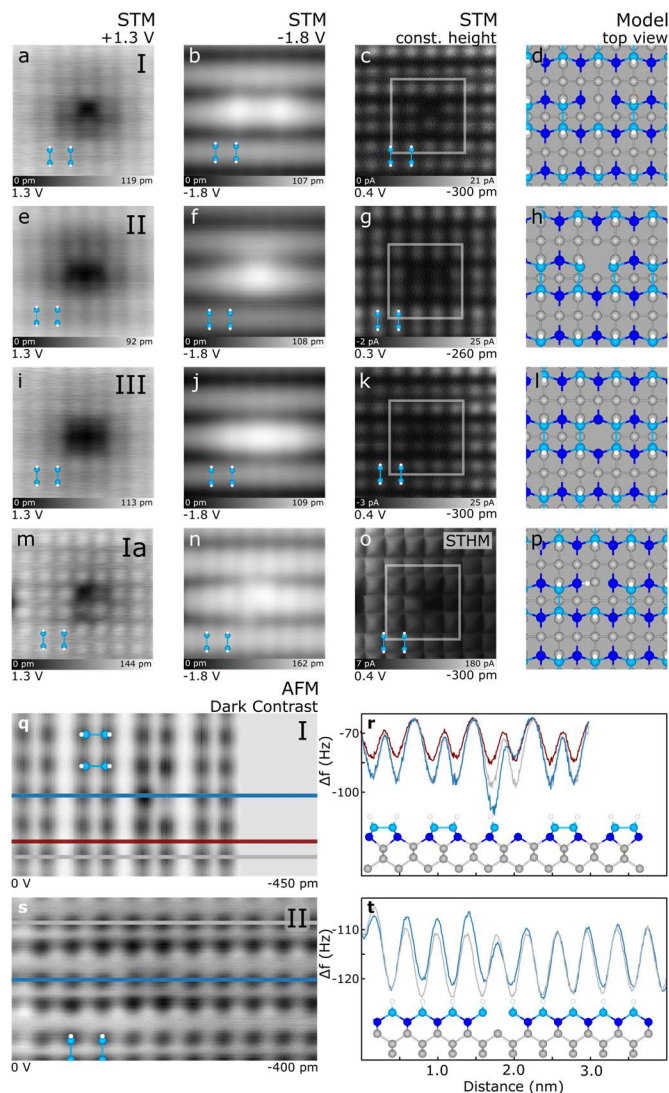
Figure 4. **Silicon vacancies at different lattice sites.** (a-d), (e-h), and (i-l) show the changing STM appearance of silicon vacancies located at different depths and lattice sites, labeled I,II, and III, respectively. (m-p) shows a suspected variation (Ia) of (a-d), in which one of the dangling bonds left from the vacancy has possibly bonded to a hydrogen. Each STM image is 3.4 nm x 3.4 nm. (q,r) show the linecuts of vacancy I in (a) while (s,t) show the linecuts of vacancy II in (e).

A more in-depth analysis of the silicon vacancy defect from Figure 2b is now given. While all of the other examined defects are observed with the same consistent appearance, the Si vacancy has been found to vary. Figure 4 shows empty states, filled states, and constant current images of 4 different configurations of the defect. Each of the configurations in 4a-d, e-h, and i-l correspond to a silicon vacancy, but located at different lattice sites as shown in the provided ball and stick models. Starting with Figure 4a (labelled I), the defect is centered around a surface lattice site affecting one side of a Si dimer, with the negative charge of the species bending the bands down locally, as shown by the radial dark depression around the defect center. The filled states STM image of 4b shows an increase in measured height, correlating again to the fixed negative charge of the defect<sup>45</sup>. Looking at the constant height STM image in Figure 4c, it appears that no atom is present at the defect lattice site. This is supported through examination of the AFM line cuts of this defect in Figure 4q,r (and Figure S4). A more negative frequency shift minimum is seen in the remaining atom of the dimer, with a shift of the minimum toward the site of the vacancy as shown in 4r. The vacancy itself shows a smaller minimum above its location (blue curve in 4r), with the magnitude of this minimum comparable to measurements over equivalent second layer Si atoms as would be measured in a cross section taken between dimers (burgundy line in 4q). This observation suggests there is no atom present, leading to a classification of this species as a Si vacancy<sup>70,71</sup>. These are predicted to exist as negative charge centers due to the degenerate doping of the crystal (See Methods). Figure 4e,h shows another silicon vacancy (labelled II), but now positioned at a different lattice site one atomic layer below the surface (as referenced to the Si atoms of the dimers). While the broad features of the STM probing in Figure 4e-g are similar, it can be seen that the defect no longer appears to affect a single atomic site, but rather reduces the apparent height of two adjacent dimers as shown in 4g. While the subsurface defect cannot be directly probed, the similarities it shares with Figure 4a strongly supports its assignment as a Si vacancy below the surface (See the ball and stick model in Figure 4t). This is further corroborated by line-cut analysis in Figure 4s,t, where the two atoms centered above the defect show a reduced minimum, as well as a horizontal shift in position towards the defect center due to a polaronic distortion induced by the vacancy's localized negative charge. The ball and stick models of Figure 4 h and t have been manually edited to show this effect.

Figure 4i-l shows the third common type of Si vacancy (labelled III). This defect shares broadly similar STM features when compared to the previous vacancy examples but now spatially shifted with respect to the Si lattice; the dark depression in Figure 4i is now symmetric in appearance and centered in the dimer row, the bright enhancement in 4j extends over more dimers, and in the constant height STM in 4k the two dimers above the defect center show a reduction in apparent height. Aligning the centre of

this defect to a model of the underlying Si lattice (See Figure 4l), along with the symmetry observed in STM analysis, it is likely the position of this vacancy is in the third atomic layer.

Figure 4m-p looks at a possible final silicon vacancy configuration (labelled 1a). With the addition of hydrogen to the chamber during sample preparation (See Methods), it is suspected that some of the hydrogen radicals can penetrate a few monolayers into the surface, allowing them to passivate dangling bonds from Si atoms immediately surrounding a vacancy<sup>70,71</sup>. Evidence of this is suggested by the vacancy in 4m being similar to the one shown in 4a, but with a few key differences. To first order, both display a dark depression on one side of a dimer indicating a missing silicon atom. Differences become apparent however when examining adjacent lattice sites to the missing atom. In 4a, the surface hydrogen atoms around the vacancy location have similar character, displaying as darker than the surrounding surface. This is in contrast to 4m where H-Si atoms to the left of the vacancy appear unperturbed, and hydrogen atoms below and to the right are of differing character. Further differences in the appearance of this configuration are also seen in the STM image of 4n when compared to 4b, with 4b having two maxima and 4n only one. The normal appearance of the surface immediately to the left in 4m supports the idea of a hydrogen penetrating the surface satisfying the left-most sub-surface dangling bond associated with vacancy (See Figure 4p), reducing the lattice strain and making the surface hydrogen above it better match the defect-free surface. Figure 4o shows an STHM image of the vacancy. This imaging method was used instead of a constant height image due to the tip functionalization at the time of imaging. Similar features consistent with the interpretation of the vacancy can be observed, mainly, the absence of corners in the STHM image above the vacancy as well as a slight negative shift in the current above the lattice intersections corresponding to the right and lower H-Si atoms.

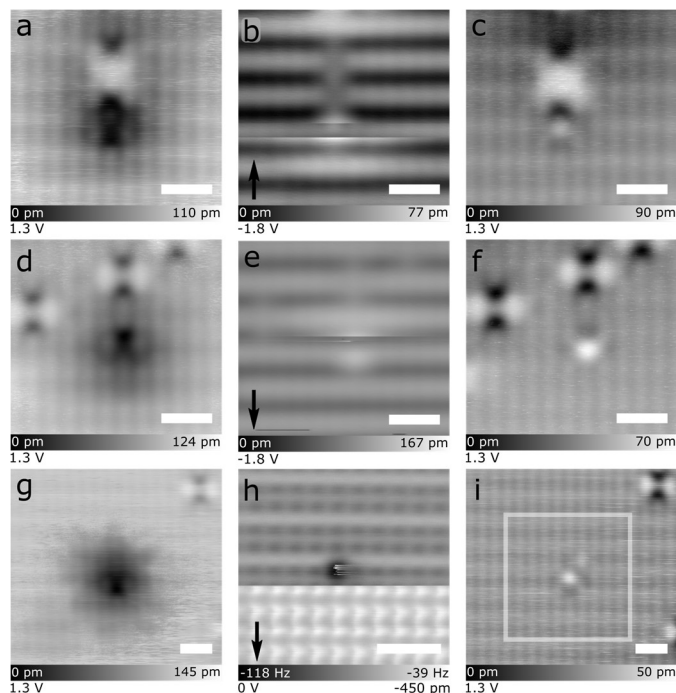
**Figure 5. Removal of a hydrogen atom from the neutral point defect.** (a-c), (d-f), and (g-i) show three instances of the neutralization of a negatively charged defect which is the precursor form of the neutral point defect. (a,d,g) Empty states images of the negatively charged H-decorated point defect before H

liberation. (b) and (e) show filled states STM removal events, while (h) shows an AFM removal event. The arrows in the lower left indicate the scan direction, with contrast changes in the scan indicating a removal event has occurred. (c,f,i) Empty states STM images of the same frames as (a,d,g), but after the H removal. The point defects no longer display charge-induced band-bending around their location. The white box in (i) indicates the size of the scan frame in (h). Scale bars are 1 nm.

We now return to a discussion of the origin of the neutral point defect. While its true nature remains inconclusive, Figure 5 provides three case examples showing they can weakly hold a H atom rendering the entire structure negative. The negatively charged nature of the H-decorated point defect can be seen in the STM empty states images of Figure 5a,d,g. In each case, the negative charge associated with the H atom is indicated by the charge-induced band bending surrounding its location. Upon scanning at a filled states imaging bias (Figure 5b,e) or using AFM (Figure 5h), a sharp change in contrast is seen when scanning over the defect. Subsequent imaging of the defect after this change in contrast is given in the empty states images of Figure 5c,f,i, showing the H atom has been removed from the structure

leaving the neutral point defect with charge-induced band bending no longer present. Further examples of the H removal along with STM I(V) and dI/dV spectroscopy of the neutral point defect can be seen in Figure S5 and S6.

Our assignment of the neutral point defect as a hydrogen trap is motivated by two observations, the first indication being the change in contrast in the AFM panel of Figure 5h. As discussed earlier, dark contrast AFM is from a silicon-terminated apex and bright contrast from a hydrogen-terminated one. The change between these two contrasts at the middle of the frame suggests the tip has potentially picked up a hydrogen atom from the defect, changing the AFM imaging character. The second observation supporting a hydrogen trap is the similarity of the negative state of the defect to physisorbed hydrogen atoms on the surface. Prior work reported that hydrogen atoms on the surface are negative under degenerate n-type doping<sup>9</sup>, while another showed they could be picked up from the surface with filled-states STM imaging<sup>33</sup>. Their similarity in appearance can also be observed in Figure S7. This evidence, together with the fact our sample preparation methodology produces many hydrogen radicals that can penetrate the surface, supports the idea that the neutral point defect behaves as a hydrogen trap. It has been reported in the literature that boron, when added to silicon, can behave as a hydrogen trap<sup>72–75</sup>. However, the areal concentration these neutral point defects are observed at (0.8–7.6 defects/10 nm<sup>2</sup>) is higher than would be expected for our arsenic doping level, or for contaminant boron from the commercial wafer processing<sup>45</sup>. Further investigation into the origin of this defect will be required for a conclusive determination.
