Investigation of Unit-1 Nuclear Reactor of the Fukushima Daiichi by Cosmic Muon Radiography

September 26, 2019

We have investigated the status of the nuclear fuel assemblies in Unit-1 reactor of the Fukushima Daiichi Nuclear Power plant by the method called Cosmic Muon Radiography. In this study, muon tracking detectors were placed outside of the reactor building. We succeeded in identifying the inner structure of the reactor complex such as the reactor containment vessel, pressure vessel, and other structures of the reactor building, through the concrete wall of the reactor building. We found that a large amount of fuel assemblies was missing in the original fuel loading zone inside the pressure vessel. It can be naturally interpreted that most of the nuclear fuel was melt and dropped down to the bottom of the pressure vessel or even below.

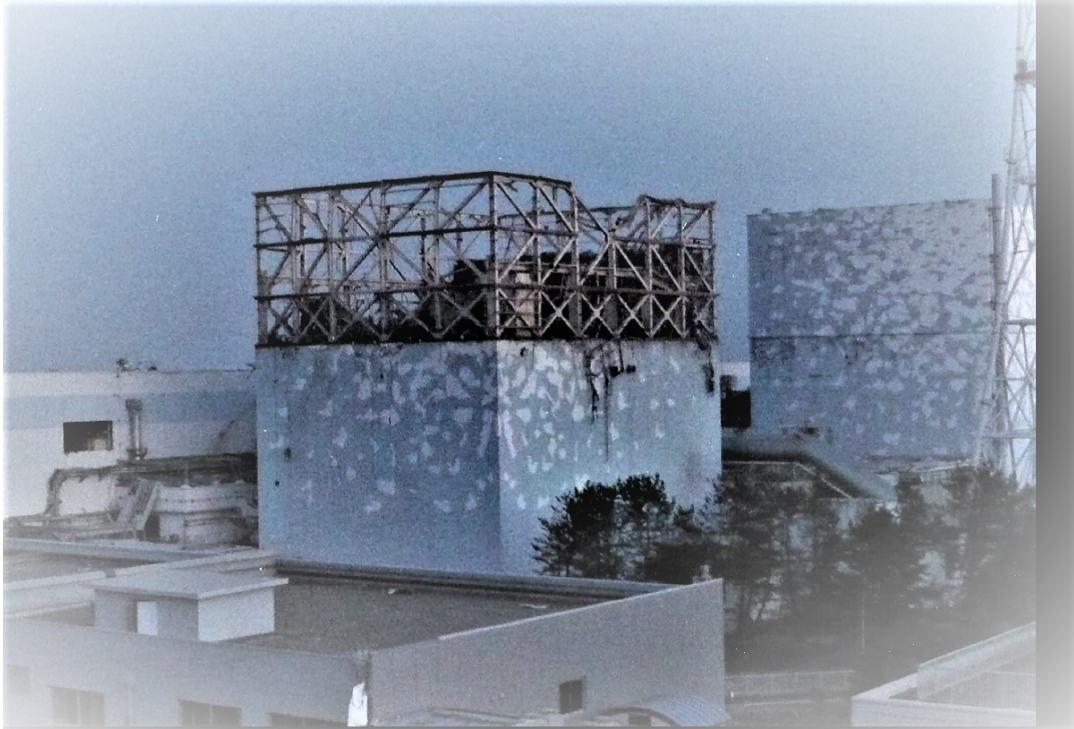
Fig. 1. Damaged Unit-1 Reactor of the Fukushima-Daiichi, viewed from north-west side. The Unit-2 building is seen to the right. (Courtesy of TEPCO).

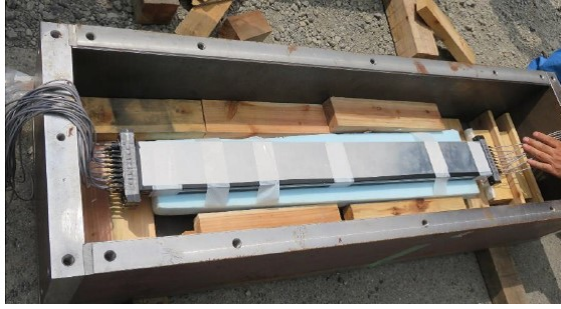
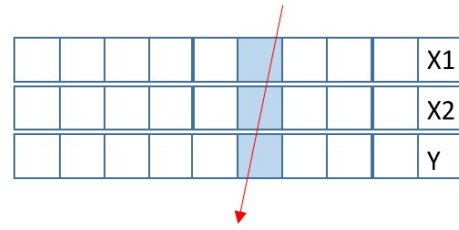
Fig 2: Sample detector (10 cm wide \times 1 m long \times 10 cm thick) placed in 5-cm thick iron shield box.
 (right) Cross-sectional view of the three-layer sample detector, indicating grouping of the three layers.

Figure 2 shows the sample detector placed in the 5-cm thick iron shield box. We brought this system near to the Unit-1 reactor building and studied the effect of the environmental radiation to cosmic muon tracking.

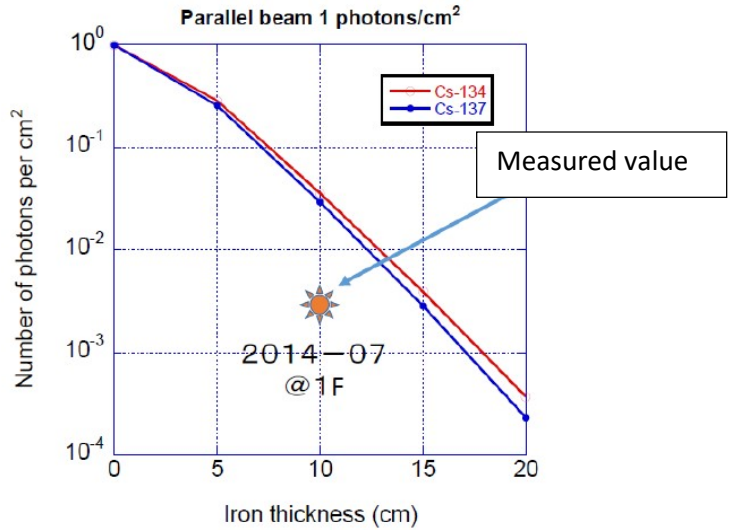
Fig. 3. Suppression factor of the gamma rays from Cs¹³⁴ and Cs¹³⁷ estimated by a GEANT simulation as a function of the thickness of the iron, assuming gamma rays are injected normally to the iron. The value measured on site for 10-cm iron is shown by star.

The suppression factors of the gamma rays from Cs^{134} and Cs^{137} were estimated by a GEANT simulation as a function of the iron thickness assuming gamma rays to hit normally to the iron [4]. The gamma yield is expected to be suppressed to 0.3 with 5-cm thick iron and to 0.03 with 10-cm thick iron, as shown in Fig. 3. To compare with the simulation results, we first used a handy radiation monitor tightly enclosed in 10-cm thick iron plates to measure directly the suppression factor at the site planned for deployment of the detector. The measured suppression is close to of 15-cm simulation, as plotted in Fig. 3, as the difference can be explained by the average path length in the measured configuration was 13 cm taking into account that the gammas are coming from any directions.

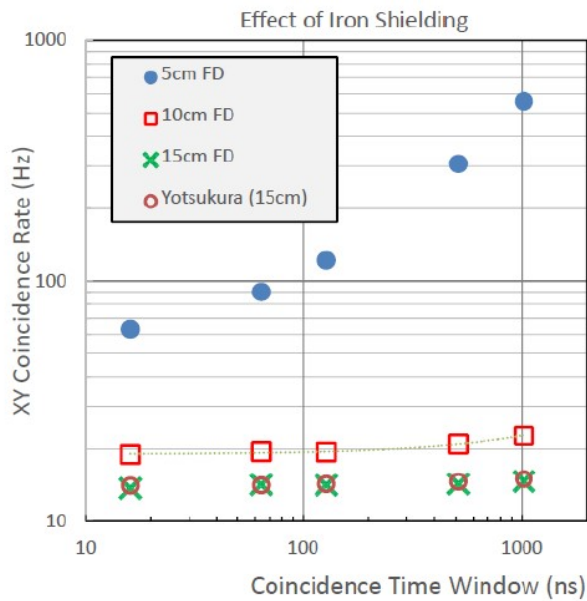
Fig. 4. Coincidence rates measured with the test detector as a function of the time window of the coincidence. The data are shown for the three iron thicknesses measured at the Fukushima-Daiichi site, and one measured at Yotsukura, about 50 km south. The ambient radiation level at Yotsukura was below one $\mu\text{Sv/h}$.

The signals of the sample detector were read out by the same system [3] as for the muon telescope where existence of coincidence hits in two layers is required. For the three-layer sample detector, we assigned the two top layers as “X” and the bottom layer as “Y”, requiring at least one hit in each group of “X” and “Y” (note all three scintillator bars run in the same direction despite for the naming X or Y). Figure 4 shows the “X1-Y” coincidence rates measured on site at the Fukushima-Daiichi for the three thicknesses of the iron shield as a function of the width of coincidence time window. As the accidental coincidence increases linearly with the coincidence time window width, the measured rate is affected by the environment radiation for the time window longer than 100 ns for 5-cm iron, and started to be affected above 1000 ns for 10-cm iron.

The typical time window we employ for the muon telescope is 16 or 32 ns. This time window needs to be multiplied by a factor 5 to 10 in evaluating the effect in the complete telescope using the present results of the sample detector, since the number of the scintillator bars (100 in the complete system) to be considered is more by this factor. We conclude that the coincidence rate is barely affected for the iron shield thicker than 10cm.

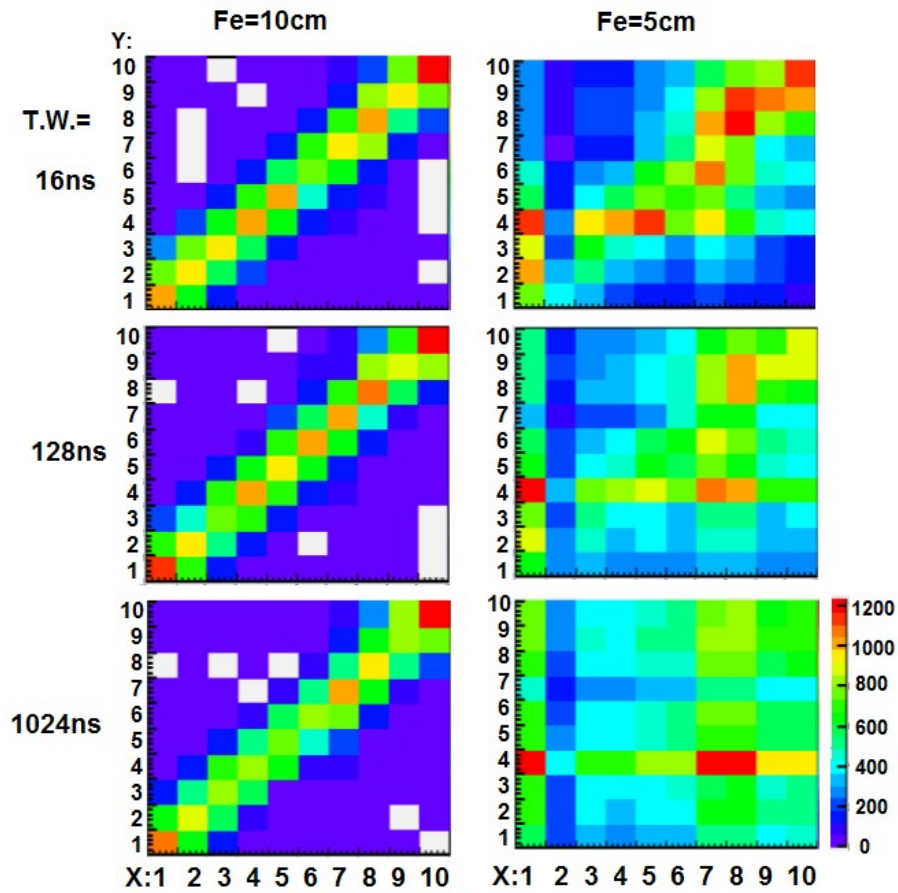
Fig. 5. X2 and Y hit correlation measured with the test detector; (left) for 10-cm iron and (right) for 5-cm iron shield. The results are shown for three typical time window widths, 16, 128 and 1024 ns.

Figure 5 shows the hit position correlation between “X1” and “Y” layers when exactly one hit is required to be found in each of “X1” and “Y”. As expected, the correlation is clearly seen for the 10-cm iron up to 1024 ns time window. For the 5-cm iron, the correlation is less clear and influenced more with increasing the time window width. The study was repeated for relaxed threshold setting, 0.8 times the nominal setting, to investigate the effect of the possible uncertainty in the threshold determination, and found small dependence.

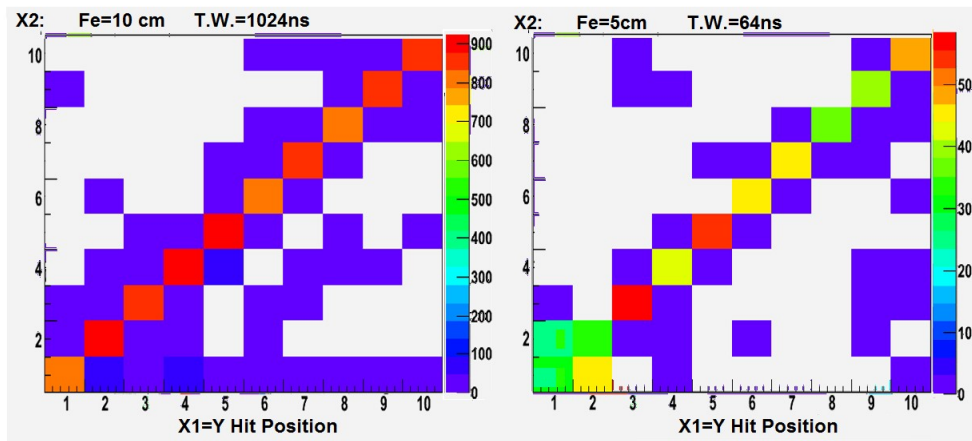
Fig. 6. X2 and Y=X1 hit correlation measured with the test detector; (left) for 10-cm iron and (right) for 5-cm iron shield. The time window widths are 1024 ns and 64 ns, respectively. The number of events in each column sum is normalized for $N(Y=X1) = 1000$.

Finally we examined whether we can find a hit in the middle layer X2 when X1 and Y recorded hits at the same channel number. The hit correlations are shown in Fig. 6 for typical cases with 10 and 5-cm iron shield thicknesses. The plots are normalized such that the number of X1=Y events is 1000. X2 hit

can be found at the proper position with efficiencies more than 90% for 10-cm iron case with time window of 1024 ns. The observed efficiency is not large for 5-cm iron, although the correlation itself is not much distorted. This can be explained by that the reference $Y=X1$ is spurious at some fraction and the corresponding $X2$ was not found as the event is spurious: once the reference is correct, $X2$ is found correctly.

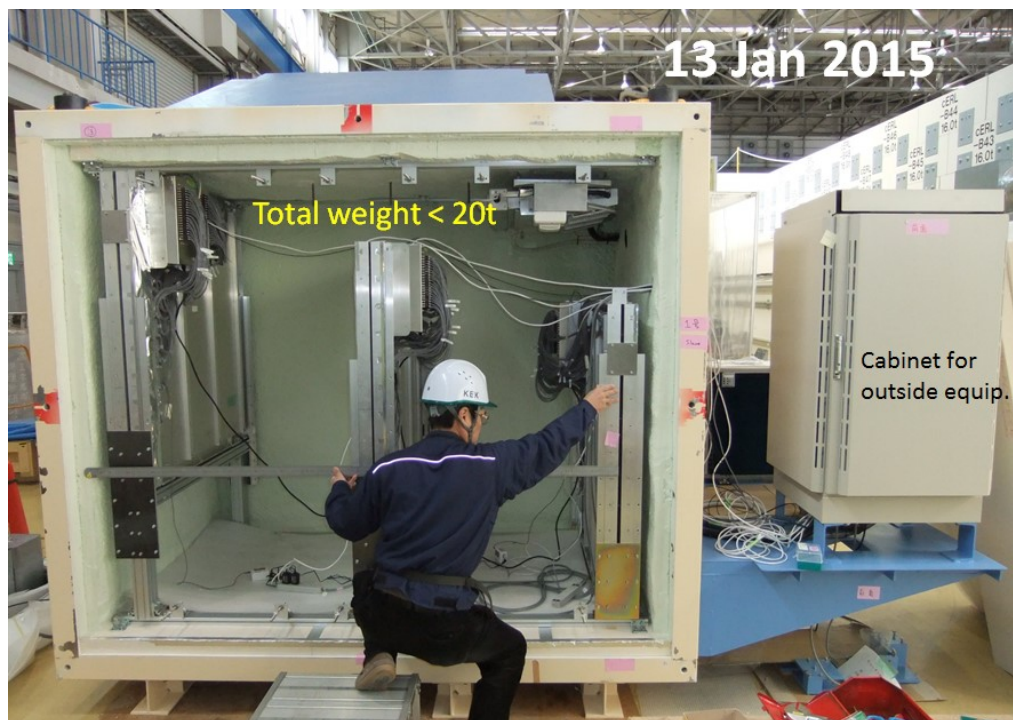
Fig. 7. The muon telescope housed in an iron shield box made of 10-cm iron plates. The relative elevation heights of the three X-Y assemblies are adjusted to target at the Unit-1 fuel loading zone. For thermal insulation, 6-cm thick plastic foam is plastered over the inner wall of the box. The cabinet next to the box houses the air-conditioner controller and data network hub for data transfer and communication with the assemblies. The total weight is 20 t.

For the detector system to be deployed for the Unit-1 observation, we selected an iron shield thickness of 10 cm and chose conservatively to install three sets of X-Y assemblies. Figure 7 shows one of the Muon Telescope systems. The detection system was equipped with an air-conditioner to provide a constant temperature inside the iron shield to be kept $20\pm 3^\circ\text{C}$ for a stable operation of the photo-device, multi-pixel photon counter (MPPC).

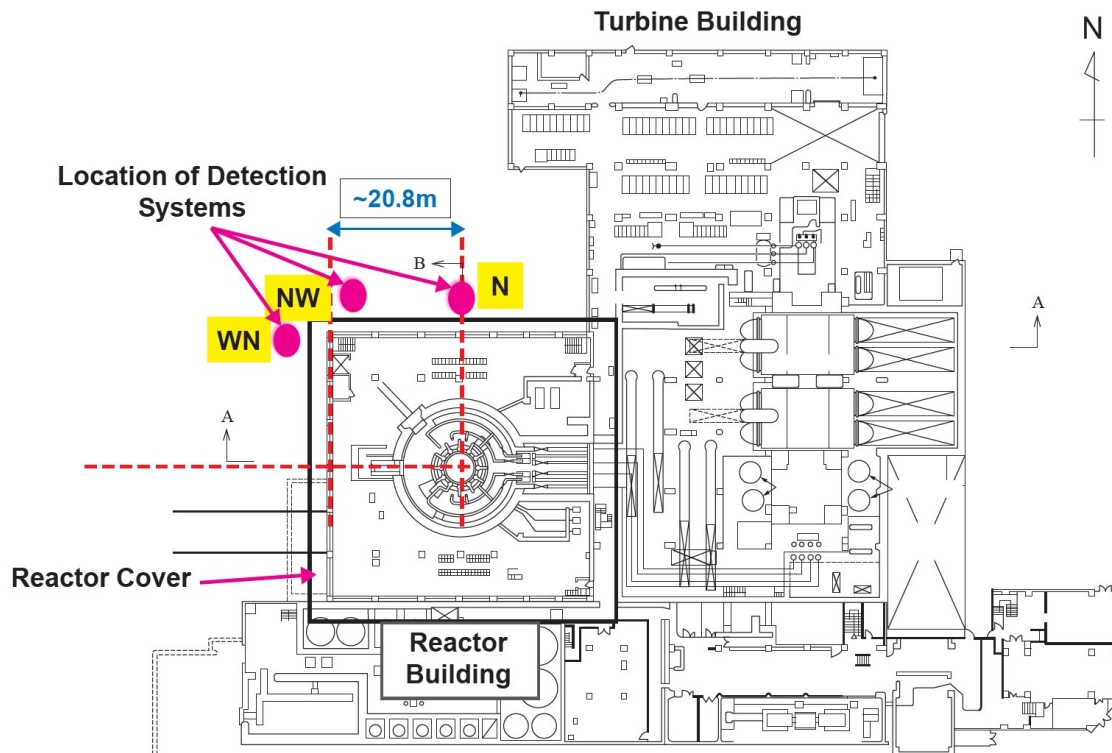
Fig. 8. A plane view of the Unit-1 reactor of the Fukushima-Daiichi. The observation of the reactor inner structure was made from the three locations marked by red circles. (Courtesy of the TEPCO).

The X-Y assemblies used for the study at the JAPC at Tokai were refurbished repairing dead channels and two Muon Telescope systems were constructed at KEK. They were moved to the Fukushima-Daiichi site, and placed in January 2015 at locations marked by red circles in Fig. 8 which

shows a plane view of the Unit-1 reactor. The two systems were placed at WN and NW initially, and one of them was moved to the point N later in summer. The distance to the reactor center is 36 m for the location WN.

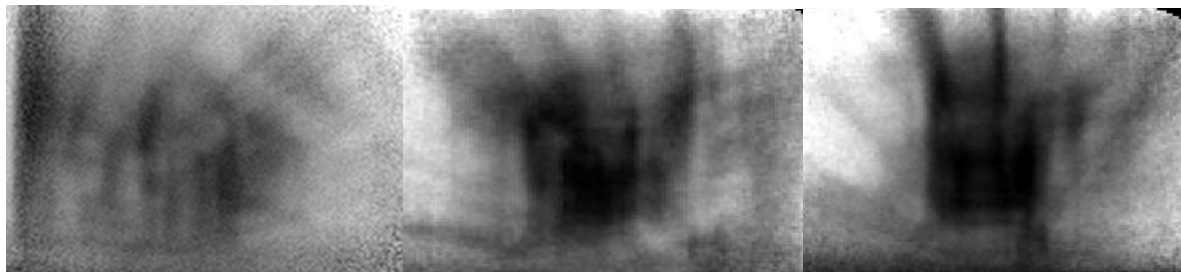
Fig. 9. Images of the Unit-1 reactor of the Fukushima-Daiichi after 90 days observed by the muon telescope placed at (left) WN, (middle) NW and (right) N points given in the figure 8.

The observation of the cosmic rays started in February 2015. We confirmed the detection systems were functioning properly in an environment of the radiation level of about $500 \mu\text{Sv/h}$. Figure 9 shows the Unit-1 reactor images after 90 days, representing the lateral muon absorption distribution, the observed event rates normalized by those obtained at KEK without obstacles in front. Larger absorption due to heavy objects is illustrated in darkness.

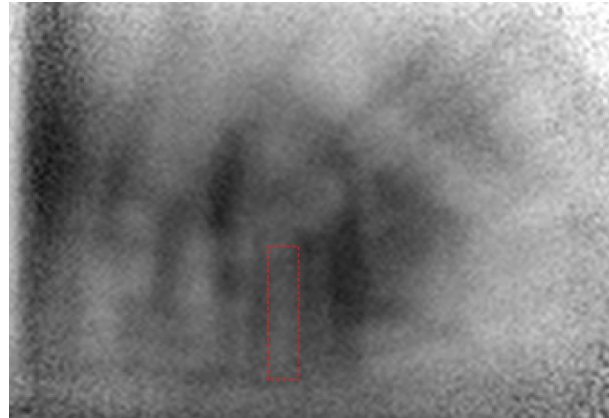
Fig. 10. The observed image from the WN point with the Reactor pressure Vessel marked by the red-dot line

The figure 10 illustrates the observed image by the muon telescope placed at the WN point with the Reactor Pressure Vessel marked with the red-dot line. The figure 11 shows the same image with the

The distribution pattern of the muon flux reduction can be translated to the distribution of heavy structures inside the reactor complex, as shown in Fig. 10 for the muon telescope placed at the northern west corner (marked as WN in Fig. 8) of the reactor building. We identified the structures such as 1) the reactor pressure vessel (RPV), 2) the reactor containment vessel (RCV), 3) the Nuclear Fuel Storage Pool, and 4) the north wall of the reactor building. From the three images, we concluded that any heavy lump of materials is not seen at the core part of the pressure vessel. This observation can be interpreted that most of the loaded nuclear fuel assemblies melted and dropped from the loading zone.

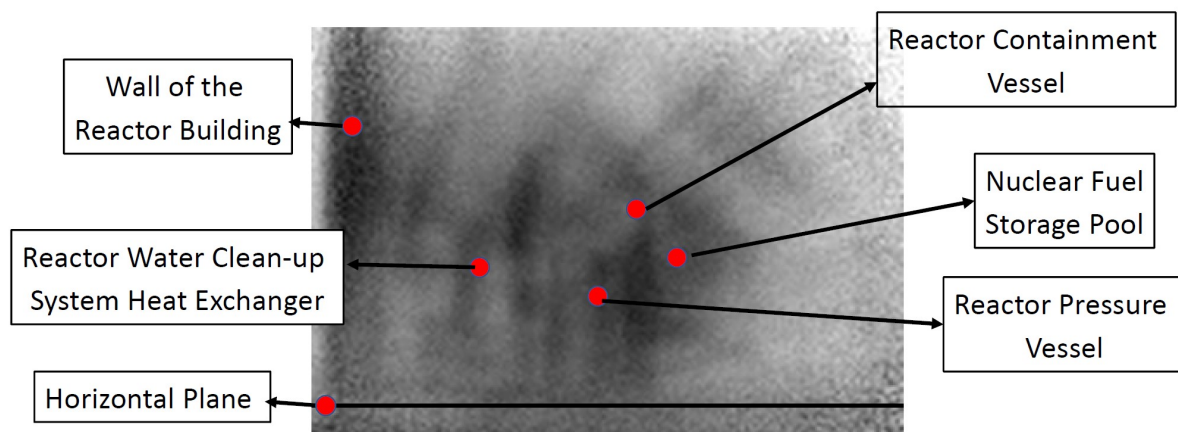
Fig. 11. Image of the Unit-1 reactor of the Fukushima-Daiichi after 90 days observed by the detection system placed northern west corner of the reactor building.

identification of the facilities in the reactor building. One notices that no sign of the existence of heavy materials such as the lump of nuclear fuel in the RPV. One naturally interprets that the nuclear fuel got melted and dropped from the original position in the RPV.

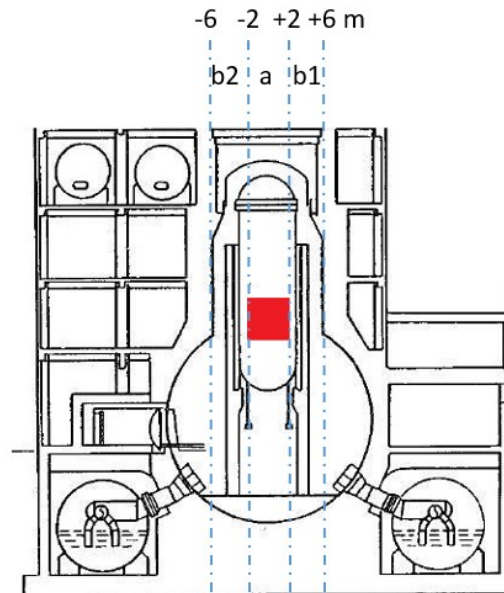
Fig 12. Structure of the Unit-1 Nuclear Reactor of the Fukushima-Daiichi. The red box represents the fuel loading zone.

The amount of heavy materials left in the RPV is a crucial information to be investigated with the present detection method. Figure 12 illustrates the structure of the Unit-1 reactor. We defined “side-band” regions and evaluated the amount of material in the “core” region from the amounts of material estimated in the side-band regions. We defined three vertical slice regions, (a), (b1) and (b2) by the point-dash vertical lines shown in Fig. 12.

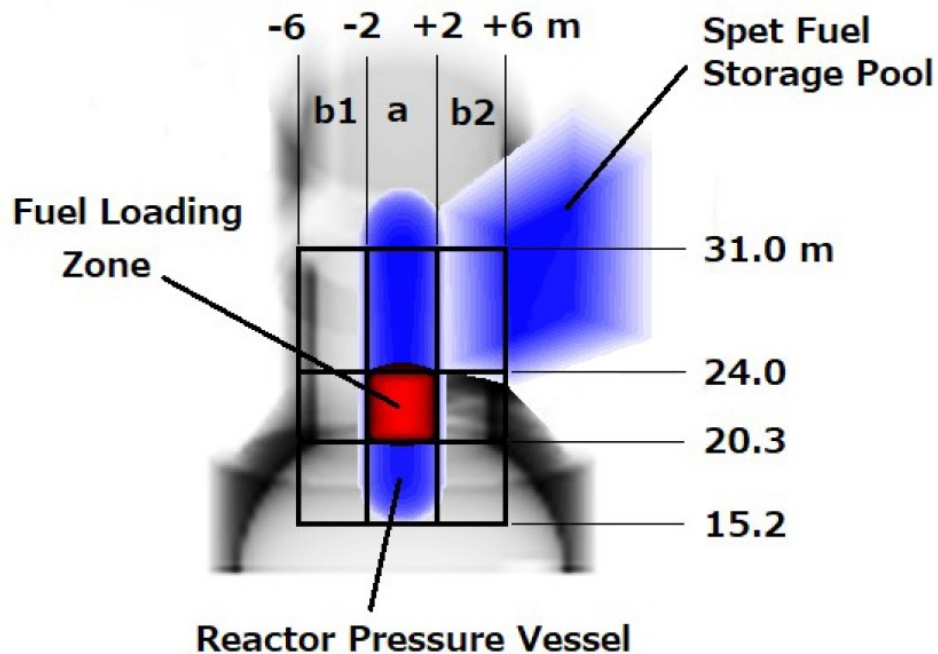
Fig 13. An artistic view of the reactor complex of the Unit-1 reactor with the Reactor Pressure Vessel and the Spent Fuel Storage Pool

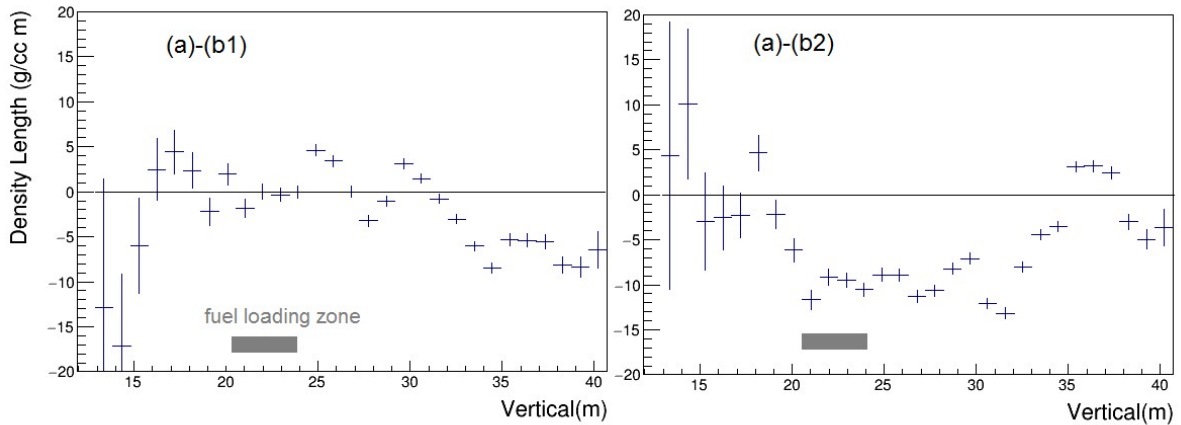
Fig 14. (left) The density length along the slice (b1) subtracted from that along slice (a); (right) the density length along the slice (b2) subtracted from that along slice (a). The vertical range corresponding to the fuel loading zone is indicated by the shaded box in the figures.

The difference of the obtained density-length distribution (a)-(b1) and of (a)-(b2) are plotted in Fig. 14. Although the material distributions in these slices are not identical, possible zenith angle dependence of the muon flux can be diminished by subtraction. In practice, the density length along (b2) is much larger due to the nuclear fuel storage pool located behind the slice of (b2). Therefore, we take only the difference (a)-(b1) for evaluating the amount of material remaining in the fuel loading zone.

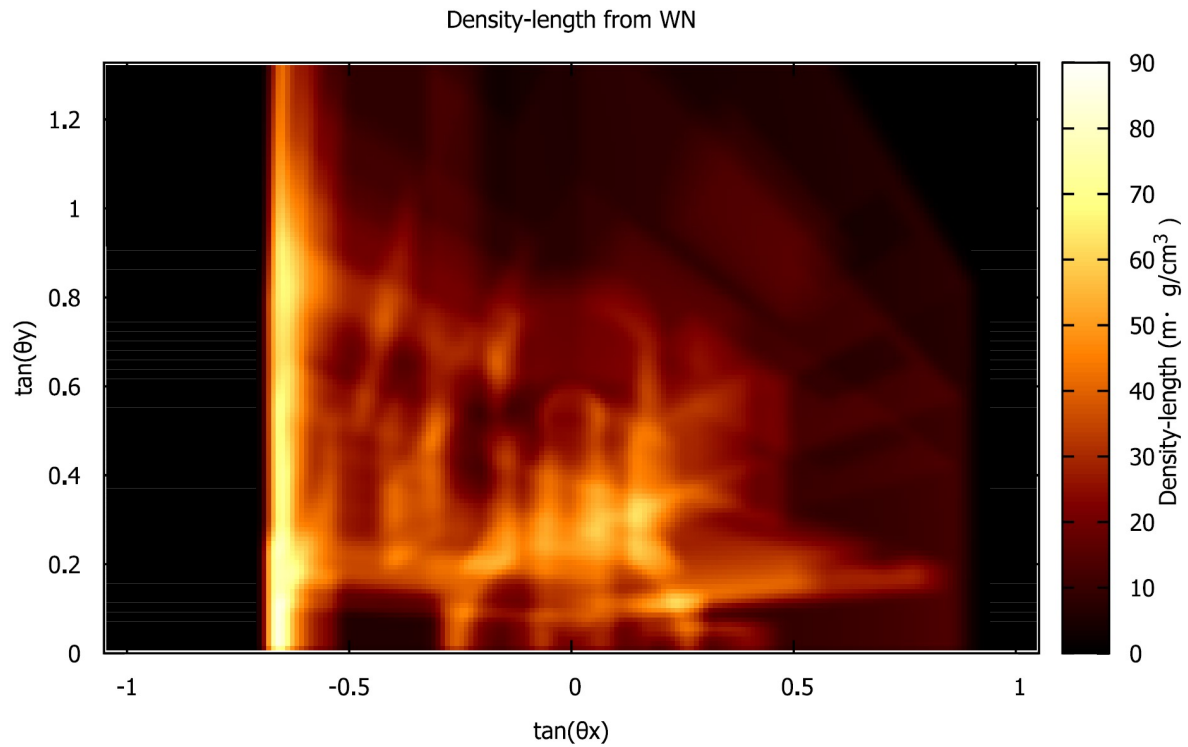
Fig. A-1 Density-length distribution (in $\text{m} \cdot \text{g}/\text{cm}^3$) viewed from the WN point in the plane of detector view area. The axes are horizontal and vertical directions of the muon tracks.

The nuclear plant building is composed mainly of shielding concrete. Figure A-1 illustrates the density-length (density multiplied by the path length) distribution of the Unit-1 nuclear plant viewed from the NW point, which was calculated using the available design drawings. It distributes in the range 30-70 $\text{m}\cdot\text{g}/\text{cm}^3$ vertically along the axis of the pressure vessel, the target region to be investigated. The density-length range in other views is within 20-80 $\text{m}\cdot\text{g}/\text{cm}^3$ and the corresponding minimum muon momenta to pass through are 4-17 GeV/c, calculated based on the continuous-slowing-down approximation (CSDA) range, see Fig. A-2.

The view area of the detector, as shown in Fig. A-1, is wide enough covering the pressure vessel (area to be investigated) and other reactor building structures. The structures can be assumed to be composed of concrete. Therefore the flux data outside the area to be investigated are related to the density-length distribution calculated using the design drawings, as a function of the muon zenith angle. Since the muon momentum is strongly dependent on the zenith angle, this method provides more reliable estimate than simply relying on the muon momentum distribution projected from the available flux measurement. Also in the calculation using the projected muon momentum distribution, we would need to assume the flux reduction to be caused by the CSDA range.

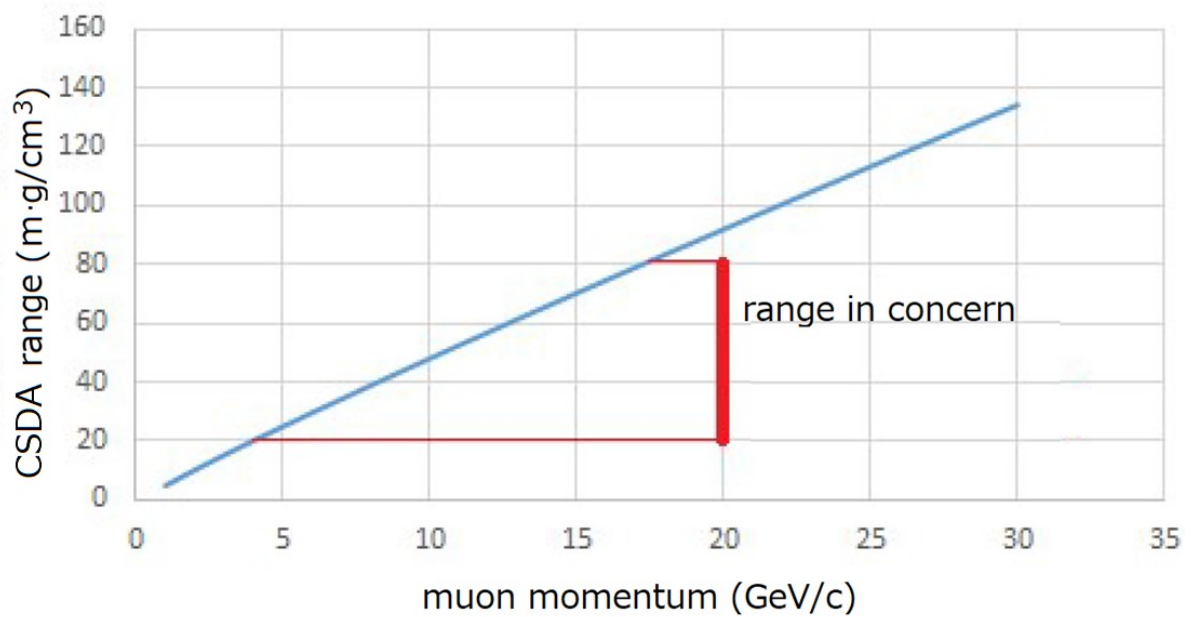
Fig. A-2 Correlation between the minimum muon momentum and the muon range. Assumed material is concrete of standard density $2.3 \text{ g}/\text{cm}^3$.

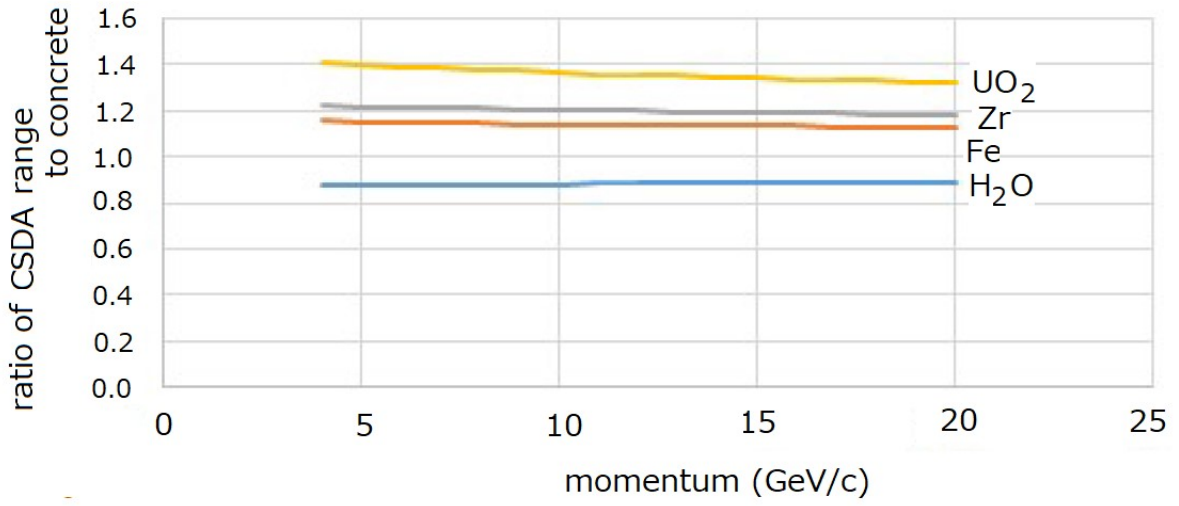
Fig. A-3 Calculated ratio of CSDA range to concrete for the materials abundant in the pressure vessel as a function of the muon momentum. The ratio for UO₂ varies from 1.41 to 1.32 (a change of 10%) in the momentum range in concern.

In the search area, we need to consider any CSDA range difference between the concrete and other materials. Figure A-3 plots the calculated CSDA range values as a function of the muon momentum for the typical materials in the search area. It should be noted that the absolute values are not identical but the momentum dependences are similar within $\pm 5\%$. The muon flux reduction should be a function of $a\rho L$ where a is the absorption coefficient related to the CSDA range, ρ is the density and L is the path length. The difference in the absolute values is taken into the systematic uncertainty in a .
