On the coarsening mechanism and deformation of borides under annealing and creep in a polycrystalline superalloy

Lola Lilensten^{1, #,*}, Aleksander Kostka², Sylvie Lartigue-Korinek³, Stoichko Antonov^{4,5}, Sammy Tin⁴, Baptiste Gault^{1,6}, Paraskevas Kontis^{1,*}

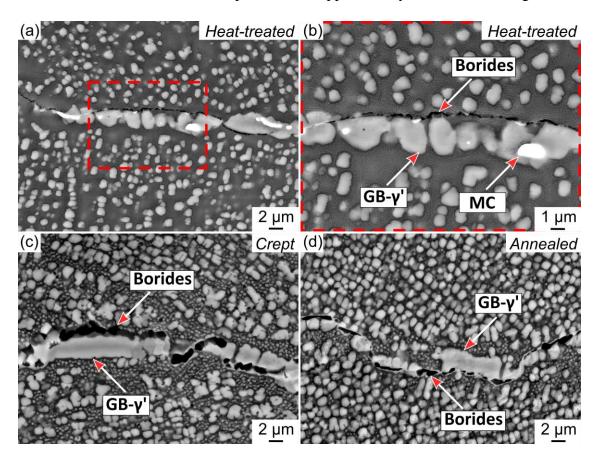
<u>Figure 1</u>: Backscattered electron micrographs of STAL15-CC alloy: a-b) after full heat treatment, c) after creep deformation at 850°C under 185 MPa load up to fracture and d) after static annealing at 850°C for 3000 hours.

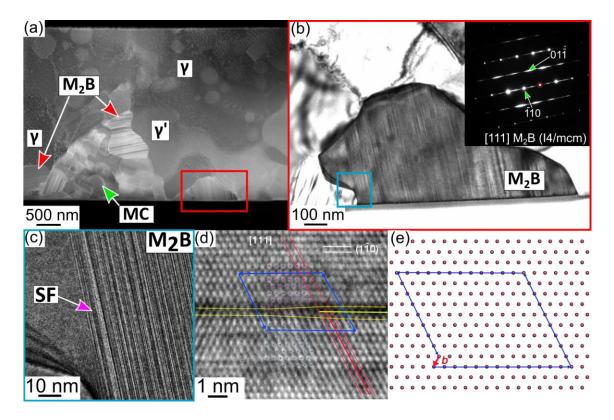
Figure 2: TEM analysis of an intergranular M₂B boride from the crept sample at 850°C. (a) TEM HAADF image of the sample showing several intergranular M₂B borides (see red arrows for instance) and an MC carbide (green arrow) along the grain boundary. (b) TEM bright field image of the boride denoted by the blue box in Figure 2a alongside with its diffraction pattern. (c) High resolution TEM image showing details of the stacking faults in the boride from Figure 2b. (d) Image of a dislocation in the boride and (e) corresponding Burgers circuit.

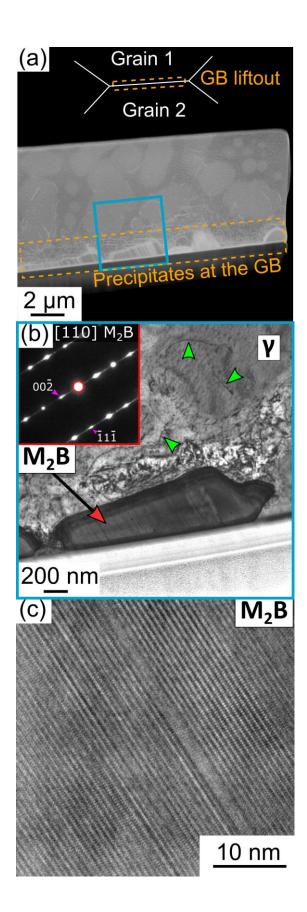
Figure 4: TEM analysis of an intergranular M_2B boride from the sample annealed for 3000 hrs at 850°C without load. (a) Schematic of the GB lift-out and TEM HAADF image of the lamella, showing precipitates along the grain boundary (orange dashed rectangle). (b) TEM HAADF image of the area denoted by the blue box in Figure 4a, showing a higher magnification of a boride, and the corresponding diffraction pattern. Green arrows point at dislocations in the neighboring γ matrix. (c) High resolution TEM image of the faulted planes of the borides in (b).

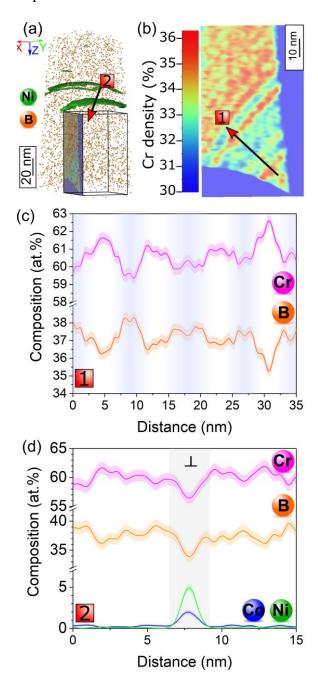
Figure 5: APT analysis of an intergranular M₂B boride from the crept sample at 850°C. (a) Atom probe reconstruction from the boride containing dislocations highlighted by isocomposition surfaces of 0.8 at.% Ni. (b) 2D density map for Cr from the box in Figure 5a. (c) 1D concentration profile across the B-rich planes indicated by the arrow #1 in Figure 5b. The B-rich planes are highlighted by a blue background area. (d) 1D composition profile across the dislocation in Figure 5a, along the arrow #2, showing an increase of Ni and Co at the dislocation core. Error bars are shown as lines filled with color and correspond to the 2σ counting error.

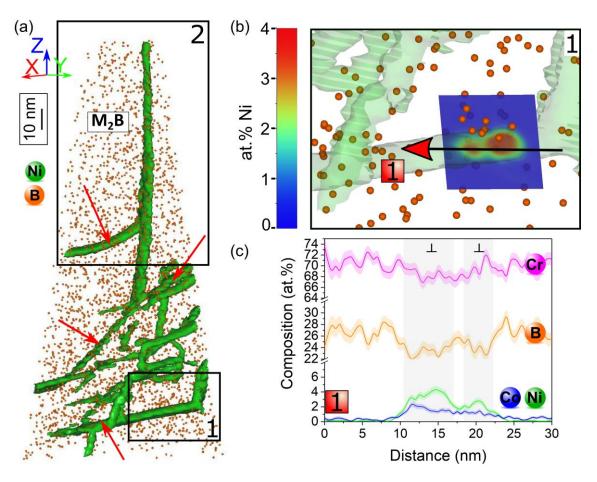
Figure 6: APT analysis of an intergranular M₂B boride from the crept sample at 850°C. (a) Atom probe reconstruction from the boride. Dislocations, highlighted by iso-composition surfaces of 1.0 at.% Ni., are denoted by red arrows. (b) Magnified view of the APT reconstruction from the rectangle 1 in Figure 6a, with a 2D concentration map plotted across a dislocation for Ni. (c) 1D concentration profiles across the dislocation indicated by the red arrow in Figure 6b. Error bars are shown as lines filled with color and correspond to the 2σ counting error.

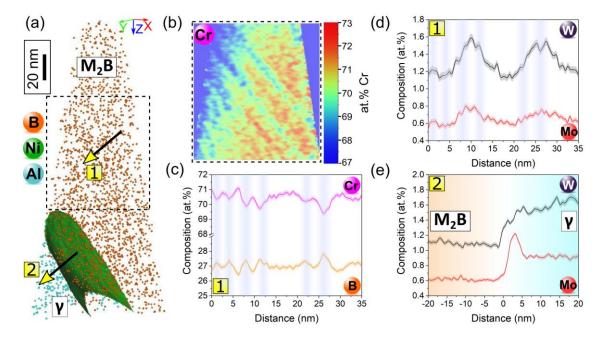
Figure 8: APT analysis of an intergranular M_2B boride from the annealed sample at 850°C. (a) Atom probe reconstruction from the boride and its interface with the γ matrix. The interface is shown with an iso-composition surface at 10 at.% Ni. (b) 2D concentration map for Cr corresponding to the black dashed boxed region in 8a. (c) and (d) 1D concentration profiles along the yellow arrow #1 in 8a for W and Mo and for Cr and B respectively. (e) Proxigram showing the W and Mo composition at the M_2B and γ interface (arrow #2 in Figure 8a). Error bars are shown as lines filled with colour and correspond to the 2σ counting error.
