One Exploit to Rule them All?

On the Security of Drop-in Replacement and Counterfeit Microcontrollers

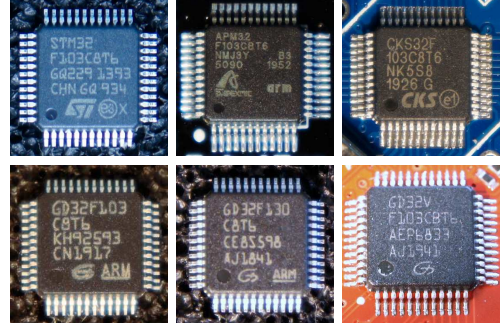
Figure 1: The Devices under Test, listed in Table 1.

For our analysis, we chose five replacements and an original device of the very popular STM32F103, a member of the STM32F1 family. They are shown in Figure 1 and listed in Table 1. In 2020, all these devices were available on the free market, sometimes advertised as STM32F103 drop-in replacements. The devices are based on an ARM Cortex-M3, except for the GD32VF103 that instead contains a RISC-V core. The GD32F130 is a special case as it does not have a direct STM32 counterpart; however, it appears to be a refined GD32F103 with additional capabilities, and most interestingly, extended security features. Thus, we analyze a broad range of devices from drop-in replacements to upgrades.

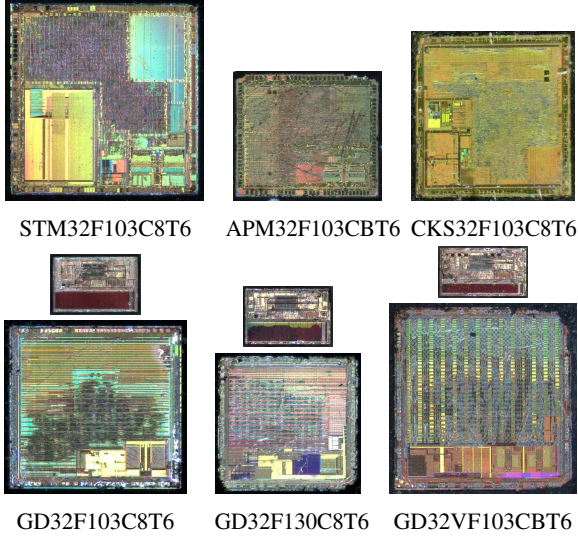
Figure 3: The silicon dies after decapping, true to scale; the exact dimensions are listed in Table 3 in Appendix A.

The chips, shown in Figure 3, are very different from each other, thus, all of them are individual developments. The sizes of the dies vary widely, as listed in Table 3 in Appendix A, even hinting at different manufacturing technologies. The GD32 devices contain two dies in their package which was seldom observed in microcontrollers. Further analysis showed, in accordance with other analyses [12, 21], that the smaller chip contains the flash memory and the larger one incorporates the remaining logic such as the CPU, SRAM, and peripherals.

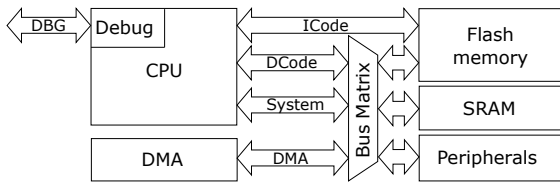
Figure 4: Simplified block diagram of the internal buses of a typical microcontroller.

system, a multitude of components is connected to the internal buses, as shown in Figure 4. The debug module, the CPU, and the Direct Memory Access (DMA) module are masters on the buses, thus, they can perform read-transactions from flash memory. For that, we test whether in RDP level 1,

As illustrated in Figure 4, the flash memory on an ARM Cortex-M based device is accessed via the data bus and instruction bus. The data bus serves data and debug accesses; the instruction bus is intended for instruction and interrupt vector fetches from flash memory [2].

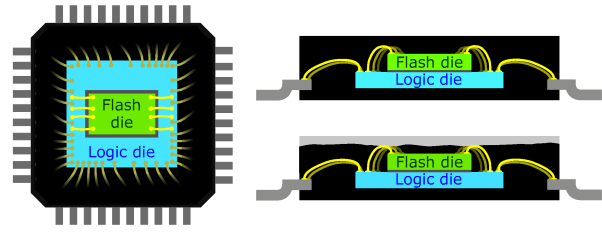
Figure 6: Top and side view of a dual-die device. The bonding wires between both dies become accessible by partially removing the casing (right, bottom).

All tested GD32 devices have a separate logic and flash memory die, as shown in Section 4.3. Both chips are stacked atop of each other and connected via bonding wires, illustrated in Figure 6. This sparked the question, whether such a design is sufficiently secure against invasive physical attacks – especially in the case of the GD32F130 that did not exhibit any debug interface vulnerabilities so far.

In order to gain access to the bonding wires for eavesdropping, the top of the casing is carefully removed via sand paper of 120 and 600 grit size. A small portion of the bonding wires' top curvature becomes sufficiently accessible to contact it momentarily with a very thin wire. Without requiring a pre-amplifier, these signals are connected to a logic analyzer.

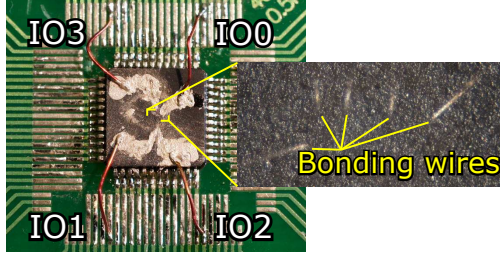
Figure 7: The prepared GD32F130 with access to all four QSPI data signals (IO0 to IO3).

To create a larger, electrically improved, and mechanically more stable contact area for further analysis, we applied conductive silver paint. A fine brush, manually made from a sin-

gle fiber of a bamboo stick, is helpful to apply the paint. Via additional thin wires, all four QSPI signals are permanently connected to the circuit board. The result of this rather tedious task is shown in Figure 7. Due to the regular communication pattern and availability of a datasheet of a functionally similar standalone QSPI flash device by GD [8], no additional signals need to be probed for reverse-engineering.

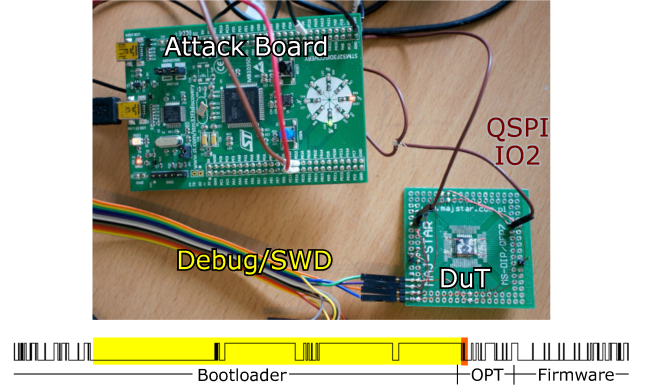
Figure 8: QSPI active manipulation setup with transaction excerpt. A fault (red) is injected into the IO2 signal to alter the option bytes, aligned to the distinct pattern (yellow) at the end of the bootloader.

showed that the RDP setting is loaded during startup and present on the bus in plain without obfuscation. The naive approach would be to interfere with the option byte loading by directly manipulating the option byte transmission. Downgrading from RDP level 2 to 1 to re-enable the debug interface is feasible by flipping any bit, however, this does not provide access to the firmware as no debug interface vulnerabilities are known for level 1. To downgrade from level 2 to 0, the option bytes would have to be altered from 0xCC33 to 0xA55A. While being at least theoretically possible, this would again require access to all four QSPI data signals at once.

The reason for this is unknown but it enables a new attack vector. Further analysis shows that the factory configuration is loaded from address 0x0400 and the option bytes are loaded from address 0x4000. Thus, by manipulating the *address* of the QSPI transaction loading the option bytes, they are forced to be loaded from the factory configuration region instead. This replaces the actual option bytes with the value 0xA55A and the device falls down to RDP level 0 – enabling full access to the entire user firmware via the debugger.

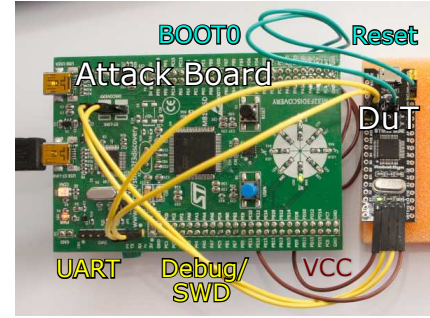
Figure 9: The setup for glitch generation, boot mode selection, and code extraction.

For the attack, we setup the DuT as shown in Figure 9. At first, we upload a two-stage exploit firmware to the SRAM with a debugger and shut down the debugger afterwards. Next, we configure SRAM-booting via the BOOT pins.

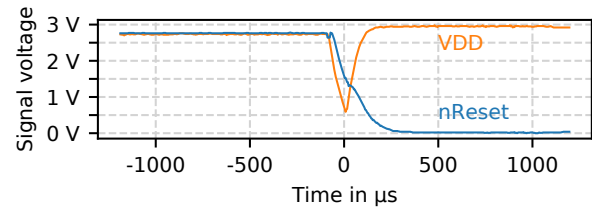
Figure 10: The VDD/supply glitch triggers a system reset.

However, the flash memory is still locked down since a debugger was connected. To release the lock down, we perform a very quick power cycle by cutting the power supply for a few hundreds of microseconds. During that glitch, we observe the microcontroller’s reset line to detect when the system goes into reset. At this moment, our setup automatically restores power, as shown in Figure 10. After this very short power-cycle, access to the flash memory is re-enabled. But due to SRAM data remanence [18], such a short interruption in the power supply leaves the data in SRAM intact.
