Wind Turbine Blade Surface Damage Detection based on Aerial Imagery and VGG16-RCNN Framework

Abstract—In this manuscript, an image analytics based deep learning framework for wind turbine blade surface damage detection is proposed. Turbine blade(s) which carry approximately one-third of a turbine weight are susceptible to damage and can cause sudden malfunction of a grid-connected wind energy conversion system. The surface damage detection of wind turbine blade requires a large dataset so as to detect a type of damage at an early stage. Turbine blade images are captured via aerial imagery. Upon inspection, it is found that the image dataset was limited and hence image augmentation is applied to improve blade image dataset. The approach is modeled as a multi-class supervised learning problem and deep learning methods like Convolutional neural network (CNN), VGG16-RCNN and AlexNet are tested for determining the potential capability of turbine blade surface damage.

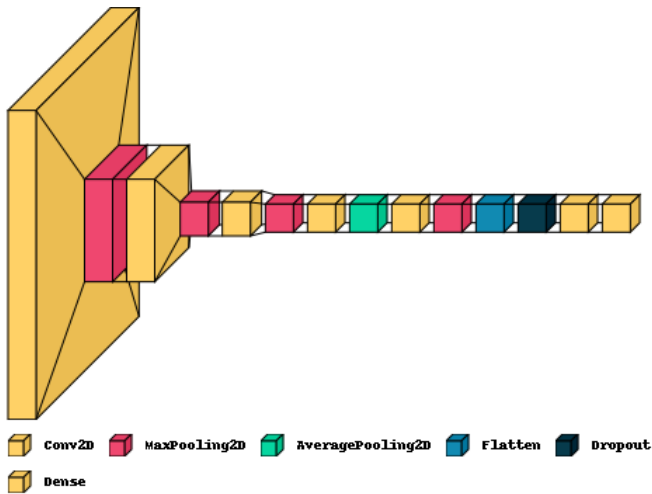
Fig. 1: Convolutional neural network architecture for wind turbine blade damage detection

An end to end method of extracting the features layer by layer shows descriptive results of faults in object detection than selecting the images. Deep learning proposed methods help provide such substantial results because of its value sharing mechanism. The extraction of the defects in the blade images is an important step in order to analyze the faults and defect features. The main aim of CNN is to run these images within the convolutional layer and pooling layer. The feature extraction is basically a sequence of these two layers being fully connected. In the case of blade images, the feature selection is done in a cleaner manner and with a local perspective of dividing the images as classes for its target recognition. When extensive pre-processing is to be avoided and raw data is to be used, this network design has been utilised to image classification in particular, images must be categorised directly. The first layer usually extracts basic features such as horizontal or diagonal edges. This output is passed on to the next layer which detects more complex features such as corners or combinational edges. As we move deeper into the network it can identify even more complex features. It aims to minimise the image's real input size by using augmentation and recognising the image's significant features. Convolution, as illustrated in the Fig. 1, decreases the size of a picture by roughly thrice depending on the number of feature detectors used and the procedure used. The feature maps of the given image are obtained by convolving the input images with the input parameter (feature filter) values as designed. The activation layer, pooling layer, and fully automated layer are the other layers available in the CNN based classification process. The annotation data is used to transform the data, and train it according to the parameter values chosen for the dataset.

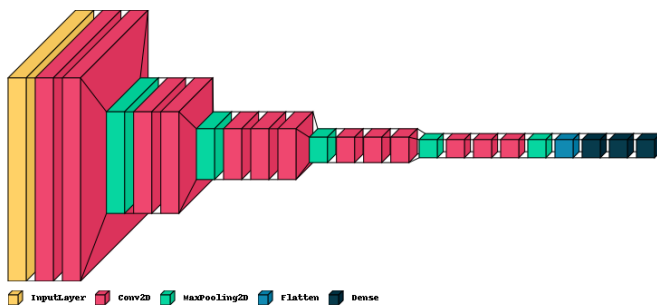
Fig. 2: VGG16-RCNN architecture for wind turbine blade damage detection

Similarly, a VGG16-RCNN [11] model architecture uses 16 convolutional layers with initial input image size of 224×224 with 64 channels of kernel size of 3×3 . VGG16-RCNN is a convolutional neural network that converts the RGB images into features and extracts the areas detecting those features. In the present case, these features include erosion, damage, and edgy surfaces. It makes the improvement over AlexNet by replacing large kernel-sized filters with multiple 3×3 kernel-sized filters one after another. VGG16-RCNN shows the highest accuracy percentage as compared to the rest of the models.

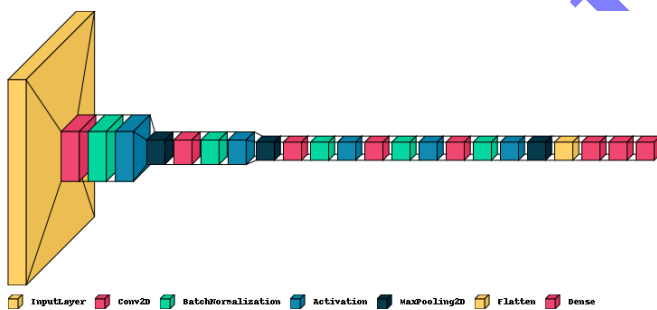
Fig. 3: AlexNet architecture for wind turbine blade damage detection

AlexNet model implemented in this study is based on the AlexNet transfer learning model [12]. The fundamental structure is made up of five convolutional structures and three fully connected layers. The features extracted from AlexNet's first five layers of training in the features the image folders are sub-classified in. In the three fully connected layers, the previous two fully connected layers output more abstract features. Despite the fact that the images of the blades with surface defects differ significantly from those in the Damage or erosion dataset, the previous five convolutional structures trained in the dataset can still extract the local features of the blade surface defects. AlexNet architecture is used for any object detection problem, showing more than 50% results than that of the basic CNN architectures.

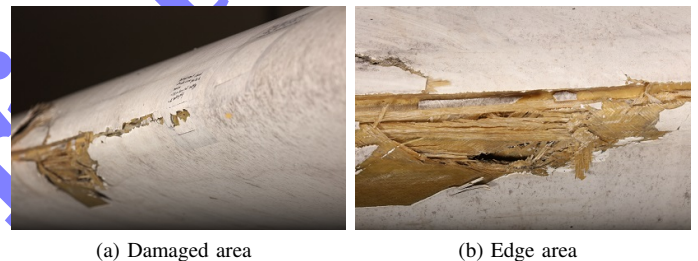
Fig. 4: Damaged and edge area for wind turbine blade

The dataset used for this research work is acquired from Mendeley- Drone inspection images of a wind turbine [13]. Common defect areas on which we have focused in this work include erosion area, edge area, reference area, and damage area. Fig. 4 and 5 depict different types of the damaged area of wind turbine blade. Reference area as shown in the images is treated as a normal image in the multi-class classification setup.

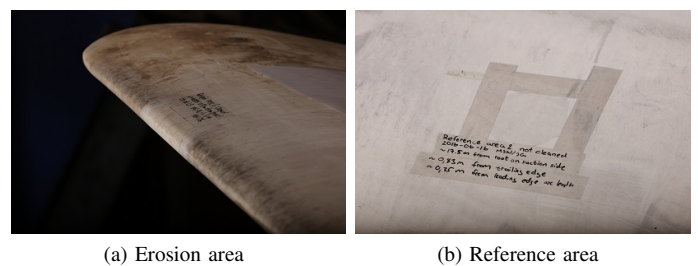
Fig. 5: Erosion and reference area for wind turbine blade

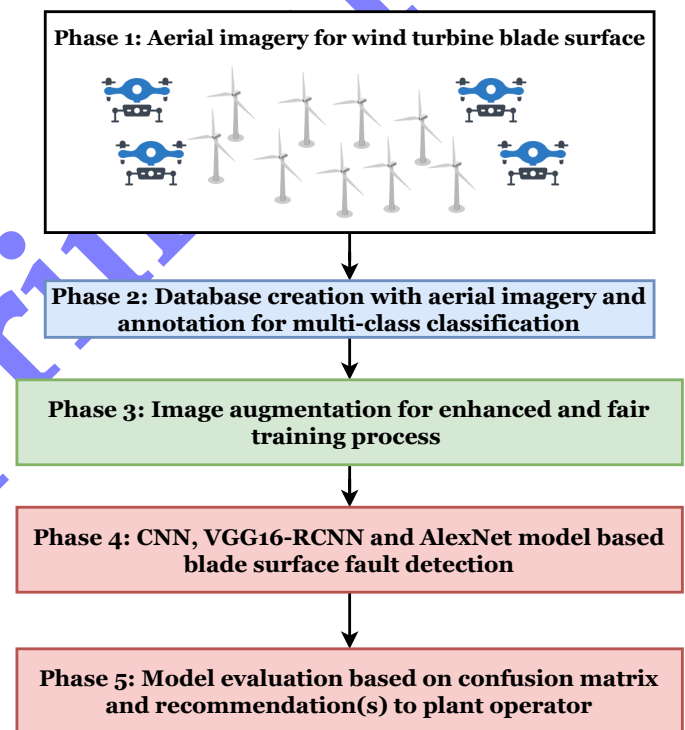
Fig. 7: Image analytics based wind turbine blade surface damage detection framework

Wind energy is a strong contender in the market of renewable sources of energy. In order to collect the wind's energy in a more efficient way. As a result, there is a high probability of damage, which is associated with the work. Thus, there is a constant demand of monitoring the blades, it will reduce the cost of operation and maintenance. Image data is the most important requirement for training a CNN model. More the data available, we can train the neural network(s) efficiently and accurately in damage classification and detection tasks. In this neural network training, we use multi-class classification based approach for wind turbine blade surface damage detection. The image data obtained from aerial imagery is deemed to classify into four classes. Multi-class classification helps the CNN model to get an idea of the extent of the damage and thereby providing insights of the damage category. Fig. 7 illustrates the image analytics based turbine blade surface damage detection framework. A drone collects the high-resolution images of turbine blades and transmits them wirelessly to a server.

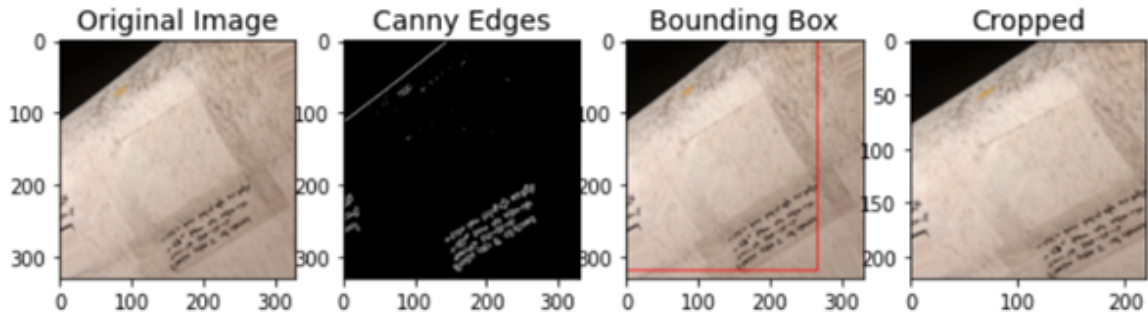
Fig. 6: A schematic of an augmented image

of the patches is a reference region, that doesn't contain any unpleasantness or damage. The last fix contains the entire of the blade's edge region and is involved a blend of seriously damaged regions, spaces of little roughness, and clear regions. The dataset initially had few images (168) and hence in particular the classification approach was suffering from class imbalance. To solve this, image augmentation is carried out on the entire dataset. Augmentation of images is a strategy that can be utilized to grow the size of the dataset by making altered forms of pictures in the dataset. Training deep learning models on a large dataset can yield skillful models, and the augmentation method can create differences in the image dataset size that can enhance the ability of a model to classify accurately. Fig. 6 shows the image after augmentation.

Properties of augmentation which are being used for the image are rotation, width-wise shift, height-wise shift, horizontal and vertical flip with zoom range. Before augmentation size of the dataset (number of images per class) was very small, but once augmentation was applied dataset size was increased and on that new augmented dataset. The keras neural network library in Python is capable of transforming the images to a version where it is easy to apply the training model over it. The less the data size of the set, it is faster to run the models over the datasets. Image Augmentation is a method on how to change the input image by certain parameters to teach the network that all images are the same regardless of the changes made. Fig. 4 and 5 illustrate the original images for different classes (or blade conditions) while Fig. 6 depicts the augmented images where the target area is zoomed and cropped accordingly.

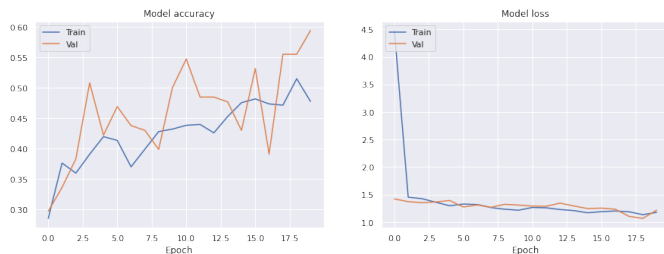
Fig. 8: Accuracy and loss for CNN

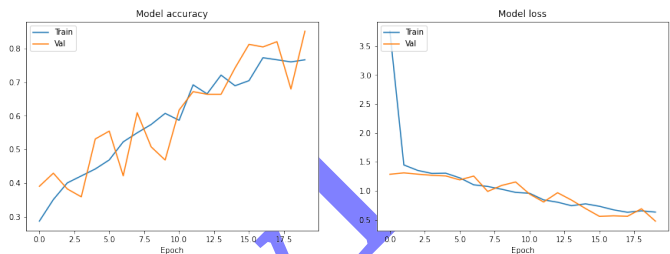
Fig. 9: Accuracy and loss for VGG16-RCNN
