Transverse Hydraulic Fracture Initiation: Insights from Intermediate-Scale Hydraulic Fracture Tests

Facility. This project, called the Enhanced Geothermal Systems (EGS) Collab project, has developed a test bed at a depth of approximately 1478 meters underground consisting of sub-horizontal injection, production, and monitoring wells. This paper presents stimulation test data, and supporting geologic/geophysical characterization data. The test data are compared to previous numerical and experimental studies to determine how well this new experimental data compares with previous modeling, laboratory, and field tests.

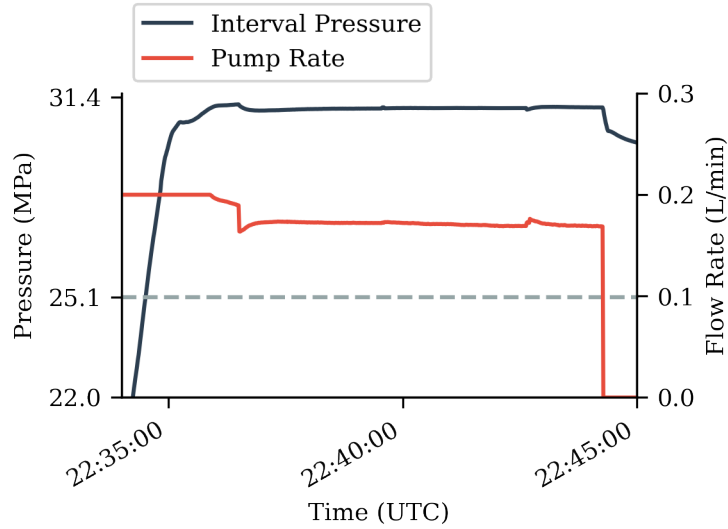
Figure 2: Plot of data during entire 1.8 L total injection for the May 21, 2018 stimulation

After a brief shut-in period a leak developed from a valve that caused venting of the interval pressure, making the data difficult to interpret. To generate a good long-term leakoff pressure data set, after the valve was fixed the interval was pressurized again at a constant rate until the fracture was evidently reopened, and the interval was again shut in. This provided an opportunity to observe the reopening response of the fracture. Figure 3 shows a plot of the data acquired during this reopening test. The reopening pressure, again interpreted from the deviation from linearity of the pressure vs. time curve, was 23.5 MPa (3412 psi), which is 1.6 MPa lower than the estimated fracture initiation pressure. Following the fracture reopening the pressure again climbed to the 31 MPa (4500 psi) pressure limit that caused the pump to reduce the injection rate.

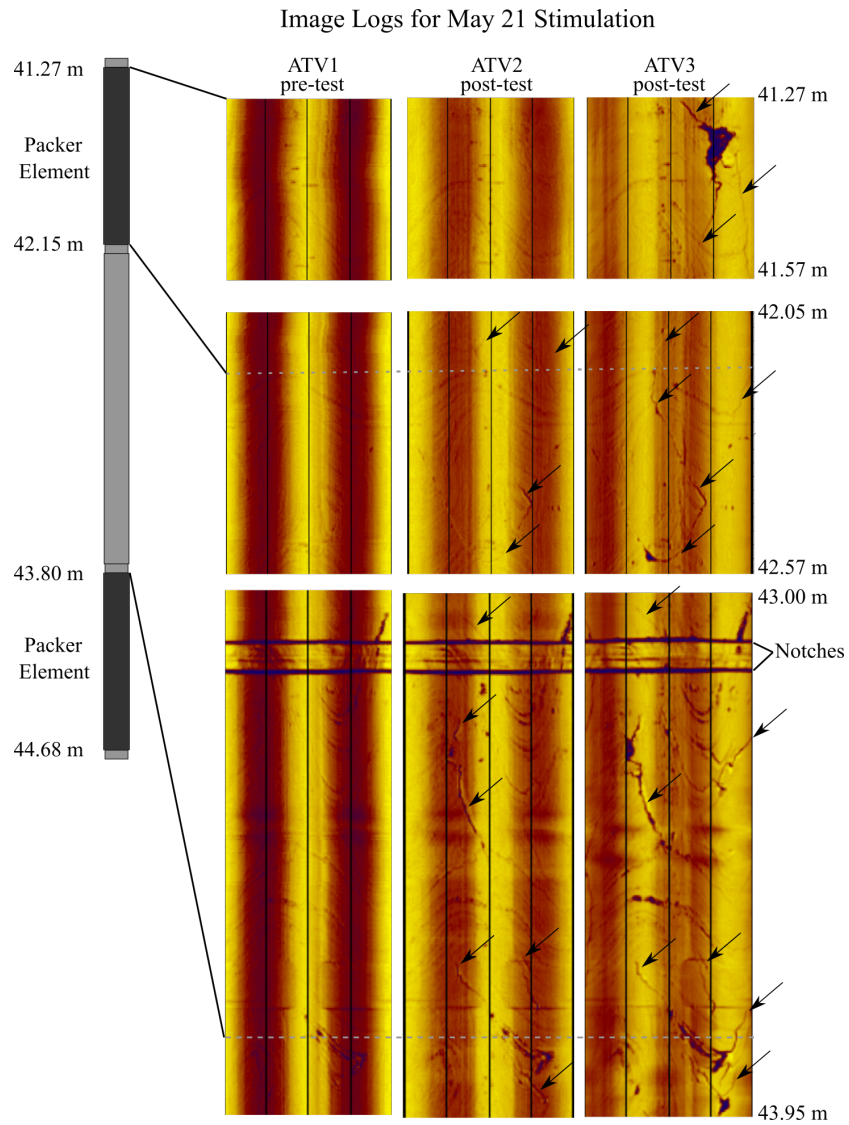
Figure 4 shows acoustic televiewer (ATV) logs that were collected in the borehole both before the stimulation (ATV1), in late May 2018 (ATV2), and again in January 2020 (ATV3). Induced fractures are identified with the thin black arrows and the two notches present in the zone are also identified. A schematic of the straddle packer system along with key alignment depths are shown in this figure for reference. These induced fractures are all sub-longitudinal to the borehole and are located primarily on the top and bottom of the sub-horizontal borehole within the interval. The induced fractures do not appear to be aligned with either the foliations or any obvious natural fracture. There are also indications of a sub-longitudinal fractures extending underneath the packers, most prominently in ATV3. These fractures were likely the cause of the rapid decline in the overnight shut-in test, and subsequent observations of leakage past the upper packer. Since the pressure rapidly

Figure 4: Acoustic (ATV) image logs collected over the zone stimulated on May 21; ATV1 was collected prior to the stimulation, ATV2 was collected shortly after the stimulation, and ATV3 was collected in January 2020 after subsequent higher pressure stimulations at this zone; the left most edge of each log is magnetic North, which is within a few degrees of the top of the borehole

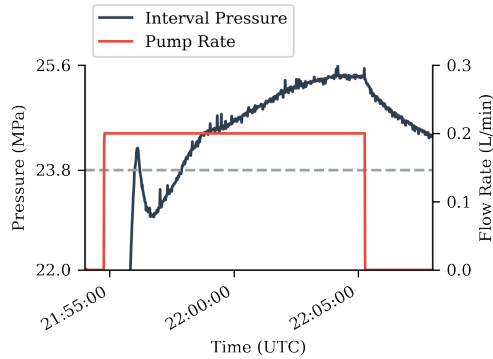
Figure 6: Plot of data during entire 1.8 L total injection for the May 22, 2018 stimulation conducted. This, and subsequent similar tests was performed by first using the pump in a constant pressure mode until a constant flow rate was achieved. Once the required flow was above approximately 50 mL/min the test continued as a step-rate test with a constant injection rate. Following this step pressure/rate test a constant rate injection at 0.4 L/min was performed until an additional 23.5 L at been injected, which was anticipated to produce a fracture radius of approximately 5 m (16.4 ft). The well was then shut in overnight. The next day another step pressure/rate test was performed followed by another period of constant rate injection at 5 L/min until the fracture had intersected the production well, after which another step pressure/rate test was performed.

transient during the shut in period was made to estimate the fracture closure pressure, radius, toughness, and leakoff coefficient (Nolte, 1988; Economides and Nolte, 2000). This interpretation resulted in an instantaneous shut-in pressure (ISIP) of 24.5 MPa (3560 psi) and a closure pressure of 21.8 MPa (3160 psi), for a net pressure of 2.7 MPa (392 psi). The analysis also estimated a radius of 2 m (6.6 ft), and a leakoff coefficient of $5.5 \times 10^{-7} \frac{\text{m}}{\sqrt{\text{s}}}$. The leakoff coefficient calculation assumes plane strain modulus of 75 GPa. The implied fracture toughness is $4.4 \text{ MPa} - \sqrt{\text{m}}$.

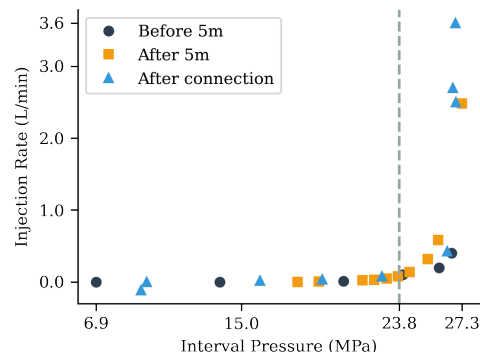
Figure 8 shows the results of these three step pressure/rate injection tests. In this figure “After connection“ means after the connection to the production well was made. A larger pump was used for the “after 5m” and “after connection” step-rate tests. Owing to the larger full-scale range, the uncertainty in the flow measurements in these tests is larger (approximately ± 50 mL/min). Because of this the lower rate measurements have a larger

Figure 8: Results of multiple step-rate tests on the May 22, 2018 stimulation

analysis of the pressure transient analysis following the initial 2.1 L injection. Specifically, significant flow into the fracture occurs at approximately 22-23 MPa (3192-3336 psi), which is close to the picked closure pressure of 21.8 MPa (3162 psi). Also, a vertical asymptote occurs in the data at approximately 27 MPa (3916 psi), which is an indication of the fracture propagation pressure. This leads to an estimated net pressure of 4-5 MPa (580-725 psi), which is slightly more than the pressure transient analysis estimate. During the shut-in period there is very little flow into the fracture, so friction losses due to tortuosity do not play a role. Therefore, a reasonable interpretation is that the difference between the estimate of the net pressure from the step-rate test and the shut-in transient test is due to near-borehole tortuosity friction loss of 1.3-2.3 MPa.
