Aircraft Skin Inspections: Towards a New Model for Dent Evaluation

Abstract

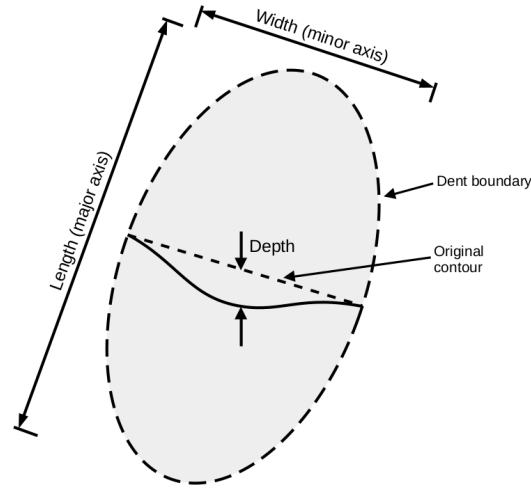
Figure 1: Traditional dimensional evaluation of dents.

During MRO operations dents must be *found, measured and evaluated* in order to identify the necessary repair actions, if any [8]. The above definition implicitly defines the currently used model for dents as a “box”, whose dimensions are equal to the length, width and depth of the dent. Moreover, it must be remarked that, as the depth is measured where the width is taken, the box might not even be the one completely containing the dent. Fig. 2 shows a set of dents falling within the same box.

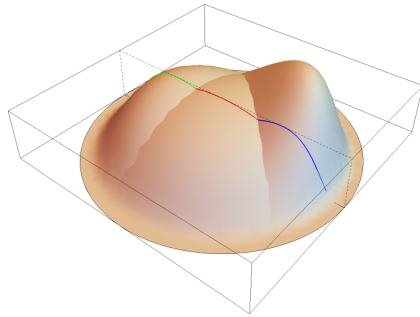
(a) Three very different dents, but falling as the same according to the SRM.

(b) Section where the width and the height should be measured.

Figure 2: SRM definition implicitly model a dent like a “box”.

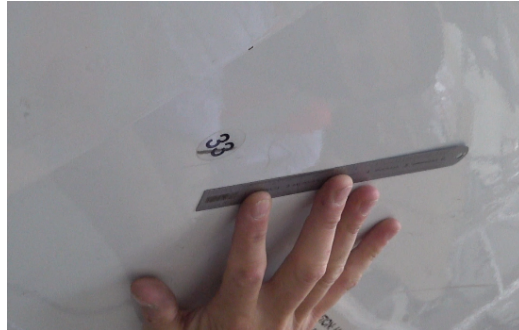
Figure 3: In the vast majority of cases, measures are collected manually.

Despite the dimensional characteristics being paramount for a proper evaluation, their reliability is undermined by many factors [2]. In fact, in the vast majority of cases, measures are collected manually by engineers by using a depth gauge and a ruler (Fig. 3), thus a certain degree of subjectivity and error is always present. To introduce measurement repeatability, 3D scanning devices are being gradually introduced in MRO. These devices produce a point cloud representation of the scanned surface and help the engineer producing a report. For example, in a study carried out by the company *8tree* the average standard deviation in width/depth ratio was 23.2 for traditional measuring and only 1.3 when using their 3D scanning device [11].

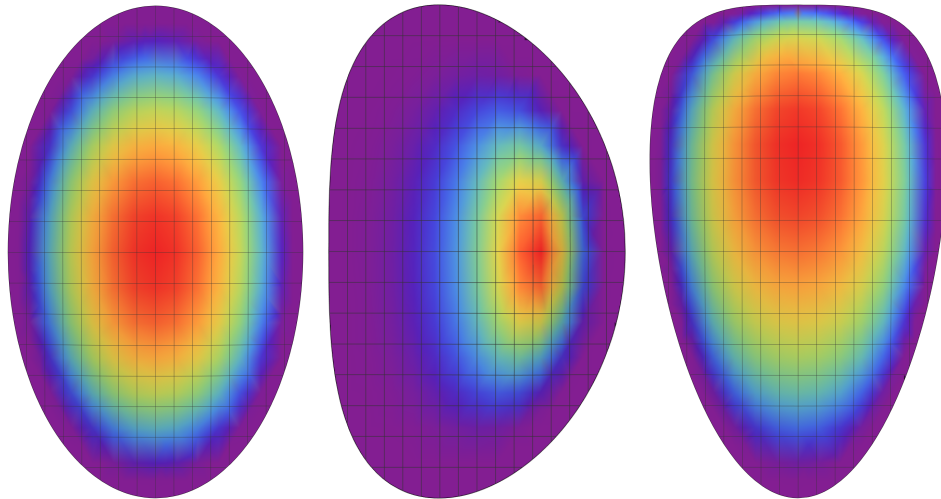
Figure 4: These three illustrative dents have all the same length and width and depth (as heatmap) and are thus classified in the same way by the SRM. However, they have evidently different shapes.

Consider, for example, the three illustrative dents represented in Fig. 4. By following the SRM to the letter, these dents should be classified in the

exact same way, yet they have completely different shapes. In all likelihood, also their structural characteristics are different.

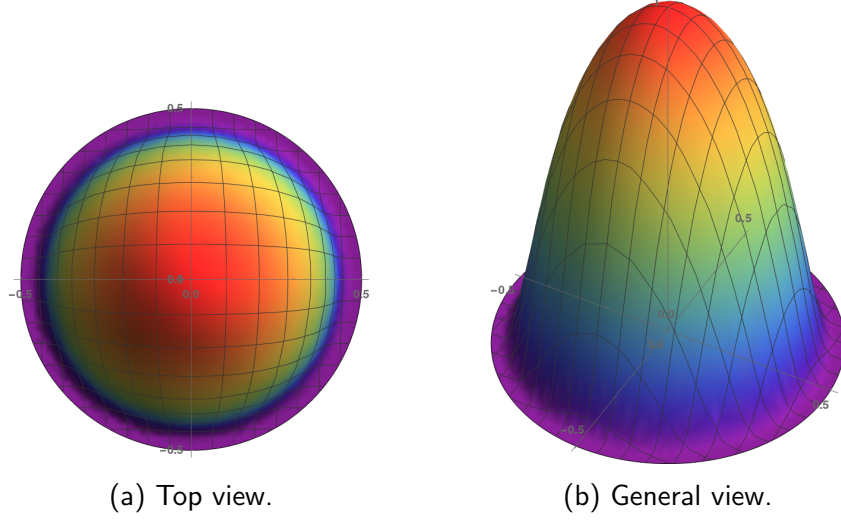
Figure 5: Reference dent function $\text{refDent}(x, y)$ with unitary xyz dimensions, $p = 1$, $s_x = s_y = 0$ and $b = e$.

The reference function $\text{refDent}(x, y)$ showed in Fig. 5 has unitary dimensions along the three axis and can be easily rescaled to produce a general dent:

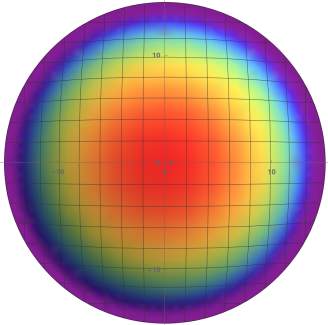
$l = 30$ $w = 30$ $d = 5$ $b = 2$ $p = 1$ $s_x = 0$ $s_y = 0$

Before discussing the possible applications in the following section, some shapes obtained with the proposed model are shown in Table 1, accompanied by their corresponding parameters. Depth values have been intentionally exaggerated for visualisation purposes.

Table 1: Examples of the proposed dent model for different parameter values, where e stands for the Euler's number.

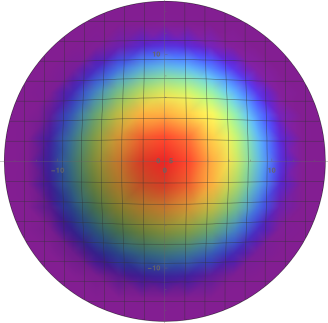
$l = 30$ $w = 30$ $d = 5$ $b = 10$ $p = 1$ $s_x = 0$ $s_y = 0$

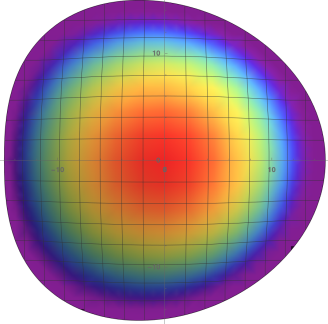
$l = 30$ $w = 30$ $d = 5$ $b = e$ $p = 0.8$ $s_x = 0$ $s_y = 0$

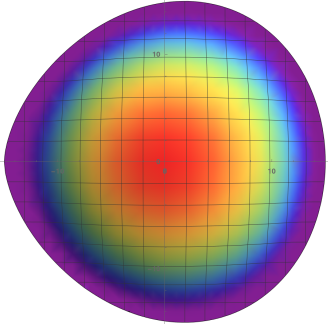
$l = 30$ $w = 30$ $d = 5$ $b = e$ $p = 1.2$ $s_x = 0$ $s_y = 0$

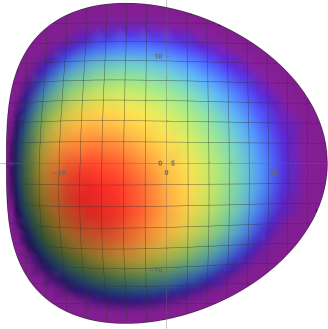
$l = 30$ $w = 30$ $d = 5$ $b = e$ $p = 0.7$ $s_x = -0.2$ $s_y = -0.1$

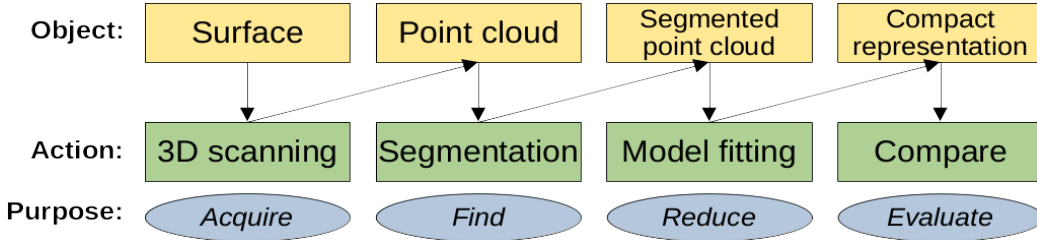
Figure 6: Expected workflow of an automated dent inspection system.

Starting from the physical surface to be assessed, its point cloud representation is acquired. Then a *segmentation* of some sort must be applied in order to actually isolate each dent by separating dented and non-dented areas [14]. In MRO, both the manual approach and the recent 3D scanners aim at extracting length, width and depth as prescribed by the SRM [16]. Reducing the amount of information to a handful of parameters is necessary to make the measure intelligible and comparable. However, as shown above, the sole measures of depth, width or length do not adequately represent the actual shape and create high degree of ambiguity in the following evaluation.

A more accurate alternative is available by means of the model proposed in Eq. (4), which can be fitted by numerical optimisation to the 3D points, providing the optimal set of 7 parameters representing that particular dent shape. This compact set of values will accurately represent the damage and will be *compared* against historical data and structural evaluations, while such comparison would not be possible by directly using 3D point cloud data. The added benefit is that storing or sharing the raw point cloud can be avoided, as the shape is faithfully represented by means of the proposed model.

The approach proposed in Fig. 6 can lead to more targeted interventions, ultimately saving costs. In order to accomplish this, the current practices are supposed to be revised and updated to embrace the increased capabilities brought by 3D scanning. This process of change has already started with the introduction of new devices, however, as part of a highly regulated and safety-critical industry, it is likely to take several years.

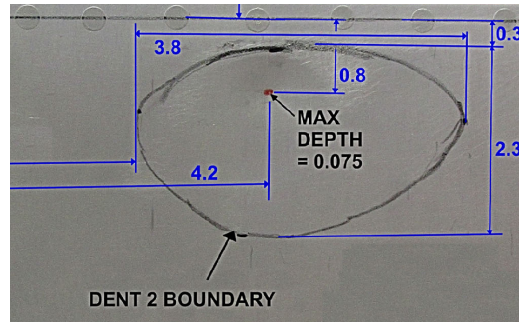
Figure 7: The complex shape of a dent cannot be expressed by only a combination of length, width and depth. In this picture the engineer relied on drawings to express the actual shape and the position of maximum depth, so that a better structural evaluation could be carried on. Even using 3D scanning, such great amount of data is ineffective if comparison is then done by means of depth and width/depth ratio only.

Fig. 7 is extracted from a “C” check report. It shows a dent manually marked and measured by the engineers. While this method may appear approximated and cumbersome, it responds to the need for communicating more about the actual dent shape, and thus obtain specific repair instructions from the aircraft manufacturer. On the other hand, one may represent the damage by its full 3D point cloud. While this is rich of data, it is not easily comparable nor manageable in terms of extracting general repair recommendations.

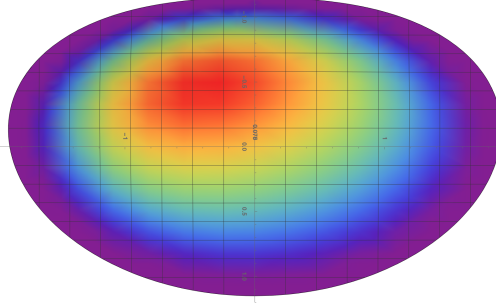
Figure 8: Shape obtained with $b = 2.7$, $l = 2.3$, $w = 3.8$, $d = 0.075$, $p = 0.85$, $s_x = -0.2$ and $s_y = -0.12$ which could potentially represent the dent of Fig. 7.

Assuming the use of a 3D scanning, instead, the shape showed in Fig. 8, calculated by means of Eq. (4), may easily approximate the actual one and with an intelligible set of only 7 parameters. While length, width and depth are the same as in the classical evaluation, the 4 extra degrees of freedom address the necessity of an accurate and compact description that was previously attempted by manual drawings only.

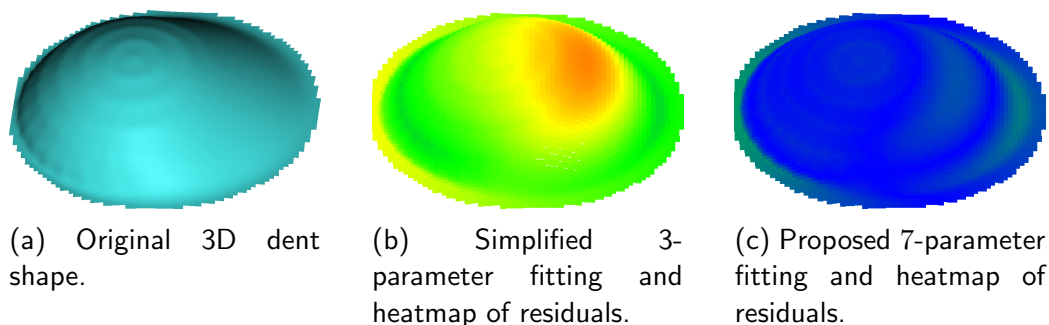
Figure 9: Dent obtained from a 45° collision and residual heatmaps (blue = 0 mm, red = 1 mm mm). The proposed model is capable to follow the natural dent shape and the MAE is reduced by an order of magnitude.

In the 45° collision example, the fitting by the simplified model gave $l = 5.55$ mm, $w = 5.09$ mm and $d = 1.46$ mm with a MAE of 0.51 mm. The proposed model found $l = 6.10$ mm, $w = 5.48$ mm, $d = 1.24$ mm, $p = 1.01$, $s_x = -0.11$, $s_y = 0.00$ and $b = 3.11$, with a MAE of only 0.053 mm. The original 3D dent and the two residuals are shown in Fig. 9, where red indicates high residual areas.

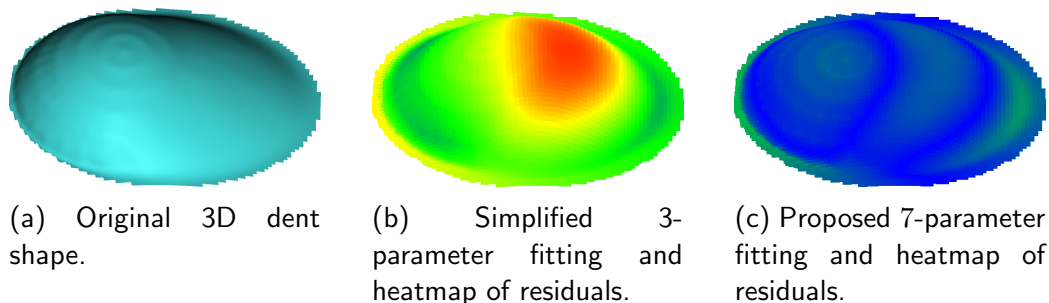
Figure 10: Dent obtained from a 60° collision and residual heatmaps (blue = 0 mm, red = 1 mm mm). Also in this case the MAE is greatly reduced.

In the 60° collision example, the fitting by the simplified model gave $l = 6.36$ mm, $w = 5.14$ mm and $d = 1.48$ mm with a MAE of 0.52 mm. The proposed model found $l = 6.66$ mm, $w = 5.21$ mm, $d = 1.12$ mm, $p = 0.96$, $s_x = -0.12$, $s_y = 0.00$ and $b = 2.37$, with a MAE of only 0.08 mm. Fig. 10 represents the original shape and the fitting residuals.
