# Bridge Damage Cause Estimation Using Multiple Images Based on Visual Question Answering

**Abstract.** In this paper, a bridge member damage cause estimation framework is proposed by calculating the image position using Structure from Motion (SfM) and acquiring its information via Visual Question Answering (VQA). For this, a VQA model was developed that uses bridge images for dataset creation and outputs the damage or member name and its existence based on the images and questions. In the developed model, the correct answer rate for questions requiring the member's name and the damage's name were 67.4% and 68.9%, respectively. The correct answer rate for questions requiring a yes/no answer was 99.1%. Based on the developed model, a damage cause estimation method was proposed. In the proposed method, the damage causes are narrowed down by inputting new questions to the VQA model, which are determined based on the surrounding images obtained via SfM and the results of the VQA model. Subsequently, the proposed method was then applied to an actual bridge and shown to be capable of determining damage and estimating its cause. The proposed method could be used to prevent damage causes

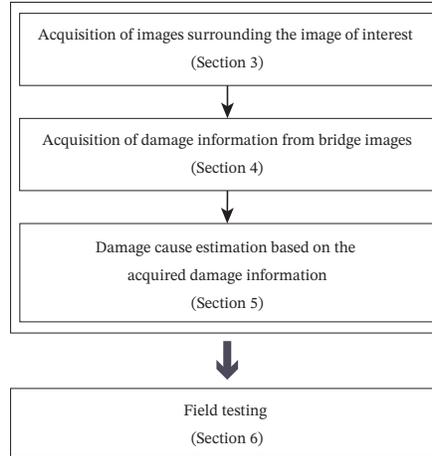
Fig. 1: Proposed framework methodology and field test

The proposed method consists of four parts: acquisition of images surrounding the image of interest (Sec. 3), acquisition of damage information from bridge images (Sec. 4), damage cause estimation based on the acquired damage information (Sec. 5), and field testing (Sec. 6). The framework is presented in Fig. 1.

Specifically, in the acquisition of images surrounding the image of interest, we explain how to obtain the area of the bridge captured by each image based on the SfM-estimated camera position coordinates. In the acquisition of damage information from bridge images, we explain how to create a dataset for VQA using bridge images, develop a VQA model based on the created dataset, and verify the model accuracy. For damage cause estimation based on the acquired damage information, we explain how to estimate the cause of damage using the developed VQA model. Finally, we describe the field test results and discuss the application of the proposed method to an actual bridge. Each of these topics is described in detail in the following sections.

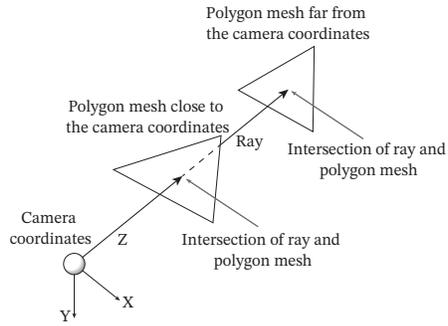
Fig. 2: Intersection of the camera direction vector and the triangular mesh

The mesh model created based on the SfM results consists of a set of triangular meshes. Therefore, the mesh model intersection points can be calculated by computing the triangular meshes that intersect the direction vectors of the camera whose coordinates have already been identified, as shown in Fig. 2. Note that the camera direction vector and the triangular mesh may intersect multiple times. Therefore, the intersection point closest to the camera coordinates is used as the shooting point coordinates.

Algorithms for determining the intersection between a triangular mesh and a ray represent a simple geometric problem and are not discussed here. For example, the Möller Trumbore intersection algorithm [28] can be used for intersection determination.

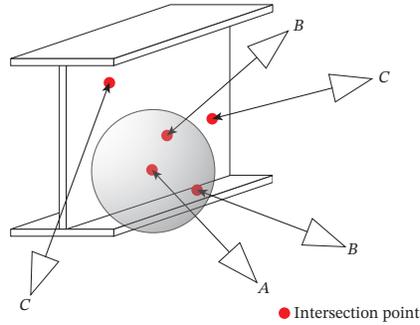
Fig. 3: Image of interest and its surrounding images

To determine the surrounding images, we assume a ball centred on the intersection coordinates between the camera that captured the image of interest (Camera A) and the model, as shown in Fig. 3. Cameras (Cameras B) whose intersection coordinates are inside the ball are treated as the images surrounding the image of interest. The other cameras (Cameras C) are considered to have little relevance to the image of interest and are not used in the subsequent analysis. In this study, for simplicity, the radius of this ball is assumed to be 1 m for determining the surrounding images. Although further discussion is needed on an

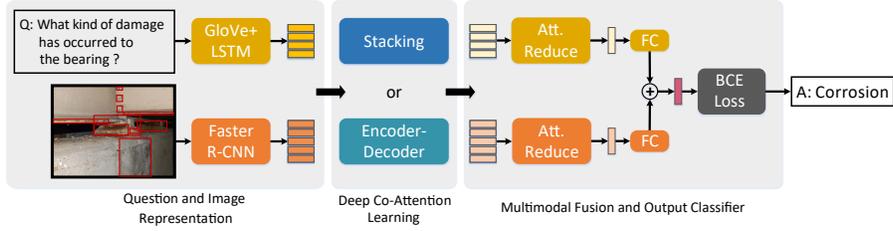
Fig. 4: Deep modular co-attention network (MCAN) flowchart [48].

For example, as shown in the MCAN flowchart in Fig. 4, if the question is ‘What kind of damage has occurred to the bearing?’ it is expected that the damage can be more accurately determined by focusing on the bearing, rather than on a location in the image that is unrelated to the content of the question. Therefore, in this study, a VQA model for bridge images was constructed using MCAN. It is worth noting that, as new VQA models are proposed, if a more accurate model is available, it can be easily adopted in the proposed framework.

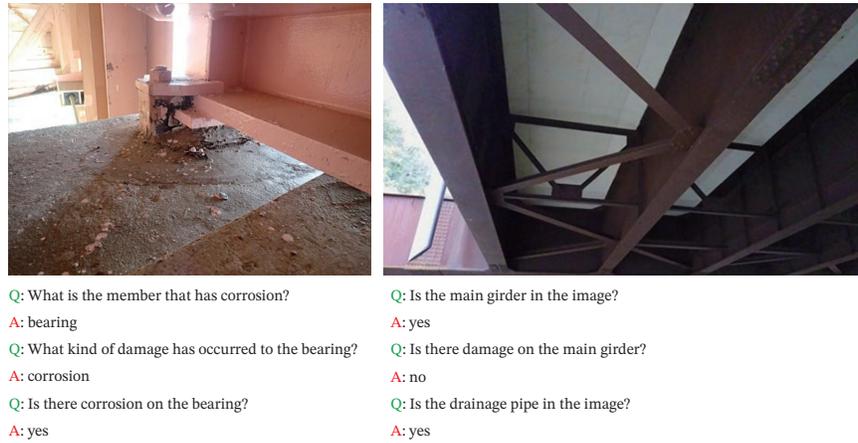
Fig. 5: Example of the created dataset

An example of the created dataset is shown in Fig. 5. For each image, questions were created asking what member is present, what damage is present, what damage occurs on what member, and so on.

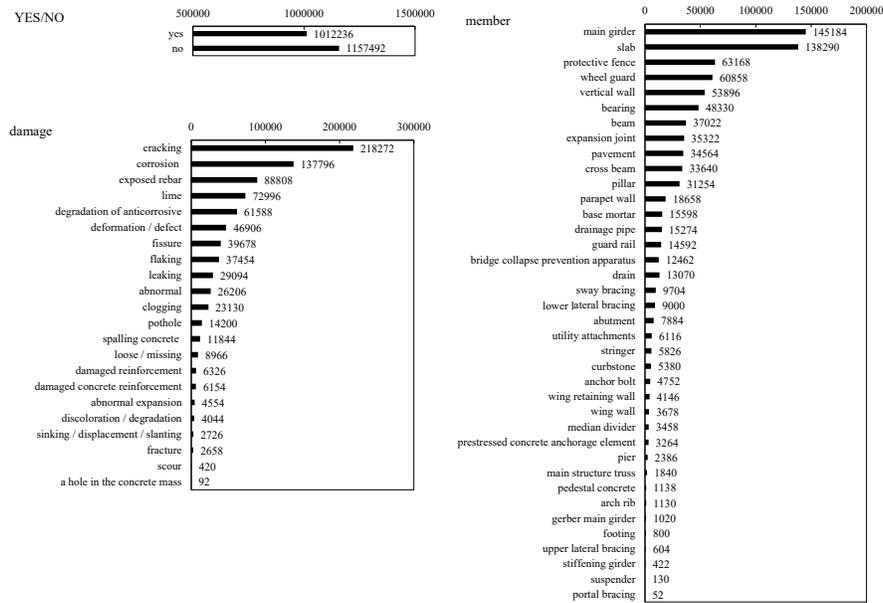
Fig. 6: Breakdown of the answers in the dataset

Some damages in the inspection report were described as a single damage (e.g., sinking/displacement/slanting of bridge abutments). Therefore, such damages were treated as a single damage in the created dataset as well. In general VQA datasets, multiple questions are prepared for each image. Therefore, in this study, we created a dataset with multiple questions for each image. The total number of questions created was 3,875,010, with an average of approximately 8.8 questions per image. The dataset consists of questions that can be answered by name of the member and damage, and ‘yes/no’ as shown in Fig. 5. There are 38 types of members and 22 types of damages. Fig. 6 shows the occurrence of each answer in the dataset.

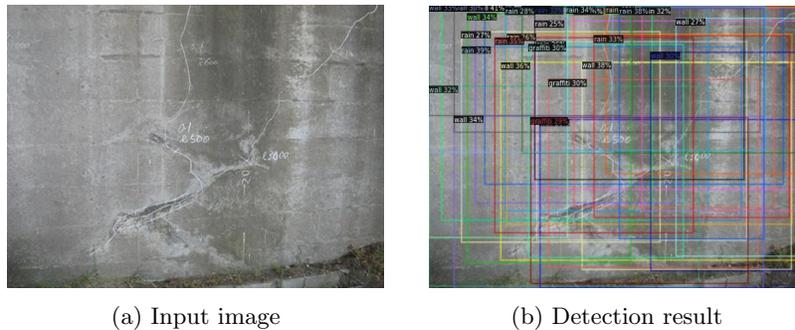
Fig. 7: Example of detection results using the Faster R-CNN

Fig. 7 shows an object detection example from an image from the created dataset using the Faster R-CNN trained on the Visual Genome dataset. Fig. 7 shows an image of a bridge abutment with water leaking, free lime, and cracks. The detection results show that ‘wall’, ‘rain’, and ‘graffiti’ were detected. As shown in the figure, the Faster R-CNN trained on the Visual Genome dataset does not directly correctly recognize objects in its object detection task. However, similar detection results in our dataset indicate the presence of similar members or damage. For example, if another image with water leaking or free lime is input, the same ‘rain’ or ‘graffiti’ detection results are expected. Therefore, by using the features obtained here as input for MCAN, VQA based on the features in each image region can be performed without creating a separate object detection dataset for bridge inspection.

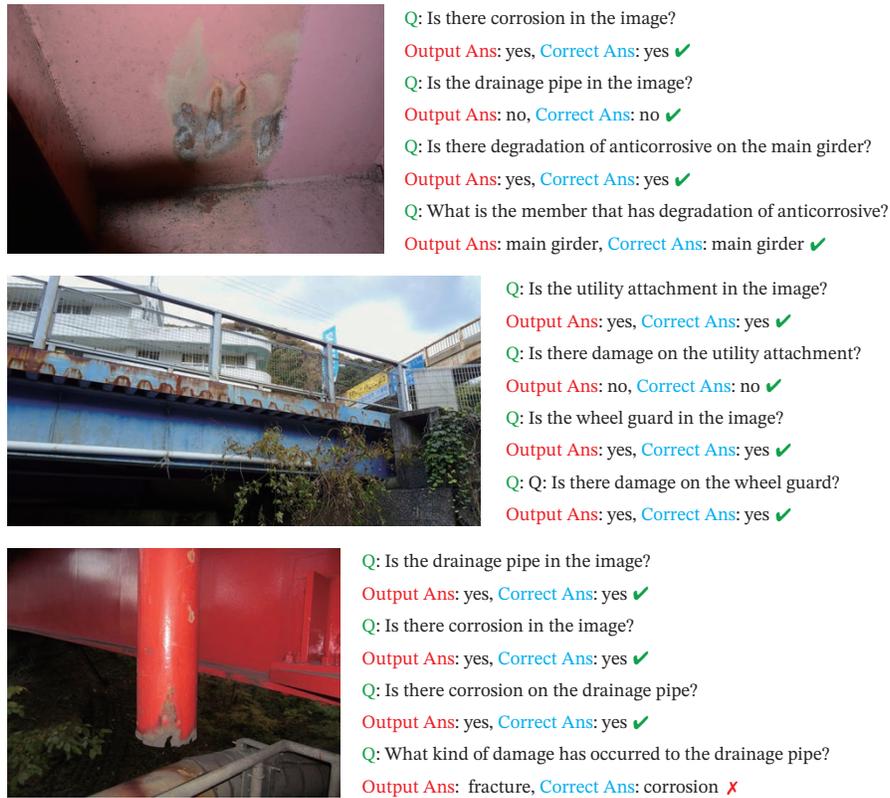
Fig. 8: Example of output results from the trained model

**Results and accuracy** An example of the test data output results from the trained model is shown in Fig. 8. The top image in Fig. 8 shows a main girder with corrosion and degradation of the anticorrosive material. In cases where this image and the question ‘Is there corrosion in the image?’ were input into the model, the model correctly returned ‘yes’. In addition, the question ‘Is the drainage pipe in the image?’ returned the correct result of ‘no’. Furthermore, the question ‘Is there degradation of the anticorrosive on the main girder?’ also returned the correct result of ‘yes’. Finally, the question ‘What is the member that has degradation of the anticorrosive?’ also returned the correct result, i.e., ‘main girder’.

The middle image in Fig. 8 shows a girder bridge captured by a UAV. This bridge has utility attachments on the exterior girders, and the question ‘Is the utility attachment in the image?’ was inputted, and ‘yes’ was output correctly. In addition, the question ‘Is there damage on the utility attachment?’ also returned the correct result of ‘no’. Furthermore, the question ‘Is the wheel guard in the image?’ also returned the correct result, ‘yes’. Finally, the question ‘Is there damage on the wheel guard?’ also returned the correct result, ‘yes’.

The lower image in Fig. 8 shows a corroded drainage pipe. In cases where this image and the question ‘Is the drainage pipe in the image?’ were input into the model, the model correctly returned ‘yes’. In addition, the question ‘Is there corrosion in the image?’ also returned the correct result of ‘yes’. Furthermore, the question ‘Is there corrosion on the drainage pipe?’ also returned the correct result, i.e., ‘yes’. However, the question ‘What kind of damage has occurred to the drainage pipe?’ was returned as ‘fracture’, which is incorrect. The drainage pipe in this image is not fractured and the tip is corroded, but fractured steel usually corrodes at the fracture point as well. Therefore, it is difficult to determine that the pipe has not fractured from this image alone. Nevertheless, the model answered most of the questions correctly.

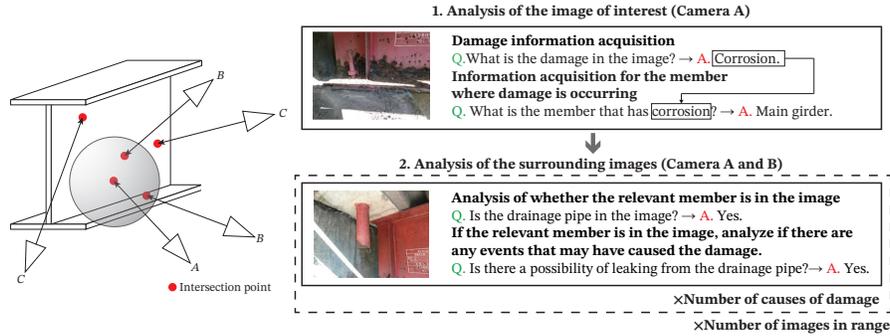
Fig. 9: Damage cause estimation process

To identify the cause of damage as described above, it is first necessary to determine whether or not these members exist in the vicinity of the corroded area. If a member is present, it is then necessary to check whether an event has occurred in that member that could have caused the damage. Based on this, the damage cause estimation process is as shown in Fig. 9.

As shown in Fig. 9, the first step is to analyse the image of interest (Camera A) (Step 1), where the type of damage in the image is determined. Then, based on the output damage name, a judgment is made regarding which member the damage is occurring in. Subsequently, based on the determined damage and member names, an analysis is performed to determine the damage cause that can be assumed in advance (Step 2). In this case, the surrounding images calculated via SfM are also used for analysis, as analysing the image of interest alone may miss information necessary for damage cause estimation. First, for the image to be analysed, it is determined if there are any members related to the assumed damage cause. If so, the system checks if there is an event that may have caused the damage to the member. In this way, the number of possible damage causes is analysed for each image. The above analysis is performed for all surrounding images, including the image of interest.

The number of images in which related members are determined to exist as a result of the analysis in Step 2 is  $N$ . Let  $M$  be the number of times that an event that could be the cause of damage is determined to occur. Then, the probability

of each damage cause is expressed as  $M/N$ . If  $M/N$  is high, it is considered that the cause of damage is more likely to be the cause of the damage determined in Step 1.

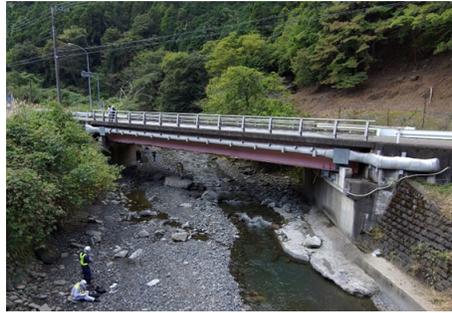
Fig. 10: Steel girder bridge used for the field test in this study

In this section, we verify whether the proposed framework can be used for damage cause estimation using actual bridge images. The bridge used in this study is the steel girder bridge shown in Fig. 10, which is managed by the Ministry of Land, Infrastructure, Transport, and Tourism of Japan. The span length and total width of the bridge are 25.4 and 9.8 m, respectively. The bridge was constructed in 1970 in the mountainous area of Yamanashi Prefecture, Japan. It has several damaged sections; particularly, there is severe corrosion on the superstructure.

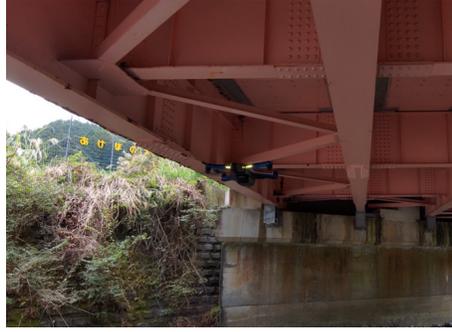
Fig. 11: Bridge images taken using a small unmanned aerial vehicle

In this study, images of this bridge were taken using Skydio 2, a small UAV developed by Skydio, as shown in Fig. 11. The focal length of the camera mounted on the UAV is approximately 4 mm, with a 35-mm-equivalent focal length of approximately 21 mm and a pixel count of approximately 12.3 megapixels ( $4056 \times 3040$  px). Then, Agisoft's Metashape was used for SfM processing. The number of images used for SfM was 541. The polygon mesh model created based on the SfM results is shown in Fig. 12.

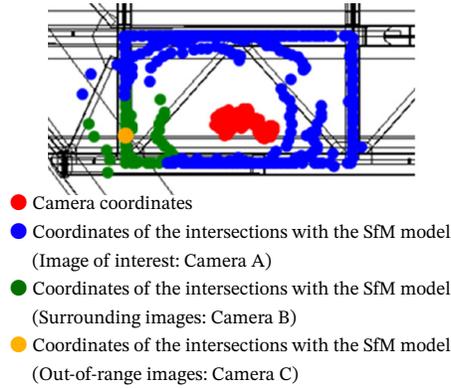
Fig. 13: Camera and intersection coordinates

The coordinate positions of each camera and the intersection coordinates obtained from each camera are shown in Fig. 13. The calculated coordinates are

projected onto a two-dimensional plan view of the bridge. The red dots in Fig. 13 indicate the coordinate positions of each camera. The orange, green, and blue dots are the intersection coordinates calculated by intersection determination with the mesh model. The orange dots are the intersection coordinates of the image of interest used to estimate the cause of damage. The green points are the intersection coordinates that exist inside a sphere with a radius of 1 m centered on the intersection coordinates of the image of interest, and the number of images is 63. The blue dots are the intersection coordinates of the out-of-range images and are not used for estimating the cause of damage. In this study, the VQA model constructed in Sec. 4 was used to estimate the cause of damage based on the images indicated by the orange and green dots in Fig. 13.

The coordinates of each camera and the intersection coordinates obtained from each camera are shown in Fig. 13. The calculated coordinates are projected onto a two-dimensional plane view of the bridge. The red dots in Fig. 13 indicate the coordinates of each camera. The orange, green, and blue dots are the intersection coordinates calculated via intersection determination with the mesh model. The orange dots are the intersection coordinates of the image of interest used for damage cause estimation. The green dots are the intersection coordinates that exist inside a ball with a 1-m radius centred on the intersection coordinates of the image of interest (the number of images is 63). The blue dots are the intersection coordinates of the out-of-range images and are not used for damage cause estimation. In this study, the VQA model constructed in Sec. 4 was used for damage cause estimation based on the images indicated by the orange and green dots in Fig. 13.

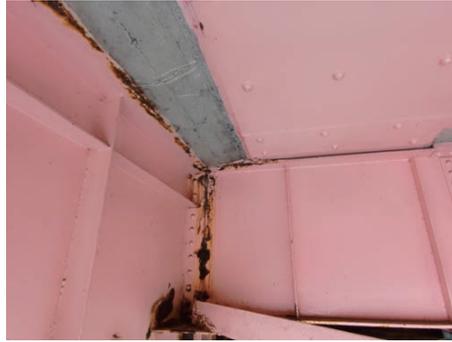
Fig. 14: Output results for the image of interest

First, VQA was used to estimate the type of damage and the member in which it occurs in the image of interest. The analysis results are shown in Fig. 14. First, a question was asked regarding what type of damage was occurring in the image of interest. In this case, the output result was ‘corrosion’. Based on the output results obtained, a question was then asked regarding which member was corroded. In this case, the result was a ‘cross beam’.

Q: What is the damage in the image?  
 A: corrosion  
 Q: What is the member that has corrosion?  
 A: cross beam

Furthermore, it is confirmed that accurate damage cause estimation is possible from actual bridge images. It is worth noting that the image of interest shown in Fig. 14 does not show leaking on the abutment. Therefore, by using the proposed method to analyse multiple images for damage cause estimation, it is possible to obtain results that cannot be obtained by analysing the image of interest alone. Moreover, as the VQA model accuracy is not perfect, diagnosis based on a single image alone may yield erroneous results. However, as demonstrated here, diagnosis based on the analysis results of multiple images can provide a more accurate diagnosis. In addition, when practicing engineers use the proposed method, it is expected to contribute to preventing overlooking

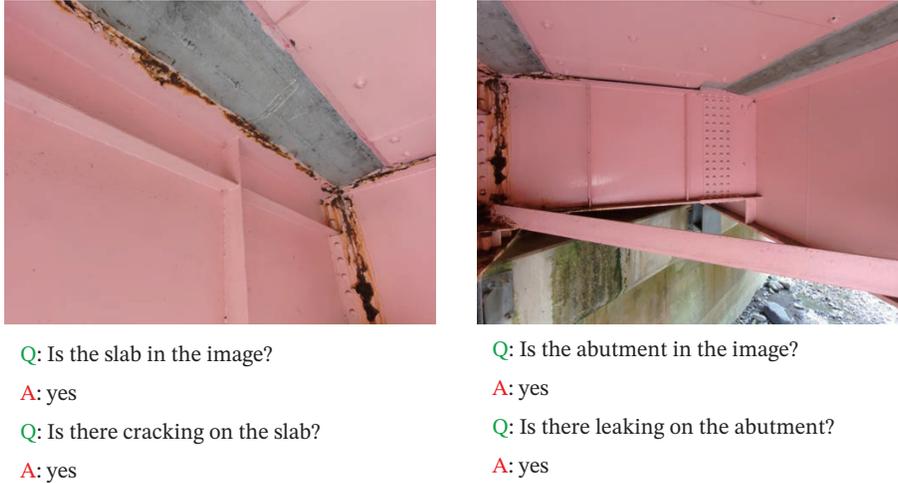
Fig. 15: Example of output results with surrounding images

Fig. 15. The left image in Fig. 15 shows an example of checking for the presence of a slab in the image and then checking for cracking on the slab. The right image in Fig. 15 shows an example of checking for the presence of an abutment in the image and then checking for the presence of leaking marks on the abutment.

Table 2 shows the damage cause estimation results. The number of members  $N$  in Table 2 indicates the number of images that were judged to contain related members that could cause corrosion. The number of damages  $M$  indicates the number of images that are estimated to show damage that could cause corrosion among the images that are determined to show relevant members. As shown in Table 2, out of the 64 images analysed, ‘slab’ was determined to be present in 61 images, with ‘cracking’ or ‘leaking’ being detected on the slab in 58 of these images. ‘Abutment’ was determined to be present in 22 images, with ‘leaking’ being detected on the abutment in 18 of these images. The drainage pipe and wheel guard were not detected in any of the 64 images analysed in this study. Therefore, these were not considered to be the cause of damage in this case. In fact, the 64 images did not show any drainage pipes or wheel guards. Based on these results, corrosion is most likely caused by cracks on the slab or leakage from the expansion joint.
