Improving Nb₃Sn Cavity Performance Using Centrifugal Barrel Polishing

In this study we will show a new method of polishing for Nb₃Sn cavities known as centrifugal barrel polishing (CBP). Using this method, Nb₃Sn coated samples are polished to a surface roughness comparable to a traditional Nb cavity after electropolishing (EP). We also investigate different methods of cleaning the Nb₃Sn surface after CBP to remove residual abrasive particles. The polished Nb₃Sn surface is analyzed using confocal laser microscopy, and scanning electron microscopy (SEM) is used to image the surface and measure the surface roughness after polishing. Transmission electron microscopy (TEM) is also used for high resolution analysis of the surface after polishing. Finally, we show that centrifugal barrel polishing can improve the performance of a Nb₃Sn SRF cavity.

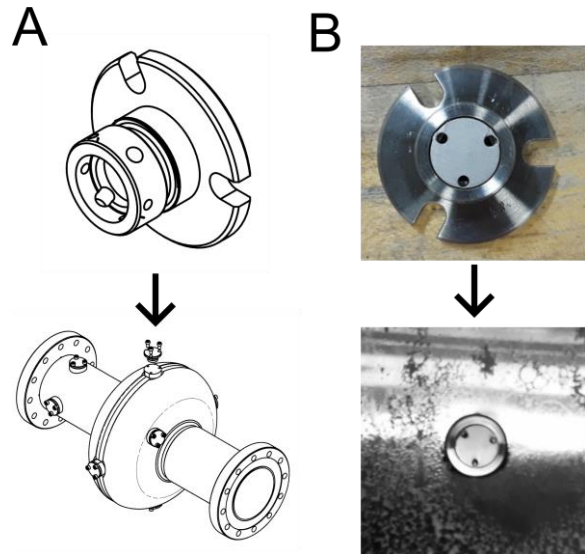
FIG. 1. (A) A schematic of the coupon cavity and the sample holder used to polish the Nb₃Sn coated samples. The sample holder can hold 1 cm diameter disks by clamping the sides of the sample with set screws. (B) Pictures of the sample holder sitting outside the coupon cavity with a sample mounted and as seen from the inside of the coupon cavity.

To test the centrifugal barrel polishing method on Nb₃Sn samples in a realistic environment, we use a coupon cavity. This cavity has multiple ports where samples are mounted. The samples sit flush with the inside surface of the coupon cavity, as is shown in Fig. 1, where they experience identical polishing conditions to a real cavity surface. This allows for sample experiments that are representative of the final cavity polishing process. Using this method we inspect the Nb₃Sn surface after polishing under a microscope to determine the best polishing parameters.

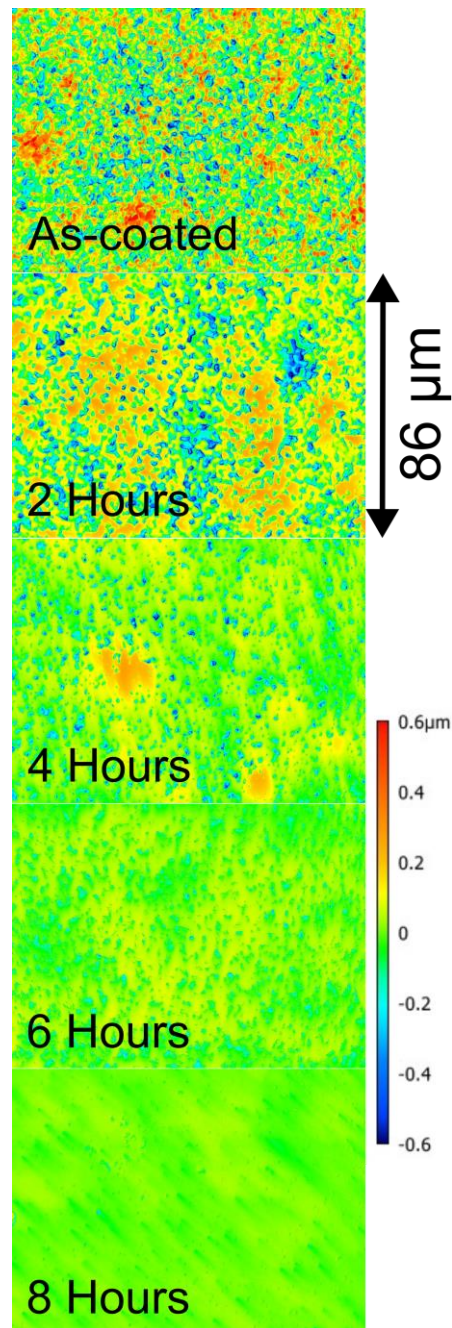
FIG. 2. Surface height maps of Nb₃Sn samples mechanically polished for different lengths of time ranging from 2 to 8 hours compared to the initial state of the Nb₃Sn coating.

The Nb₃Sn samples were polished for different lengths of time ranging from 2 to 8 hours using the wooden spheres or the felt cubes as the carrier material. A height map of the polished samples is shown in Fig. 2. The smoothness of the samples clearly improves as longer polishing is applied.

By comparing the surface optical micrographs over time, it is clear that material is preferentially removed from the highest point on the surface, causing the sharp peaks on the surface to be removed quickly while valleys in the surface are left untouched. This is different from EP, which preferentially smooths areas with high curvature including both peaks and valleys. Due to this different smoothing mechanism, surface roughness is minimized when the thickness of material removed is equal to the height difference between the highest and lowest point on the surface, which is around 1 μm . This is confirmed by the sample experiments, after 8 hours of polishing only the deepest valleys of the initial coating remain.

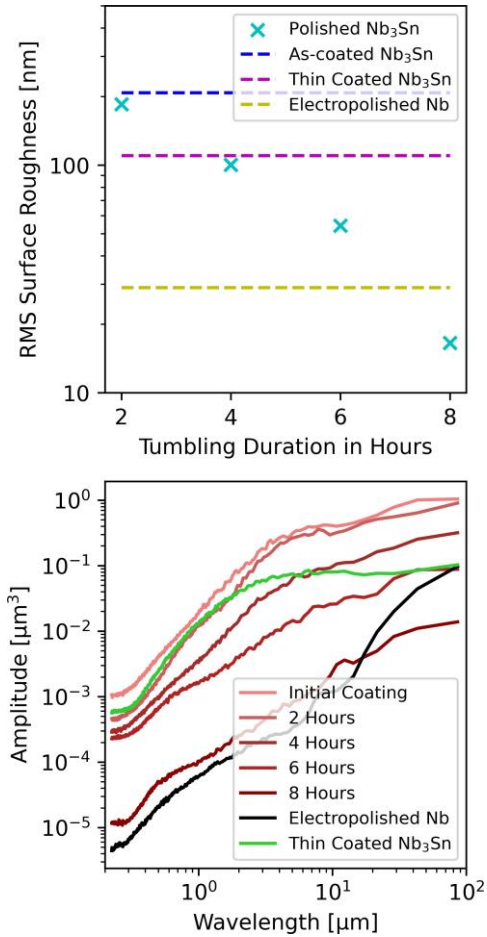
FIG. 3. Surface roughness of Nb_3Sn samples mechanically polished for different lengths of time calculated from the surface height maps (top). The power spectral density (PSD) of the surface profile after different amounts of tumbling as well as the PSD of electropolished Nb and a thinly coated Nb_3Sn film (bottom).

The surface height maps are used to calculate the root mean square (RMS) surface roughness of the samples and is shown in Fig. 3. After 6 hours of polishing the surface roughness is comparable to the surface roughness of the well performing, thinly coated Nb₃Sn coatings created at FNAL[2]. After 8 hours of polishing, the surface roughness is comparable to a typical Nb surface after EP. This level of smoothness has never been achieved for Nb₃Sn cavities until now. At this level of surface roughness, the performance degradation caused by field enhancement due to surface roughness should be greatly reduced.

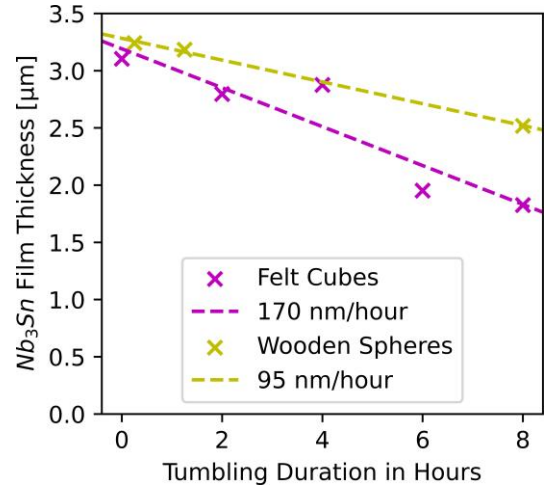
FIG. 4. The thickness of the Nb_3Sn film after mechanically polished for different lengths of time using felt cubes or wooden spheres as the polishing media.

The thickness of the film is measured after polishing using FIB/SEM. Our measurements show that only a small amount of material is removed even after 8 hours of polishing. Samples polished using the felt media show an average removal rate of 170 nm/hour whereas the wooden media shows an average of 95 nm/hour removal rate. The starting thickness of the samples is between 3-3.5 μm . After 8 hours of polishing there is still over 1.5 μm of Nb₃Sn left on the surface. To completely shield the Nb substrate from the RF fields only a few hundred nanometers of material are required, since the London penetration depth of Nb₃Sn is approximately 100 nm[1].

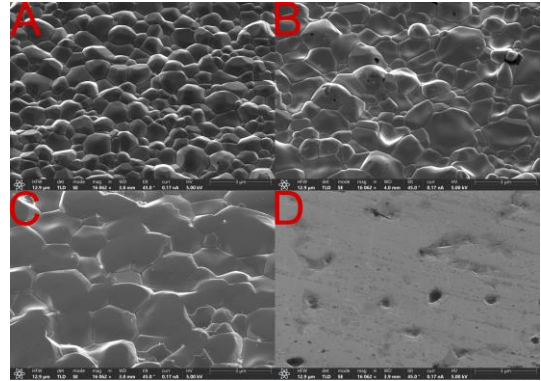
FIG. 5. SEM micrographs of a Nb_3Sn thin coated sample (A), standard coated sample (B), a sample after polishing for 2 hours (C), and a sample after polishing for 6 hours (D).

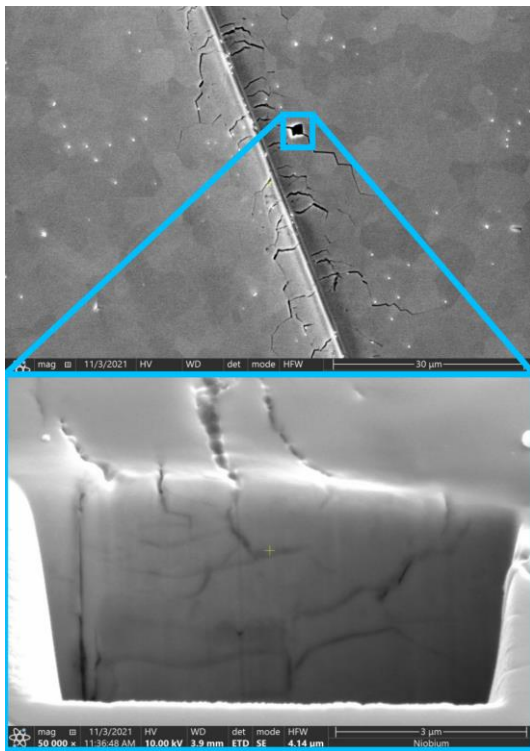
FIG. 6. SEM micrograph showing a Nb_3Sn sample polished for 30 hours using wooden spheres and a colloidal abrasive suspension. Nb_3Sn films polished using wooden spheres show microscopic scratches and cracks on the surface. A square hole is cut into the surface, visible in the top micrograph to expose a cross section of a crack. The cross section shows that the cracks penetrate deep into the film.

The surface of the polished samples was analyzed using SEM and TEM to look for surface damage or chemical changes on the surface caused by the tumbling or cleaning process. As seen in Fig. 6 and Fig. 7, the Nb₃Sn samples polished using wooden spheres were damaged resulting in microscopic scratches on the surface and a damaged layer consisting of a nanometer-scale disordered Nb₃Sn layer. No surface damage was detected on samples polished using the felt cubes. Since the surface damage may negatively affect the cavity performance, the felt cubes are best to use for polishing Nb₃Sn.

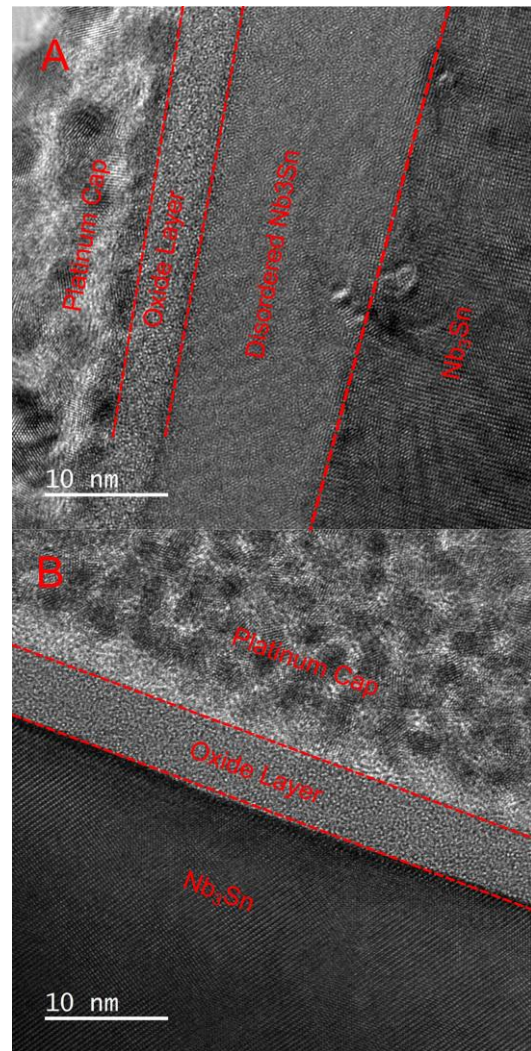
FIG. 7. TEM images of a Nb_3Sn sample polished using wooden spheres (A) and felt cubes (B). The polishing procedure creates a 10 nm thick layer of disordered Nb_3Sn on the sample polished with wooden spheres which is not present on the sample polished by felt cubes.

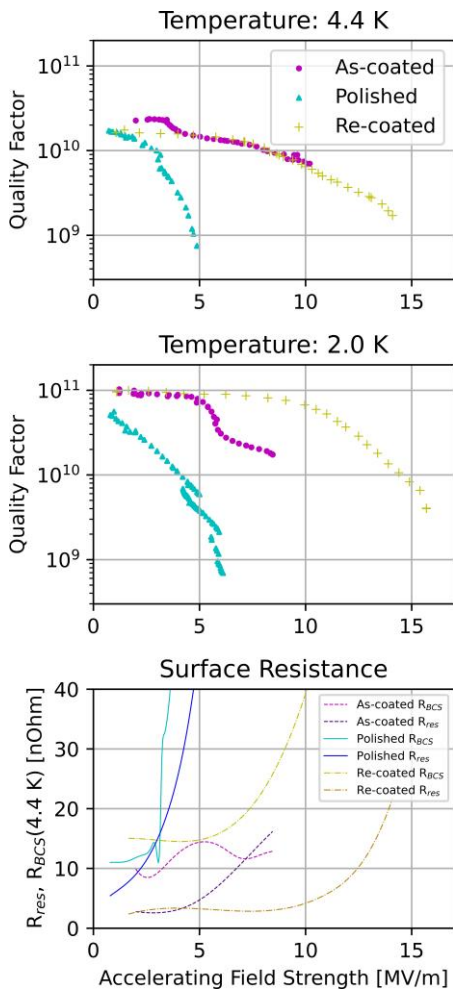
FIG. 8. The RF performance of the Nb₃Sn-coated SRF cavity before and after mechanically polished and after a recoating treatment. The residual resistance of the cavity is calculated from the 2.0 K measurements under the assumption that the BCS resistance is negligible at this temperature. We assume that the additional resistance measured at 4.4 K is entirely BCS resistance. These assumptions may be false if there are multiple Nb₃Sn phases on the surface.

The as-coated performance of the cavity was poor compared to most other Nb_3Sn cavities reaching an accelerating gradient of around 10 MV/m with a Q of 10^{10} at 4.4 K. After the polishing is applied, the cavity exhibits Q -slope (the quality factor decreases with increasing accelerating field), and the maximum gradient was only 5 MV/m.

After the cavity was treated with the recoating treatment, detailed in Section III A, the Q -slope is ameliorated and the maximum accelerating gradient increases to 15 MV/m. The quality factor of the cavity was also improved over the as-coated state at 2.0 K, but not at

4.4 K. Fig. 8 shows the performance of the cavity after each step.
