# Ultrasonic elastography for the prevention of breast implant rupture: detection of an increase with stiffness over implantation time

*Breast implants are widely used after breast cancer resection and must be changed regularly to avoid a rupture. To date, there are no quantitative criteria to help this decision. The mechanical evolution of the gels and membranes of the implants is still under investigated, although it can lead to early rupture. In this study, 35 breast explants having been implanted in patients for up to 17 years were characterized by ex vivo measurements of their mechanical properties. Using Acoustic Radiation Force Impulse (ARFI) ultrasound elastography, an imaging method for non-destructive mechanical characterization, an increase in the stiffness of the explants has been observed. This increase was correlated with the implantation duration, primarily after 8 years of implantation. With an increase of the shear modulus of up to a factor of nearly 3, the loss of flexibility of the implants is likely to lead to a significant increase of their risk of rupture. A complementary analysis of the gel from the explants by mass spectrometry imaging (MSI) and liquid chro

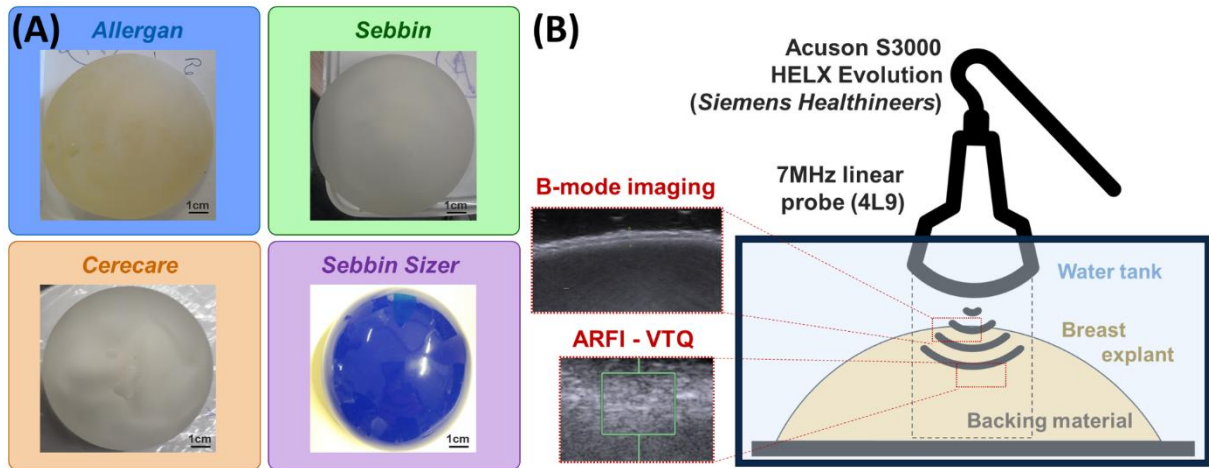
**Fig. 1.** (A) Example of explants from the 4 manufacturers. (B) Illustration of the experimental configuration. The explants were immersed in water. The membrane thickness was measured using B-mode imaging and the gel stiffness quantified by ARFI VTQ elastography.

The explants were immersed in water to facilitate ultrasound transmission, as illustrated in

Fig. 1. The samples were scanned using a clinical ultrasound system (*Acuson S3000 HELX Evolution, Siemens Healthineers, Erlangen, Germany*) with a 4L9 linear array transducer centered at 7 MHz. The multi-layer membrane of each explant was observed, and their thicknesses measured using B-mode imaging. Based on the generation of shear waves by focused ultrasound in the organ and then the detection of their propagation velocity by ultrasound imaging, ARFI (Acoustic Radiation Force Impulse) imaging methods (Nightingale et al., 2002, 2001; Palmeri et al., 2008) allows to extract non-invasively the mechanical properties. The gel stiffness was then quantified using Virtual Touch Quantification (VTQ), a shear wave elastography method based on ARFI imaging. Shear wave

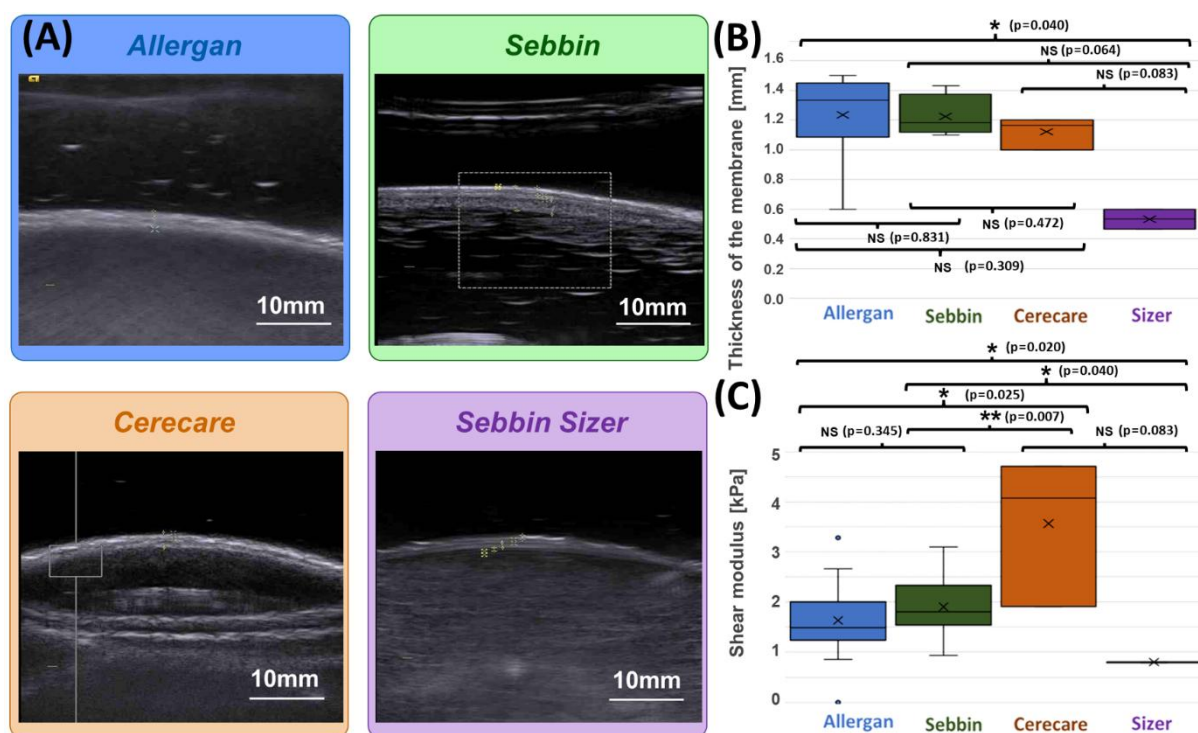
**Fig. 3.** (A) Examples of B-mode images for the measurement of membrane thickness of implants from each of the four types of implants. Images are presented at the same scale. Membrane thicknesses (B) and then shear moduli measured by ARFI method (C) are compared without dissociation as a function of prosthesis age or implantation time. (NS:  $p$ -value > 0.05, \*:  $p$ -value < 0.05, \*\*:  $p$ -value < 0.01, \*\*\*:  $p$ -value < 0.001)

The different layers of the membrane appeared on B-mode imaging with 2 layers for *Allergan* and *Cerecare* and 3 to 5 layers for *Sebbin* and *Sebbin Sizer* (

Fig. 3(A)). The membranes had a thickness of  $1.2 \pm 0.2$  mm,  $1.2 \pm 0.1$  mm,  $1.1 \pm 0.1$  mm and  $0.5 \pm 0.1$  mm for *Allergan*, *Sebbin*, *Cerecare* and *Sebbin Sizer*, respectively (

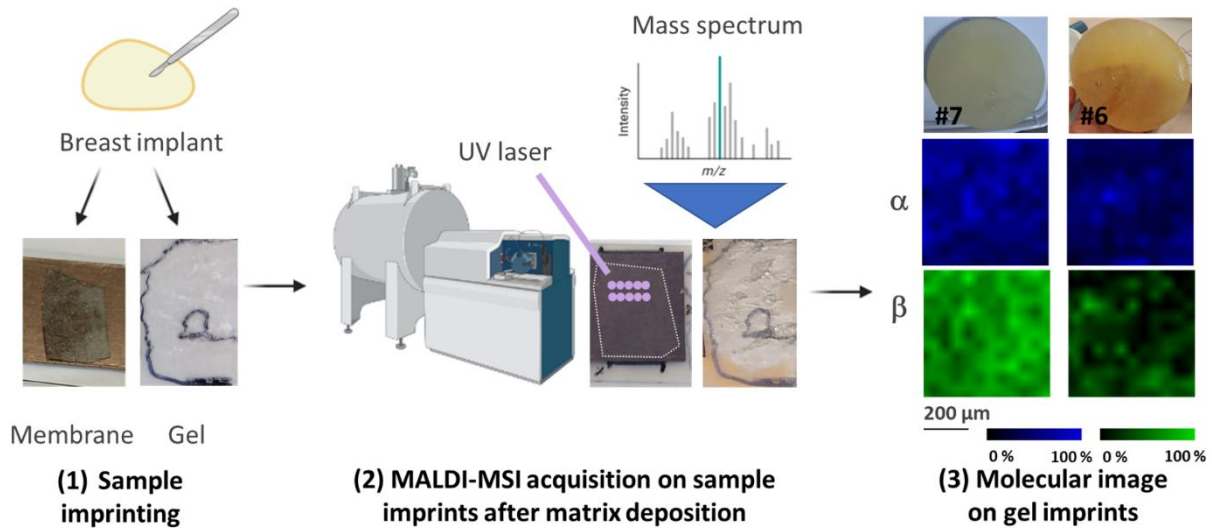
**Fig. 2.** MALDI-MSI workflow for the molecular analysis of membrane and gel from breast implants. (1) Membrane and gel were separated and directly deposited on an ITO-coated glass slide (gel) or imprinted on a copper tape covering the slide (membrane). (2) MALDI ionization matrix was applied before shooting the samples with a laser to obtain molecular images from membrane and gel. Molecules were identified by data base interrogation. (3) MALDI-MSI performed on the gel from *Allergan* textured samples #6 and #7 indicate presence of 3-ketocholesterol ( $\alpha$ ) and 7-ketocholesterol ( $\beta$ ).

After the ultrasound tests, two *Allergan* explants (#6 and #7) were used for matrix assisted laser desorption/ionization mass spectrometry imaging (MALDI-MSI) analysis (Fig. 2). The aim is to determine: (1) whether organic compounds from the surrounding biological breast tissues were likely to be found in the gel of the explants after having crossed the membrane; (2) whether they would be able to provide hypotheses as to the modification of the mechanical properties of the inner gel.

From MALDI-MSI, Phosphoglycerides were found on the membranes and metabolites of cholesterol (3-ketocholesterol and 7-ketocholesterol - 3KC and 7KC, respectively) originating from the breast tissues were detected homogeneously within the gel (Fig. 2). This was confirmed in LC-HRMS/MS, showing that these organic molecules were able to cross the membranes and diffuse in the gel. The amount of 7KC was quantified at  $2.36 \pm 0.63 \mu\text{g/mL}$  and  $0.92 \pm 0.38 \mu\text{g/mL}$  in samples #6 and #7, respectively.

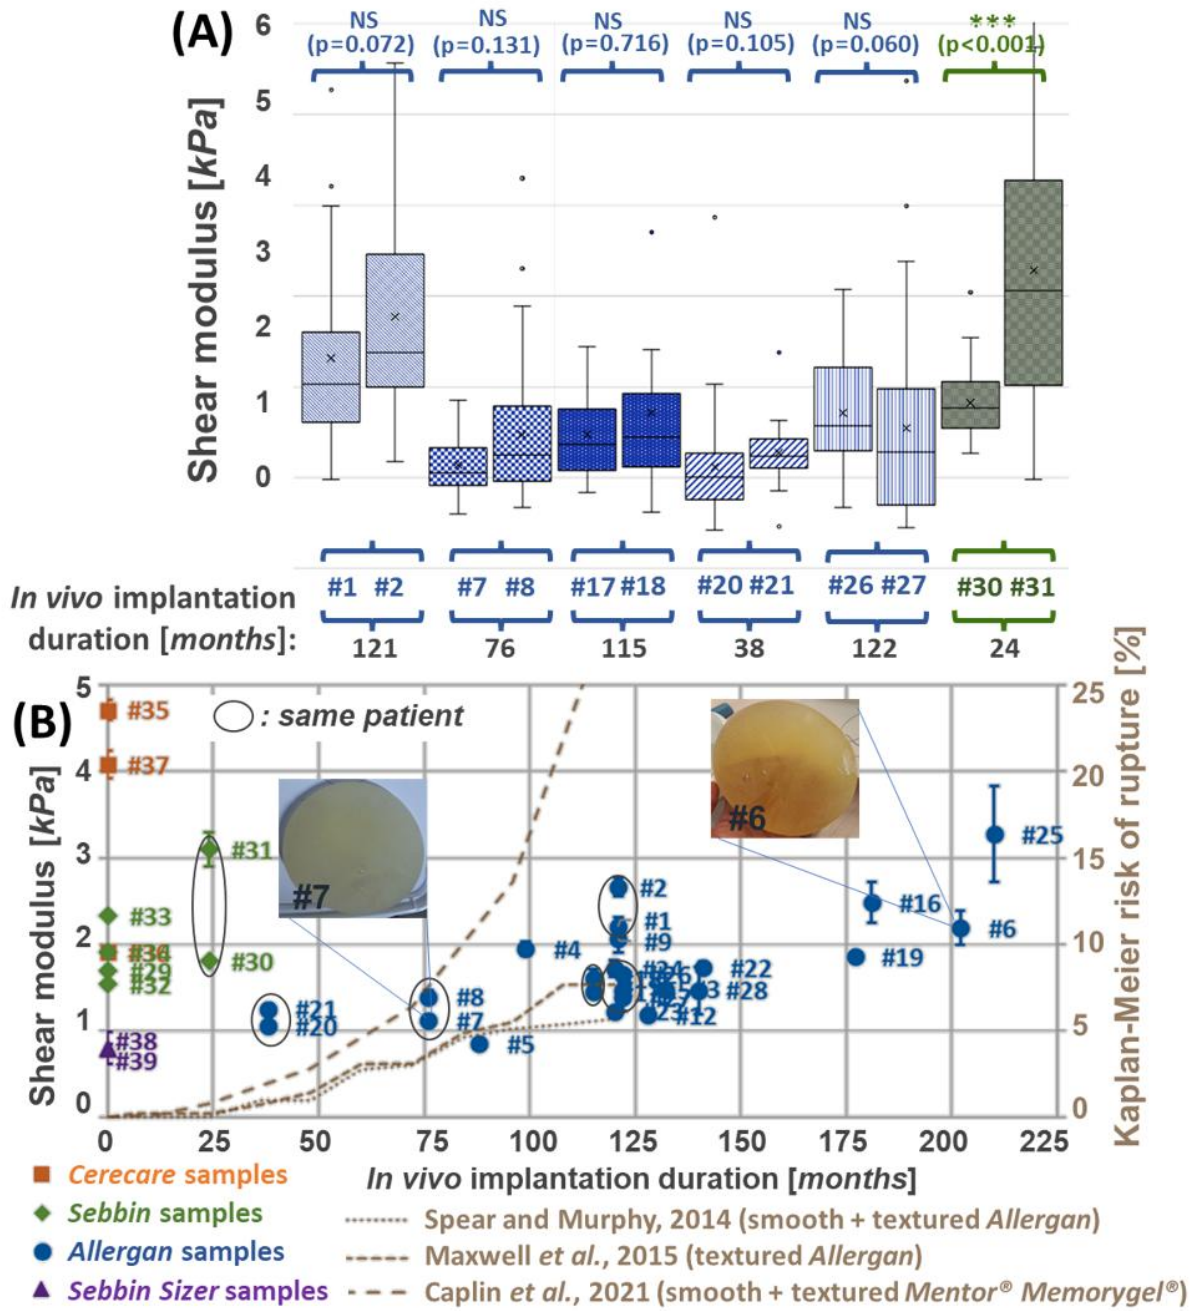
**Fig. 4.** (A) Paired comparison of stiffness values by ARFI measurements of explants from the same patients. Explant shear modulus is presented as a function of implantation duration for *Allergan* textured in blue and *Sebbin* / *Cerecare* / *Sebbin Sizer* smooth implants in green, orange and purple, respectively, collected in this study (B) (primary axis). A clear correlation between implantation time and implant stiffness appeared significantly ( $PCC = 0.67$ ,  $r_s = 0.5$ ). The evolution of the shear modulus is compared to that of the rupture risk (Kaplan-Meier risk rate (Kaplan and Meier, 1958)) reported in the literature (brown, secondary axis) (Caplin et al., 2021; Maxwell et al., 2015; Spear and Murphy, 2014). (NS:  $p$ -value  $> 0.05$ , \*:  $p$ -value  $< 0.05$ , \*\*:  $p$ -value  $< 0.01$ , \*\*\*:  $p$ -value  $< 0.001$ )

For *Allergan*, we had 5 pairs of explants, extracted from the same patient two by two. A pair-wise comparison of the stiffness of these explants shows similar values (Fig. 4(A)). This is not the case for the only pair of *Sebbin*. For *Sebbin* a real significant difference appears between the two implants. Fig. 4(B) shows in blue the *ex vivo* analysis of the stiffness of the silicone gel of the 24 *Allergan* explants (textured) over their implantation duration.

The mechanical properties of all the explants tested showed a significant increase of stiffness in time after about 8 years of implantation and this increase is correlated with the implantation duration (PCC = 0.67,  $r_s = 0.5$ ). An explant carried for 210 months is 3 times stiffer than for 38 months. This quasi-linear behavior in two parts has an inflection point around 8 years of implantation (PCC of 0.72 and 0.85 for <7 and >9 years, respectively). The evolution of the shear modulus is compared to that of the rupture risk (Kaplan and Meier, 1958) reported in the literature (Caplin et al., 2021; Maxwell et al., 2015; Spear and Murphy, 2014). Although only a few prospective systematic analyses have been conducted (Bodin et al., 2015), a similar trend is observed.

First differences appeared by visual observation of the general external aspect of the explants, the oldest ones often presenting an accentuated yellowish aspect, suggesting exchanges with the biological tissue (Fig. 4(B)).
