Rapid post-disaster infrastructure damage characterisation enabled by remote sensing and deep learning technologies - a tiered approach

Nadiia Kopiika^(a,g), Andreas Karavias^(b,g), Pavlos Krassakis^(b,g), Zehao Ye^(a), Jelena Ninic^(a), Nataliya Shakhovska^(e,c,d,g), Nikolaos Koukouzas^(b), Sotirios Argyroudis^(e,f,g), Stergios-Aristoteles Mitoulis^{(*) a,f,g}

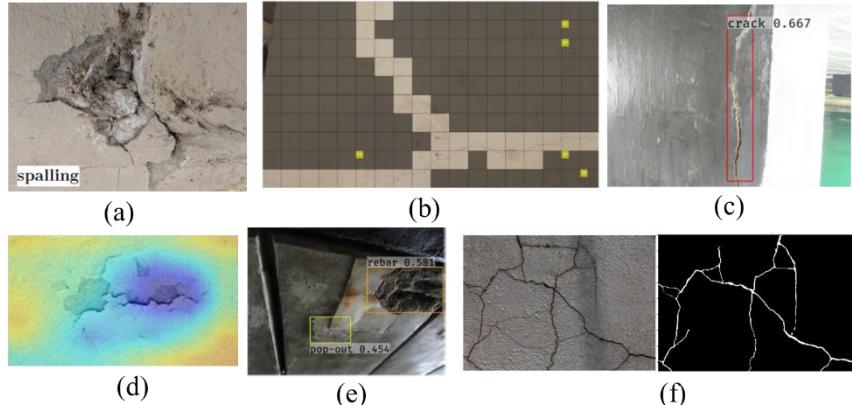
Figure 1. Computer Vision tasks empowered by Deep Learning for (a) image classification; (b) patch-wise classification; (c-d) object localisation; (e) object detection; (f) semantic segmentation.

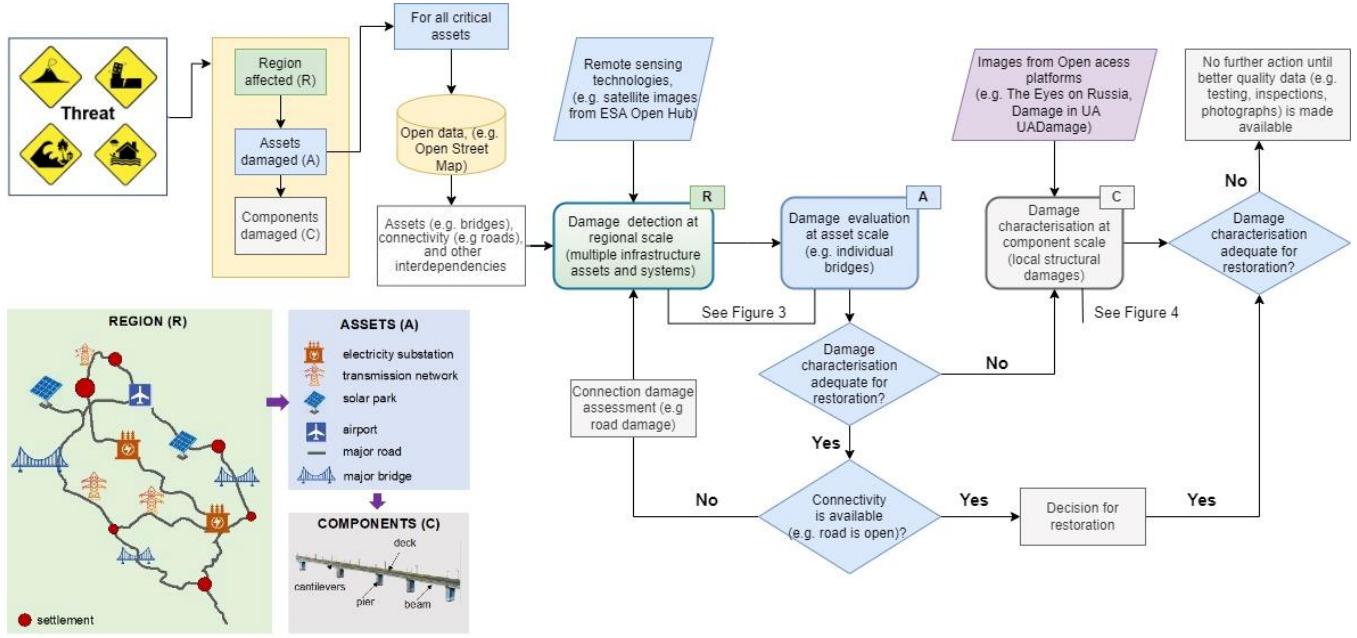
Figure 2. Framework for automated damage characterisation at different scales: regional (R), asset (A) and component (C) toward decisions for restoration. The framework description continues with figures 3 and 6.

Figure 2 describes the integrated framework for automated damage characterisation toward decisions for restoration. The figure indicates different scales of assessment, i.e. region (R), asset (A) and component (C). More detail regarding the research specific terminology is available in the Appendix A. The methodology commences with the threat identification and proceeds with the selection of the assessment scale: for all the assets residing within the region of interest, openly available data are used to map the critical assets and their interdependencies. Damage detection at regional and asset scale is conducted (see more in Figure 3), by employing remote sensing technologies, e.g., ESA Open Hub. If the damage characterisation results to high level of confidence, and hence, to accurate damage characterisation, then the only hurdle to designing and applying a restoration strategy is the connectivity, and therefore, accessibility to the asset. For example, if the asset is a bridge, connectivity to the bridge will be sought both through the road network, which the bridge belongs to, and through other routes that may lead to critical regions. If access to the asset is possible, then we can proceed with decisions, detailed designs, and the restoration strategy. If not, then the level of damage of the connection (e.g., road connecting the bridge) should be assessed using the same method. In this case, damage characterisation for the connectivity (e.g., roads) is also conducted by remote sensing.

If damage characterisation at scale (A) is insufficient for making decisions and designs for restoration, then additional information is required to inform decision-making. That would lead to higher level of accuracy by

characterising damage at (C) scale, using high-resolution images from open-access platforms (see Figure 4). Based on this a decision can be made that the damage characterisation is adequate to proceed with the restoration strategy. Otherwise, better quality data should be sought (e.g., testing, inspections) to proceed with designs of restoration and adaptation measures.

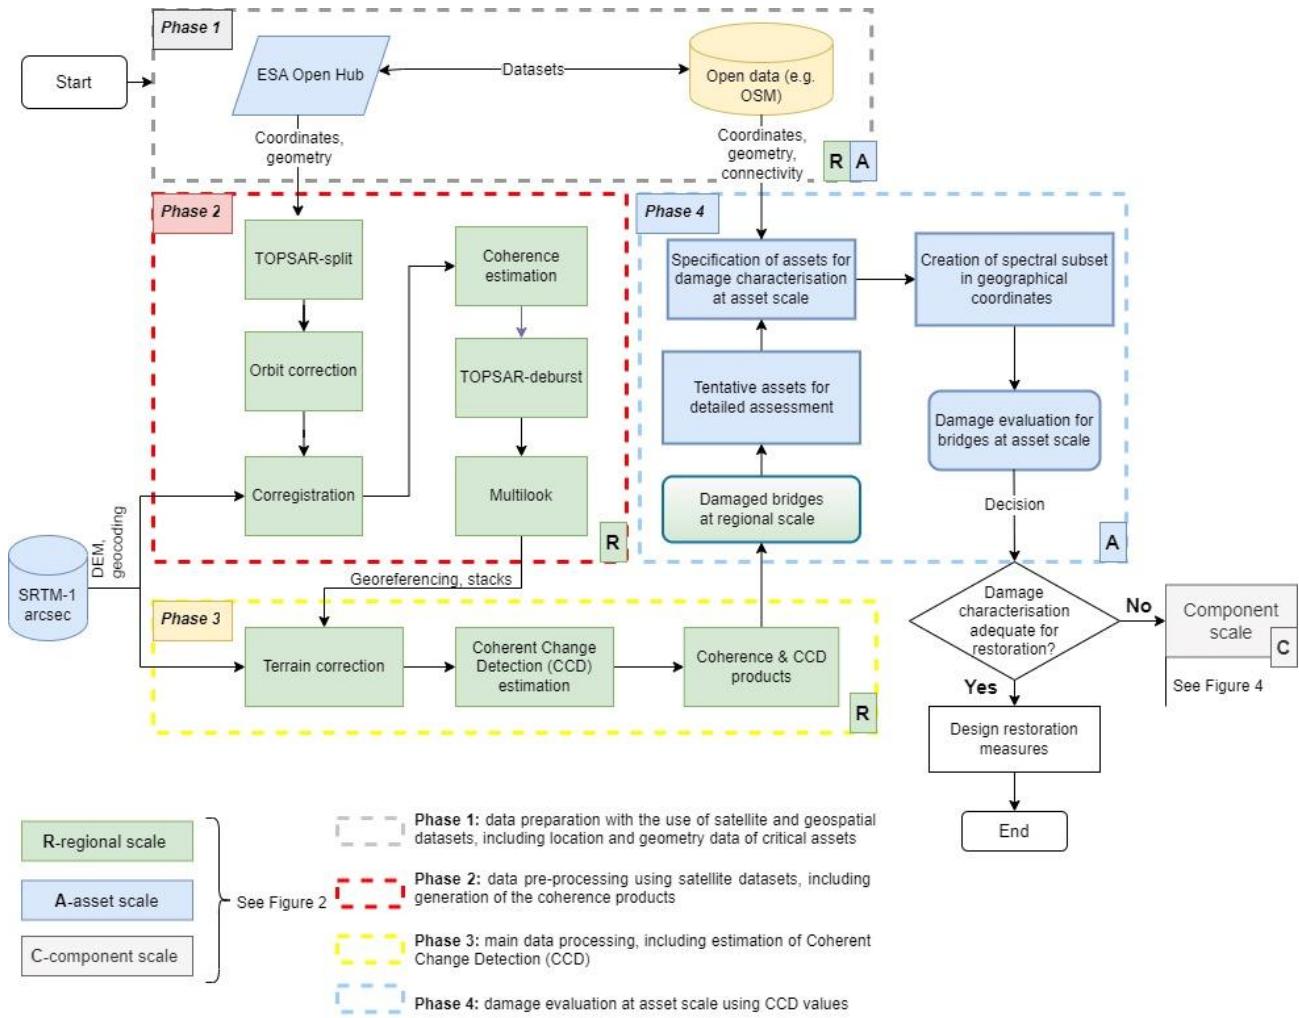
Figure 3. Workflow for damage evaluation at regional (R) and asset (A) scale based on four phases: Phase 1 (grey-dashed box): data preparation with the use of satellite and geospatial datasets, including location and geometry data of critical assets, residing within the boundaries of the selected study area; Phase 2 (red-dashed box): data pre-processing using satellite datasets, including generation of the Coherence products (e.g., Sentinel-1 SAR SLC images); Phase 3(yellow-dashed box): main data processing, including estimation of Coherent Change Detection (CCD) and development of a semi-automated method for the damage detection on infrastructure assets, e.g., bridges; and Phase 4 (blue-dashed box): damage evaluation at asset scale using CCD values.

In **Phase 1**, the Sentinel-1 mission interferometric wide swath (IW) SAR images are obtained in ascending and descending geometry, covering the region of interest, and the assumed time of hazard from open access platforms (e.g., ESA Open Hub) [80], [81]. Simultaneously, for the preliminary estimation of the geographic coordinates of the affected assets, data can be obtained from open-access data platforms, e.g., OpenStreetMap (OSM) [83] and crowdsourcing [84],[85],[86]). This includes, e.g., transport route disruption, disrupted connectivity in the region, and destruction of assets and connections reported in social and other open-source platforms. **Phase 2** includes the pre-processing of Sentinel-1 SAR SLC images using the Sentinel Application Platform (SNAP) architecture [82]. The left part of the workflow describes the process of splitting the images on the selected sub-swath with the specific bursts that cover the study area (TOPSAR split). This includes orbital correction by using the precise orbit files (Orbit correction). Subsequently, the images are coregistered using the Digital Elevation Model of Shuttle Radar Topography Mission (DEM SRTM) -1 arcsec [87]. With this exercise the interferometric pairs before and after the damage are generated. A coherence estimation is implemented in every interferometric pair followed by the

“TOPSAR-deburst” and “Multilook” steps. Next, the coherence products are geocoded using the DEM SRTM-1 arcsec and grouped in stacks in order to calculate the CCD. The damage detection takes place during **Phase 3**, the main processing stage, which involves the geospatial analysis for two stacks of images: a pair of pre-damage products and a pair of one pre- and one post- damage products. First, the image pairs are georeferenced via Terrain correction. Then, InSAR coherence products, calculated for the two pairs of SAR images, are calculated, serving as an indicator of the similarity in radar reflections between examined datasets. The result represents the level of correlation in the phase of the corresponding pixels of the two images. Any changes in the backscattered signal of the satellite are recognised as decorrelation of the phase. As a result, changes in the scene from one acquisition to the next are detected and recorded. Changes between the two images reduces the coherence value and negatively affects the accuracy over the distance measurement between the antenna of the satellite and Earth’s surface [88]. The coherence (γ), which is also defined as the complex correlation coefficient between two SAR scenes, u_1 and u_2 , is estimated using Equation (1) [89]:

In **Phase 4**, coherence and CCD products are integrated into a Geographic Information System (GIS), e.g., ArcGIS, QGIS, to illustrate the built environment or ground surface, where CCD values indicate potential change, and hence, damage if this refers to structural assets. Specifically, the products of this phase highlight the changes between periods before- and after- the induced damage, offering a semi-automatic way of detecting significant changes. Based on that, the coherence and CCD products are considered mutually in order to focus on areas close to the investigated asset of interest. Thus, coherence tells us about the consistency or stability of surfaces, and CCD products help us spot changes over time and to pinpoint areas thus identify signs of damage that may require inspection and repair. After defining their coordinates, assets of interest are examined in more detail using open data sources (e.g., Google Maps, OSM) and Setinel-1 images for cross-validation and specification for the final assessment. The spectral subset region in geographical coordinates using WKT-format is used to indicate the area of interest of each assessed asset. Then, the results are exported to GIS environment for illustration, geographical collocation, and damage characterisation at asset scale. Thus, different ranges of CCD results indicate different damage levels, which can be local or global. This classification of damage to different prescribed levels can be performed based on engineering criteria as described in section 4.2 and Figure 10.

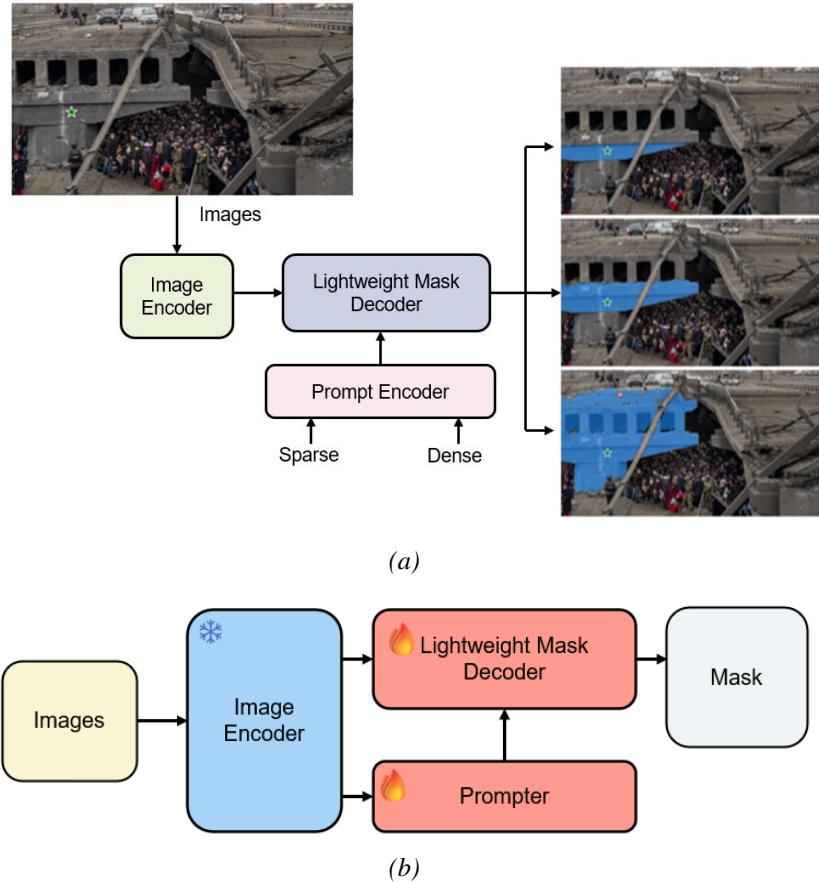
Figure 4. (a) Segment Anything Model Overview [91]: The architecture of the SAM model includes a heavyweight image decoder, a prompt decoder, and a lightweight mask encoder. The image decoder generates image embeddings, and the prompt decoder accepts two types of prompts: sparse (points, bounding boxes, text) and dense (masks) from human, converting prompts into prompt embeddings. The mask decoder generates

corresponding masks based on both the image and prompt embeddings. The diagram illustrates an input with a point prompt (green star) on the main body of a bridge. SAM then generates three different masks corresponding to the whole, parts, and subparts of the bridge. Such original SAM architecture relies on manual prompts and cannot autonomously perform CV tasks; (b) **SAM-based RSPrompter with prompter** [92]: This architecture replaces the prompt encoder with prompter which can receive output from the image encoder and extracting key features to train itself in generating the required prompts, enabling the algorithm to execute automatically. Heavy SAM's image encoder will be frozen and not participate in training. Such architecture can perform CV tasks automatically, and maintain state-of-the-art levels compared with other instance segmentation models.

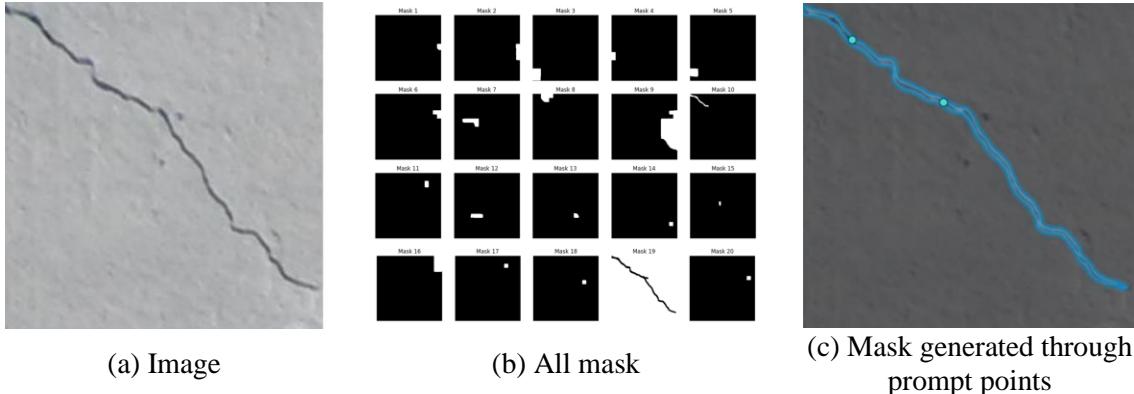
Figure 5. Generation of the mask required by the user through prompt points at component scale

A suitable prompt can accurately generate the masks required by the user. As shown in Figure 5, only two prompt points are needed to select the most matching mask, which is the crack in the figure that is used for component damage characterisation. This new method transforms the way we assess damage at structural component level.

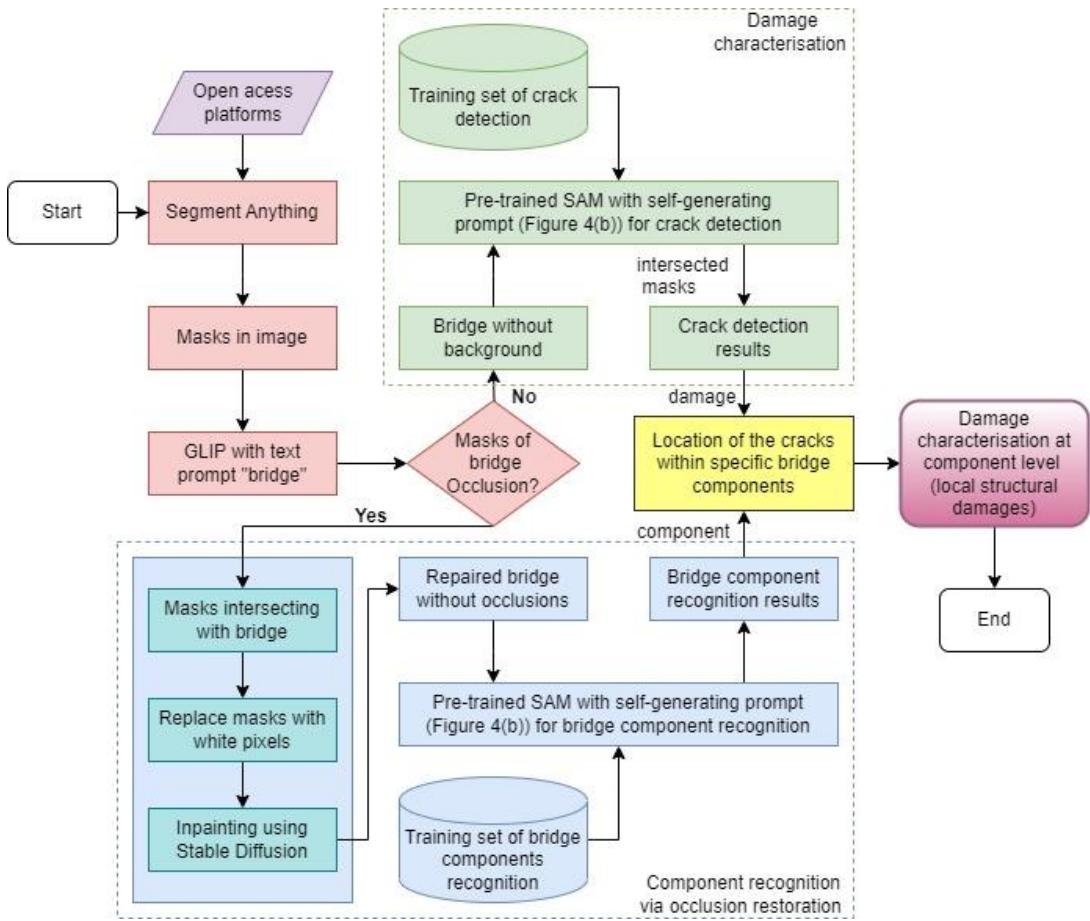
Figure 6. Flowchart, illustrating the damage characterisation method at component scale.

Starting with the selected images collected from open platforms, the input image is firstly processed using SAM's anything mode to detect all potential masks present in the image. Subsequently, each mask is assigned labels, and those with the “bridge” label are singled out. Following this step, a decision is made based on whether there is occlusion, in which case damage characterisation follows the occlusion restoration (blue dashed box in Figure 6) or not (green dashed box in Figure 6), where damage characterisation is performed.

The damage characterisation process utilises the masks of bridge identified previously, excluding all pixel except those within the bridge masks. Utilising a pre-trained SAM with self-generating prompt, the model can automatically detect damage, such as cracks. The other process first captures masks intersecting with the bridge. These intersected masks are considered areas requiring treatment, employing stable diffusion for inpainting. This process generates the missing parts of the bridge structure due to occlusions. Subsequently, similar to the process of damage characterisation, another pre-trained SAM with self-generating prompt automatically performs bridge component recognition tasks based on the repaired bridge image. Finally, the identification outcomes from both processes merge, enabling the determination of where the damages have occurred within the bridge components. This is a fully automated procedure that facilitates the damage characterisation for detection of structural damages at the component scale.

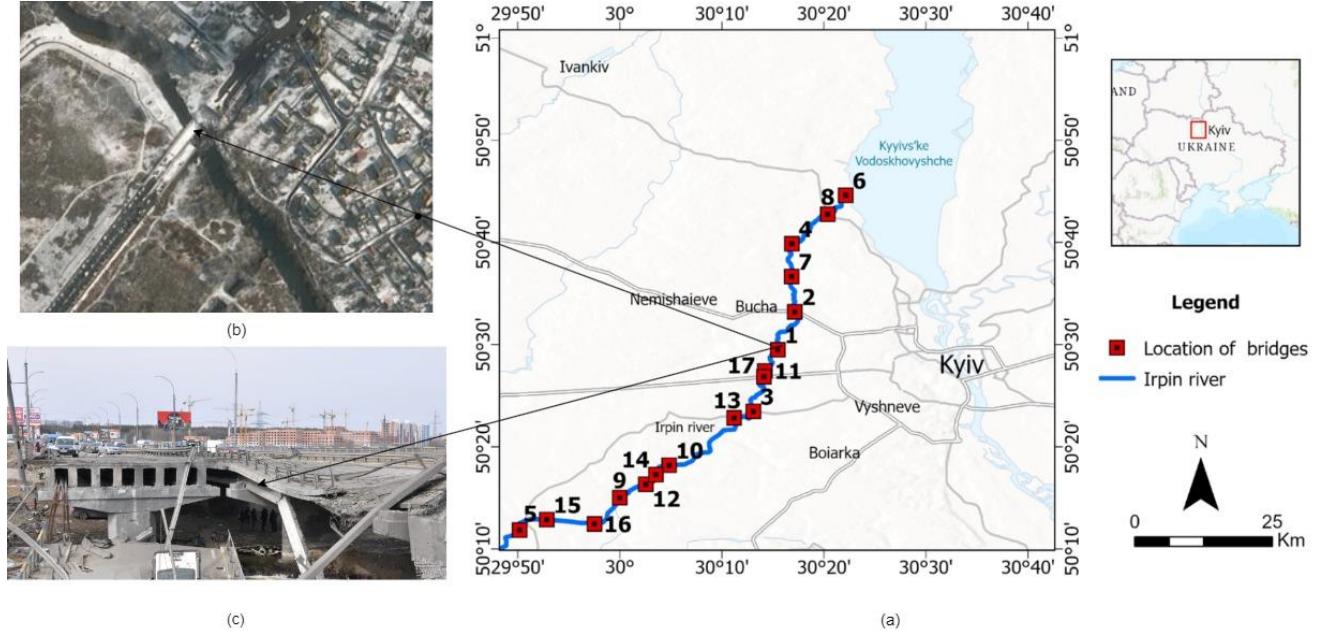
Figure 7. (a) Case study area, west of Kyiv, Ukraine (the numbers indicate bridge IDs). Examples of damage evidence on bridge over the Irpin river (B1 in this case study) from open-access data: (b) satellite imagery of the damaged bridge captured by Maxar [100] and (c) witness of extensive destruction of the same bridge from social media [101].

accessible for assessment and decision-making due to the ongoing hostilities, gave the motivation for this case study (Figure 7). The aim of this case study is to validate the efficiency of the framework proposed herein, by identifying and characterising the level of damage of selected bridges along Irpin river, and therefore, enhance the resilience of the area by accelerating decision-making. The assessment is at the three scales described above (from regional to component), by implementing the methodology described in section 3.

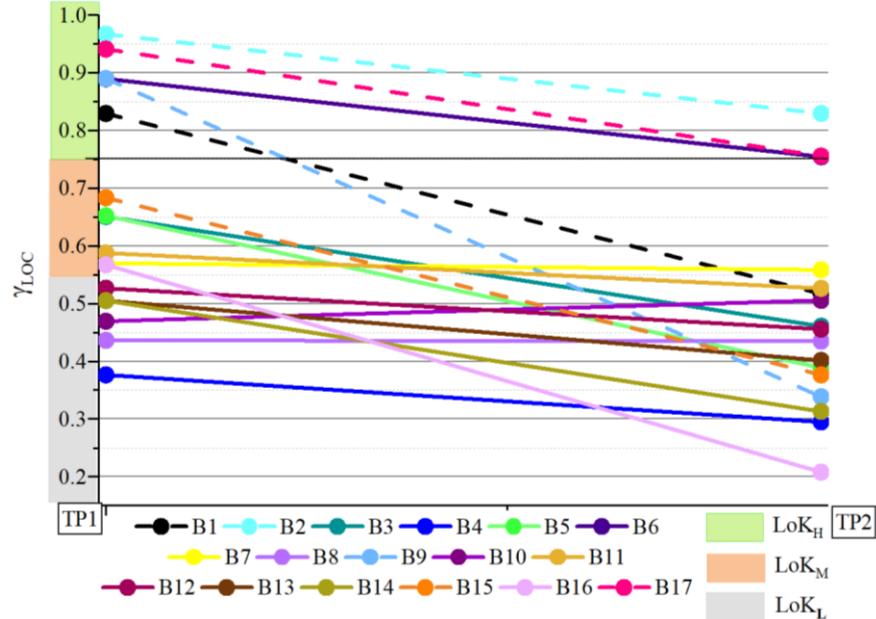
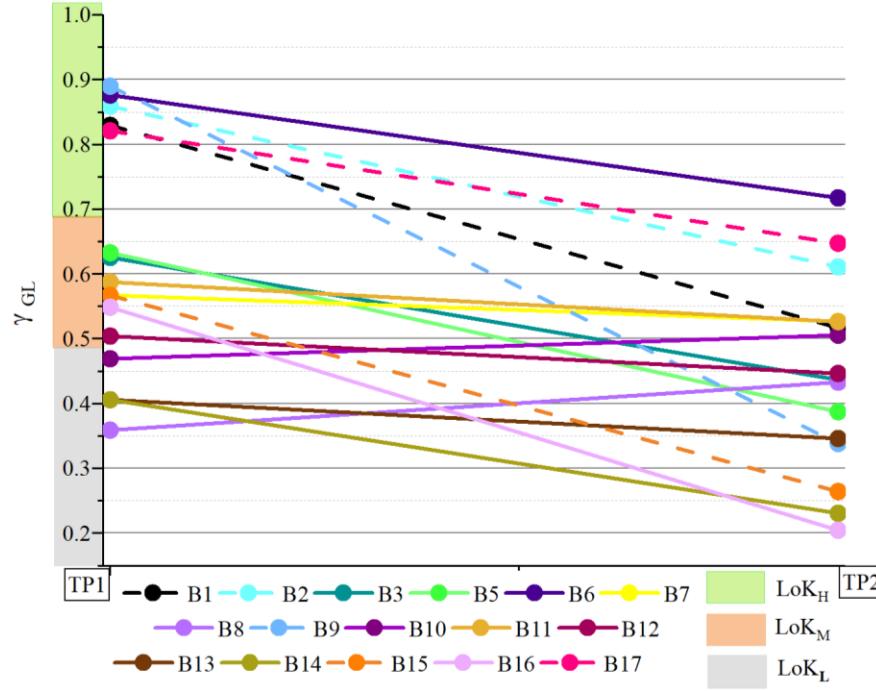
Figure 8. Change of coherence values within the estimated period (before and after the damage): (a) maximum values for local damage characterisation, (b) mean values, for global damage characterisation. Dashed lines correspond to bridges with greatest coherence changes. Time period 1 (TP1) includes temporal dataset before the beginning of destruction (between 19/01/2022 and 12/02/2022), while time period 2 (TP2), corresponds to dataset of extensive shelling (between 12/02/2022 and 01/04/2022).

As the use of Sentinel-1 low resolution images provides limited opportunity for accurate identification of the damage level, for some of the assets the resolution of images was not sufficient. This is because the coherence values were very low (e.g., below 0.5) for the pairs of the images examined. However, for some structures the proposed approach has demonstrated the outstanding capability of damage assessment when access is restricted. The pairs of images, for which coherence results before the hazard occurrence (TP1) were high (above 0.7), are of high reliability. Taking into account these remarks, the coherence between the first image pair was used to assess the applicability of the method developed in damage characterisation and decision making. All assets were classified by the Level of Knowledge (LoK) that reflects the degree of reliability of results. This is based on the image resolution that influences the coherence between the pair of images at TP1. Three LoK are considered based on engineering judgement, i.e., low (LoK_L), medium (LoK_M), and high (LoK_H). All the coherence values below 0.5 indicate low quality of satellite products for damage evaluation in this paper (see Table 1, Figure 8 and Figure 9).

accuracy, see Figures 8 and 9, where different ranges of reliability are clearly indicated. Bridges with values of $LoK < 0.4$, were neglected during damage evaluation, as this data were not reliable for assessing the level of damage (for instance for B4, B8, B10-B14, B16).

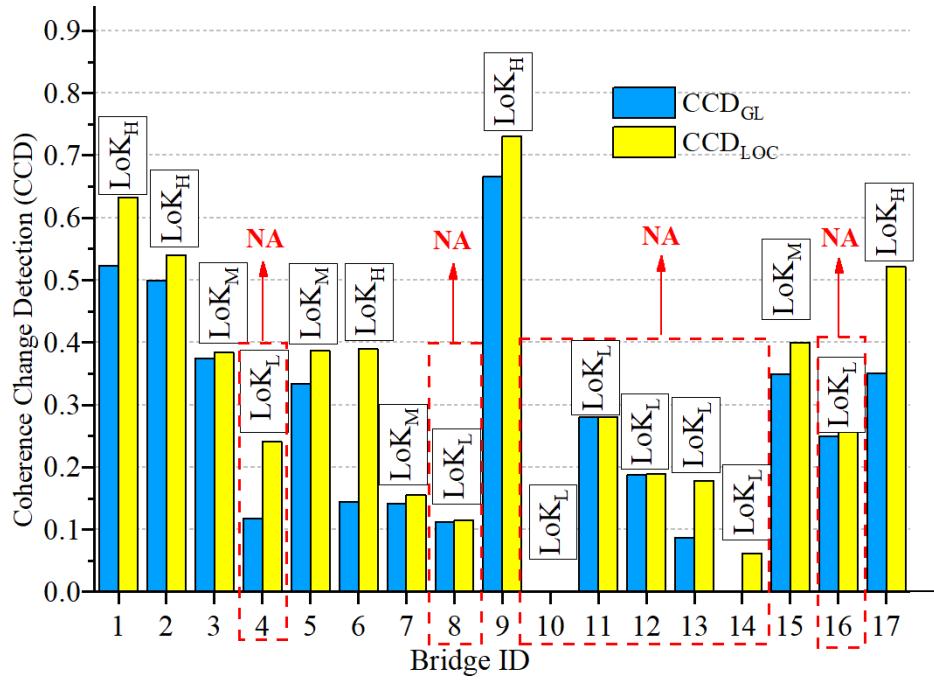
Figure 9. Coherence Change Detection (CCD) and level of knowledge (LoK) for the bridges studied. CCD_{LOC} values correspond to the maximum CCD for the area of the asset and local damage. CCD_{GL} values correspond to the mean destruction within the area of the analysed structure. NA (not applicable) indicates bridges, for which the estimated coherence between SAR images from the time period 1 (TP1) was low. These assets were classified as those having Low Level of Knowledge (LoK_L) and, thus, were excluded from further analysis.

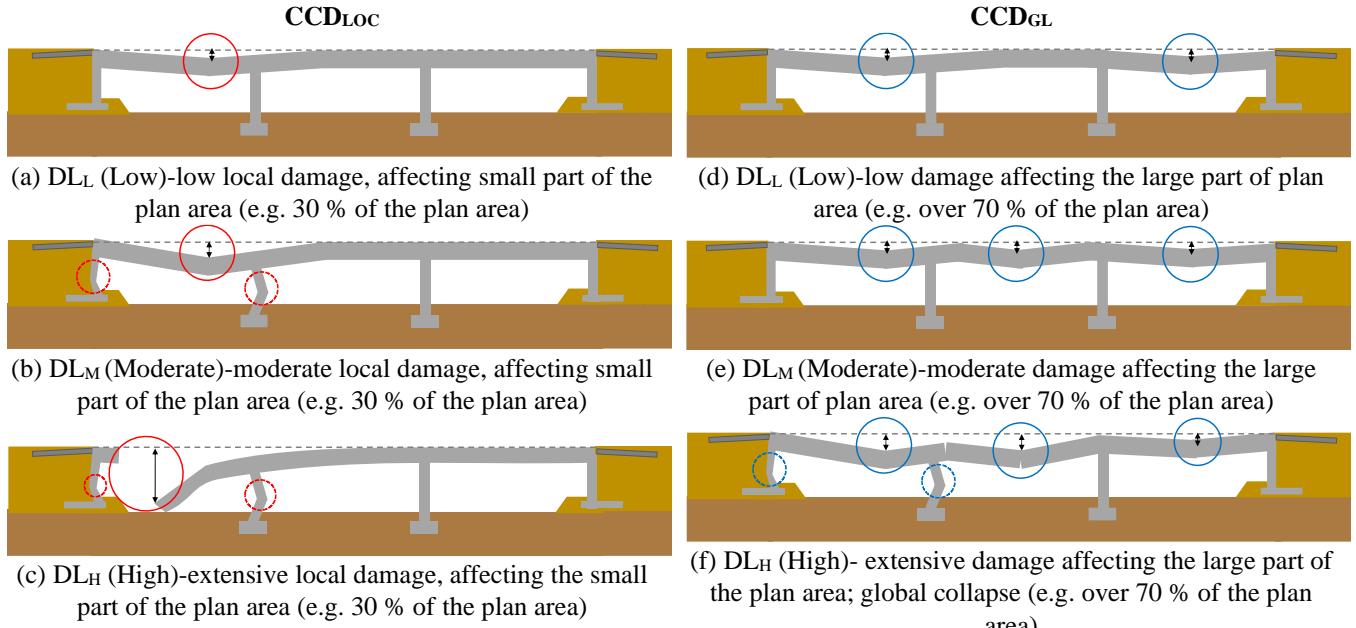
Figure 10. Illustration of different types of damage level (DL), identified by (a,b,c) CCD_{LOC} and (d,e,f) CCD_{GL} .

Continuous line red circles indicate CCD_{LOC} values, corresponding to local damage and continuous line blue circles outline CCD_{GL} values, associated with global damage that affects most of the area of the bridge deck. The dashed line circles indicate potential damage which may not be verifiable by satellite imagery.

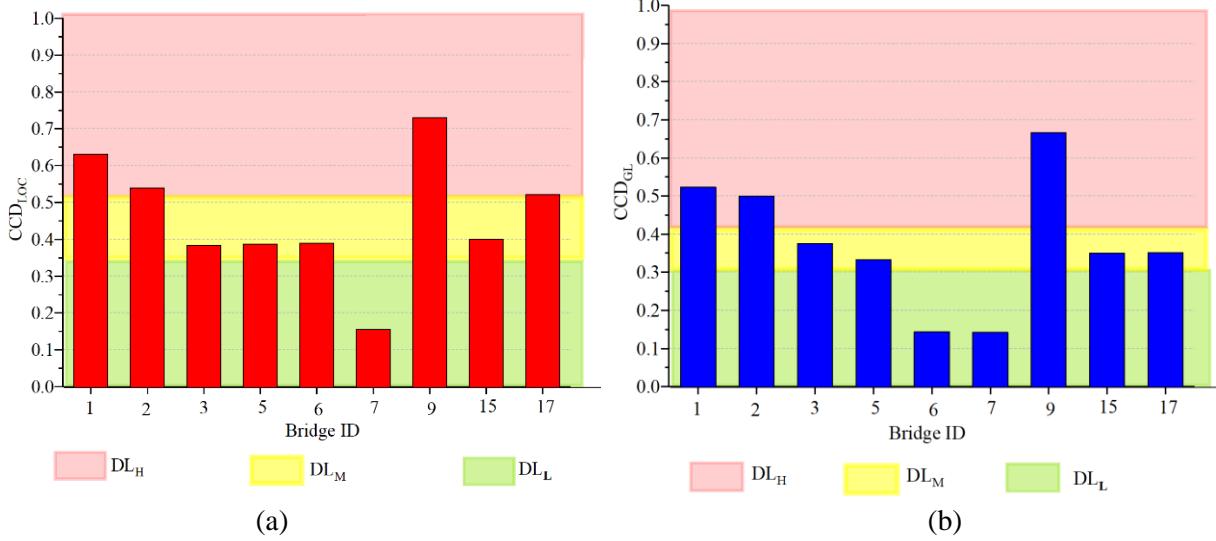
Figure 11. *CCD values within the estimated period (before and after the disaster): (a) maximum CCD_{LOC} values, corresponding to localised damage of the bridge, (b) CCD_{GL} values, indicating the mean destruction affecting a large part of the area. DL is the damage level characterisation: L (low), M (medium) and H (high) (see Table 3).*

Changes in coherence within two pre-damage and two pre- and post-damage images were employed for characterising the level of asset damage, as per section 3.2. The results for the CCD_{LOC} and CCD_{GL} between two pairs of images are given in columns 6 and 7 of Table 2. Figure 11 shows the CCD for the analysed bridges. To translate these CCD values into damage, CCD_{LOC} values correspond to the greatest change of coherence, localised in specific areas across the entire plan view area of the asset. Thus, CCD_{LOC} indicates extensive local damage of the bridge. In contrast, high CCD_{GL} values indicate global damage affecting the largest part of the asset plan view area. For example, if a bridge is damaged locally by shelling, which however has not affected the entire bridge, this will lead to a high value of CCD_{LOC} and a lower value of CCD_{GL} . To translate these CCD values into damage, CCD_{LOC} values correspond to the greatest change of coherence, localised in specific areas across the entire plan view area of the asset. Thus, CCD_{LOC} indicates extensive local damage of the bridge. In contrast, high CCD_{GL} values indicate global damage affecting the largest part of the asset's plan view area.

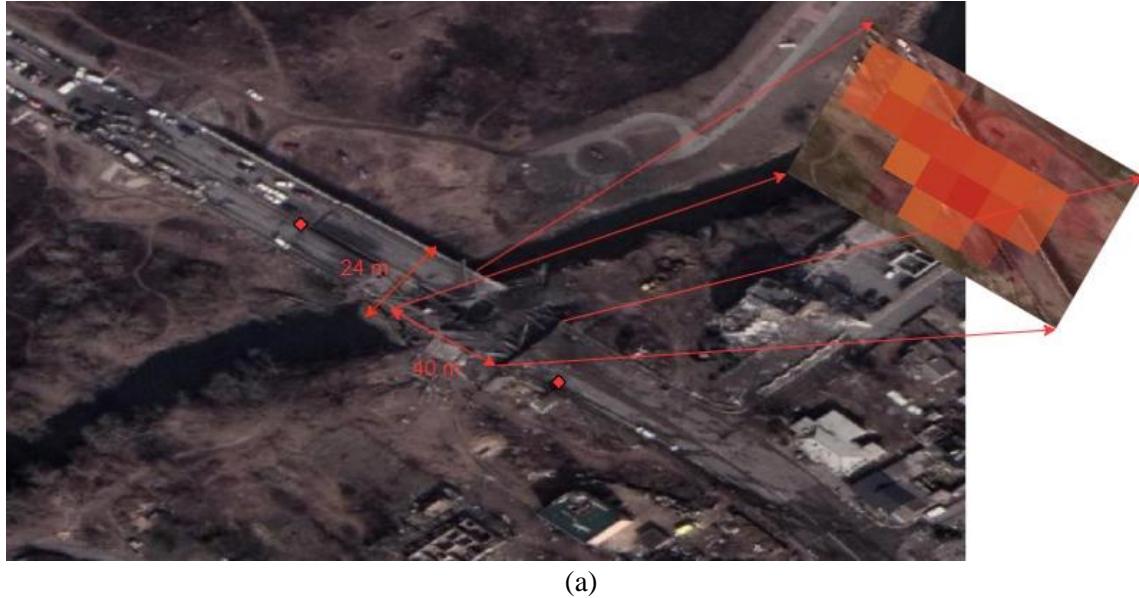
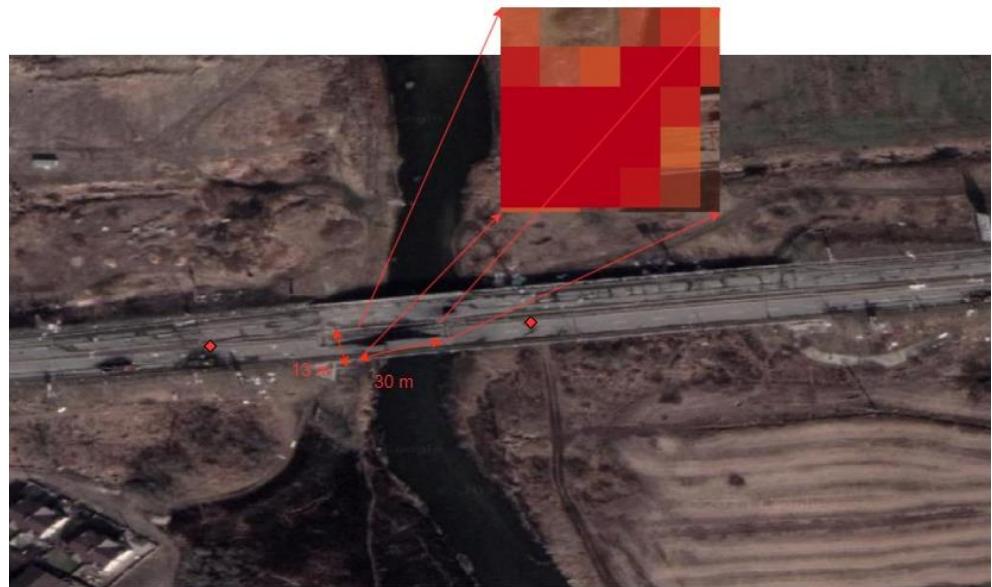
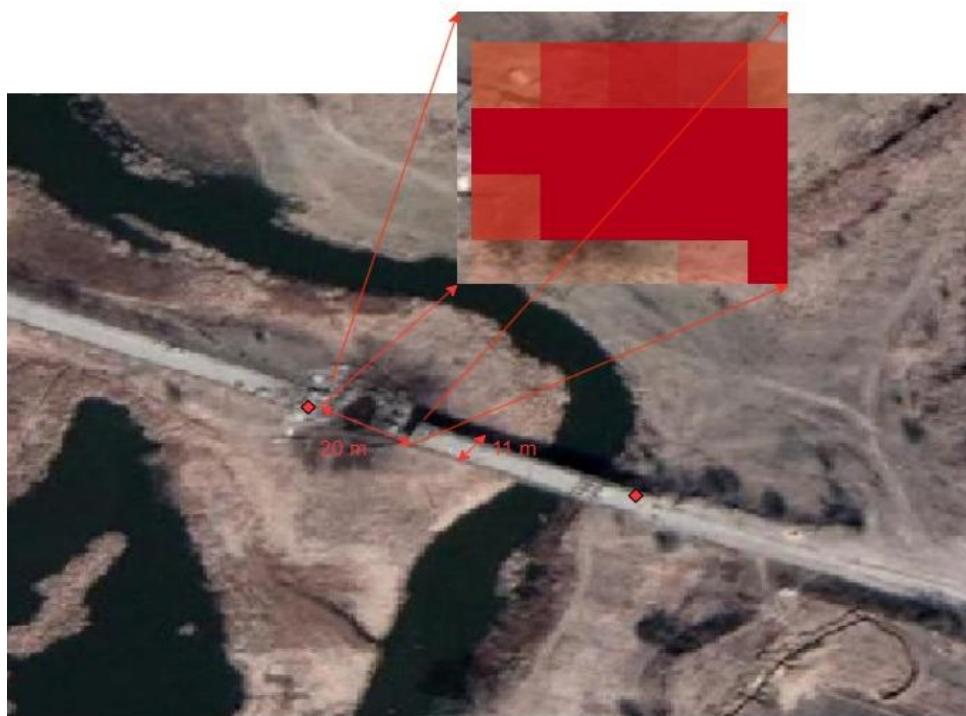
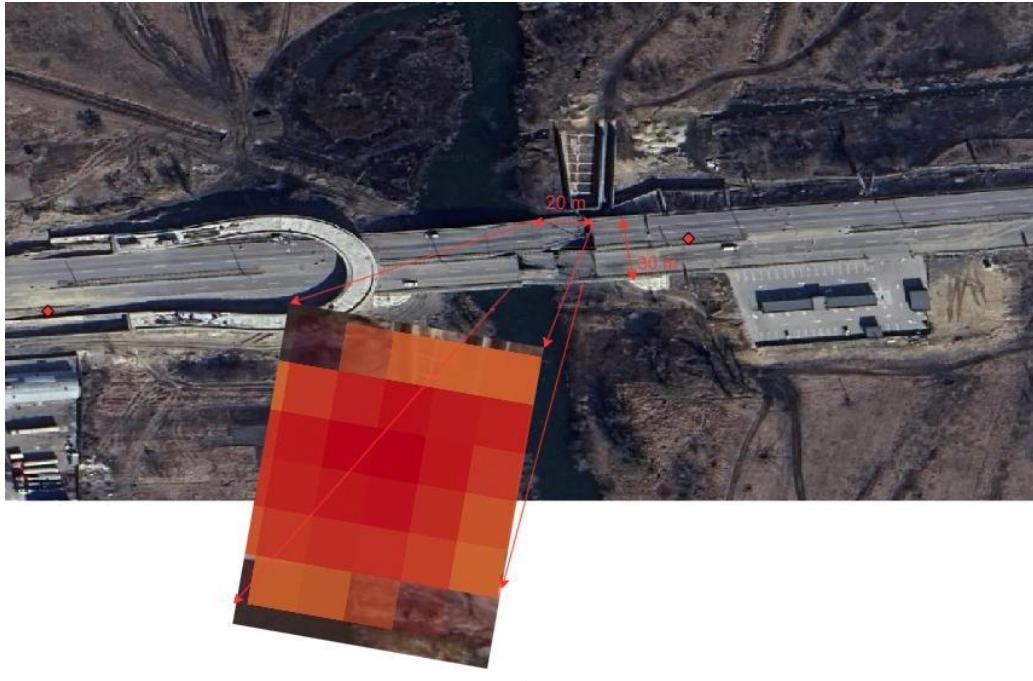
Figure 12. Damage characterisation, demonstrating High LoK: (a) B1- DL_H , (b) B2- DL_H , (c) B9- DL_H , (d) B17- DL_M . Red points indicate two end nodes of the bridge (see Table A.1 in Appendix A). Approximate dimensions of damaged bridge area are provided. Red pixels highlight zone of the asset with DL_H . Additional results for bridges with Low and Medium DL are given in the Appendix A, Figures A.3-A.5

During the analysis, limitations were identified relating to the (a) spatial resolution of the satellite, (b) sequence of events, (c) line of sight. Geospatial datasets and GIS environment were utilised for additional illustration of potentially disrupted areas on bridges identified at asset scale (Appendix A, Figures A.3-A.5). Also, some examples of damage detection and evaluation for assets of LoK_H that have the most extensive destruction (DL_H) are shown in Figure 12.

datasets) dimensions of bridges can be estimated (see Table A.1 in Appendix A) and the area (size) of the damaged zone for each of assets can be calculated (see Figure 12). This information is used to facilitate restoration strategies, utilising Goole Earth pro photos at different periods, for the damaged bridges (e.g., Figure 13), depending on, e.g., the location and type of bridge. In addition, Figures 12-13 illustrate useful information regarding the traffic disruption and corresponding impact on infrastructure operability in the region can be obtained from open-access sources. Hence, the extent of damage to a bridge directly correlates with the disruption to traffic flow. For instance, the destruction of B1 (see Figure 12a and Figure 13a) extends across the entire width of the bridge, resulting in the complete disruption of traffic on P30 highway, a regionally significant route traversing the territory of the Kyiv region with a total length of 6.4 km. In particular, the disruption of this transport route resulted in the isolation of a portion of the region from the capital city, Kyiv, leading to significant social and economic repercussions. Damage characterisation of the B1 bridge is investigated in more detail at component level (see section 4.3). Similarly, as B2 and B17 also are vital for the operability of international transport routes, their destruction causes crucial consequences for the logistics. Thus, the open access geospatial datasets were used to analyse the impact of inoperability of each of bridges on overall infrastructure (see more details in Appendix A). It can be summarized that the integration of damage evaluation results from diverse data sources supports efficient restoration planning and execution for hazard-affected regions, aiding in minimizing downtime, optimizing traffic flow, and expediting the reinstatement of traffic capacity through effective stakeholder coordination and implementation of traffic management strategies.

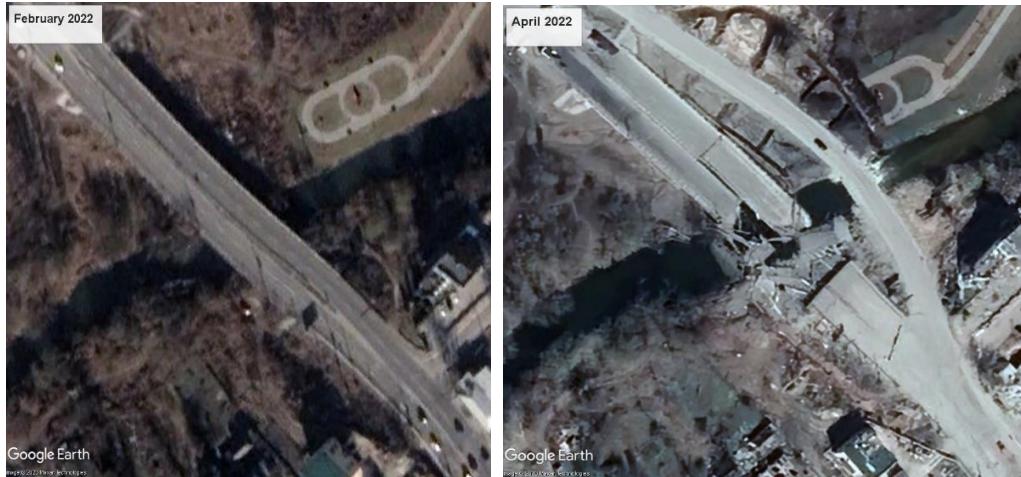
(a) B1: LoK_H ; DL_H ; $CCD_{GL}=0.523$; $CCD_{LOC}=0.623$
(on the right a temporary diversion route was constructed to bypass the bridge)

Figure 13. High spatial resolution images from Google Earth Pro used to validate the damage characterisation of bridges B1, B2, B9 and B17 as per Sentinel-1 coherence and CCD products.

Geospatial datasets were used for the validation of the damage level at asset scale. The cross-validation applied in this research entails the comparison of the CCD damage characterisation results outlined with the high spatial resolution images obtained by Google Earth Pro. The latter provides details on roads, buildings, and other infrastructure. These data served in this paper as an additional visual validation of the results, as per Figure 13. The images on the left were captured before the damage, while the images on the right were taken from March and April 2022. Thus, visual comparison between photos of assets, obtained before the beginning of shelling (October, February 2022) and after the period of the most extensive destruction in the region (April, March 2022) demonstrate an excellent agreement with the results outlined above.

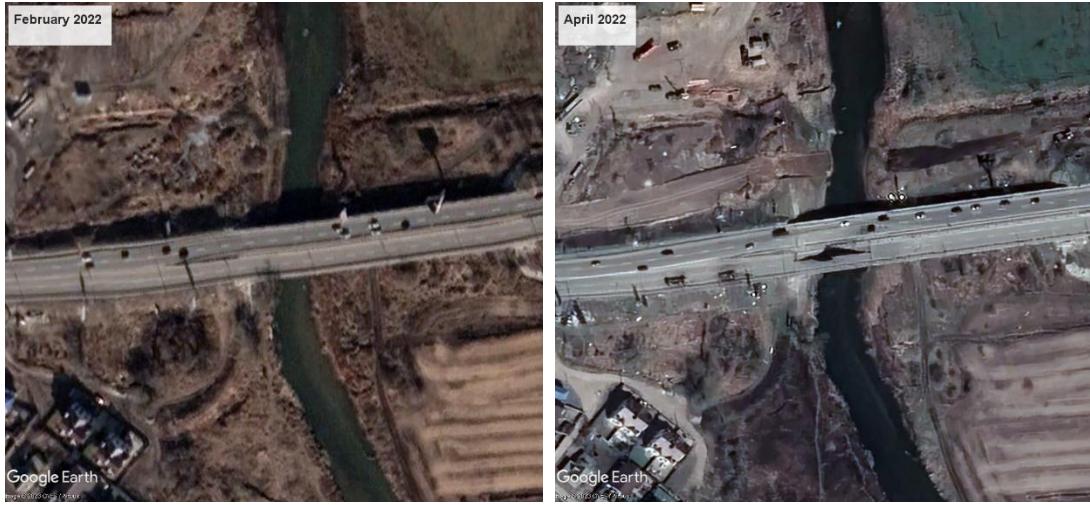
(b) B2: LoK_H ; DL_H ; $\text{CCD}_{\text{GL}}=0.499$; $\text{CCD}_{\text{LOC}}=0.540$

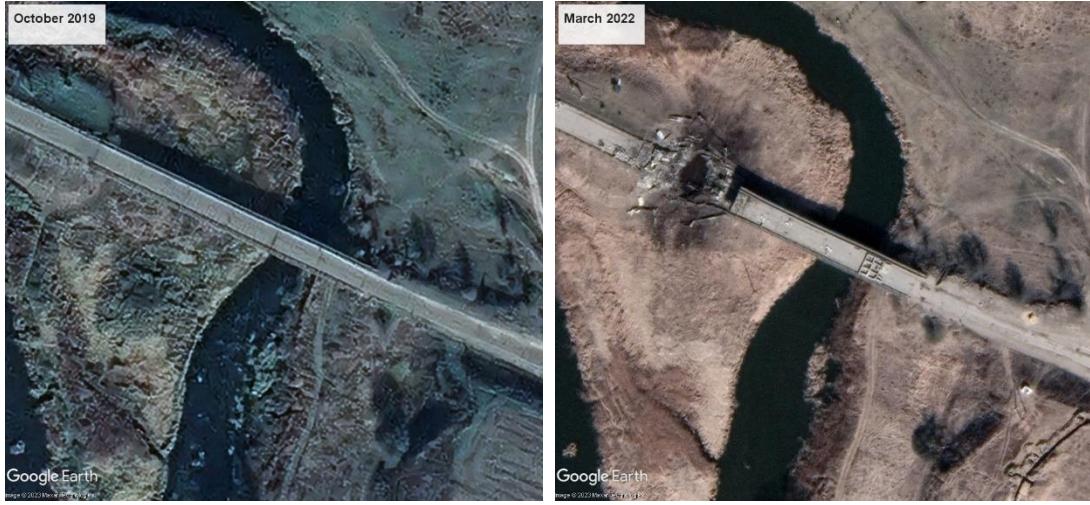
(c) B9: LoK_H ; DL_H ; $\text{CCD}_{\text{GL}}=0.666$; $\text{CCD}_{\text{LOC}}=0.730$

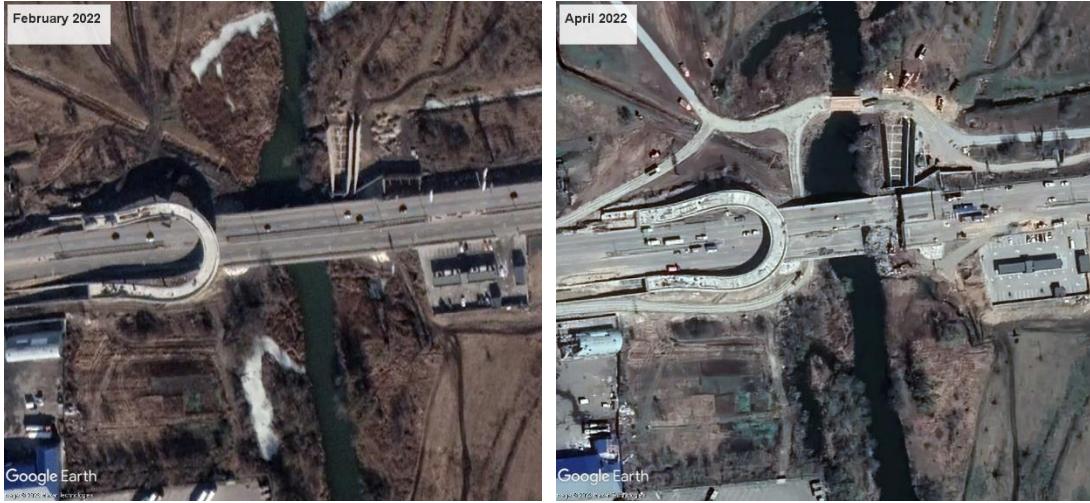
(d) B17: LoK_H ; DL_M ; $\text{CCD}_{\text{GL}}=0.351$; $\text{CCD}_{\text{LOC}}=0.521$ (on the right a temporary diversion route was constructed to bypass the bridge)

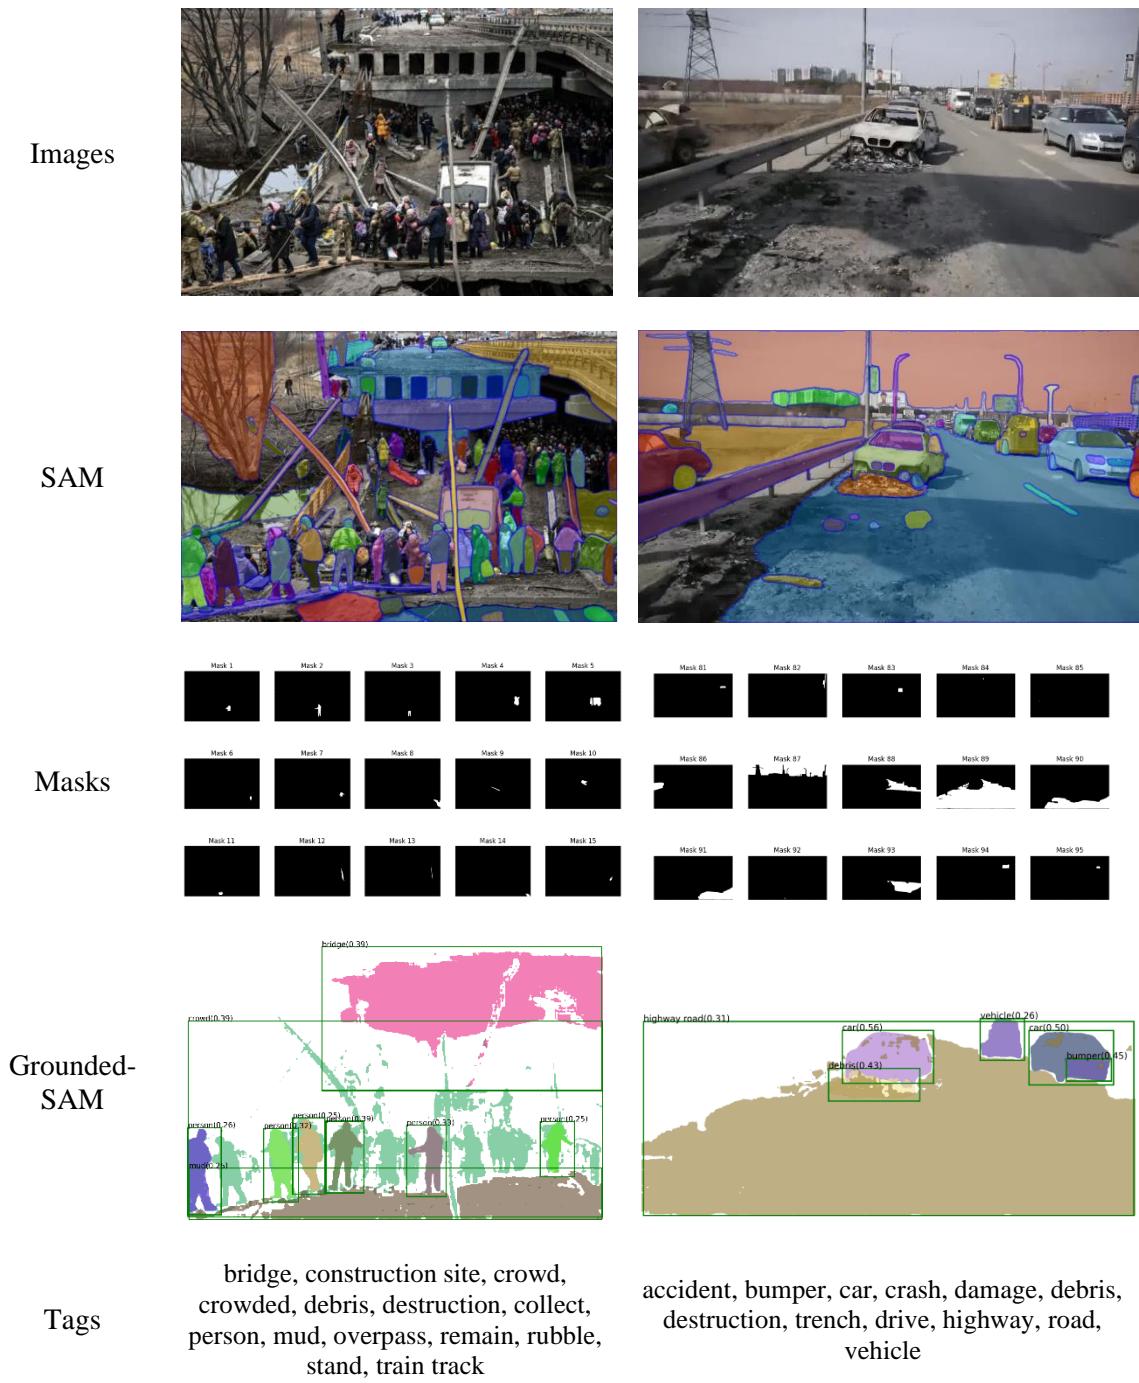
Figure 14. The outputs of SAM and Grounded-SAM for damage detection (e.g. crack) of bridge at component level.

The outputs of SAM and Grounded-SAM are shown in Figure 14. Firstly, the input images undergo mask extraction using SAM everything mode. The visual representation of SAM segmentation results is showcased in the second row, while the individual mask outcomes are presented in the third row. Subsequently, employing Grounding DINO [93], labels were matched with the obtained masks, excluding masks below the recognition threshold from display, and the results are displayed in the Grounded-SAM row. Additionally, all labels extracted from the masks, and some other descriptive words from Grounding DINO are presented in the ‘tags’ row.

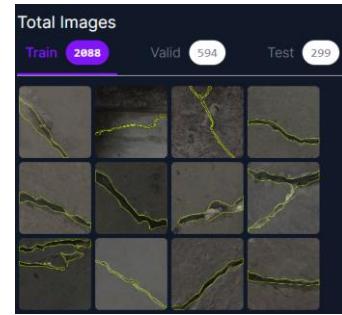
(f) Training Set for Crack Detection [96]

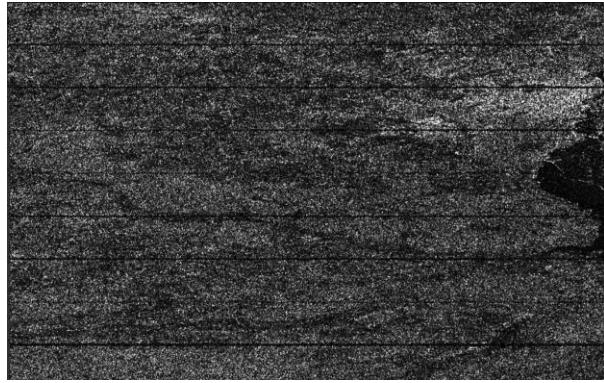
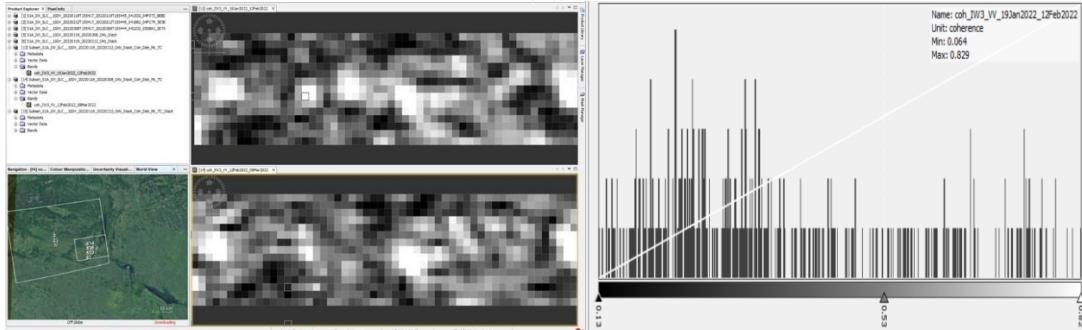
Figure A.1. Coherence products for evaluation of satellite imagery quality for damage evaluation: (a) coherence products for the whole area of the Sentinel image and (b) corresponding coherence values and histogram for the localised area of the asset (after subset application). E.g. in (b) most of the pixels within the assessed area have values of lower than 0.5, while the maximum $\gamma_{LOC}=0.85$). Thus, the products do not have the substantial quality for damage evaluation.
