Rapid post-disaster infrastructure damage characterisation enabled by remote sensing and deep learning technologies - a tiered approach

Nadiia Kopiika^(a,g), Andreas Karavias^(b,g), Pavlos Krassakis^(b,g), Zehao Ye^(a), Jelena Ninic^(a), Nataliya Shakhovska^(e,c,d,g), Nikolaos Koukouzas^(b), Sotirios Argyroudis^(e,f,g), Stergios-Aristoteles Mitoulis^{(*) a,f,g}

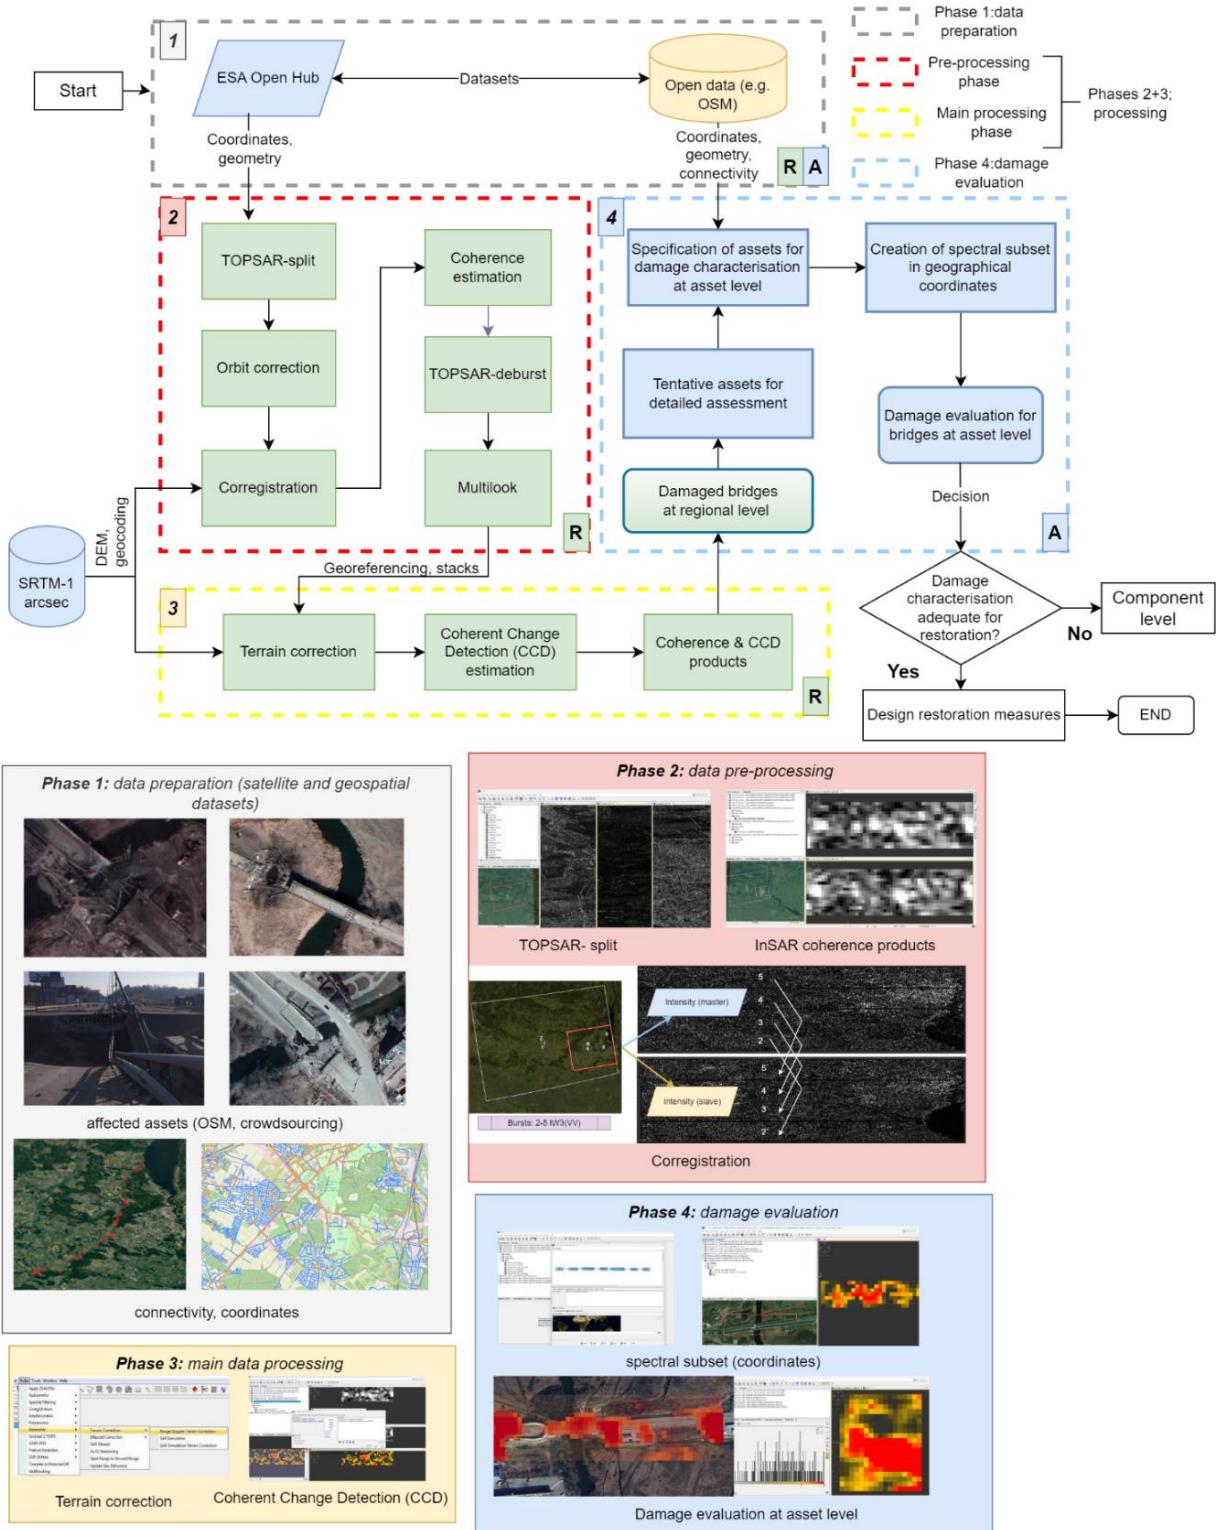
Figure A.2. Workflow for damage characterisation at regional (R) and asset (A) scale based on four phases: **Phase 1** (grey-dashed box): data preparation with the use of satellite and geospatial datasets, including location and geometry data of critical assets, residing within the boundaries of the selected study area; **Phase 2** (red-dashed box): data pre-processing using satellite datasets, including generation of the Coherence products (e.g. Sentinel-1 SAR SLC images); **Phase 3** (yellow-dashed box): main data processing, including estimation of Coherent Change Detection (CCD) and development of a semi-automated method for the damage detection on infrastructure assets, e.g. bridges; and **Phase 4** (blue-dashed box): damage evaluation at asset scale using CCD.

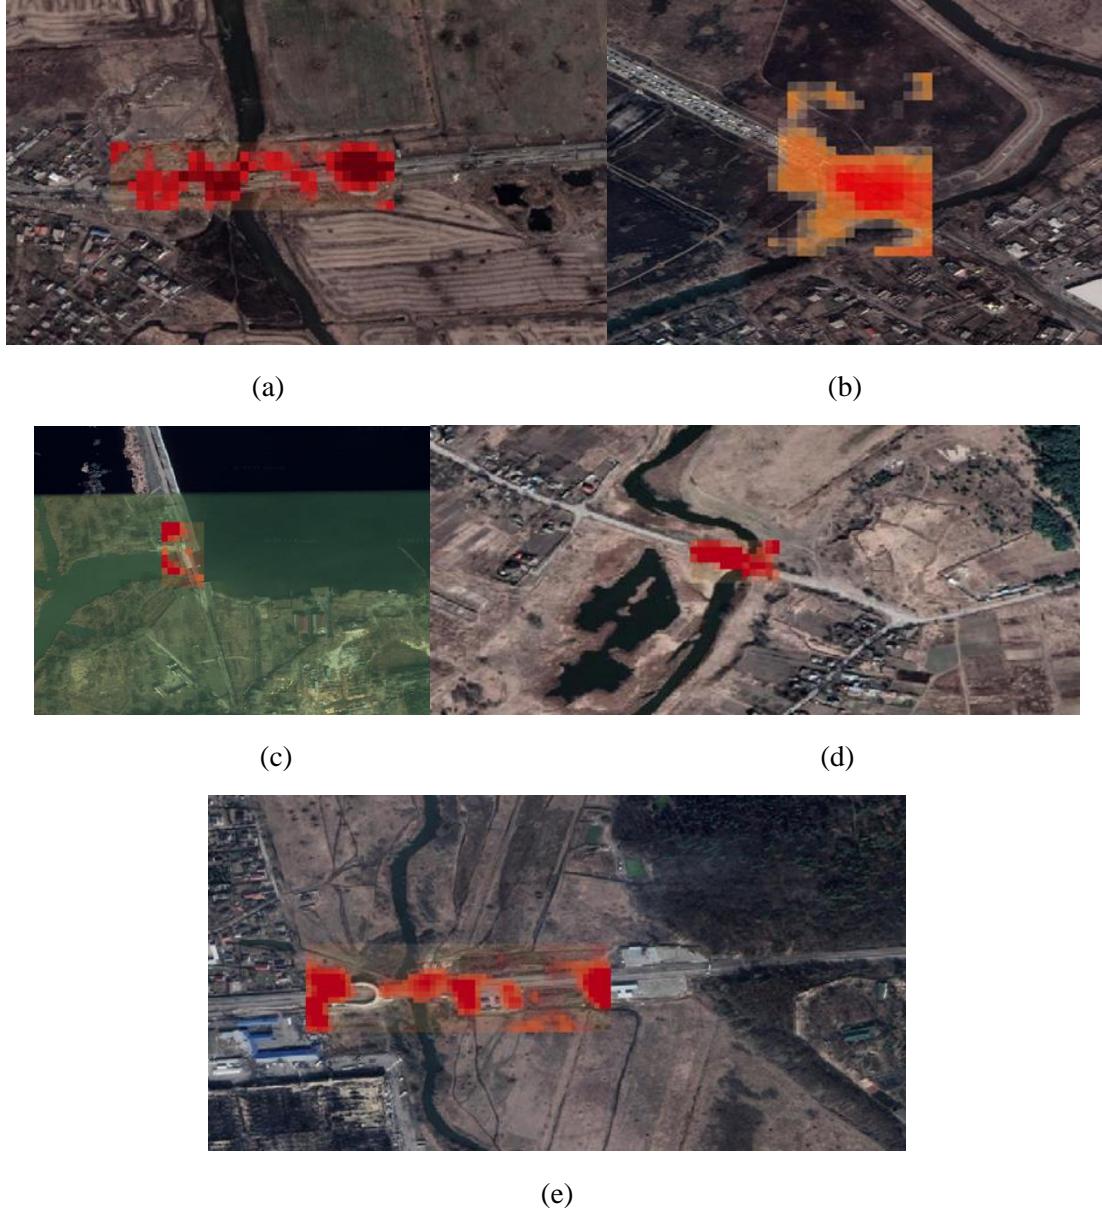
Figure A.3. Damage evaluation at asset scale with LoK_H : (a) B1 with DL_H ; (b) B2 with DL_H ; (c) B6 with DL_L ; (d) B9 with DL_H ; (e) B17 with DL_H

This section includes details on damage assessment of 17 bridges (asset scale) at different levels of data reliability (LoK) and DL. Figure A.3 shows high level of reliability of results (assets with High LoK), Figure A.4 demonstrates medium level of reliability of results (assets with Medium LoK). Although assets with the lowest LoK (due to low resolution or small size) were excluded from analysis in the paper, they are presented in Figure A.5 in order to illustrate the possible limitation of the method.

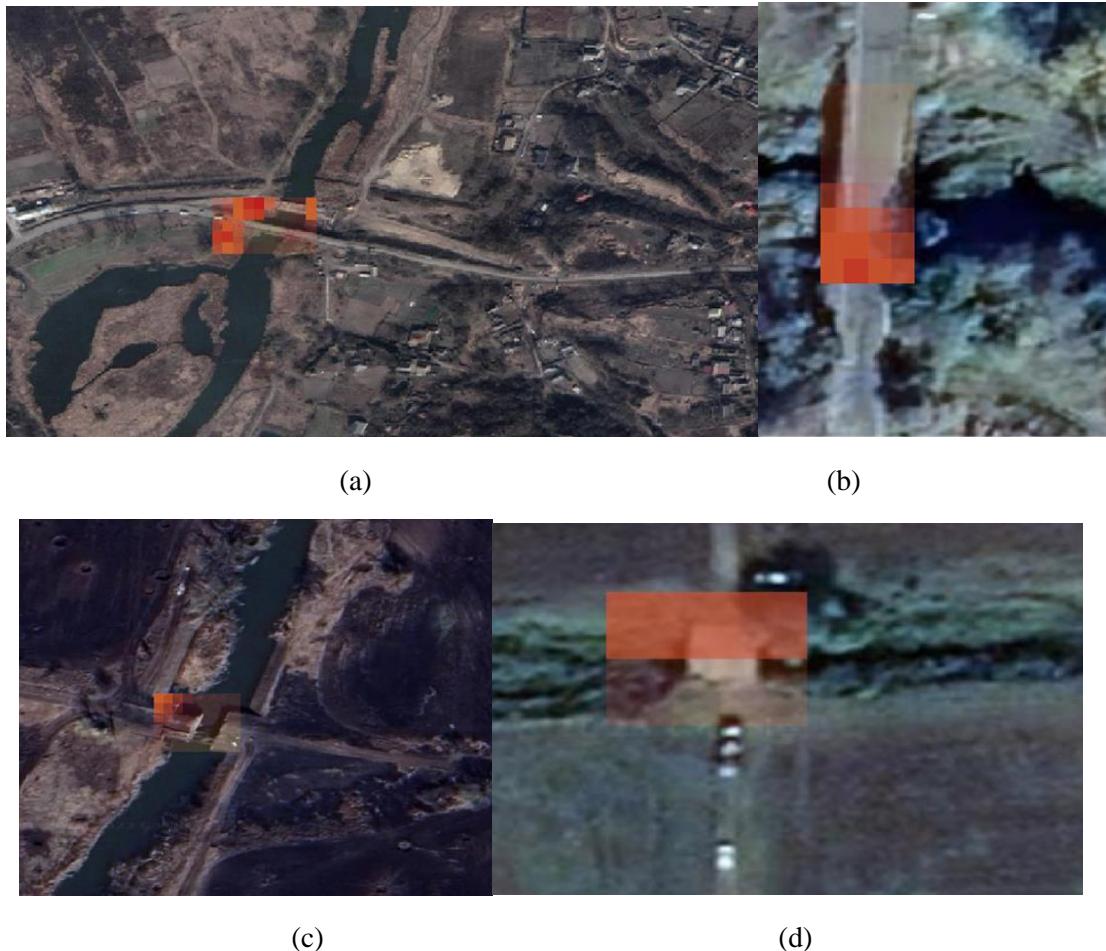
Figure A.4. Damage evaluation at asset scale with LoK_M : (a) B3 with DL_M ; (b) B5 with DL_L ; (c) B7 with DL_L ; (d) B15 with DL_M

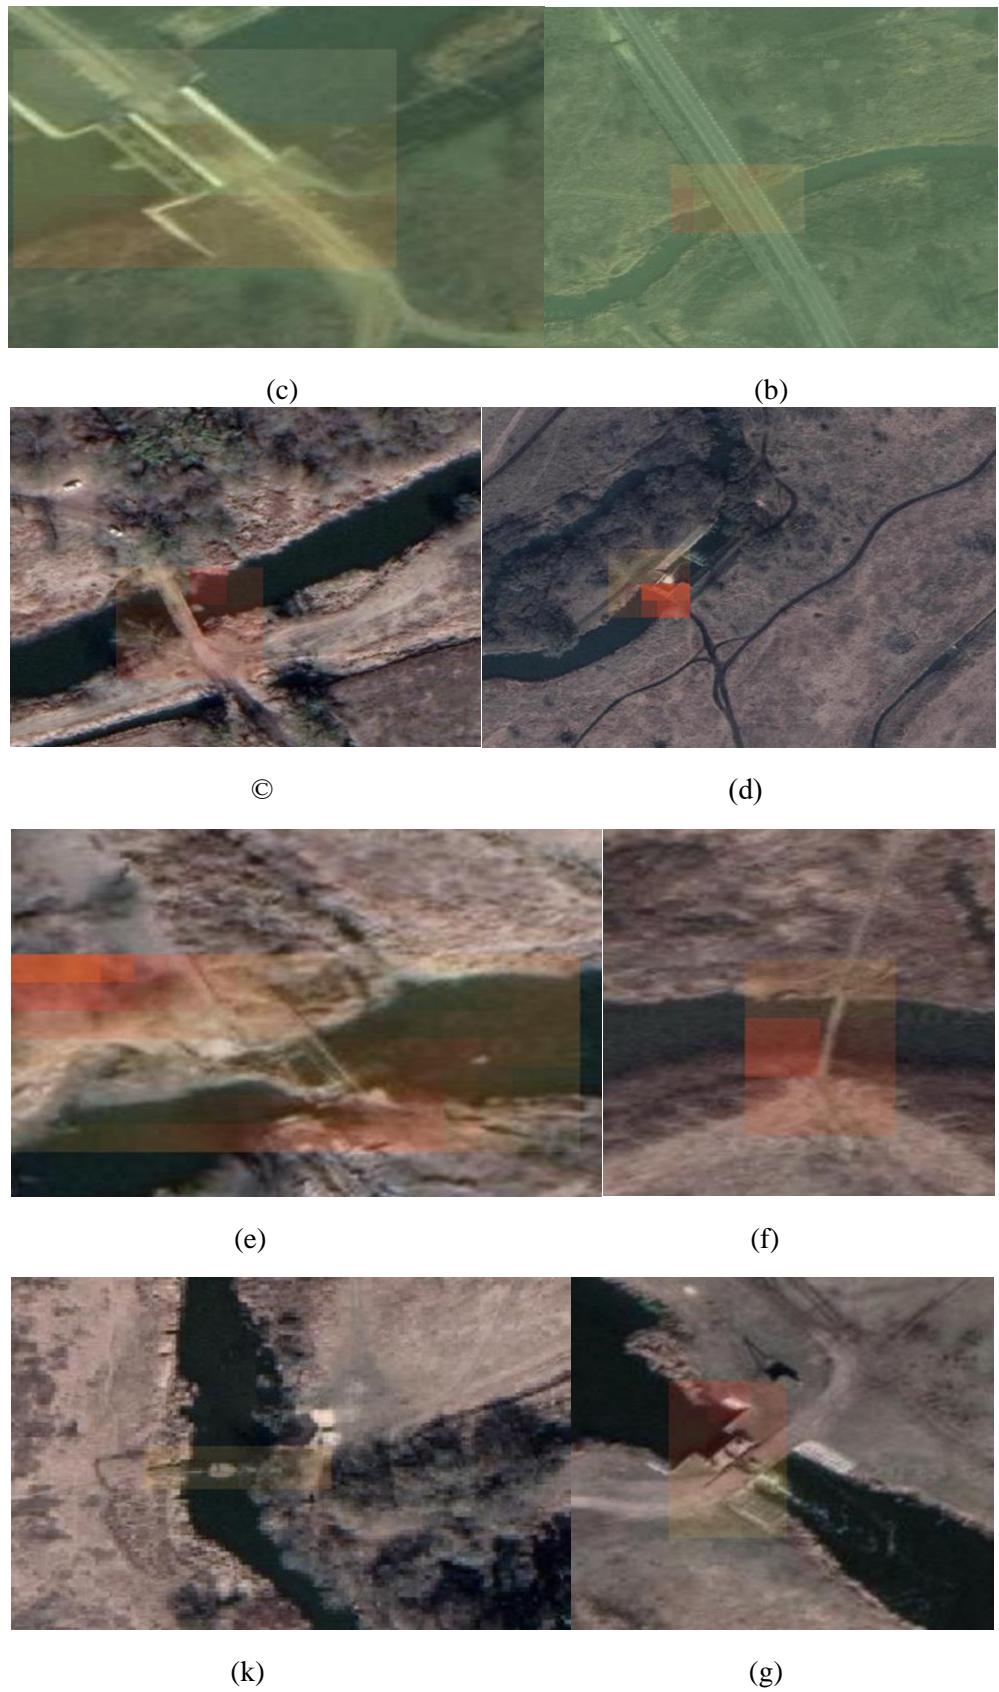
Figure A.5. Cases with LoKL at asset scale, which demonstrate the limitation in applying the methodology for damage assessment: (a) B4, (b) B8; (c) B10; (d) B11; (e) B12; (f) B13; (g) B14; (k) B16.
