Barely-Visible Surface Crack Detection for Wind Turbine Sustainability

Sourav Agrawal, Isaac Corley, Conor Wallace, Clovis Vaughn, and Jonathan Lwowski

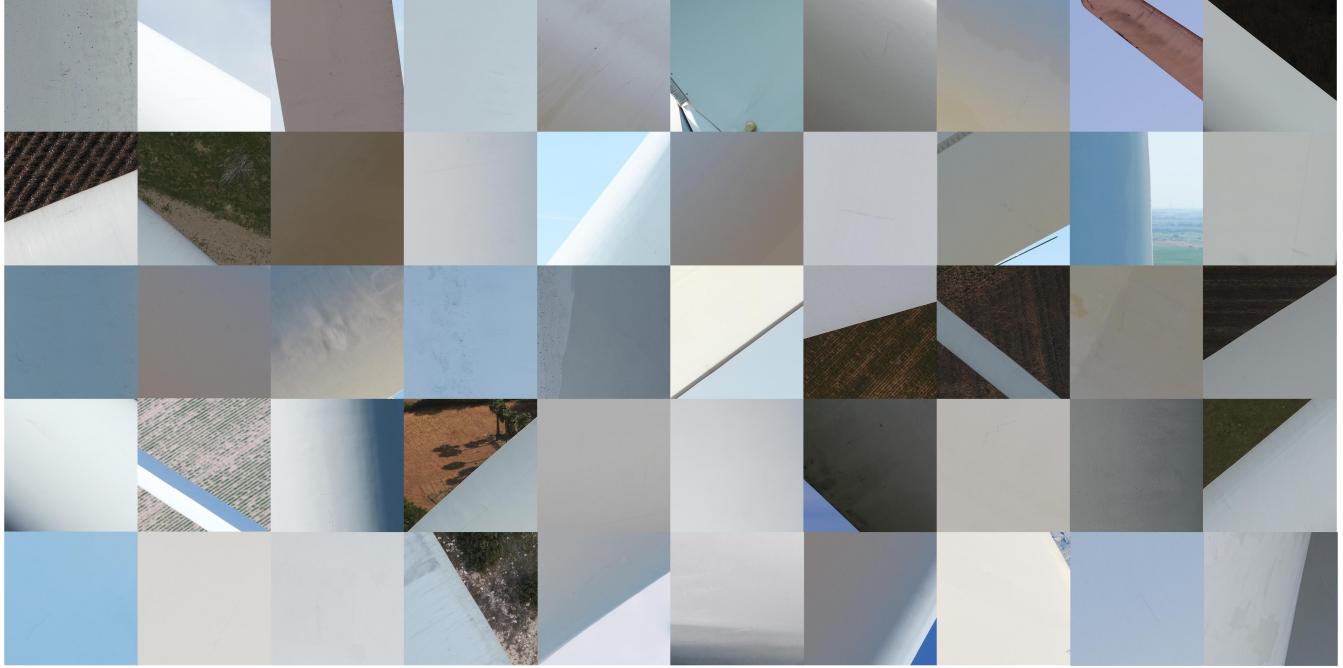
Fig. 1: **Can you spot the cracks in these images?** Hairline cracks are barely visible and commonly confused with stains and markings from dirt or grease. However, these defects can lead to catastrophic and irreparable damage to wind turbines if left untreated. This figure contains sample tiles from our *Zeitview Crack Detection* (ZVCD) dataset of annotated barely-visible surface cracks collected from inspections across the globe. This dataset is used to train our turbine crack detection pipeline for the inspection of renewable wind energy sources.

In most cases, cracks will appear as black lines on a blade that is painted white, but the length and width of the line can vary significantly. These cracks may only be a few centimeters long and less than a millimeter wide in some cases, making identification difficult even on a clean blade that is fully painted white [6]. Furthermore, detection can suffer when the blade is dirty or when image quality is poor. One of the greatest sources of a false identification is a dirt or grease mark that has streaked across the blade. There are subtle visual differences between these cases and true cracks, resulting in automated methods which struggle with overproducing false positives.

Given our preprocessed dataset, we then split our dataset by turbine, not by image, using a 90/10 train/val split criterion, such that no tile from the same image will be in both sets. We further manually create a very hard subset of our val set as test set which contains the least visible surface cracks. Samples of this set can be viewed in Figure 1.

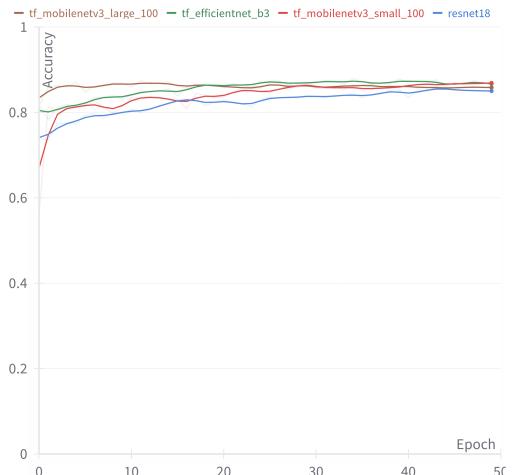
Fig. 3: **Validation accuracy performance during training of different models.** We observe that all the models have converged well and show similar performance.

We report the metrics for each model on the ZVCD test set in Table II. For additional insight we display the validation accuracy performance throughout training in Figure 3. We further compute efficiency metrics – total number of parameters, floating-point operations per second (FLOPS), and runtime (ms) – for each model using the fvcore [35] library with a batch size of 1 and an image size of $3 \times 1024 \times 1024$.

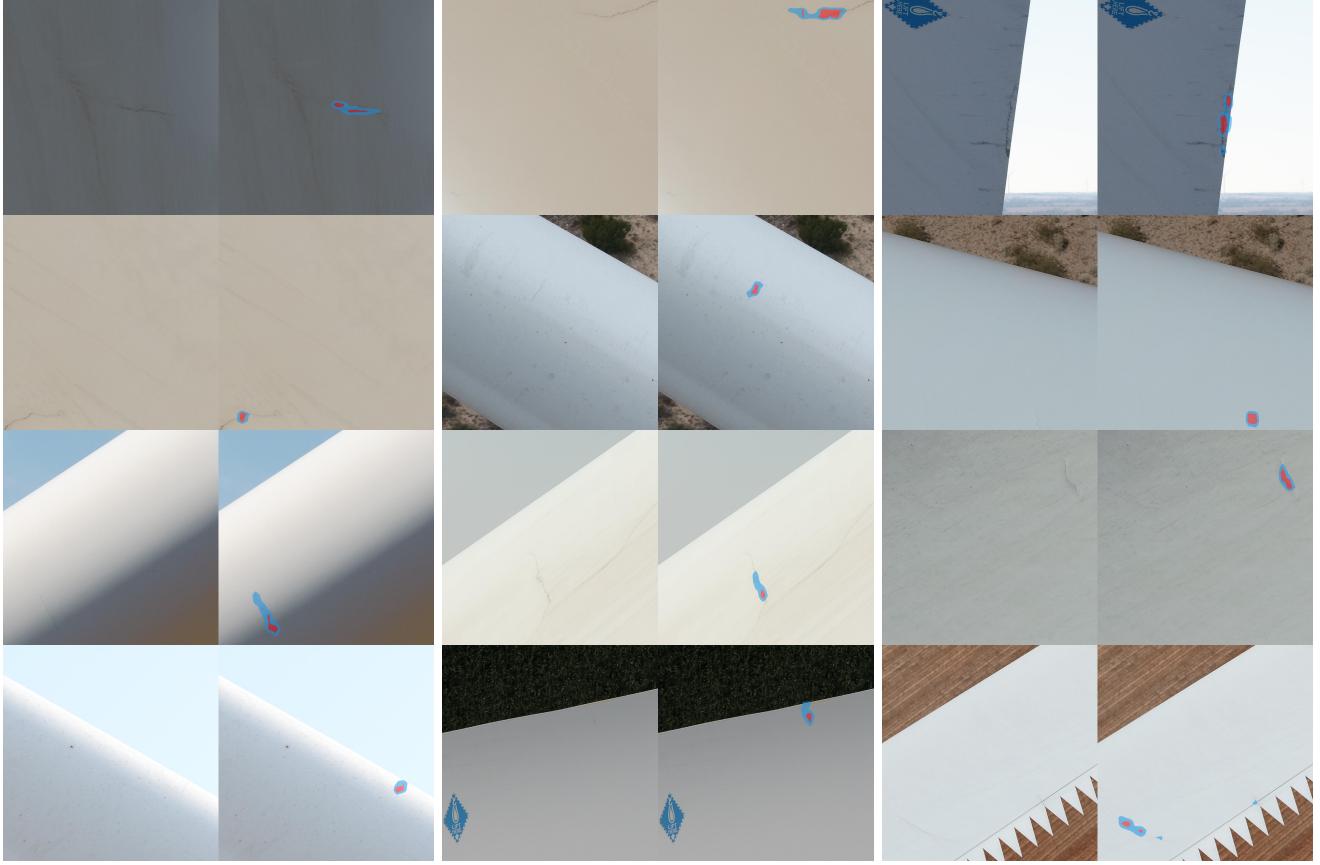
Fig. 4: **Sample Crack Detection Region Proposals using the GradCAM method [38].** Our pipeline provides region proposals to a human analyst who then reviews and further diagnoses barely-visible surface hairline cracks for severity categorization and repair recommendations. We first compute the GradCAM attributions w.r.t the crack detection class model output. We then post-process the attribution heatmap using the normalize and polygonize operations.

GradCAM attribution heatmaps are typically noisy and require additional post-processing to create an accurate localization of detected cracks. Furthermore, storage of heatmaps in the cloud is costly, therefore post-processing to convert region proposals into polygons is necessary. We perform the following steps to convert the attribution heatmaps to localized polygons and provide visual examples in Figure 4.

Normalizing We normalize the attributions within a tile using the min and max statistics.

Clipping We remove attribution outliers by clipping the normalized heatmap to the percentile range [0, 98].

Contour Detection We utilize contour detection to segment regions with high attribution. We find best results by retrieving only the extreme outer contours and compressing to only obtain the endpoints. We find this as a simple, yet effective method for localizing the cracks within a tile’s heatmap.

Polygonization Given the raster-level heatmaps outlines, we then convert them into N-point polygons.

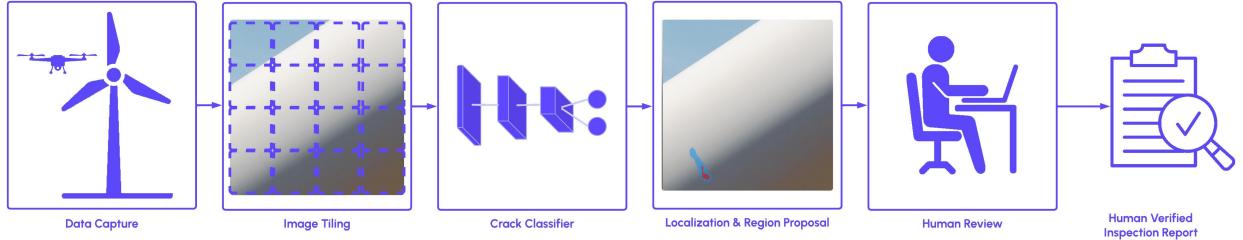
Fig. 5: **Our turbine crack detection pipeline diagram.** Our pipeline consists of automated acquisition of overlapping imagery of each turbine blade using DJI UAVs and our flight planning algorithms. Each image is then decomposed into 1024 x 1024 tiles which we then run our classifier on. Next, we compute and postprocess the gradient attribution heatmap on the high confidence predicted tiles. Our analysts are then shown these proposal regions containing cracks for review and in-depth analysis for inspection report generation.

In this section, we discuss Zeitview’s currently deployed turbine crack detection pipeline. The pipeline is split into 3 components: image acquisition, inference, and post-processing. The pipeline is entirely automated until the last stage which requires a human-in-the-loop for final review. A visualization of the end-to-end pipeline is provided in Figure 5.

For each turbine, we utilize DJI drones to fly a pre-planned flight path which performs a pass of each of a turbine’s three blades on all four sides: suction side, pressure side, trailing edge, and leading edge. We utilize a gimbal to orient the camera in such a way that it is orthogonal to the surface of the blade along the entire pass. For each pass, the drone stops to capture an image of the blade at waypoints spaced approximately three meters apart. This means that for a typical 50 meter blade, we capture 18 images per pass, generating a total set of 216 images per turbine.

After image acquisition, the pilot then uploads the imagery to our cloud infrastructure. Images are then tiled into 1024×1024 patches.

Once the images have been tiled, we run our classifier in batched processing form and filter out low confidence predictions with a threshold, $\tau = 0.5$. Because the images are tiled we have an approximate location on the blade which contains potential cracks. We further localize the cracks into region proposals by computing the gradient attributions w.r.t the crack output class using the GradCAM method [38].
