A Method to check the Connectivity for the ATLAS TRT Detector

N. Ghodbane ^a, X. Pons ^a, O. M. Rohne ^b

Abstract

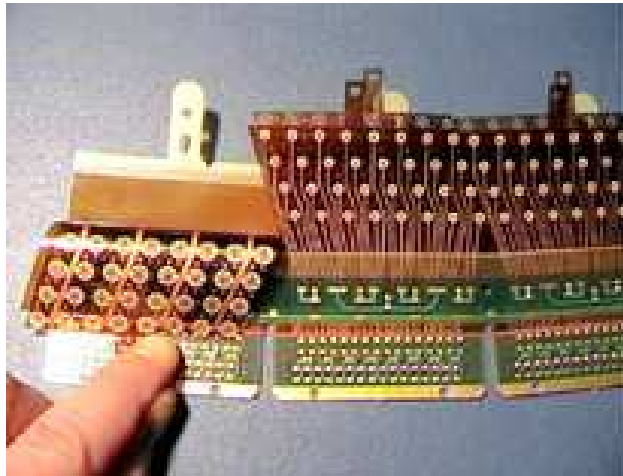
Figure 1: Photograph of a Wheel End-cap Board (WEB) of the ATLAS TRT End-cap detector.

The main interface of each of these wheels to the outside world consists of 2×32 flex-rigid printed circuit boards called Wheel End-cap Board or WEB as shown in Fig. 1, used to connect the straws to the high-voltage supply and to collect the signal from the wire to the front-end electronics.

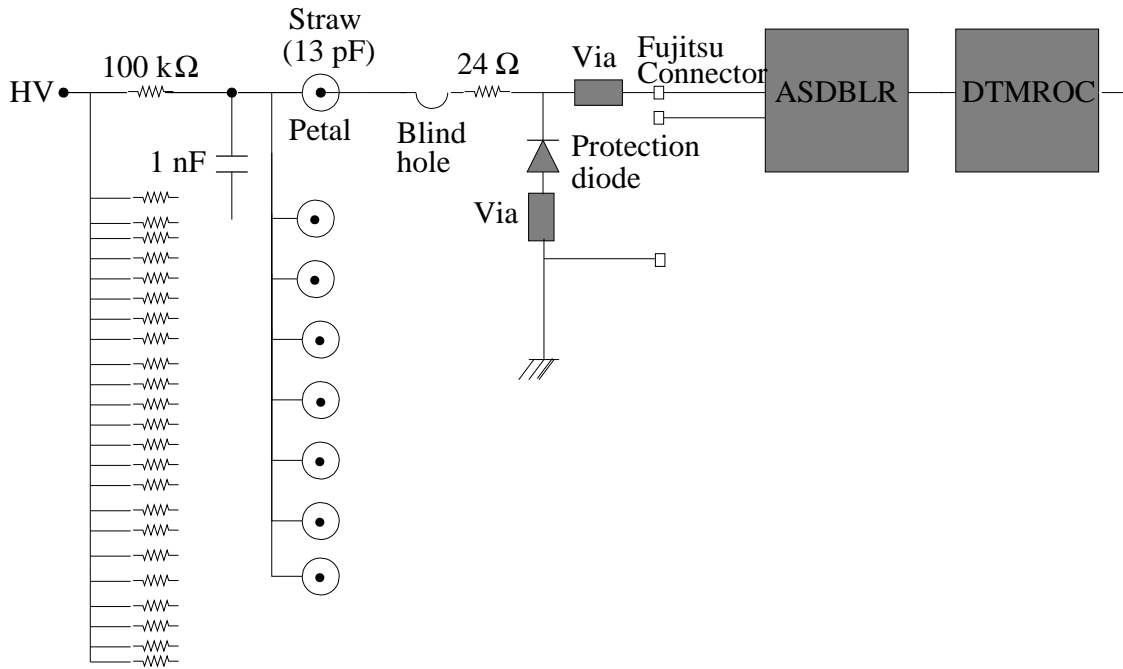
A schematic view of one channel is presented on Fig. 2, with some specific details of the WEB connection to the anode wires which are relevant to the results presented in this note (blind holes and vias).

Figure 2: Schematic view of a TRT end-cap readout chain.

During these so-called *acceptance tests* (AT), straws found to be out of specifications are disconnected from their high voltage group by un-soldering the 24Ω protection resistor (Fig. 2). Careful studies have shown that most of the problematic channels are due to metallisation cracks in the signal vias or (more rarely) blind holes of the WEBs, as shown by the photograph in Fig. 3.

Then, using a battery-operated pF-meter, the different Fujitsu male connectors on the detector are probed looking at some abnormal capacitance from active pin to ground. This method, combined with the value obtained with the rate integral technique, permits to locate the problem on the detector side, at the via close to the active pin of the Fujitsu, or at the blind hole or directly at the straw as depicted on Fig. 2. Abnormal channels show usually a capacitance value lower by more than 5 pF than the average of the corresponding WEB. Finally a last technique uses the special "diode check" function of a volt-meter. A small DC current is injected between the diode ground and the signal output and then the forward voltage drop of the diode is measured. An abnormal value, with respect to the Fujitsu average, is directly linked to a problem of one of the two vias as shown on Fig. 2.

Volts is applied between the anode and the cathode of each of the straws. Under these conditions, micro-discharges occur near the straws or on the WEBS, the signal is then collected, amplified and shaped by the ASDBLR which ternary output is then fed into the DTMROC for digitization. As it is shown on Fig. 2, a problem in the electronic chain, like a bad metalization, or a problem with one of the electronic components will directly appear, since for this particular channel, the high-level threshold accumulation state will not be reached. The accumulation mode technique implements the following algorithm:

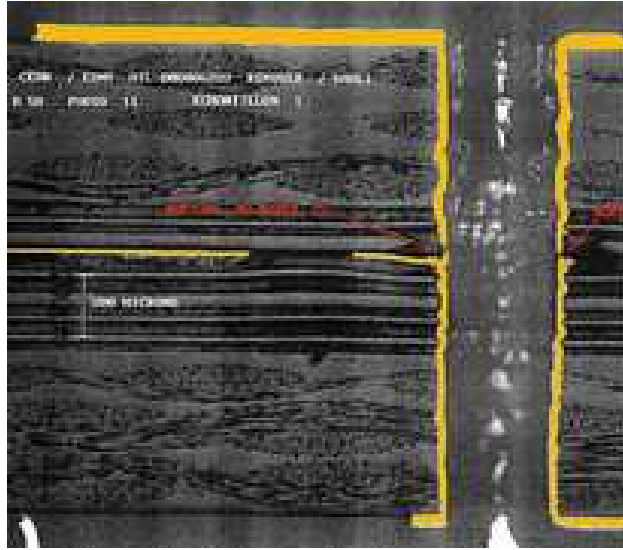
Figure 3: Crack due to a bad metallisation of one signal via of a TRT end-cap WEB.

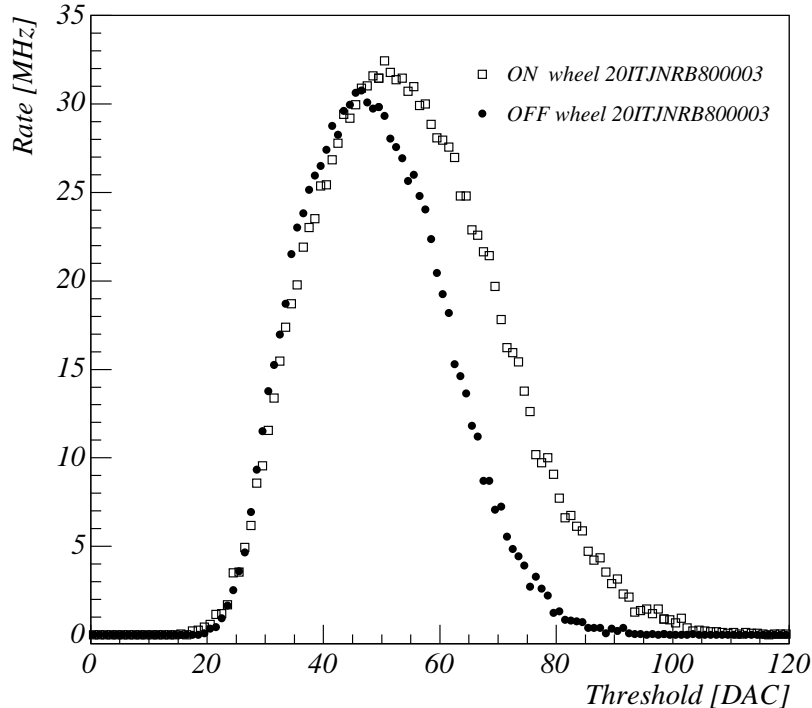
The first method used to characterise and quantify the board performance is the noise rate shown in Fig. 4 as a function of the low-level threshold applied to the ASDBLR chip. This rate is defined as the number of transitions from low to high discriminator level output for a given DAC setting of the low-level threshold. For small discriminator values of the DAC setting, the output level is almost always high for all eight time bins and the number of transitions therefore drops to zero for low values of the low-level threshold.

For higher values of the DAC setting, the number of transitions from low to high increases and reaches a maximum in the region between 40-50 DAC counts (near the zero threshold of the comparator of the ASDBLR chip). The typical value of the maximum corresponds to the maximum bandwidth of the ASDBLR ($\simeq 35$ MHz). For even larger DAC settings, the number of transitions decreases and reaches the design specifications (a rate of about 300 kHz) for low-threshold values of about $\simeq 100$ -120 DAC counts, which corresponds to a low-threshold close to 200 eV.

As show in Fig. 4, once the front-end electronics board is connected to the TRT wheel, the input load increases to that of the WEB plus the straw itself and therefore the total Equivalent Noise Charge (ENC) is larger. This results then in a broader noise rate curve, which can be used to identify disconnected channels.

Figure 4: Noise rate as a function of the low-level threshold DAC setting for a TRT end-cap board, when measured off-detector (full circles) and on-detector (open squares). For an operational setting of close to 200 eV (\simeq 100-120 DAC counts), the noise counting rate per straw is about 300 kHz.

Several quantities, based on the noise rate curve shown in Fig. 4, have been investigated:

- the $\simeq 2\%$ occupancy level (summed over three bunch crossing) corresponding to a rate of 300 kHz;
- within the approximation of a Gaussian distribution for the noise rate curve, the σ obtained from a Gaussian fit to the distributions of Fig. 4;
- the integral of the noise rate curves can be computed and compared as shown in Fig. 5.

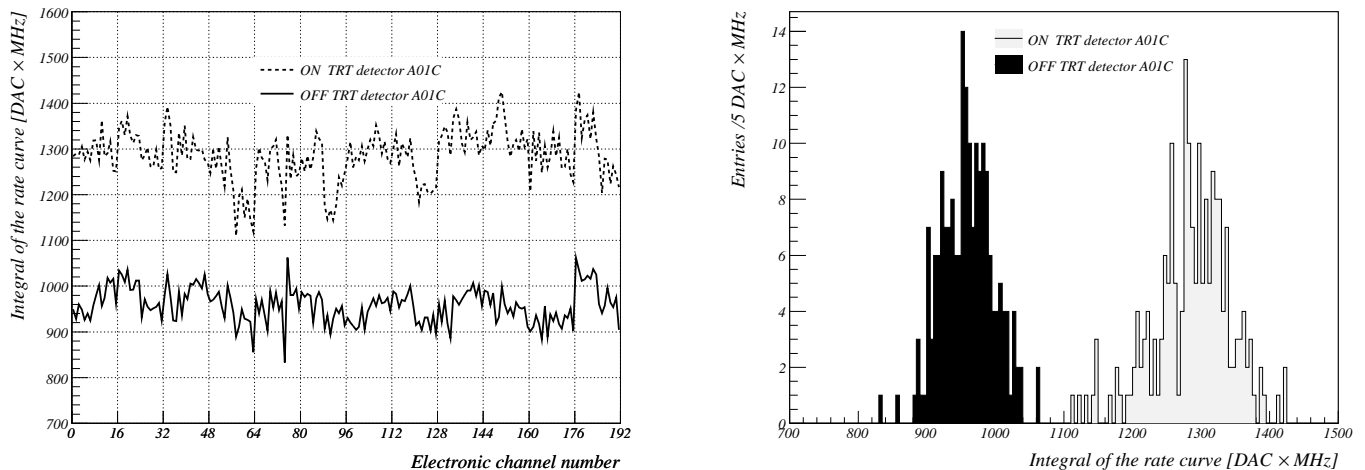
Fig. 5 clearly demonstrates the good discrimination potential of the integral noise rate, since a separation of about 300 counts (DAC \times MHz) is observed on average between the off-

Figure 5: Left: integral of the noise rate curve for one module (192 channels) on- (dashed line) and off- a TRT endcap-detector. Right: distribution of the integrals of the rate curves for one TRT endcap WEB (192 channels) off (black histogram) and on detector.

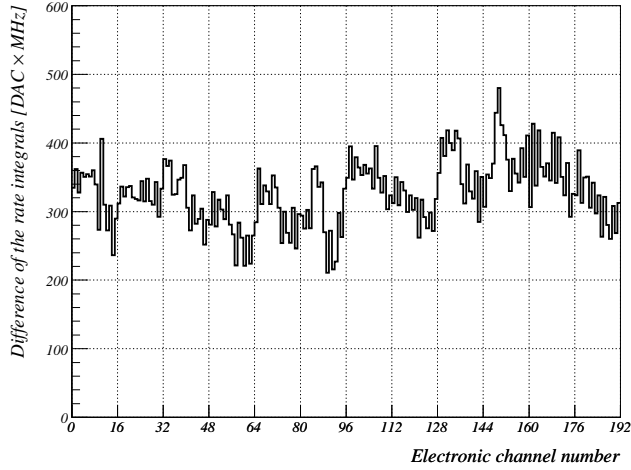
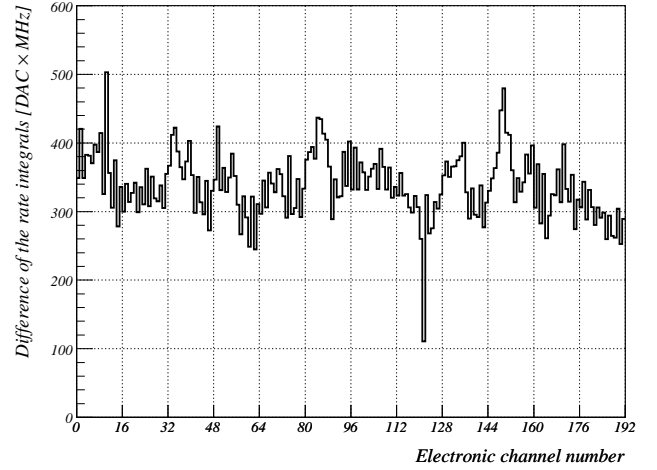
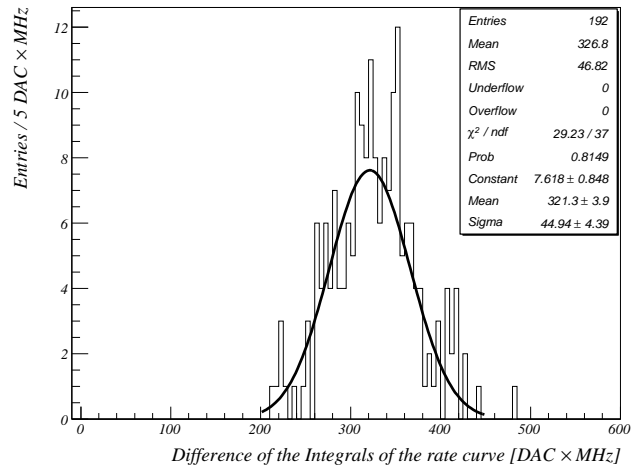
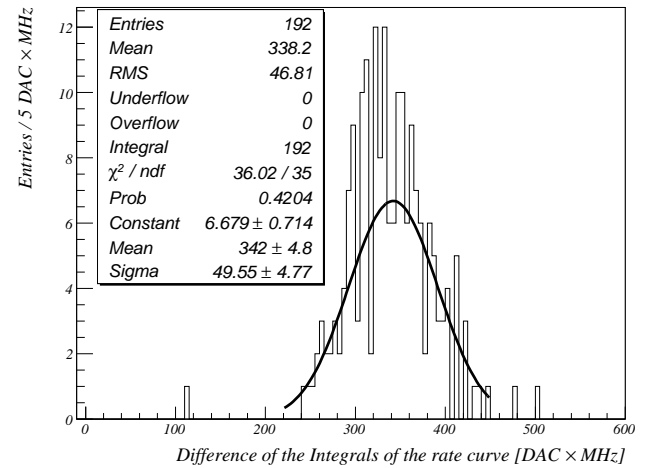
This is illustrated on Fig. 6 which shows the difference between the two noise rate integrals for a well-behaved WEB and for a WEB with one channel displaying metallisation problems not seen during the acceptance testing. For the well-behaved WEB, the distribution is centered around 320 DAC×MHz counts with a Gaussian RMS of about 50 DAC×MHz counts. Problematic channels appear at much lower values and front-end board behavior have been removed by fitting each distribution to find its mean and RMS.

Figure 6: Top: Distribution of the difference between the noise rate integral on-detector and off-detector as a function of channel number for a well-behaved WEB (left) and for a WEB with one channel displaying metallisation problems not identified by the acceptance tests (right). Bottom: distribution of the noise rate integral difference for the same WEBs as above.

The mean value of the distributions shown in Fig. 6 are also quite sensitive to the two analogue voltages used to power the ASDBLR chips. A small shift of one of these voltages from its nominal setting at ± 3 Volts will result in a shift of the noise rate integral difference distribution. A careful study of the possible systematic effects due to these analogue voltages was performed by changing the voltage settings by ± 0.1 Volts for the noise scan measurements both on- and off-detector. These result in large shifts of the noise rate integral difference distributions from 250 to 390 DAC × MHz. To minimise such effects, at each measurement on- and off-detector, the applied analogue voltages were tuned to be within ± 0.02 Volts of the nominal ± 3 Volts.

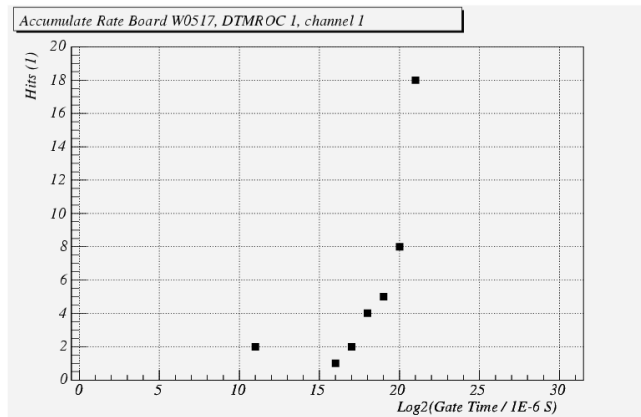
Figure 7: Total number of events with a high-level threshold bit using the accumulation mode for a total of 50 L1A software triggers.

Fig. 7 shows typical values for n_i for different gating times τ_i . As expected, n_i , the number of events for which the accumulation mode is reached, increases as the gating time τ_i is longer.

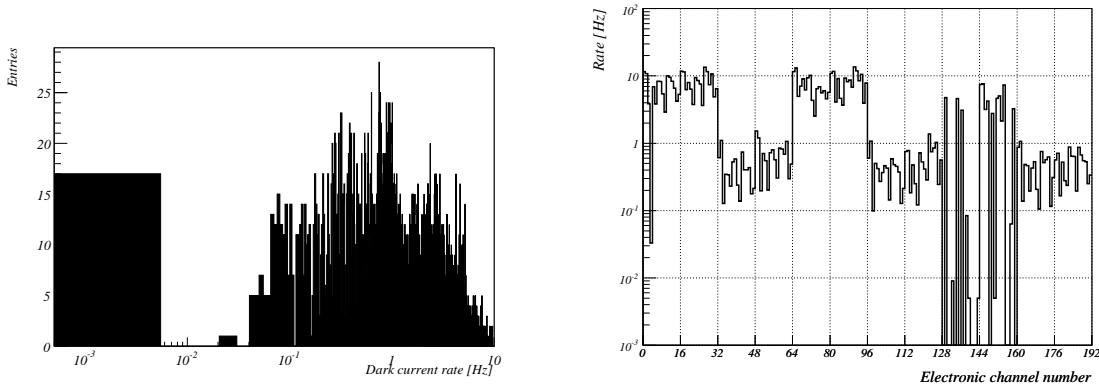
A distribution of the rate is shown on Fig. 8. Typically, working channels have a rate value greater than 0.1 Hz, whereas problematic ones have values below 0.01 Hz. For some TRT endcap-wheels, the accumulation rate distribution shows clearly a larger activity on one of the lowest of the two 4-Planes wheels, whereas for other ones a rate of about 1 Hz is measured across all the readout channels.

Figure 8: Rate distribution for one TRT endcap WEB, using the DTMROC accumulation mode. Problematic channels have a very low activity, i.e. accumulation mode rates below 10 mHz.

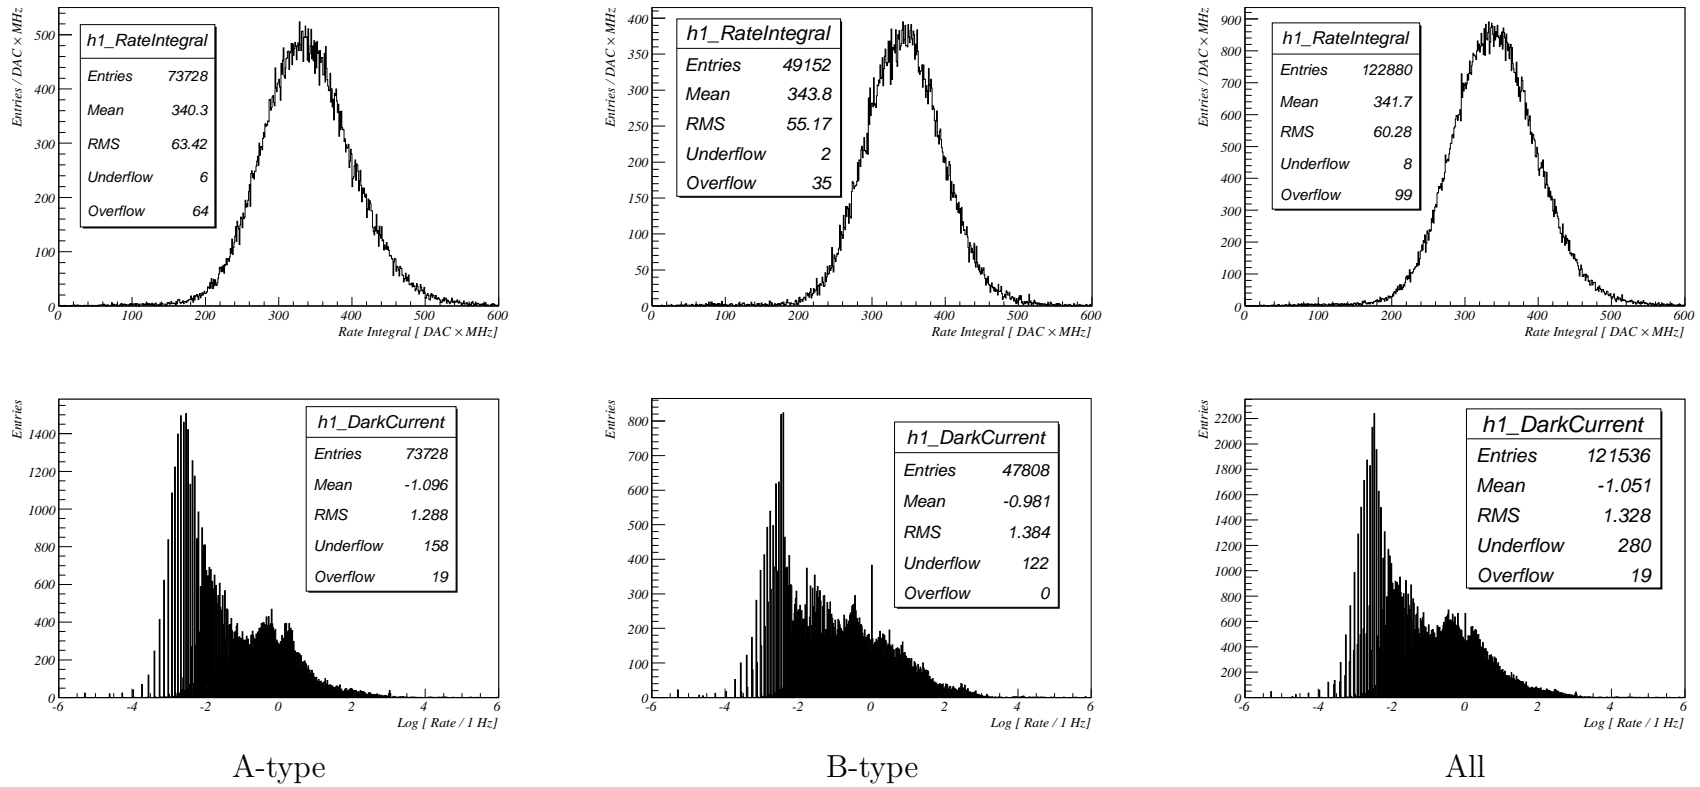
Figure 9: Noise scan rate integral distribution (upper) and associated accumulation mode dark current rate for both A-Type and B-Type TRT endcap-detectors.

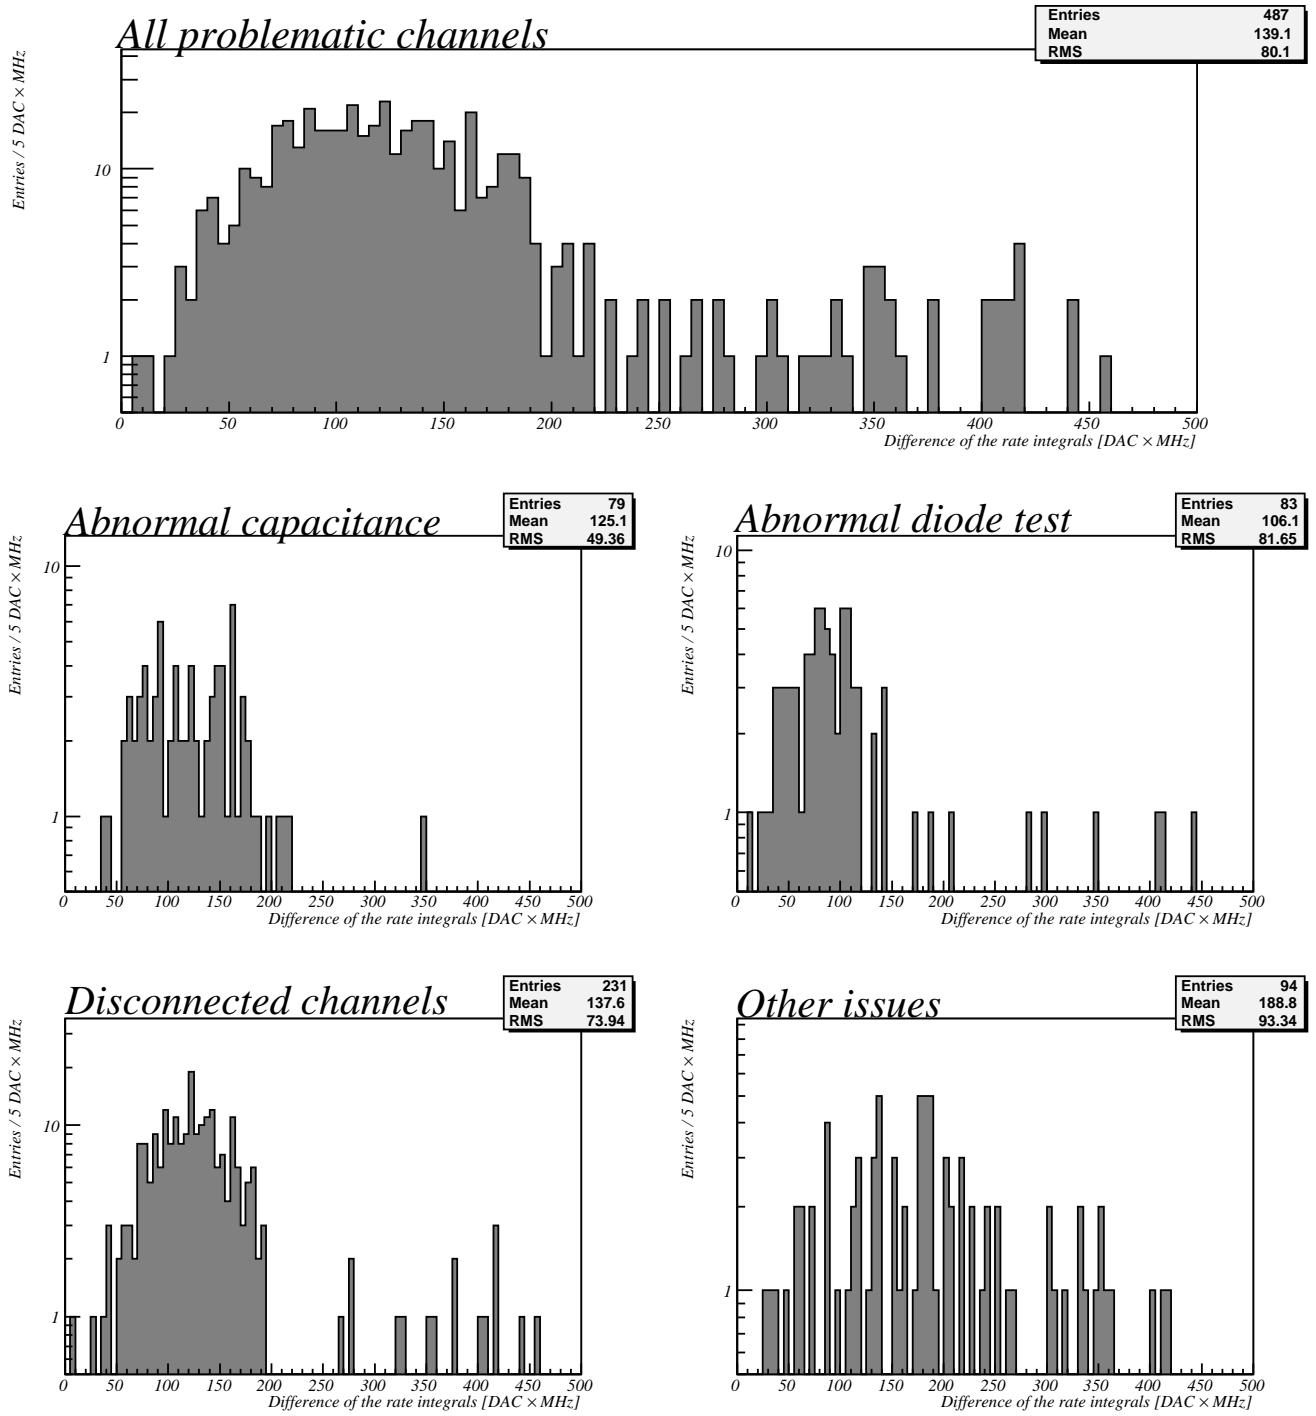
Figure 10: Rate integral distribution of the different problematic channels for A-type and B-type TRT wheels.

Finally, only 487 readout channels are found not to be responding. These channels comprise 231 channels for which the protection resistors were unsoldered after they failed the serie of acceptance tests. Typically, these channels are characterised by a noise scan rate integral difference value about 130 DAC×MHz counts, much lower than the WEB average (below three σ of the mean value μ). The total distribution of the rate integral is presented on Fig. 10. In addition, their corresponding accumulation mode rate is about 10 times lower than

The efficiency of the two methods described in the previous section is clearly established. it enables to find 256 new problematic channels, most of them being reported non working by both methods. For instance, only 40 channels are not found by the noise scan based technique (see Fig. 10, 11, 12, 13, 14 and 15).

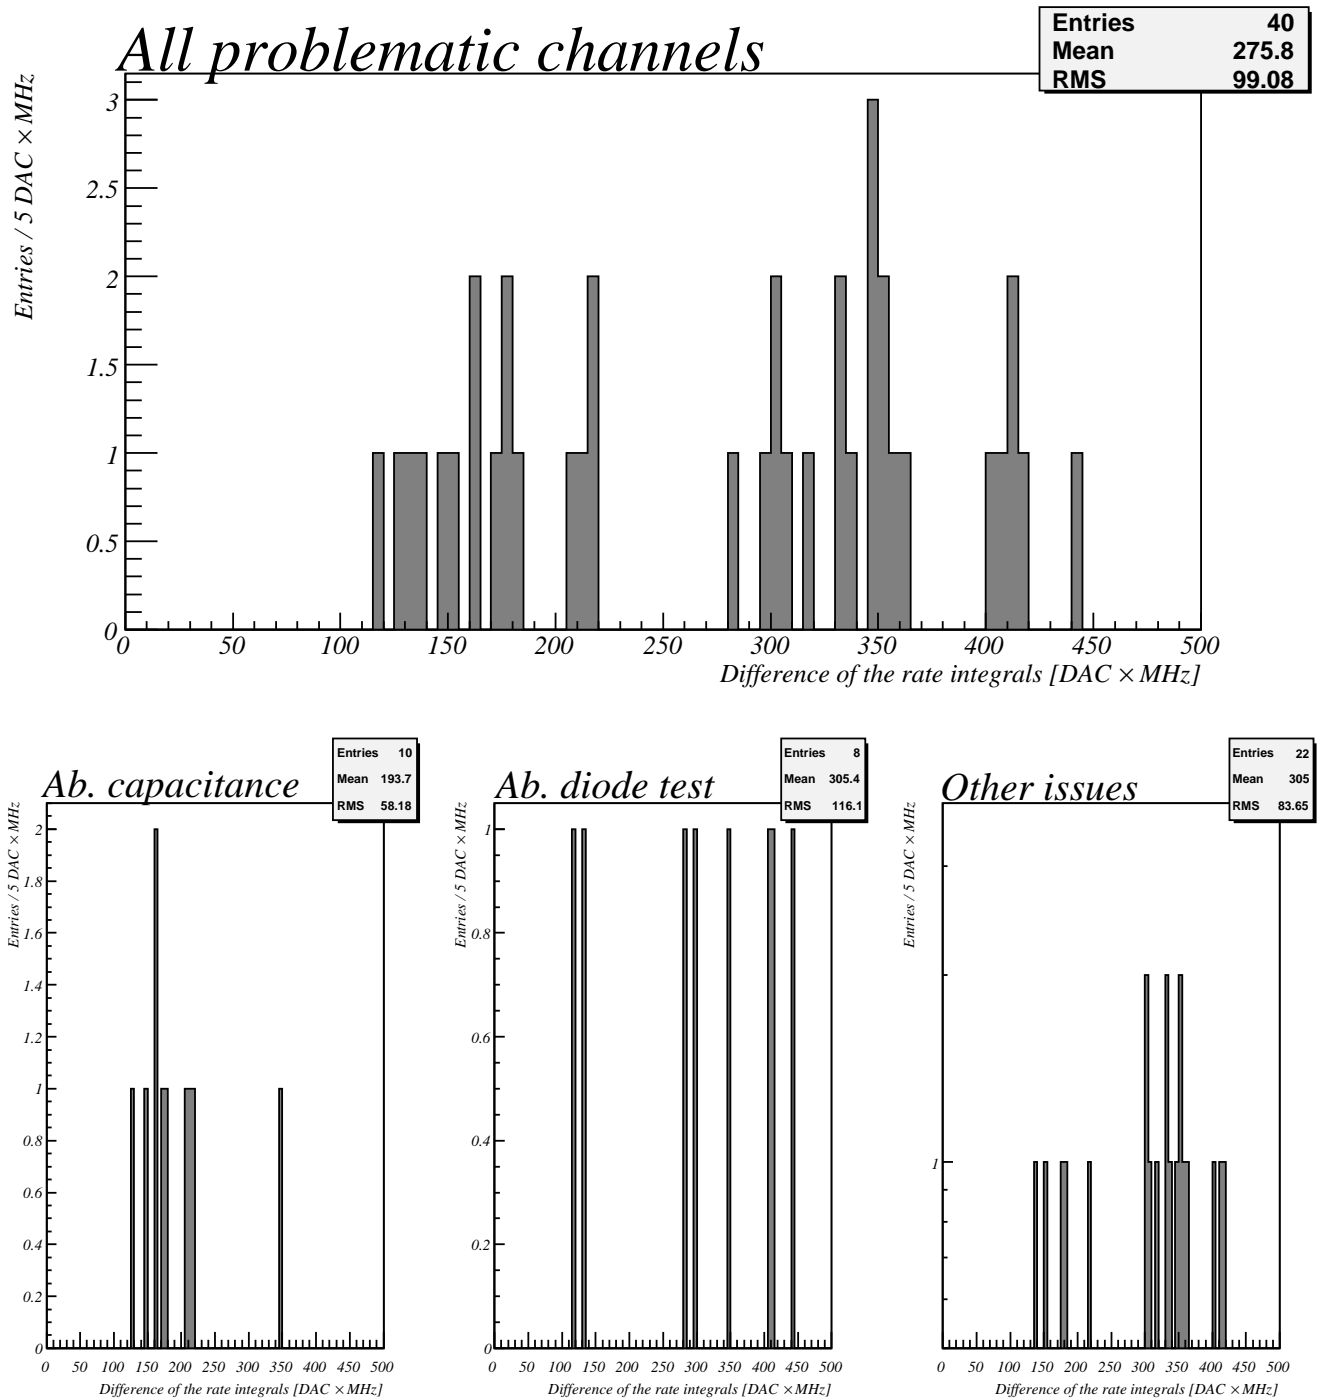
Figure 11: Rate integral distribution of the different problematic channels failing the Noise Scan technique for A-type and B-type TRT wheels.

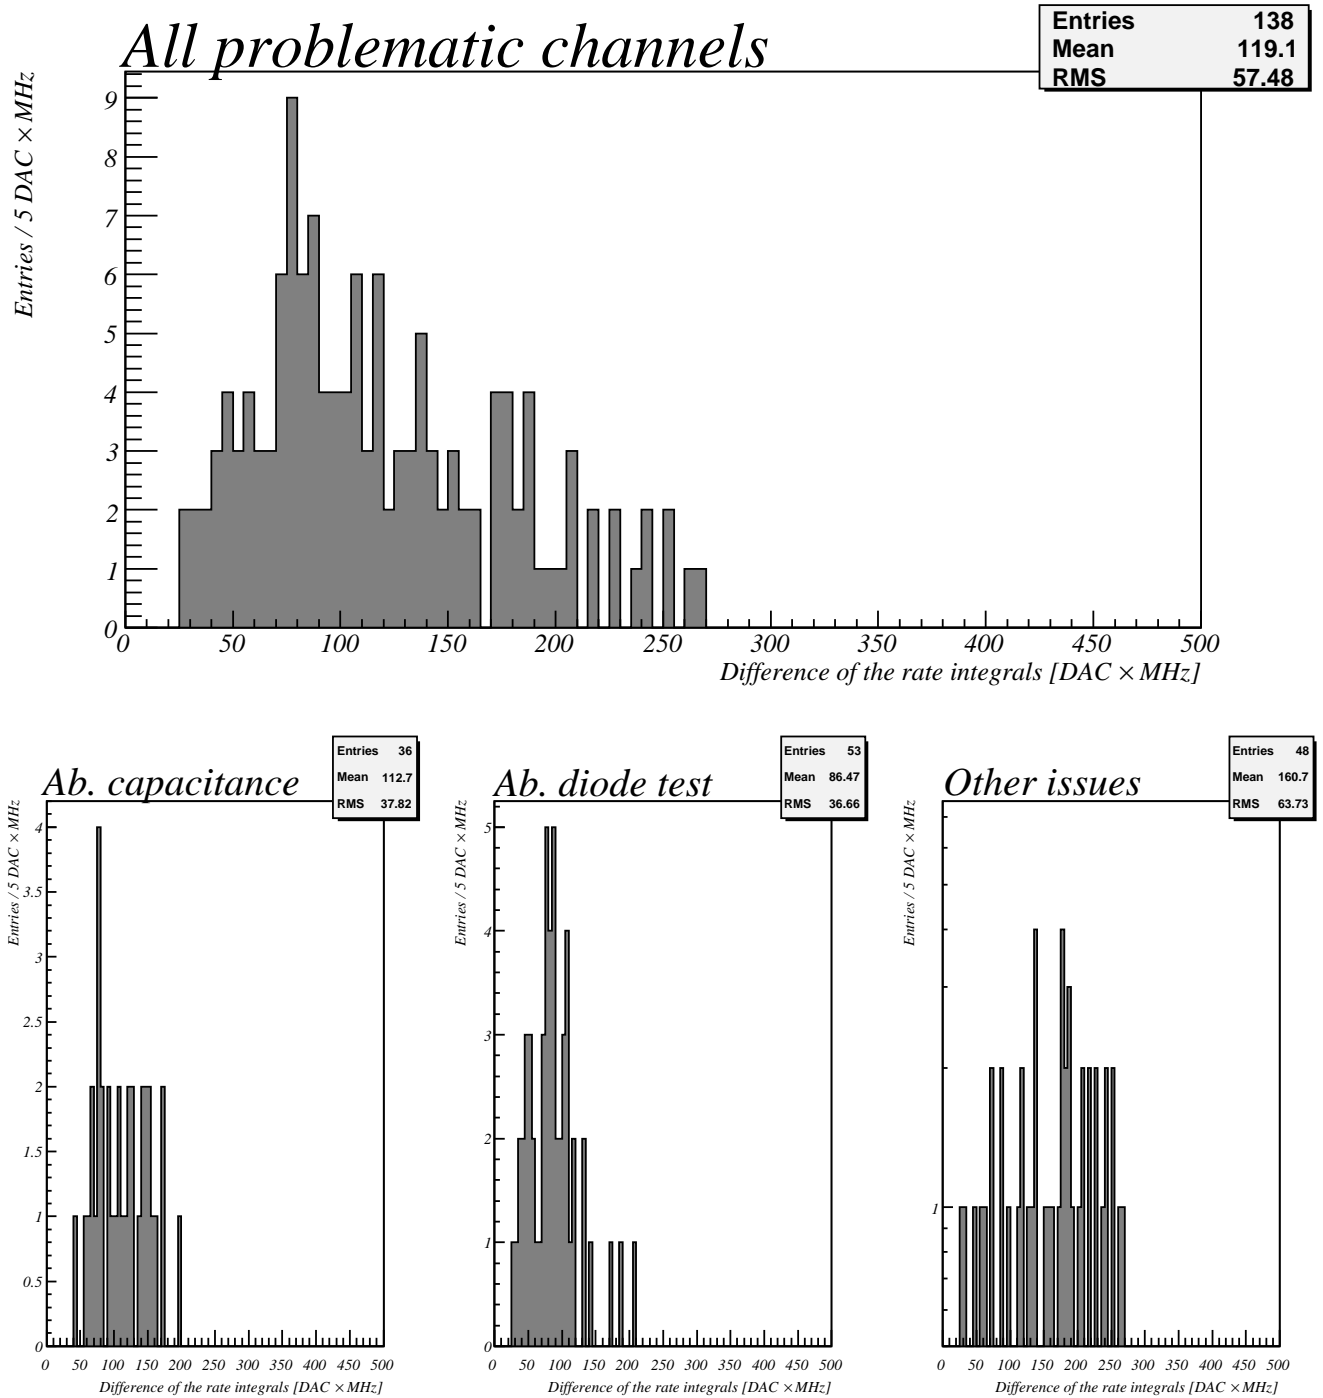
Figure 12: Rate integral distribution of the different problematic channels failing the Accumulation mode technique for A-type and B-type TRT wheels.

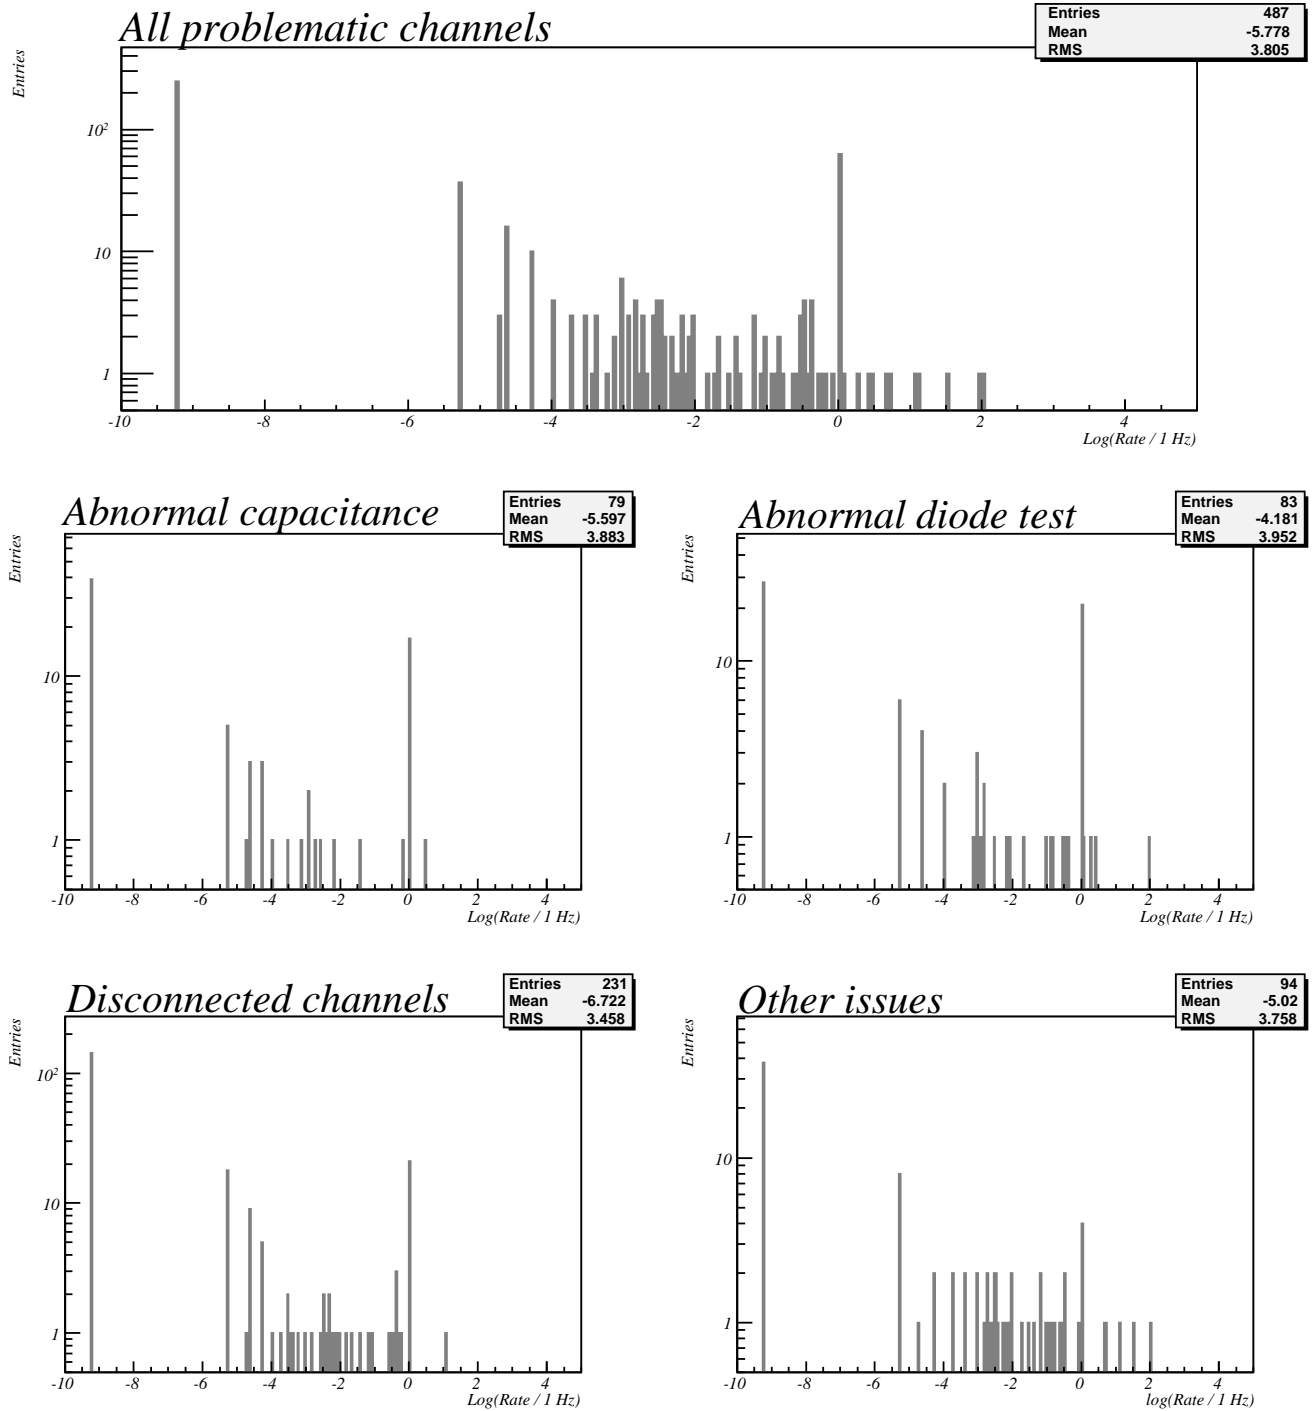
Figure 13: Dark current rate distribution of the different problematic channels for A-type and B-type TRT wheels.

the WEB average, below 0.01 Hz and reaches for most of these channels a typical value of 0 Hz (see Fig. 13).

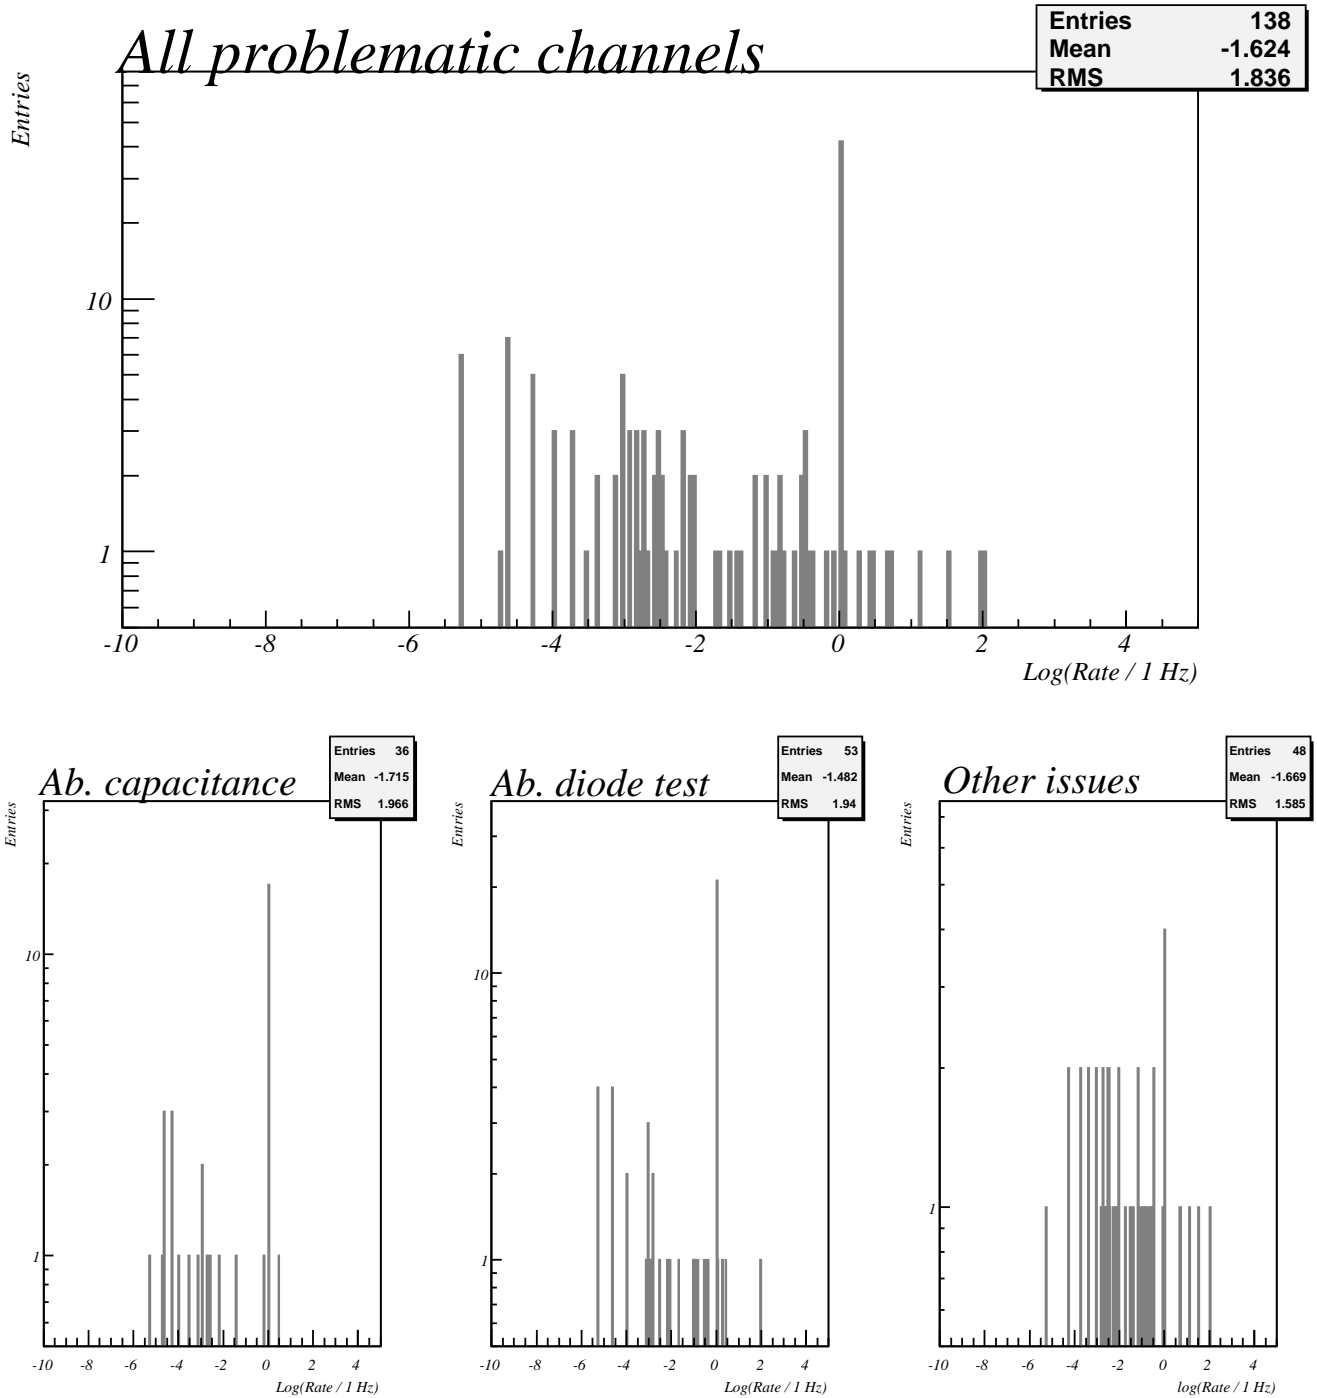
Figure 14: Dark current distribution of the different problematic channels failing the Accumulation mode technique for A-type and B-type TRT wheels.

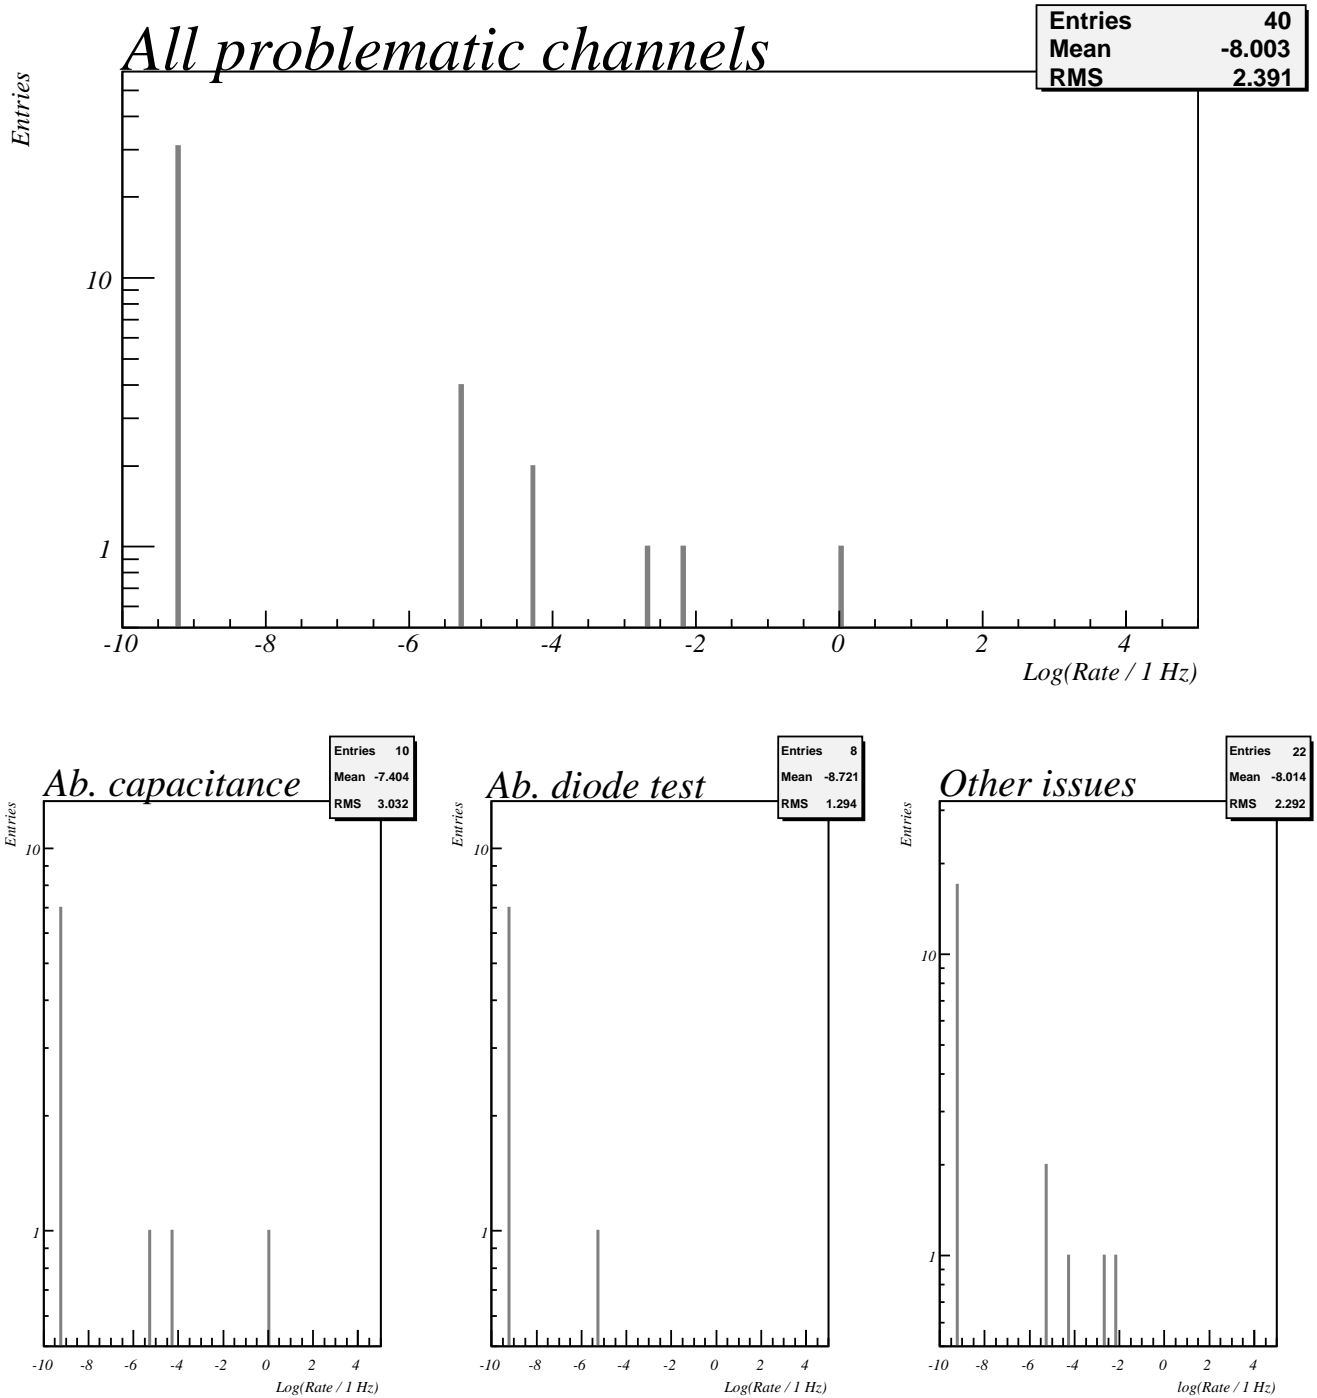
Figure 15: Dark current distribution of the different problematic channels failing the Noise Scan technique for A-type and B-type TRT wheels.
