A Method to check the Connectivity for the ATLAS TRT Detector

N. Ghodbane ^a, X. Pons ^a, O. M. Rohne ^b

Abstract

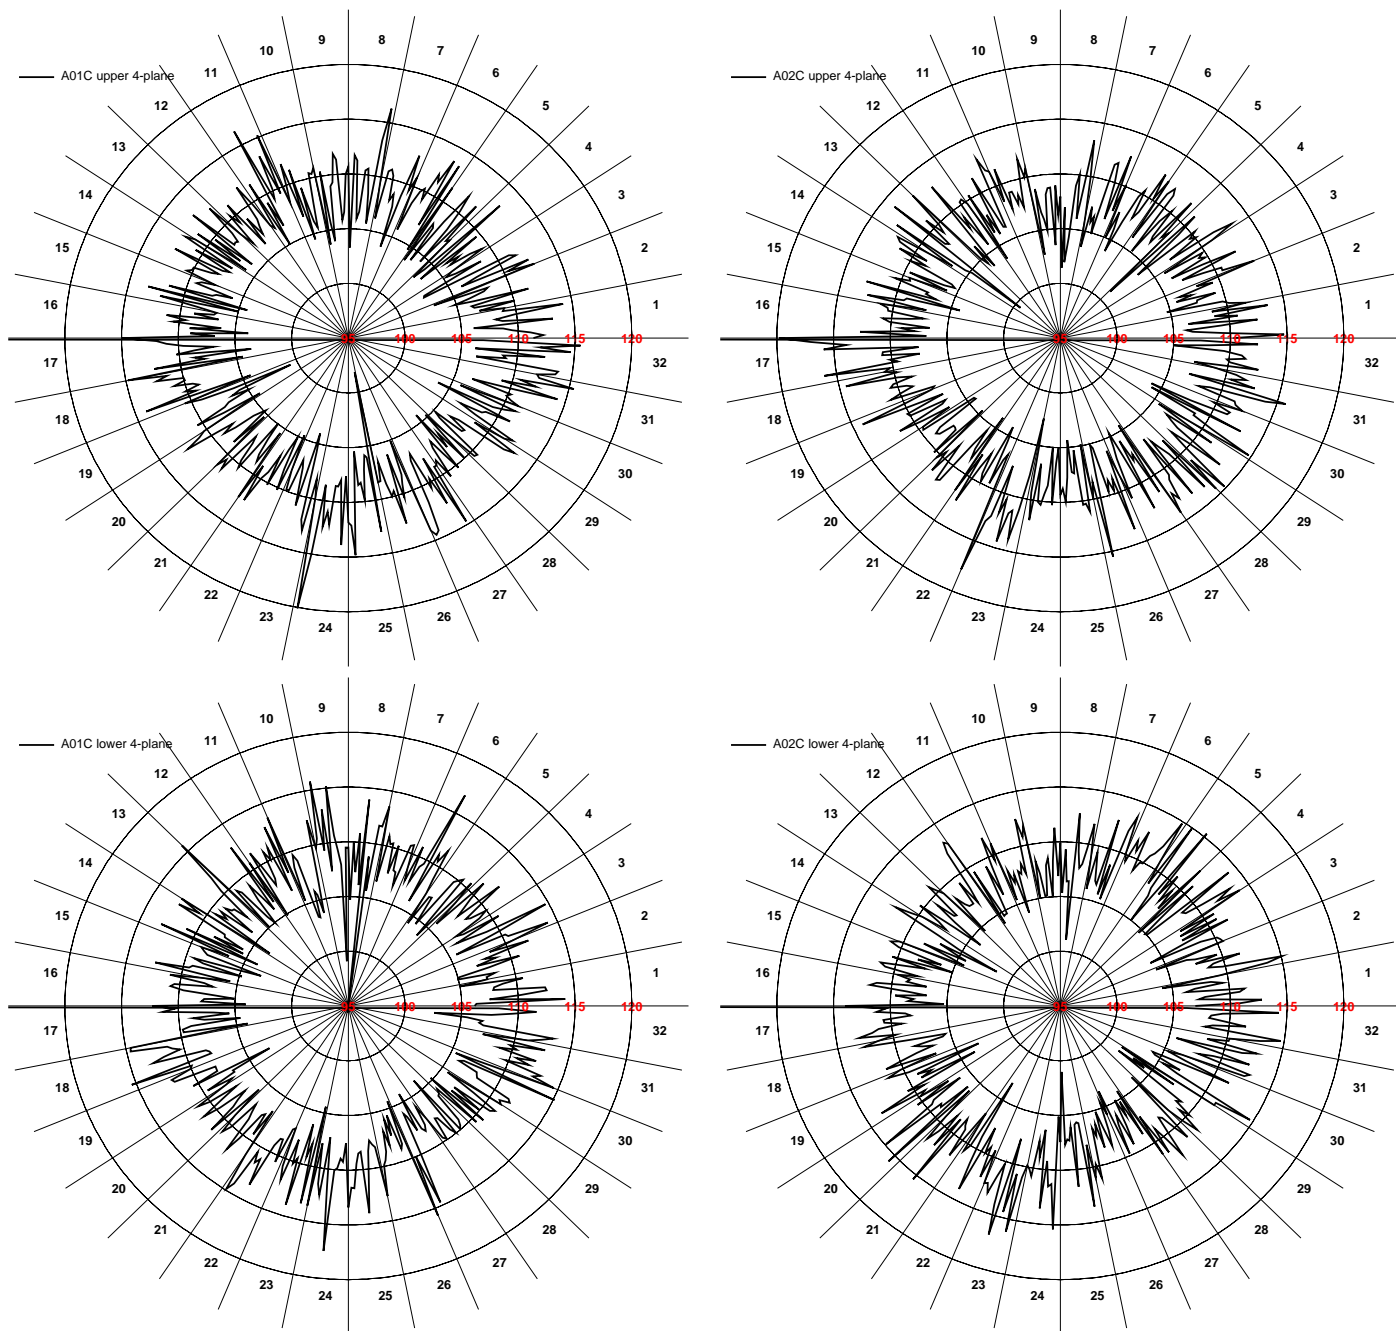
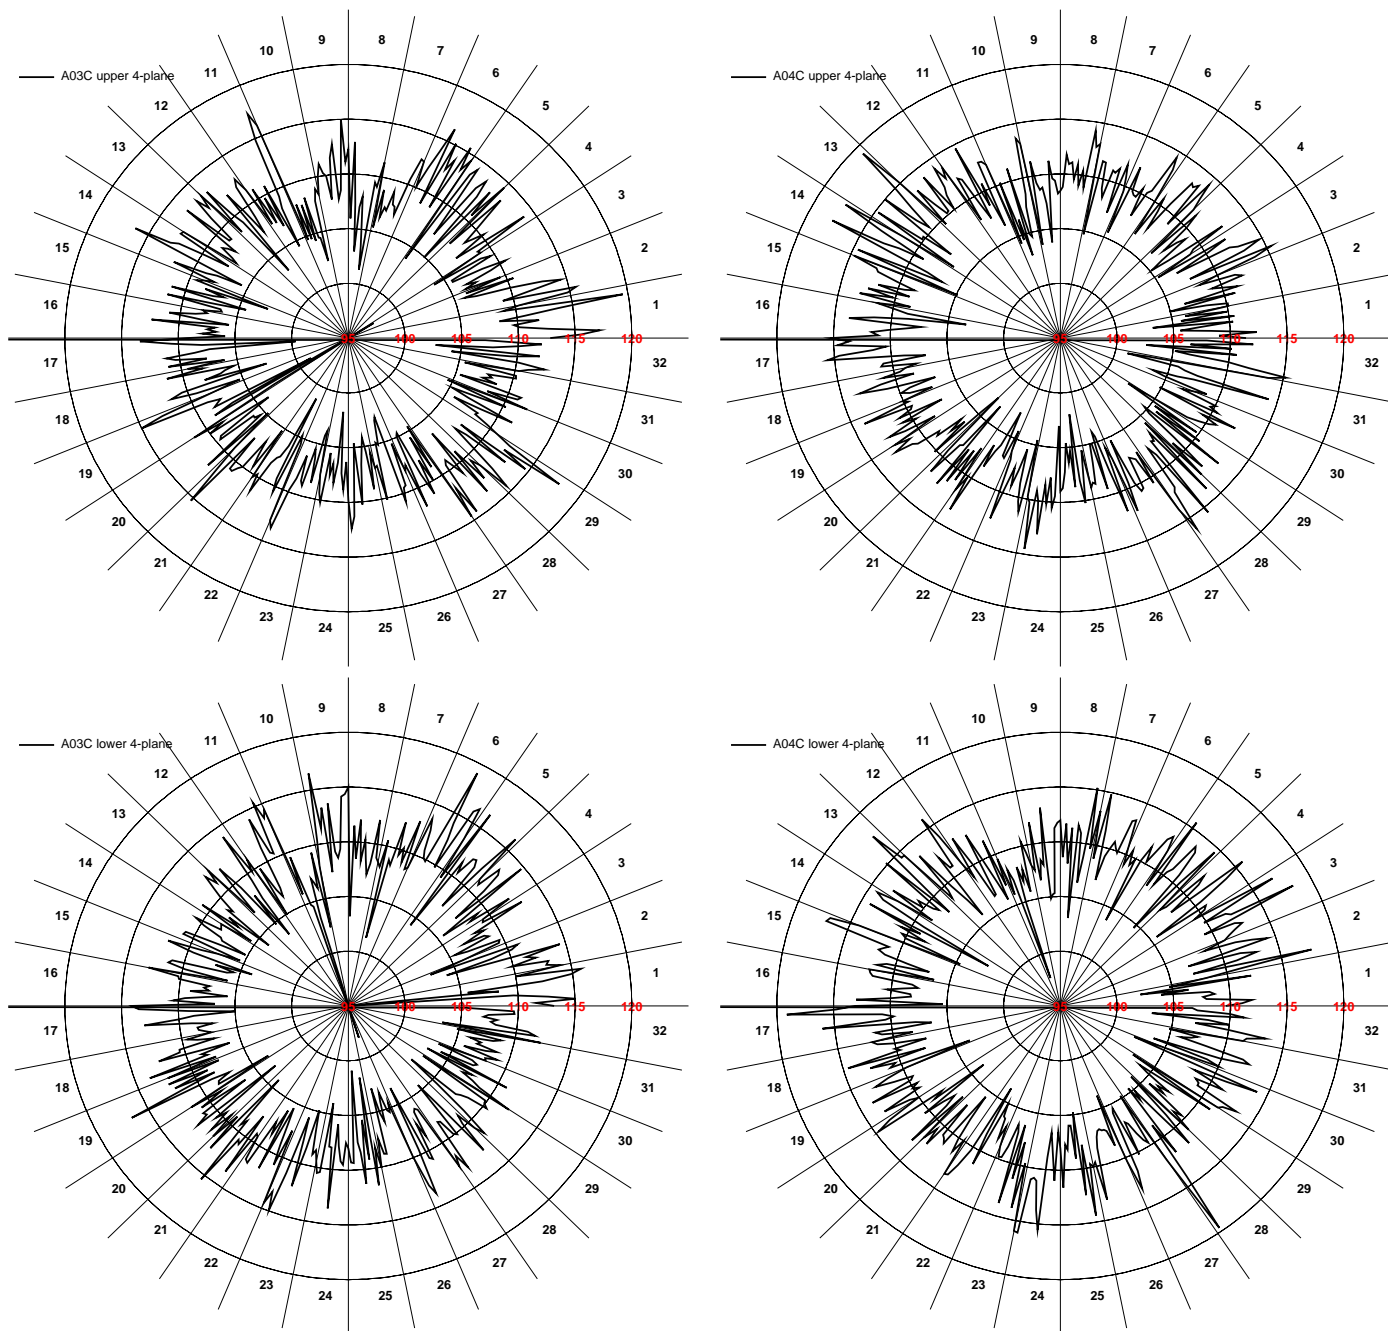
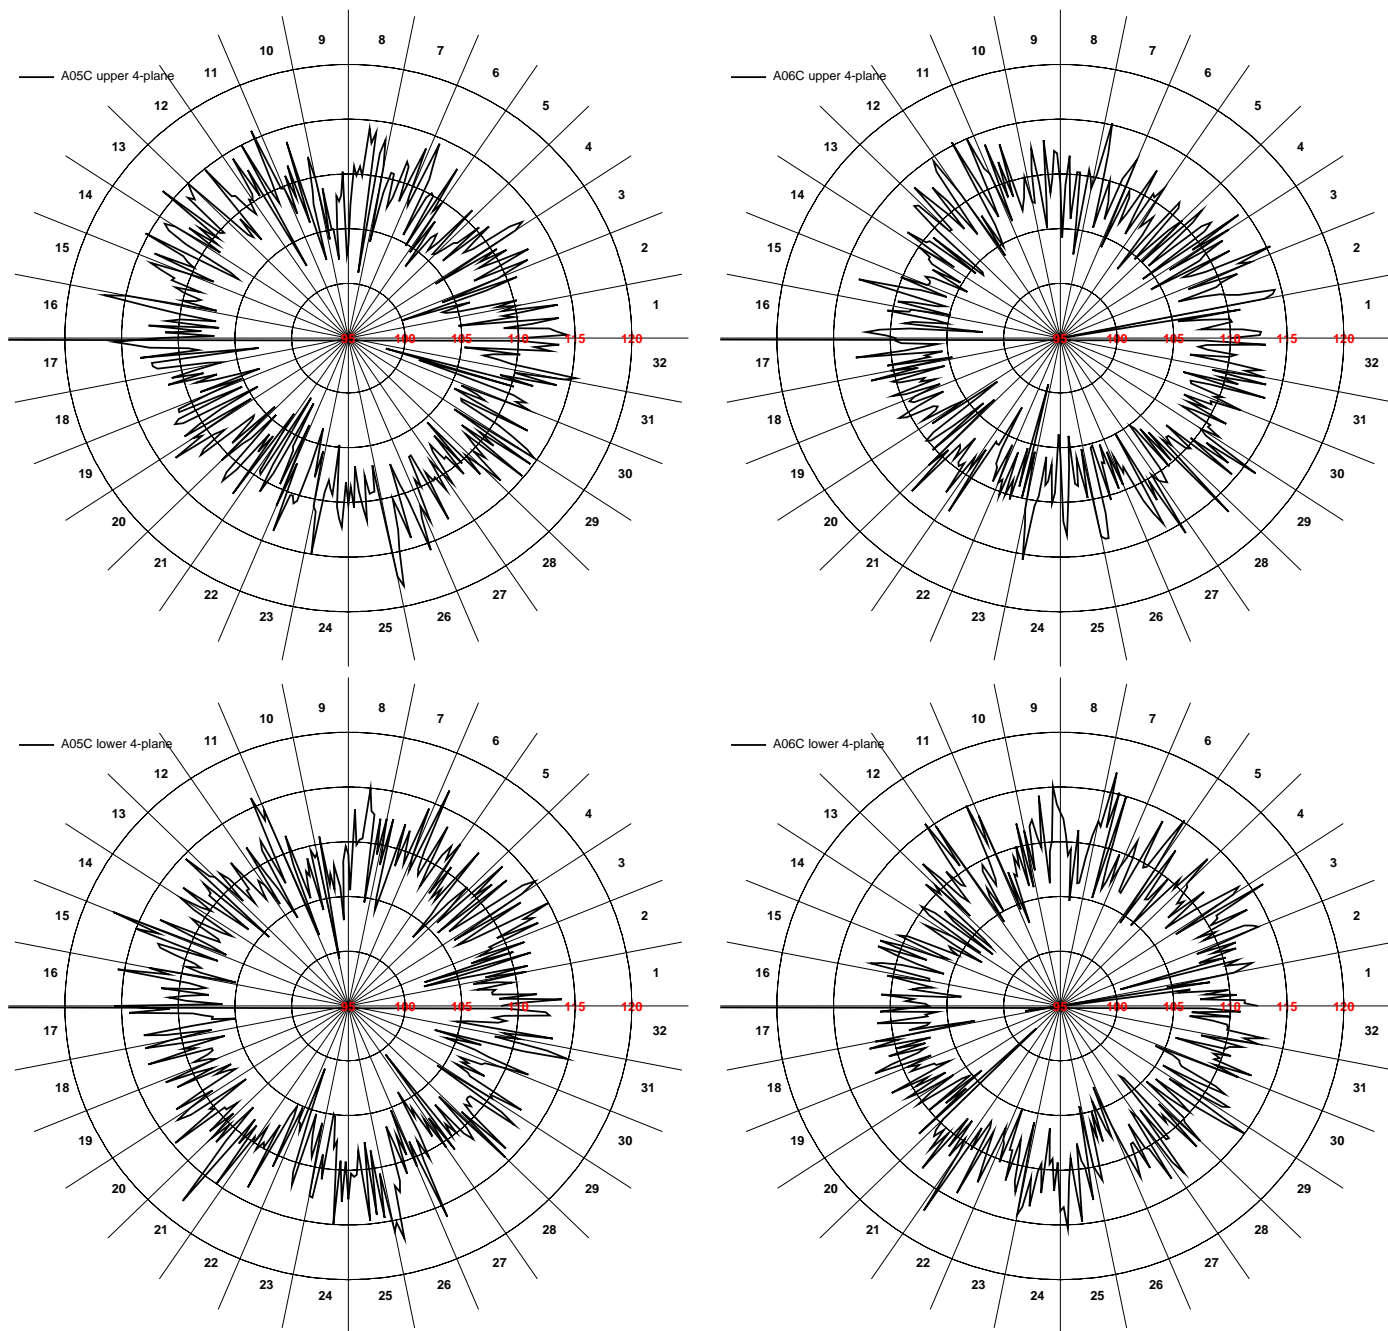
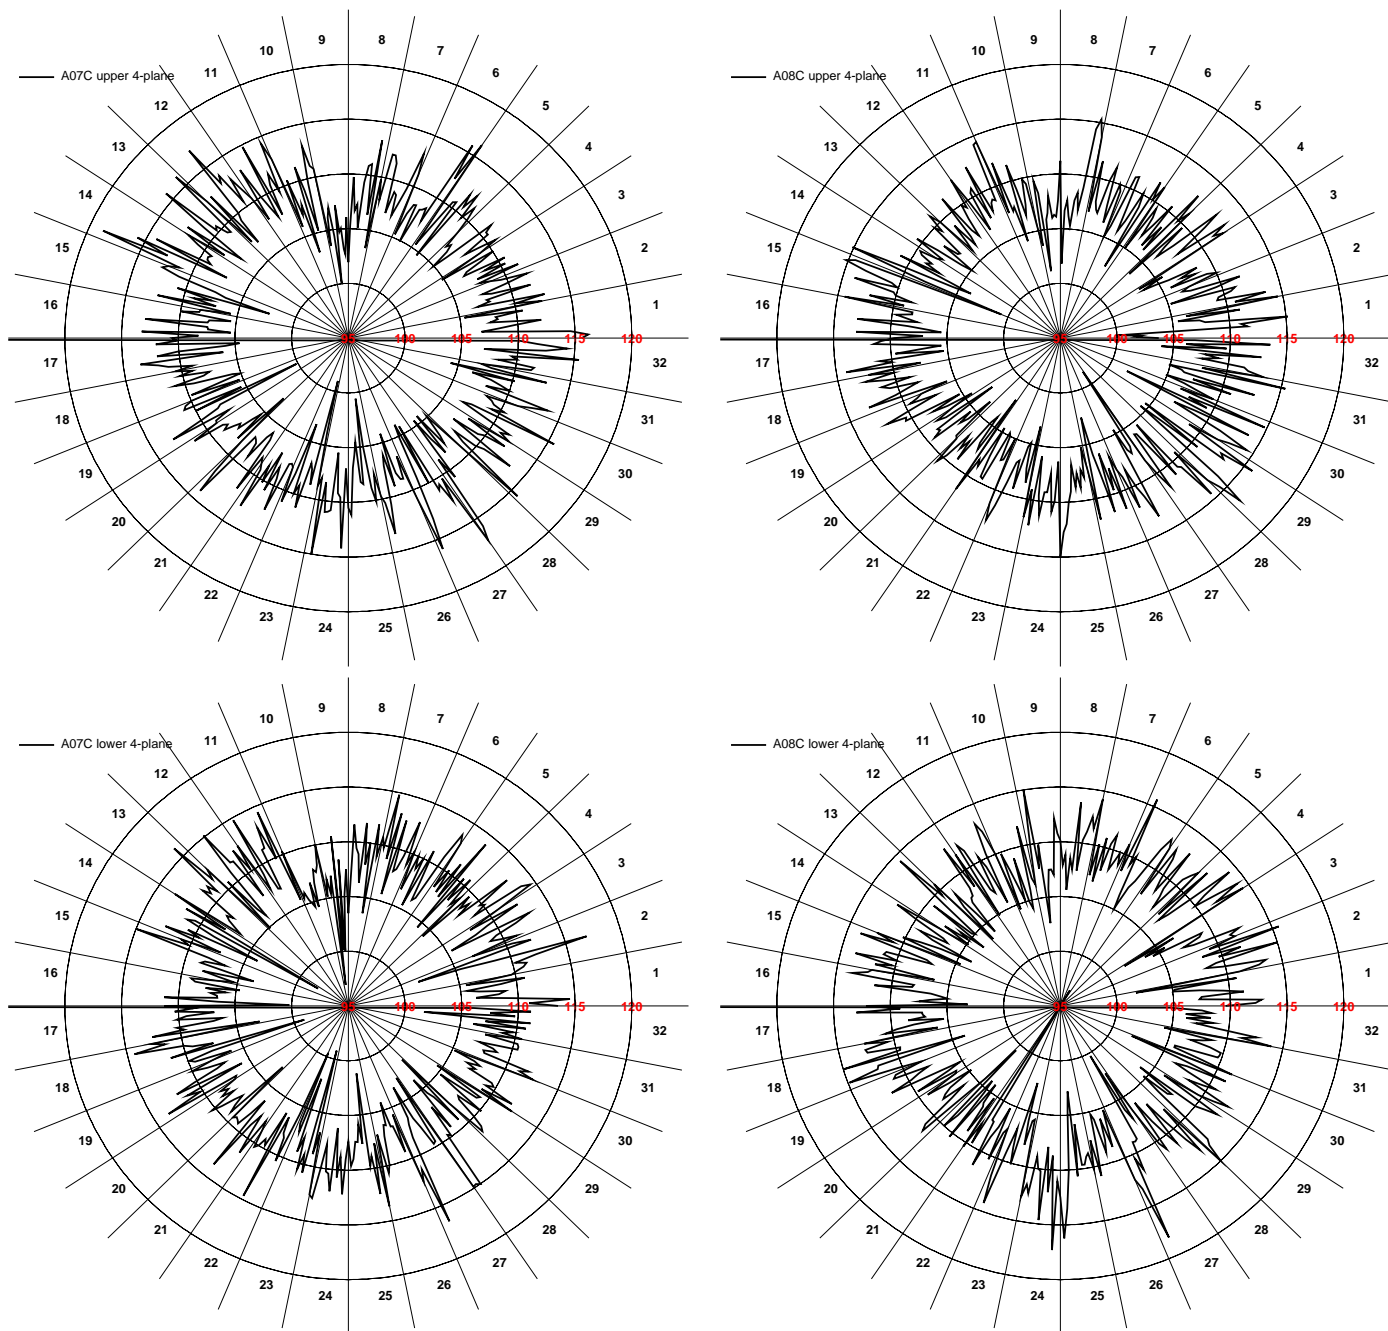
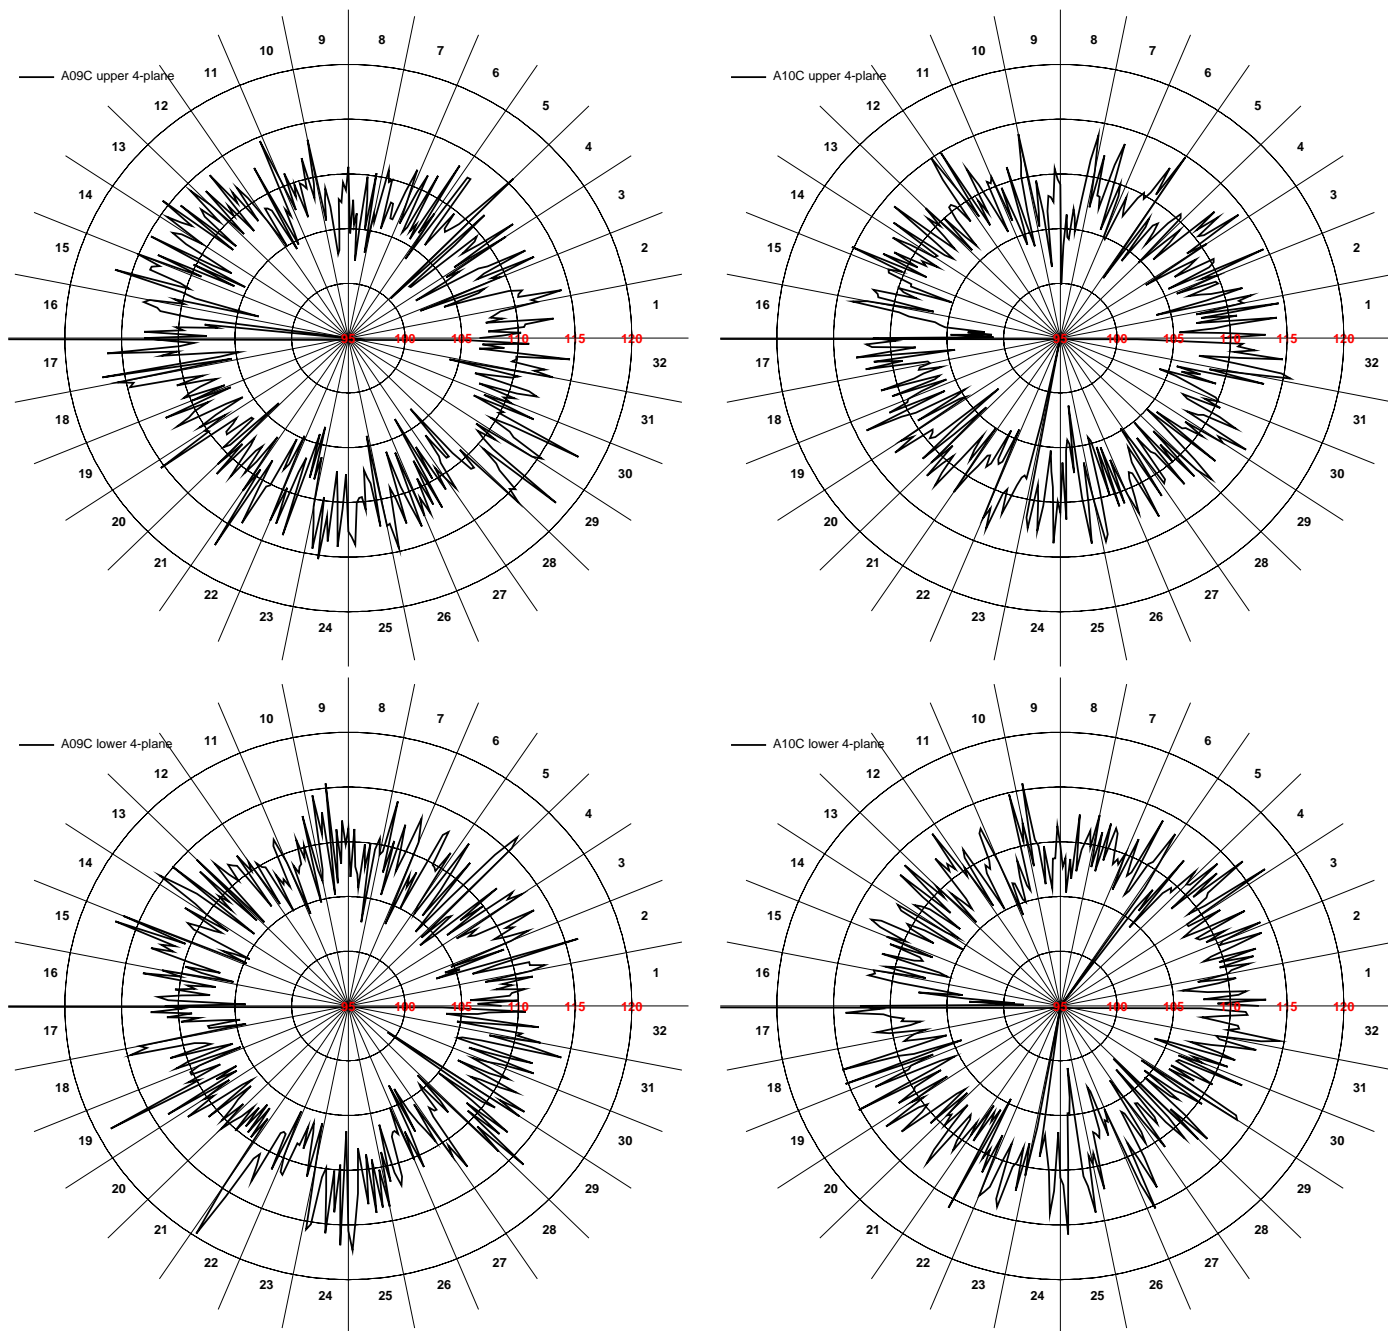
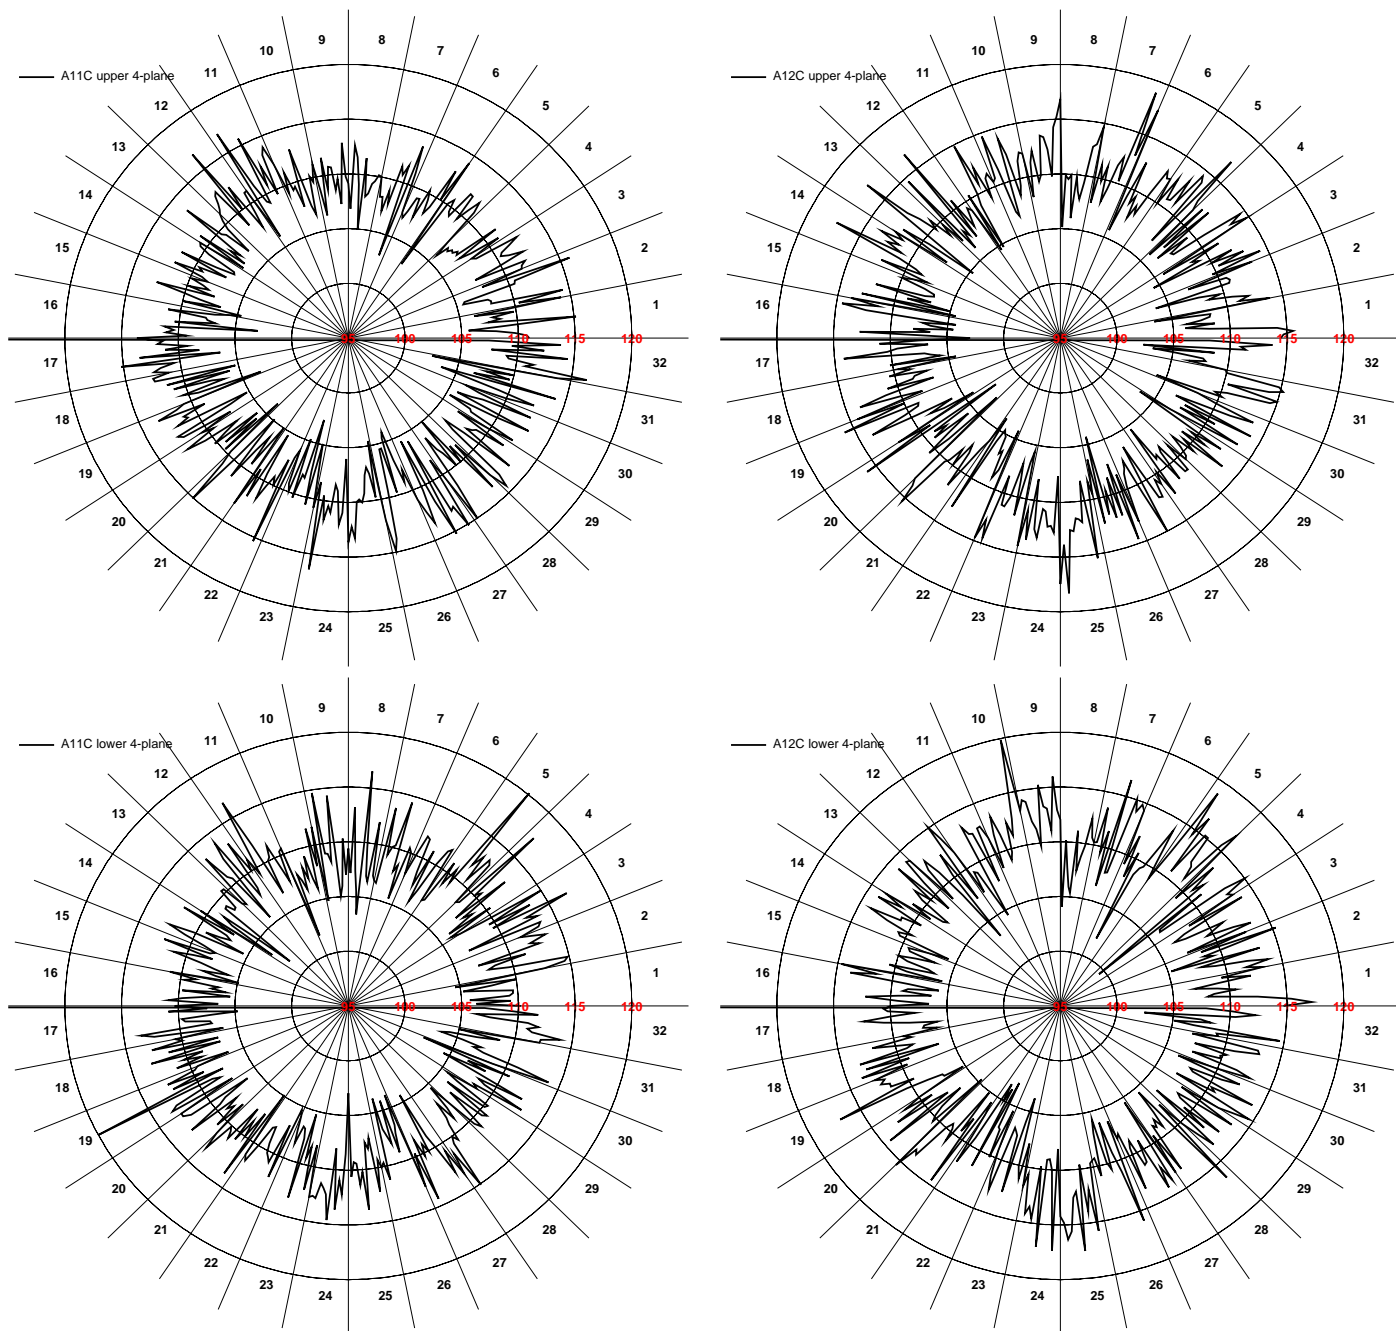
Figure 16: Average per ASDBLR 300 kHz DAC low-threshold for the two upper and lower 4-planes wheels A01C and A02C.

Figure 17: Average per ASDBLR 300 kHz DAC low-threshold for the two upper and lower 4-planes wheels A03C and A04C.

Figure 18: Average per ASDBLR 300 kHz DAC low-threshold for the two upper and lower 4-planes wheels A05C and A06C.

Figure 19: Average per ASDBLR 300 kHz DAC low-threshold for the two upper and lower 4-planes wheels A07C and A08C.

Figure 20: Average per ASDBLR 300 kHz DAC low-threshold for the two upper and lower 4-planes wheels A09C and A10C.

Figure 21: Average per ASDBLR 300 kHz DAC low-threshold for the two upper and lower 4-planes wheels A11C and A12C.

A powerful technique to identify possible problems for the different readout channels of the ATLAS Transition Radiation Tracker has been described. Applied to the case of one TRT endcap-detector, it shows that 99.6 % of the readout channels are perfectly operational. The remaining 0.4 % are essentially due to metallisation issues of the active WEBs. Moreover, several goals concerning electronics performance and not discussed in this report, have been achieved, like for instance the $\simeq 2\%$ occupancy corresponding to a low-level threshold at about 110-120 DAC counts (see Fig. 16 to Fig. 25).

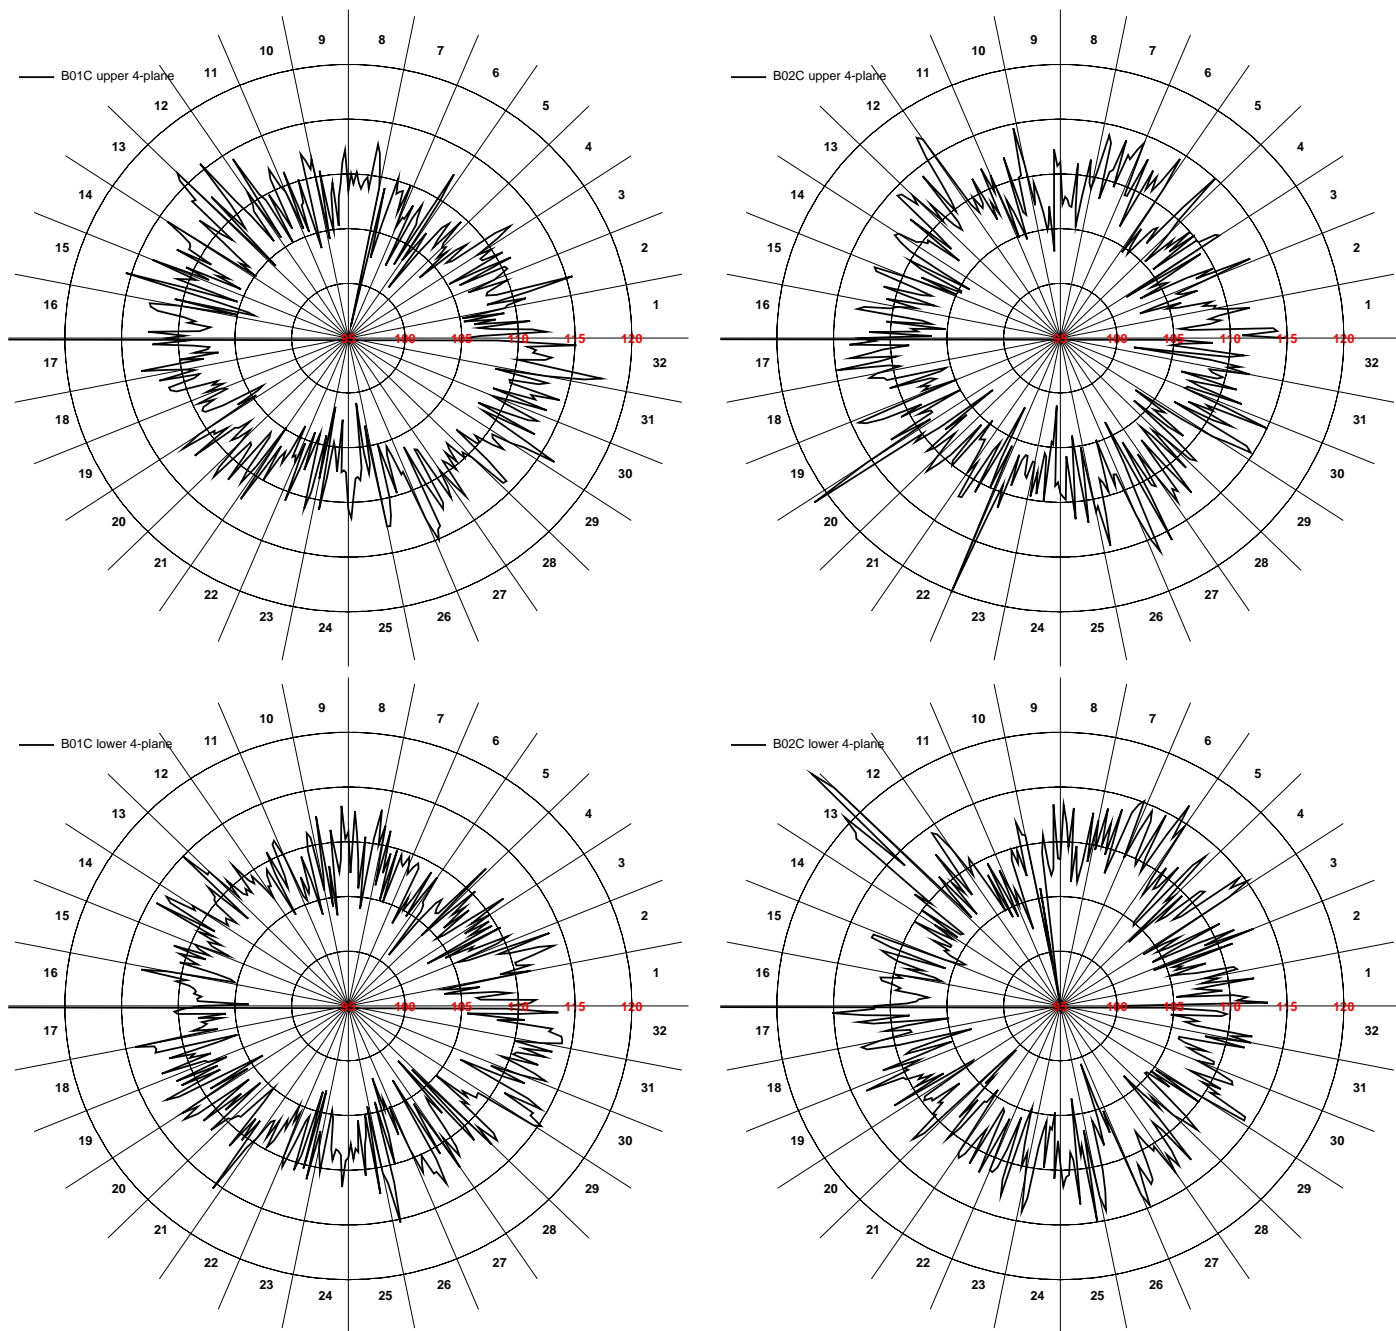
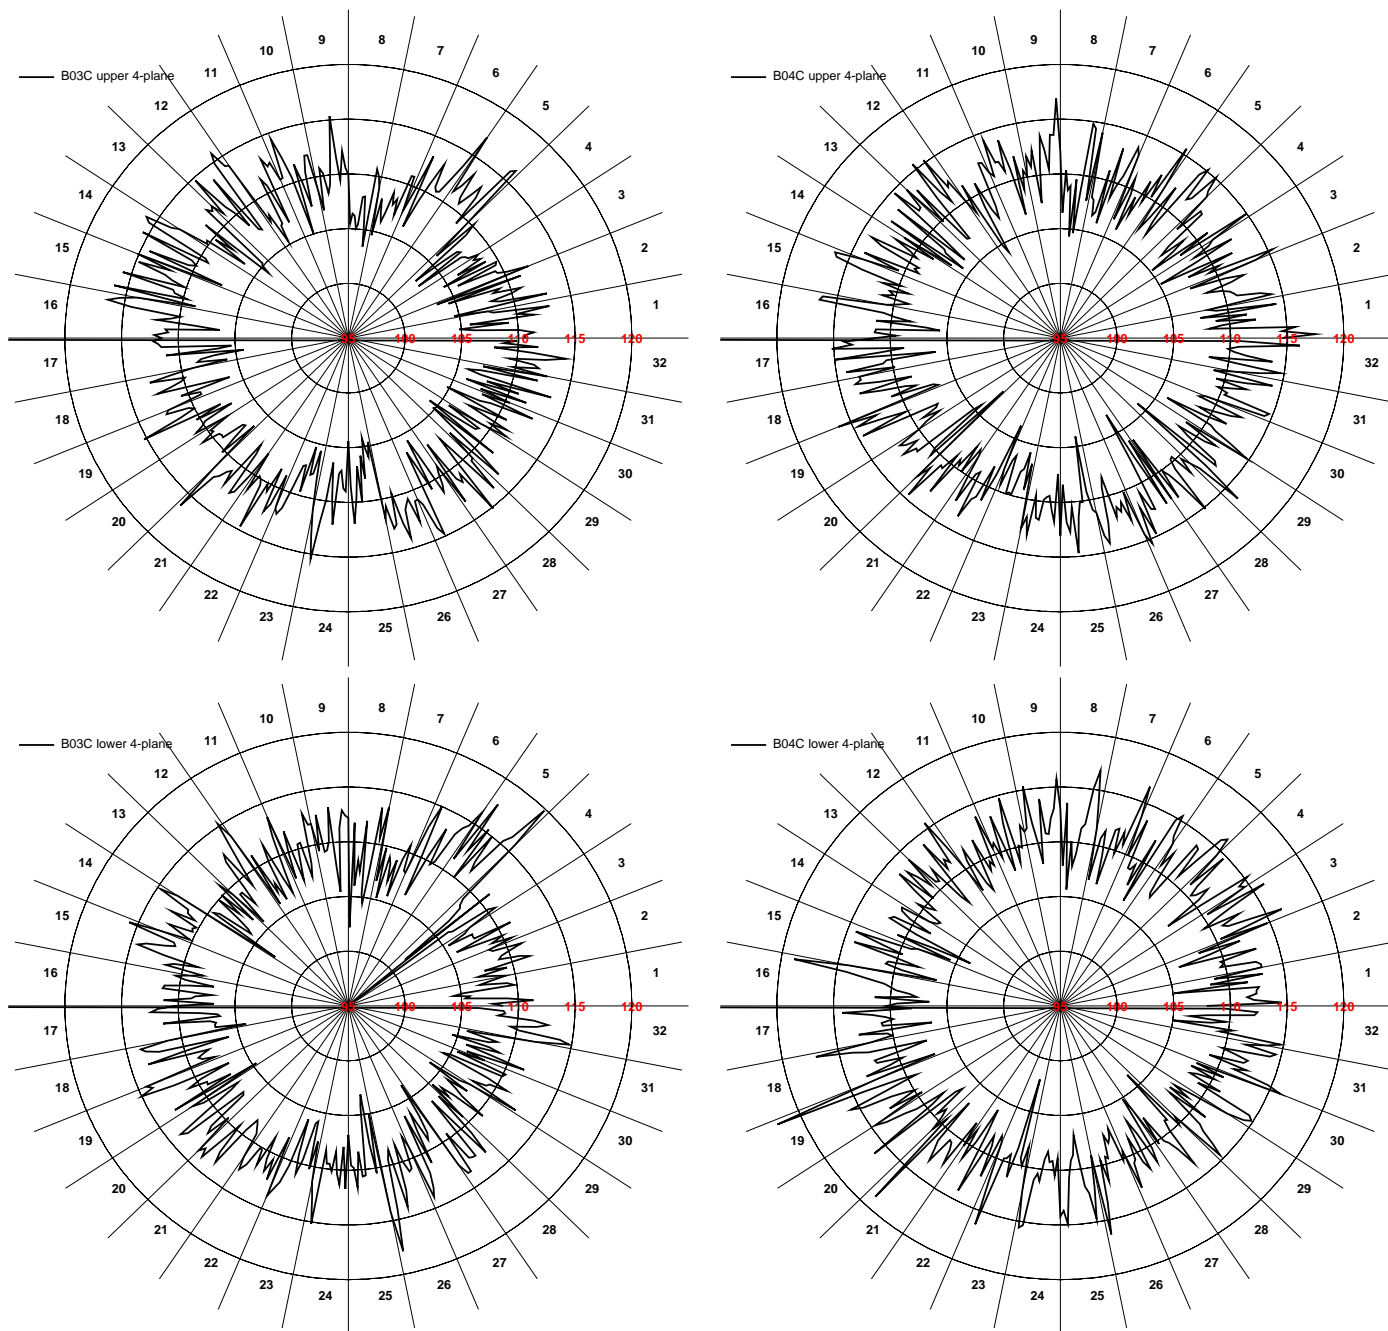
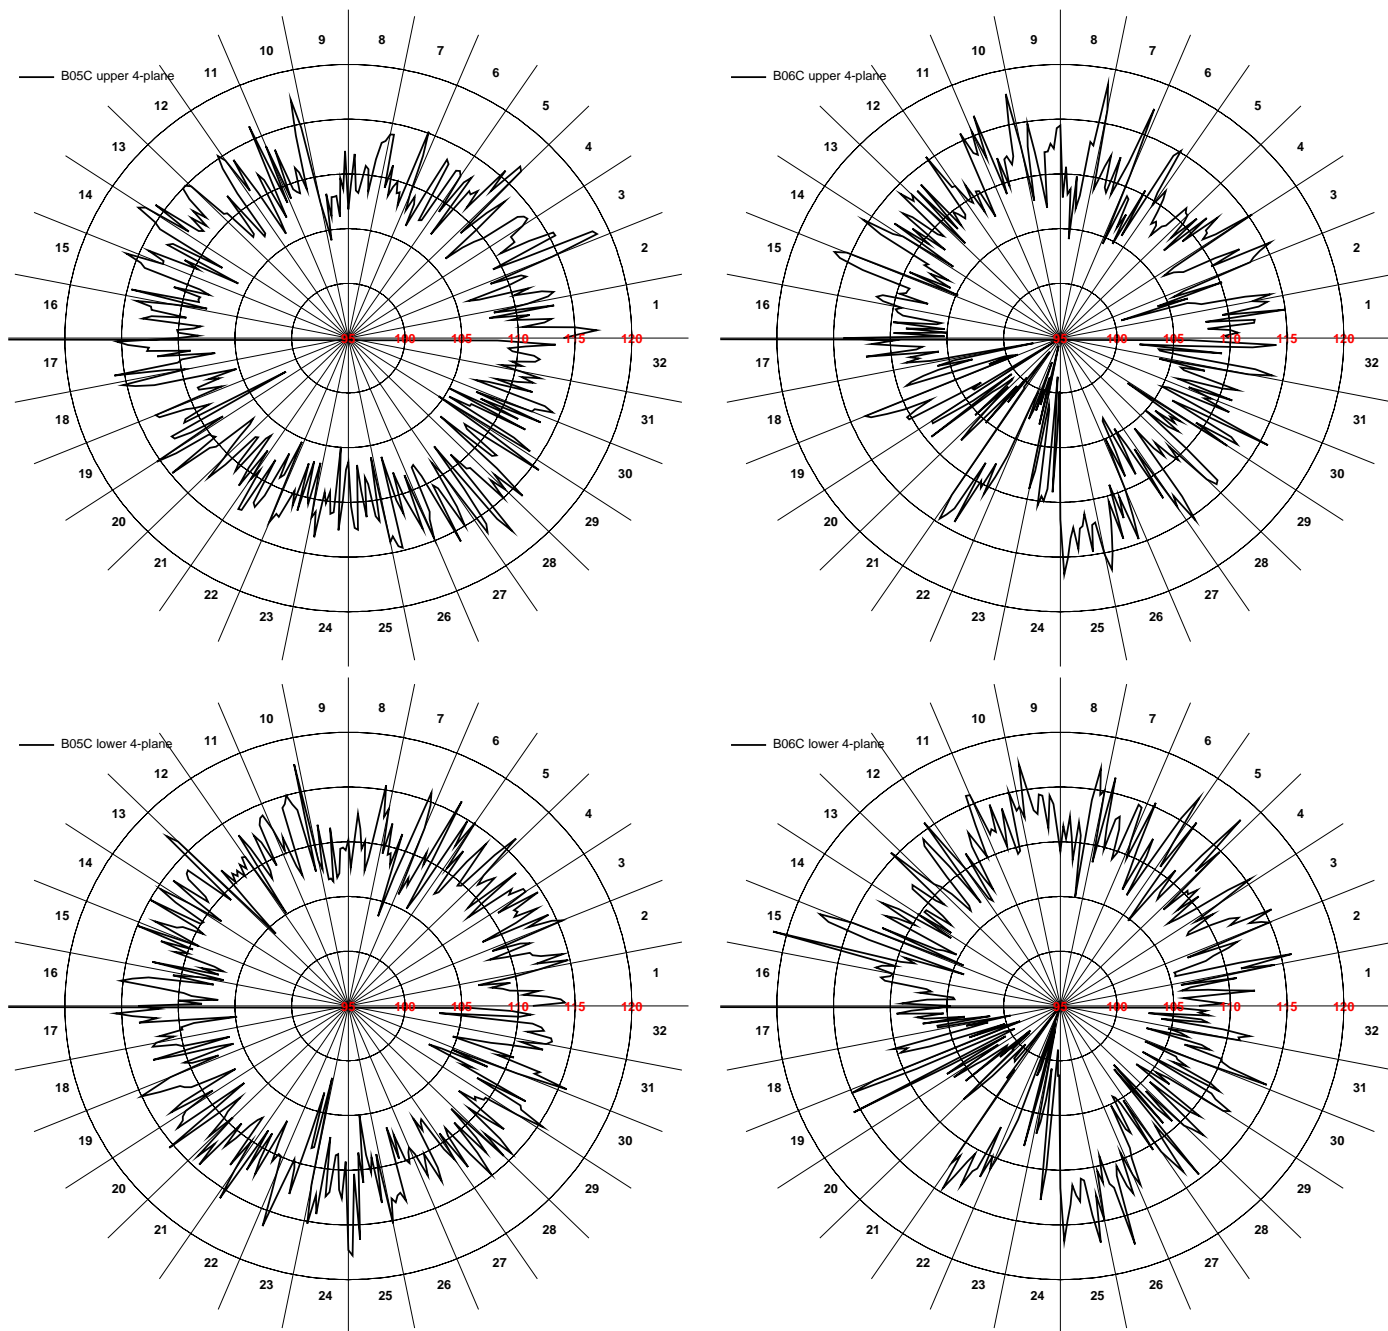
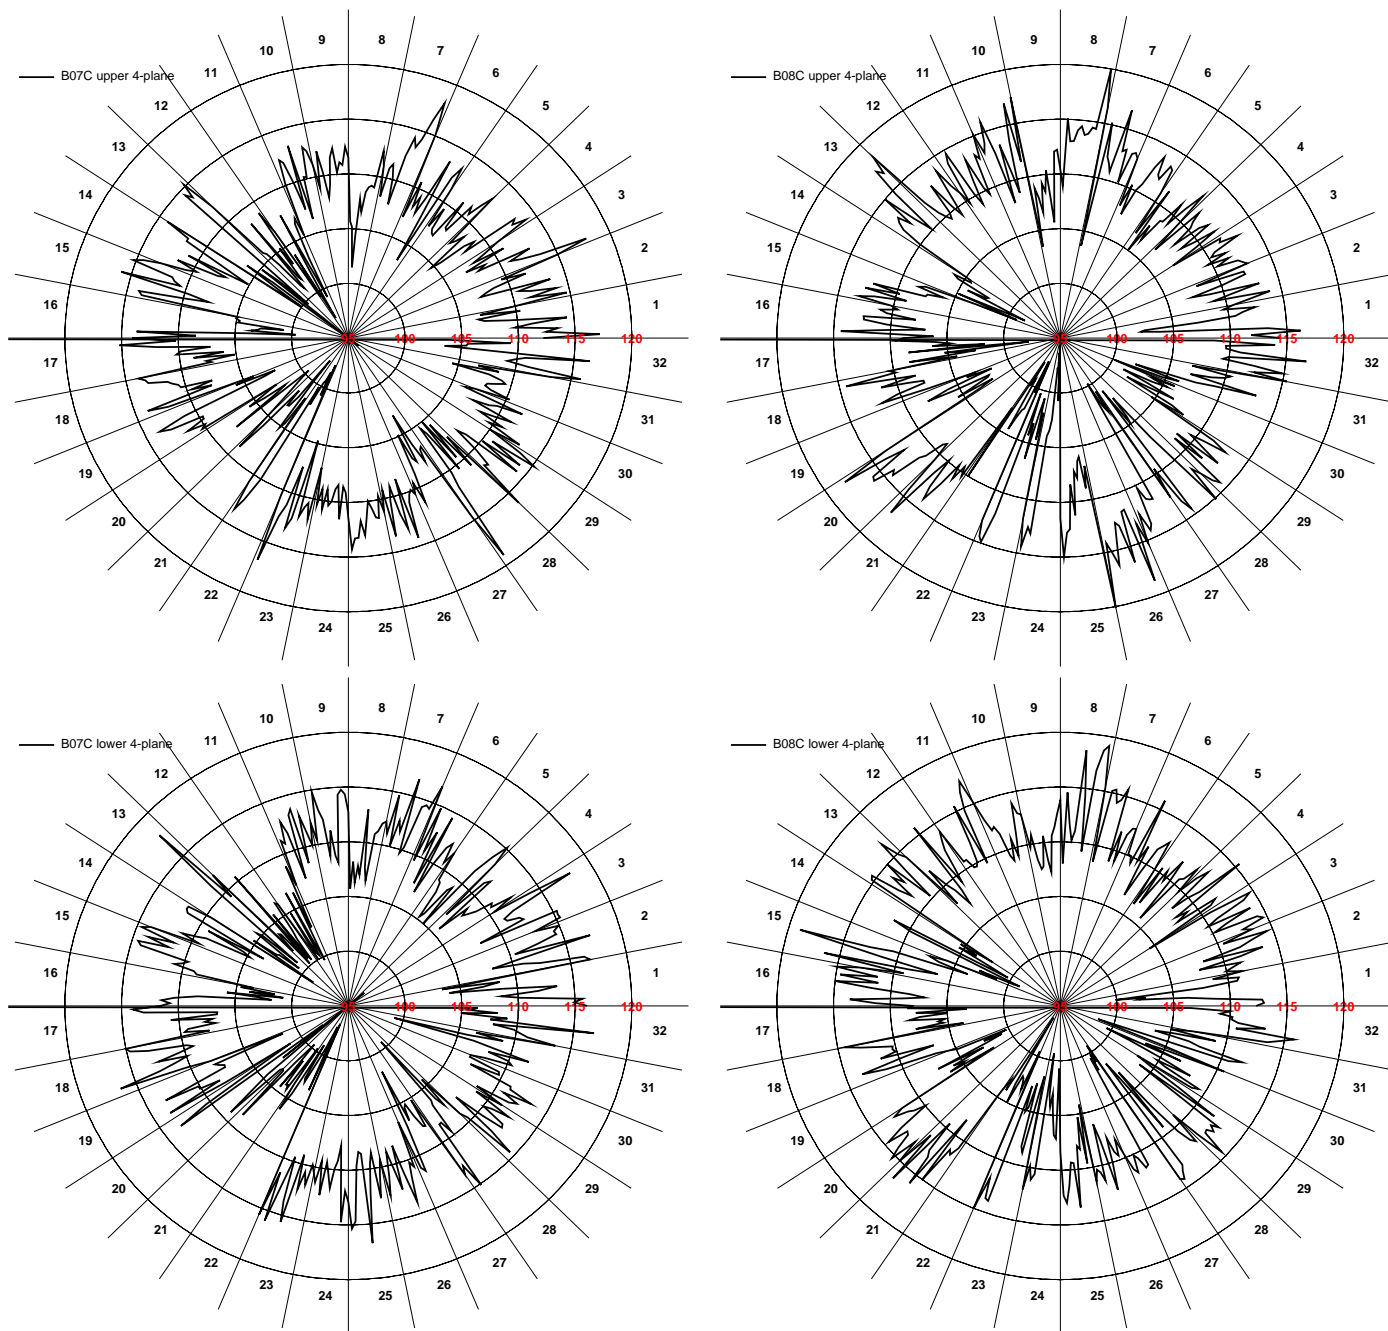
Figure 22: Average per ASDBLR 300 kHz DAC low-threshold for the two upper and lower 4-planes wheels B01C and B02C.

Figure 23: Average per ASDBLR 300 kHz DAC low-threshold for the two upper and lower 4-planes wheels B03C and B04C.

Figure 24: Average per ASDBLR 300 kHz DAC low-threshold for the two upper and lower 4-planes wheels B05C and B06C.

Figure 25: Average per ASDBLR 300 kHz DAC low-threshold for the two upper and lower 4-planes wheels B07C and B08C.
