# Nanoscale insights on the origin of the Power MOSFETs breakdown after extremely long high temperature reverse bias stress

**Abstract.** In this work, the origin of the dielectric breakdown of 4H-SiC power MOSFETs was studied at the nanoscale, analyzing devices that failed after extremely long (three months) of high temperature reverse bias (HTRB) stress. A one-to-one correspondence between the location of the breakdown event and a threading dislocation propagating through the epitaxial layer was found. Scanning probe microscopy (SPM) revealed the conductive nature of the threading dislocation and a local modification of the minority carriers concentration. Basing on these results, the role of the threading dislocation on the failure of 4H-SiC MOSFETs could be clarified.

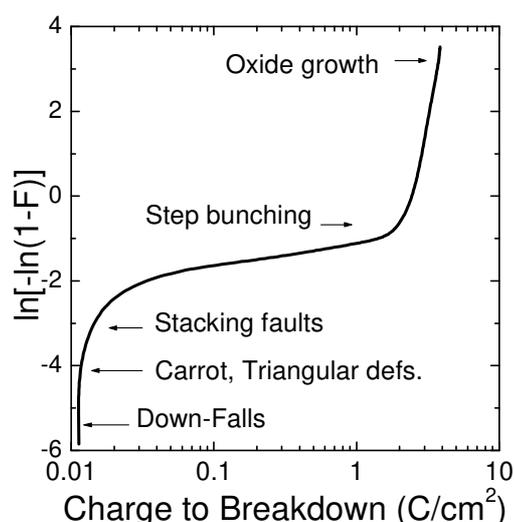
Fig. 1: Schematic representation of a typical Weibull distribution of 4H-SiC MOS capacitors referenced with defects that may affect the device lifetime.

Fig. 1 graphically depicts the possible impact of several types of crystalline defects on the typical Weibull failure statistics of 4H-SiC MOS devices [12]. A device can be defined robust when the amount of charge flowed in the insulator before breakdown is larger than  $1 \text{ C/cm}^2$ . As can be seen, the oxide growth quality only affects the intrinsic devices population (high charge-to-breakdown). On the other hand, surface defects, like down-falls, carrots and step-bunching, produce the appearance of the extrinsic breakdown population (low charge-to-breakdown). However, the role of threading dislocations (threading screw dislocations (TSDs) and threading edge dislocations (TEDs)) as killer defects for 4H-SiC MOSFETs is still unclear [13,14].

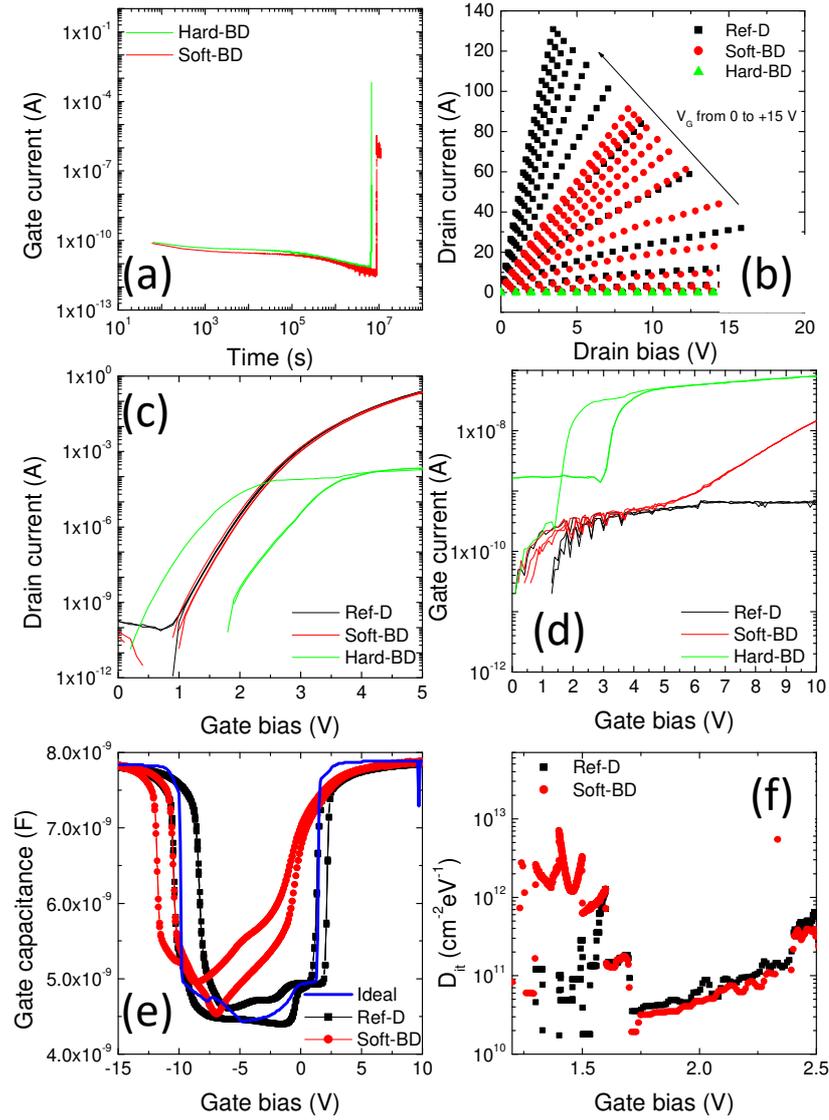
Fig. 2: (a)  $I_G$ - $t$  in HTRB (b)  $I_D$ - $V_D$  (c)  $I_D$ - $V_G$  (d)  $I_D$ - $V_G$  (e)  $C$ - $V$  and (f)  $D_{it}$ - $V_G$

Fig. 2a shows the gate current of two failed devices test at  $140^\circ\text{C}$  and  $V_{\text{DS}}=600 \text{ V}$  for  $10^7 \text{ s}$ . For one device the current was limited to  $10^{-7} \text{ A}$  (Soft breakdown Soft-BD device), while the second was not limited (Hard breakdown Hard-BD device). In the mentioned HTRB configuration, the maximum of the electric field in the insulator is about  $4.6 \text{ MV/cm}$ . As can be seen in Fig. 2b, the  $I_{\text{D}}-V_{\text{D}}$  characteristics of the two failed devices are compared with those of a device that survived to the HTRB test (Reference Ref-D device). While the device Soft-BD shows a degradation of the output characteristics compared to Ref-D, the Hard-BD does not show the typical working device behavior, since no gate modulation on the drain conduction is observed (no  $I_{\text{D}}-V_{\text{D}}$  is measured at high  $V_{\text{G}}$ ). Analogously, by repeating three times the  $I_{\text{D}}-V_{\text{G}}$  characteristics (Fig. 2c) on each device, it is possible to notice a similar behavior of Ref-D and Soft-BD (with no shift of the characteristics). On the other hand, Hard-BD shows a normally-on behavior and a shift of the transfer characteristics, thus indicating the occurrence of a charge trapping. Furthermore, the gate current (Fig. 2d) collected with a similar procedure shows an increase at  $V_{\text{G}}>2\text{V}$  for Soft-BD compared to Ref-D, thus indicating a partial degradation of the insulator due to an enhanced conduction. The Hard-BD shows a significant gate current enhancement and the shift occurring by repeating the measurements confirms the occurrence of charge trapping.

Furthermore, the  $C$ - $V$  curves collected at 1 kHz on the Ref-D and Soft-BD were compared with the ideal curve calculated with SILVACO tools (Fig. 2e). The  $C$ - $V$  curve of the Ref-D is in good agreement with the ideal  $C$ - $V$  curve, except for the hysteresis due to the charge/discharge of pre-existing interface states [15]. On the other hand, the  $C$ - $V$  curve of Soft-BD is stretched (Fig. 2e), due to the presence of interface states. The interface states density ( $D_{it}$ ) vs gate capacitance was determined from the curves stretch out and is reported in Fig. 2f. In power MOSFET, the gate contact and the gate insulator are fabricated covering simultaneously a p-type (body) and an n-type region (JFET). Hence, for a given gate bias value the energy levels in the body and in the JFET region are not identical. Hence, the  $D_{it}$  profiling shown in Fig. 2f is not converted as a function of the energy position but it is kept as a function of the gate bias. Nevertheless, the direct comparison between identical devices can give useful information on the creation of interface states. The comparison of the  $D_{it}$  profiles of the Ref-D and Soft-BD reveals that the  $D_{it}$  near the 4H-SiC conduction band edge ( $V_G=2.5V$ ) is about  $10^{12}cm^{-2}eV^{-1}$  in both cases. On the other hand, in the case of Soft-BD an increase of the  $D_{it}$  at mid-gap is observed, thus indicating the creation of these additional states during HTRB failure. Hence, it can be argued that these mid-gap states created during the HTRB can act as donor like introducing an effective positive charge in the MOS

system. This can contribute with the progressive reduction of the gate current observed in Fig. 2a together with and hole-trapping in the insulator.

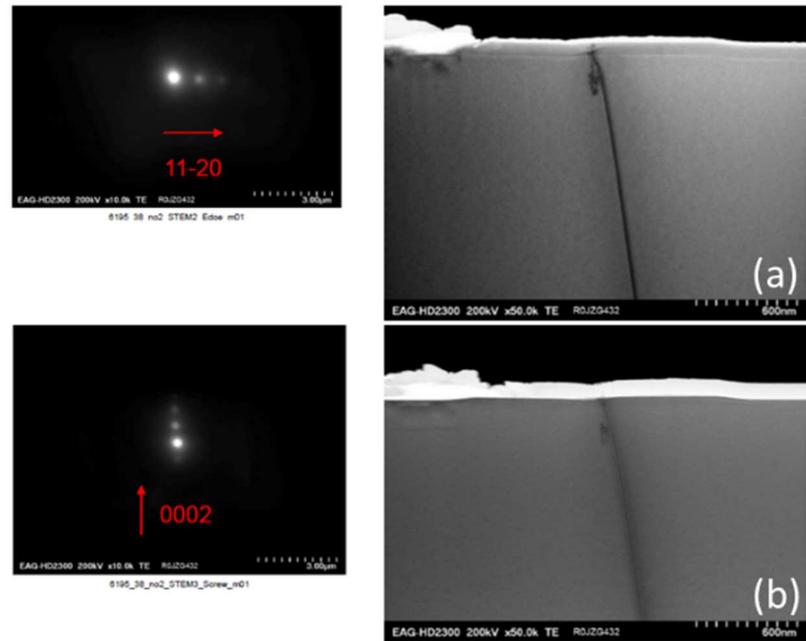
Fig. 3: (a) Cross section TEM in 2-beams configuration [11-20] (b) Cross section TEM in 2-beams configuration [0002].

TEM in cross section allowed to detect the presence of a threading dislocation (TD) running along the epitaxial layer from the substrate up to the surface. The TEM dual beam investigation ([11-20] and [0002]) shown in Figs. 3a and 3b allowed to establish the mixed nature of the dislocation. In particular, the dislocation shows up with the [11-20] spot (edge) and with the [0002] spot (screw). In fact, it was unclear whether threading dislocations (screw and edge) behave as killer defects in 4H-SiC MOSFETs. Threading dislocations have been suspected [13,16] and absolved [14,17] of inducing early device breakdown.

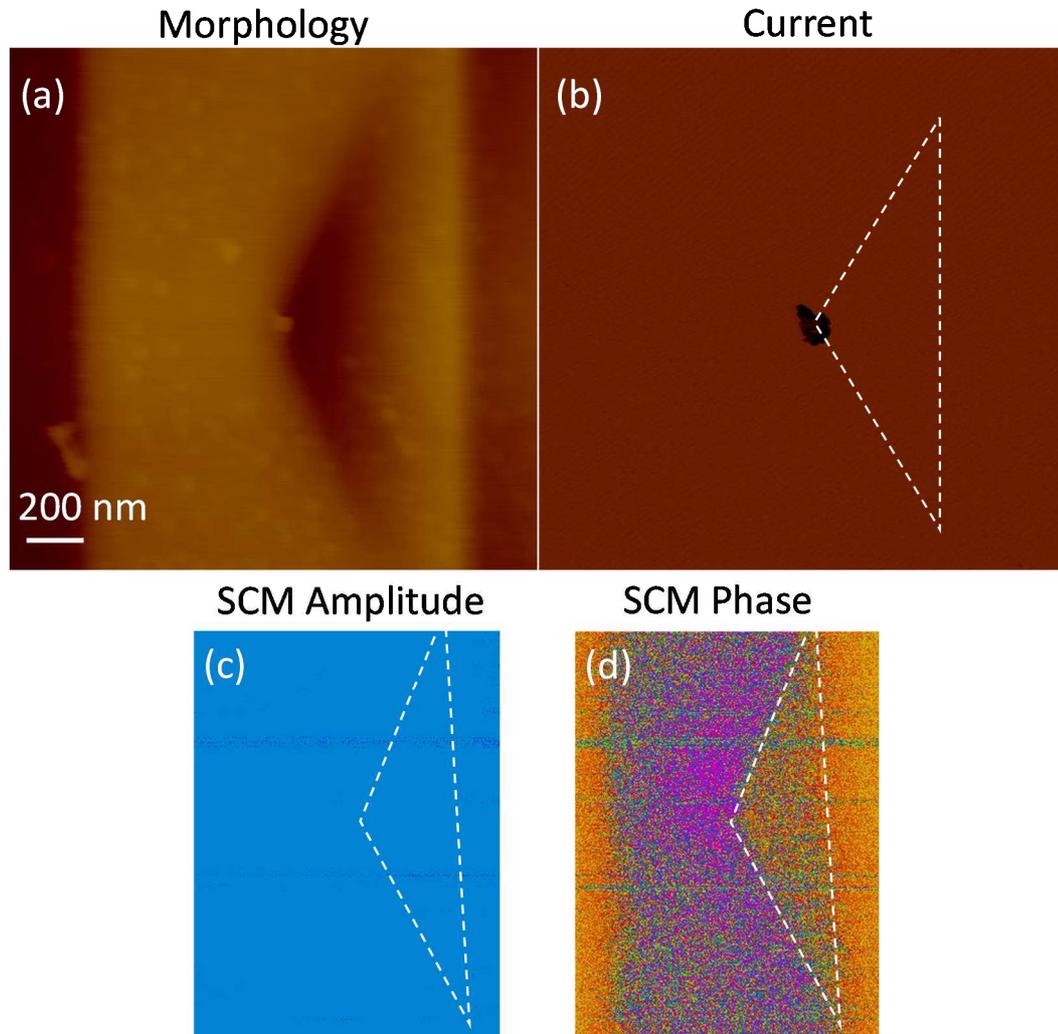
Fig. 4: (a) 4H-SiC AFM morphology in the JFET region (b) C-AFM Current map showing the enhanced conduction in the TD. (c) SCM amplitude showing the homogeneous doping concentration in the triangular defect region. (d) SCM phase showing variation in the triangular defect region.

AFM (Fig. 4a) performed in the JFET region, where the dislocation reaches the surface, allowed to visualize an isosceles triangle with the vertex in the [11-20] direction, about 25 nm deeper than the surface. Moreover, the C-AFM current map (Fig. 4b) showed a homogeneous conductivity on the surface. Noteworthy, the current is at least two orders of magnitude larger on the isosceles triangle vertex, i.e., where the TD is reaching the surface.

SCM collected simultaneously the impedance variation both in amplitude (Fig. 4c) and phase (Fig. 4d). Generally, the SCM signal amplitude is related to the net active dopants concentration in the region underneath the tip, while the phase signal is sensitive to the type carriers in the region underneath the tip. In the present case, the amplitude is not affected by the presence of the triangular defect (Fig. 4c), thus indicating no significant doping variation in the defect region. On the other hand, the SCM phase (Fig. 4d) varies within in the triangular defect region. In general, SCM phase variation suggests a variation of minority carrier concentration (holes) occurred in the investigated (JFET) region. The SCM experimental result agrees with the theoretical calculation provided by *Łazewski et al* [18] that employed density functional theory calculations of the energy levels and the effective band gap of the TD. They have found some localised broad states inside the TD, producing an effective reduction of the semiconductor band gap. This band gap shrinking occurs preferentially pulling up the valence band [18]. Hence, the variation in the valence band edge produces a variation in the generation/recombination of the minority carries in the JFET region where the TD is located and the breakdown occurred. Thus, the holes concentration in the JFET region can be noticeable increased.

The local increase of the holes concentration near the TD can be a source for hot holes injection into the insulator. This suggests that the local variation of the semiconductor electronic properties in the presence of the TD in the JFET region act as an accelerator for the insulator breakdown kinetics.
