Strength, corrosion resistance and cellular response of interfaces in bioresorbable poly-lactic acid/Mg fiber composites for orthopedic applications

Journal of the Mechanical Behavior of Biomedical Materials, accepted for publication.

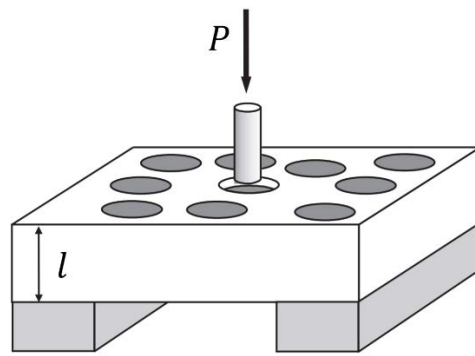
Fig. 1. Schematic of the fiber push-out test

Push-out tests of the fibers were carried out in the thin slices that were placed on a metallic support with a central groove of $\approx 200 \mu\text{m}$ in width (Fig. 1). The fiber to be tested was positioned manually at the center of groove with the help of an optical microscope and loaded in

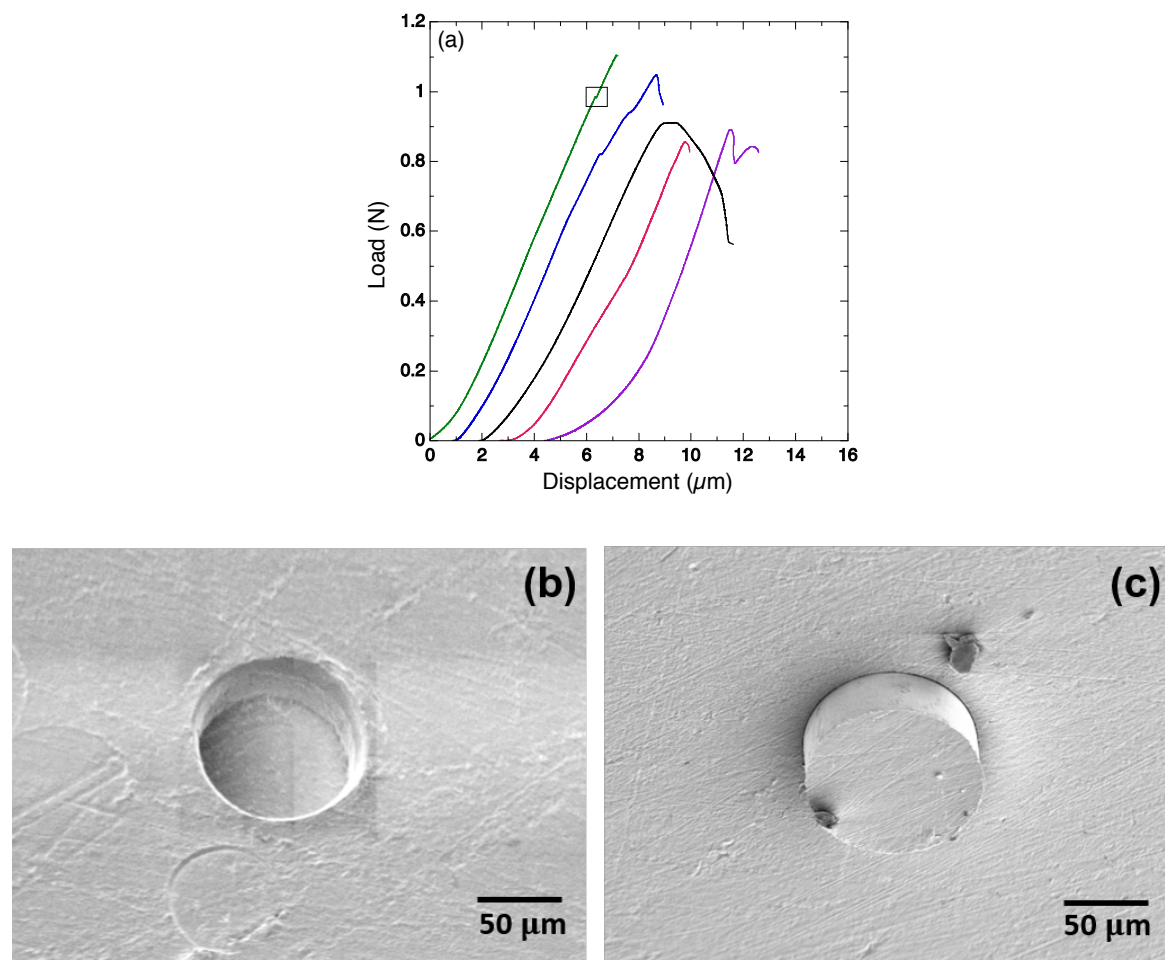
Fig. 2. (a) Representative load-displacement curves of the push-out tests in as-manufactured Mg/PLA composites. (b) Secondary electron SEM image of the top surface of the slice after the push-out test. (c) *Idem* of the bottom surface.

Representative load-displacement curves of five push-out tests on isolated fibers of Mg/PLA composites are plotted in Fig. 2a. The initial shape of the curves was concave due to the elastic bending of the thin slice in the groove of the metallic support and was followed by a linear region with a slope of 200 ± 26 N/mm. The small differences in the slope between fibers could be attributed to the position of the fiber with respect to the groove. Further deformation led to a non-linear behavior which was associated with the progression of crack from the fiber/matrix interface at the bottom of the slice to the top. Other sources of non-linearity observed in push-out tests, such as plastic deformation of the matrix [26] or of the fibers [29] were not found during the visual inspection of the pushed-out fibers (Fig. 2b) and can be neglected due to the small load attained during the tests. The load dropped abruptly to zero after the maximum load was attained as a result of the complete fracture of the interface in shear, which was associated

with push-out of the fiber (Figs. 2b and 2c). It should be noted that the final displacement of the fiber was much larger than the displacement of the indenter at the peak load, indicating a brittle failure mode.

Some push-out curves showed a fluctuation in the load-displacement curve prior to the maximum load, as indicated by the square in Fig. 2a. It has been reported that these events are associated with the nucleation of small cracks at the interface at the bottom of the slice [22].

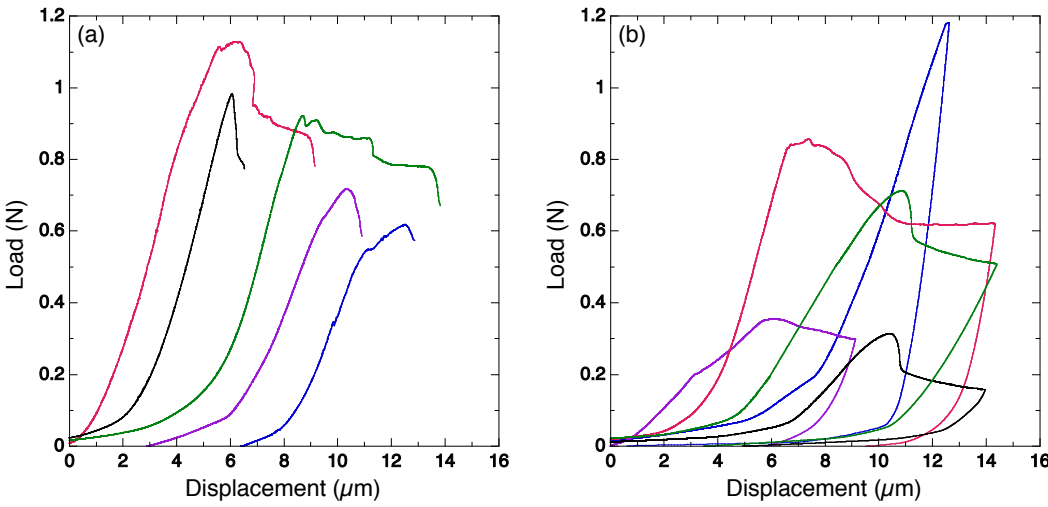
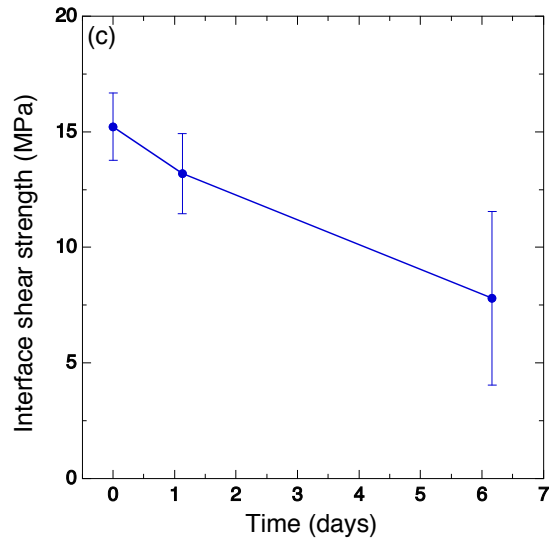
Fig. 3. (a) Load-displacement curves of the push-out tests in Mg/PLA composite after 27 hours immersed in PBS. (b) *Idem* after 148 hours. (c) Influence of immersion in PBS on the interface shear strength in Mg/PLA composites.

The load-displacement curves of the push-out tests in composite plates immersed in PBS during 27 and 148 hours are plotted in Figs. 3a and 3b, respectively. The push-out tests in the samples

immersed for 27 hours showed a more marked concave region at the beginning of the test (as compared with the as-manufactured samples), that could be attributed to uneven surfaces resulting from grinding/polishing because of the deterioration of the composite, indicating that the bending stiffness of the composite plate has decreased significantly. In addition, two samples showed an extended region with constant, negative slope after the peak-load, which was associated with the progressive push-out of the fiber against frictional forces at the broken interface. Nevertheless, interface failure was also brittle in these cases and the fibers protruded from the bottom of the slice at the end of the tests in all samples. The concave region at the beginning of the test and the extended region with negative slope after the peak load were more important in the samples tested after 148 hours in PBS (Fig. 3c). Moreover, the scatter in the shape of the load-displacement curves and in the peak-load increased dramatically due to the localized effects of corrosion. However, fiber pop-out from the bottom surfaces was never observed. Fluctuations in load-displacement curves before peak load were not observed in most of the degraded samples which is an indication of stable crack growth at interface. It should be noted, however, that the large deflection of the samples degraded during 148 h may lead to large normal tensile stresses at interface which could influence the actual value of the interface strength calculated from eq. (1).

The average value (and the corresponding standard deviation) of the interface shear strength according to eq. (1) is plotted in Fig. 3c as a function of the immersion time in PBS. The reduction in shear strength is very fast and is close to 50% of the initial value after just 6 days.

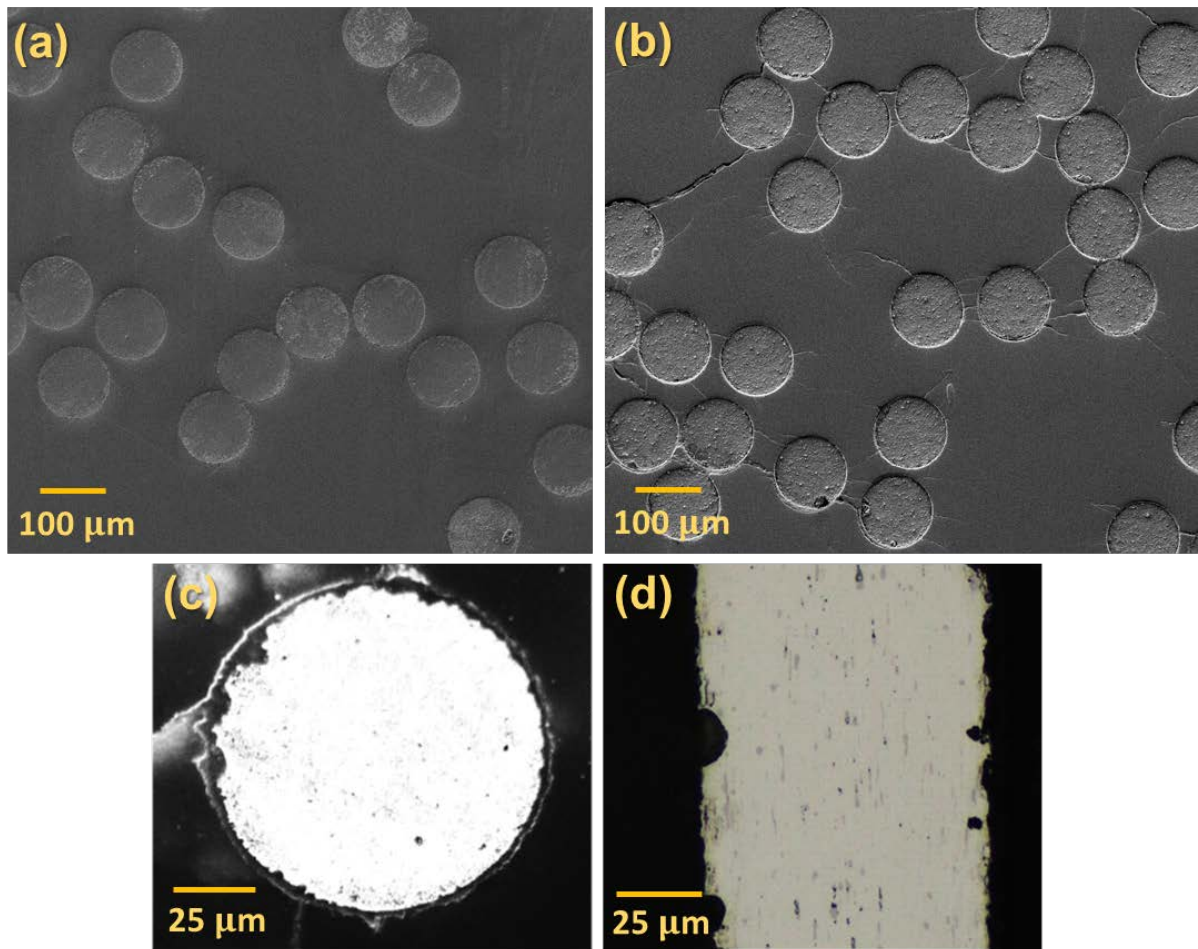
Fig. 4. Microstructure of the Mg/PLA composite (a) before immersion and (b) after 148 hours of immersion in PBS showing fiber pitting and matrix cracking. (c) Optical micrograph of the cross-section of a degraded fiber. (d) Optical micrograph of the longitudinal section of a corroded fiber.

The cross-sections of the composite before (Fig. 4a) and after (Fig. 4b) immersion in PBS during 148 h at 37°C are shown in the SEM image in Figs. 4a and 4b, respectively. Damage is localized at the fiber/matrix interface in the form of corrosion pits in the Mg fibers, which can be seen in the fiber cross-sections perpendicular (Fig. 4c) and parallel (Fig. 4d) to the fiber axis, as well as matrix cracks that tend to link adjacent fibers. The map of the distribution of different chemical elements in the composite cross-section, obtained by energy-dispersive X-ray spectroscopy, is shown in Fig. 5. An oxygen-rich corrosion layer is found at the fiber/matrix interface and sometimes also within the matrix cracks that link the fibers. Traces of Y can also be found in this layer.

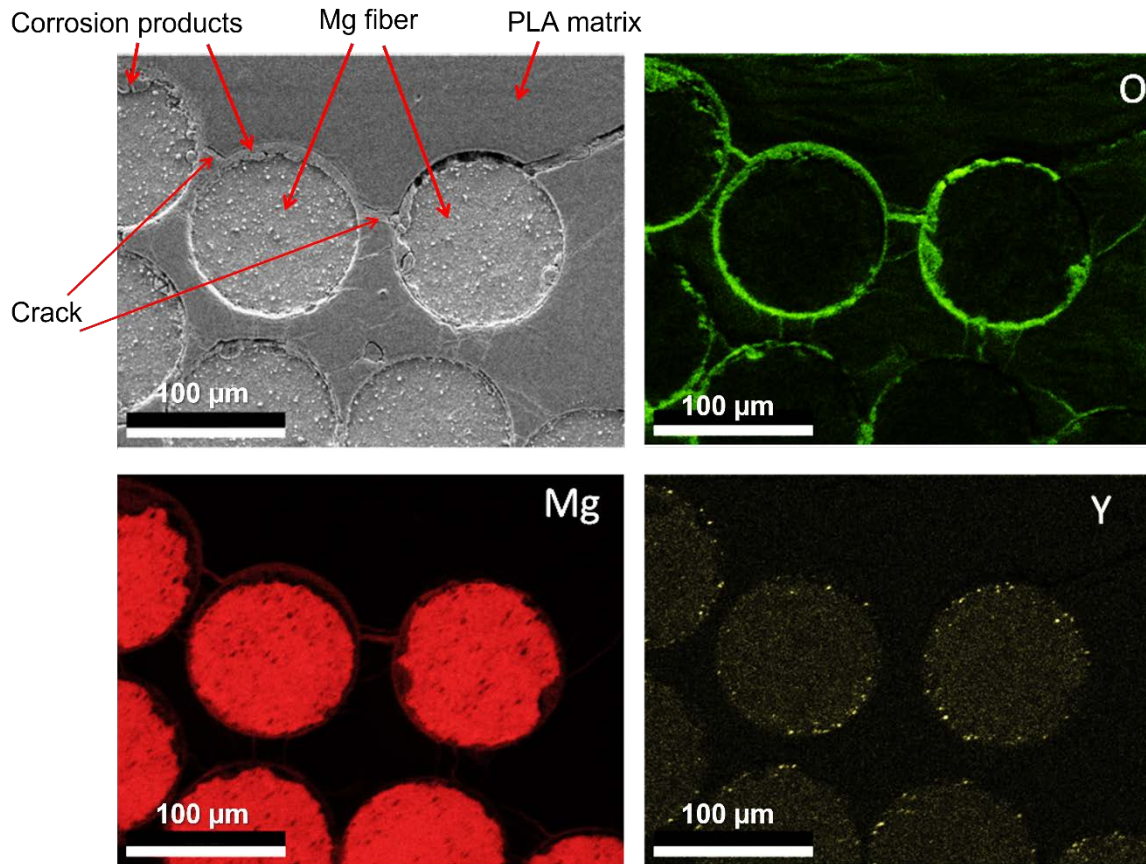
Fig. 5. (a) Secondary electron SEM micrograph showing the details of corrosion at the fiber/matrix interface after 148 h in PBS at 37°C. (b-d) Element map of O, Mg and Y obtained by energy-dispersive X-ray spectroscopy.

and, according to eq. (2), failure of the PLA at the interface will take place when the corrosion layer reaches $\approx 1.44 \mu\text{m}$. Eq (3) takes into account that the compressive stresses in the radial direction at the interface may induce additional stress concentrations in an incipient radial crack emanating from the corrosion layer. The radial cracks in the PLA facilitate the penetration of water to the interface, leading to pitting corrosion of the fibers and to the fast degradation of the composite because the PLA matrix no longer protects the fiber from corrosion. Further fiber degradation leads to the opening of the cracks in the PLA, which are eventually filled with corrosion products, as shown in Fig. 5.

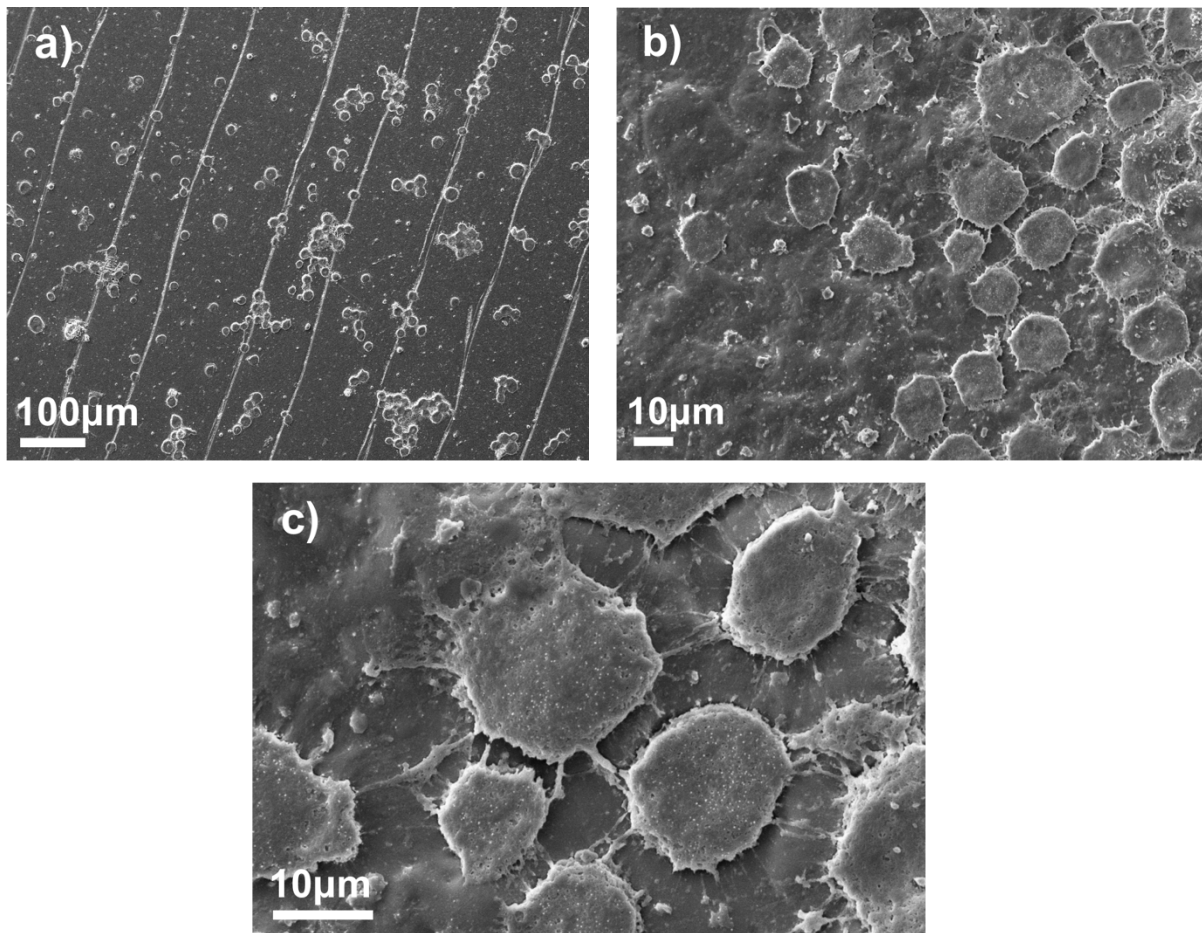
Fig. 6. SEM micrographs of the MC3T3-E1 pre-osteoblasts deposited on the longitudinal surface of the composite (a,b). Cells attached to PLA showed a round shape and close cell-cell and cell-material contact due to filipodia structures (c).

Cells were deposited on the longitudinal and transversal surfaces on the Mg/PLA composites. They were in contact with the PLA in the longitudinal surface and with Mg and PLA in the transversal one. The cells deposited on the longitudinal surface of the composite grew uniformly on the PLA, as it can be seen in SEM micrographs at different magnifications (Figs. 6a and 6b). The lines on the surface of the longitudinal samples are a result of the cutting process (Fig. 6a) and the cells align and respond to this pattern at the microscale. Nevertheless, cells were able to grow homogeneously on the longitudinal surface of the samples made up by PLA. Moreover, they showed a round shape and close cell-cell and cell-material contact due to filipodia structures (Fig. 6c), which indicates a strong attachment of the cells to the surface. A reduction in the number of cells was observed, however, in the transversal cross-section (Fig. 7a).

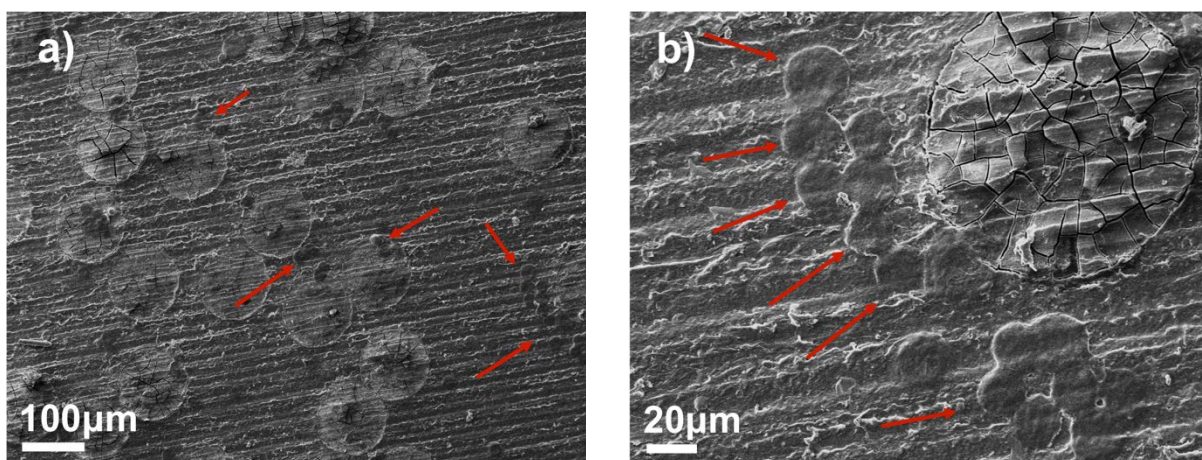
Fig. 7. (a, b) SEM micrographs of MC3T3-E1 pre-osteoblasts deposited on the transversal surface of the composite. Cells are indicated with red arrows, while fibers show a circular shape with 100 μm in diameter. Cells were mainly attached to the PLA but not to the Mg fibers.

Moreover, the cells were attached to the PLA but not to the Mg fibers, which showed evidence of the build-up of corrosion products thwarting adhesion (Fig. 7b).

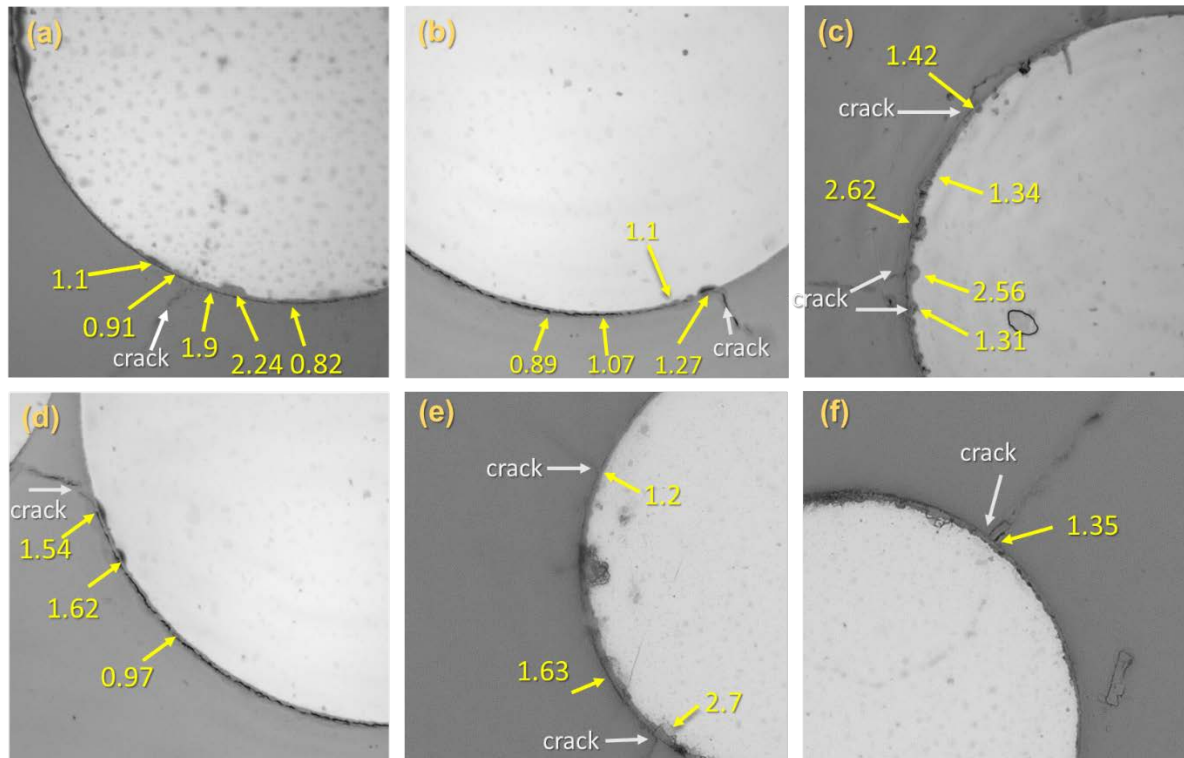
Fig. 8. (a - f) Optical micrographs showing small cracks in the PLA in the samples immersed in PBS for 27 h. The thickness of the corrosion layer in the Mg fibers at these locations was measured and the corresponding values (in μm) are indicated in the figure.

In order to validate the results of the analytical model, a number of small cracks in the PLA, emanating from the Mg fibers, were selected in the cross-section of the sample immersed in

PBS during 27 h. The thickness of the corrosion layer on the fiber was measured at these crack locations, as shown in Fig. 8. They were in the range 1.0 to 1.5 μm , in agreement with the predictions of the theoretical model.

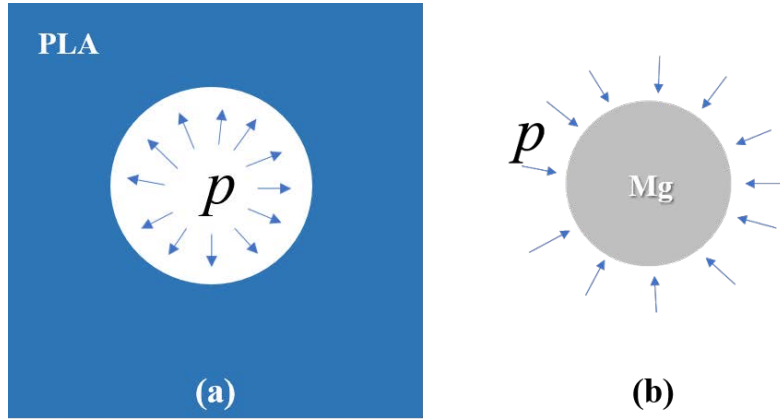
Fig. A1. Schematics of the thermo-elastic problems. (a) Cylindrical cavity subjected to an uniform internal pressure $-p$. (b) Cylindrical fiber subjected to an uniform lateral pressure $-p$.

A simplified thermo-elastic analysis is presented to determine the stresses in the PLA matrix at the interface with a circular Mg fiber as a result of the thermal expansion mismatch between matrix and fibers and of the expansion of the corrosion products in an annular region of the fiber of thickness e_0 . The circular fiber of radius R is embedded in an infinite matrix and the thermo-elastic problems of a cylindrical cavity subjected to an uniform internal pressure p (Fig. A1a) and of a cylindrical fiber subjected to an uniform lateral pressure p (Fig. A1b) are solved independently.

The elastic solution of the cylindrical cavity subjected to an internal pressure P can be found in the literature [1]. The radial (σ_r) and circumferential (σ_θ) stresses in the matrix decrease with R^{-2} and they are maximum at $r=R$

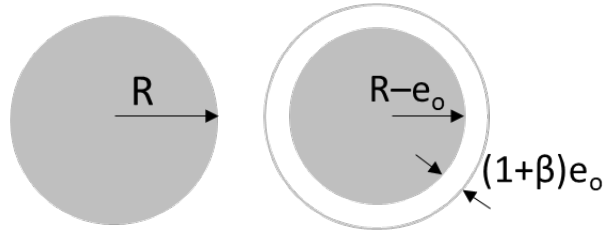
Fig. A2. Schematic of the change in the fiber radius due to the transformation of a layer of Mg of thickness e_0 in $Mg(OH)_2$.

During the uniform corrosion of the fiber, a layer of Mg of thickness e_0 is transformed in $Mg(OH)_2$, but the volume expansion associated with corrosion leads to a layer of corroded material of thickness $e = (1 + \beta)e_0$ (Fig. A2). β stands for the linear expansion coefficient due to the formation of the corrosion products. It can be determined as one third of the total increase in volume when one mol of Mg ($m_{Mg} = 24.3$ g) is transformed in one mol of $Mg(OH)_2$ ($m_{Mg(OH)_2} = 58.42$ g) as
